Guelph Innovation District (GID) Lands, Blocks 1 & 2

Geotechnical Investigation Report

328 Victoria Road South and 588 Stone Road East,
Guelph, Ontario

MTE File No.: 46927-104

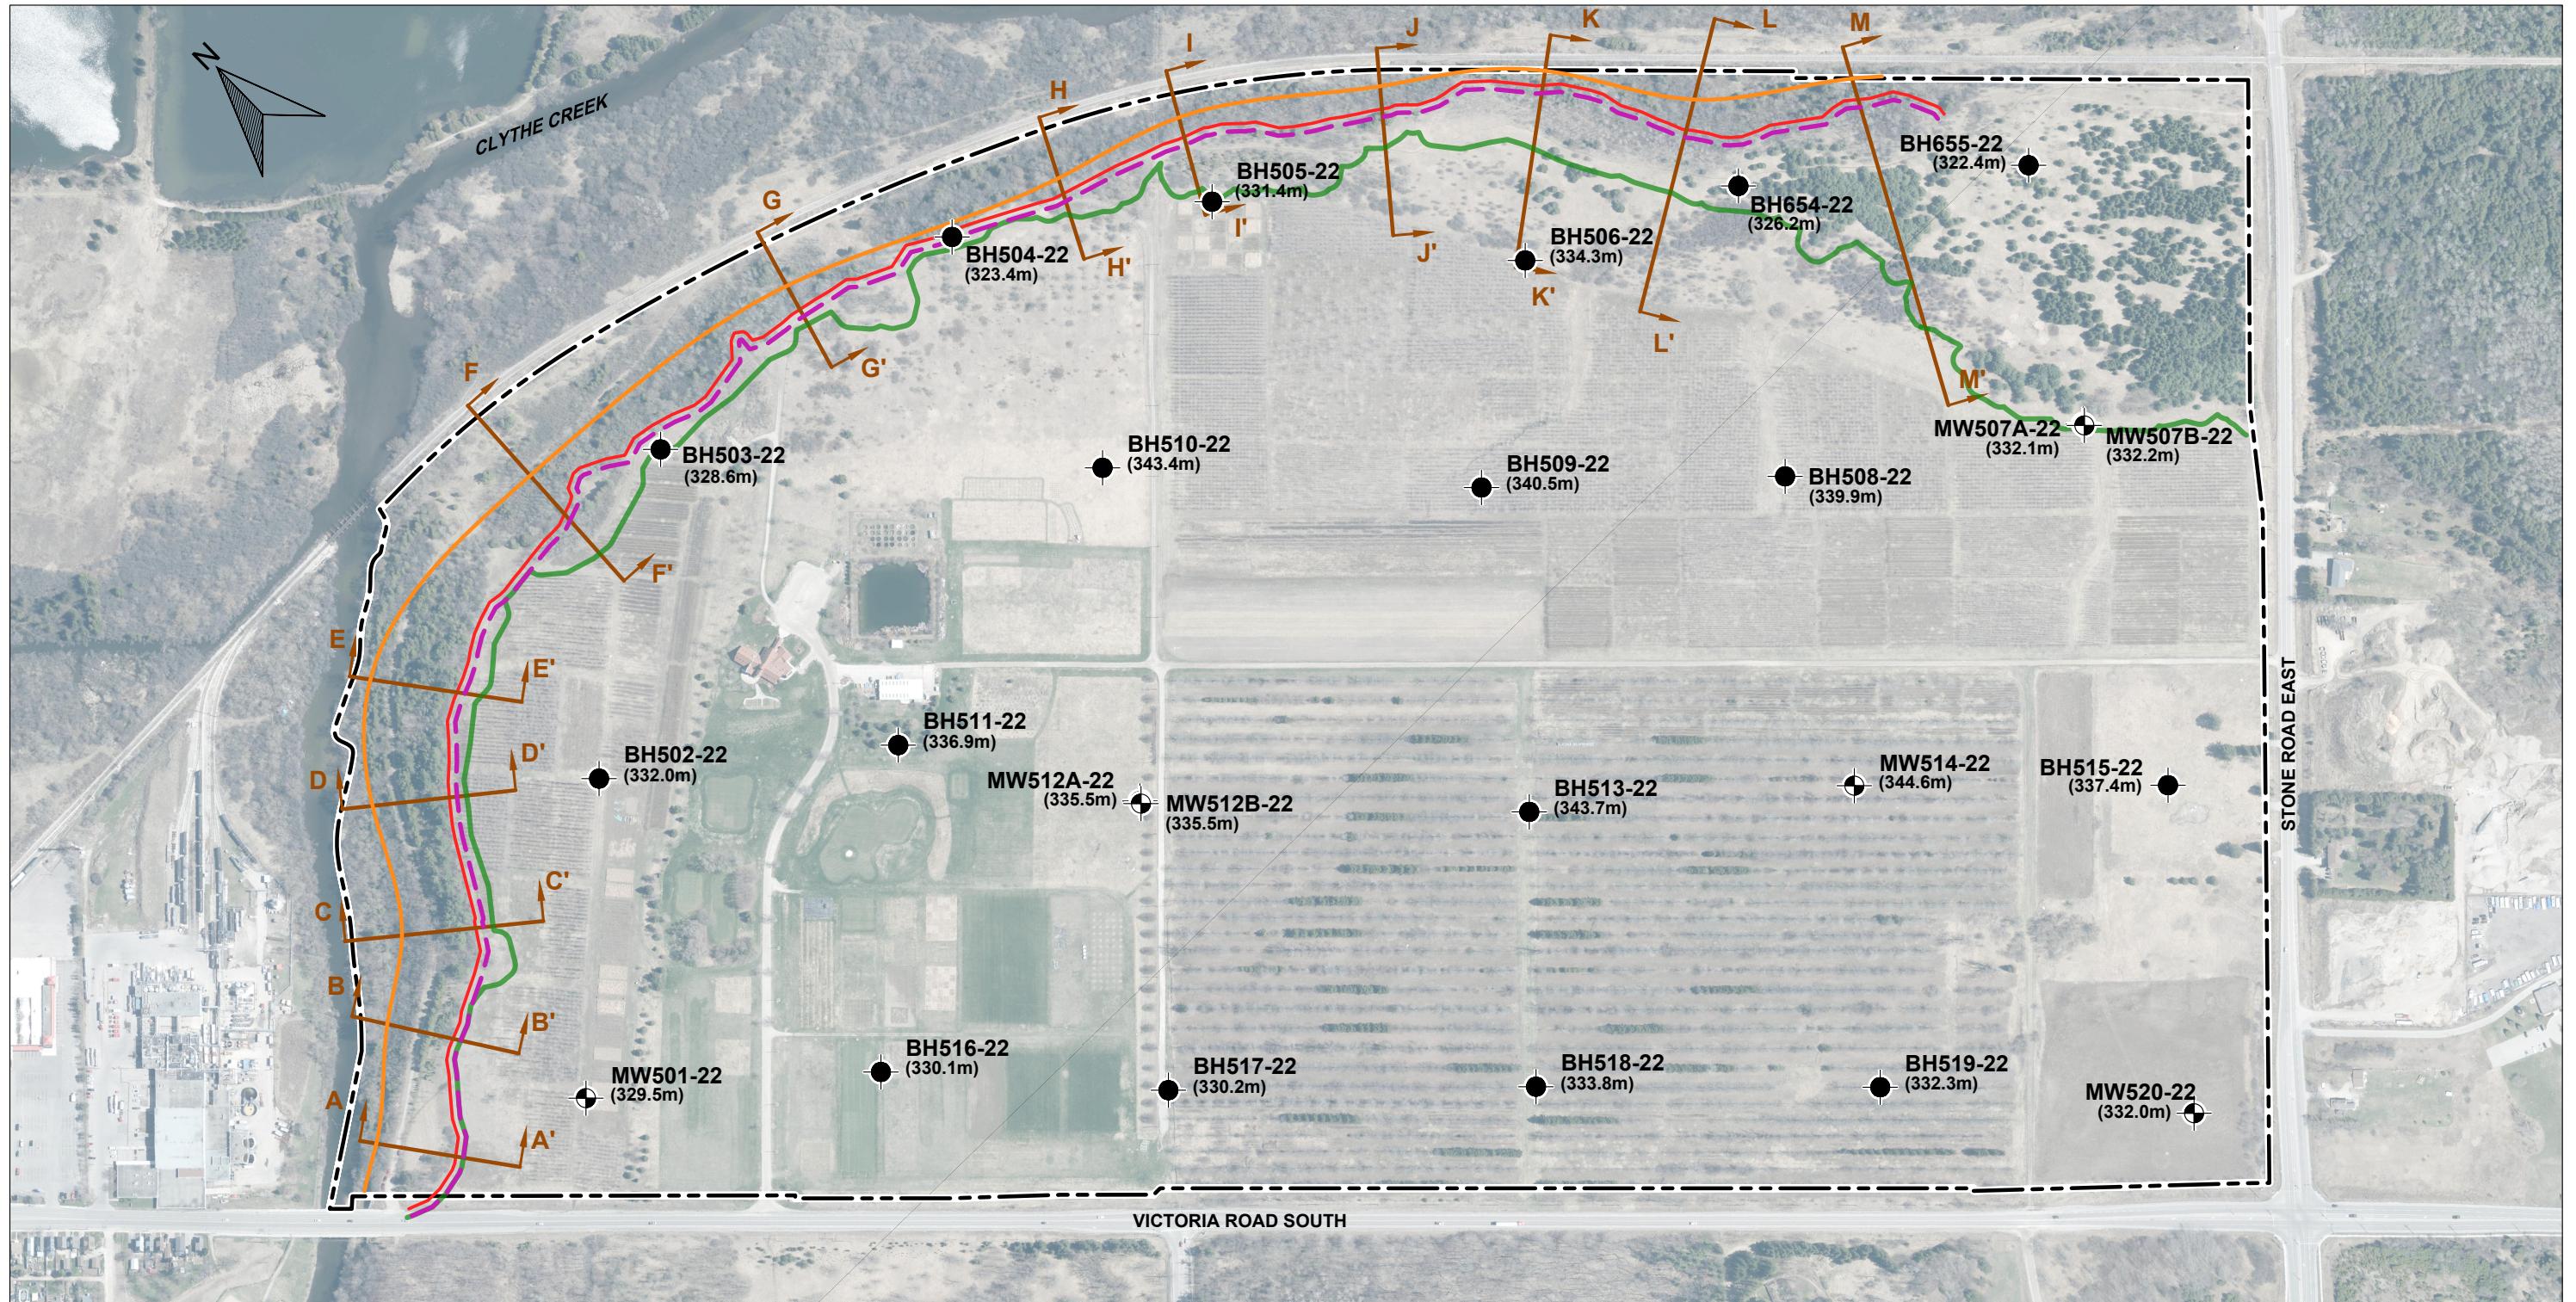
FIGURE 1

PROJECT			
GEOTECHNICAL INVESTIGATION			
GUELPH INNOVATION DISTRICT LANDS			
588 STONE ROAD EAST			
GUELPH, ONTARIO			
TITLE			
SITE PLAN			
Drawn	DCH	Scale	AS SHOWN
Checked		Project No.	46927-104
Date	March 11/25	Rev No.	0

For the near vertical to vertical exposed bedrock faces, it is MTE's recommendation that a FOS of 1.5 would be achieved with a setback of 1.0 horizontal to 1.0 vertical (1.0H to 1.0V). The stable slope line incorporating the 1.0H to 1.0V setback is illustrated on **Figure 1**.

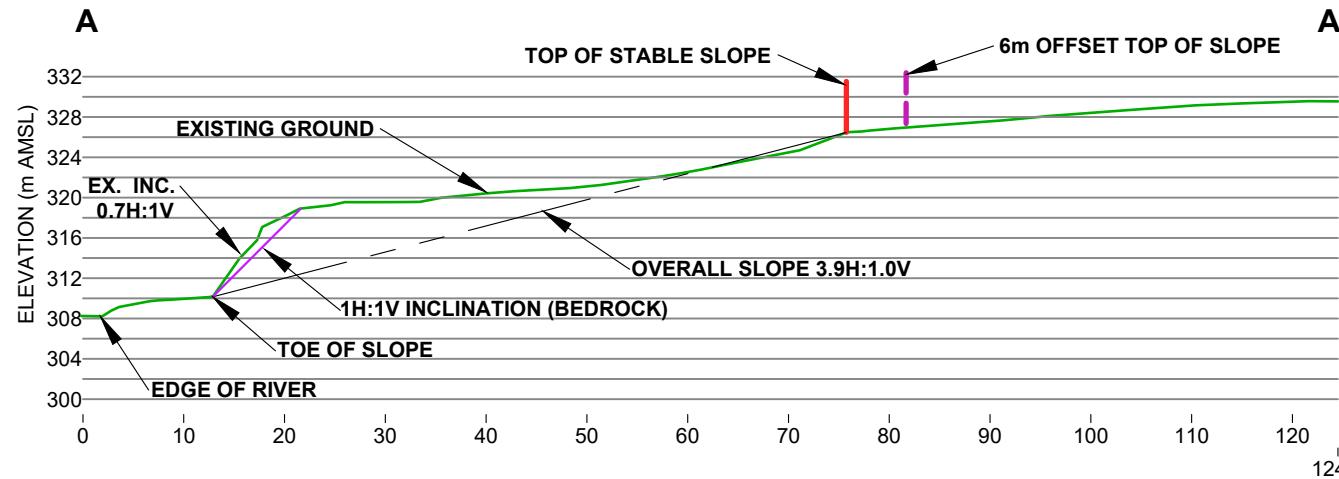
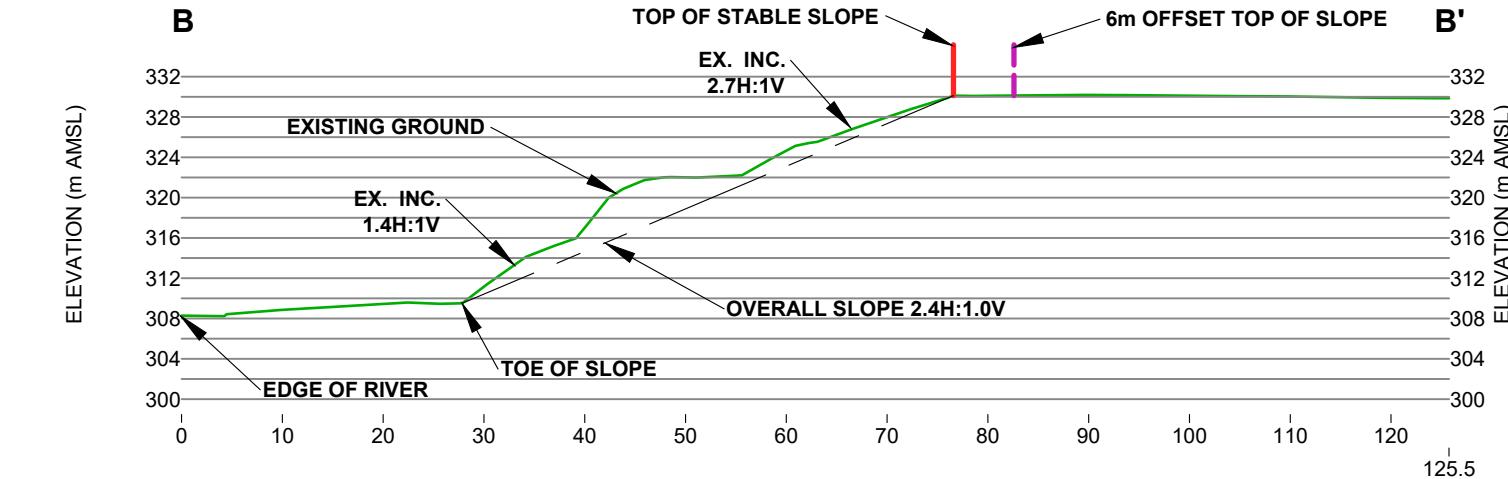
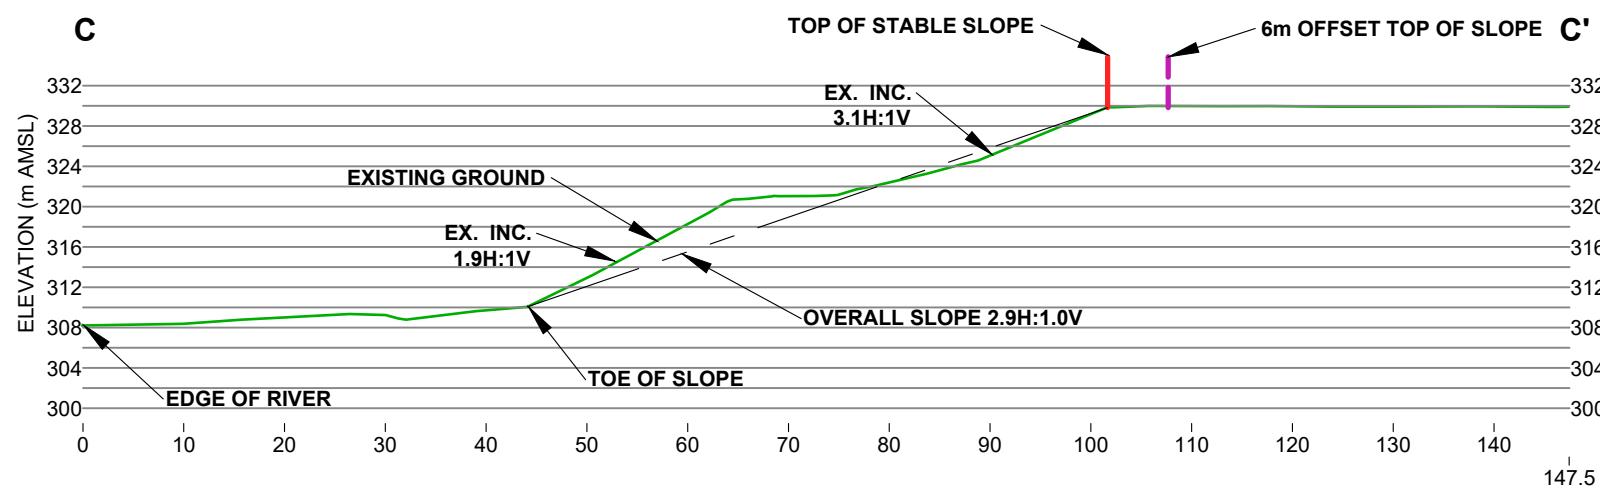
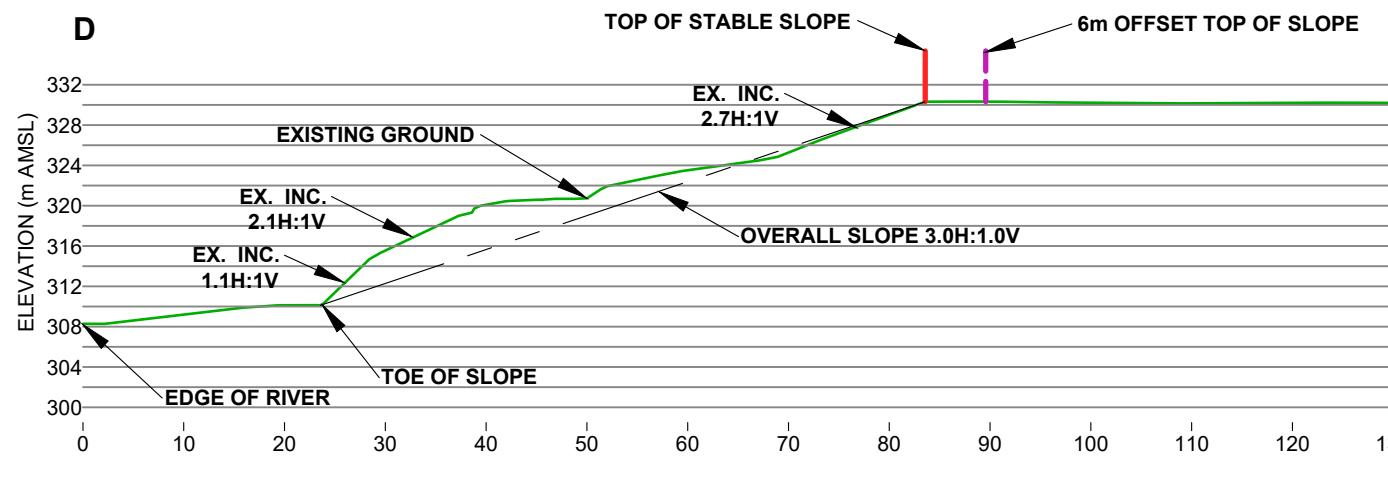
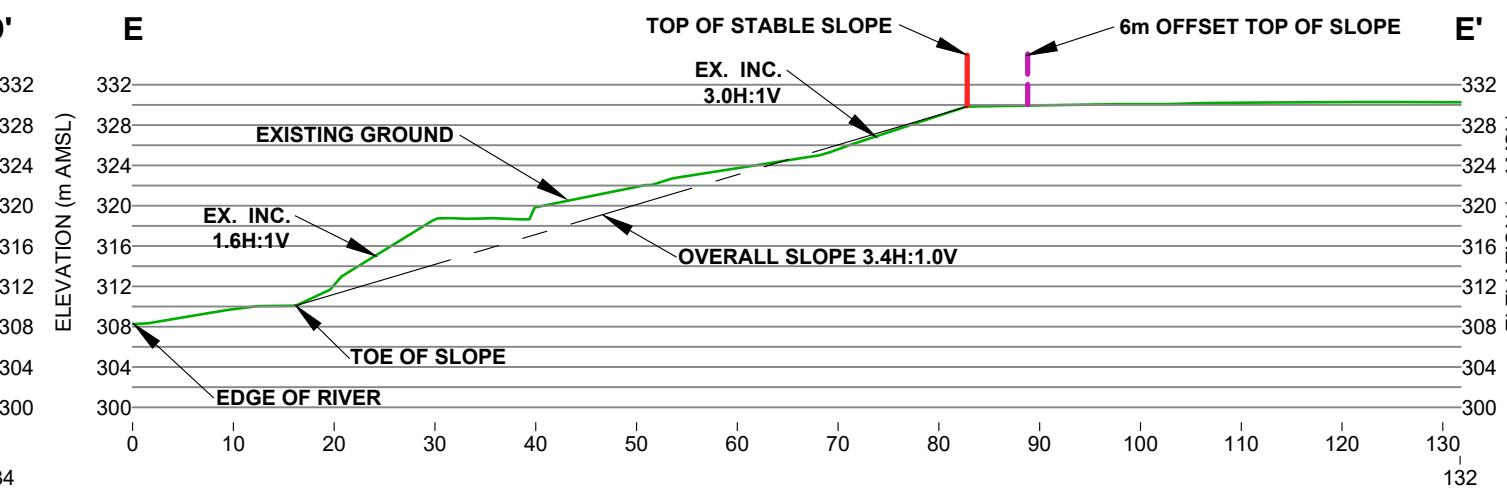
FIGURE 2

MTE <small>Engineers, Scientists, Surveyors</small>		PROJECT	
		GEOTECHNICAL INVESTIGATION	
GUELPH INNOVATION DISTRICT LANDS		588 STONE ROAD EAST	
GUELPH, ONTARIO		TITLE	
CROSS-SECTIONS		A to E	
Drawn	DCH	Scale	AS SHOWN
Checked		Project No.	46927-104
Date	March 11/25	Rev No.	0

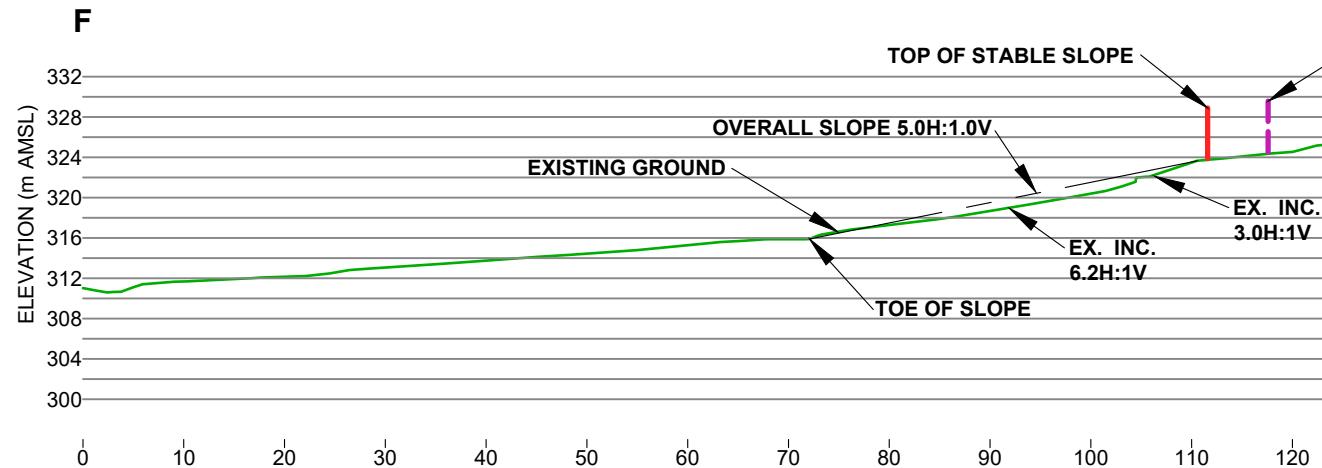
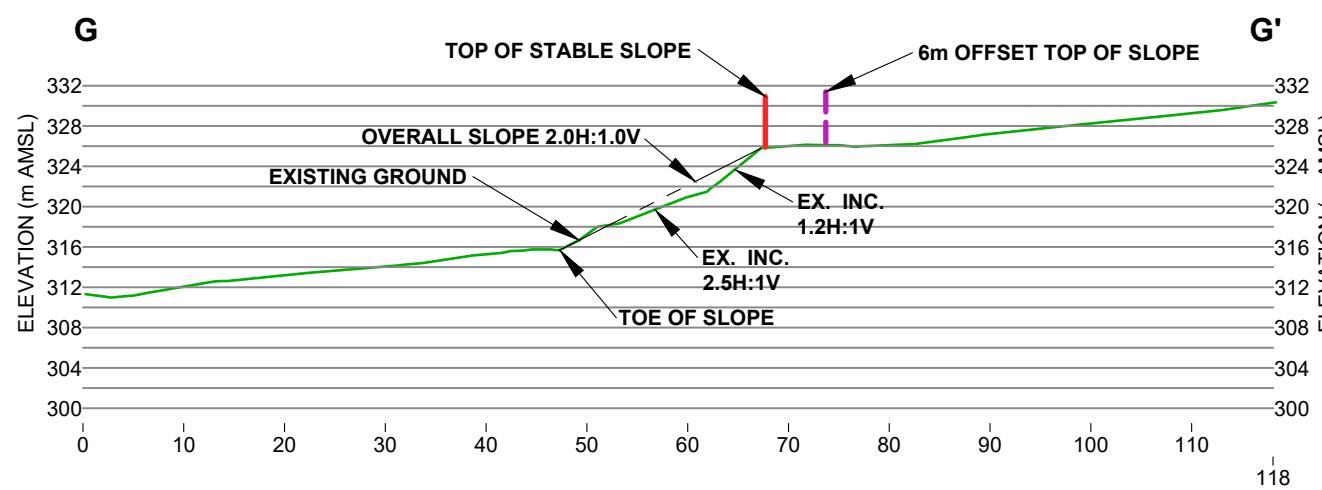
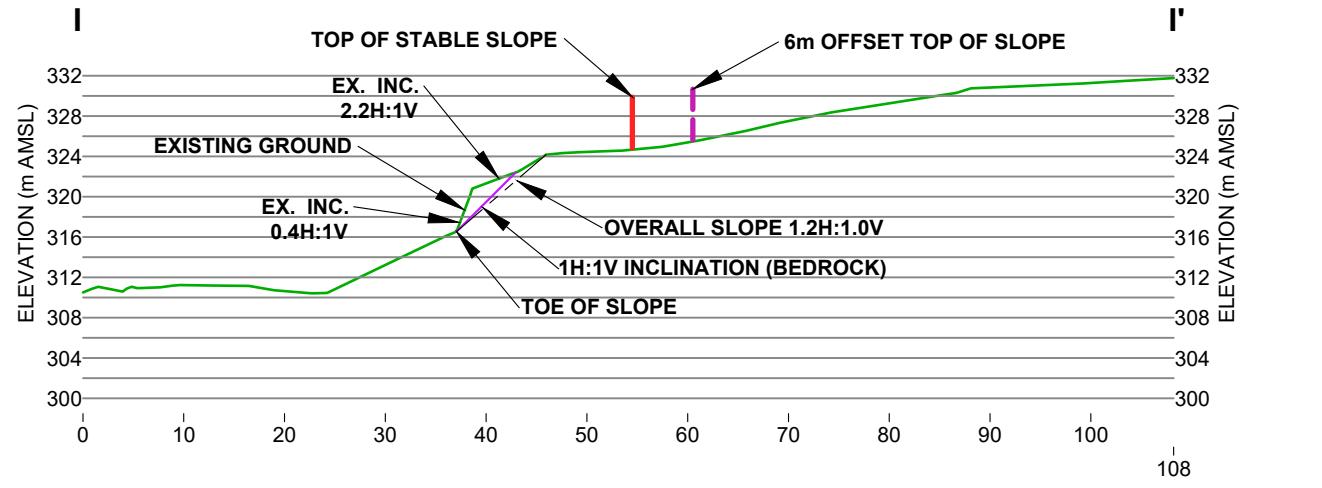
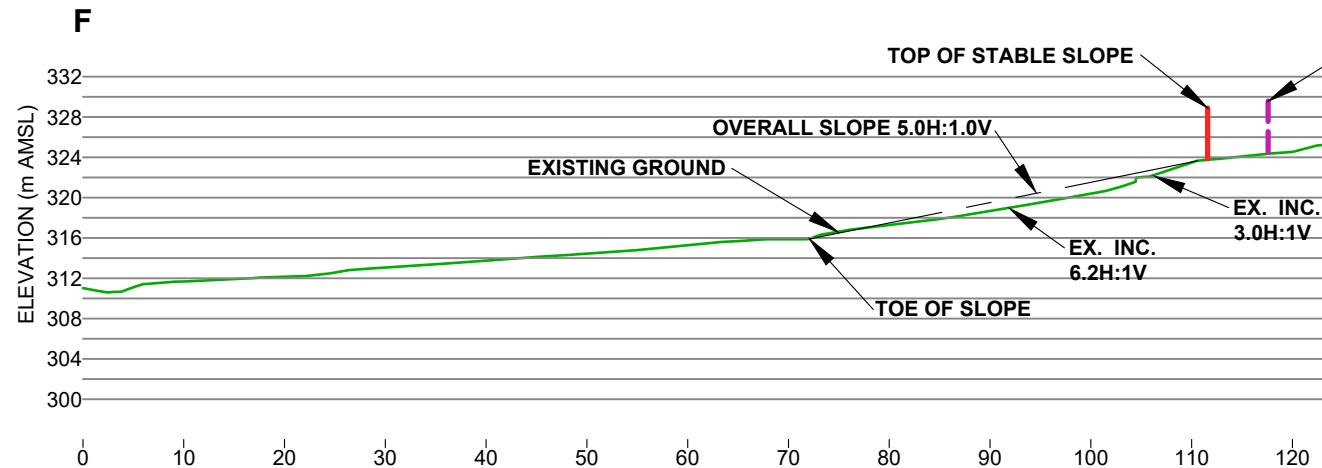
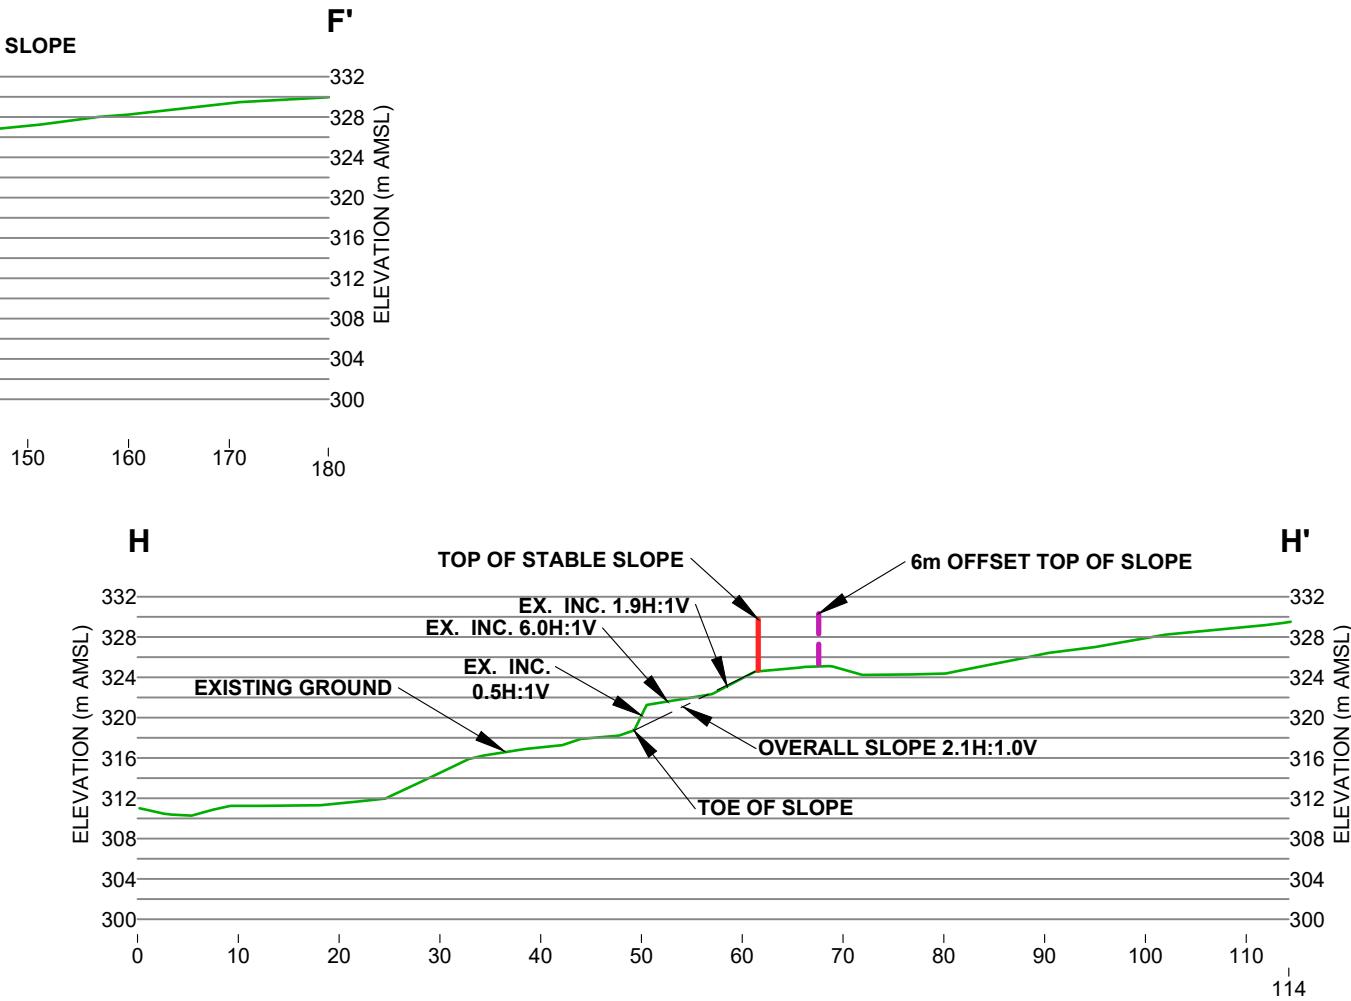
FIGURE 3

Engineers, Scientists, Surveyors		PROJECT	
		GEOTECHNICAL INVESTIGATION	
GUELPH INNOVATION DISTRICT LANDS			
588 STONE ROAD EAST			
GUELPH, ONTARIO			
TITLE			
CROSS-SECTIONS			
F to I			
Drawn	DCH	Scale	AS SHOWN
Checked		Project No.	46927-104
Date	March 11/25	Rev No.	0

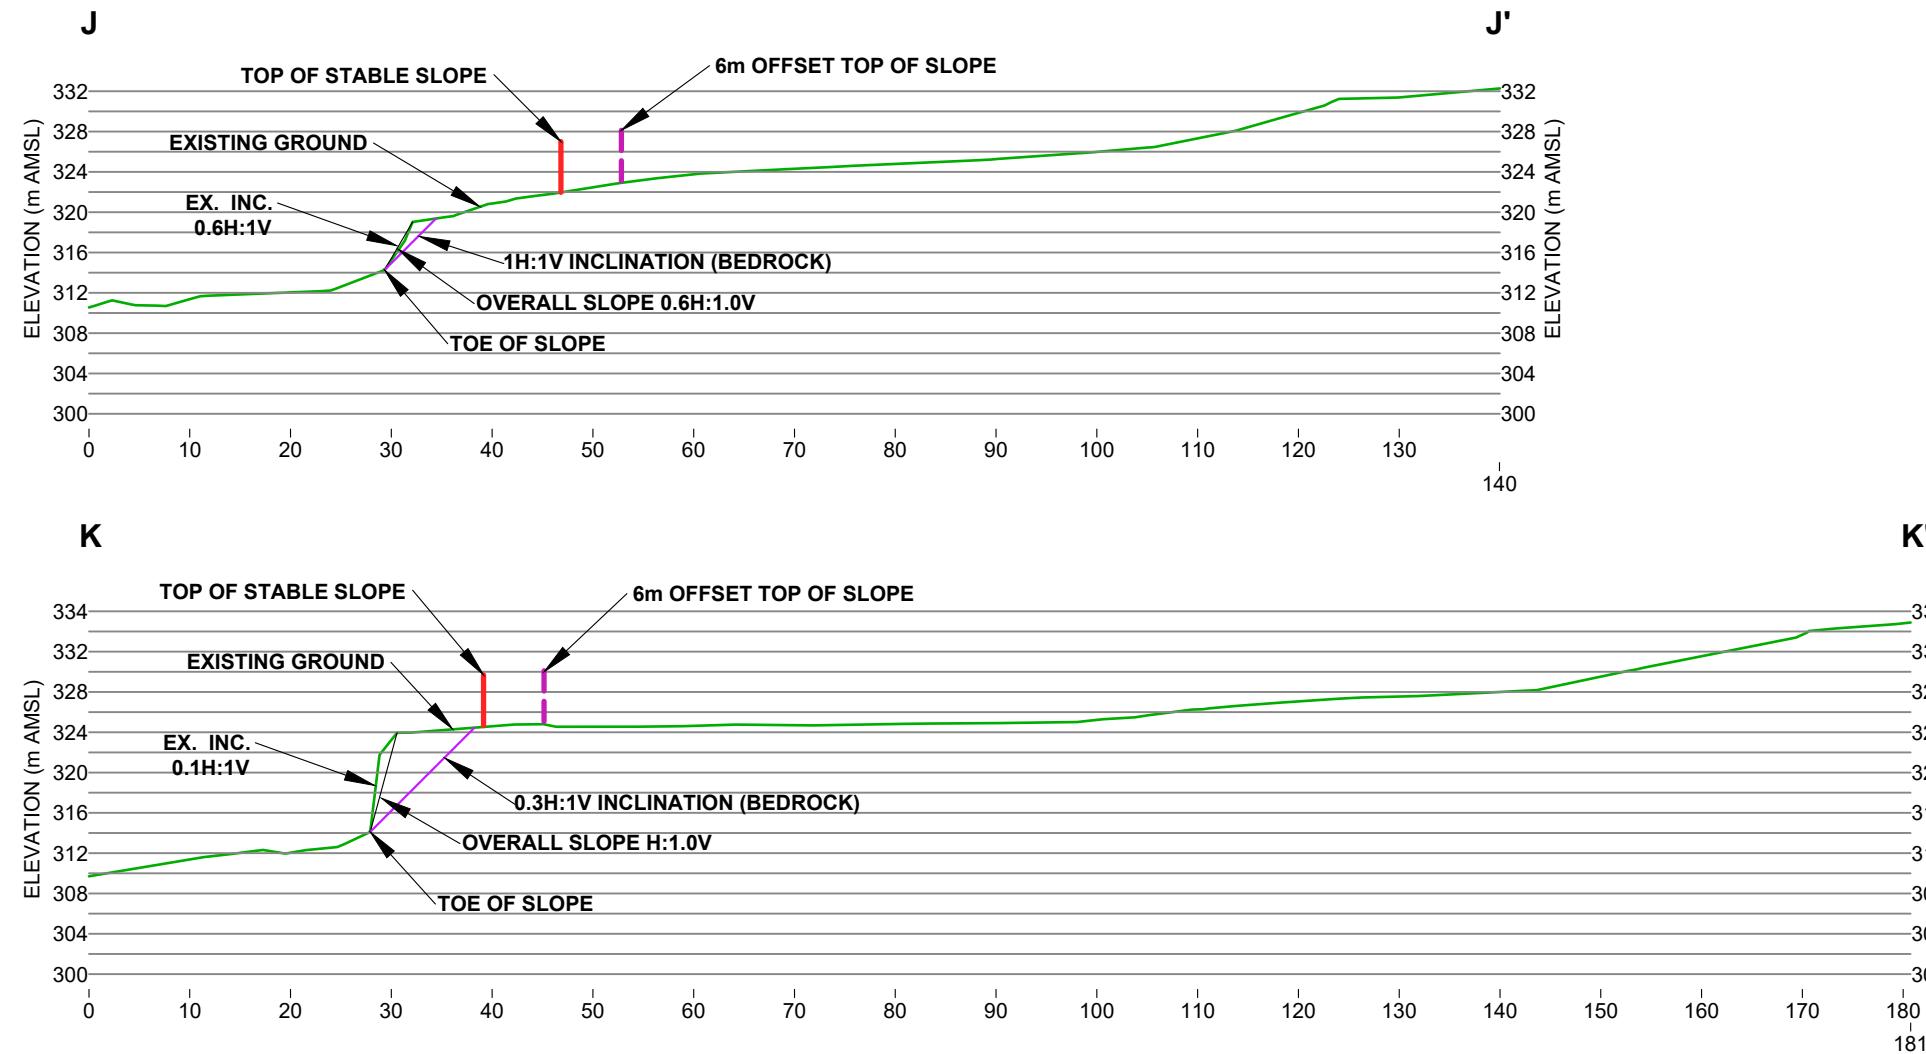
FIGURE 4

Figure 4 – Cross Sections J to K

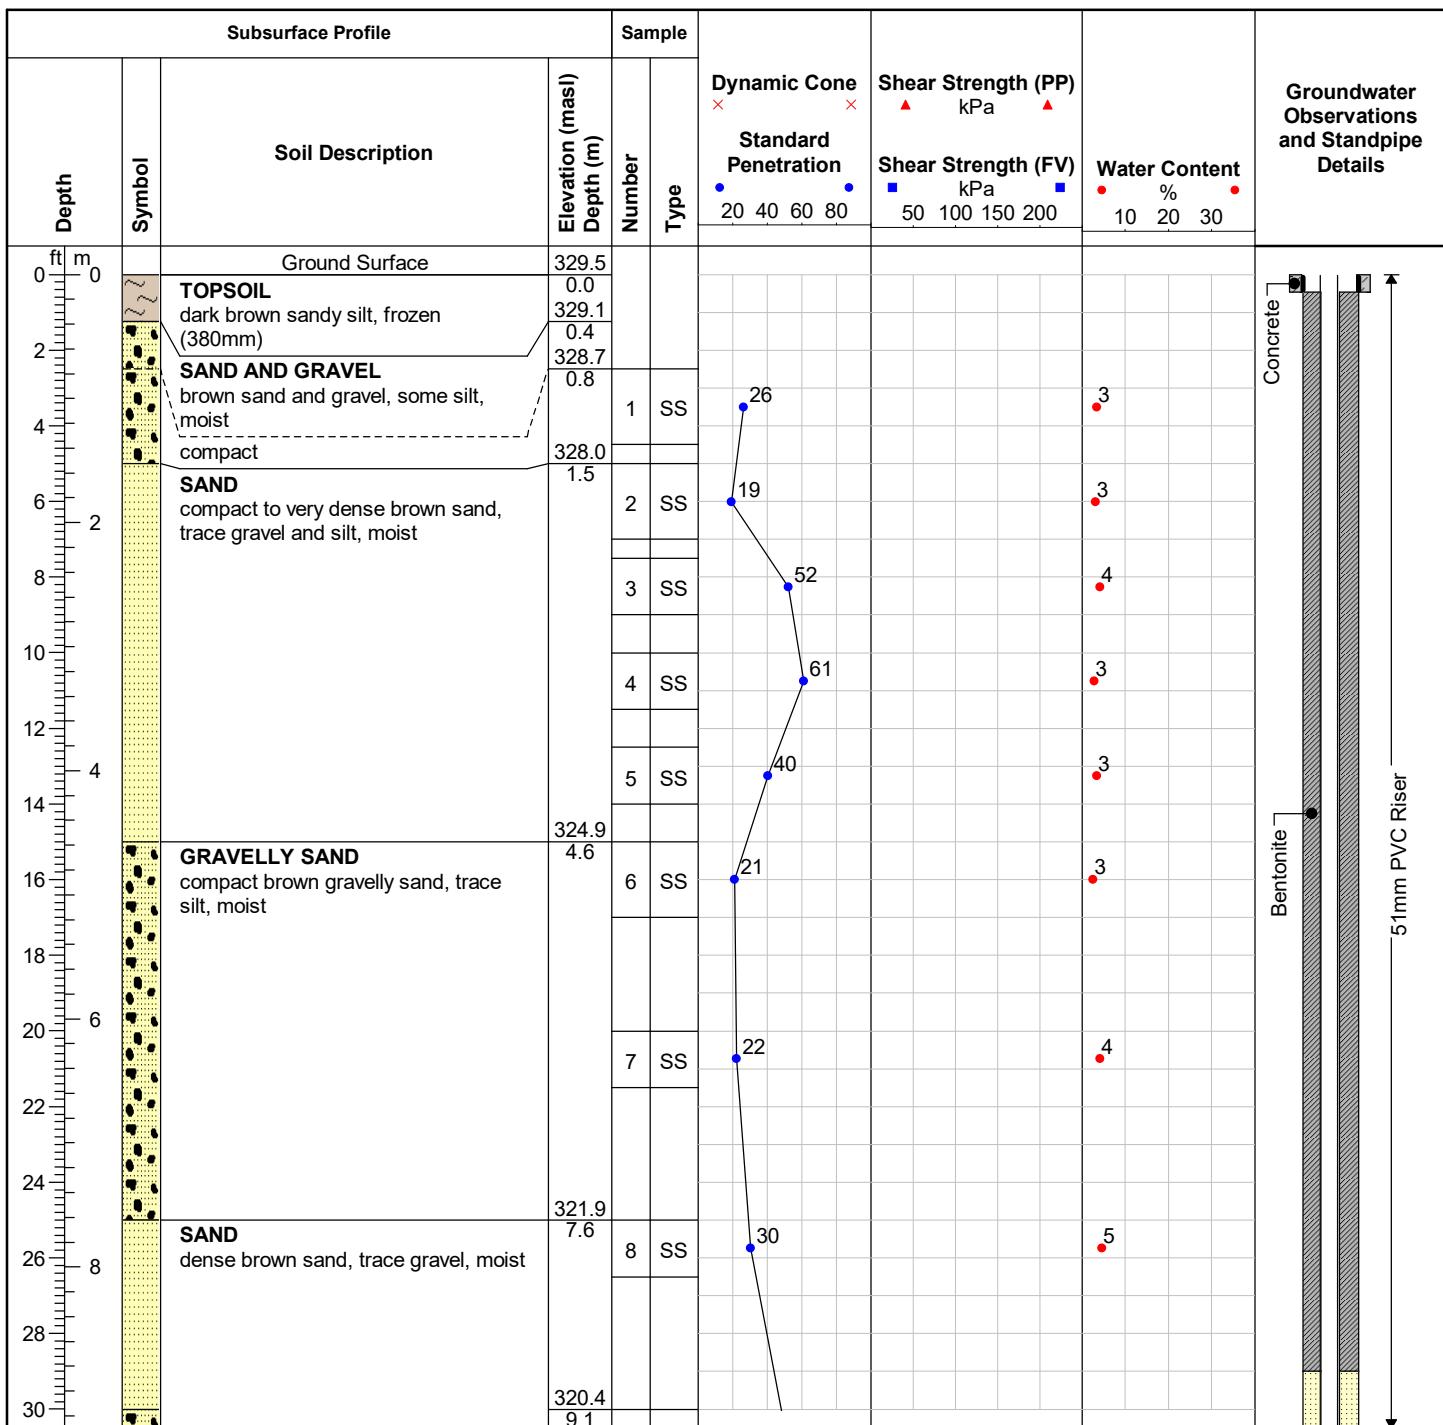
ID No.: MW501-22**Project Name:** Guelph Innovation District Lands**MTE File No.:** 46927-104**Client:** Fusion Homes**Site Location:** 588 Stone Road East, Guelph, ON**Date Completed:** 2/28/2022**Drilling Contractor:** Envirocore**Drill Rig:** D50T Track Mounted**Drill Method:** Hollow Stem Augers**Protective Cover:** Monument Casing

Auger refusal at 11.1mbgs on suspected bedrock.
Borehole dry upon drilling completion.
Well dry on March 8, 2022.

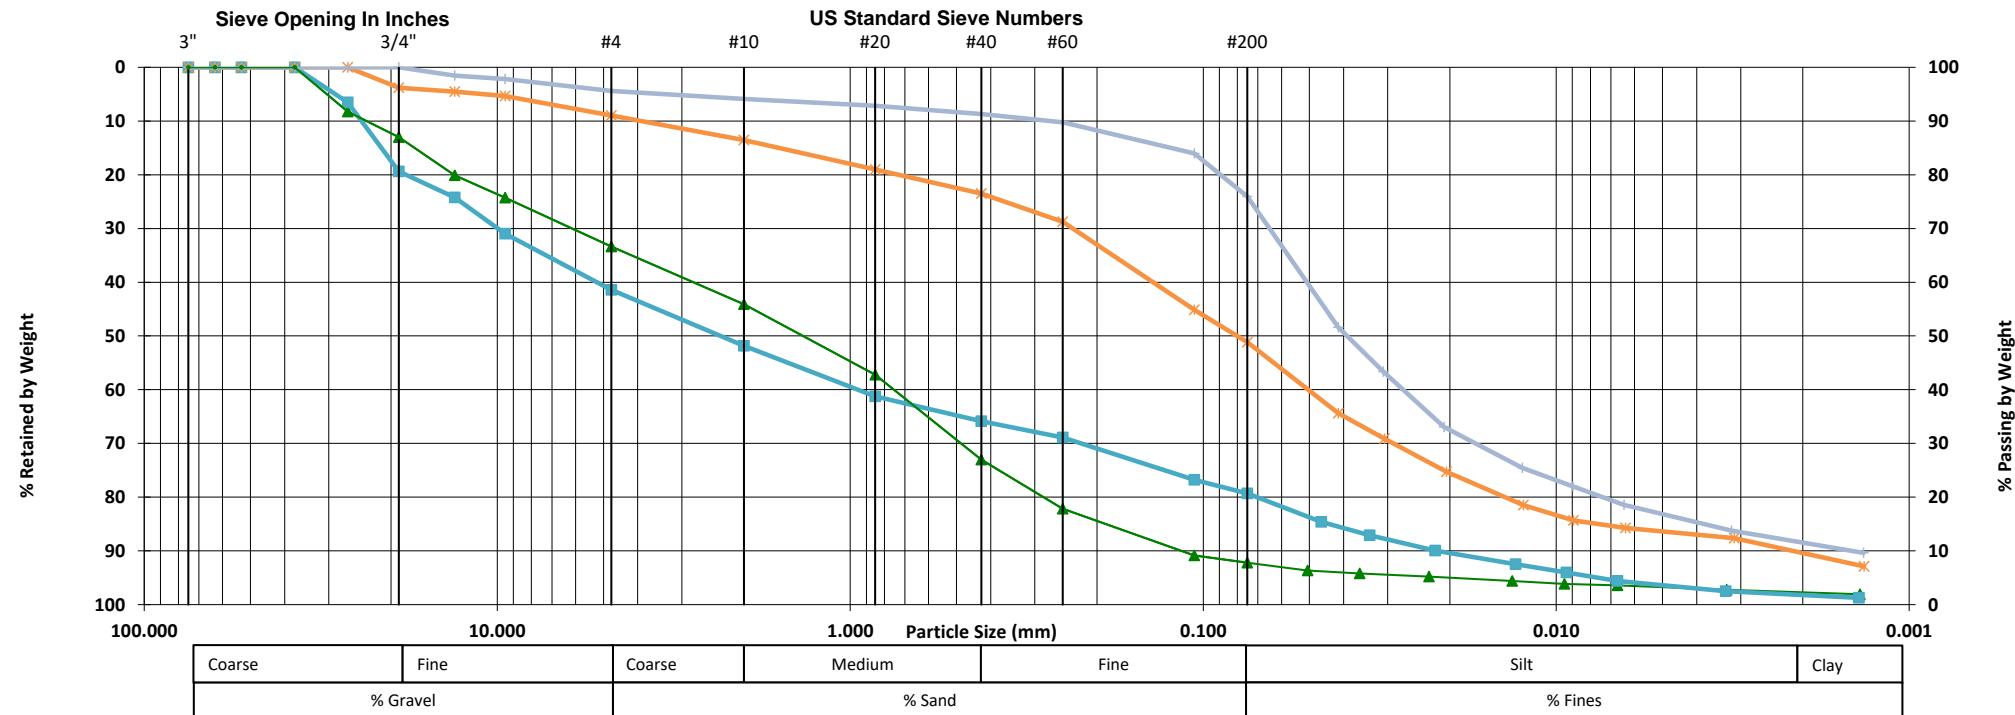
Symbol	Borehole ID	Sample #	Sample Depth	Description
▲	MW501-22	SS-3	2.3-2.9 mbgs	Gravelly SAND, trace Silt and Clay
■	MW501-22	SS-9	9.1-9.8 mbgs	GRAVEL and SAND, some Silt, trace Clay
✳	MW507-22	SS-6	4.6-6.1 mbgs	SAND and SILT, trace Clay and Gravel
✚	MW512-22	SS-7	6.1-6.7 mbgs	SILT, some Sand and Clay, trace Gravel

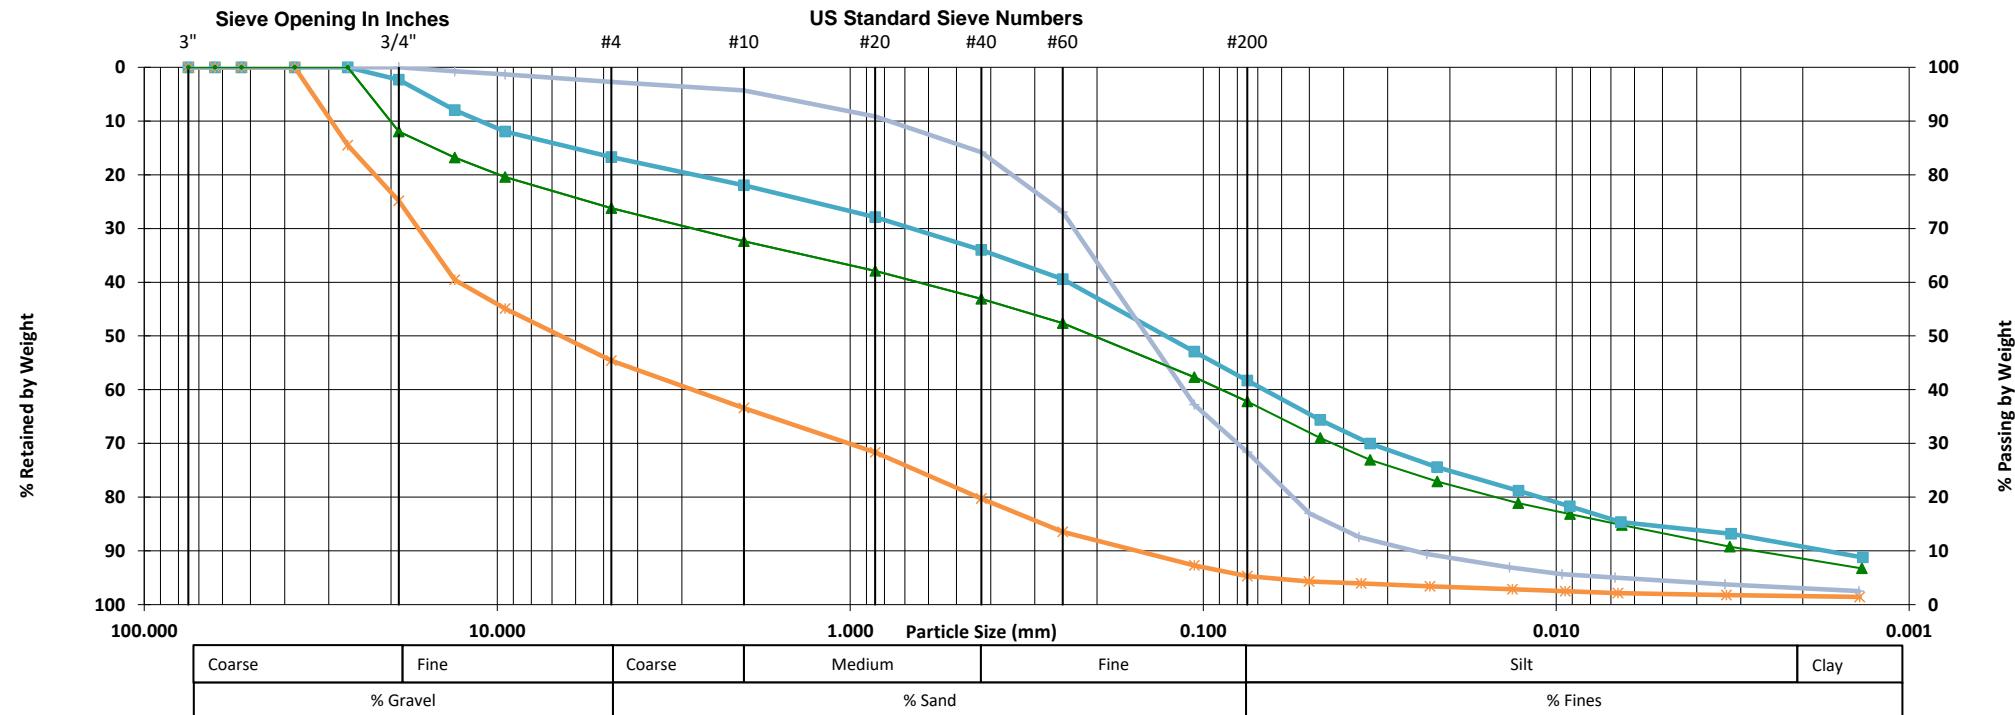
Symbol	Borehole ID	Sample #	Sample Depth
▲	MW514-22	SS-7	6.1-6.7 mbgs
■	MW514-22	SS-8	6.9-7.5 mbgs
✖	MW520-22	SS-3	2.3-2.9 mbgs
▬	MW520-22	SS-8	6.1-6.7 mbgs

Description
 Silty Gravelly SAND, trace Clay
 Silty SAND, some Gravel and Clay
 SAND and GRAVEL, trace Silt
 Silty SAND, trace Clay and Gravel

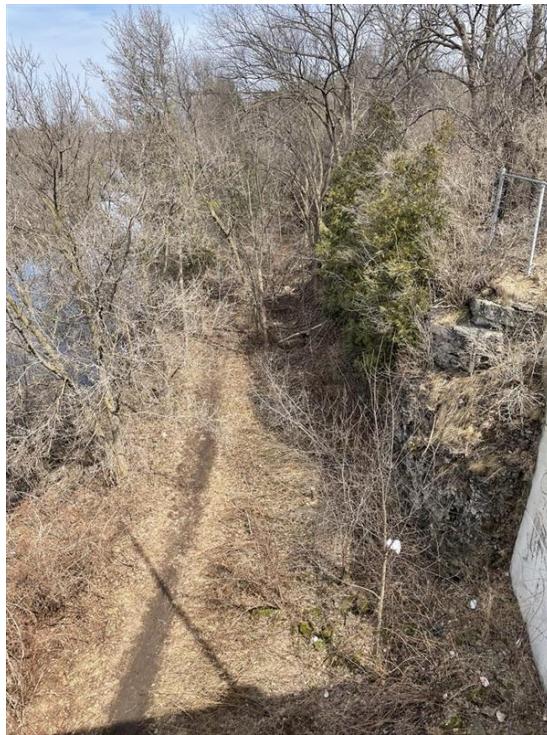
Photograph No. 1 – Looking from Victoria Street Bridge, view of steep exposed bedrock face on right with river on left.

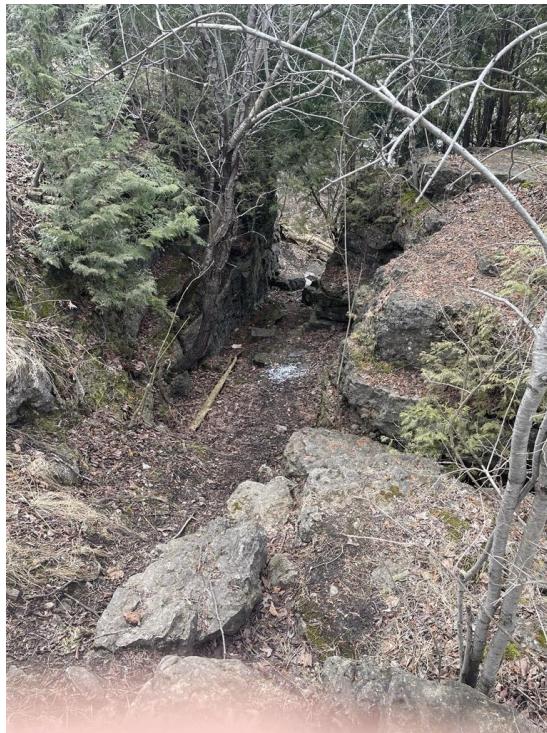
Photograph No. 2 – View of crack in steep bedrock near Section A-A'.

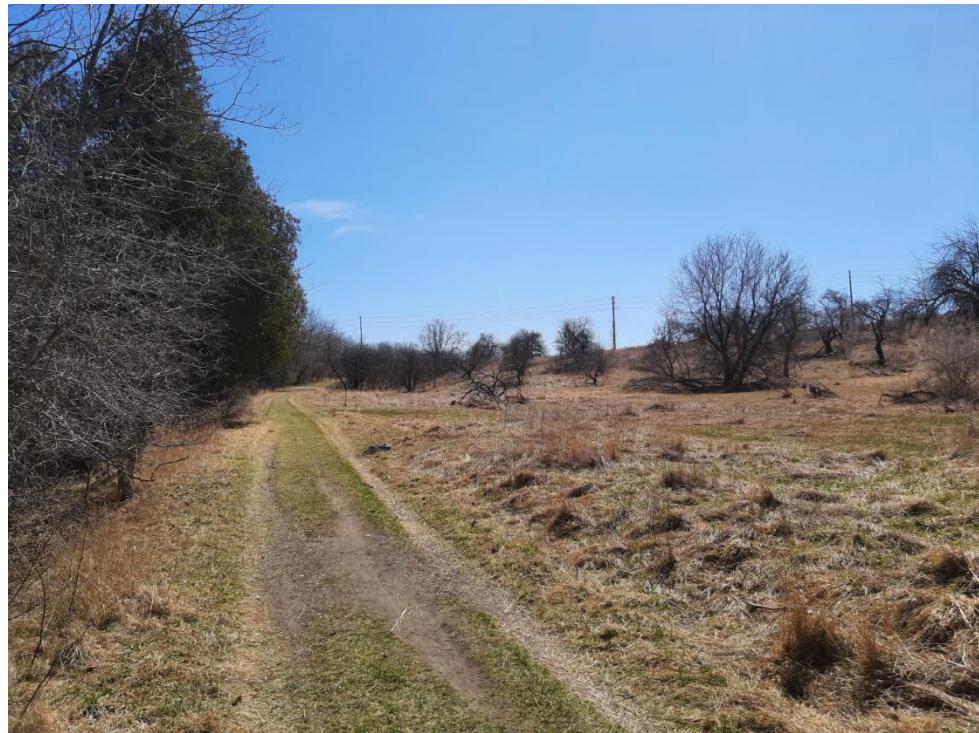
Photograph No. 4 – Looking south along top of slope near Section H-H'.

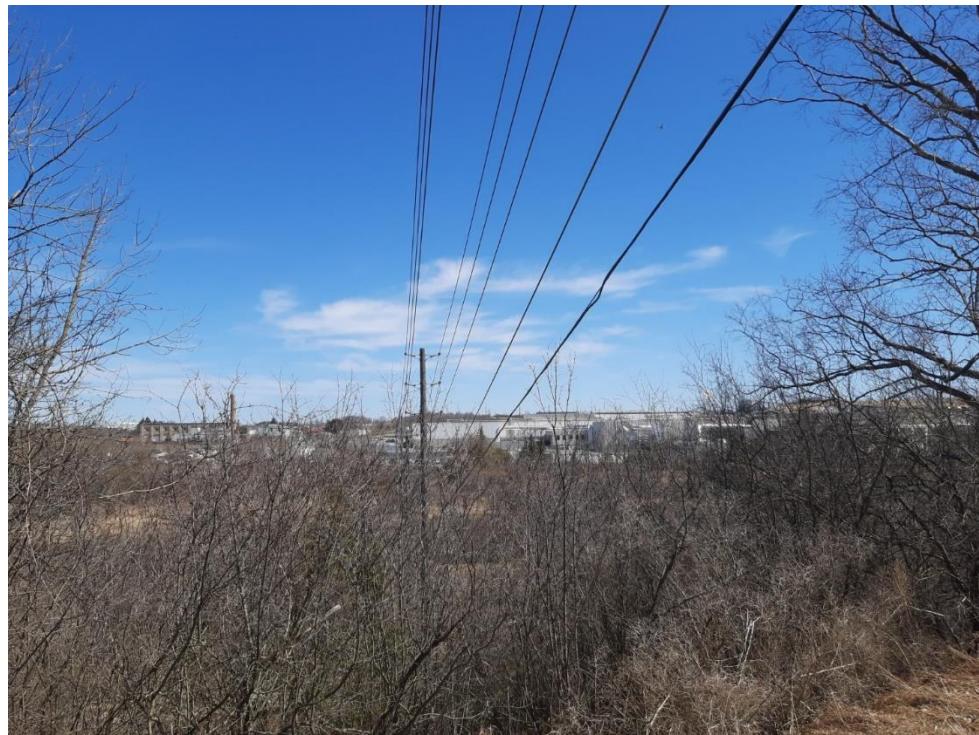
Photograph No. 5 – Looking down the slope at location of hydro crossing between Sections H-H' and I-I'.
