# Guelph Innovation District (GID) Lands, Blocks 1 & 2

## Hydrogeological Assessment

328 Victoria Road South and 588 Stone Road East  
Guelph, ON

**MTE File No.:** 46927-104

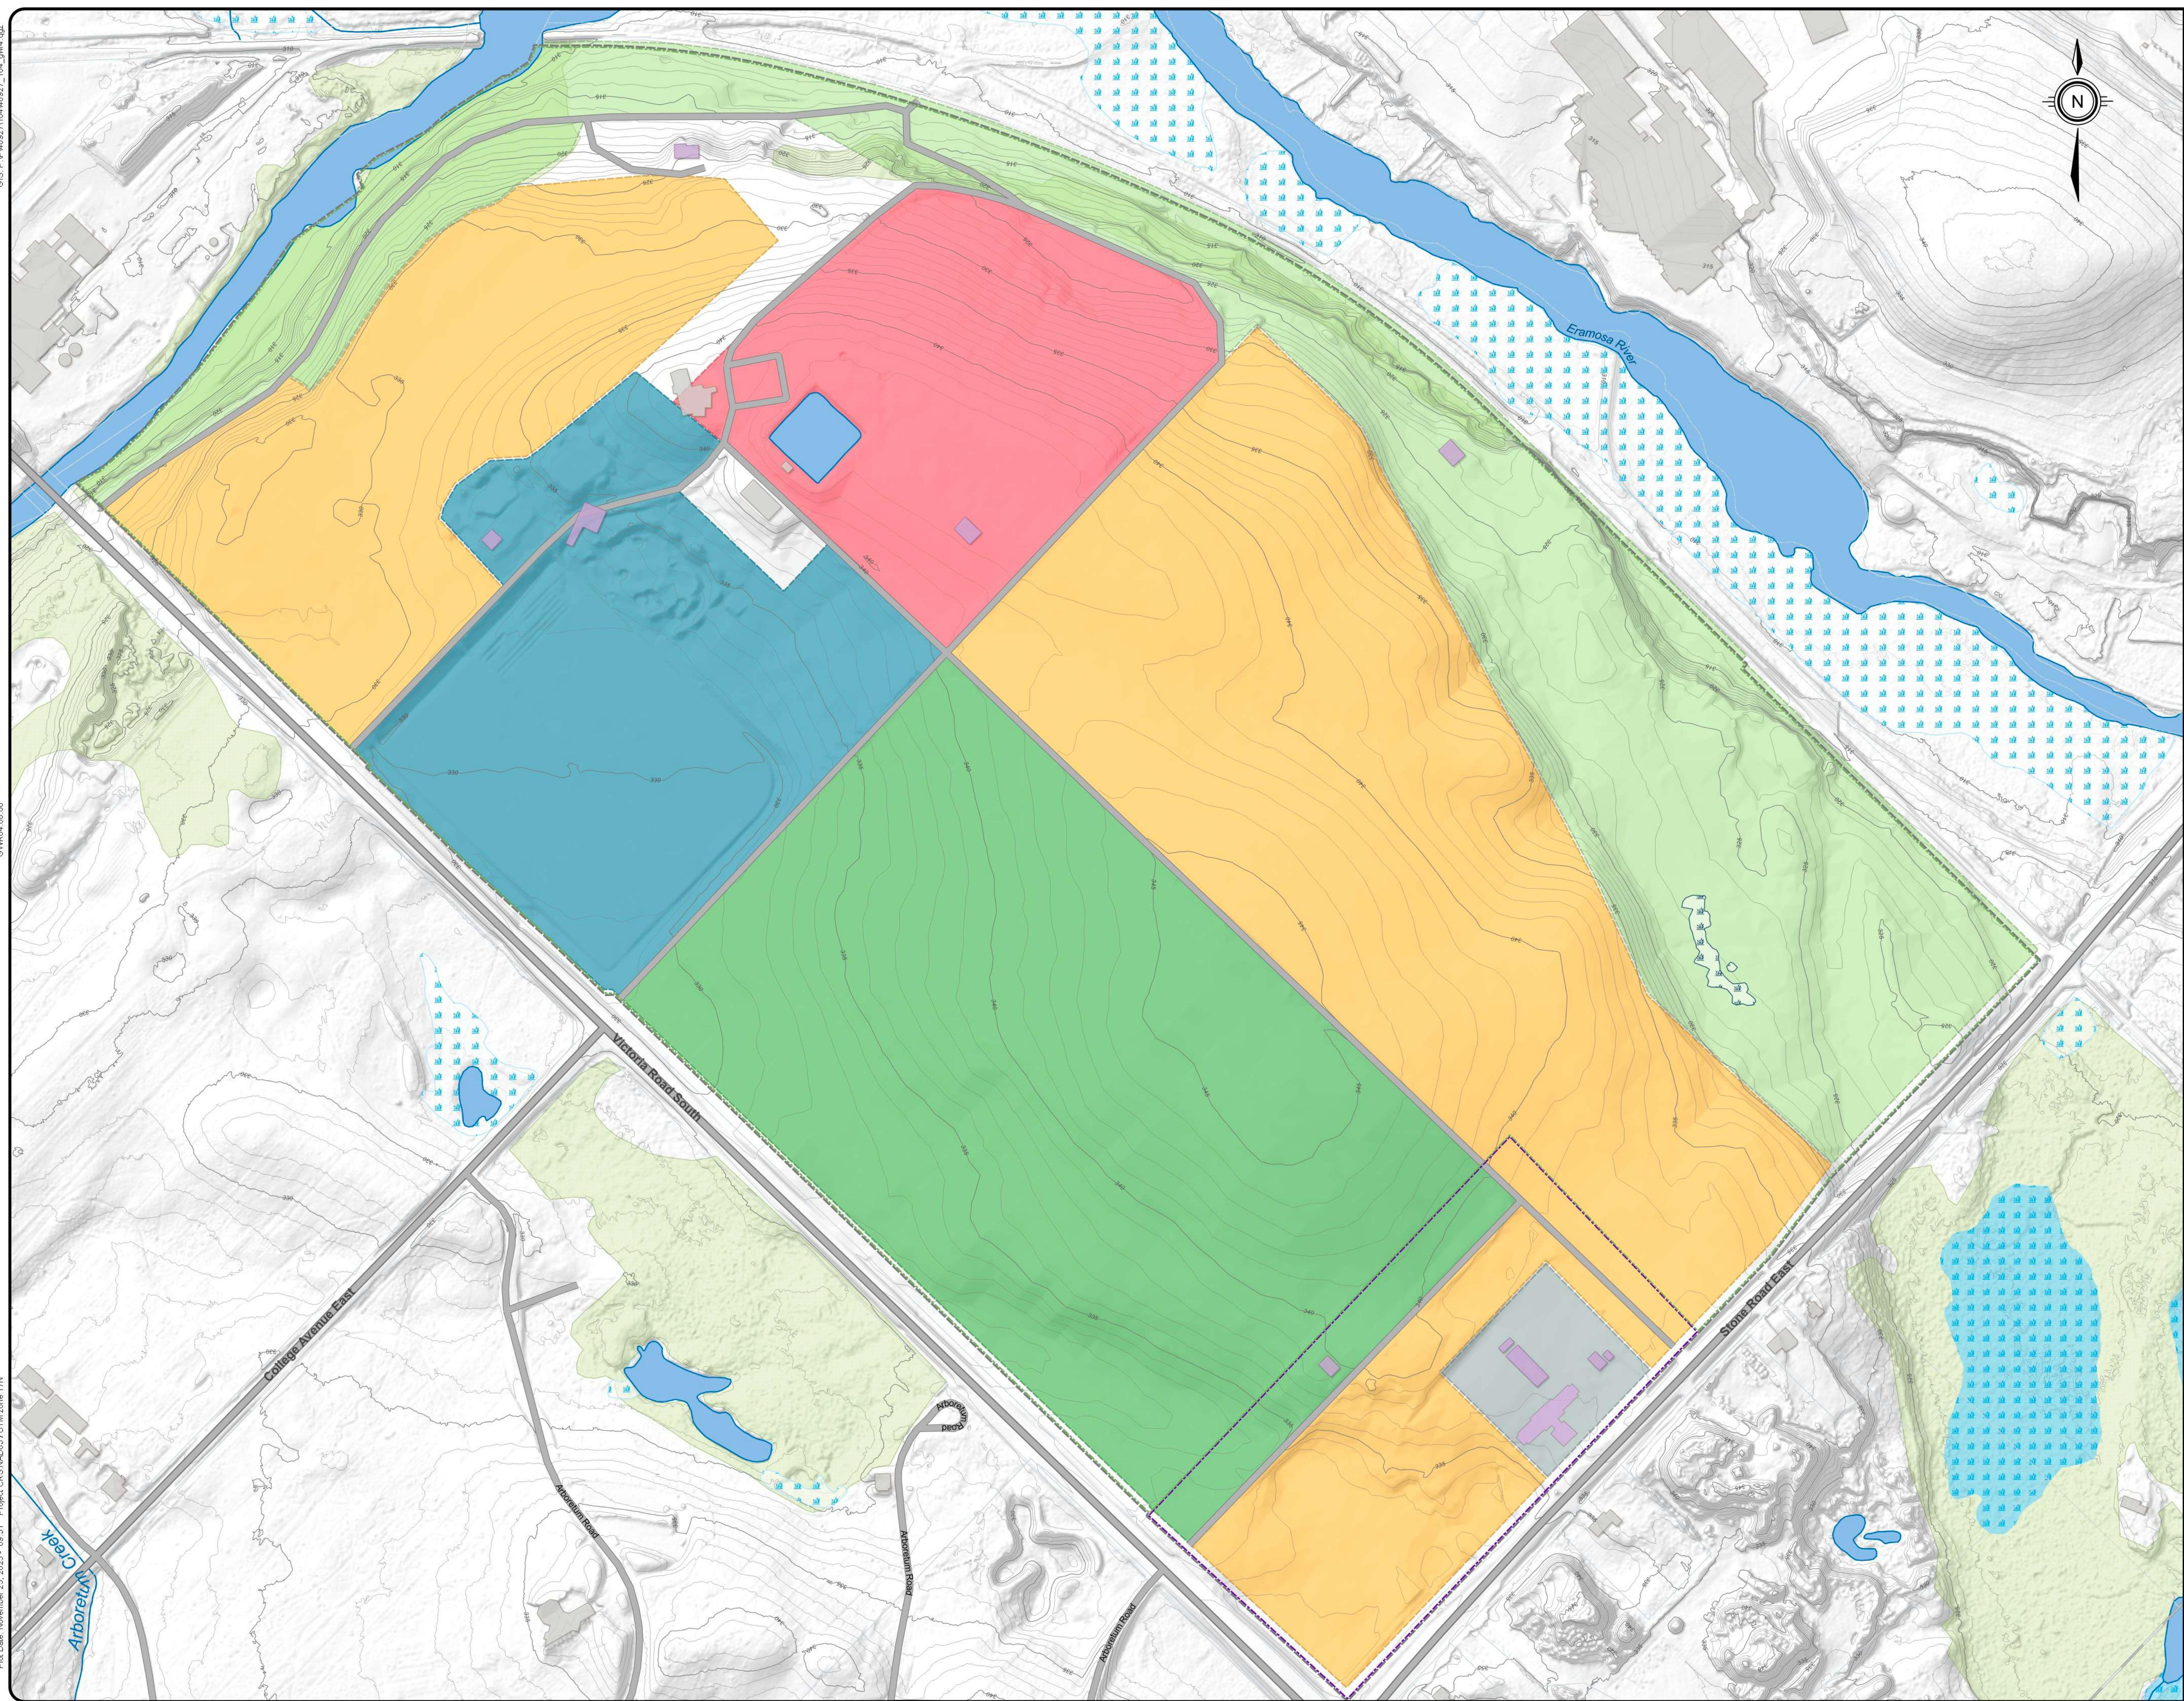
3a

The Site is developed with three buildings (Frost Building, maintenance workshop, pump house), a gravel parking lot, and an irrigation pond/lagoon within the west central portion of the Site. The remainder of the Site consists of gravel laneways, natural heritage areas, former agricultural, agroforestry, and turfgrass research lands. The former land uses are presented on **Figure 3a**.
