Project 976

**Re: 44, 56, 66 & 76 Arkell Road Proposed Residential Development
Environmental Implementation Report – Terms of Reference**

**44, 56, 66 and 76 Arkell Road Proposed Residential Development
Environmental Implementation Report
Terms of Reference
June 26, 2015**

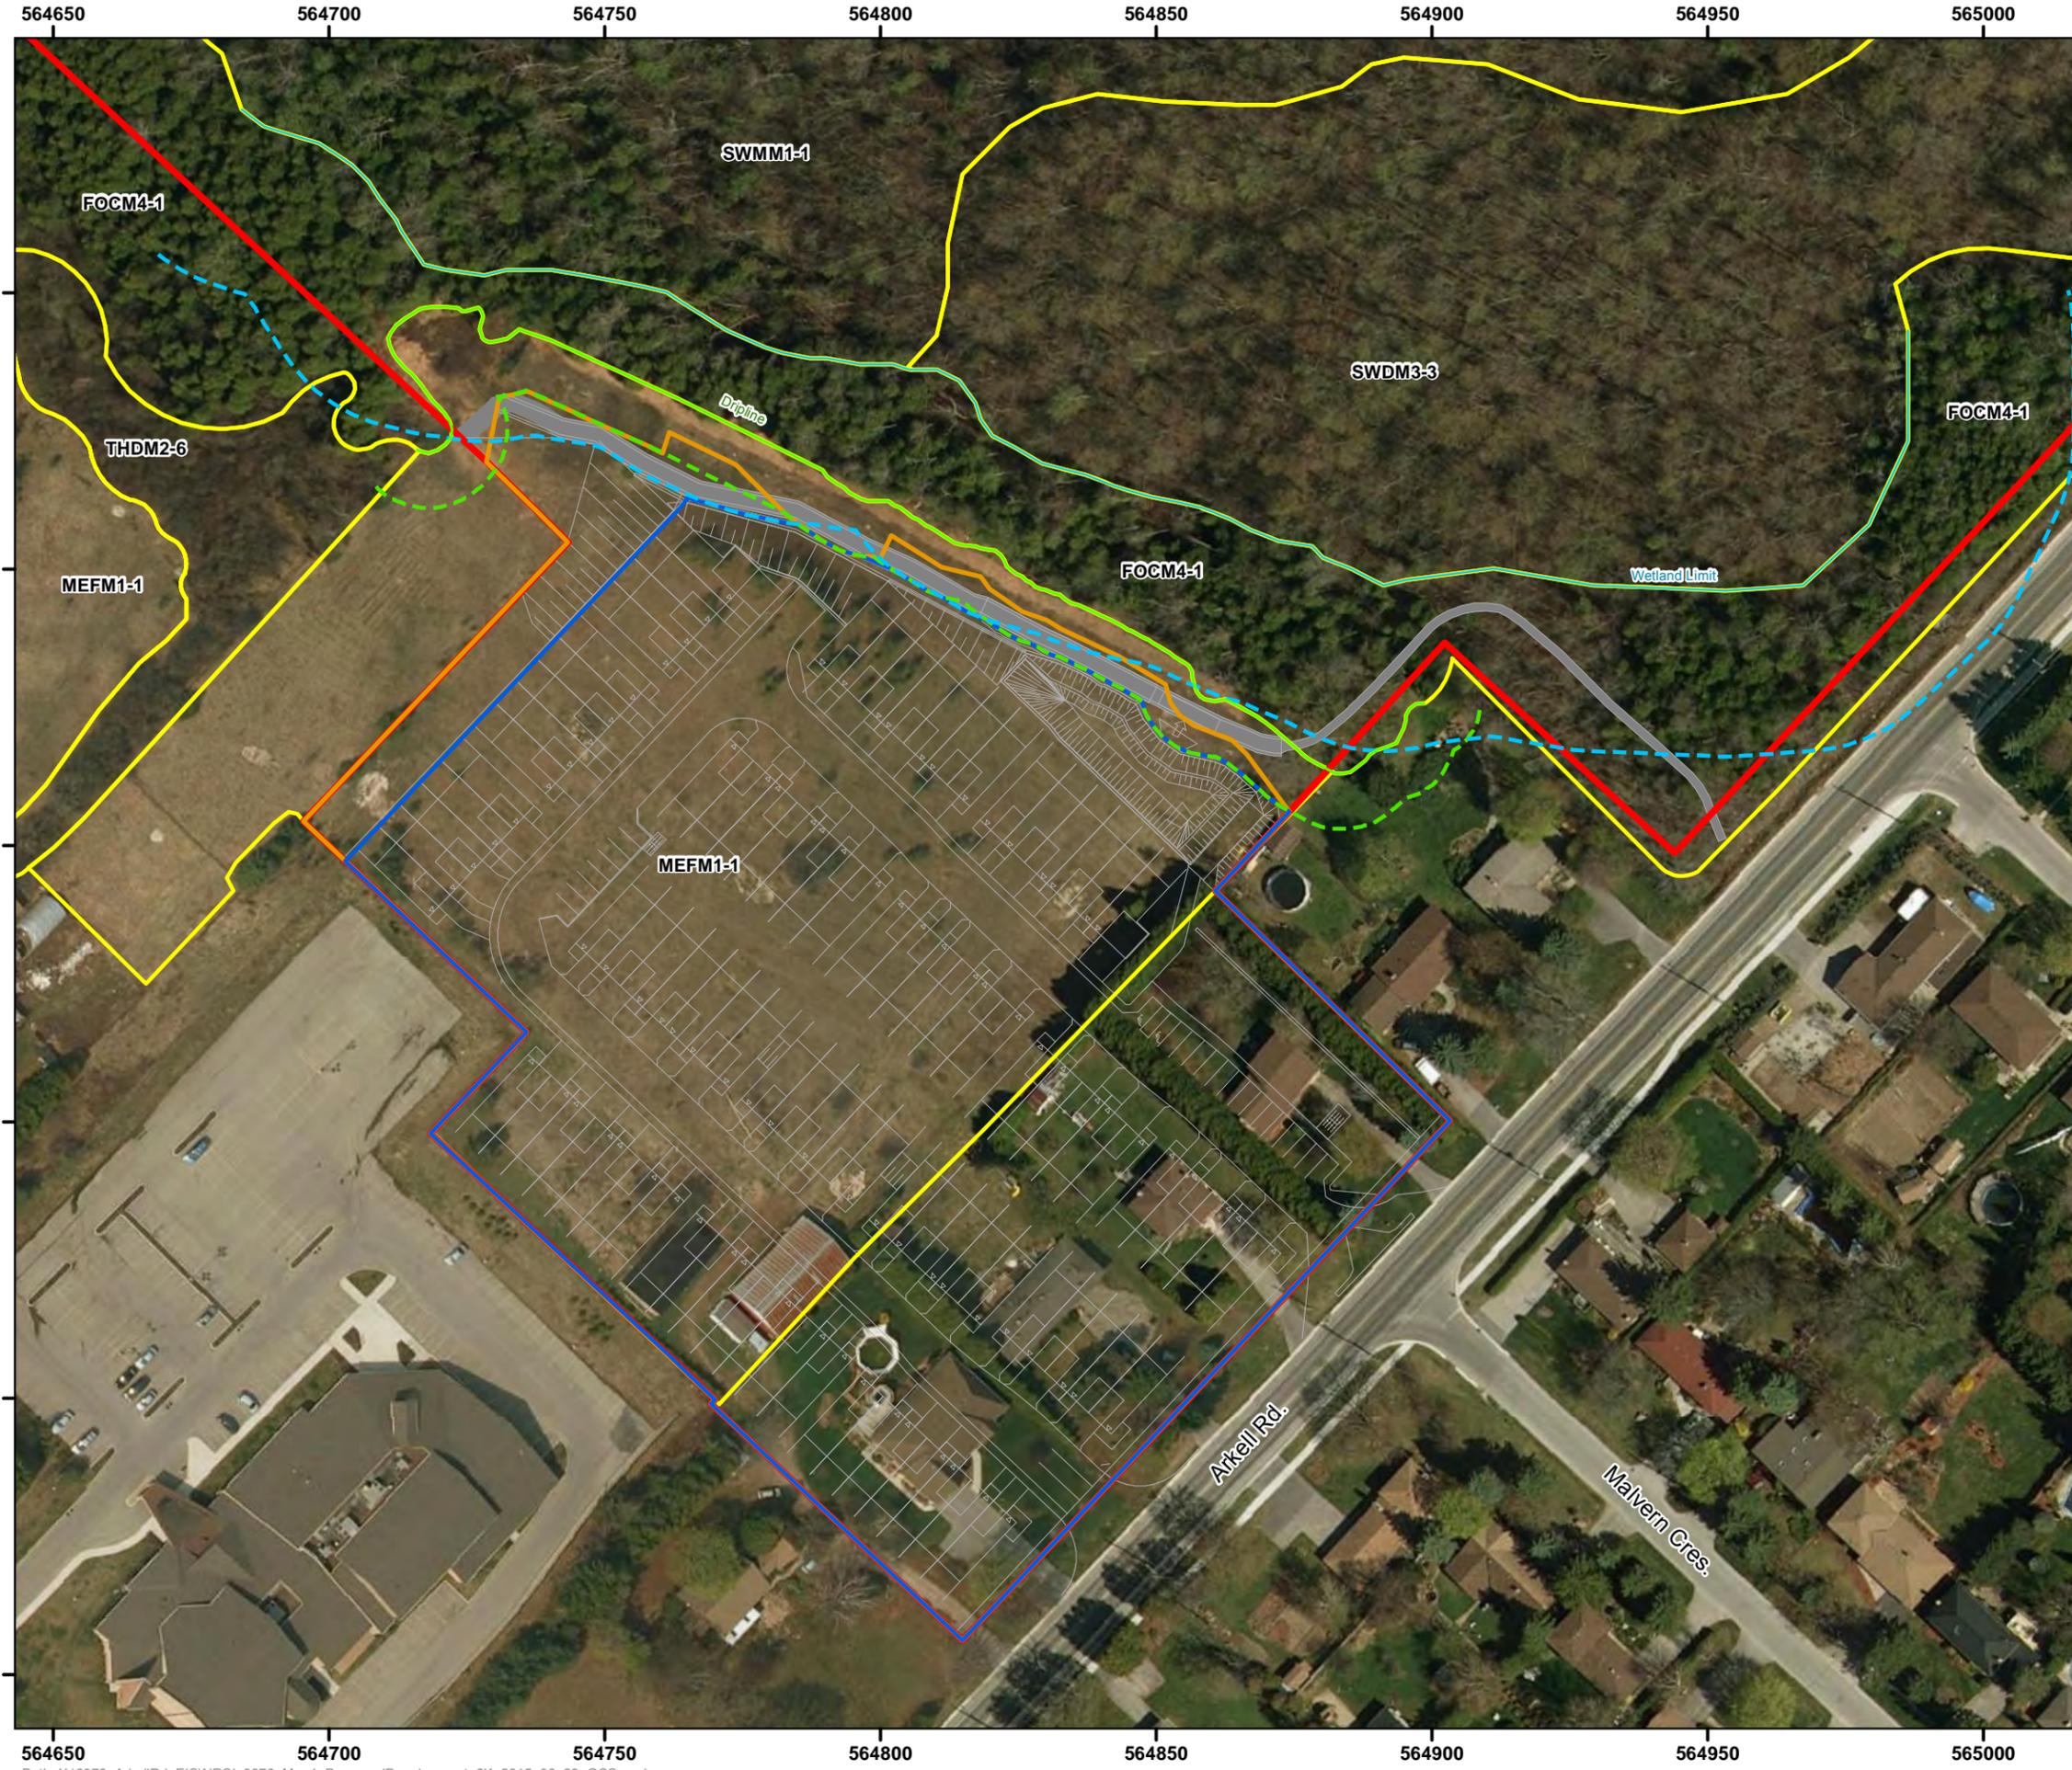
- Property Boundary
 - Future Subject Property Boundary
 - ▭ Proposed Pedestrian Trail
 - Development Area Limit
 - Proposed Development
 - Dripline (NRSI December 2012)
 - Wetland Boundary (Reviewed by GRCA - July 26, 2010)
 - - - 30m Wetland Buffer
 - - - 10m Dripline Buffer
 - Ecological Land Classification (ELC)
- (FOCM4-1) Fresh-Moist White Cedar Conifer Forest Type
 (MEFM1-1) Goldenrod Forb Meadow Type
 (SWDM3-3) Swamp Maple Mineral Deciduous Swamp Type
 (SWMM1-1) White Cedar-Hardwood Mineral Mixed Swamp Type
 (TAGM1) Coniferous Plantation
 (THDM2-6) Buckthorn Deciduous Shrub Thicket Type

The proposed development also incorporates the construction of a pedestrian trail through the woodland/wetland buffers and a portion of the adjacent woodland, from the north subject property boundary to Arkell Road. This conceptual trail alignment was designed to meet the requirements of the City’s Trail Master Plan as mapped in OPA 48. The trail will comprise a 2.5 m wide graded stone dust base along most of its length outside of the woodland, while the southernmost segment from the SWM facility to Arkell Road will comprise a 1.5 m wide light-duty design wooden boardwalk (Map 1). The trail will be conveyed to City ownership.

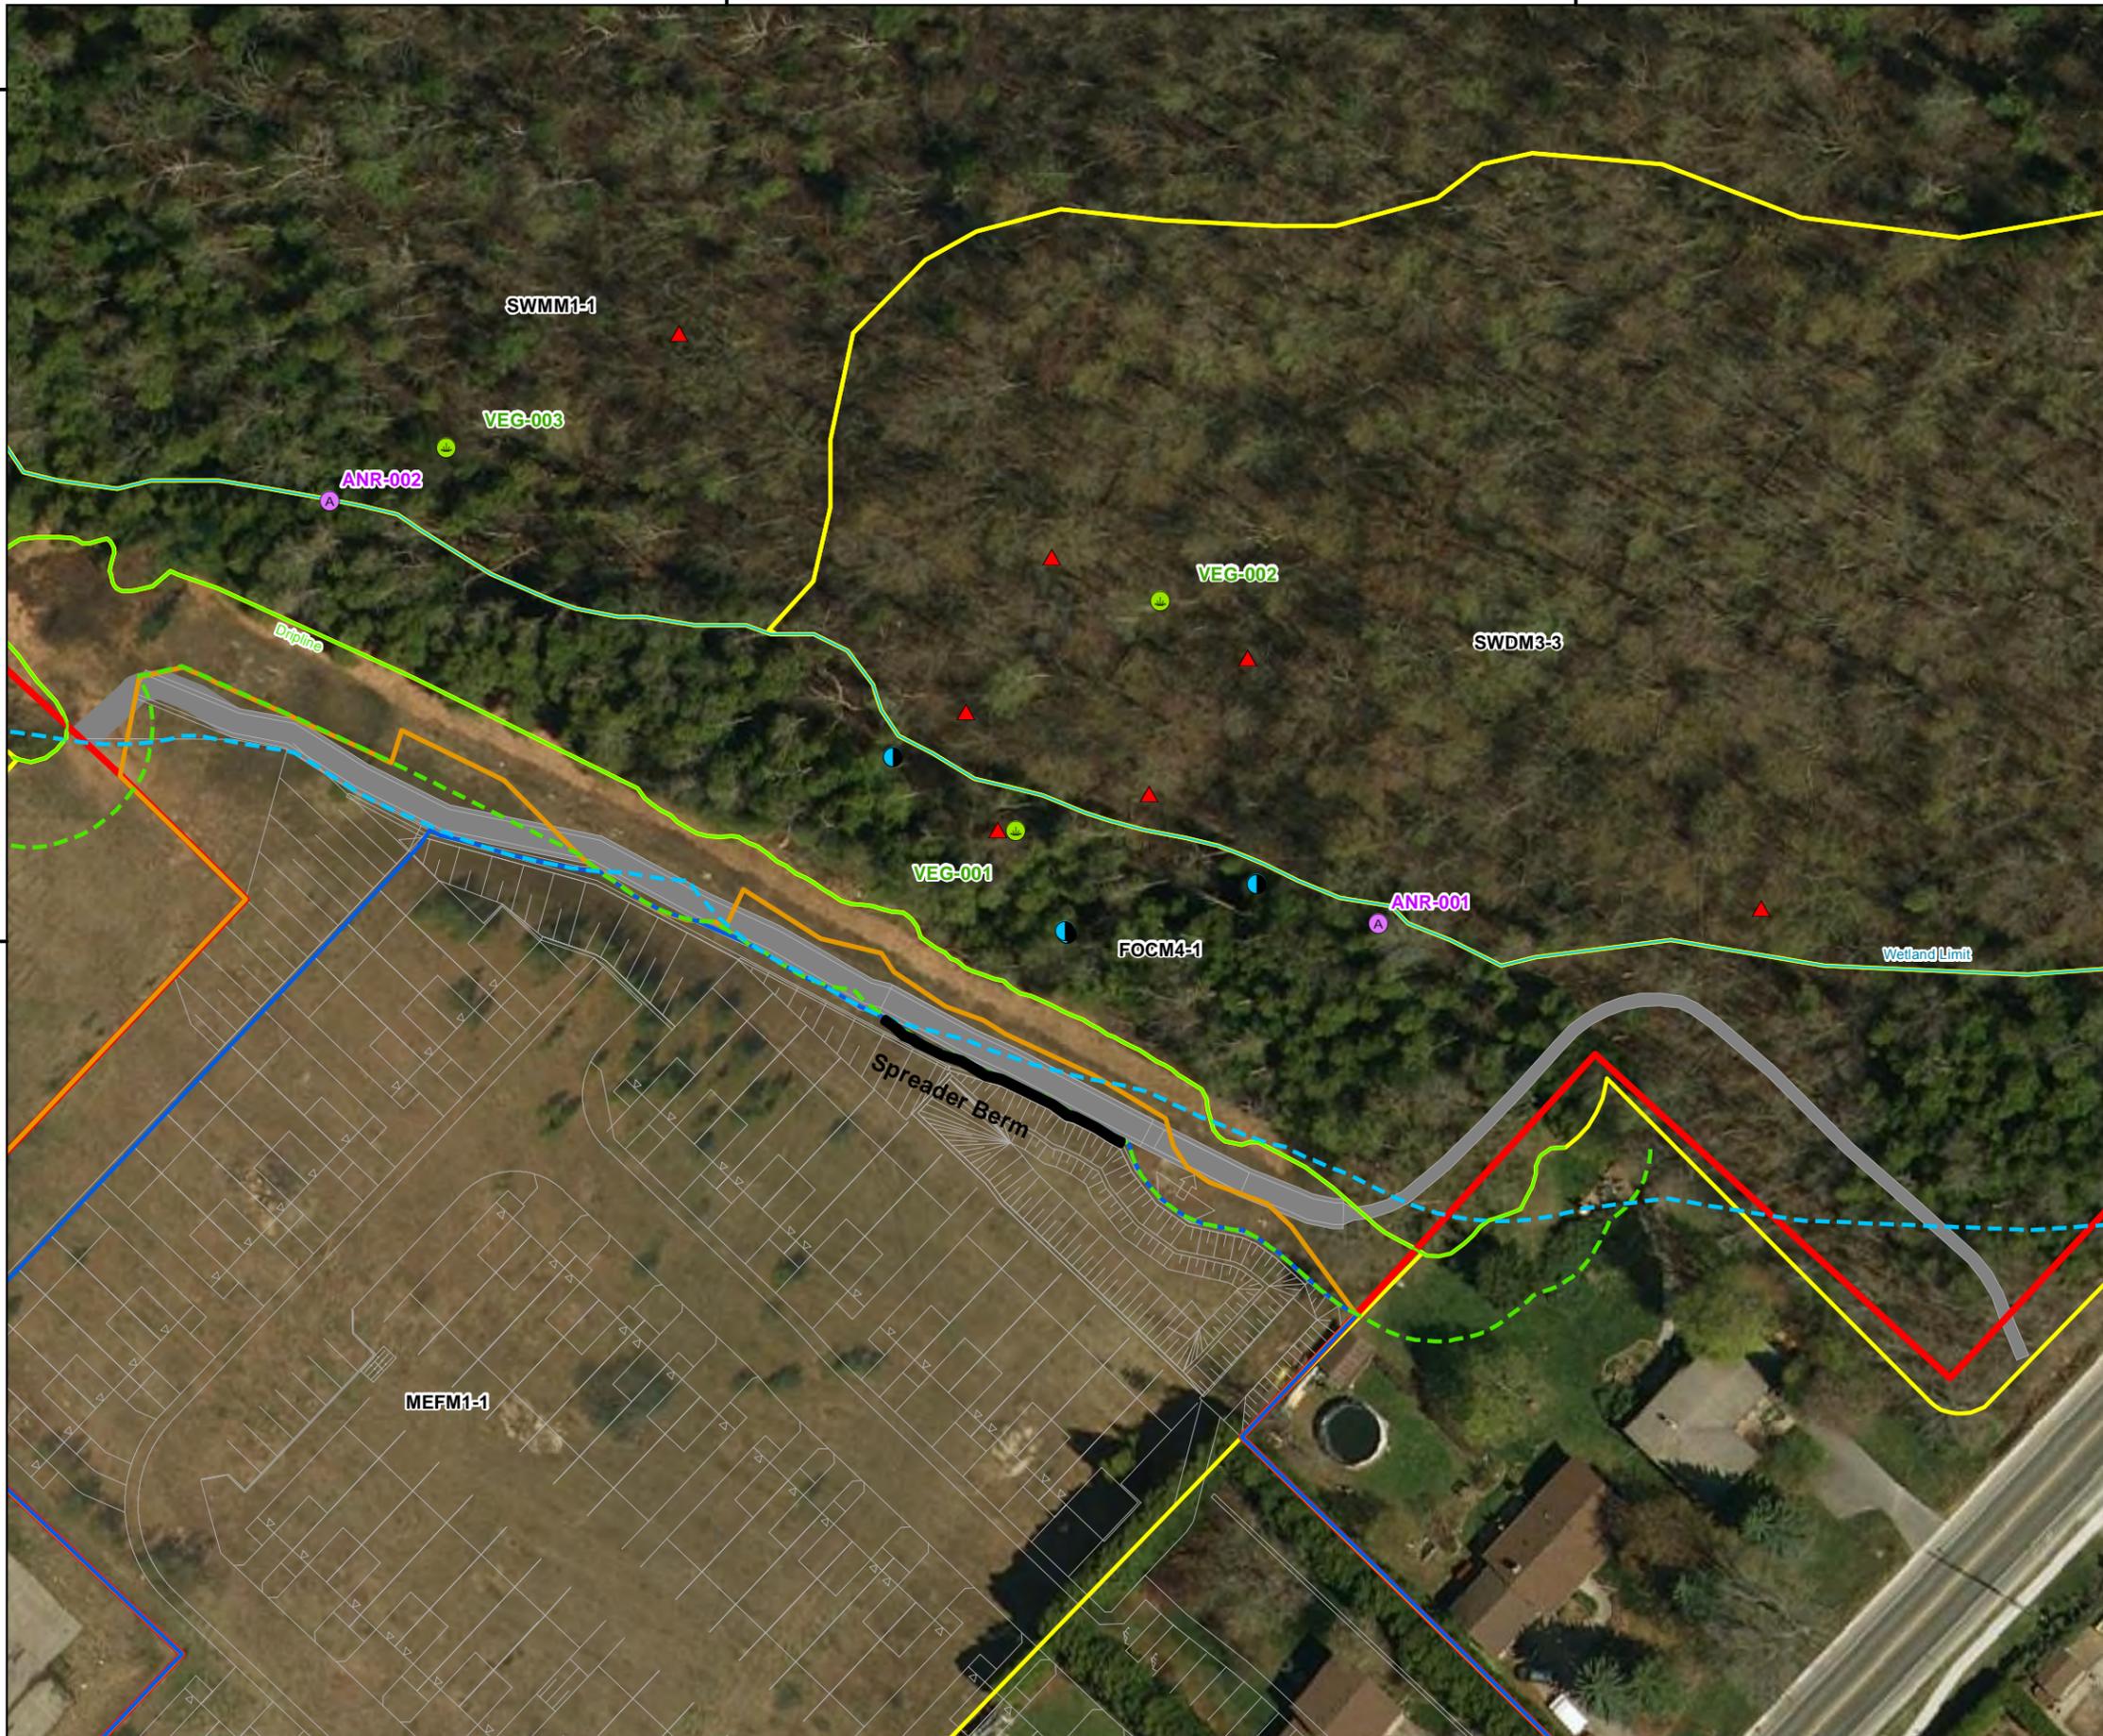
- Property Boundary
- Future Subject Property Boundary
- Development Area
- Proposed Development
- Spreader Berm
- Vegetation Monitoring Plot
- Piezometer Location
- ▲ Surface Water Monitoring Locations
- ▲ Anuran Monitoring Station
- ▭ Proposed Pedestrian Trail
- Dripline (NRSI December 2012)
- - - Wetland Boundary (Reviewed by GRCA - July 26, 2010)
- - - 30m Wetland Buffer
- - - 10m Dripline Buffer
- ▭ Ecological Land Classification (ELC)
 - (FOCM4-1) Fresh-Moist White Cedar Conifer Forest Type
 - (MEFM1-1) Goldenrod Forb Meadow Type
 - (SWDM3-3) Swamp Maple Mineral Deciduous Swamp Type
 - (SWMM1-1) White Cedar-Hardwood Mineral Mixed Swamp Type
 - (TAGM1) Coniferous Plantation
 - (THDM2-6) Buckthorn Deciduous Shrub Thicket Type

Three permanent 10x10 m vegetation sampling plots have been established as shown on Map 2: two within the potential stormwater discharge zone of influence, while one additional reference plot has been established outside of the potential zone of influence. Within each of these sampling plots, subsamples will be monitored for trees, shrubs and herbaceous vegetation. The permanent sample plots will be returned to each monitoring event, while the smaller subsampling quadrants within the plots will be selected randomly within the larger plot. The corner of each plot will be marked with a steel bar to permanently mark its location. A photograph of each plot will be taken each year at the same time of year, same location, in the same direction, for comparison over time.
