Phase I Environmental Site Assessment 78 Eastview Road, Guelph, Ontario

Prepared for: 2589618 Ontario Inc.

Prepared by: Premier Environmental Services Inc.

Premier Project Number: 616116.CE

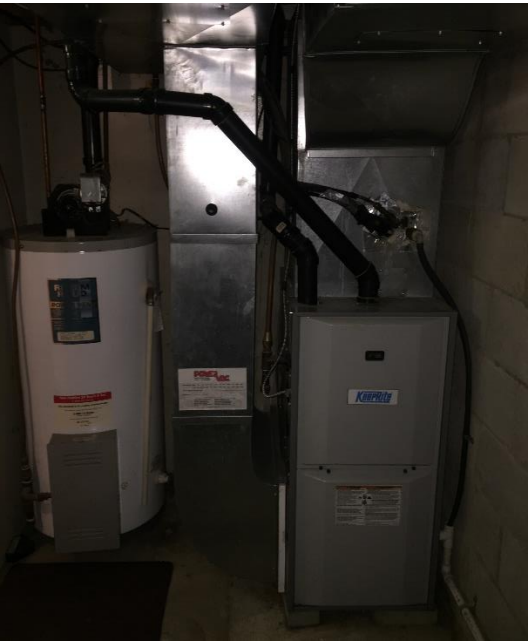
Client Name: 2589618 Ontario Inc.		Site Location: 78 Eastview Road, Guelph, Ontario	Project No. 616116.CE
Photo No. 3	Date: 08-Aug-17

Direction Photo Taken: N/A			
Description: Natural gas furnace and water heater located in the basement of the single-family house.

Heating and cooling for the house is provided by a natural gas-fired furnace and electric air conditioning system (Photo No. 3).

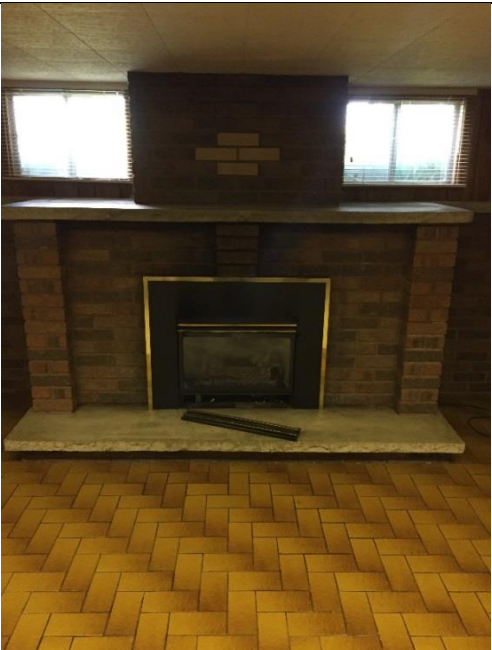
Photo No. 4	Date: 08-Aug-17

Direction Photo Taken: N/A		
Description: Gas fireplace located in the basement of the single-family house.

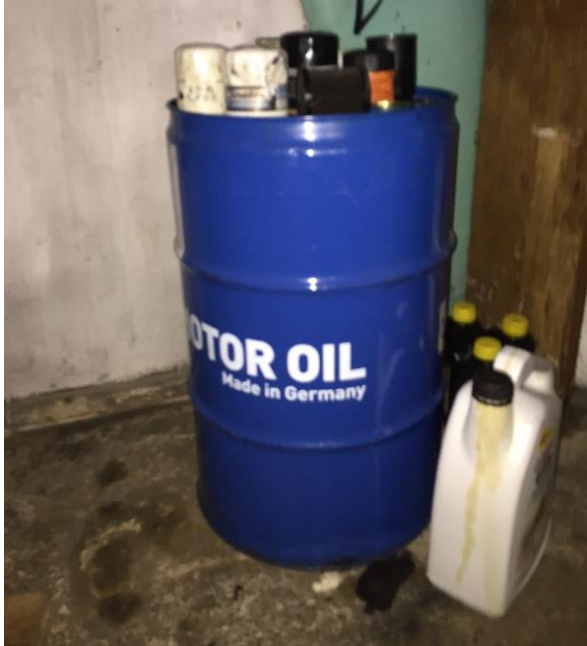
Client Name: 2589618 Ontario Inc..		Site Location: 78 Eastview Road, Guelph, Ontario	Project No. 616116.CE
Photo No. 5	Date: 08-Aug-17

Direction Photo Taken: N/A			
Description: Motor oil stored in the garage on the subject property.

- One metal drum of motor oil in the garage (Photo No. 5); and
- Other chemicals used for motor vehicle maintenance were observed in the garage.
