**PRELIMINARY REMEDIAL ACTION PLAN  
FORMER IMICO PROPERTY  
200 BEVERLEY STREET  
GUELPH, ONTARIO**

**DECOMMISSIONING CONSULTING SERVICES**

April 2014

701996

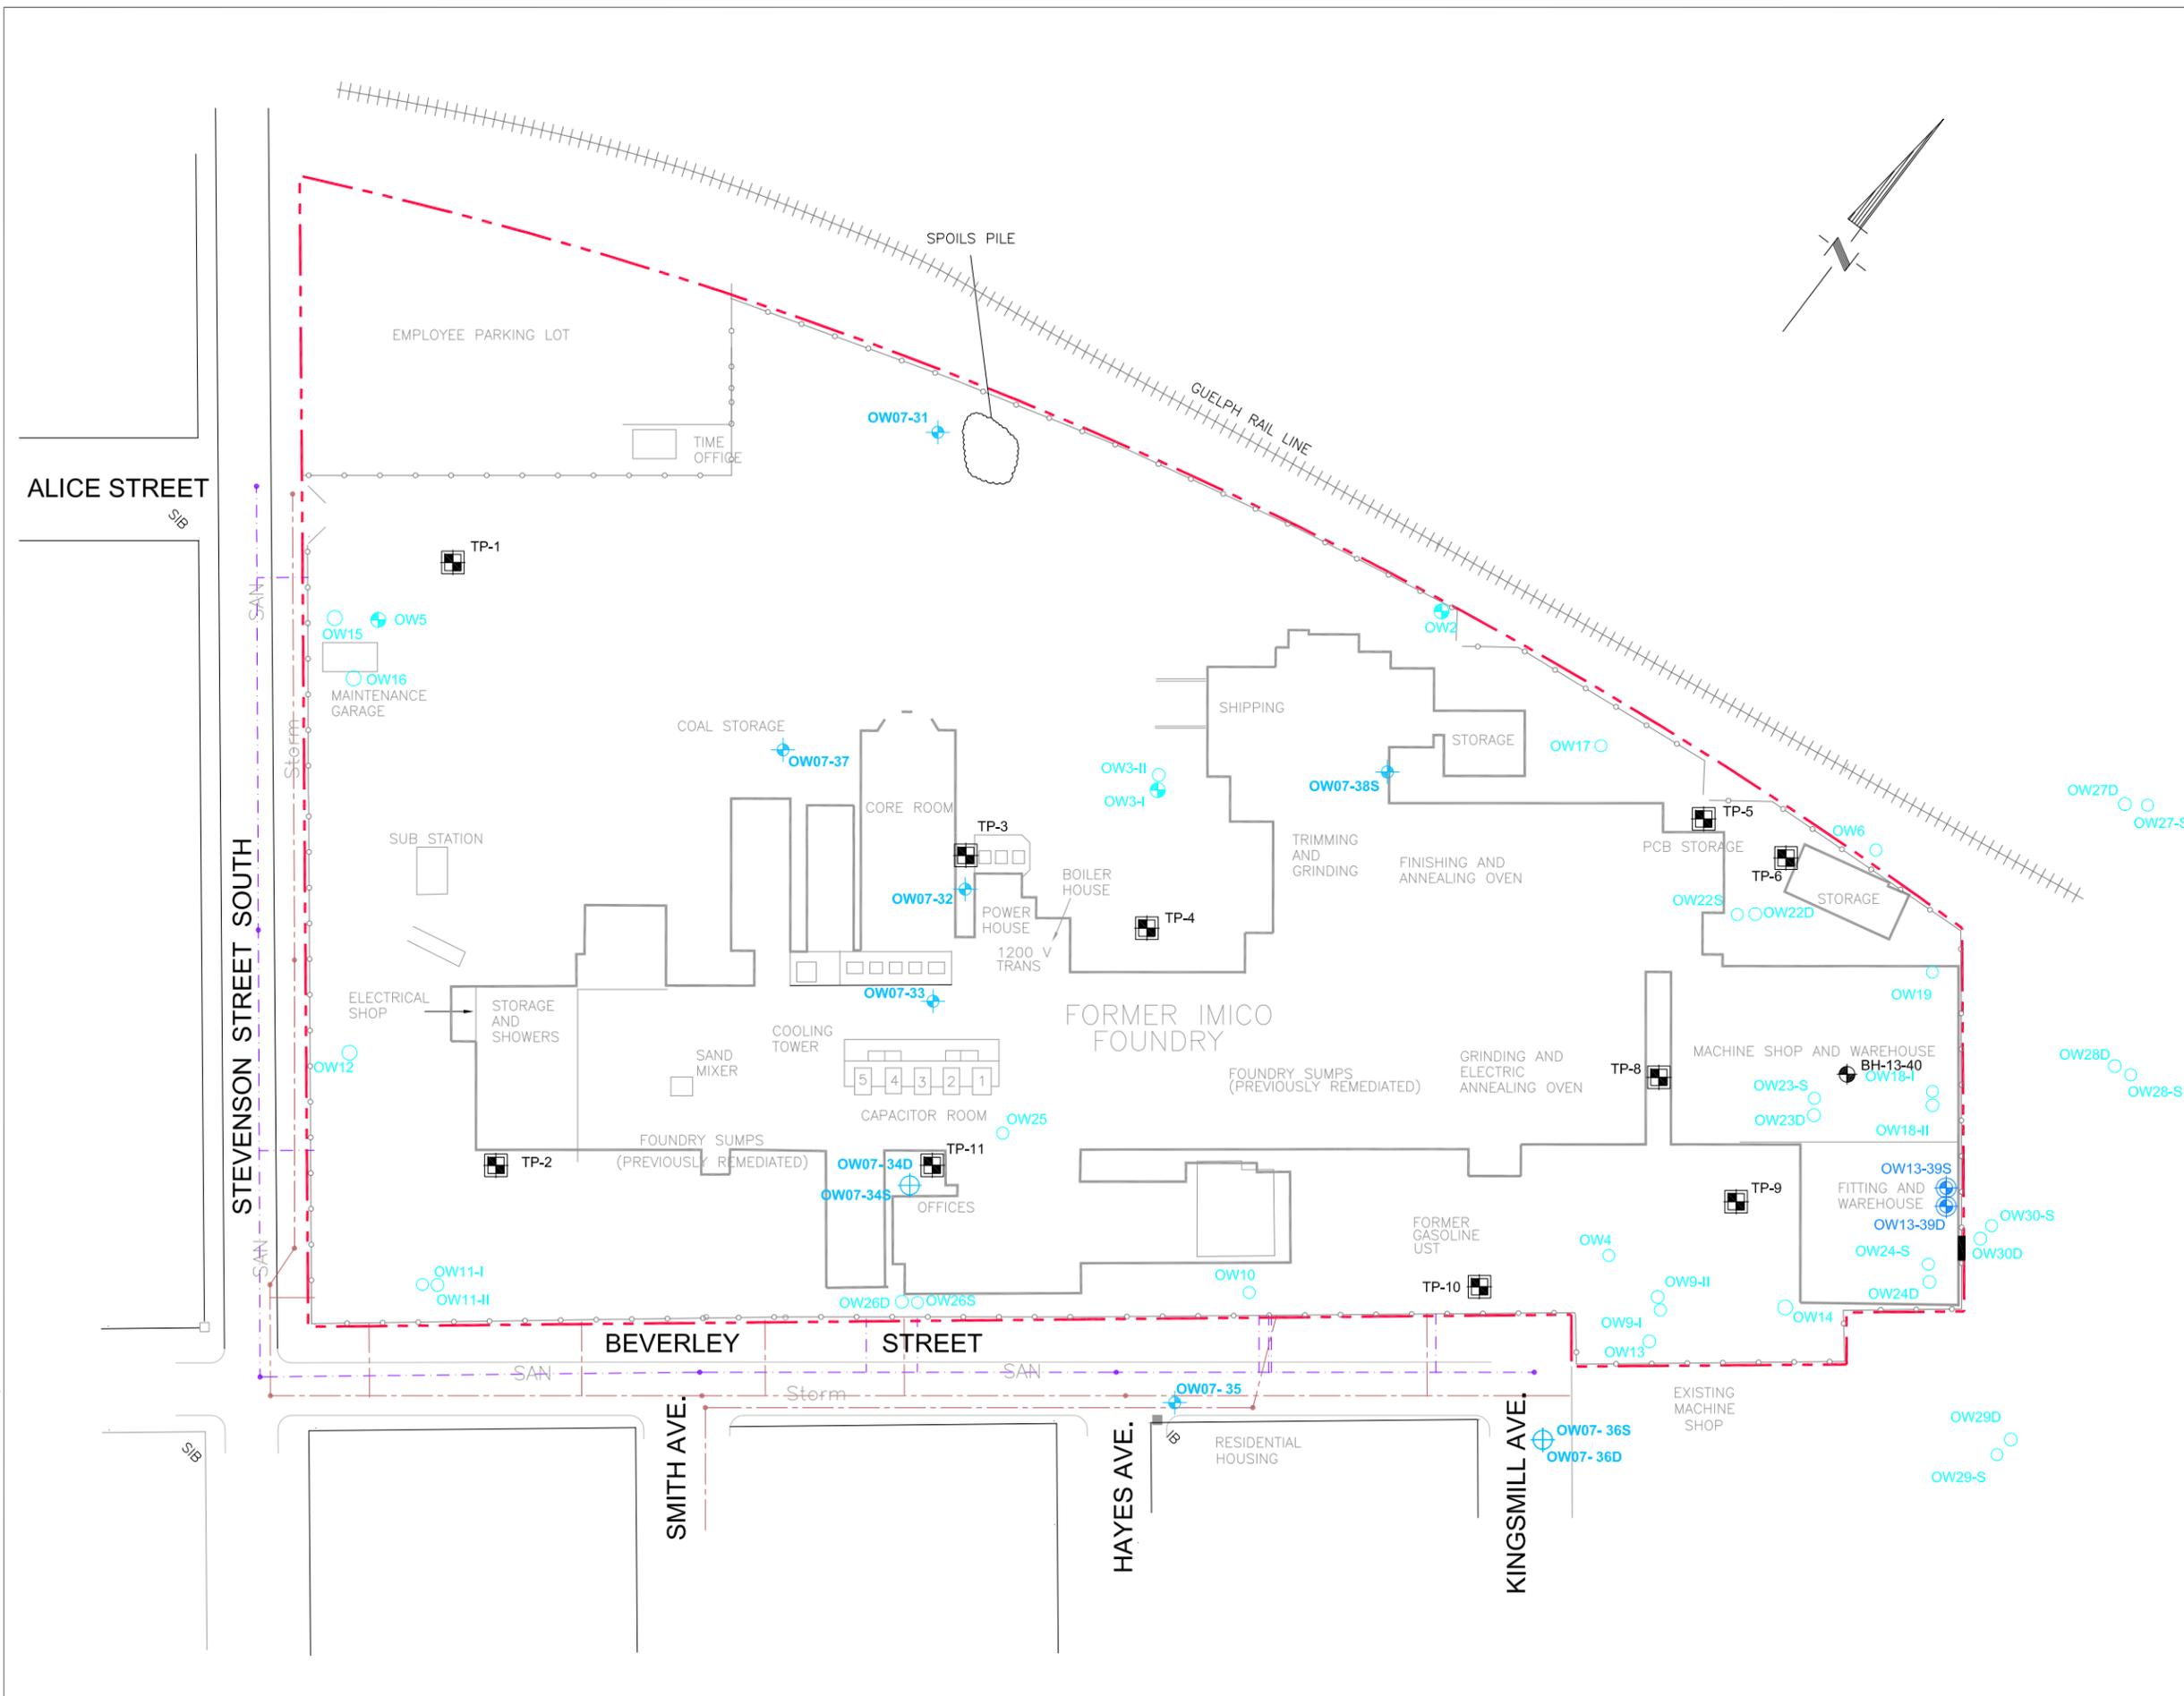
CITY OF GUELPH  
 200 BEVERLEY STREET, CITY OF GUELPH  
**FORMER IMICO FACILITY  
 REMEDIAL ACTION PLAN**  
 BOREHOLE AND  
 MONITORING WELL LOCATIONS

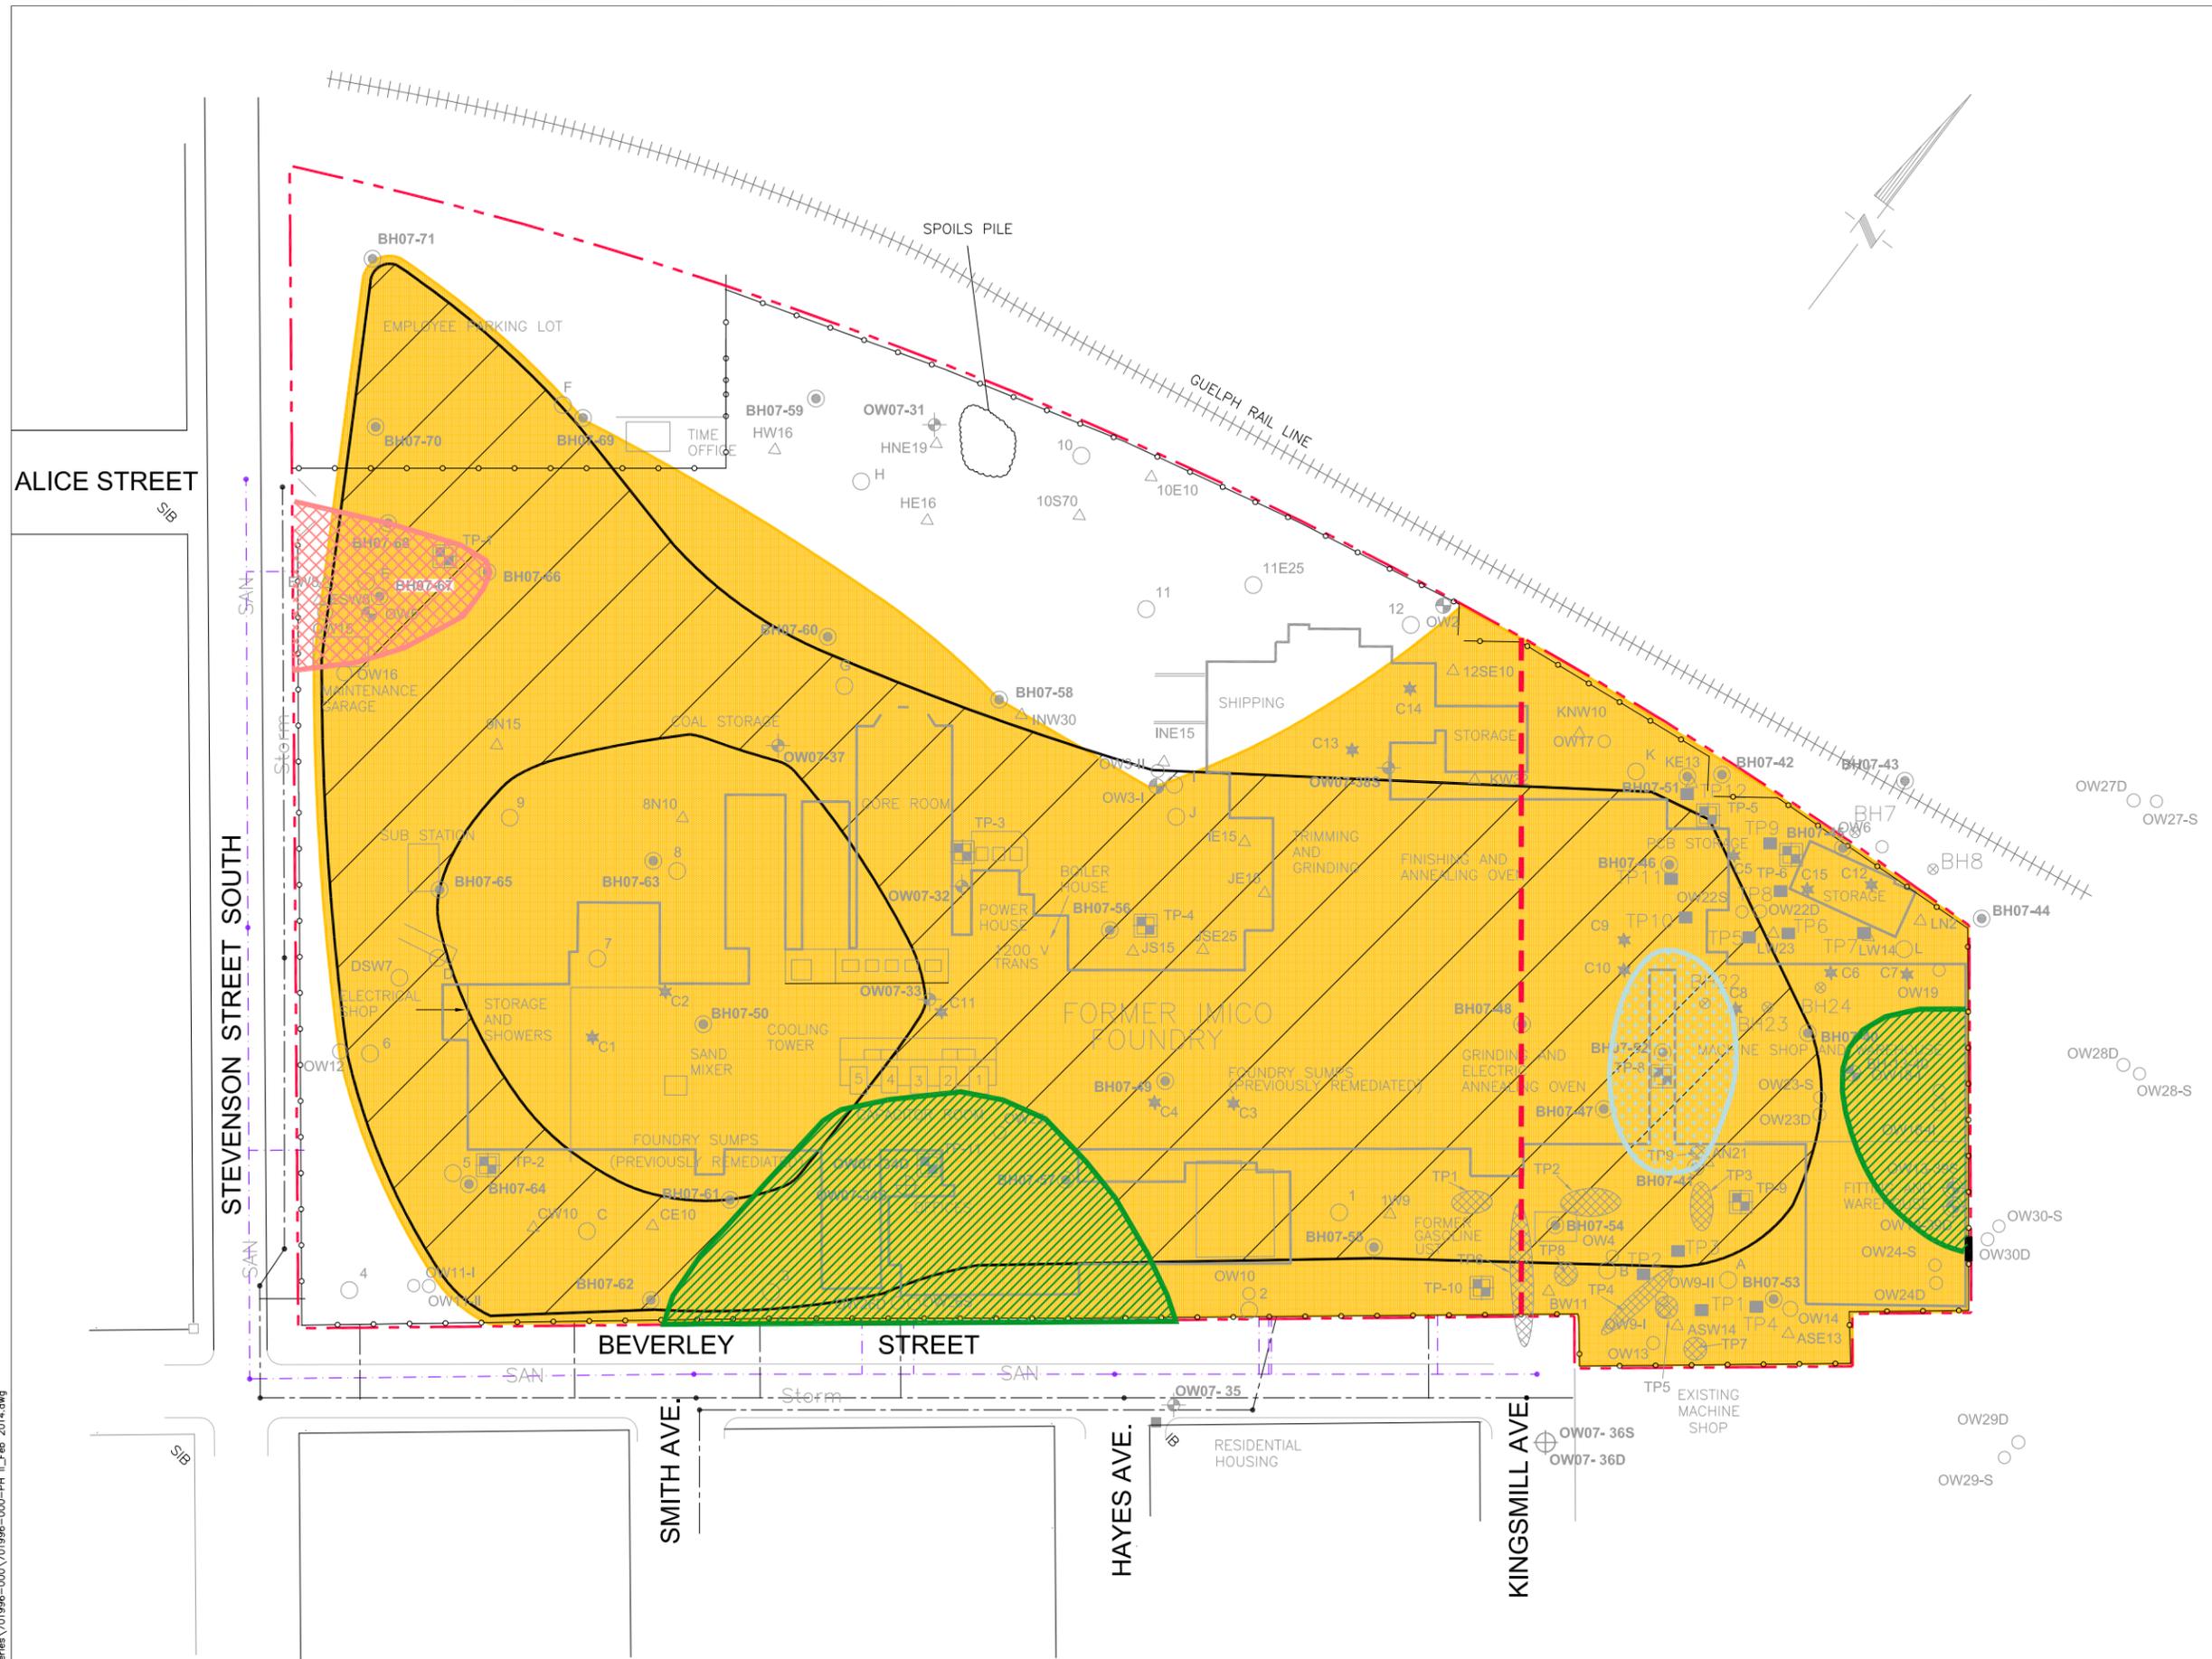
FEB. 2014      1:1250      701996-RAP-5.1

- EXTENT OF METALS
- EXTENT OF PAH IMPACTS
- EXTENT OF PCB IMPACTS
- EXTENT OF VOC IMPACTS
- EXTENT OF PHC IMPACTS
- PROPOSED LINE SEVERING PROPERTY
- EXISTING PROPERTY LINE

As may be seen, the metals and PAHs exceeding the MOE Table 6 SCS are widespread across the property. It should also be noted that the extent of metals is based on the sampling locations. Considering the previous site use as a metal foundry, metals may be more widespread than that detected during the previous investigations. It would be therefore prudent to assume that metals and PAHs in the soil are present across the site.

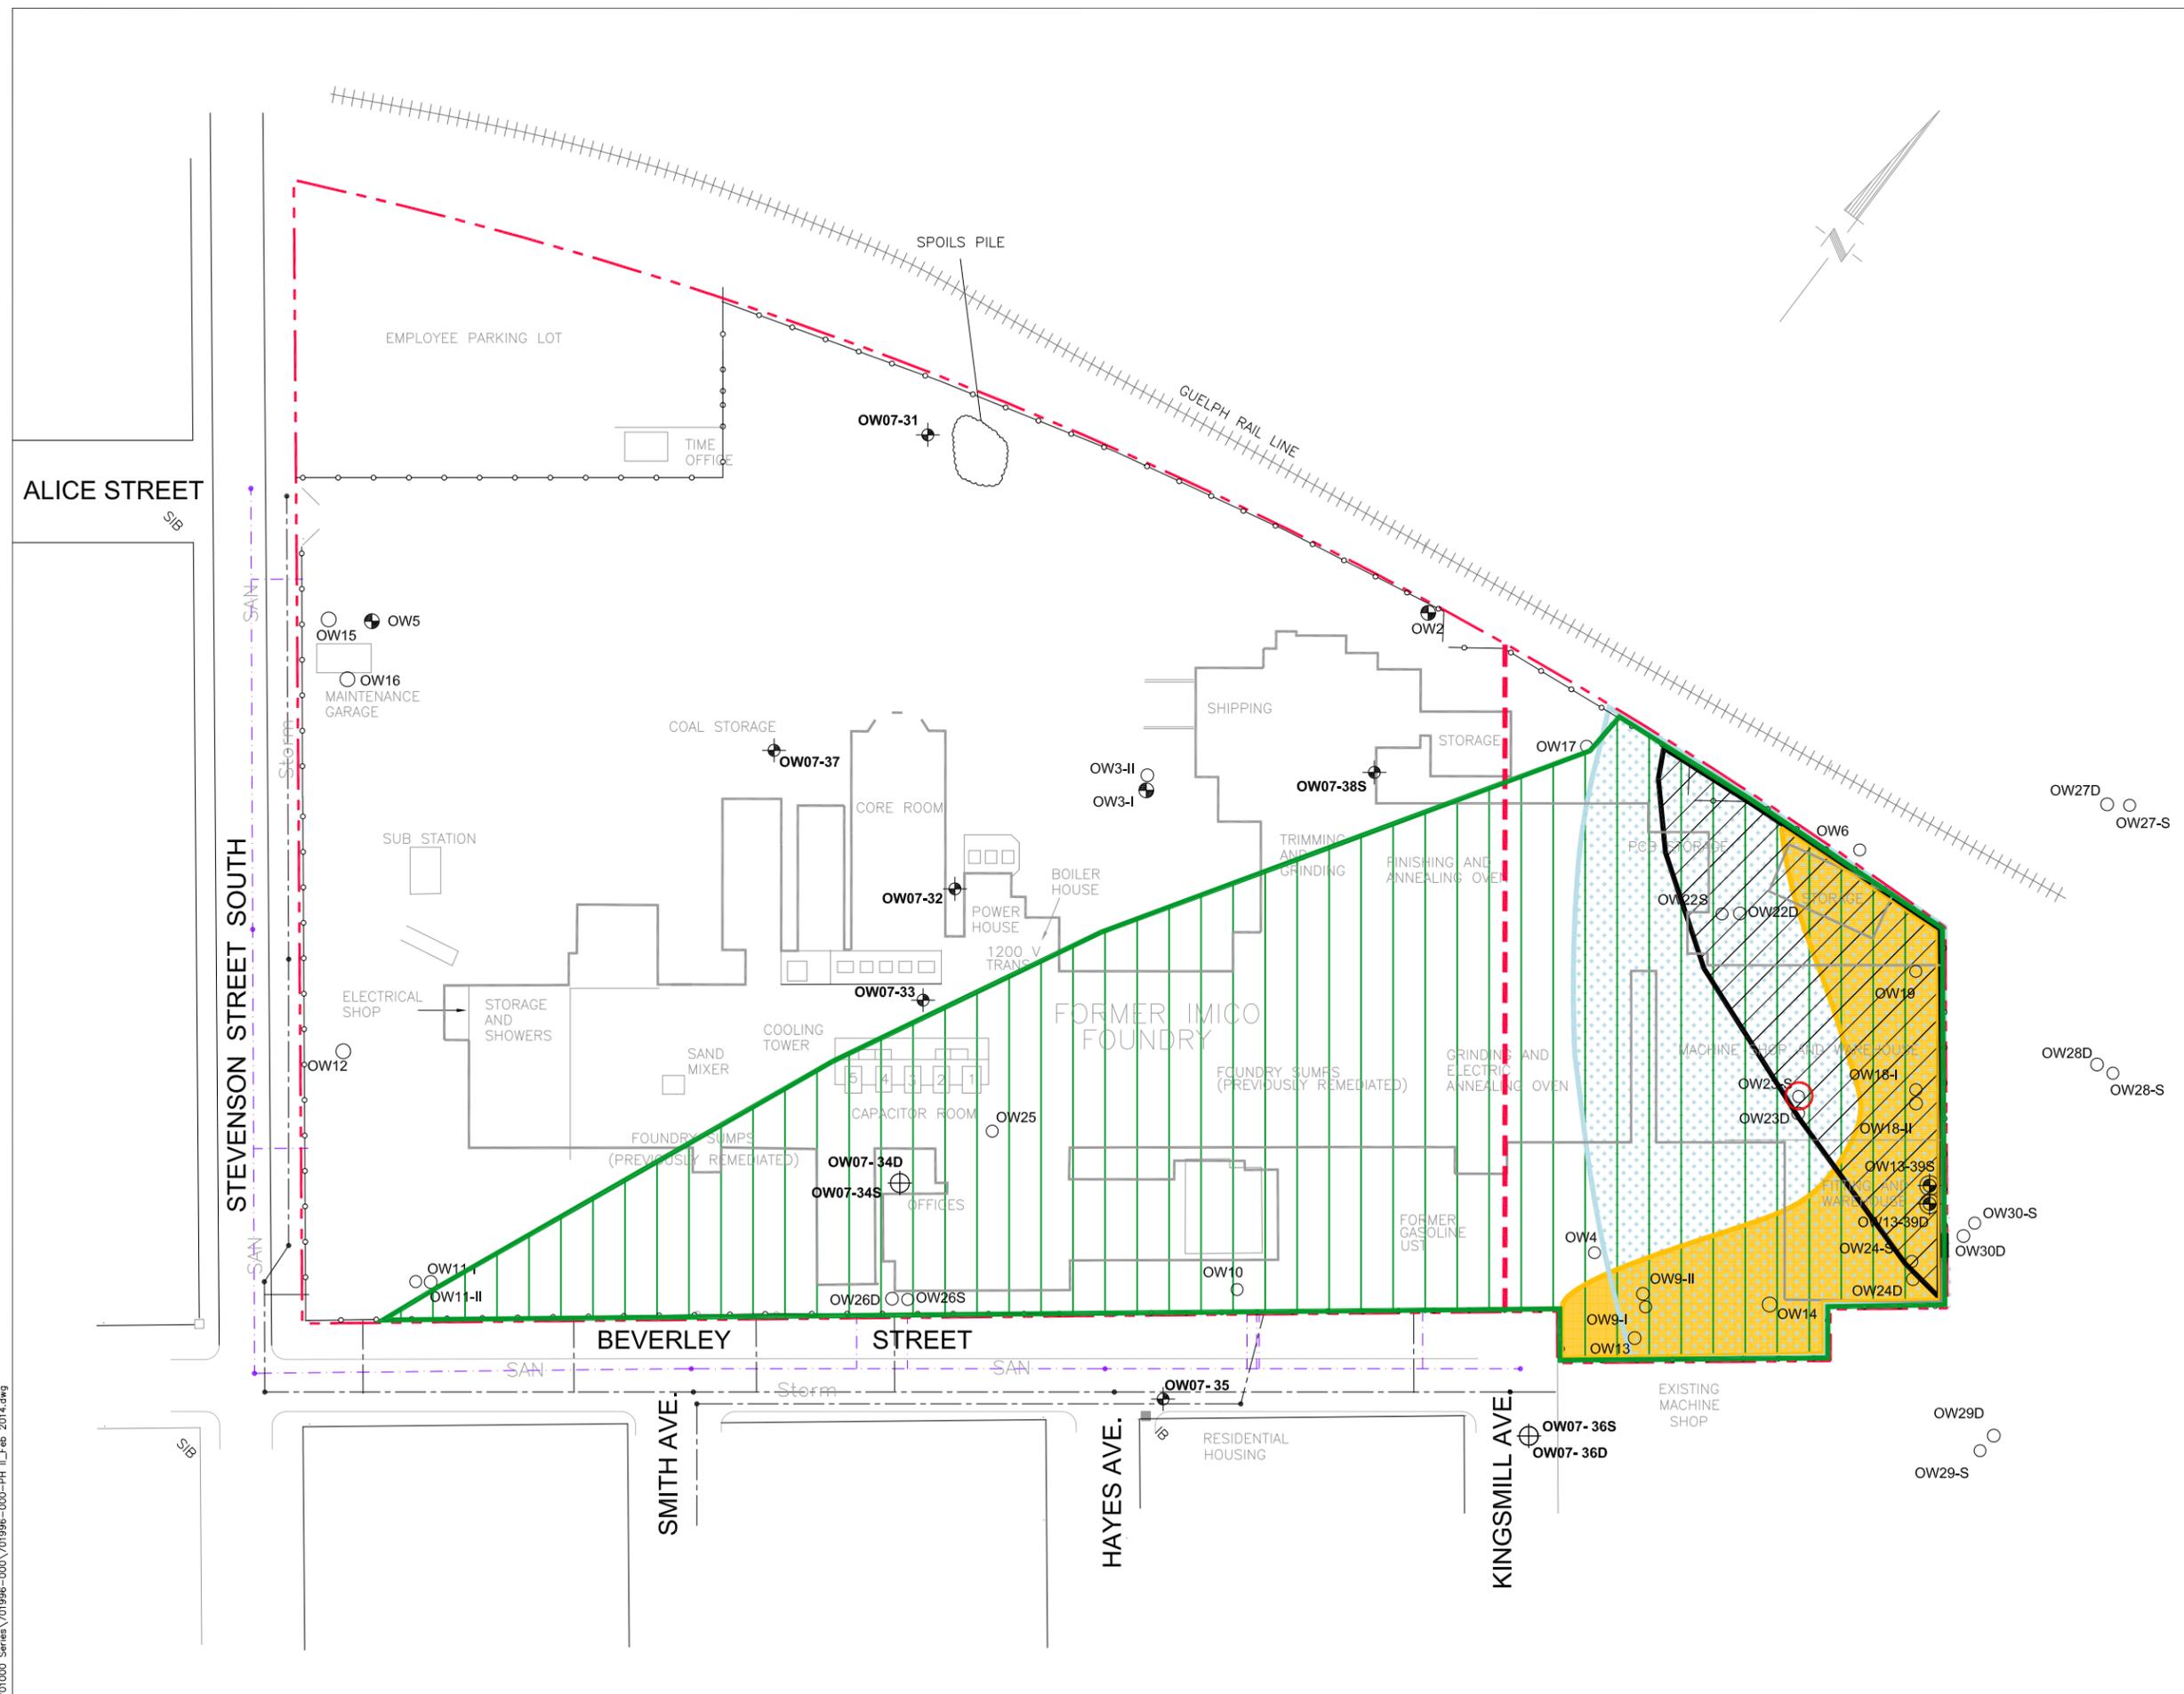
- EXTENT OF VOCs CONTAMINATION
- EXTENT OF PHCs CONTAMINATION
- EXTENT OF PAHs CONTAMINATION
- EXTENT OF METALS CONTAMINATION
- FREE PRODUCT ON GROUNDWATER SURFACE
- PROPOSED LINE SEVERING PROPERTY
- EXISTING PROPERTY LINE

The limits of groundwater impact, based on the investigations completed by AECOM in 2012 and 2013 are shown on Drawing 701996-RAP-5.2. As may be seen the impacts are generally restricted to the east end of the property and along the south property line. The major impacts in the groundwater are VOCs (TCE and its degradation products).

Contaminants in the groundwater at the east end of the property were generally found to the east of a line extending north from the center line of Kingsmill Avenue. In this area PAHs, PHCs and VOCs exceeded the applicable MOE Table 6 SCS.

In addition, free product was detected in one monitoring well OW23S, located in the former machine shop and warehouse area. At this time the composition of the free product has not been determined. However, based on the analytical results of the groundwater it appears to be PHC based. In this monitoring well the F2 fraction was detected at 13,000 ug/L (Table 6 SCS 150 ug/L), F3 at 580,000 ug/L (Table 6 SCS 500 ug/L) and F4 at 23,000 ug/L (Table 6 SCS 500 ug/L). In addition a number of PAHs (chrysene, fluoranthene, phenanthrene and pyrene) were found in excess of their applicable MOE Table 6 SCS.
