Phase One Environmental Site Assessment

Project Name
Phase One Environmental Site Assessment
68-76 Wyndham Street South, Guelph, Ontario

Project Number
KCH-00252519-A0

Date Submitted
May 30, 2019

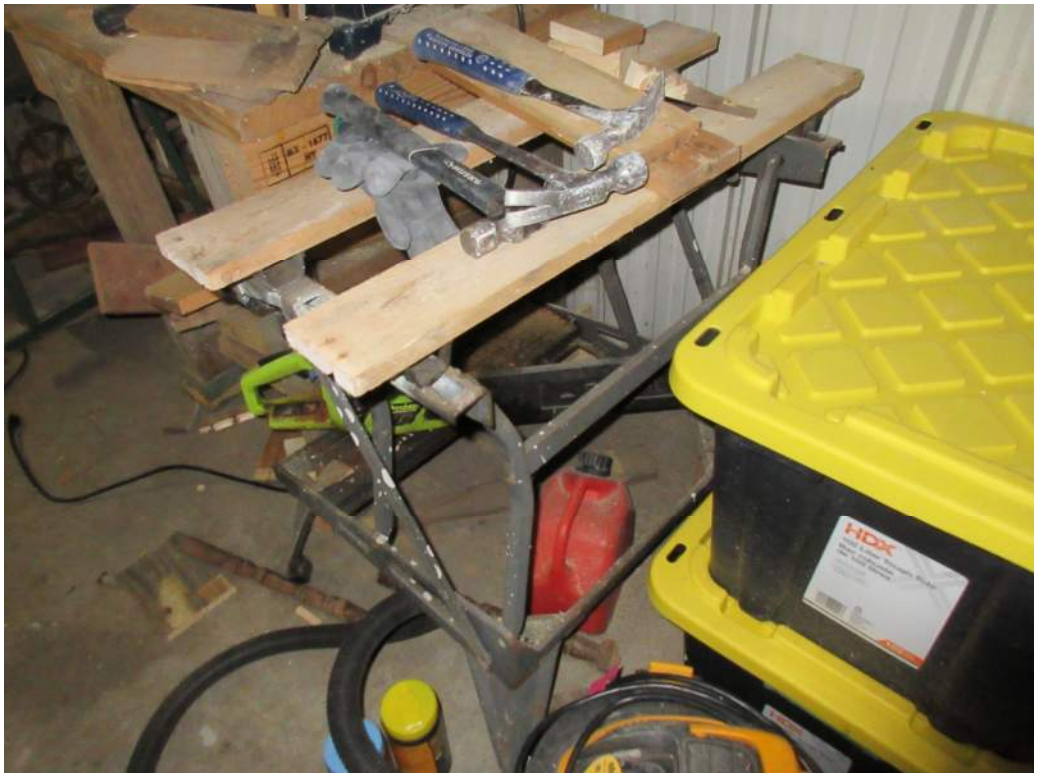
Photograph No. 24 View of fuel storage in garage at 76 Wyndham St. S.
