## **Drawing Package for Consultant RFP**

**Fire Hall #3**

**115 Stone Rd**

## Detailed Structural Assessment Report

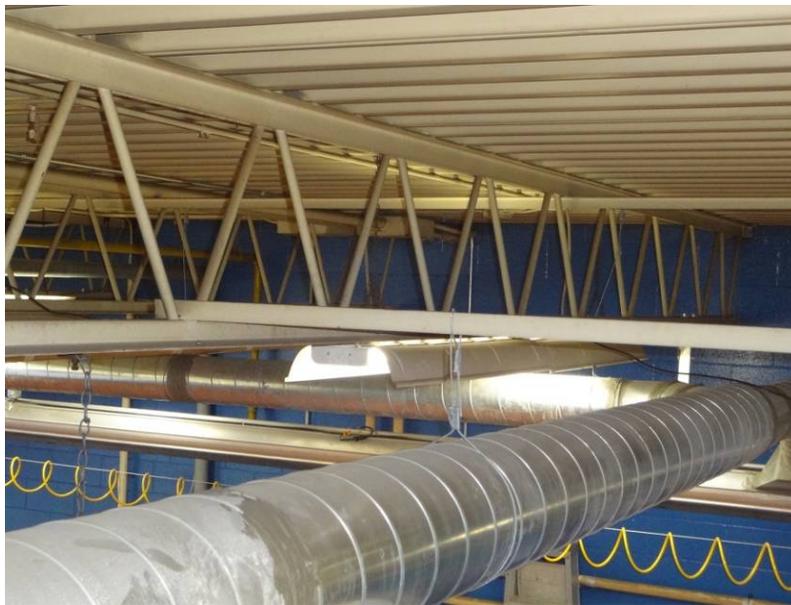
Photograph "2"  
Roof joist system at apparatus floor  
Duct work, lighting fixtures

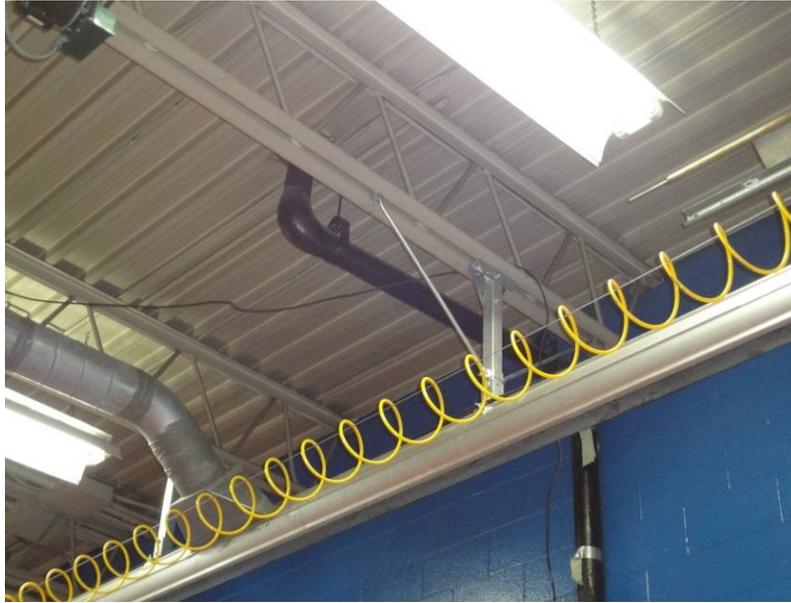
Plymovent exhaust system, gas-fired radiant heaters and lighting fixtures are attached to the bottom chord of the roof OWSJs. It is recommended that the manufacturer of the products provide a letter certifying that the installation of the products has been carried out as per the manufacturers' technical and installation guide and that the installation has been reviewed by a professional engineer confirming that the additional loads due to operation of the products would not compromise the structural integrity of the supporting structure(s).

Photograph "5"  
Plymovent system suspended from the bottom chord of the roof joists

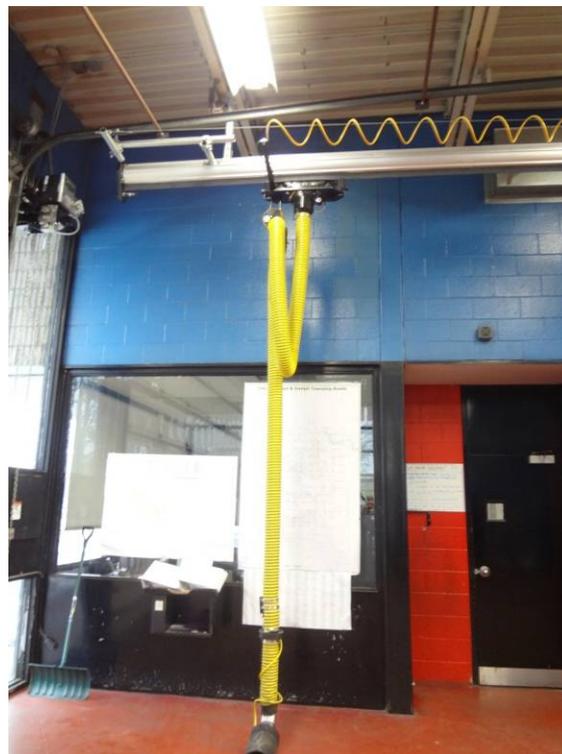
Photograph "6"  
Apparatus floor  
Plymovent system suspended from the bottom chord of the roof joists

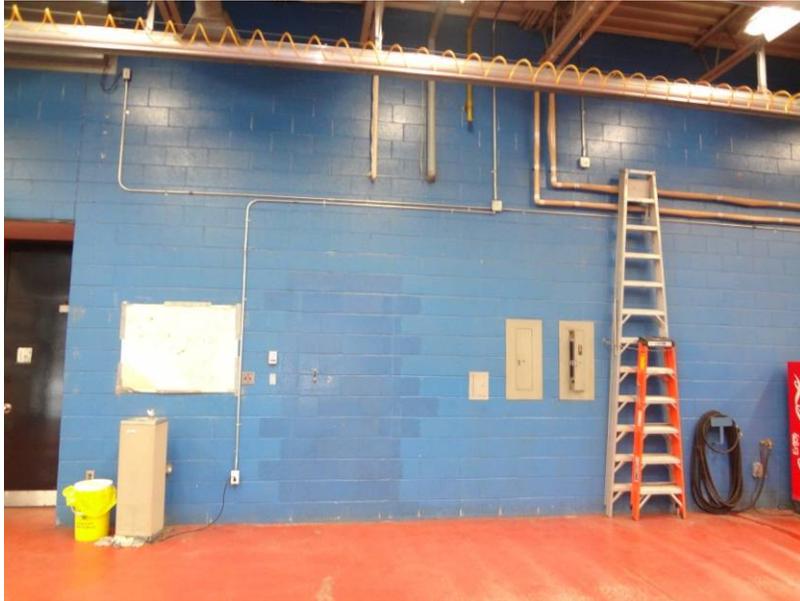
Photograph “7”  
Apparatus floor  
Alterations to the Multipurpose Room (Door opening sealed with blocks)

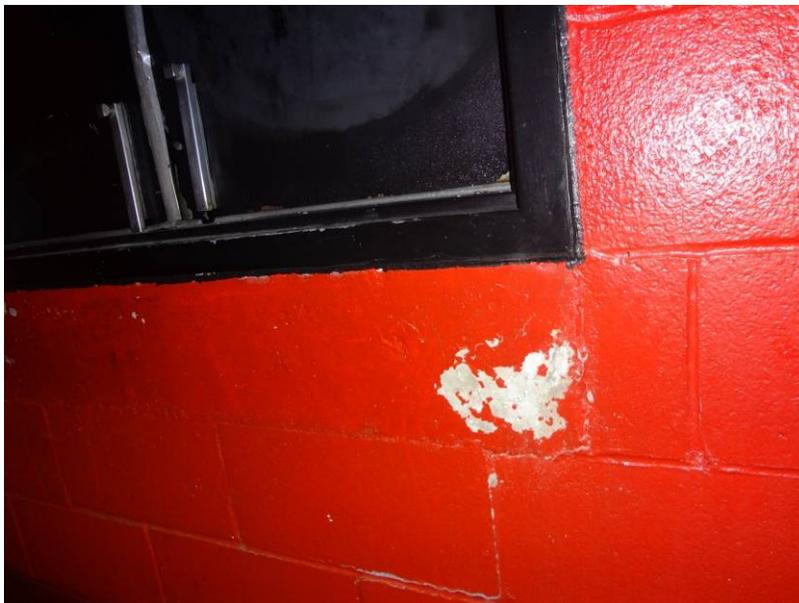
Photograph "14"  
Fire Hose Storage Tower  
Paint delamination

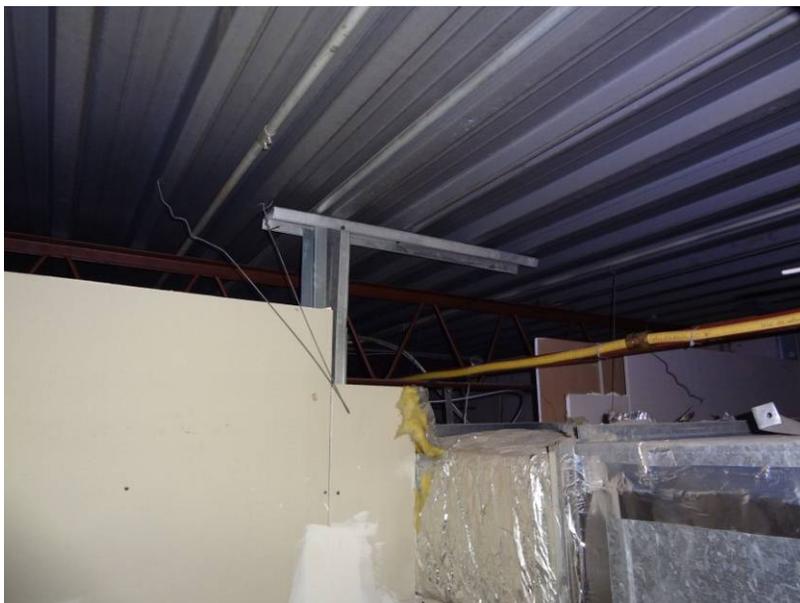
As a systematic deficiency, we have noted that some of the interior block walls aren't sealed to the soffit of the roof deck or to the roof framing. There are concrete blocks that are loose in place with no proper supporting structure. Top of the concrete block walls must be laterally braced. All duct penetrations through the block walls must be properly framed and reinforced. The repair work must include the required application of fire stopping and smoke sealant to all pipe penetrations through the fire rated assemblies where breached.

Photograph "22"  
Demising wall separating Dormitory and Multipurpose Room  
Laterally unsupported wall

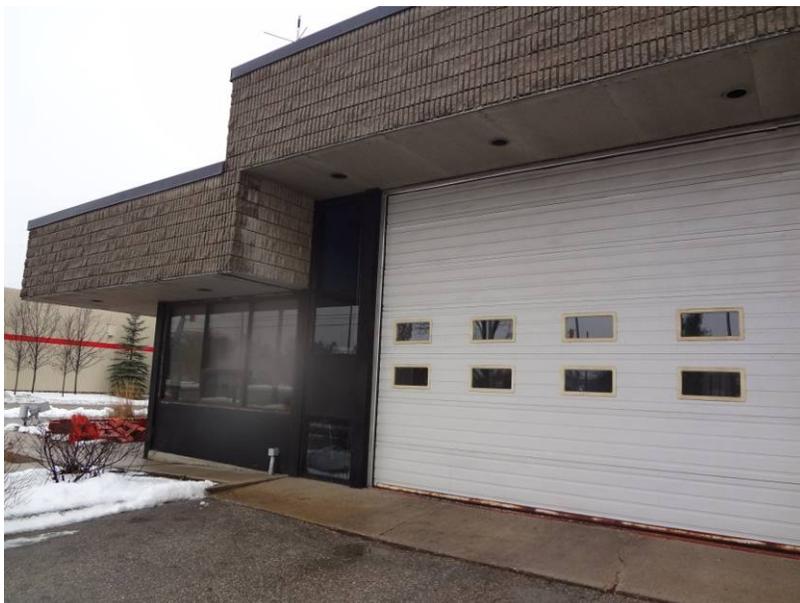
The exterior steel framing and the soffit of the cantilevered portion of the roof overhangs (canopies) are covered with transite boards (asbestos fibre cement boards) that are mechanically fastened to the supporting structure. The fastening screws are corroded. The transite boards are locally cracked and delaminated from the supporting structure at the edges. The sealant material at the edges of the suspended soffit is locally cracked and has failed.

Photograph "26"  
Roof overhang (canopy) at the south elevation

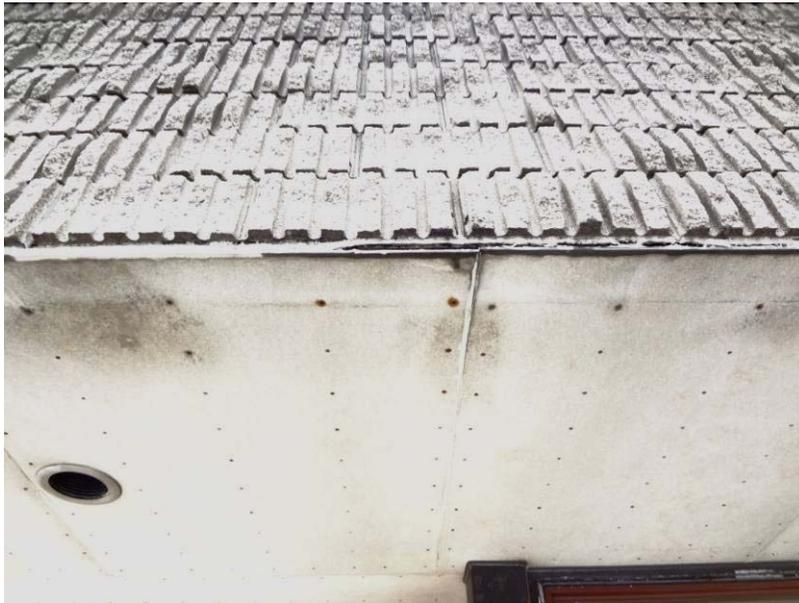
Photograph "27"

Roof overhang (canopy) at the south elevation

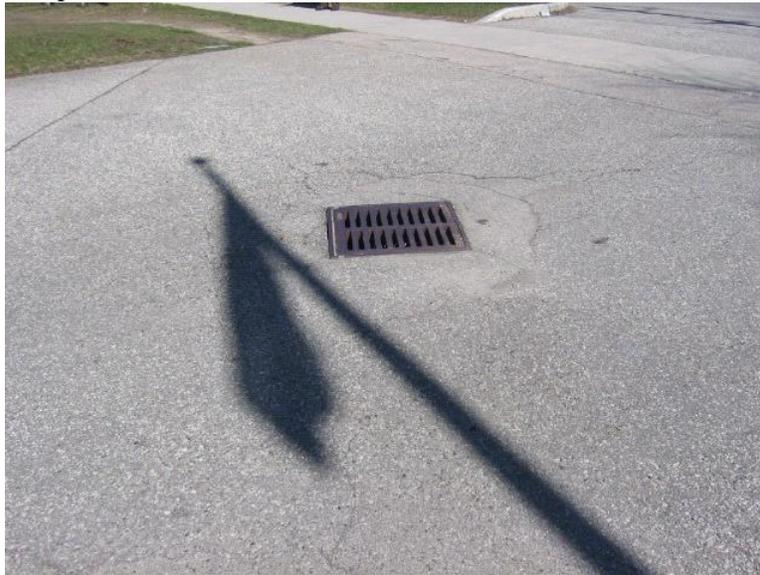
The drainage of the driveways and surface parking was noted to be adequate.

Photo 2: Typical catchbasin located within the garage main entrance

It is unlikely that any substantial repairs to the site drainage characteristics will be required within the study period.

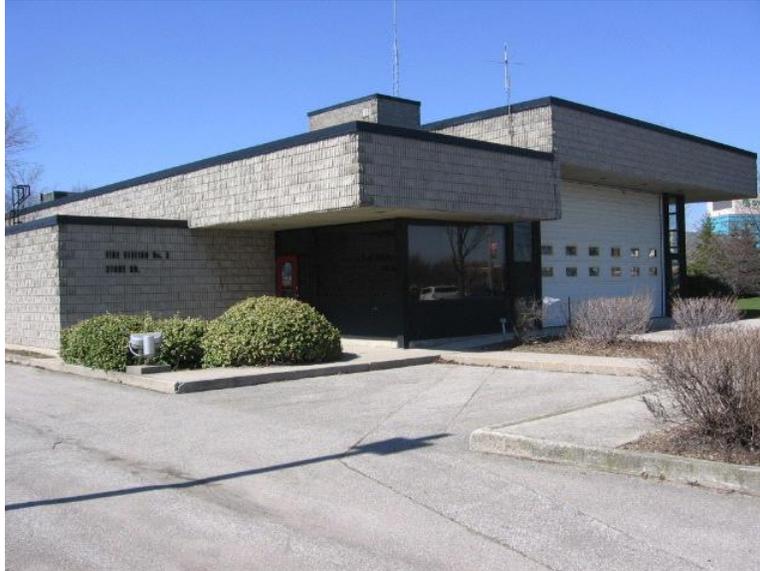
The landscaping was in generally fair condition at the time of the site review.

Photo 3: Landscaping around the front entrance

In order to bring the general landscaping up to the standard of the original assumed design, replanting will be required to some of the shrubs and flowerbeds.

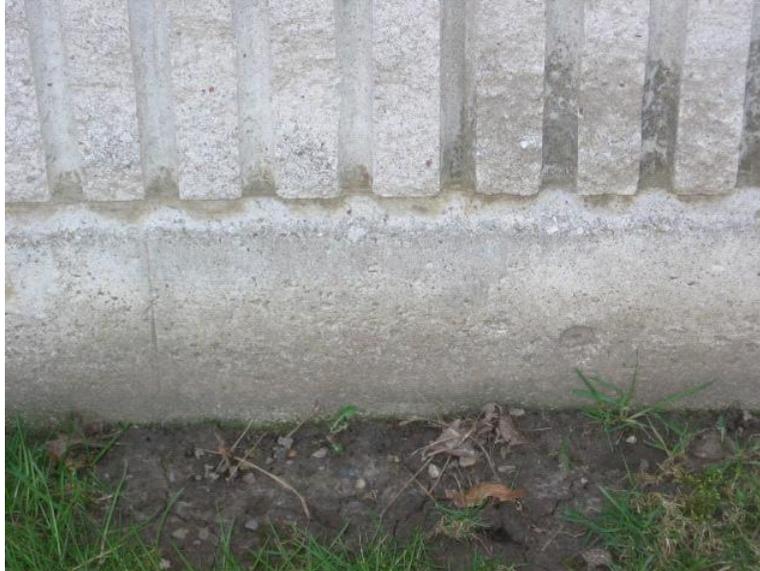
The foundation walls appeared to be in generally good condition at the time of the site review.

Photo 5: General photo of cast-in-place concrete foundation walls

The condition of the foundation walls indicate that no current capital expenditures appear to be necessary. It is unlikely that significant repairs to the foundation walls above the threshold amount would be required within the study period.

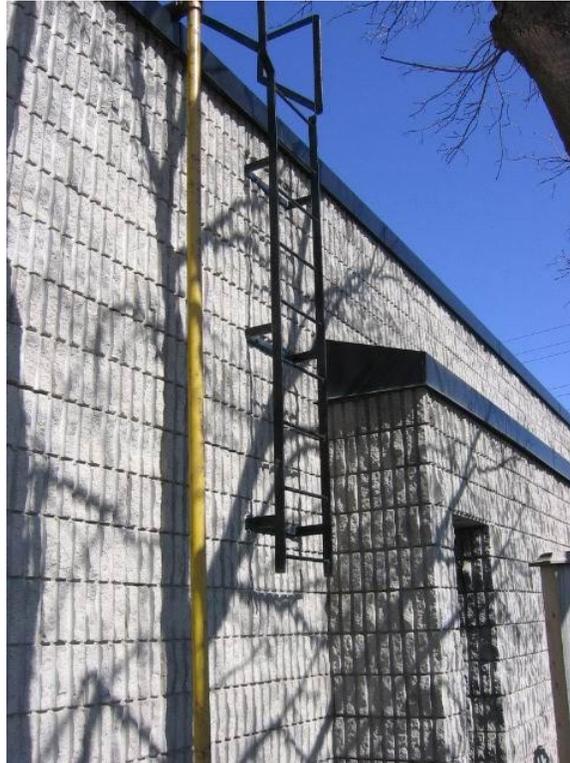
The painted access ladder was in generally good condition, with no signs of damage or distress.

Photo 6: Wall mounted roof access ladder located on the west elevation

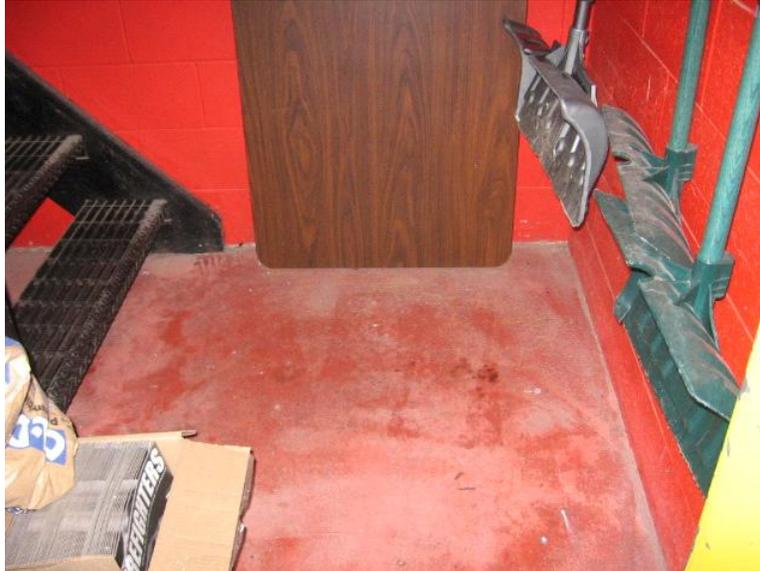
The floor finishes within the service areas were in generally fair condition at the time of the site review, with signs of wear and tear.

Photo 14: Typical painted slab within stairwell of fire hose tower located off of the garage

**BI6** We do not anticipate any capital costs associated with this item, as any painting and touch-ups should be performed as part of ongoing maintenance.

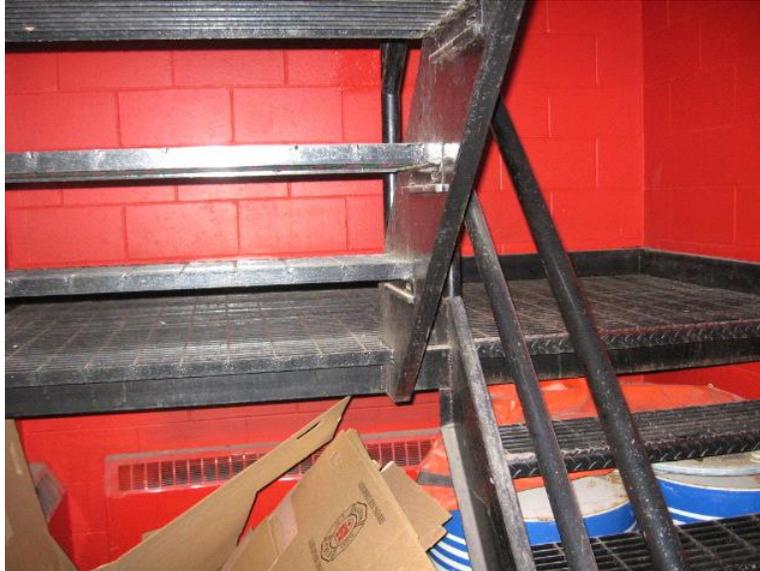
The stairway treads were in good condition at the time of the site review.

Photo 15: Prefabricated steel staircase within the fire hose tower

- BI7** No significant current remedial action is required. The cost of any repairs or painting of the steel staircase is under the threshold value associated with this assignment.

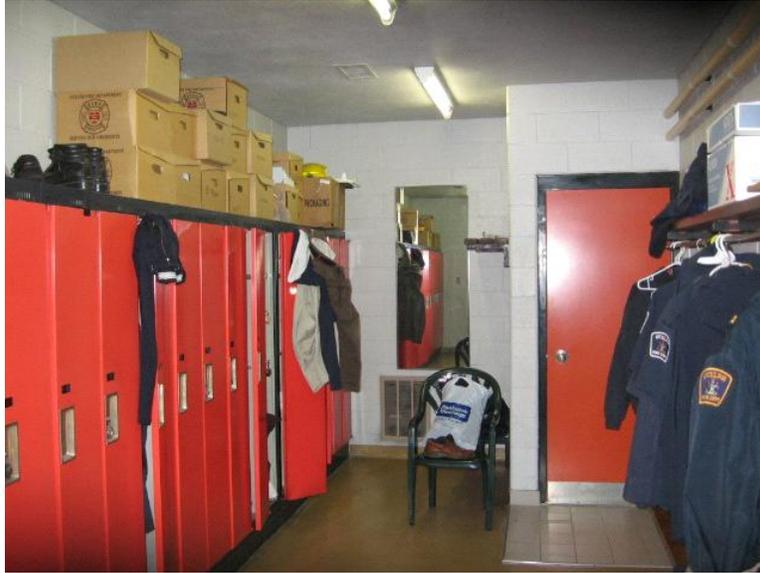
The storage lockers were in generally good condition at the time of the site review.

Photo 16: Lockers located within the men's washroom

- BI9** No current remedial action is required. Budget for refurbishing of the storage locker areas every 30 years.

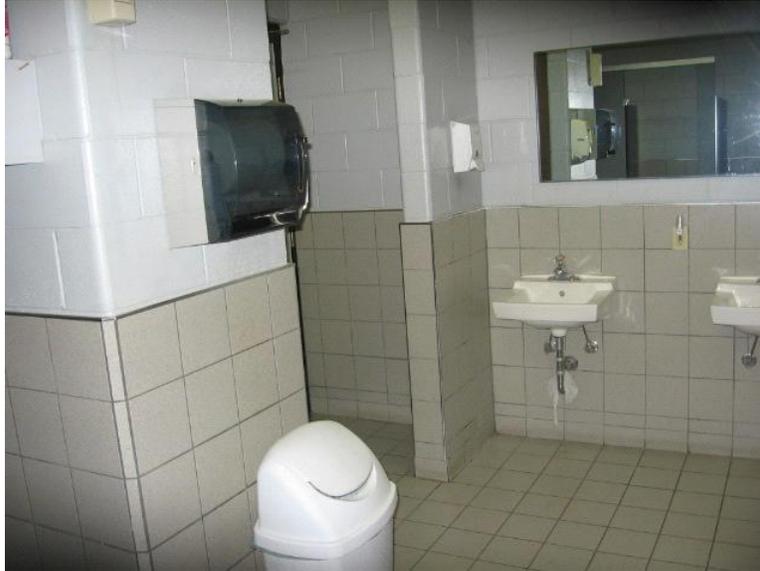
The washroom finishes were in generally good condition at the time of the site review.

Photo 17: General layout of finishes within men's washroom

Based on the current age and condition, we do not anticipate replacement within the term of this assignment.

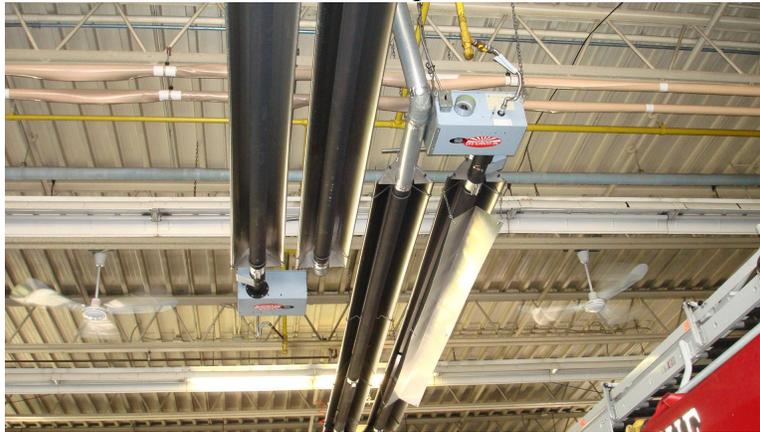
The heating system in the apparatus bay area consists of gas-fired infrared heaters. Heating in the rest of the fire station is provided by a rooftop unit and electrical radiant heaters. The roof top unit is nine years old and appeared to be in fair condition, the infrared heaters are six years old and in fair condition. The electrical radiant heat equipment is approximately 31 years old and appeared to be in fair condition.

Photo 18: Infrared tube heaters in the apparatus area

**MS1**

Replace two infrared heaters in the apparatus bays at 10 years of age, funded by maintenance budget. Budget to replace the electrical heaters at the same time.

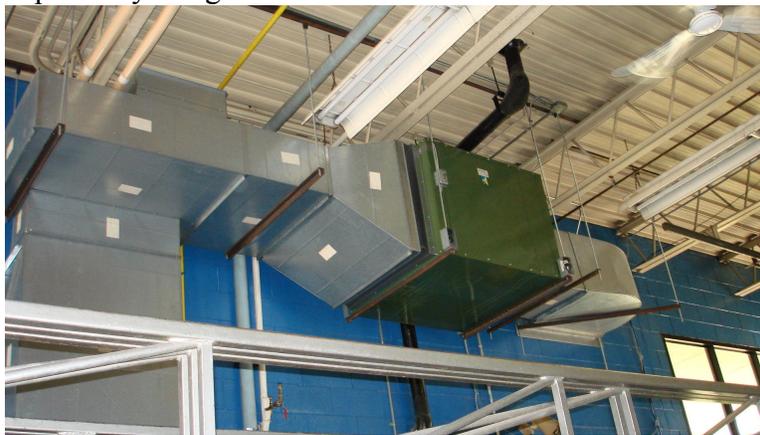
The apparatus exhaust fan, F3-EF-3, is interlocked with the carbon monoxide (CO) detection system and only turns on when CO levels created by the fire trucks exceed the set limit. This fan does not run often relative to building general exhaust and therefore has an extended life expectancy. Regular maintenance should continue to be carried out.

Photo 21: Apparatus bays exhaust fan, F3-EF-3

**MS3**

Budget for replacement of the exhaust fans at 20 years of age.

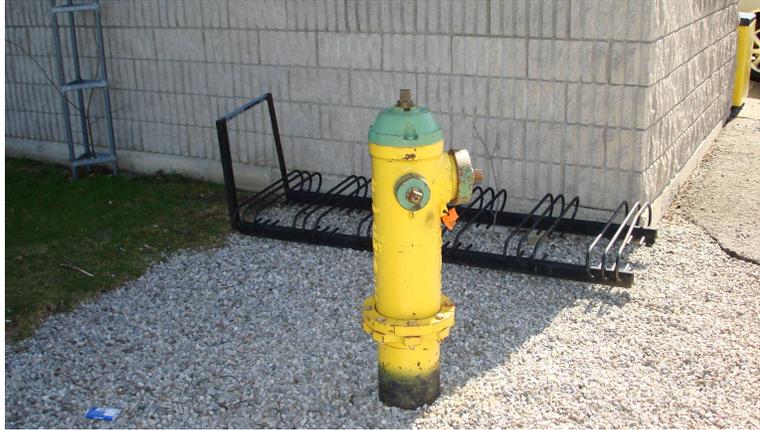
Photo 24: Local fire hydrant

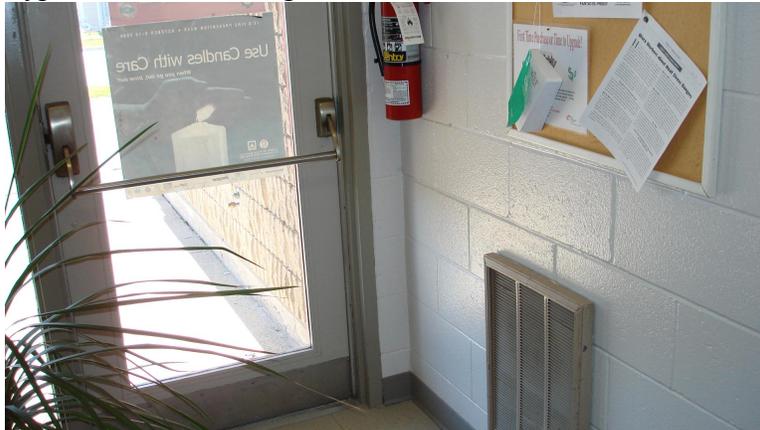
Type A/B/C fire extinguishers are located in corridors or exits.

Photo 25: Fire extinguisher by exit door

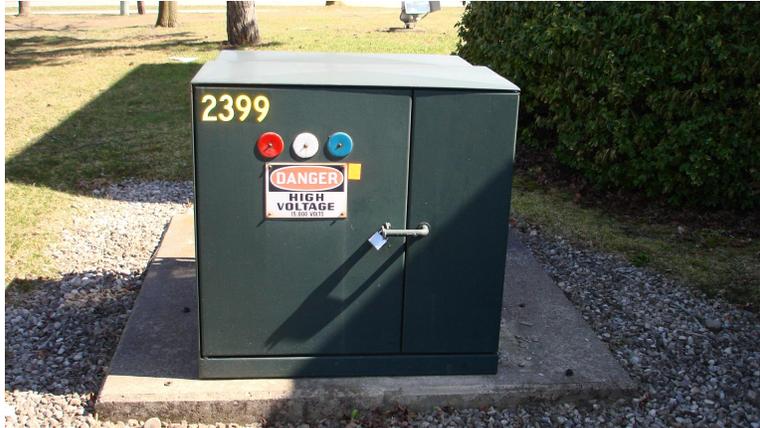
A 15,000-volt transformer, oil-filled type, is located outside and appeared to be in good condition.

Photo 26: Utility owned transformer

#### ES1

The transformer appeared to be 30 years of age and is not likely to contain PCBs, however it is recommended that Guelph Hydro be contacted to confirm the presence or absence of PCBs in the oil. No capital expenditures above the established threshold are anticipated within the study period.

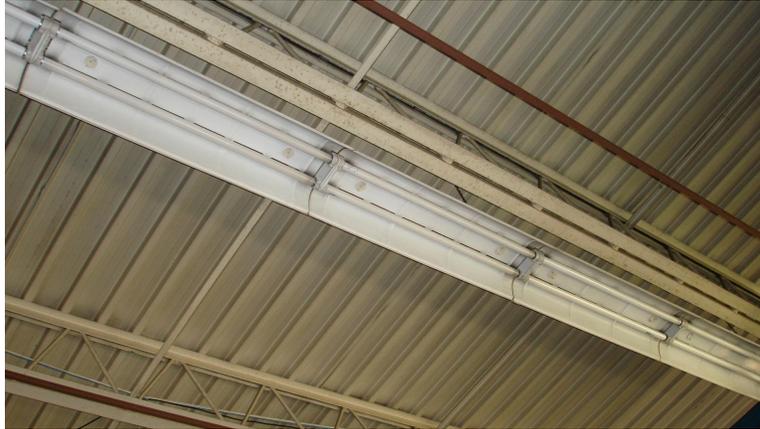
Photo 28: T-12 fluorescent bulbs, apparatus bays

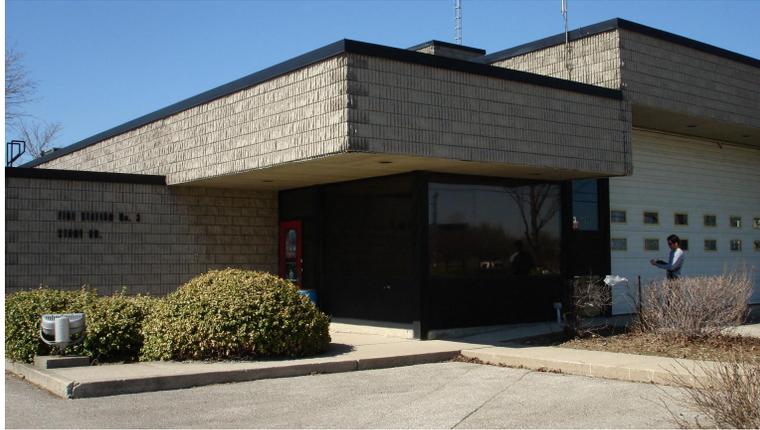
The facility has outdoor lighting consisting of two WideLite fixtures mounted on the ground and under soffits, providing security and parking lot illumination. The source of lighting is metal halide and halogen, respectively, and are time-switch controlled. The halogen fixtures are in fair condition.

Photo 29: Soffit exterior lighting

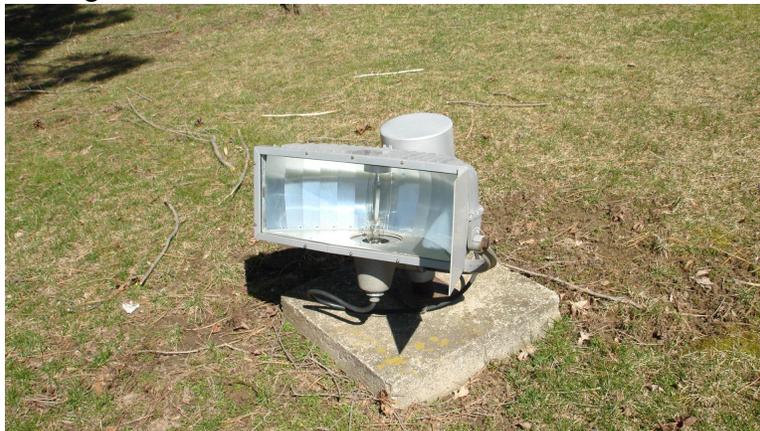
The two metal halide light fixtures were refurbished two years ago and are in good condition.

Photo 30: Exterior lighting, mounted on grade

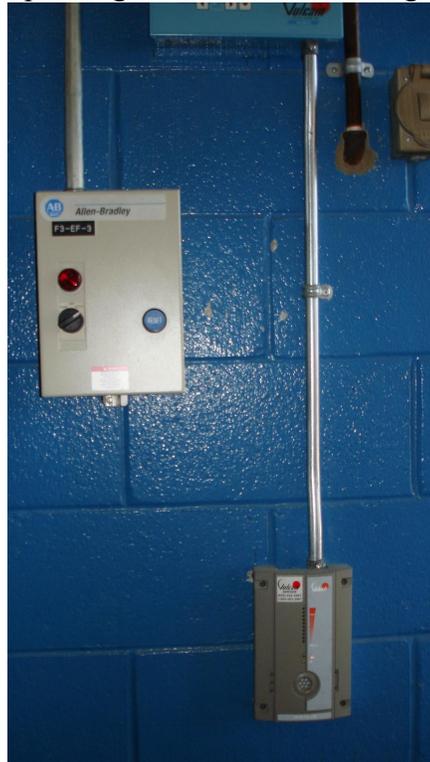
Carbon monoxide (CO) detectors were installed in the apparatus area and appear to be in good condition. When found malfunctioning, smoke or CO detectors should be repaired or replaced immediately as part of the regular operating and maintenance budgets.

Photo 31: CO detector interlocked with F3-EF-3, apparatus exhaust fan

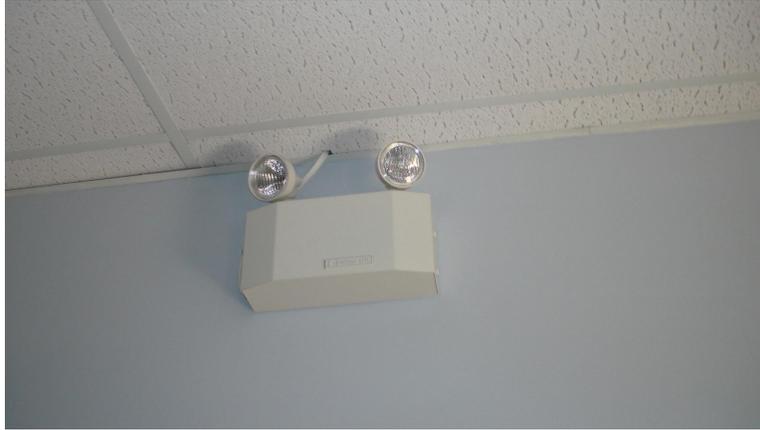
The lights use internal batteries and appear to be in good condition. They are tested regularly by the health & safety staff.

Photo 33: Emergency light head, battery pack type

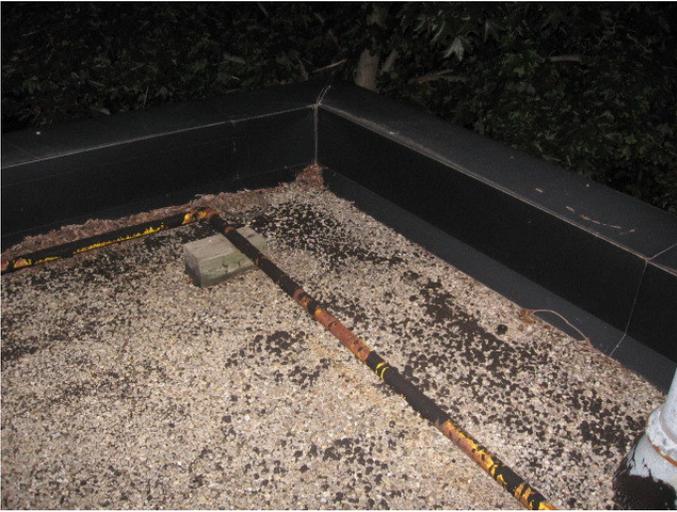
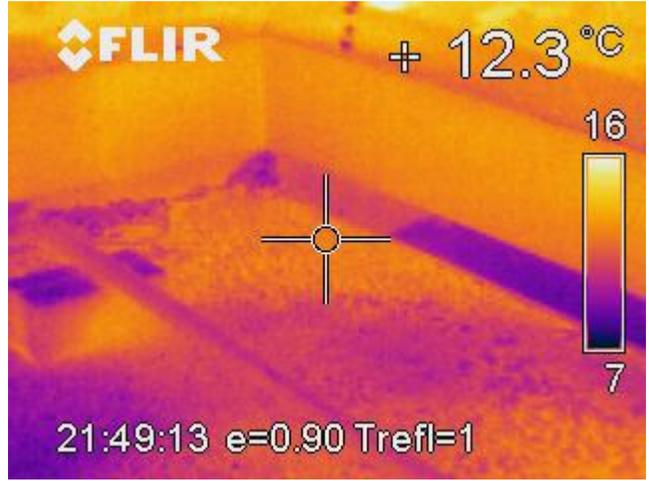
During our survey of this roof area, we noted a few areas of interest. Most of the warmer areas observed from thermal imaging appeared to correspond with areas where "blueberries" were congregated. Blueberries are small beads of excess asphalt membrane bleeding to the surface, typically occurring around roof penetrations and along vertical joints during application. Photographs of a typical blueberries and the associated thermogram have been included as Figure 1, for reference. These areas are not indicative of wet insulation boards or roof leakage.

**Figure 1:** Typical photograph and thermogram identifying the effects of blueberries and the associated thermal images.

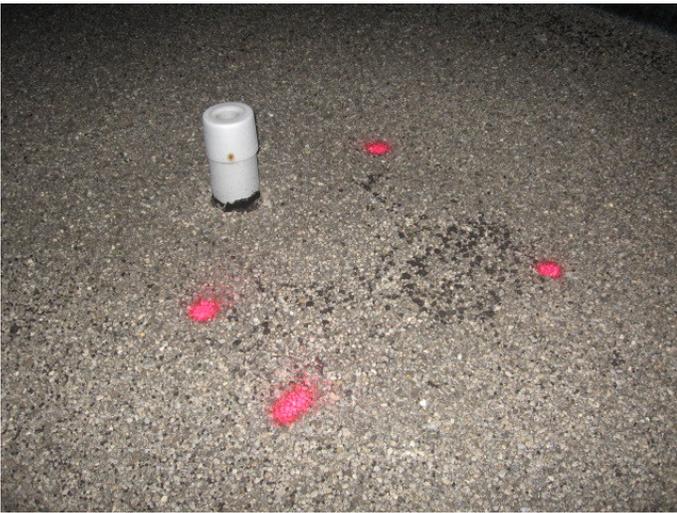
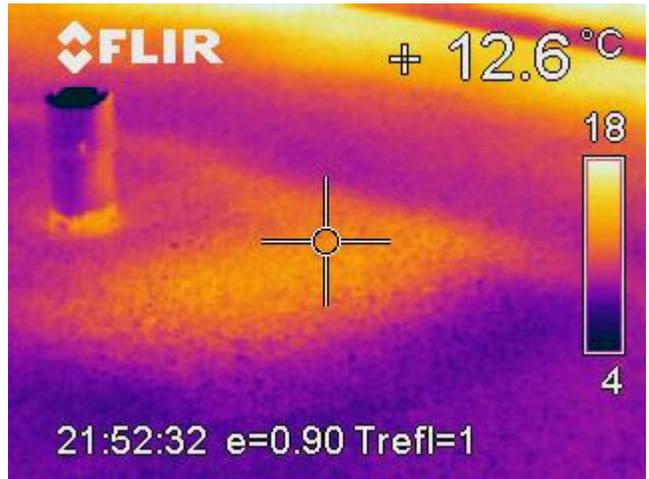
We noted three locations on the main garage roof that appeared to be possible areas of wet insulation boards. Two of these areas were near exhaust vent stack penetrations and consisted of a rectangular pattern indicative of wet insulation. Photographs and thermograms of these locations have been included as Figures 2 and 3. The regular light photographs suggest that blueberries may have influenced the observed thermal profiles in these areas.

**Figure 2:** Photograph and thermogram identifying warmer areas, indicative of wet insulation at an exhaust vent penetration.

The IR survey identified a few small areas of possible wet insulation indicative of water leakage in the built-up roof areas. The roof surface appeared to be in good condition, considering its age. We were not informed of any current or previous roof leaks at or around these locations, and hence repairs are likely not warranted at this time. Aside from the roof replacement at the end of its service life indicated in the cost summary tables, no additional repairs are warranted.

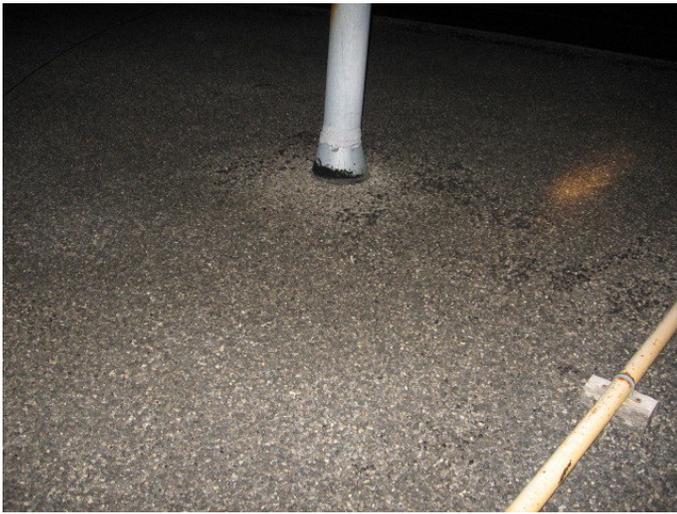
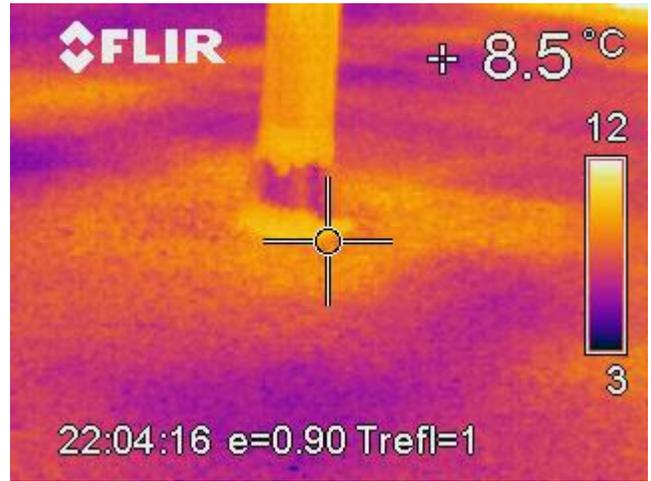
**Figure 3:** (a) shows the area around a vent pipe where the thermal profile in (b) was observed. (a) suggests that the thermal profile might be influenced by the blueberries in this area.

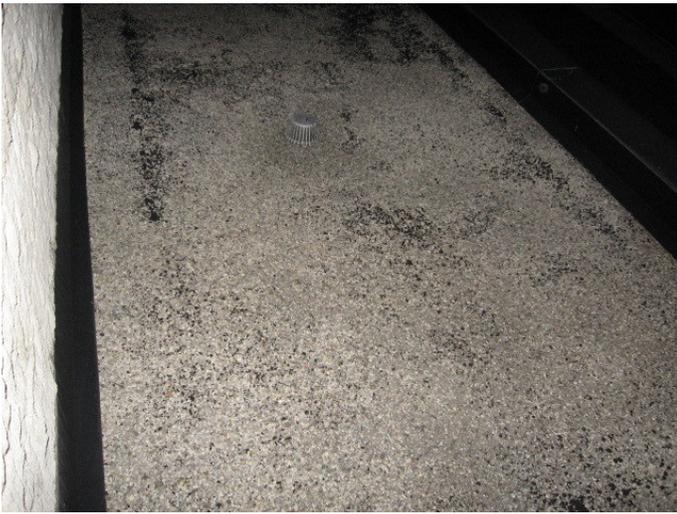
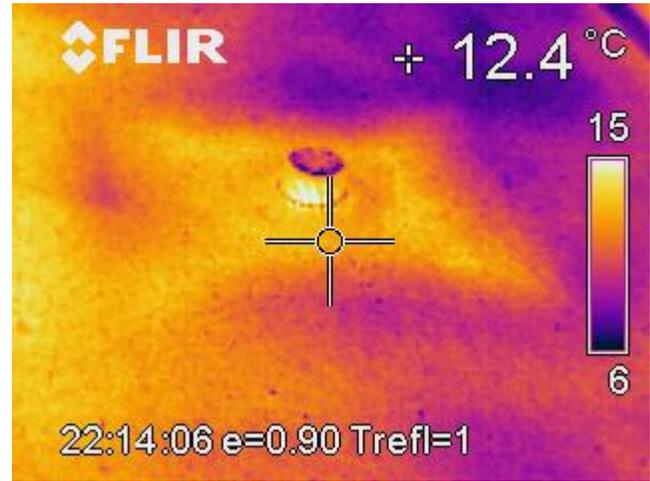
The last area of possible leakage was noted on the lower west roof at a roof drain. This area identified a distinct rectangular profile, and no blueberries were noted corresponding to the thermal image. Figure 5 contains a regular lit photograph and thermogram of this area.

**Figure 5:** Photograph and thermogram of the roof drain on the lower west roof, identifying a distinct rectangular profile, indicative of a wet insulation board.

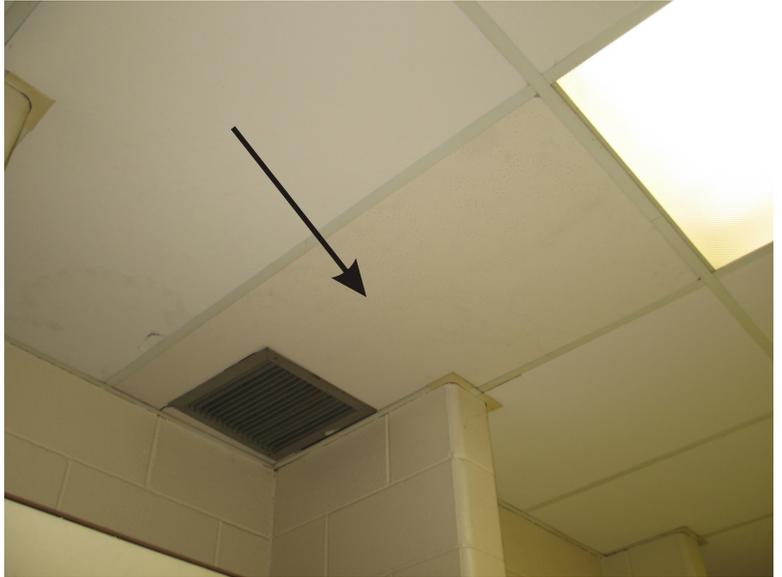
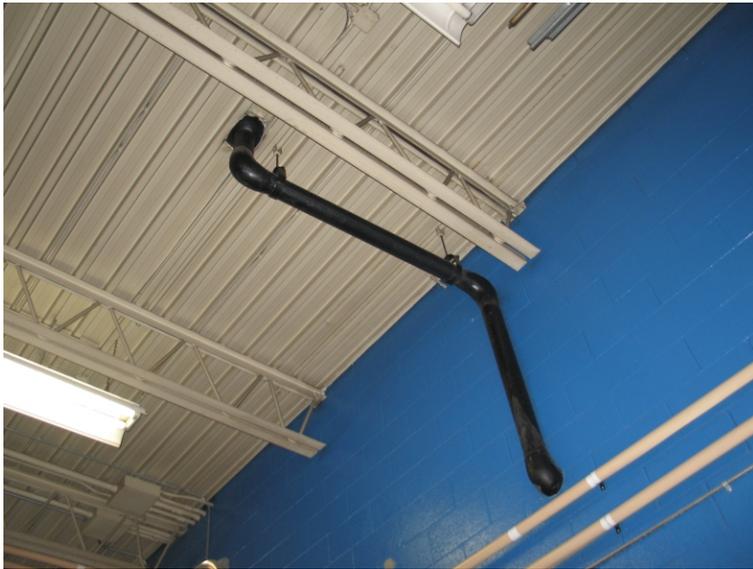
Figure 2: Fire Hall #3, Guelph, Ontario

Transite Rainwater Leader Piping in Garage. The Fittings for the piping in this room do not contain asbestos.

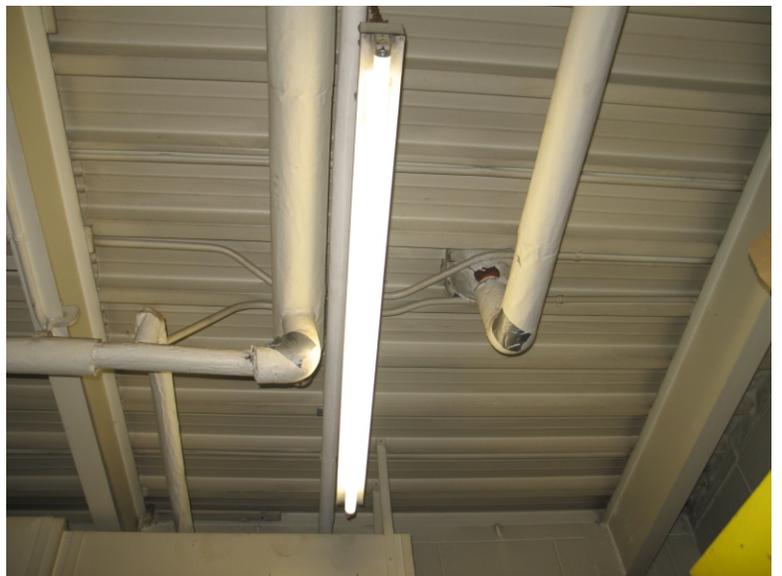
Figure 3: Firehall #3, Guelph, Ontario

All Fittings in Room 112 contain asbestos
