Building Condition Assessment and Preventative Maintenance Plan

Victoria Road Community Complex Guelph, Ontario July 2005

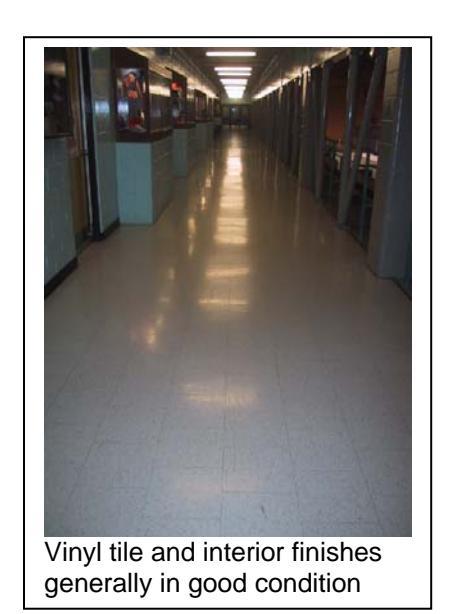
Description, Assessment and Recommendations: Most of the service areas have painted or unpainted concrete floors. The meeting rooms on the third floor, the concession room on the third floor have vinyl tile, which appears to be original to the 1975 construction. Some of the tiles near the concession area have already been replaced. Thirty years is a normal life expectancy for vinyl tile and this tile is reaching the end of its life expectancy. Recommend planning for the replacement of this original tile in about 7 years. The third floor corridor along the gallery to the ice arena has a vinyl tile floor however this tile is a different colour than the tile in the meeting rooms. The tile in the corridor is in good condition and may have been replaced since the 1975 construction. The tile in the third floor corridor will likely last the duration of the study period. The flooring in most of the public traffic areas is a mastic material call ceramite and is original to the construction of the

building. This material appears to be in good condition, and should continue to where well in the future. The original construction indicated the ceramite was installed in the wet areas of the pool change rooms and the showers. In 1983 about \$57,000 was spent to add ceramic tile to the pool deck which had been coloured concrete and to replace the ceramite in the pool change rooms and the showers. The ceramic tile should have a long life expectancy and should last the duration of the study period. Originally the only room with a carpet was the third floor lounge; however renovations to the pool offices, the male/female exercise rooms and the offices off the main floor lobby have added carpets to these spaces. The carpets were generally in good condition, the lounge carpet had several stains. Recommend planning on the replacement of the carpets in about 5 years and thereafter on a 15 year cycle. The ice rink change rooms, the player's benches and the corridor between these change rooms and the ice rink has rubber mats. These mats are in good condition.

Replace Carpet		
Quantity Estimate:	235 m2	
Unit Cost Estimate:	\$35 /m2	
Cost Estimate:	\$8,225	
Life Span Analysis:	Expected Life Span:	15 years
	Effective Age:	5 years
	Remaining Life:	5, 20 years
Replace Vinyl Floorin	ng	
Quantity Estimate:	180 m2	
Unit Cost Estimate:	\$65/m2	
Cost Estimate:	\$11,700	
Life Span Analysis:	Expected Life Span:	30 years
	Effective Age:	23 years
	Remaining Life:	7 years
Replace Rubber Floc	pring	-
Quantity Estimate:	450 m2	
Unit Cost Estimate:	\$65/m2	
Cost Estimate:	\$29,250	
Life Span Analysis:	Expected Life Span:	30 years
	Effective Age:	10 years
	Remaining Life:	20 years

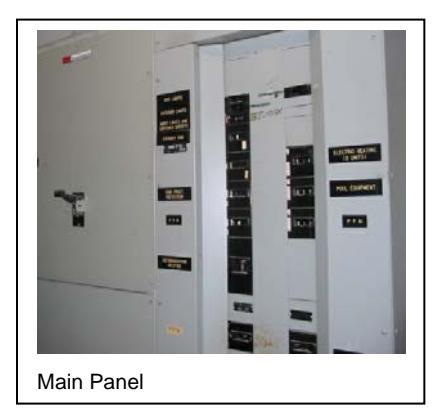
The main distribution panel for the complex is a Federal Pioneer 800 amp 347/600-volt three-phase four-wire panel, which is located in the main ground floor electrical room. Visually the panel appears in good condition. Thermographic scans should be implemented on this equipment at a minimum of once every two years to ensure all connections are tightly secured to the panel bus. A thermogrphic infrared scan was taken of this equipment at the time of the

inspection. This report is attached to this report as a detailed reference. Refer to Appendix C.

Management reports copper conductor is used through out the building. The estimated cost of the entire electrical system is identified below. Although the electrical system is expected to last the life of the building we recommend that an allowance of 5% of the total cost of the electrical system be budgeted every 4 years after 35 years.

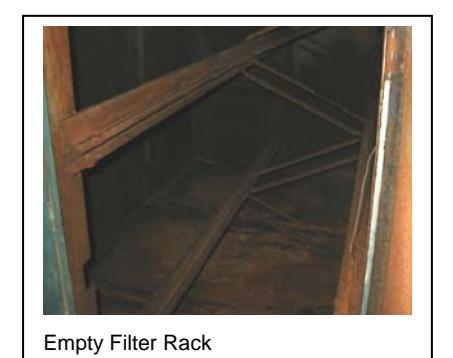
- Temprite natural gas fired air handler (model #: GTDM-65-C, serial # 128/3) at 813,000 BTUH with 5 HP 575 volt blower section. Labelled Lobby Rink Change room supply. Filters were clean at time of inspection.
- Temprite natural gas fired air handler (model #: GTDM-85-C, serial # 128/2) at 1,063,000 BTUH with 5 HP 575 volt blower section. Labelled Natatorium Change room supply. Filters were clean at time inspection.

- Temprite natural gas fired air handler (model #: GTDM-175-C, serial # 128/1) at 1,563,000 BTUH with 15 HP 575 volt blower section @ 18,000 CFM. Labelled Natatorium supply. Filter rack was empty at the time of the inspection.
- Trane natural gas fired unit heater (model #: GF01200A) with input capacity of 125,000 BTUH.

The above equipment is controlled by a DDC building automation system, which actuates a building vintage pneumatic control system. The system with the exception of the DDC control system is the vintage of the building and may be approaching the end of its life cycle.

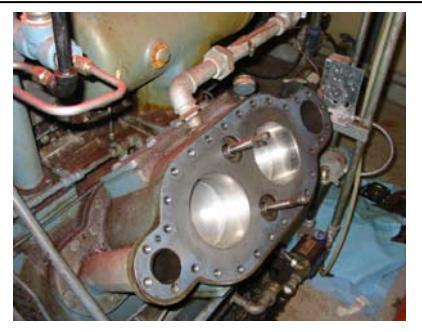
Compressor

- Two Chil-con Products Ltd. (model #: RA16168-509 C870449A-1 and RA16168-509 C870449A-2) heat exchangers.
- Two 75 HP Lincoln reciprocating compressors with 575 volt motors and 1986 manufacture date tag.
- Peerless 3HP (type 825) circulating pump
- 1 HP pump with Century motor

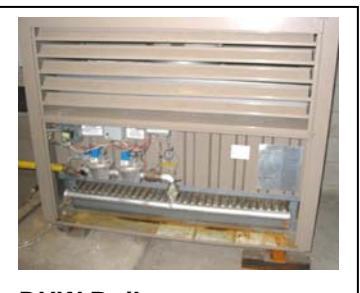
DHW Boiler

- A.O. Smith 1,000 US gallon concrete lined hot water storage tank installed in 2004.
- A.O. Smith (model #: DW1350S110EZ14, serial #: 103343) natural gas fired boiler with an input capacity of 1,350,000 BTUH.
- New Bell & Gossett 1 HP (estimated) re-circulation pump.

The combination of the large boiler and massive storage has the capacity to supply much more hot water than is required for the number of faucets and shower. This system may be over substantially sized. The Zamboni room closet contains the following equipment:
