**Heritage Guelph Meeting
12:00 noon – 2:00 pm
Monday, June 8, 2015
1 Carden St., City Hall**

CULTURAL HERITAGE CONSERVATION PLAN - STAGE 1

5 Arthur Street South, Guelph, Ontario

Issued: May 28, 2014
Revised: July 7, 2014
Revised with City Comments: May 5, 2015
Final Revision: June 2, 2015

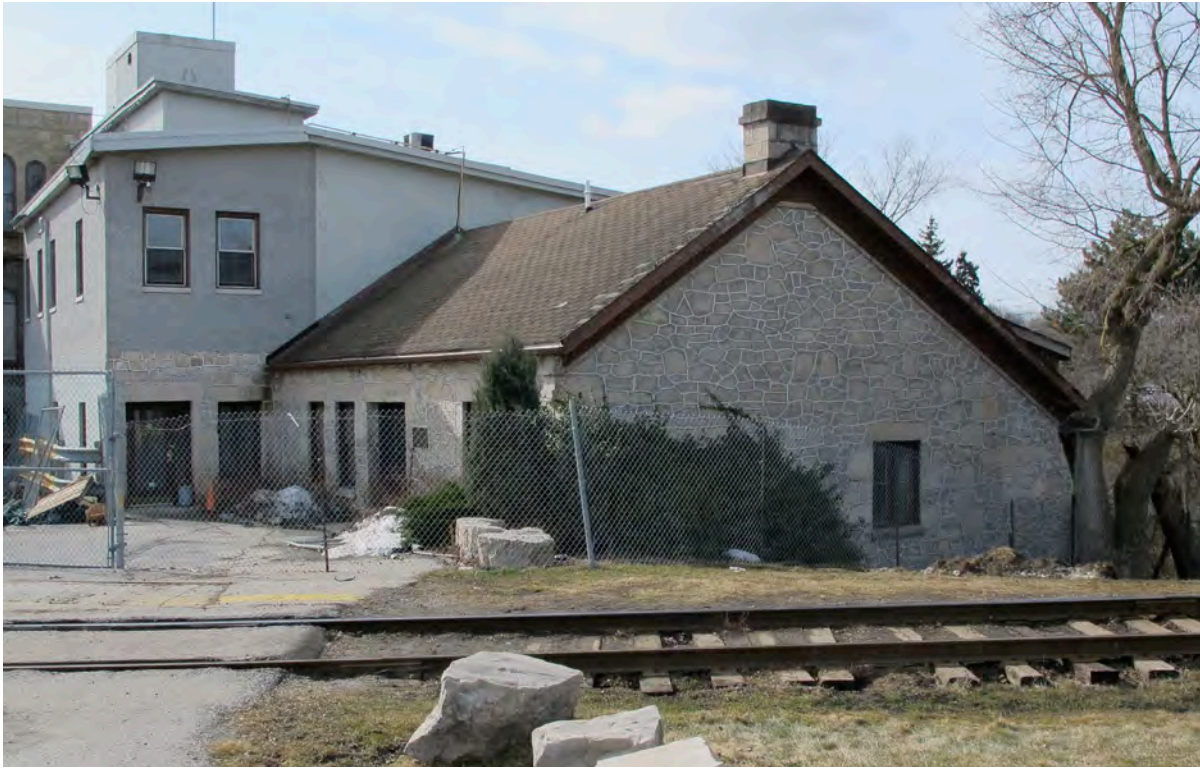
4. Building #1, North Elevation, 2014 (Source: ERA)

The Office Building is a limestone building with a gable roof. It has a one-storey appearance on the north elevation (see figure 4) and east elevation (see figure 5), and reveals a second storey on the west elevation overlooking the Speed River (see figure 6). There is a short stone chimney at the peak of the north elevation. The south elevation is attached to Building 2.

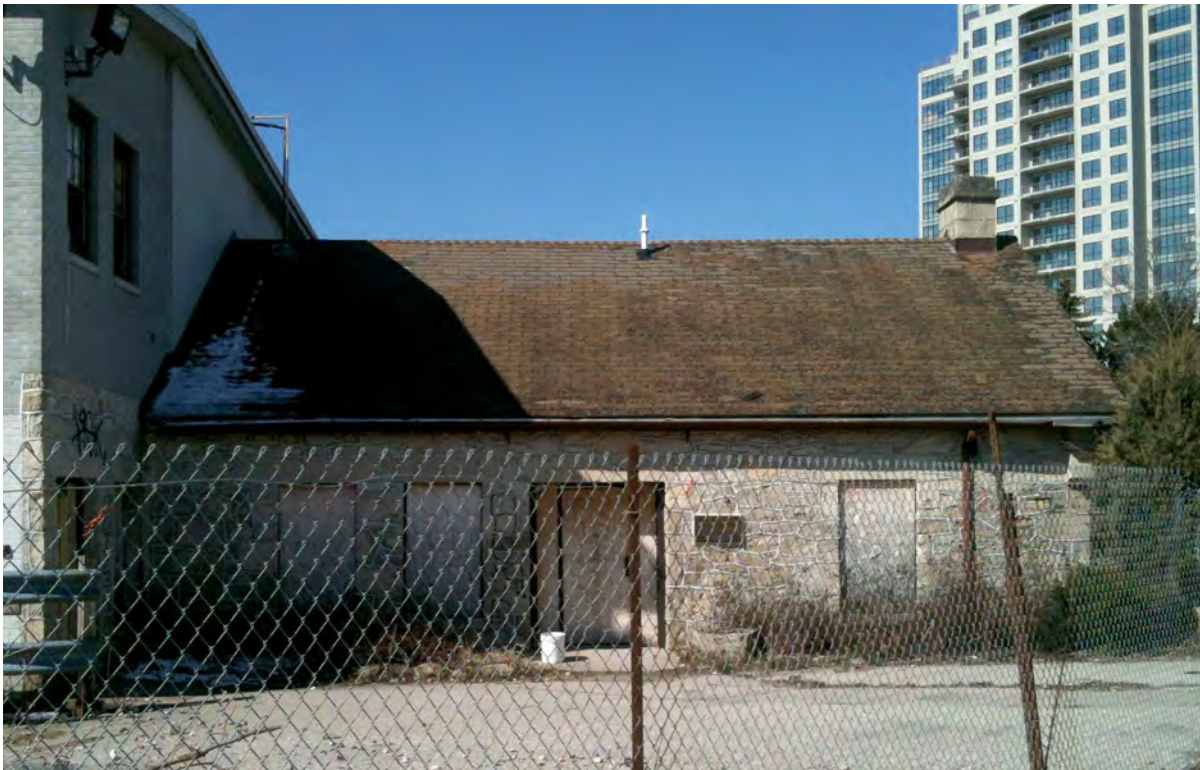
5. Building #1, East Elevation (Source: ERA)

The front (east) elevation displays a centrally located front entrance with two window openings to the south and a single window opening to the north (see figure 5). There are two smaller window openings on the north elevation. All openings have stone lintels and the windows have stone sills. On the north and east elevations, the random pattern limestone walls currently display ribbon pointing and quoined corners.

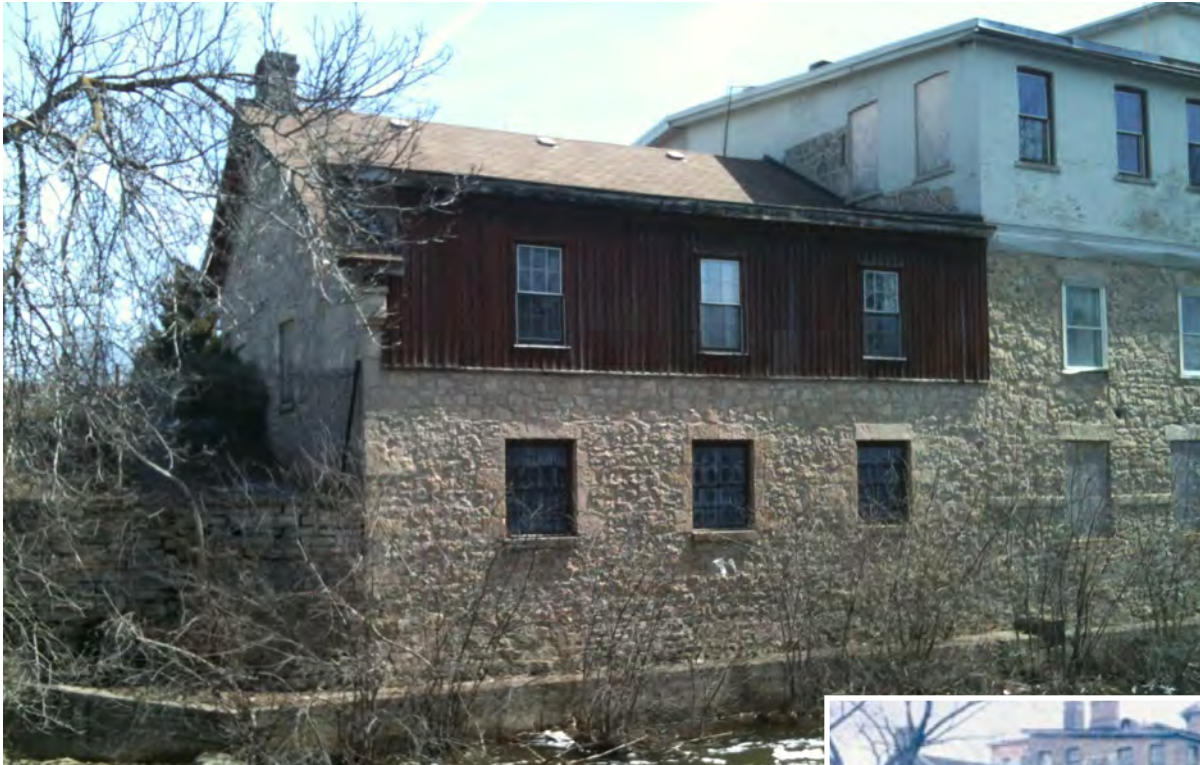
6. Building #1, West Elevation, 2014 (Source: ERA)

On the west elevation, the roof has a full-length shed dormer that allows for a full second floor (see figure 6). This dormer was added in 1979; the roof originally had a gable roof profile (see

The building appears to be in sound condition. The accessible openings on the north and east elevation are protected with plywood and the entrance is locked. There is an eavestrough and downspout on the east elevation. There is no raingear at the west elevation.

1. No further preventative maintenance work is required for Building #1 at this time.
2. Provide no new raingear in the short-term as there is no evidence of water damage or infiltration, and access to install raingear on the west elevation is difficult due to the building's location directly adjacent to the Speed River.
3. Have a heritage building professional undertake an annual inspection of the building to ensure it remains secure and weather-tight. This is providing that ERA receives a quarterly update on any changes to the building condition and associated repairs.

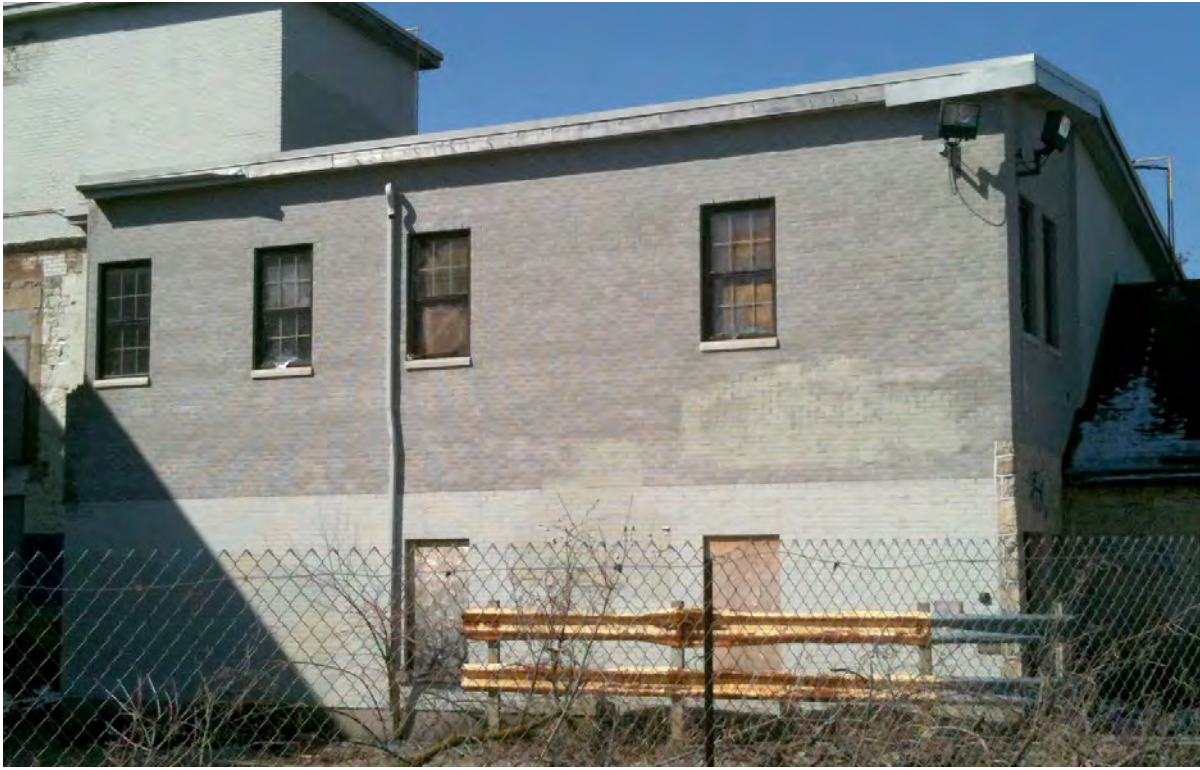
16. Building #2a, East Elevation, 2014 (Source: ERA)

The east elevation (see figure 16) displays six window openings with concrete/stone sills, two at the ground floor level and four at the second floor. The 6-over-6 sash wood windows appear to be circa 1970s.

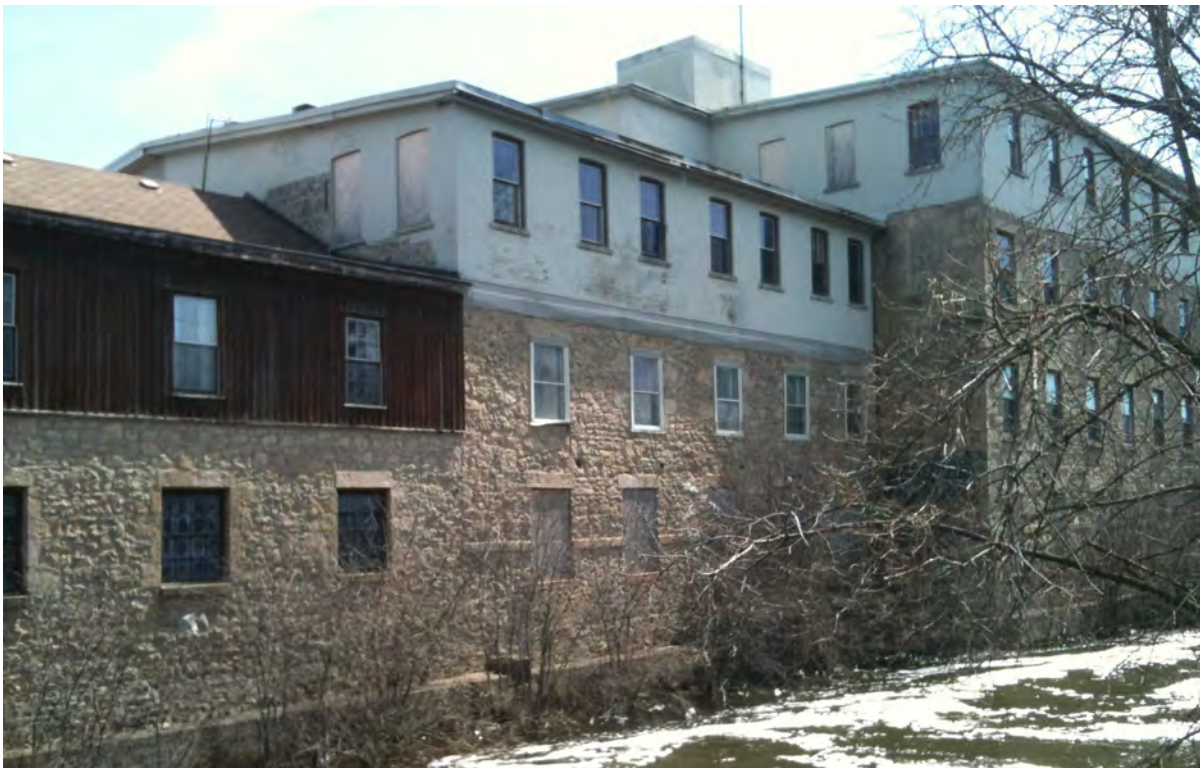
17. Building #2a, West Elevation, 2014 (Source: ERA)

On the west elevation (see figure 17), the random pattern limestone wall has flush mortar joints and a horizontal stone band course that runs at mid-level to the basement floor windows. The window openings within the limestone (at the lower two floors) are laid out in five equal bays. The basement level windows have a stone lintel and sill akin to the Office Building. The ground floor windows appear to have a concrete/stone lintel beneath a large (older) stone lintel and the sill is clad in metal. This suggests that these windows have been modified. There are seven window openings on the second (upper) floor set in pairs. These windows have a shallow brick arch and appear to be replacement (circa. 1970s). See figure 20 for representative examples of these three window constructions.

The building appears to be in sound condition. There is some masonry joint deterioration and pockets, but these do not appear to be causing active deterioration. The accessible openings on the east elevation are protected with plywood and the exit door is locked. The building has no raingear.

1. No further preventative maintenance work for Building #2a at this time.
2. Provide no new raingear in the short-term as there is no evidence of water damage or infiltration, and access to install raingear on the west elevation is difficult due to the building's location directly adjacent to the Speed River.
3. Have a heritage building professional undertake an annual inspection of the building to ensure it remains secure and weather-tight. This is providing that ERA receives a quarterly update on any changes to the building condition and associated repairs.

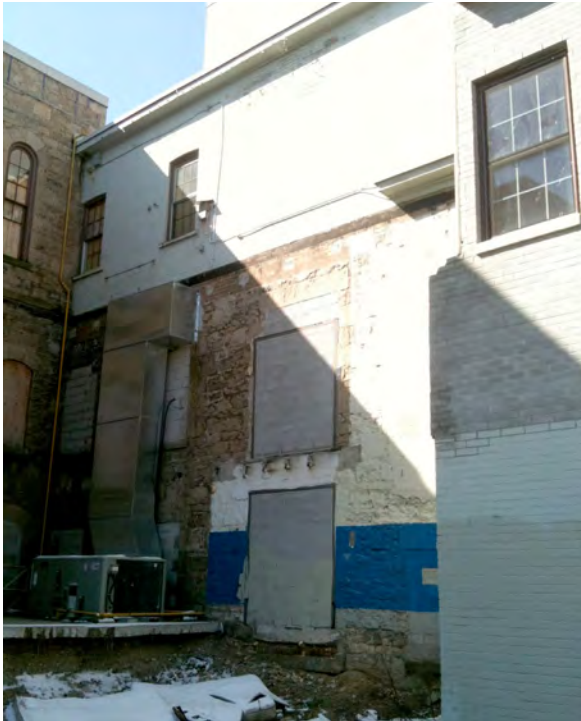
22. Building #2b, East Elevation, 2014 (Source: ERA)

The east elevation is attached to the Tower Building (see figure 22). Areas north and south of this addition are visible. The exterior wall is limestone and brick. It displays blocked in openings, some with stone lintel and sills, and a door opening at ground level. The openings vary in size and some appear to have been modified.

There are two 6-over-6 wood windows (similar to Building 2a) at the third floor level. Much of the masonry has been painted and there are exposed ends of steel beams below a former opening.

- d) New pointing should be finished to match the appearance of adjacent mortar joints in profile, colour and texture.
2. In 2015, repair the masonry surrounding exposed ends of steel beams as specified by the heritage consultant and identified in the drawings.

- c) Finish the rebate at the perimeter of the steel with a bead of sealant - Tremco Dymeric 240 or approved equal.
3. Provide no new raingear in the short-term as there is no evidence of water damage or infiltration, and access to install raingear on the west elevation is difficult due to the building's location directly adjacent to the Speed River.

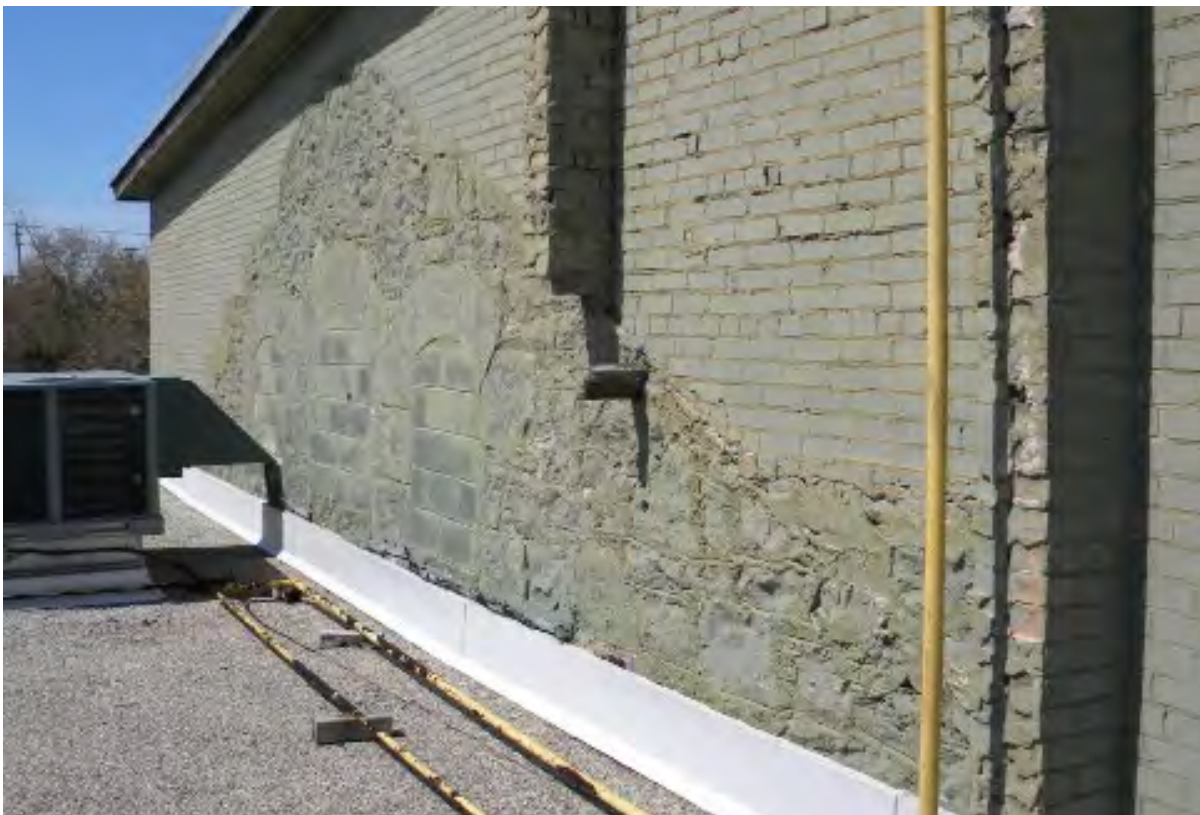
24. Building #2b, South Elevation, original roof gable (Source: City of Guelph)

On the south elevation, the wall is primarily limestone with a partial brick third storey (see figure 23). The original roof gable is still visible (see figure 24). The majority of the masonry has been painted and there are areas that have been treated with cement parging. All window and door openings have all been blocked in.

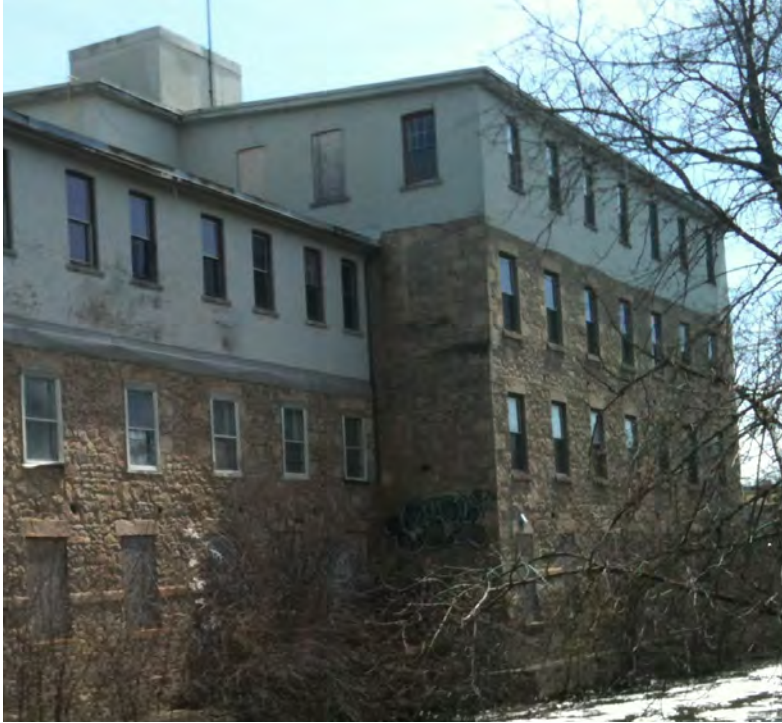
25. Building #2b, North and West Elevations, 2014 (Source: ERA)

The north elevation is attached to the Building 2a and a portion of the wall is visible at the west side (see figure 25). The window openings in the rubble-stone have been infilled with stone. There are three window openings at the third floor. The brick addition at the third floor (post 1908) is painted.

The west elevation (see figure 25) has a random stone pattern with quoining at the corners except for the third floor which is painted brick (see figure 28). The wall has seven equal bays of windows. The window openings in the rubble-stone have a stone sill and lintel. The windows at the third floor are similar to the 1970s windows of Building 2a.

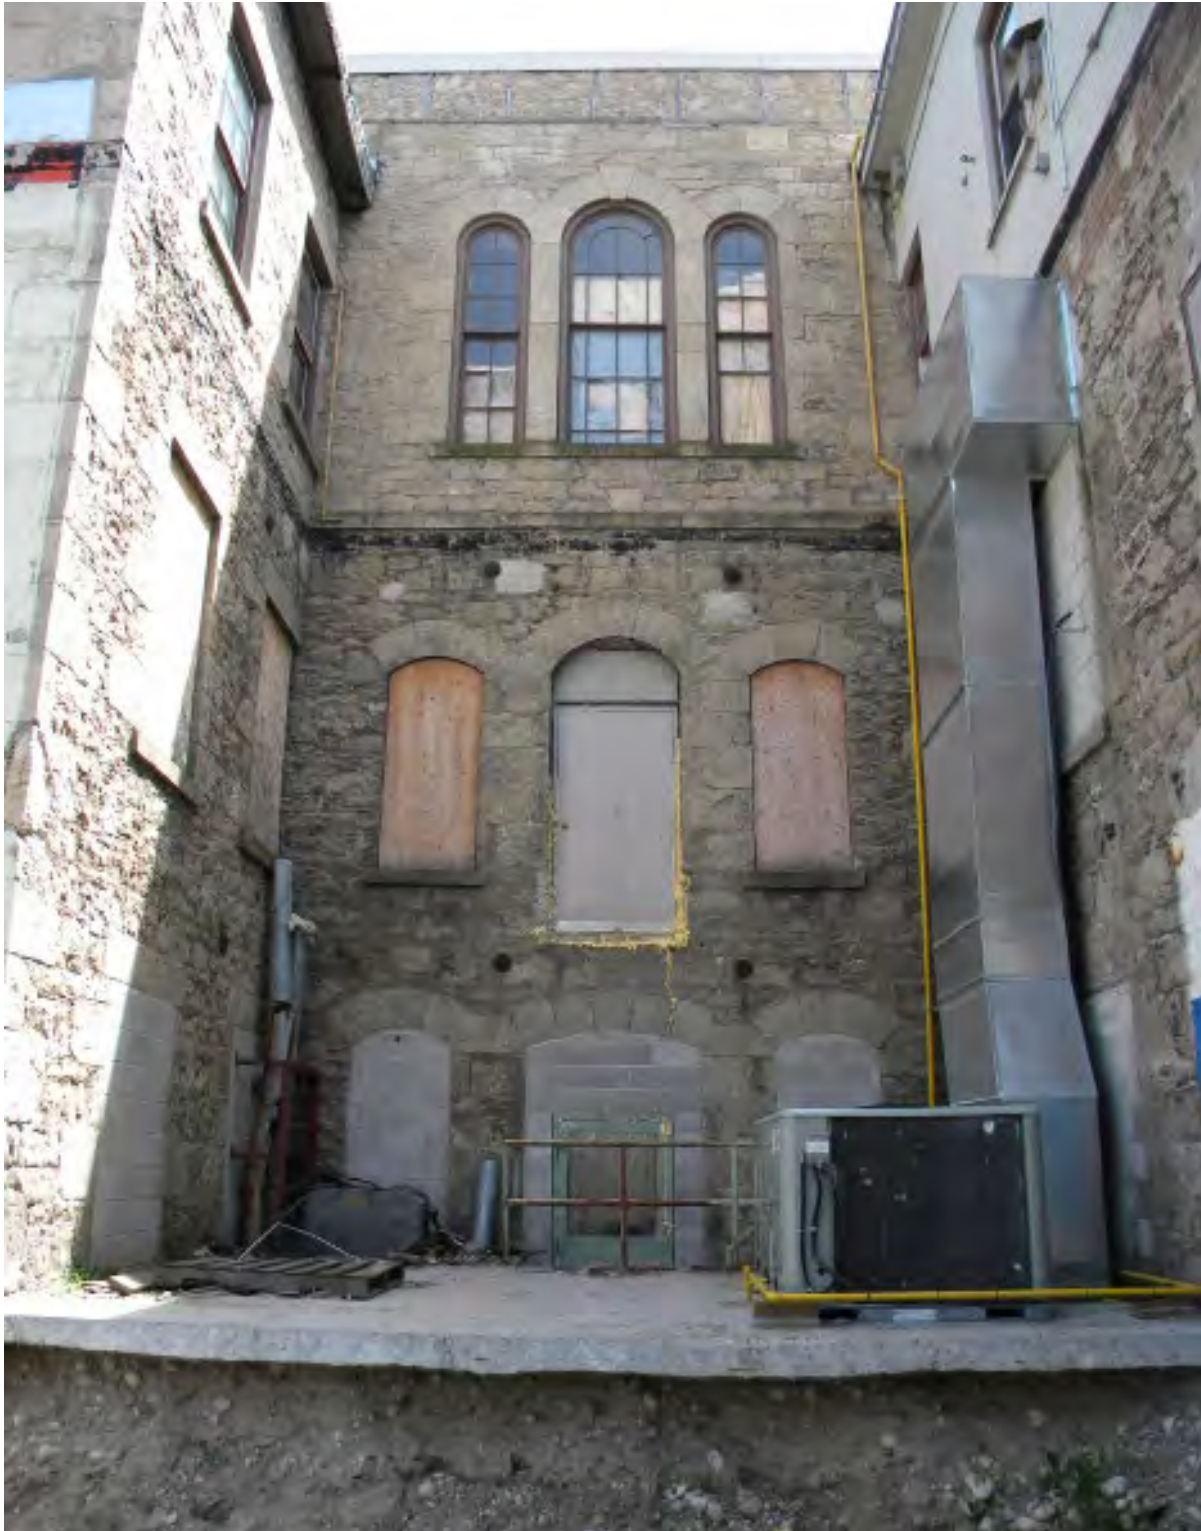
31. Building #2c, North Elevation, 2014 (Source: ERA)

At the north elevation, there are three openings on all floors (see figure 31). On the ground and second floors there is a central door opening with a window opening on either side. The openings have round dressed stone arches or ‘voussoir’ lintels and stone sills. The third floor displays a tripartite window with a larger central window. The third floor windows have round stone arches with a keystone at the top of the centre window and a continuous stone sill (see figures 30 and 31). The side windows are 6-over-6 sash oriented vertically. The central window is a 12-over-12 sash with thinner panes at the perimeter. The windows at the third floor are understood to be the only original wood windows remaining on site.

The building generally appears to be in sound condition. Unfortunately, the muntin bars at one of the original wood sash windows (west most) have been damaged despite plywood protection on the interior side. The building has no raingear.

1. In 2015, provide plywood protection on the exterior side of the original wood windows as directed in the Mothballing Guidelines in the HIA:
 - a) Provide ¾" (19mm) exterior grade plywood to the exterior side of the window opening.
 - b) Plywood panels should be screwed in place on wood blocking frames set into the door and widow openings, and properly ventilated to the exterior.
 - c) Adjust existing wood windows to allow for interior ventilation. Open sash to provide a venting gap at the top and bottom of the window opening.
2. Provide no new raingear in the short-term as there is no evidence of water damage or infiltration.
3. Have a heritage building professional undertake an annual inspection of the building to ensure it remains secure and weather-tight. This is providing that ERA receives a quarterly update on any changes to the building condition and associated repairs.

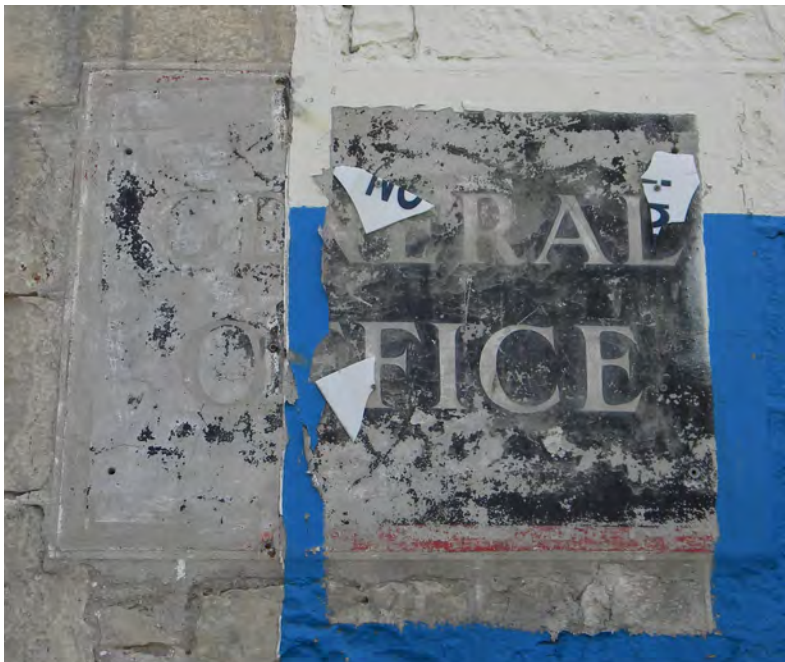
37. Building #2d, North Elevation, General Office' sign (Source: City of Guelph)

rectangular panel at the east corner at the ground floor that reads 'General Office' (see figure 37). Fusion Homes has provided a mural on the north elevation (see figure 36).

3. In 2015, provide a downspout at the eavestrough on the south elevation as the mortar joints below downspout connection are deteriorating.
4. In 2015, provide protection at "General Office" sign (see figure 44).

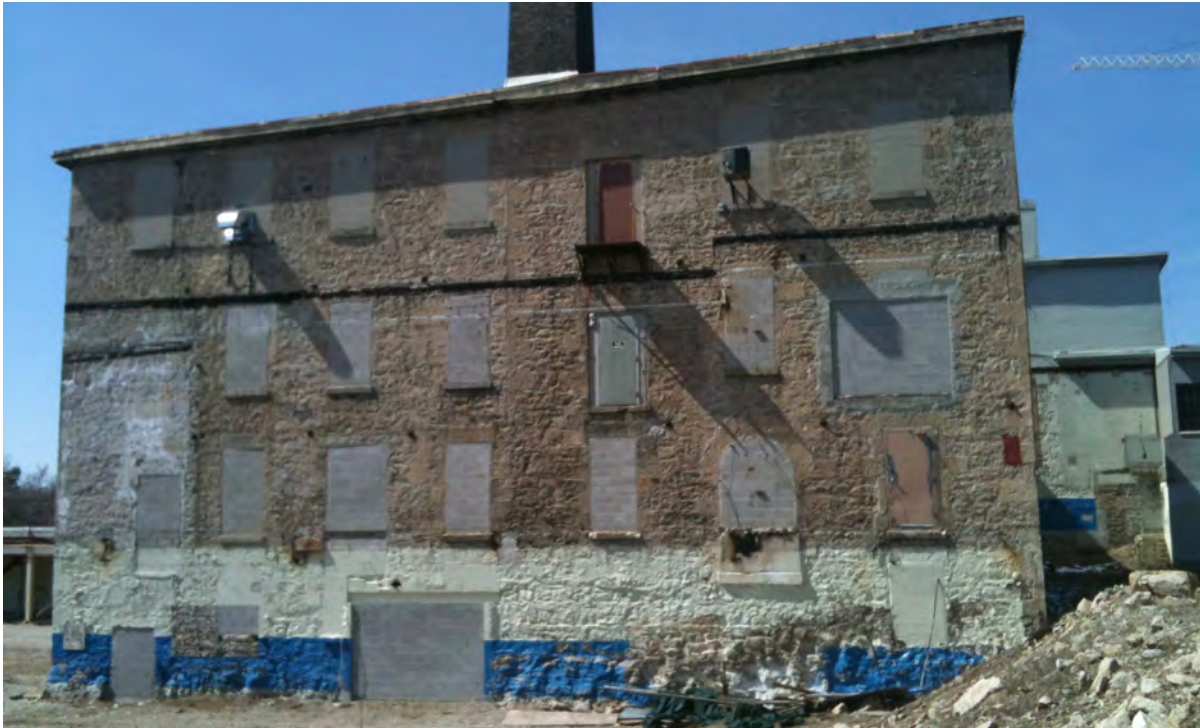
39. Building #2d, East Elevation (Source: ERA)

The east elevation is generally organized into seven bays (see figure 39). The original window and door openings appear to be rectangular with a stone sill and lintel. The exception is a few arched openings. Many of the openings have been modified. The openings have been infilled with concrete block (with the exception of two door openings). The lowest floor area has been painted and select areas of the wall have received cement parging. There is a brick chimney on the inside of the east wall, north of center (see figure 43).

5. In 2015, document and dismantle the top 15 brick courses of the chimney, salvaging bricks for reconstruction. Repoint open brick joints in the top course from above. Provide 3/4" (19mm) exterior grade plywood with waterproof membrane with drop flashing at low edge. Provide vent with insect screen along top edge. Slope to drain on main building roof. *** Coordinate with staff if found to be 'Chimney Swift' bird habitat.

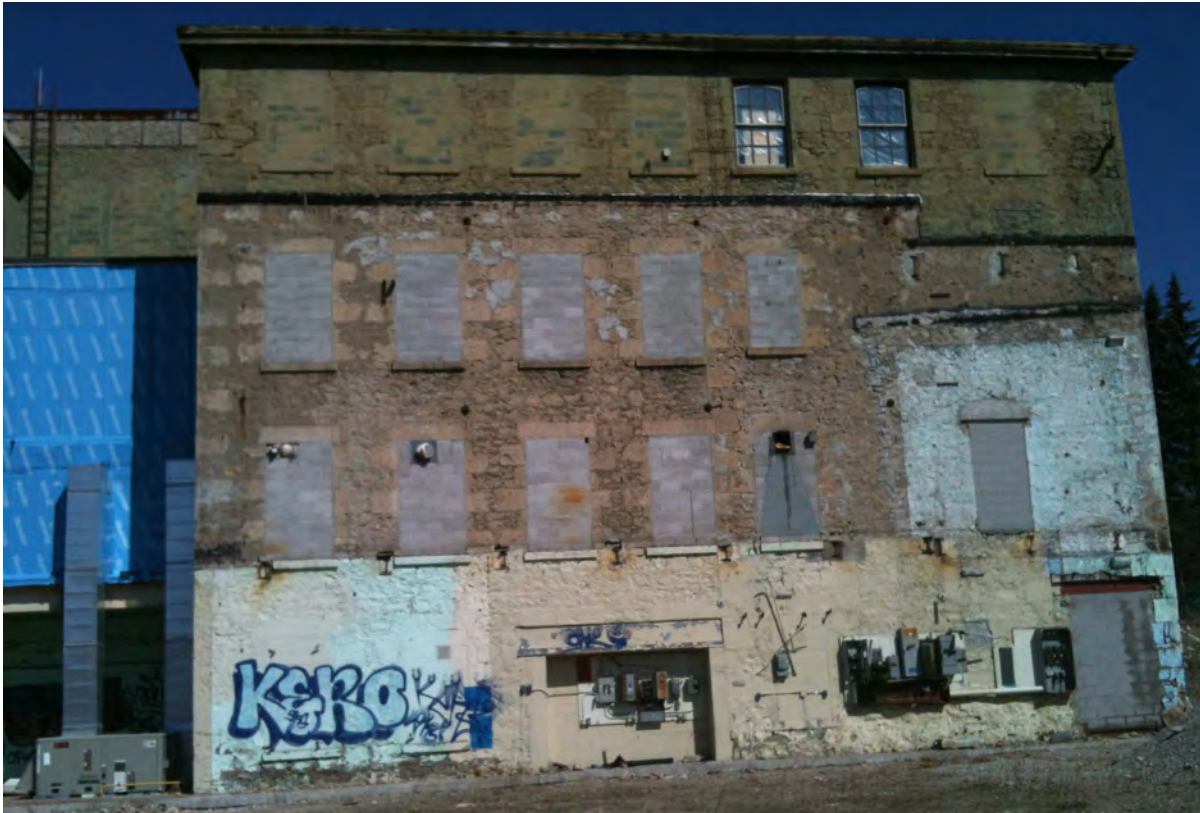
40. Building #2d, South Elevation, 2014 (Source: ERA)

The south elevation is also organized into seven bays (see figure 40). The original window and door openings appear to be rectangular with a stone sill and lintel. The openings have been infilled with concrete block; the exception is two window openings at the

The building generally appears to be in sound condition. There are select areas of deteriorated mortar joints that require repair in the short-term. The areas of deterioration are either close to grade, at former building connection points or along cracks (as indicated on the annotated drawings). The brick chimney displays spalled bricks and deteriorated mortar joints, most notably at the upper 4'-0" (1200mm) (see figure 41). The building has limited raingear.

1. In 2015, repoint identified areas of deteriorated mortar joints and cracks with a soft hydraulic lime-based mortar as specified by the heritage consultant and identified in the drawings..
 - a) Remove paint from masonry at areas of work. Acceptable cleaning methods include a low pressure hot water wash or, if required, Peel Away Smart Strip by Dumond.
 - b) Clean out loose material in deteriorated joint and cut out to a minimum depth of $\frac{3}{4}$ " (19mm) prior to repointing.
 - c) Repoint with hydraulic lime mortar.
 - d) New pointing should be finished to match the appearance of adjacent mortar joints in profile, colour and texture.

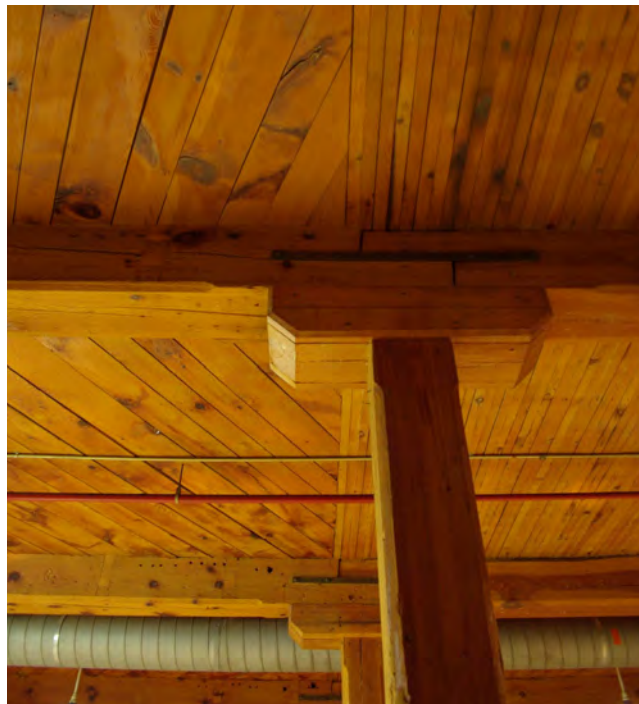
42. Building #2d, heavy timber structure and wood ceiling. (Source: City of Guelph)
