ARBORIST REPORT

ALMA Guelph Phase 2
Guelph, Ontario

Arborist Report for Development Applications

Date of Inspection:

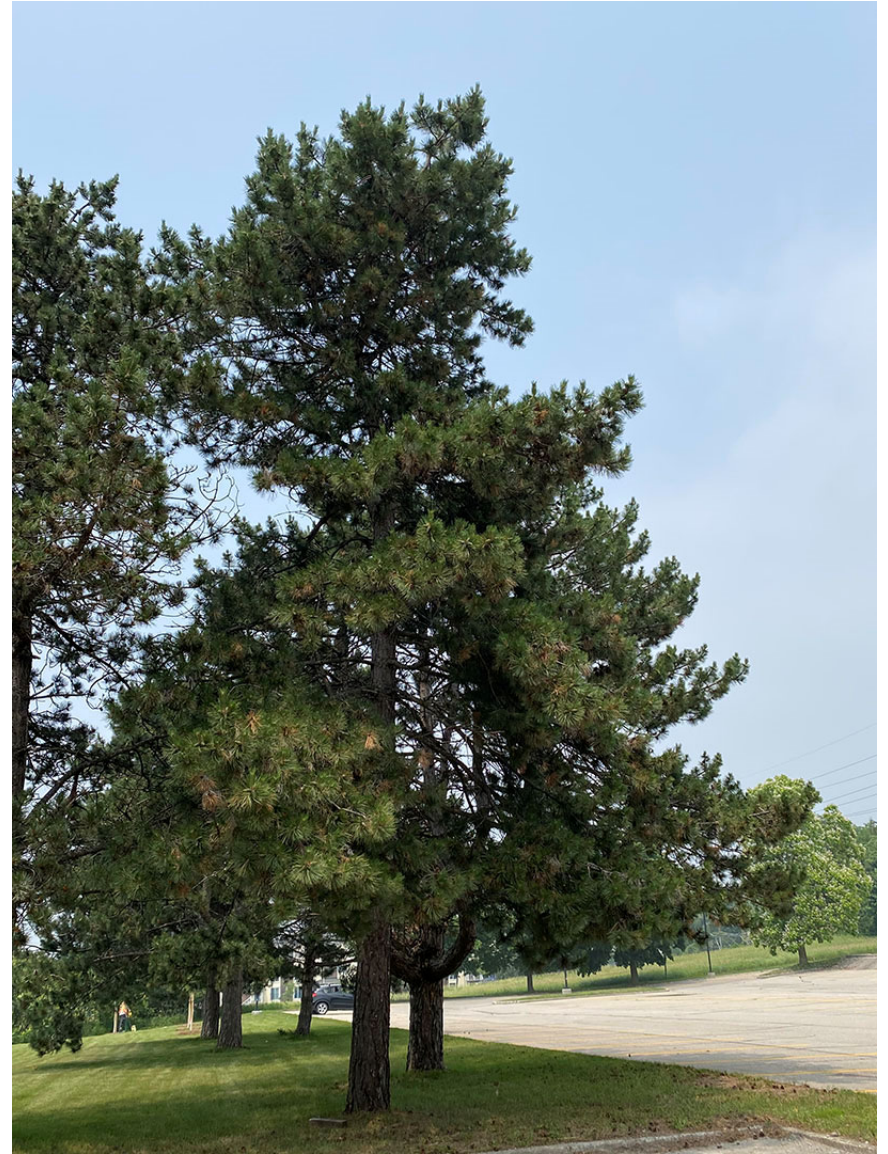
Fig. 66 - Trees T63, T64

63	Austrian pine Pinus nigra	41	4.0	6	Poor	Poor form to trunk and crowns; thinning crown condition; crown deadwood; trunk lean.	Remove - Construction	Private Onsite	No
64	Austrian pine Pinus nigra	53	4.0	6	Very poor	Very poor formed tree; large scaffold branch; thinning crown.	Remove - Construction	Private Onsite	No
65	Austrian pine Pinus nigra	50	5.0	8	Poor	Poor formed tree; crown deadwood; crown raised.	Remove - Construction	Private Onsite	No
66	Austrian pine Pinus nigra	32	4.5	7	Poor	Poor formed tree; trunk lean; crown deadwood; crown raised.	Remove - Construction	Private Onsite	No
67	Austrian pine Pinus nigra	49	6.0	10	Fair	Trunk with no major visible defects; balanced crown form.	Remove - Construction	Private Onsite	Yes
68	Black walnut Juglans nigra	19 @ 1m	4.5	7	Good to fair	High LCR; dense crown condition; balanced crown form; somewhat crooked trunk form.	Remove - Construction	Private Onsite	Yes

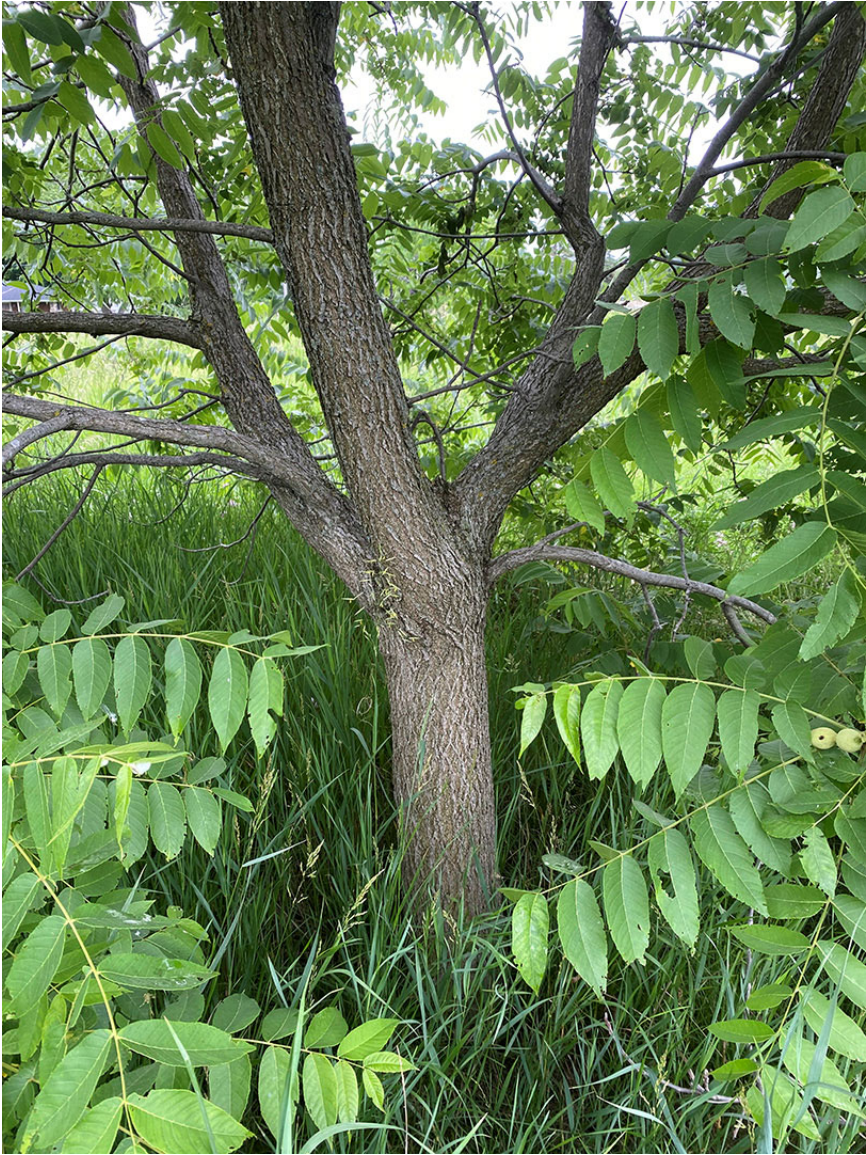
Fig. 73 - Tree T69

69	Black walnut Juglans nigra	17.5	4.5	7	Good	High LCR; dense crown condition; balanced crown form.	Remove - Construction	Private Onsite	Yes
Tree group #1	2 black walnuts, 4 Northern catalpas Juglans nigra, Catalpa speciosa (6 trees)	average 10cm	7.0	12	Fair	Closely grouped trees with lack of live inside crowns; sumac vegetation abutting tree grouping.	Remove - Construction	Private Onsite	Yes
