Biennial Bridge Inspection Report

Niska Road Over Speed River Bridge

No. 00001

August-29-12

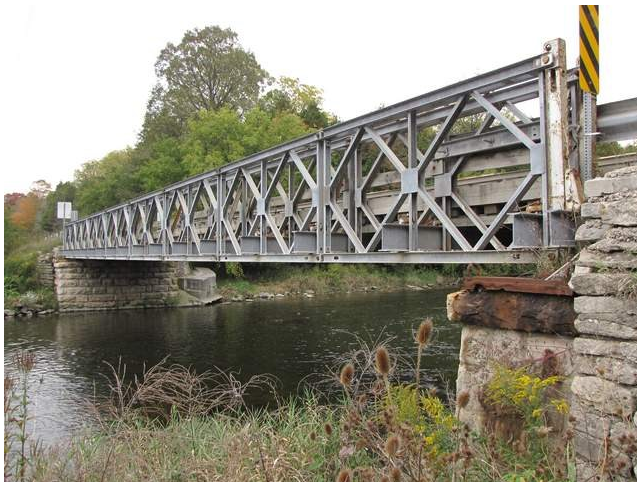
South Elevation.

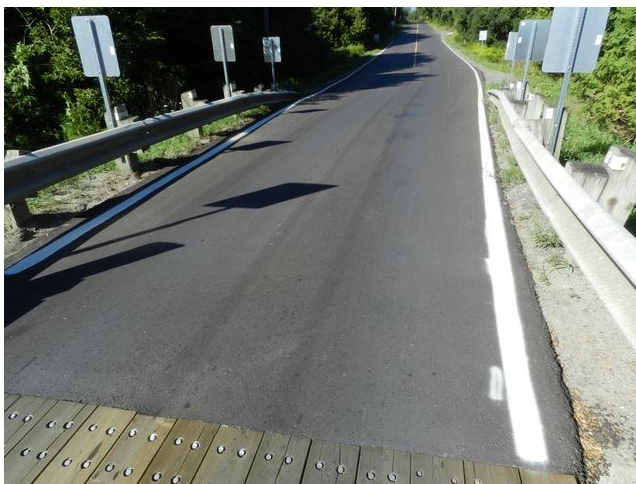
Element Group:	West Approach			Length:	NA		
Element Name:	Approach			Width:	NA		
Location:	Single Element			Height:	NA		
Material:	Asphalt			Count:	NA		
Element Type:	Primary Element			Total Quantity:	5.81		
Environment:	Severe			Limited Inspection	<input type="checkbox"/>		
Protection System:	Edge Sealing					Performance Deficiencies	Maintenance Needs
Condition Data:	Units	Exc.	Good	Fair	Poor		
	tonnes	0	5.81	0	0	00	00
Comments: None							
Urgency : None <input type="checkbox"/> 6-10 years <input checked="" type="checkbox"/> 1-5 years <input type="checkbox"/> < 1 year <input type="checkbox"/> Urgent <input type="checkbox"/>							
Recommended Work : Ancillary Replacement Estimated Cost: \$6,541

Overall View.

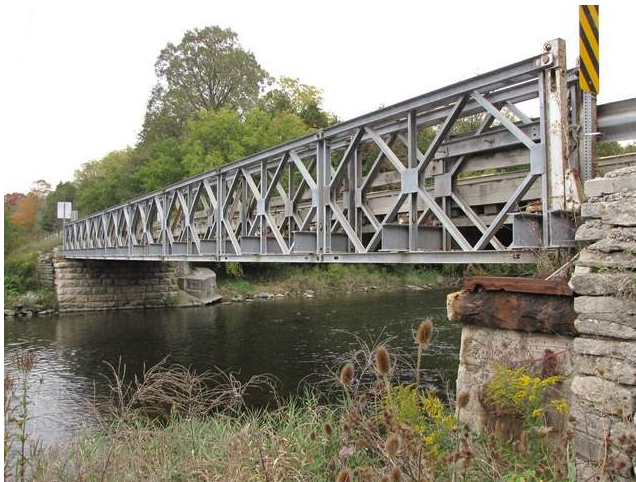
The following defects were noted in the elements comprising this component: The truss consist of 25 tonnes of steel. In total, an estimated 1% exhibits severe general deterioration and replacement is warranted. The estimated remaining service life is 5 years.

Element Group:	Truss					Length:	NA	
Element Name:	Truss					Width:	NA	
Location:	Single Element					Height:	NA	
Material:	Steel					Count:	NA	
Element Type:	Primary Element					Total Quantity:	25	
Environment:	Severe					Limited Inspection	<input type="checkbox"/>	
Protection System:	None					Performance Deficiencies	Maintenance Needs	
Condition Data:	Units	Exc.	Good	Fair	Poor			
	tonnes	0	23.5	1.25	0.25	00	00	
Comments:	End verticals showing severe corrosion should be replaced.							
Urgency :	None <input type="checkbox"/>	6-10 years <input type="checkbox"/>	1-5 years <input checked="" type="checkbox"/>	< 1 year <input type="checkbox"/>	Urgent <input type="checkbox"/>			
Recommended Work :	Replacement					Estimated Cost: \$500,793

South Side.

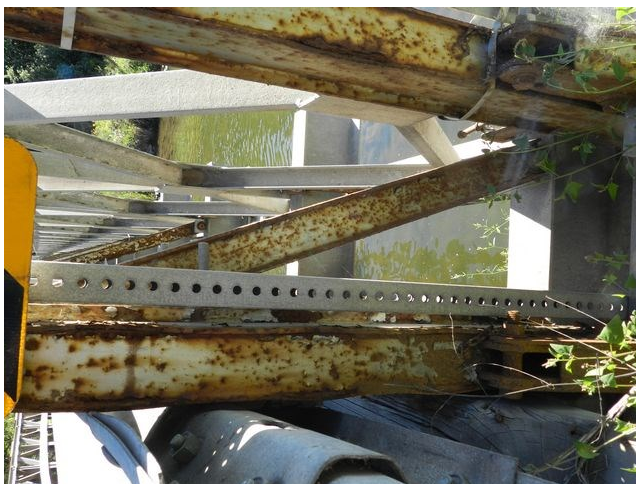
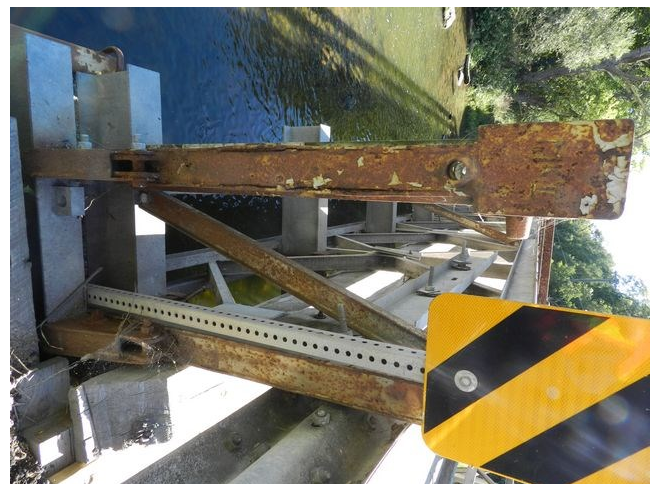
Element Group:	Truss					Length:	1.55	
Element Name:	Verticals					Width:	0.1	
Location:	Single Element					Height:	0.05	
Material:	Steel					Count:	96	
Element Type:	Any					Total Quantity:	38.4	
Environment:	Severe					Limited Inspection	<input type="checkbox"/>	
Protection System:	None					Performance Deficiencies	Maintenance Needs	
Condition Data:	Units	Exc.	Good	Fair	Poor			
	m2	0	36.86	0.77	0.77	16	07	
Comments: End verticals showing severe corrosion and bent flanges should be replaced.								
Urgency : None <input type="checkbox"/> 6-10 years <input type="checkbox"/> 1-5 years <input checked="" type="checkbox"/> < 1 year <input type="checkbox"/> Urgent <input type="checkbox"/>								
Recommended Work : See Primary Element

West End.

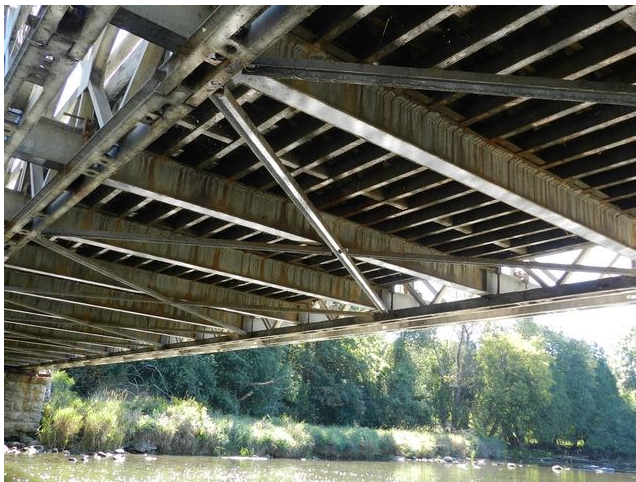
The following defects were noted in the elements comprising this component: The floor beams consist of 4.4 tonnes of timber. In total, an estimated 5% exhibits light general deterioration and replacement is warranted. The estimated remaining service life is 20 years.

Element Group:	Floor Beams				Length:	3.85	
Element Name:	Floor Beams				Width:	0.12	
Location:	Single Element				Height:	0.26	
Material:	Timber				Count:	19	
Element Type:	Primary Element				Total Quantity:	73.2	
Environment:	Severe				Limited Inspection	<input type="checkbox"/>	
Protection System:	None				Performance Deficiencies	Maintenance Needs	
Condition Data:	Units	Exc.	Good	Fair	Poor		
	m2	0	71	2.2	0	00	00
Comments: None							
Urgency : None <input checked="" type="checkbox"/> 6-10 years <input type="checkbox"/> 1-5 years <input type="checkbox"/> < 1 year <input type="checkbox"/> Urgent <input type="checkbox"/>							
Recommended Work : Replacement Estimated Cost: \$7,555

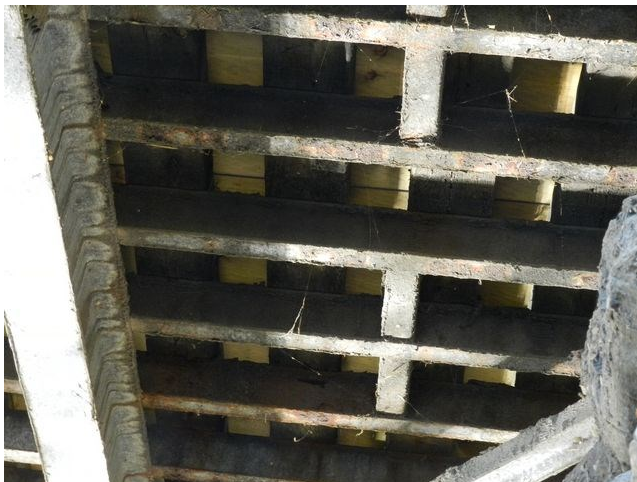
The following defects were noted in the elements comprising this component: The stringers consist of 4.5 tonnes of steel. In total, an estimated 8% exhibits medium general deterioration and replacement is warranted. The estimated remaining service life is 15 years.

Element Group:	Stringers				Length:	24.4	
Element Name:	Stringers				Width:	0.05	
Location:	Single Element				Height:	0.1	
Material:	Steel				Count:	15	
Element Type:	Primary Element				Total Quantity:	15	
Environment:	Moderate				Limited Inspection	<input type="checkbox"/>	
Protection System:	Galvanized Steel				Performance Deficiencies	Maintenance Needs	
Condition Data:	Units	Exc.	Good	Fair	Poor		
	each	0	13.65	1.35	0	00	00
Comments: Stringers show medium corrosion on the top and bottom flange.							
Urgency : None <input checked="" type="checkbox"/> 6-10 years <input type="checkbox"/> 1-5 years <input type="checkbox"/> < 1 year <input type="checkbox"/> Urgent <input type="checkbox"/>							
Recommended Work : Replacement Estimated Cost: \$49,820

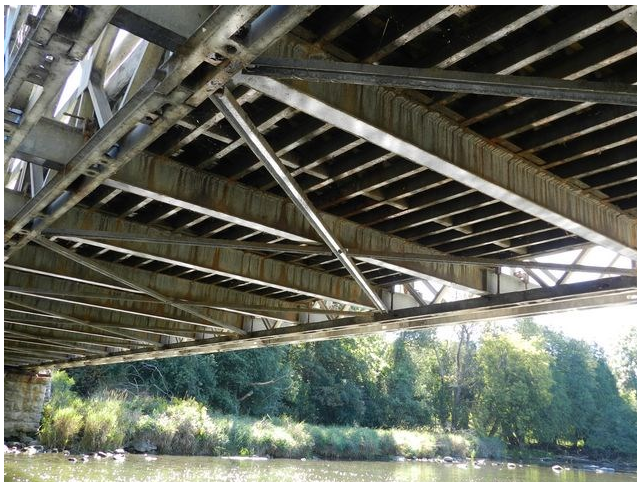
Element Group:	Bracing				Length:	5.2	
Element Name:	Bracing				Width:	NA	
Location:	Single Element				Height:	NA	
Material:	Steel				Count:	24	
Element Type:	Primary Element				Total Quantity:	24	
Environment:	Benign				Limited Inspection	<input checked="" type="checkbox"/>	
Protection System:	Galvanized Steel					Performance Deficiencies	Maintenance Needs
Condition Data:	Units	Exc.	Good	Fair	Poor		
	each	0	24	0	0	00	00
Comments: none							
Urgency : None <input checked="" type="checkbox"/> 6-10 years <input type="checkbox"/> 1-5 years <input type="checkbox"/> < 1 year <input type="checkbox"/> Urgent <input type="checkbox"/>							
Recommended Work : Replacement Estimated Cost: \$9,225

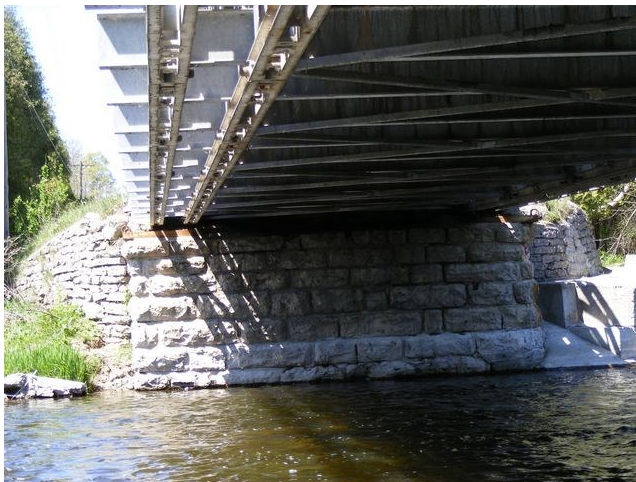
The following defects were noted in the elements comprising this component: The abutment consists of 46 tonnes of masonry. In total, an estimated 5% exhibits severe general deterioration and replacement is warranted. The estimated remaining service life is 5 years.

Element Group:	West Abutment				Length:	NA	
Element Name:	Abutment				Width:	NA	
Location:	Single Element				Height:	NA	
Material:	Masonry				Count:	NA	
Element Type:	Primary Element				Total Quantity:	46	
Environment:	Benign				Limited Inspection	<input type="checkbox"/>	
Protection System:	None					Performance Deficiencies	Maintenance Needs
Condition Data:	Units	Exc.	Good	Fair	Poor		
	tonnes	0	30.36	13.8	1.84	16	17
Comments:	There is medium to severe mortar loss between the blocks at the waterline, most noticeable on the west abutment and also medium to severe isolated spalling. Bearings show severe corrosion and bearing seats show severe disintegration.						
Urgency :	None <input type="checkbox"/>	6-10 years <input type="checkbox"/>	1-5 years <input type="checkbox"/>	< 1 year <input checked="" type="checkbox"/>	Urgent <input type="checkbox"/>		
Recommended Work :	Replacement				Estimated Cost:	\$157,965

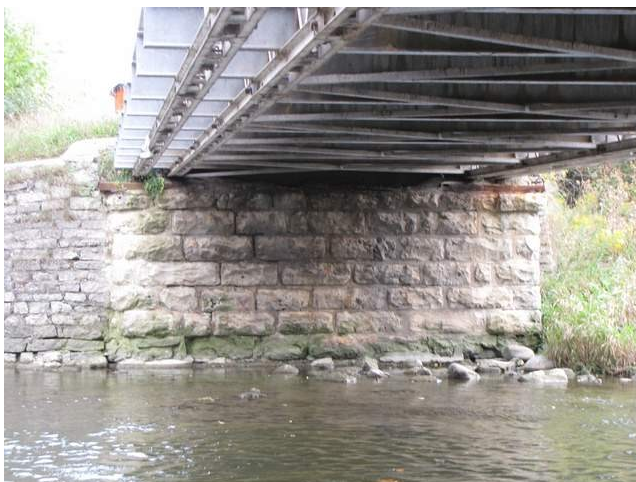
The following defects were noted in the elements comprising this component: The abutment consists of 46 tonnes of masonry. In total, an estimated 4% exhibits severe general deterioration and replacement is warranted. The estimated remaining service life is 1 years.

Element Group:	East Abutment				Length:	NA	
Element Name:	Abutment				Width:	NA	
Location:	Single Element				Height:	NA	
Material:	Masonry				Count:	NA	
Element Type:	Primary Element				Total Quantity:	46	
Environment:	Benign				Limited Inspection	<input type="checkbox"/>	
Protection System:	None					Performance Deficiencies	Maintenance Needs
Condition Data:	Units	Exc.	Good	Fair	Poor		
	tonnes	0	29.44	14.72	1.84	16	17
Comments:	There is medium to severe mortar loss between the blocks at the waterline, and also medium to severe isolated spalling. Bearings show severe corrosion and bearing seats show severe disintegration.						
Urgency :	None <input type="checkbox"/>	6-10 years <input type="checkbox"/>	1-5 years <input checked="" type="checkbox"/>	< 1 year <input type="checkbox"/>	Urgent <input type="checkbox"/>		
Recommended Work :	Replacement				Estimated Cost: \$157,965

East Side.

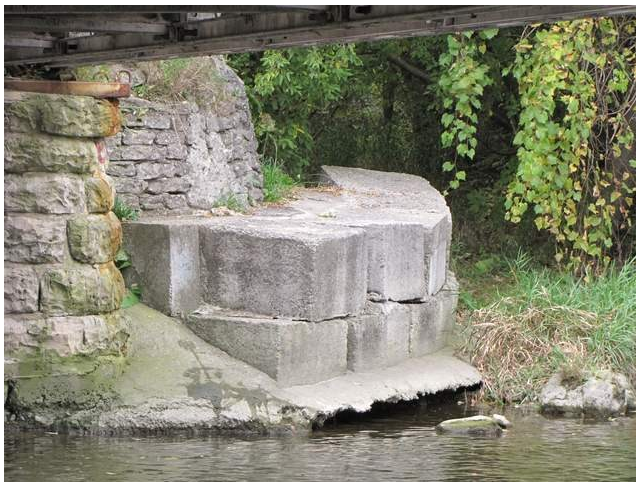
The following defects were noted in the elements comprising this component: The north exterior retaining wall consists of 18.29 tonnes of mass concrete. In total, an estimated 20% exhibits medium general deterioration. The estimated remaining service life is 5 years. The entire component will undergo ancillary replacement. The south retaining wall consists of 26.88 tonnes of other. In total, an estimated 5% exhibits severe general deterioration and replacement is warranted. The estimated remaining service life is 5 years. The north retaining wall consists of 26.88 tonnes of masonry. The entire element exhibits medium general deterioration and replacement is warranted. The estimated remaining service life is 10 years.

Element Group:	West Retaining Wall	Length:	NA				
Element Name:	North Exterior Retaining Wall	Width:	NA				
Location:	North Exterior	Height:	NA				
Material:	Mass Concrete	Count:	NA				
Element Type:	Gravity	Total Quantity:	18.29				
Environment:	Benign	Limited Inspection	<input type="checkbox"/>				
Protection System:	None	Performance Deficiencies	Maintenance Needs				
Condition Data:	Units	Exc.	Good	Fair	Poor		
	tonnes	0	14.63	3.66	0	03	17
Comments:	Continuing settlement expected due to undermining.						
Urgency :	None <input type="checkbox"/>	6-10 years <input type="checkbox"/>	1-5 years <input checked="" type="checkbox"/>	< 1 year <input type="checkbox"/>	Urgent <input type="checkbox"/>		
Recommended Work :	Ancillary Replacement		Estimated Cost: \$9,092

Northwest Side.

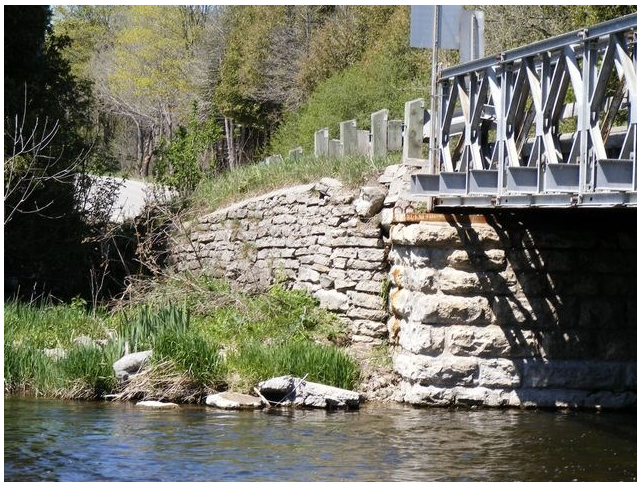
The following defects were noted in the elements comprising this component: The south retaining wall consists of 33.41 tonnes of masonry. In total, an estimated 40% exhibits severe general deterioration and replacement is warranted. The estimated remaining service life is 5 years. The north retaining wall consists of 36.72 tonnes of masonry. In total, an estimated 5% exhibits severe general deterioration and replacement is warranted. The estimated remaining service life is 10 years.

Element Group:	West Retaining Wall				Length:	NA	
Element Name:	SouthRetaining Wall				Width:	NA	
Location:	South				Height:	NA	
Material:	Other				Count:	NA	
Element Type:	Gravity				Total Quantity:	26.88	
Environment:	Benign				Limited Inspection	<input type="checkbox"/>	
Protection System:	None					Performance Deficiencies	Maintenance Needs
Condition Data:	Units	Exc.	Good	Fair	Poor		
	tonnes	0	11.29	14.25	1.34	16	17
Comments: Some loss of wall at top and also loss of mortar.							
Urgency : None <input type="checkbox"/> 6-10 years <input type="checkbox"/> 1-5 years <input checked="" type="checkbox"/> < 1 year <input type="checkbox"/> Urgent <input type="checkbox"/>							
Recommended Work : Replacement Estimated Cost: \$42,512

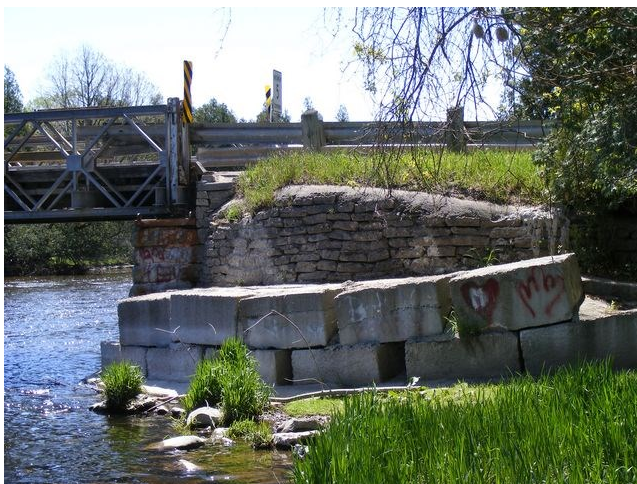
Element Group:	West Retaining Wall				Length:	NA	
Element Name:	NorthRetaining Wall				Width:	NA	
Location:	North				Height:	NA	
Material:	Masonry				Count:	NA	
Element Type:	Gravity				Total Quantity:	26.88	
Environment:	Benign				Limited Inspection	<input type="checkbox"/>	
Protection System:	None					Performance Deficiencies	Maintenance Needs
Condition Data:	Units	Exc.	Good	Fair	Poor		
	tonnes	0	0	26.88	0	16	17
Comments: None							
Urgency : None <input type="checkbox"/> 6-10 years <input checked="" type="checkbox"/> 1-5 years <input type="checkbox"/> < 1 year <input type="checkbox"/> Urgent <input type="checkbox"/>							
Recommended Work : Replacement Estimated Cost: \$56,683

Northwest Side.

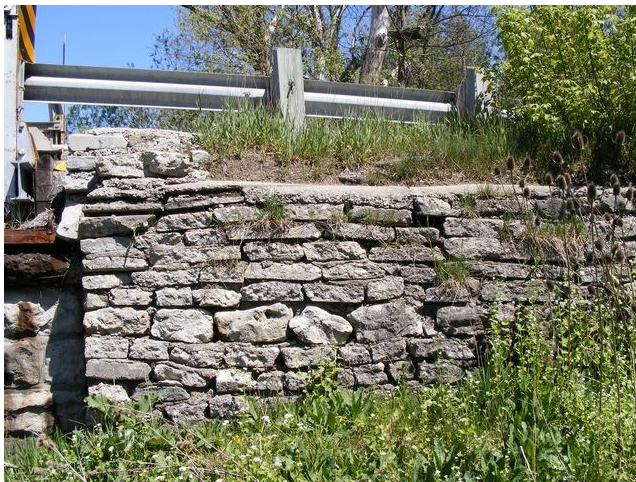
5.7.46 East Retaining Wall - SouthRetaining Wall

Element Group:	East Retaining Wall				Length:	NA	
Element Name:	SouthRetaining Wall				Width:	NA	
Location:	South				Height:	NA	
Material:	Masonry				Count:	NA	
Element Type:	Gravity				Total Quantity:	33.41	
Environment:	Benign				Limited Inspection	<input type="checkbox"/>	
Protection System:	None					Performance Deficiencies	Maintenance Needs
Condition Data:	Units	Exc.	Good	Fair	Poor		
	tonnes	0	18.38	9.69	5.35	16	17
Comments:	There is severe loss of mortar how ever this does not appear to affect performance significantly.						
Urgency :	None <input type="checkbox"/>	6-10 years <input type="checkbox"/>	1-5 years <input checked="" type="checkbox"/>	< 1 year <input type="checkbox"/>	Urgent <input type="checkbox"/>		
Recommended Work :	Replacement				Estimated Cost:	\$70,453

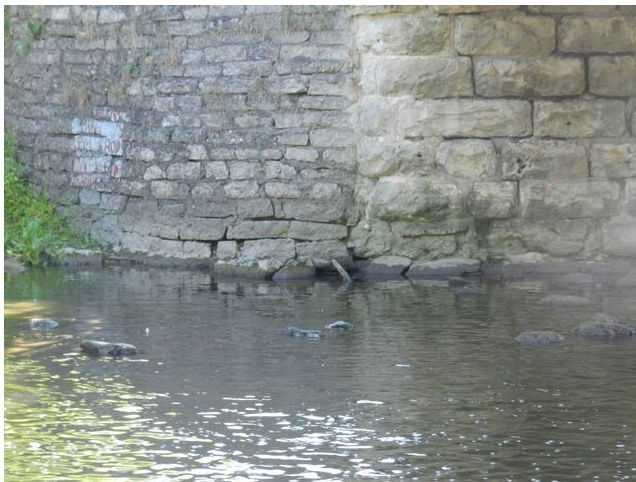
5.7.48 East Retaining Wall - NorthRetaining Wall

Element Group:	East Retaining Wall				Length:	NA	
Element Name:	NorthRetaining Wall				Width:	NA	
Location:	North				Height:	NA	
Material:	Masonry				Count:	NA	
Element Type:	Gravity				Total Quantity:	36.72	
Environment:	Benign				Limited Inspection	<input type="checkbox"/>	
Protection System:	None				Performance Deficiencies	Maintenance Needs	
Condition Data:	Units	Exc.	Good	Fair	Poor		
	tonnes	0	23.87	11.02	1.84	00	17
Comments:	There is loss of mortar at the base of the retaining wall.						
Urgency :	None <input type="checkbox"/>	6-10 years <input checked="" type="checkbox"/>	1-5 years <input type="checkbox"/>	< 1 year <input type="checkbox"/>	Urgent <input type="checkbox"/>		
Recommended Work :	Replacement Estimated Cost: \$77,434

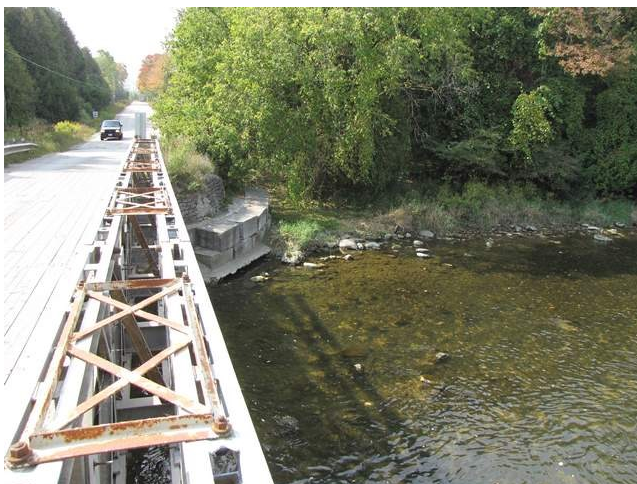
5.7.50 West Embankment - Embankment

Element Group:	West Embankment	Length:	NA				
Element Name:	Embankment	Width:	NA				
Location:	Single Element	Height:	NA				
Material:	Soil	Count:	1				
Element Type:	Primary Element	Total Quantity:	1				
Environment:	Severe	Limited Inspection	<input type="checkbox"/>				
Protection System:	None	Performance Deficiencies	Maintenance Needs				
Condition Data:	Units	Exc.	Good	Fair	Poor		
	all	0	1	0	0	00	00
Comments: None							
Urgency :	None <input type="checkbox"/>	6-10 years <input checked="" type="checkbox"/>	1-5 years <input type="checkbox"/>	< 1 year <input type="checkbox"/>	Urgent <input type="checkbox"/>		
Recommended Work :	Ancillary Replacement		Estimated Cost: \$6,025

Overall View.

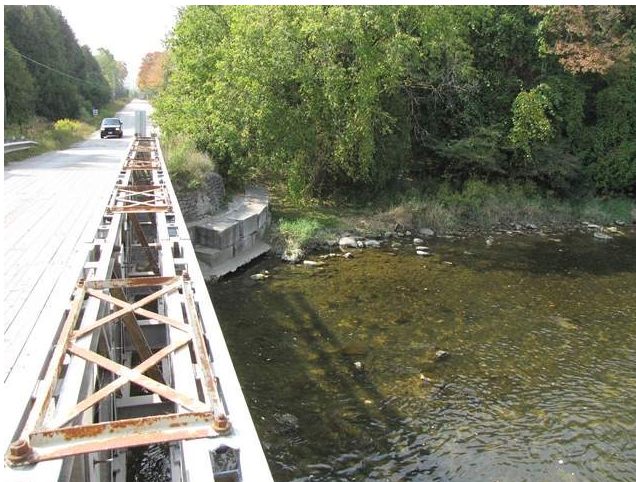
5.7.51 West Embankment - Slope Protection

Element Group:	West Embankment				Length:	NA	
Element Name:	Slope Protection				Width:	NA	
Location:	Single Element				Height:	NA	
Material:	Foliation				Count:	1	
Element Type:	Any				Total Quantity:	1	
Environment:	Severe				Limited Inspection	<input type="checkbox"/>	
Protection System:	None					Performance Deficiencies	Maintenance Needs
Condition Data:	Units	Exc.	Good	Fair	Poor		
	all	0	1	0	0	00	00
Comments: None							
Urgency : None <input type="checkbox"/> 6-10 years <input checked="" type="checkbox"/> 1-5 years <input type="checkbox"/> < 1 year <input type="checkbox"/> Urgent <input type="checkbox"/>							
Recommended Work : See Primary Element

Southwest Side.

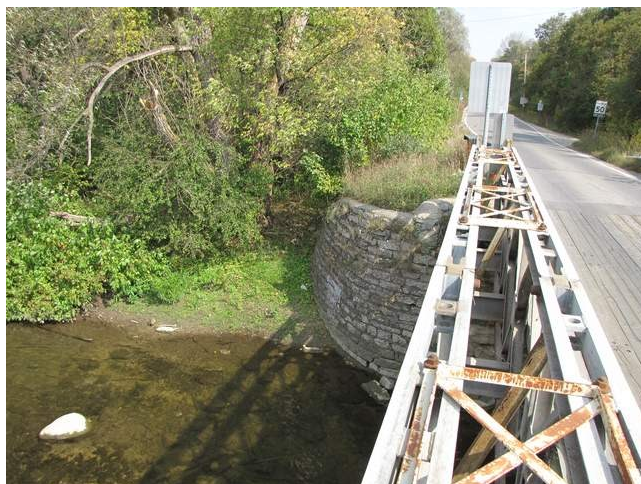
5.7.52 East Embankment - Embankment

Element Group:	East Embankment	Length:	NA				
Element Name:	Embankment	Width:	NA				
Location:	Single Element	Height:	NA				
Material:	Soil	Count:	1				
Element Type:	Primary Element	Total Quantity:	1				
Environment:	Severe	Limited Inspection	<input type="checkbox"/>				
Protection System:	None	Performance Deficiencies	Maintenance Needs				
Condition Data:	Units	Exc.	Good	Fair	Poor		
	all	0	1	0	0	00	00
Comments: None							
Urgency : None <input type="checkbox"/> 6-10 years <input checked="" type="checkbox"/> 1-5 years <input type="checkbox"/> < 1 year <input type="checkbox"/> Urgent <input type="checkbox"/>							
Recommended Work : Ancillary Replacement Estimated Cost: \$6,025

East Side.

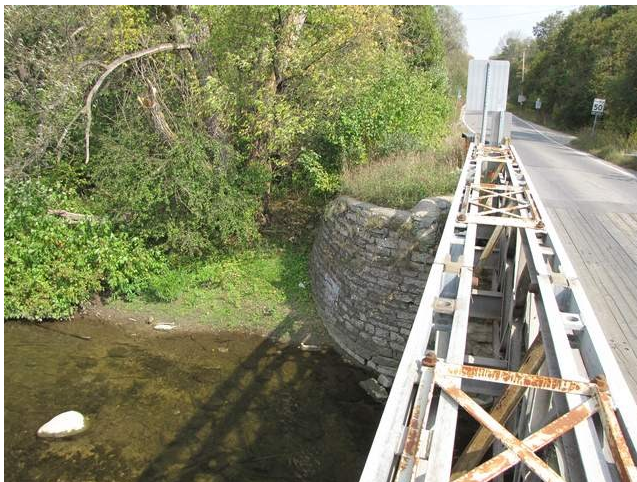
5.7.53 East Embankment - Slope Protection

Element Group:	East Embankment				Length:	NA	
Element Name:	Slope Protection				Width:	NA	
Location:	Single Element				Height:	NA	
Material:	Foliation				Count:	1	
Element Type:	Any				Total Quantity:	1	
Environment:	Severe				Limited Inspection	<input type="checkbox"/>	
Protection System:	None					Performance Deficiencies	Maintenance Needs
Condition Data:	Units	Exc.	Good	Fair	Poor		
	all	0	1	0	0	00	00
Comments:	None						
Urgency :	None <input type="checkbox"/>	6-10 years <input checked="" type="checkbox"/>	1-5 years <input type="checkbox"/>	< 1 year <input type="checkbox"/>	Urgent <input type="checkbox"/>		
Recommended Work :	See Primary Element

East Side.

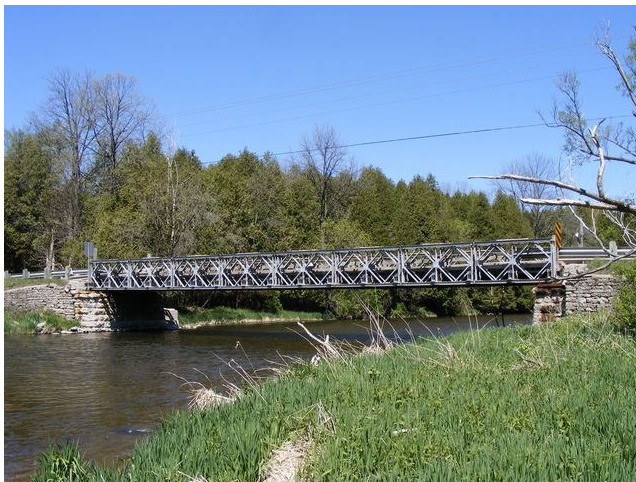
5.7.54 Foundation - Foundation

Element Group:	Foundation					Length:	NA	
Element Name:	Foundation					Width:	NA	
Location:	Single Element					Height:	NA	
Material:	Compacted Fill					Count:	1	
Element Type:	Primary Element					Total Quantity:	1	
Environment:	Benign					Limited Inspection	<input checked="" type="checkbox"/>	
Protection System:	None					Performance Deficiencies	Maintenance Needs	
Condition Data:	Units	Exc.	Good	Fair	Poor			
	each	0	1	0	0	00	00	
Comments: None								
Urgency : None <input checked="" type="checkbox"/> 6-10 years <input type="checkbox"/> 1-5 years <input type="checkbox"/> < 1 year <input type="checkbox"/> Urgent <input type="checkbox"/>								
Recommended Work : Reinstallation Estimated Cost: \$89,284

South View.

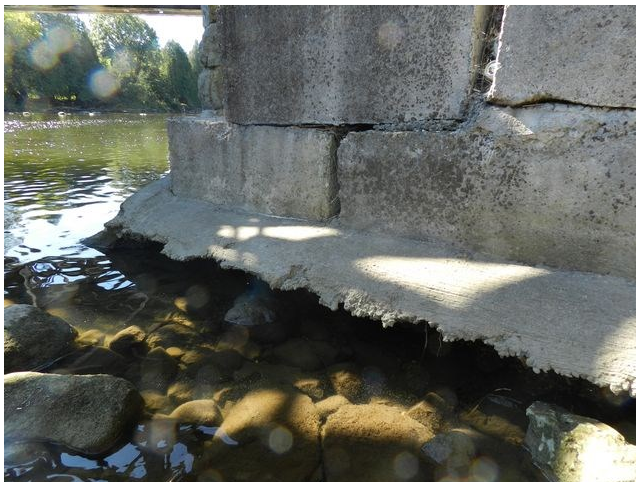
5.7.55 Foundation - NorthFoundation

Element Group:	Foundation				Length:	NA	
Element Name:	NorthFoundation				Width:	NA	
Location:	North				Height:	NA	
Material:	Compacted Fill				Count:	1	
Element Type:	Primary Element				Total Quantity:	1	
Environment:	Benign				Limited Inspection	<input checked="" type="checkbox"/>	
Protection System:	None					Performance Deficiencies	Maintenance Needs
Condition Data:	Units	Exc.	Good	Fair	Poor		
	each	0	0.77	0.03	0.2	16	13
Comments:	Undermining of the north west concrete retaining wall may further affect the stability of the retaining wall.						
Urgency :	None <input type="checkbox"/>	6-10 years <input type="checkbox"/>	1-5 years <input type="checkbox"/>	< 1 year <input checked="" type="checkbox"/>	Urgent <input type="checkbox"/>		
Recommended Work :	Reinstallation				Estimated Cost:	\$15,797

Northwest Side.

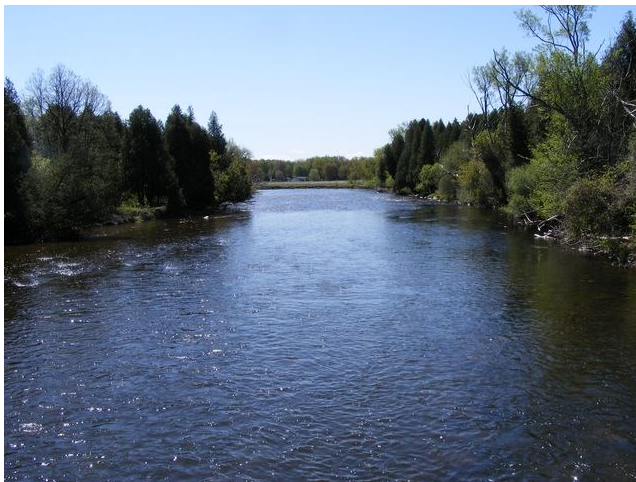
5.7.56 Watercourse - Watercourse

Element Group:	Watercourse					Length:	NA	
Element Name:	Watercourse					Width:	NA	
Location:	Single Element					Height:	NA	
Material:	Any					Count:	1	
Element Type:	Straight					Total Quantity:	1	
Environment:	Benign					Limited Inspection	<input type="checkbox"/>	
Protection System:	None					Performance Deficiencies	Maintenance Needs	
Condition Data:	Units	Exc.	Good	Fair	Poor			
	all	0	1	0	0	00	00	
Comments: None								
Urgency : None <input checked="" type="checkbox"/> 6-10 years <input type="checkbox"/> 1-5 years <input type="checkbox"/> < 1 year <input type="checkbox"/> Urgent <input type="checkbox"/>								
Recommended Work : Defer to Element Level

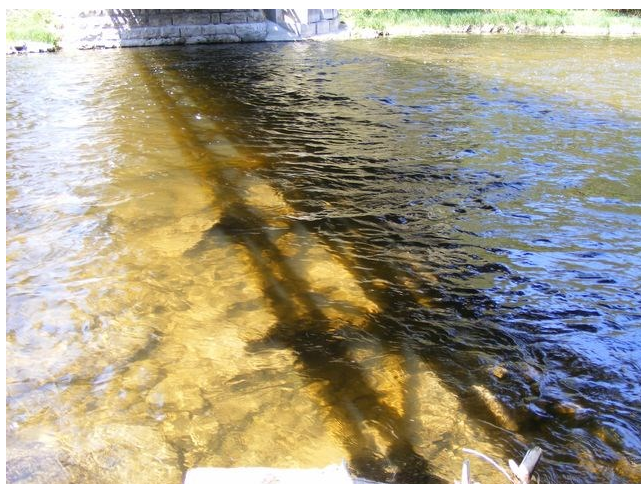
5.7.57 Watercourse - Bottom

Element Group:	Watercourse				Length:	NA	
Element Name:	Bottom				Width:	NA	
Location:	Single Element				Height:	NA	
Material:	Soil				Count:	NA	
Element Type:	Natural				Total Quantity:	120.54	
Environment:	Benign				Limited Inspection	<input type="checkbox"/>	
Protection System:	None				Performance Deficiencies	Maintenance Needs	
Condition Data:	Units	Exc.	Good	Fair	Poor		
	m2	0	120.54	0	0	00	00
Comments: None							
Urgency : None <input checked="" type="checkbox"/> 6-10 years <input type="checkbox"/> 1-5 years <input type="checkbox"/> < 1 year <input type="checkbox"/> Urgent <input type="checkbox"/>							
Recommended Work : None

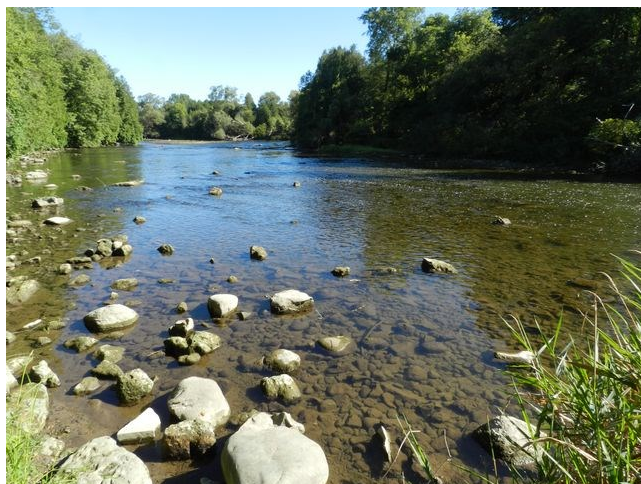
5.7.58 Watercourse - Upstream Section

Element Group:	Watercourse				Length:	NA	
Element Name:	Upstream Section				Width:	NA	
Location:	Single Element				Height:	NA	
Material:	Soil				Count:	NA	
Element Type:	Uncontrolled				Total Quantity:	60.27	
Environment:	Benign				Limited Inspection	<input type="checkbox"/>	
Protection System:	None				Performance Deficiencies	Maintenance Needs	
Condition Data:	Units	Exc.	Good	Fair	Poor		
	m2	0	60.27	0	0	00	00
Comments: None							
Urgency : None <input checked="" type="checkbox"/> 6-10 years <input type="checkbox"/> 1-5 years <input type="checkbox"/> < 1 year <input type="checkbox"/> Urgent <input type="checkbox"/>							
Recommended Work : None

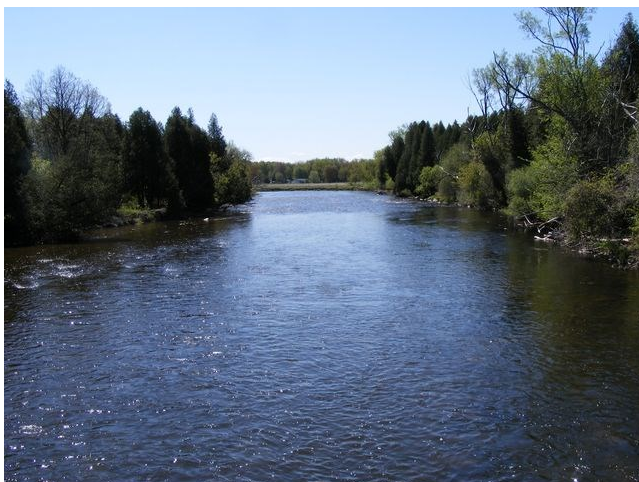
5.7.59 Watercourse - Downstream Section

Element Group:	Watercourse				Length:	NA	
Element Name:	Downstream Section				Width:	NA	
Location:	Single Element				Height:	NA	
Material:	Soil				Count:	NA	
Element Type:	Uncontrolled				Total Quantity:	60.27	
Environment:	Benign				Limited Inspection	<input type="checkbox"/>	
Protection System:	None				Performance Deficiencies	Maintenance Needs	
Condition Data:	Units	Exc.	Good	Fair	Poor		
	m2	0	60.27	0	0	00	00
Comments: None							
Urgency : None <input checked="" type="checkbox"/> 6-10 years <input type="checkbox"/> 1-5 years <input type="checkbox"/> < 1 year <input type="checkbox"/> Urgent <input type="checkbox"/>							
Recommended Work : None
