Biennial Bridge Inspection Report

Niska Road Over Speed River Bridge

No. 00001

April 14, 2014

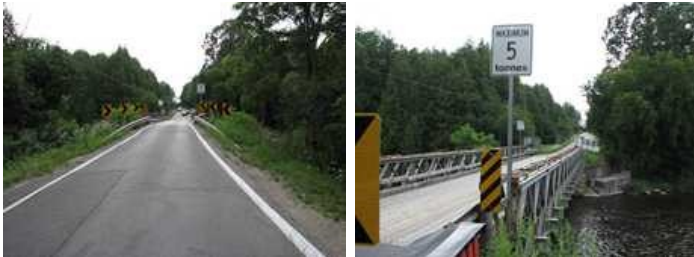
Observed Defect: [Structural Inadequacy](#)

Suggested Maintenance: [Minor Repair, Removal or Installation](#)

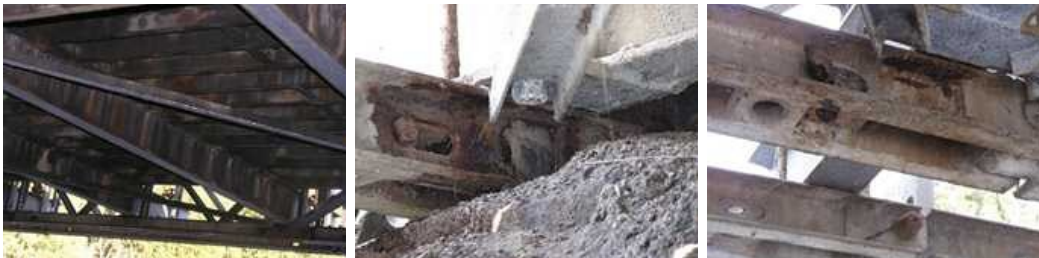
Truss - Bottom Chords - Bottom

Observed Defect: [Severe Corrosion](#)

Suggested Maintenance: [Minor Repair, Removal or Installation](#)

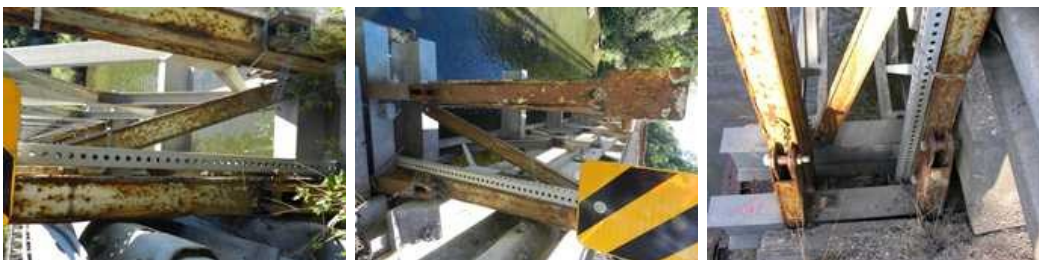
Truss - Verticals

Observed Defect: [Severe Corrosion](#)

Suggested Maintenance: [Minor Repair, Removal or Installation](#)

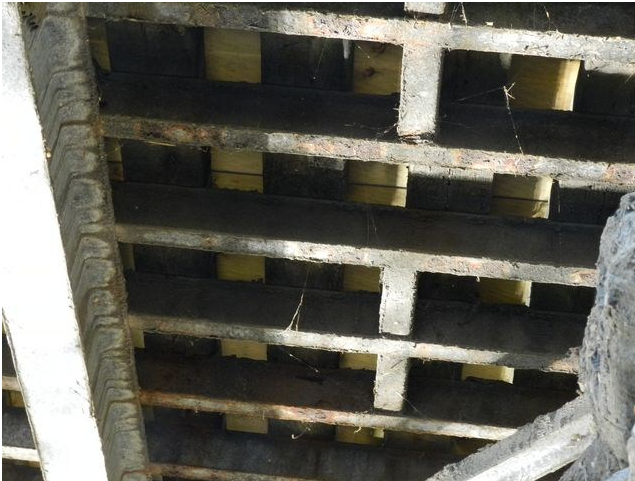
South End. Showing typical fair condition

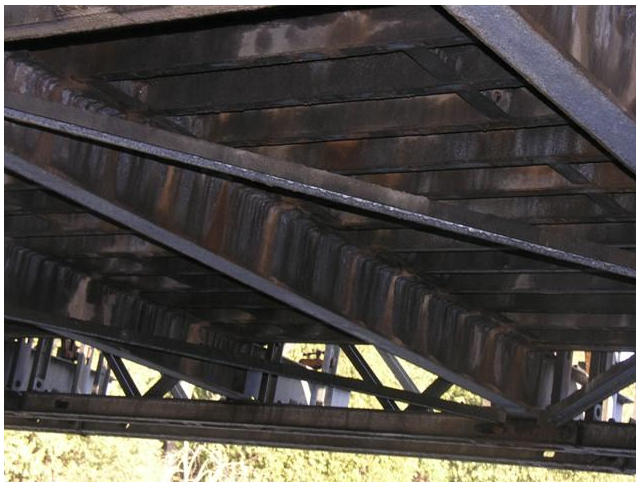
South Surface. Showing generally good condition

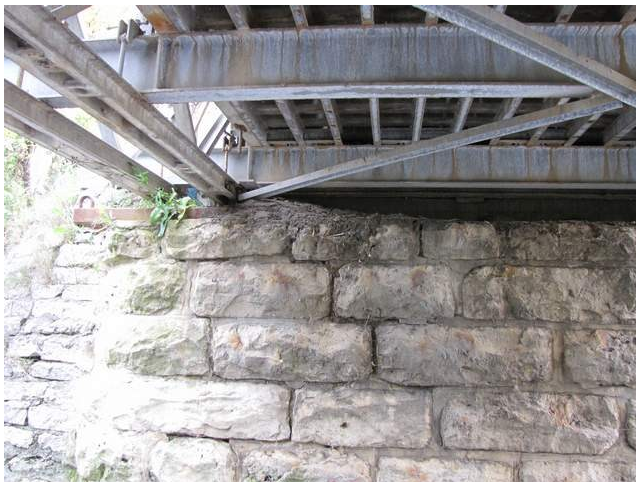
West End. Showing generally good condition

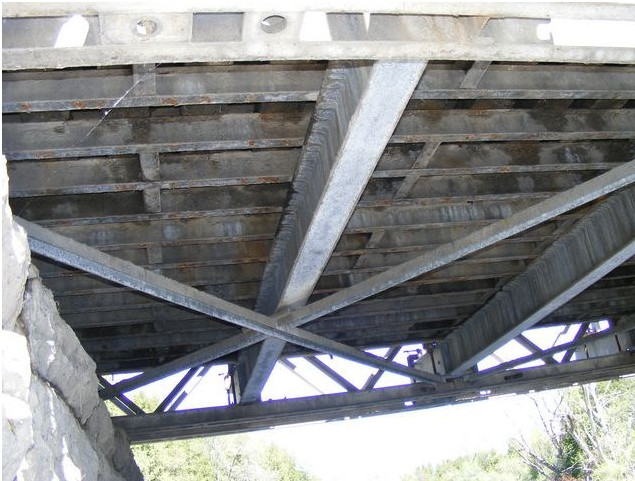
West End. Showing generally good condition

Recommended Work : [See Primary Element](#)

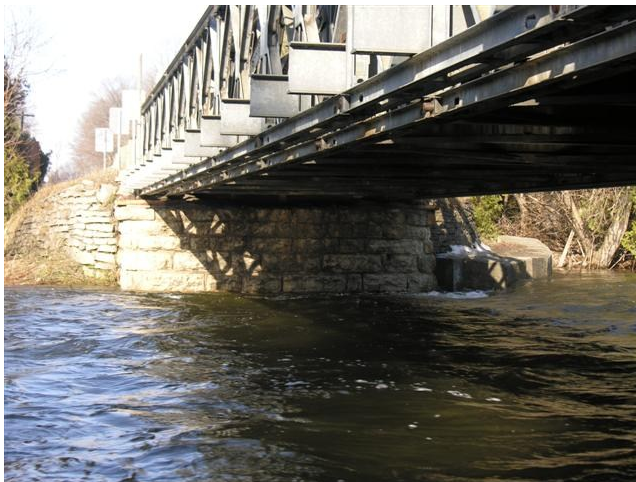
Element Group:	West Abutment				Length:	N/A	
Element Name:	Abutment				Width:	N/A	
Location:	Single Element				Height:	N/A	
Material:	Masonry				Count:	N/A	
Element Type:	Primary Element				Total Quantity:	46	
Environment:	Benign				Limited Inspection	<input type="checkbox"/>	
Protection System:	None					Performance Deficiencies	Maintenance Needs
Condition Data:	Units	Exc.	Good	Fair	Poor		
	tonnes	0	25.3	11.5	9.2	16	17
Comments:	Bearing plates are affected by severe corrosion and the thin concrete layer intended probably as a bearing area is in partial poor condition and progressively deteriorates (this may eventually lead to slight superstructure settlement). Isolated medium to severe loss of mortar and splitting also noted along the bottom side of the abutment wall.						
Urgency :	None <input type="checkbox"/>	6-10 years <input type="checkbox"/>	1-5 years <input checked="" type="checkbox"/>	< 1 year <input type="checkbox"/>	Urgent <input type="checkbox"/>

Recommended Work :	Defer to Element Level

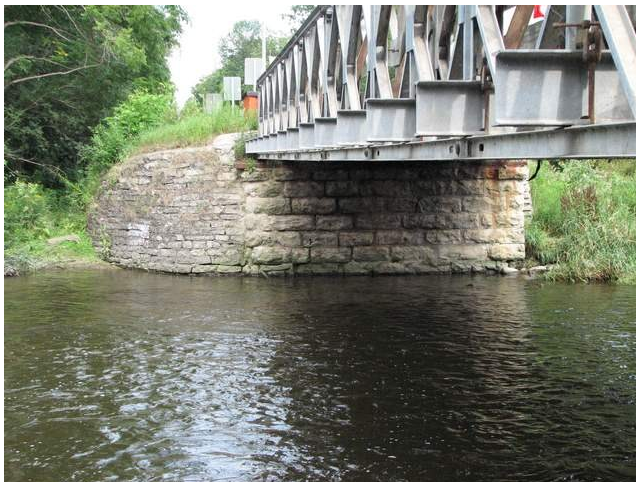
East Side.

Element Group:	East Abutment				Length:	N/A	
Element Name:	Abutment				Width:	N/A	
Location:	Single Element				Height:	N/A	
Material:	Masonry				Count:	N/A	
Element Type:	Primary Element				Total Quantity:	46	
Environment:	Benign				Limited Inspection	<input type="checkbox"/>	
Protection System:	None					Performance Deficiencies	Maintenance Needs
Condition Data:	Units	Exc.	Good	Fair	Poor		
	tonnes	0	25.3	11.5	9.2	16	17

Comments: Bearing plates are affected by severe corrosion and the thin concrete layer intended probably as a bearing area is in partial poor condition and progressively deteriorates (this may eventually lead to slight superstructure settlement). Isolated medium to severe loss of mortar and splitting also noted along the bottom side of the abutment wall.

Urgency : None ☐ 6-10 years ☐ 1-5 years ☒ < 1 year ☐ Urgent ☐

Recommended Work : [Defer to Element Level](#)

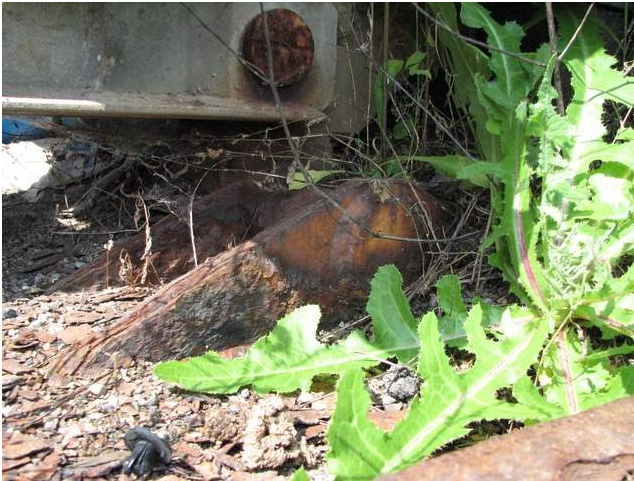
Element Group:	East Abutment					Length:	N/A	
Element Name:	Bearings					Width:	N/A	
Location:	Single Element					Height:	N/A	
Material:	Any					Count:	2	
Element Type:	Plate					Total Quantity:	2	
Environment:	Severe					Limited Inspection	<input type="checkbox"/>	
Protection System:	None							
Condition Data:	Units	Exc.	Good	Fair	Poor	Performance Deficiencies	Maintenance Needs	
	each	0	0	1	1	05	17	
Comments:	Bearing plates are affected by severe corrosion (this may eventually result in slight settlement of the superstructure).

East Side. Showing severe corrosion.

Urgency : None ☐ 6-10 years ☐ 1-5 years ☒ < 1 year ☐ Urgent ☐

Recommended Work : Replacement

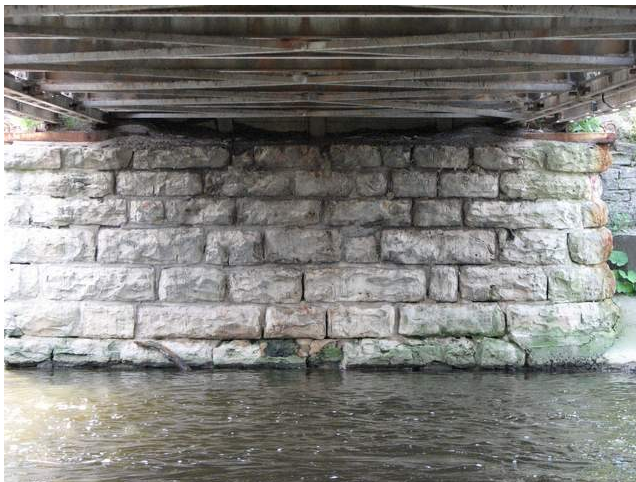
Side.

Element Group:	West Abutment					Length:	N/A	
Element Name:	Abutment Wall					Width:	5.9	
Location:	Single Element					Height:	2.2	
Material:	Masonry					Count:	1	
Element Type:	Any					Total Quantity:	12.5	
Environment:	Benign					Limited Inspection	<input type="checkbox"/>	
Protection System:	None						Performance Deficiencies	Maintenance Needs
Condition Data:	Units	Exc.	Good	Fair	Poor			
	m2	0	9	2.5	1		00	17
Comments:	Isolated severe loss of mortar noted (especially along the base).

Urgency : None ☐ 6-10 years ☐ 1-5 years ☒ < 1 year ☐ Urgent ☐

Recommended Work : Replacement

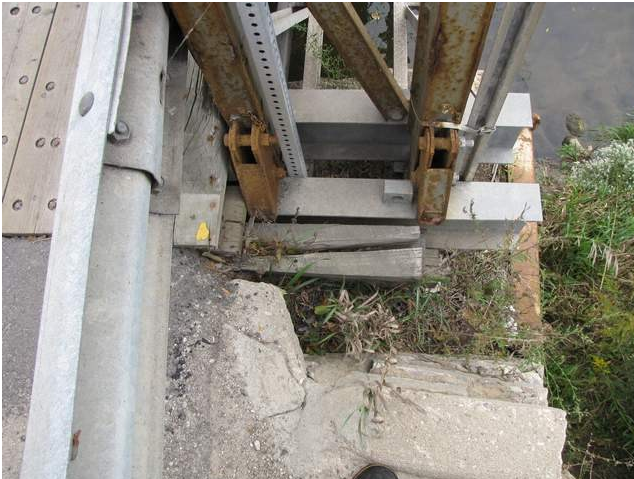
Element Group:	West Abutment			Length:	N/A		
Element Name:	Ballast Wall			Width:	5.9		
Location:	Single Element			Height:	0.5		
Material:	Timber			Count:	1		
Element Type:	Any			Total Quantity:	3		
Environment:	Benign			Limited Inspection	<input type="checkbox"/>		
Protection System:	None				Performance Deficiencies		Maintenance Needs
Condition Data:	Units	Exc.	Good	Fair	Poor		
	m2	0	1.95	0.75	0.3	16	17
Comments:	The west side exhibits severe deterioration.

Side. Showing severe deterioration.

Urgency : None ☐ 6-10 years ☐ 1-5 years ☒ < 1 year ☐ Urgent ☐

Recommended Work : Timber Replacement

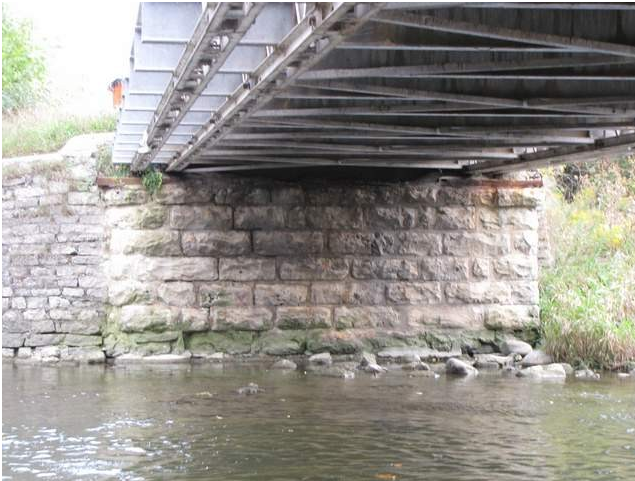
East Side.

Element Group:	East Abutment			Length:	N/A		
Element Name:	Ballast Wall			Width:	5.9		
Location:	Single Element			Height:	0.5		
Material:	Timber			Count:	1		
Element Type:	Any			Total Quantity:	3		
Environment:	Benign			Limited Inspection	<input type="checkbox"/>		
Protection System:	None						
Condition Data:	Units	Exc.	Good	Fair	Poor	Performance Deficiencies	Maintenance Needs
	m2	0	3	0	0	00	00
Comments:	None.

Urgency : None ☐ 6-10 years ☒ 1-5 years ☐ < 1 year ☐ Urgent ☐

Recommended Work : Timber Replacement

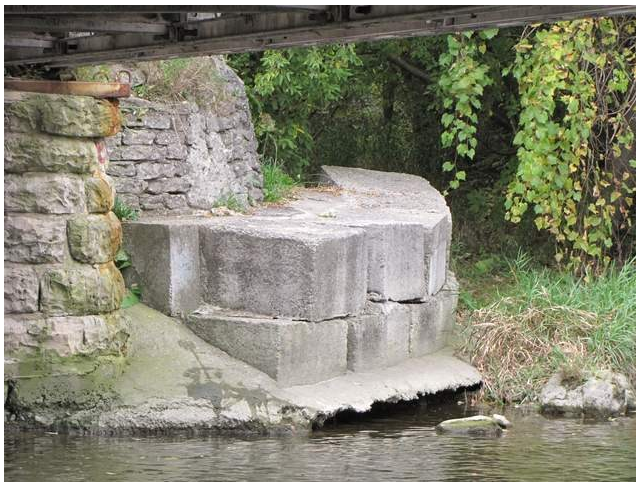
Northwest Side.

Element Group:	West Retaining Wall			Length:	N/A		
Element Name:	NorthRetaining Wall			Width:	N/A		
Location:	North			Height:	N/A		
Material:	Mass Concrete			Count:	N/A		
Element Type:	Gravity			Total Quantity:	18.29		
Environment:	Benign			Limited Inspection	<input type="checkbox"/>		
Protection System:	None				Performance Deficiencies		Maintenance Needs
Condition Data:	Units	Exc.	Good	Fair	Poor		
	tonnes	0	14.63	3.66	0	03	17
Comments:	Continuing settlement expected due to undermining.

Urgency : None ☐ 6-10 years ☒ 1-5 years ☐ < 1 year ☐ Urgent ☐

Recommended Work : Ancillary Replacement

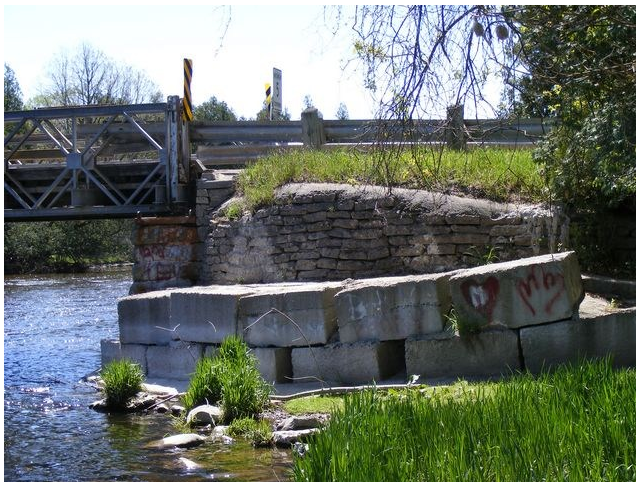
Northwest Side.

Element Group:	West Retaining Wall			Length:	8		
Element Name:	Vertical Surface			Width:	N/A		
Location:	Single Element			Height:	1.75		
Material:	Masonry			Count:	1		
Element Type:	Any			Total Quantity:	14		
Environment:	Benign			Limited Inspection	<input type="checkbox"/>		
Protection System:	None						
Condition Data:	Units	Exc.	Good	Fair	Poor	Performance Deficiencies	Maintenance Needs
	m2	0	0	14	0	16	17
Comments:	None.

Urgency : None ☐ 6-10 years ☒ 1-5 years ☐ < 1 year ☐ Urgent ☐

Recommended Work : [See Primary Element](#)

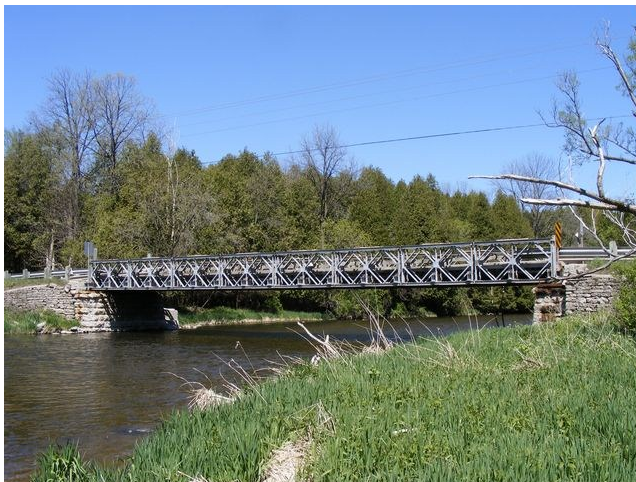
South View .

Element Group:	Foundation					Length:	N/A	
Element Name:	Foundation					Width:	N/A	
Location:	Single Element					Height:	N/A	
Material:	Steel Piles					Count:	1	
Element Type:	Primary Element					Total Quantity:	1	
Environment:	Benign					Limited Inspection	<input checked="" type="checkbox"/>	
Protection System:	None							
Condition Data:	Units	Exc.	Good	Fair	Poor	Performance Deficiencies	Maintenance Needs	
	each	0	0.8	0	0.2	00	00	
Comments:	<p>The waterbed along the west abutment exhibits medium degradation and taking into account that water flow encroaches against the substructure/footing it may be further affected by high volume of water. The condition of foundation should be regularly checked and proper measures should be taken if necessary.</p>							
Urgency :	None <input type="checkbox"/>		6-10 years <input type="checkbox"/>		1-5 years <input type="checkbox"/>		< 1 year <input checked="" type="checkbox"/>

Recommended Work :	Reinstallation							
							Urgent <input type="checkbox"/>

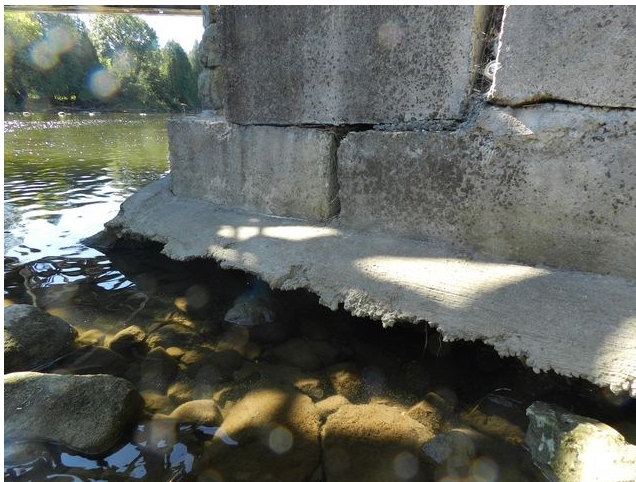
Northw est Side.

Element Group:	Foundation					Length:	N/A	
Element Name:	NorthFoundation					Width:	N/A	
Location:	North					Height:	N/A	
Material:	Steel Piles					Count:	1	
Element Type:	Primary Element					Total Quantity:	1	
Environment:	Benign					Limited Inspection	<input checked="" type="checkbox"/>	
Protection System:	None							
Condition Data:	Units	Exc.	Good	Fair	Poor	Performance Deficiencies	Maintenance Needs	
	each	0	0.77	0.03	0.2	16	13	
Comments:	<p>The foundation of the north west retaining wall is being progressively undermined. The retaining wall may unstable during high volume water (in case of collapse the road system and the superstructure possibly may be severely affected). Further condition of the west foundation should be closely monitored.</p>							
Urgency :	None <input type="checkbox"/>		6-10 years <input type="checkbox"/>		1-5 years <input type="checkbox"/>		< 1 year <input checked="" type="checkbox"/>

Recommended Work :	Reinstallation							
							Urgent <input type="checkbox"/>

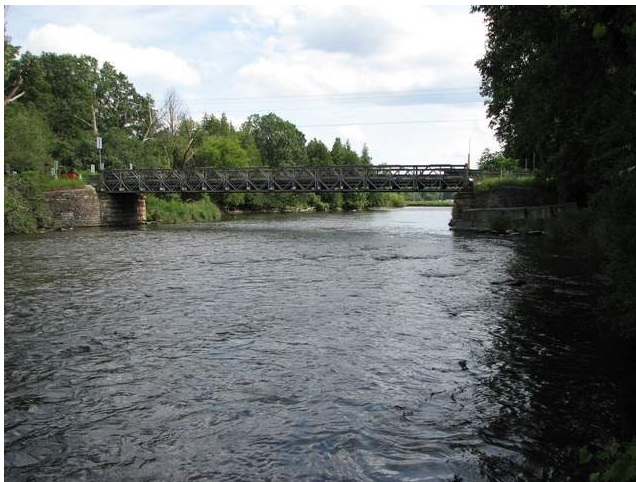
Overall View . Showing condition.

Urgency : None ☐ 6-10 years ☐ 1-5 years ☐ < 1 year ☒ Urgent ☐

Recommended Work : [Defer to Element Level](#)
