> XCG File No.: 5-2705-23-01 July 5, 2021

Phase I Environmental Site Assessment 9 Valley Road and 1242, 1250, 1260, and 1270 Gordon Street, Guelph, Ontario

Prepared for: **THE TRICAR GROUP** 3800 Colonel Talbot Road London, Ontario N6P 1H5

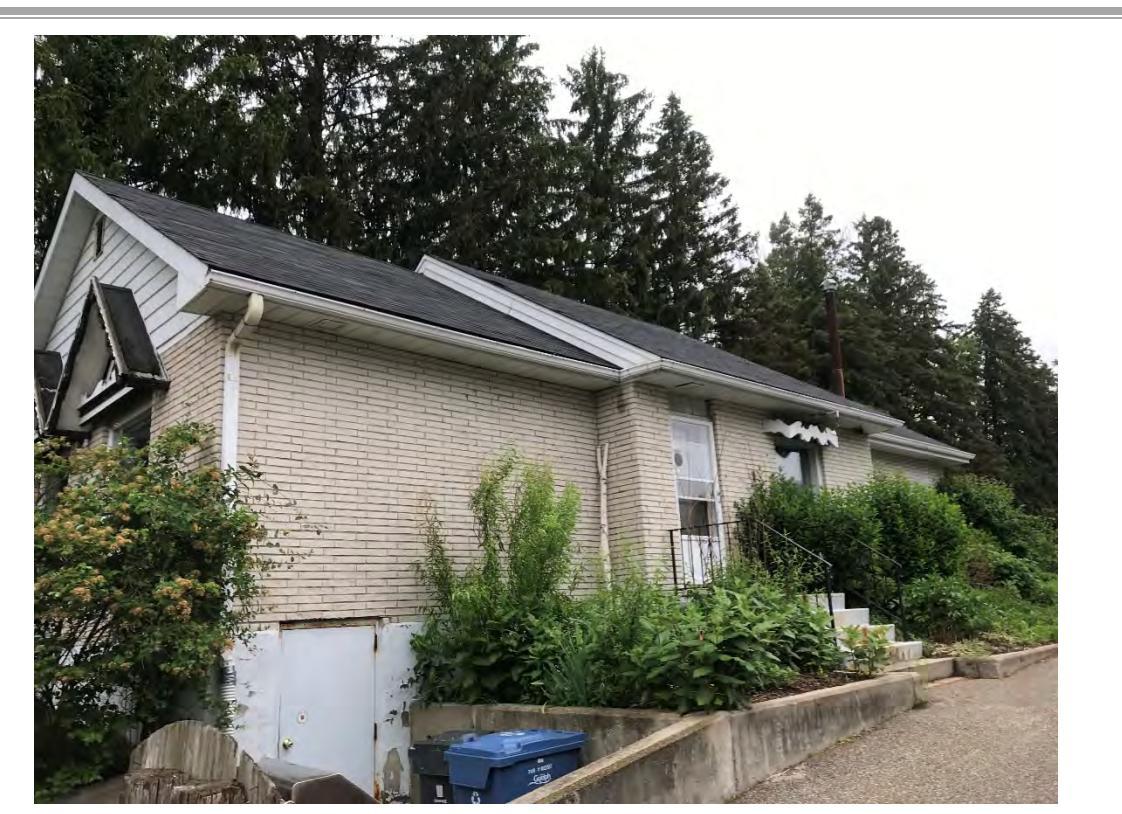
Photo 3: View of the southeast side of the dwelling located at 1270 Gordon Street looking north.

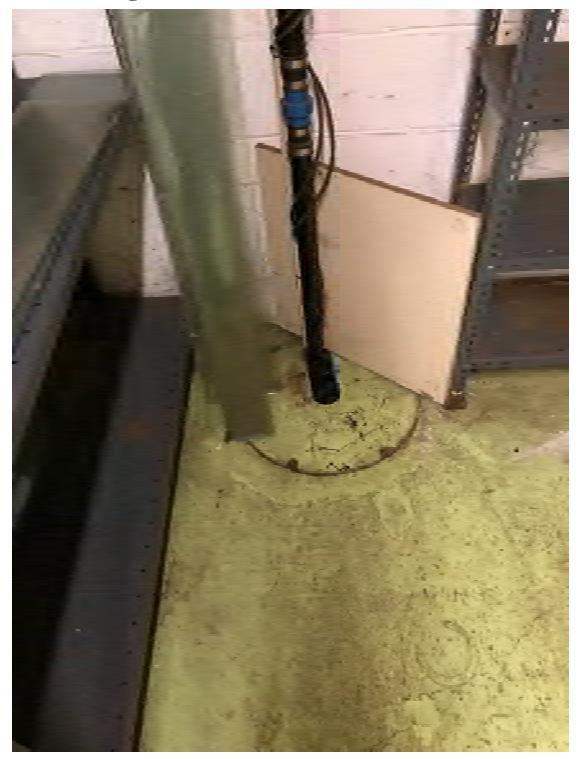
Photo 4: View of the sump pump in northeast portion of the basement of the dwelling at 1270 Gordon Street.

The presence of floor drains, pits, and sumps was investigated by XCG through observations made during the site visit. At the time of the site visit, no floor drains or pits were observed within the subject buildings. A sump was observed in the basement of 1270 Gordon Street. The sump appeared to be in good condition and no odours around the sump were noted. Tricar personnel indicated the sump pump discharges directly to the municipal storm sewer system.

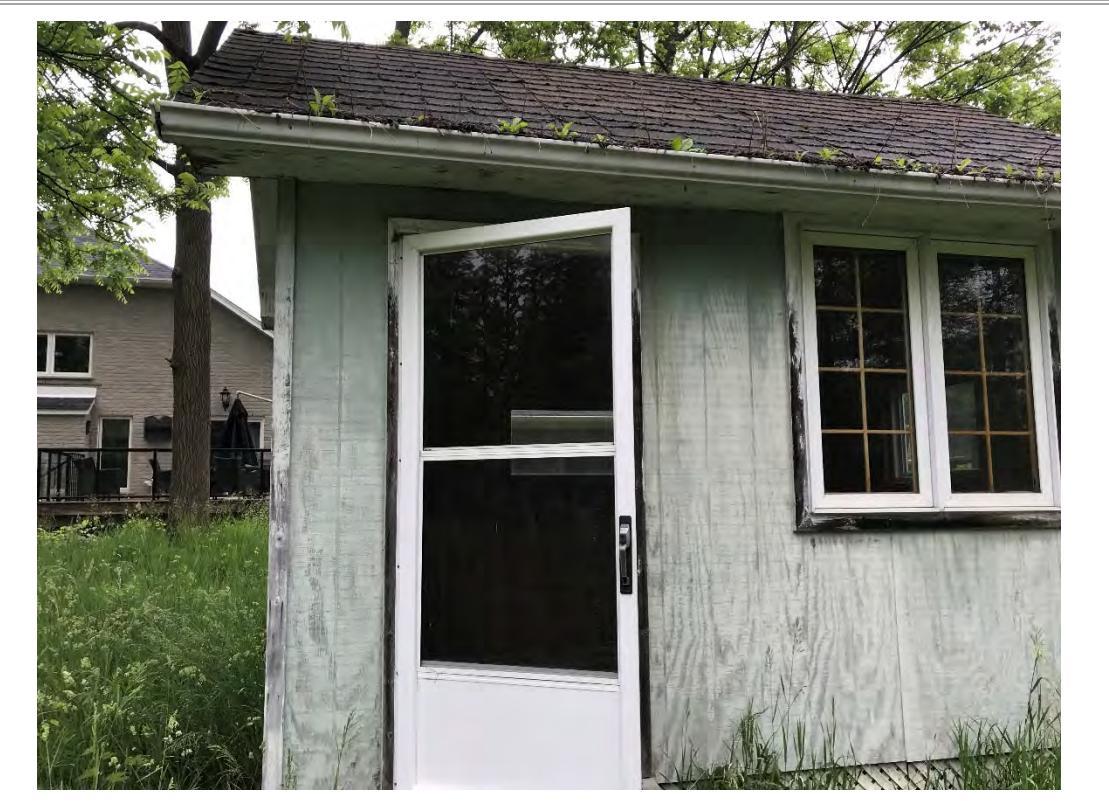
Photo 5: View of the shed located at the northeast portion of the property located at 1242 Gordon Street, looking west.

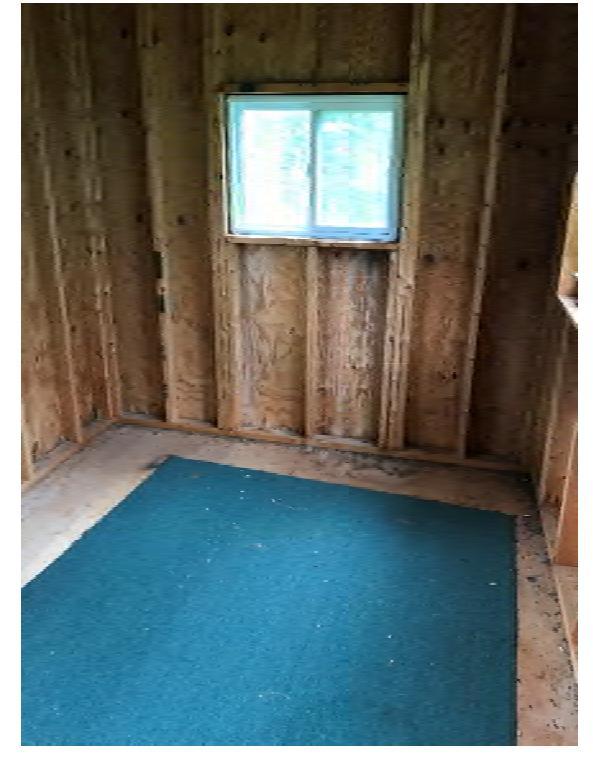
Photo 6: View of the inside of the shed located at the northeast portion of the property located at 1242 Gordon Street.

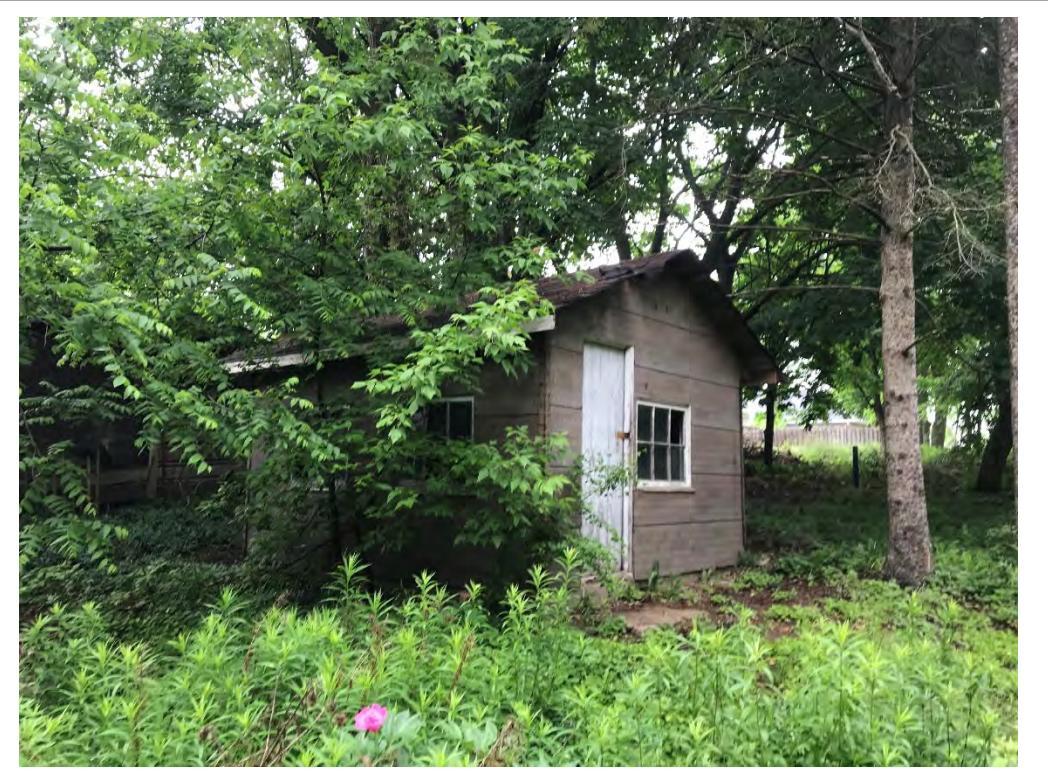
Photo 7: View of the shed located at the southwest portion of the property located at 1242 Gordon Street, looking northwest.

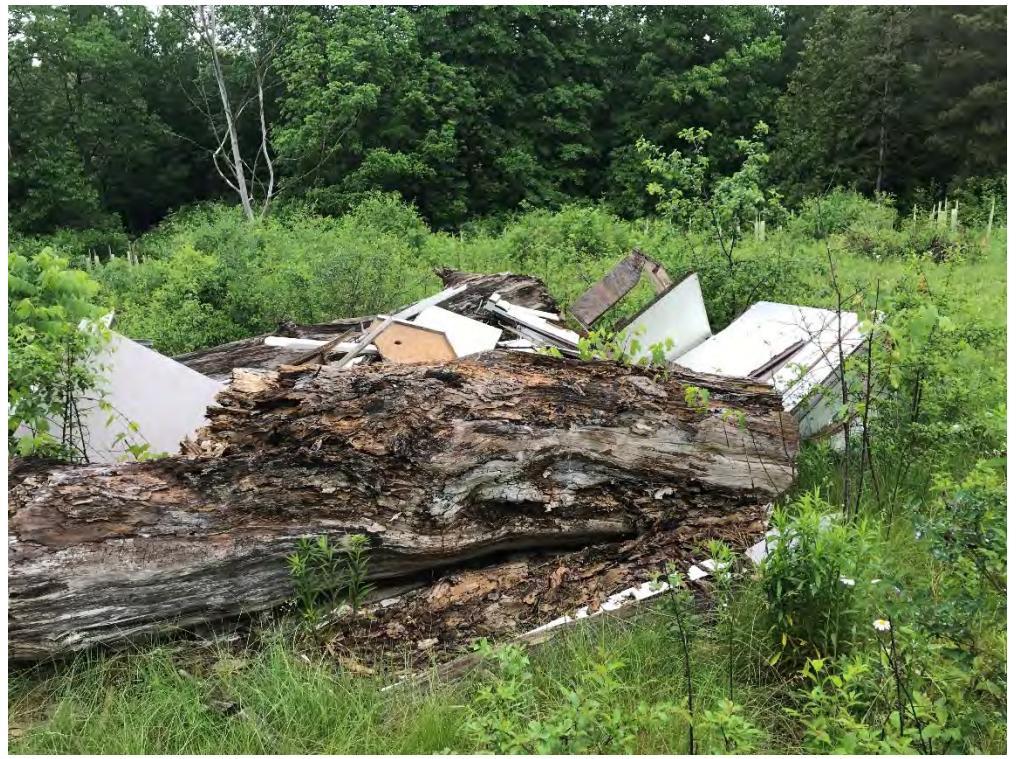
Photo 8: View of the pile of furniture located at the northeast portion of the property located at 1250 Gordon Street, looking north.

At the time of the site visit, piles of debris (wood, stone, plastic, fabric, glass, furniture, etc.) were observed on the exterior surfaces of the subject site. The piles of debris were observed throughout properties 1242, 1250, and 1260 Gordon Street. XCG did not observe any evidence of on-site solid waste burial. Based on the nature of the debris it is not interpreted to represent a source of significant impact to the subject site, however the material will need to be appropriately disposed of off-site.

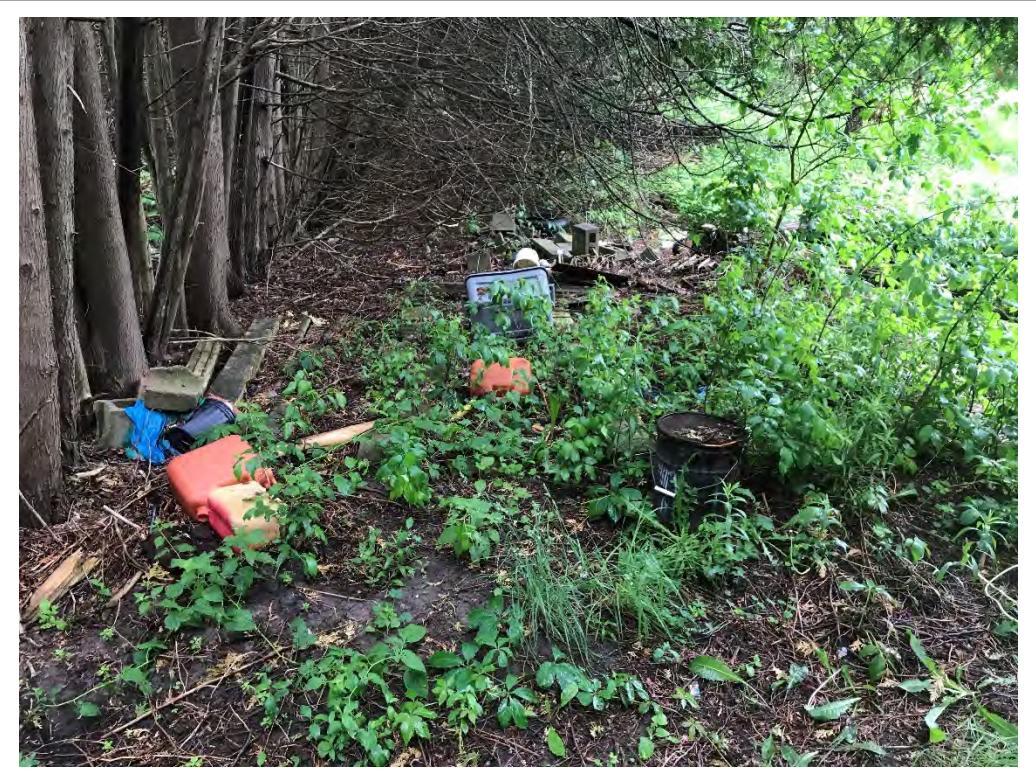
Photo 9: View of the debris pile with gasoline containers located in the center of the property located at 1260 Gordon Street, looking west.

At the time of the site visit, cleaning supplies was observed at 1270 Gordon Street. Portable gasoline containers were observed disposed of in a debris pile located at 1250 Gordon Street. Numerous disposed retail-sized containers of motor oil were observed around the burn pile located on the central portion of 1260 Gordon Street.

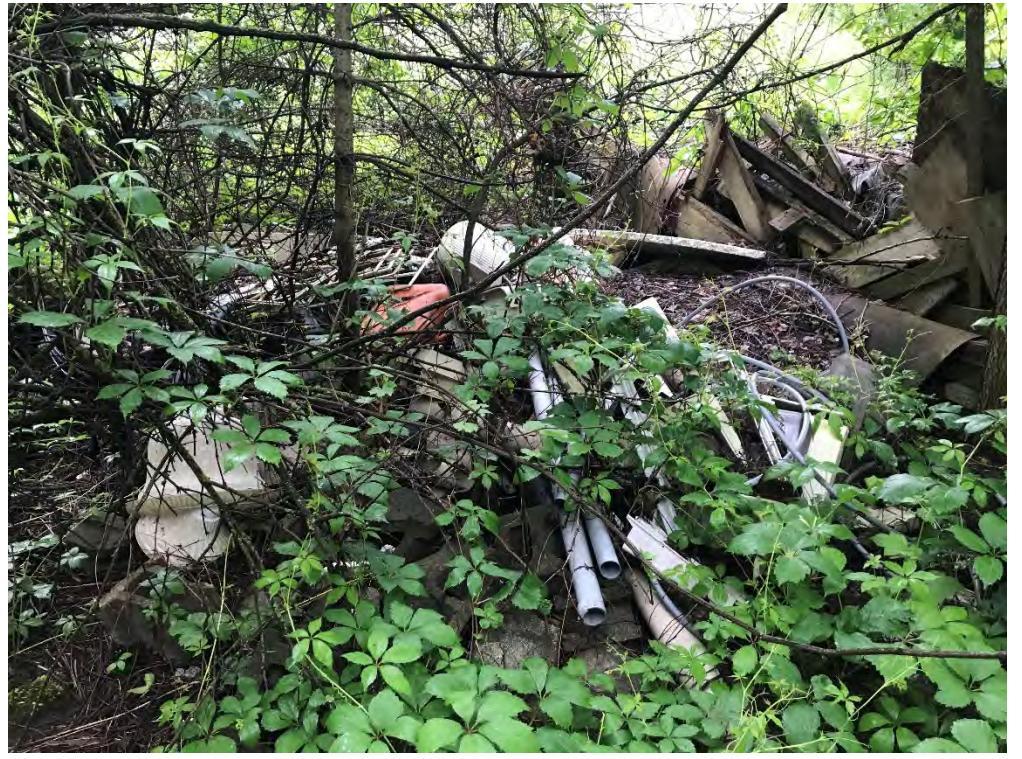
Photo 10: View of the burn pile with oil cans located in the center of the property located at 1260 Gordon Street, looking north.

Review of the analytical results indicated that total xylenes were detected at one surficial soil sample location in the vicinity of the burn pile at a concentration marginally above the current MECP site condition standards (SCS) for residential land use in a potable groundwater condition. A soil sample collected from a deeper sample interval [1.5 to 2.1 metres below ground surface(bgs)] contained total xylene concentrations below the laboratory reportable detection limit, as well as below the MECP SCS.

XCG interpreted the elevated concentration of xylenes in the surface soil sample as an isolated occurrence, with impacts anticipated to be limited to the immediate vicinity of the burn pit and not expected to extend beyond a depth of 0.5 metres bgs. XCG also indicated that the detected soil impacts could be addressed through excavation and appropriate off-site disposal during future site development activities. As such, XCG does not interpret the soil impacts detected in the vicinity of the burn pile to represent a source of significant environmental concern.

The focussed soil quality investigation conducted by XCG in 2018 determined that minor soil impacts were present in the vicinity of the burn pile located at 1260 Gordon Street; however, these impacts were not interpreted to represent a source of significant contamination.

One pile of wood debris located at 1260 Gordon Street appeared to be an old burn pile. As discussed in Section 4.7, numerous fuel oil conditioner canisters were also located around the burn pit area. However, based on the analytical results from the focussed soil quality investigation conducted by XCG in 2018, the burn pile was not identified as a source of significant contamination at the subject site.
