Re: Addendum #2 to Cityview Ridge EIS

Cityview Ridge Environmental Impact Study Addendum #2 – 26th July, 2013

Evaluation of Impact from Revised Draft Plan of Subdivision (March 19th 2013), Potential Impacts from Proposed Trail and Responses to comments provided by EAC.

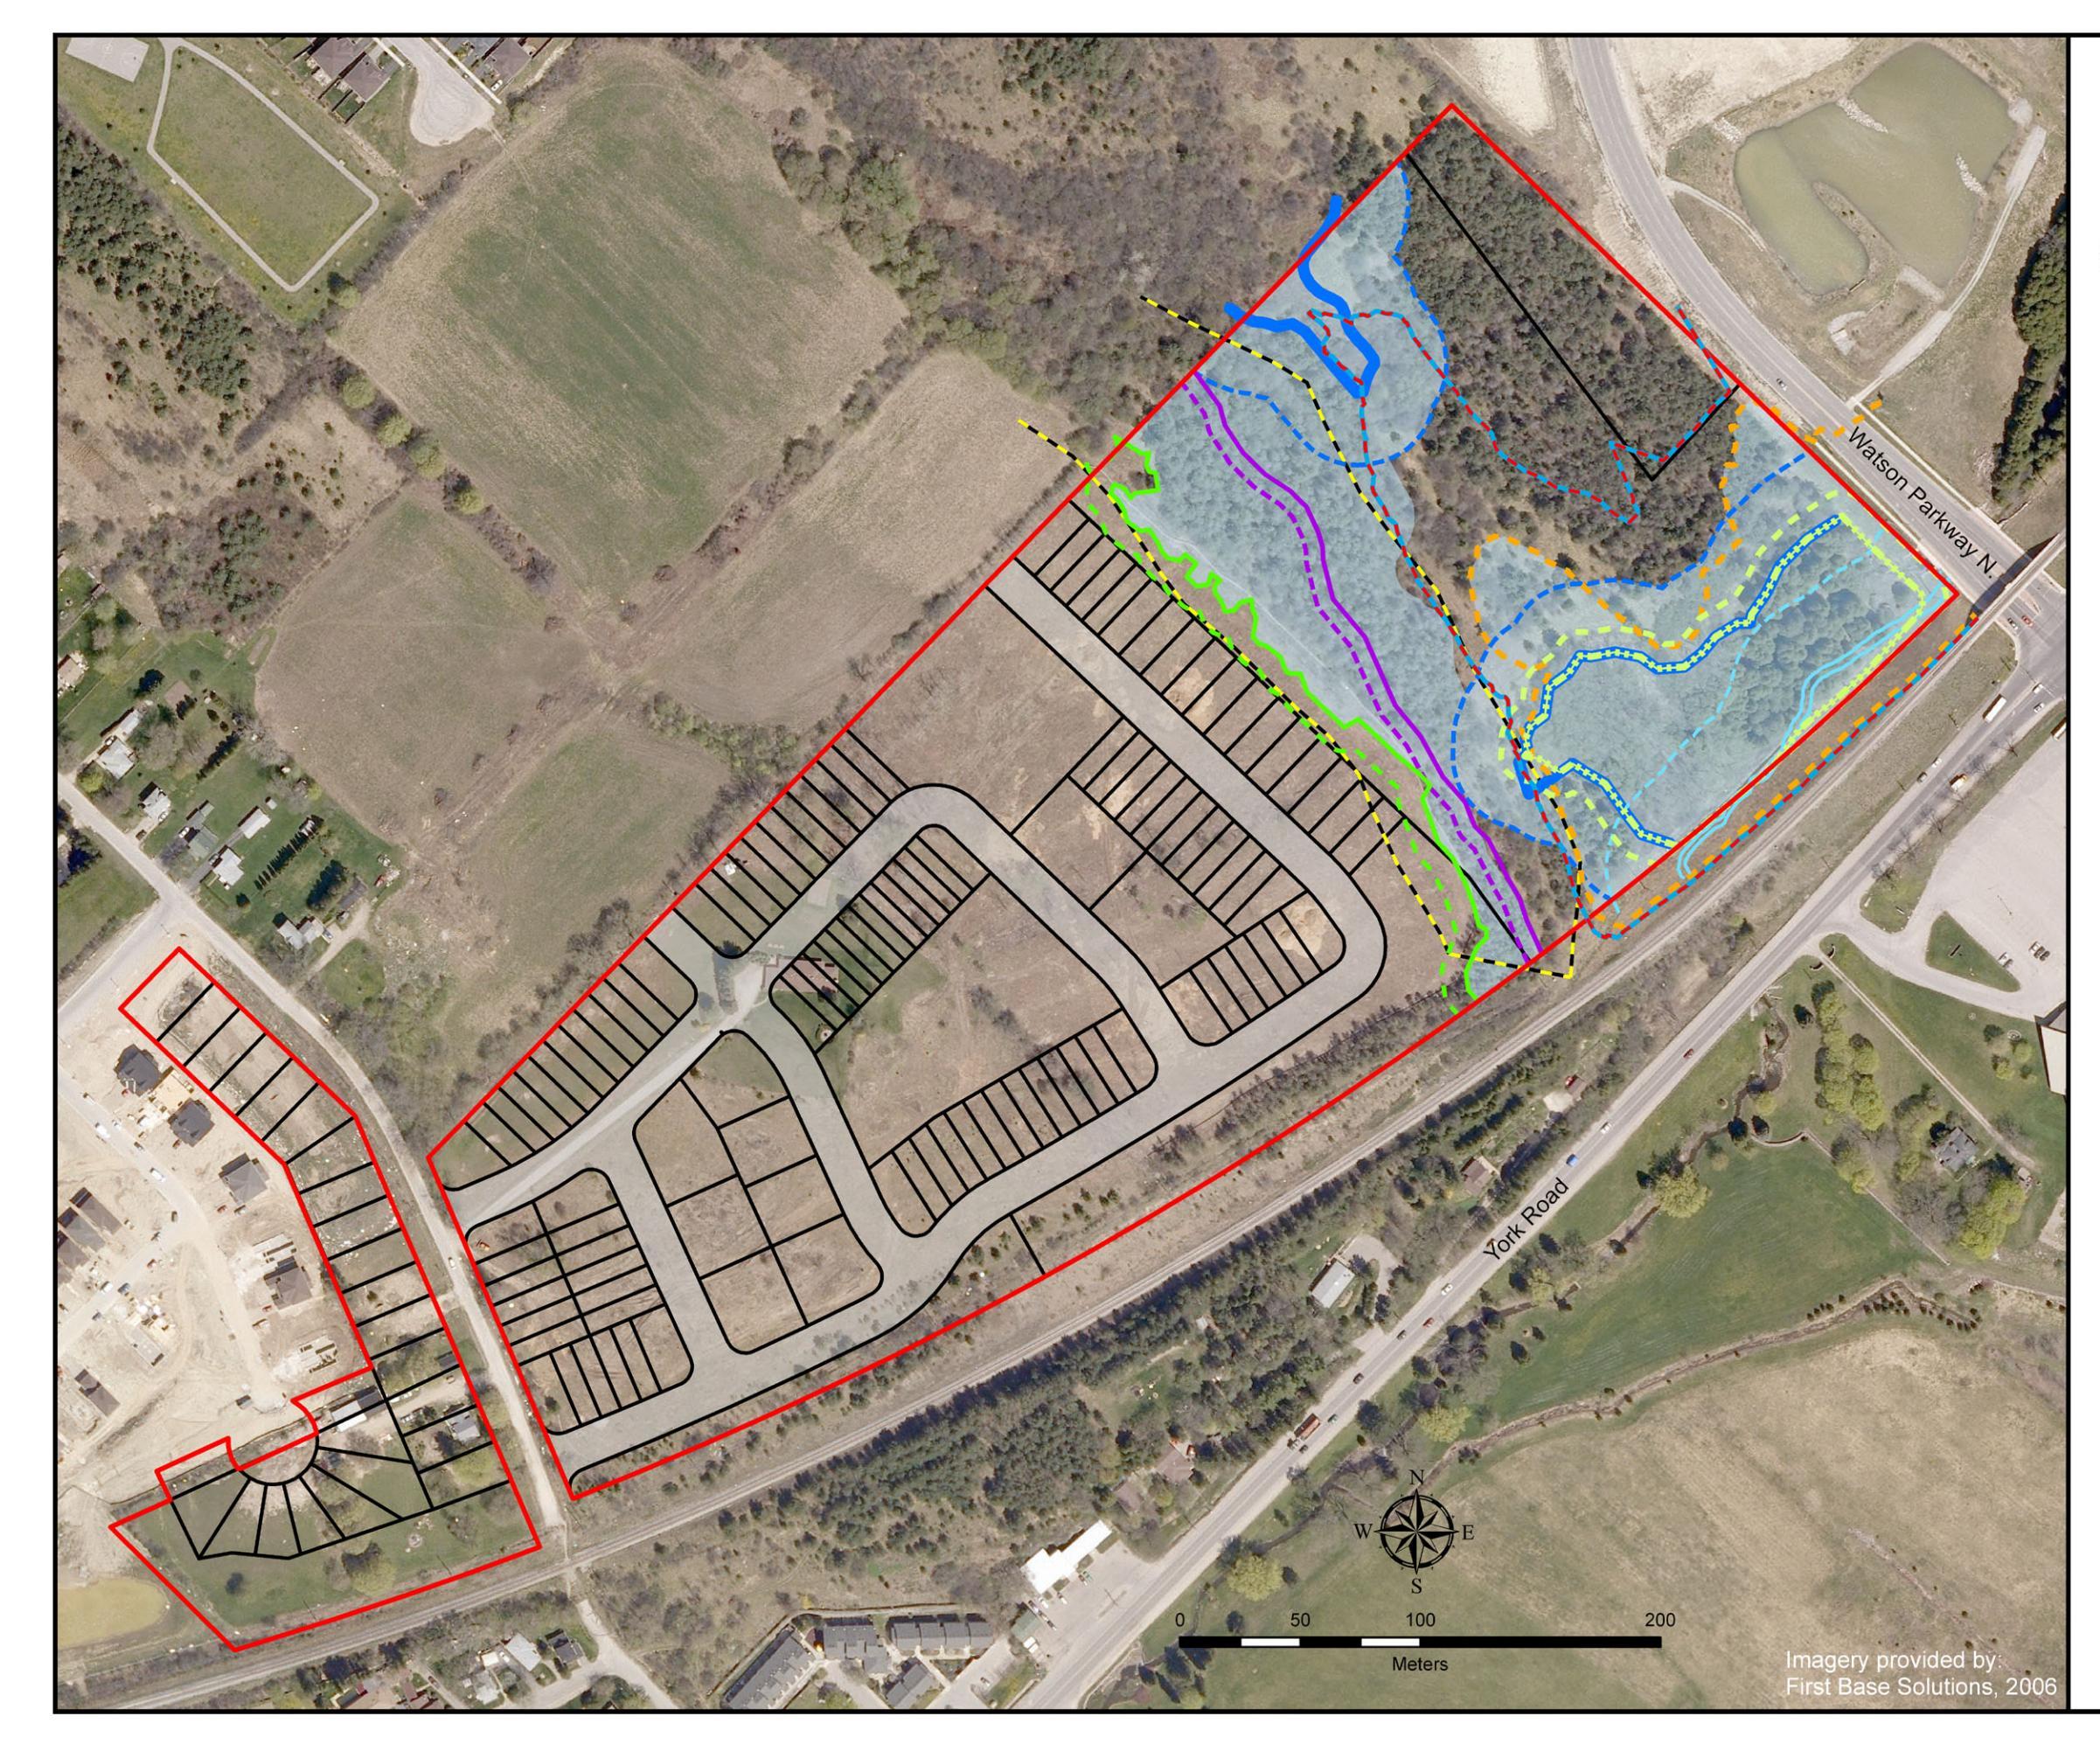
Figure 1: Revised Draft Plan (Mar 2013) and Environmental Constraints

Figure 1 (appended) illustrates the revised draft plan with the environmental constraints identified in the original EIS. Figure 1 in this addendum thus replaces Figure 3 in the EIS. A comparison of the two Figures shows that the revised plan is contained within the same development area as the original plan. The lot configuration on the east side of "Street 6", adjacent to the slopes and associated constraints, is identical on the two plans, thus the evaluation and conclusions provided in the original EIS (February 2012) remain unchanged:

The revised draft plan offers opportunities for reducing impacts to the existing trees on the subject lands. The Tree Inventory and Compensation Plan (section 6.0 in the EIS) documented 100 trees in the hedgerow along the north boundary of the subject lands that would require removal owing to the grading requirements of the lots in that area. In the revised plan, a park block (Block 107) has been located on the north boundary, displacing 8 lots from the original

plan. Thus there is opportunity to retain the hedgerow trees along the north boundary in the location of the proposed park block. It is recommended that the exact number of trees that can be retained in the park block be established as part of the Environmental Implementation Report. The tree compensation plan can be adjusted at that time consistent with the formula provided in the EIS.

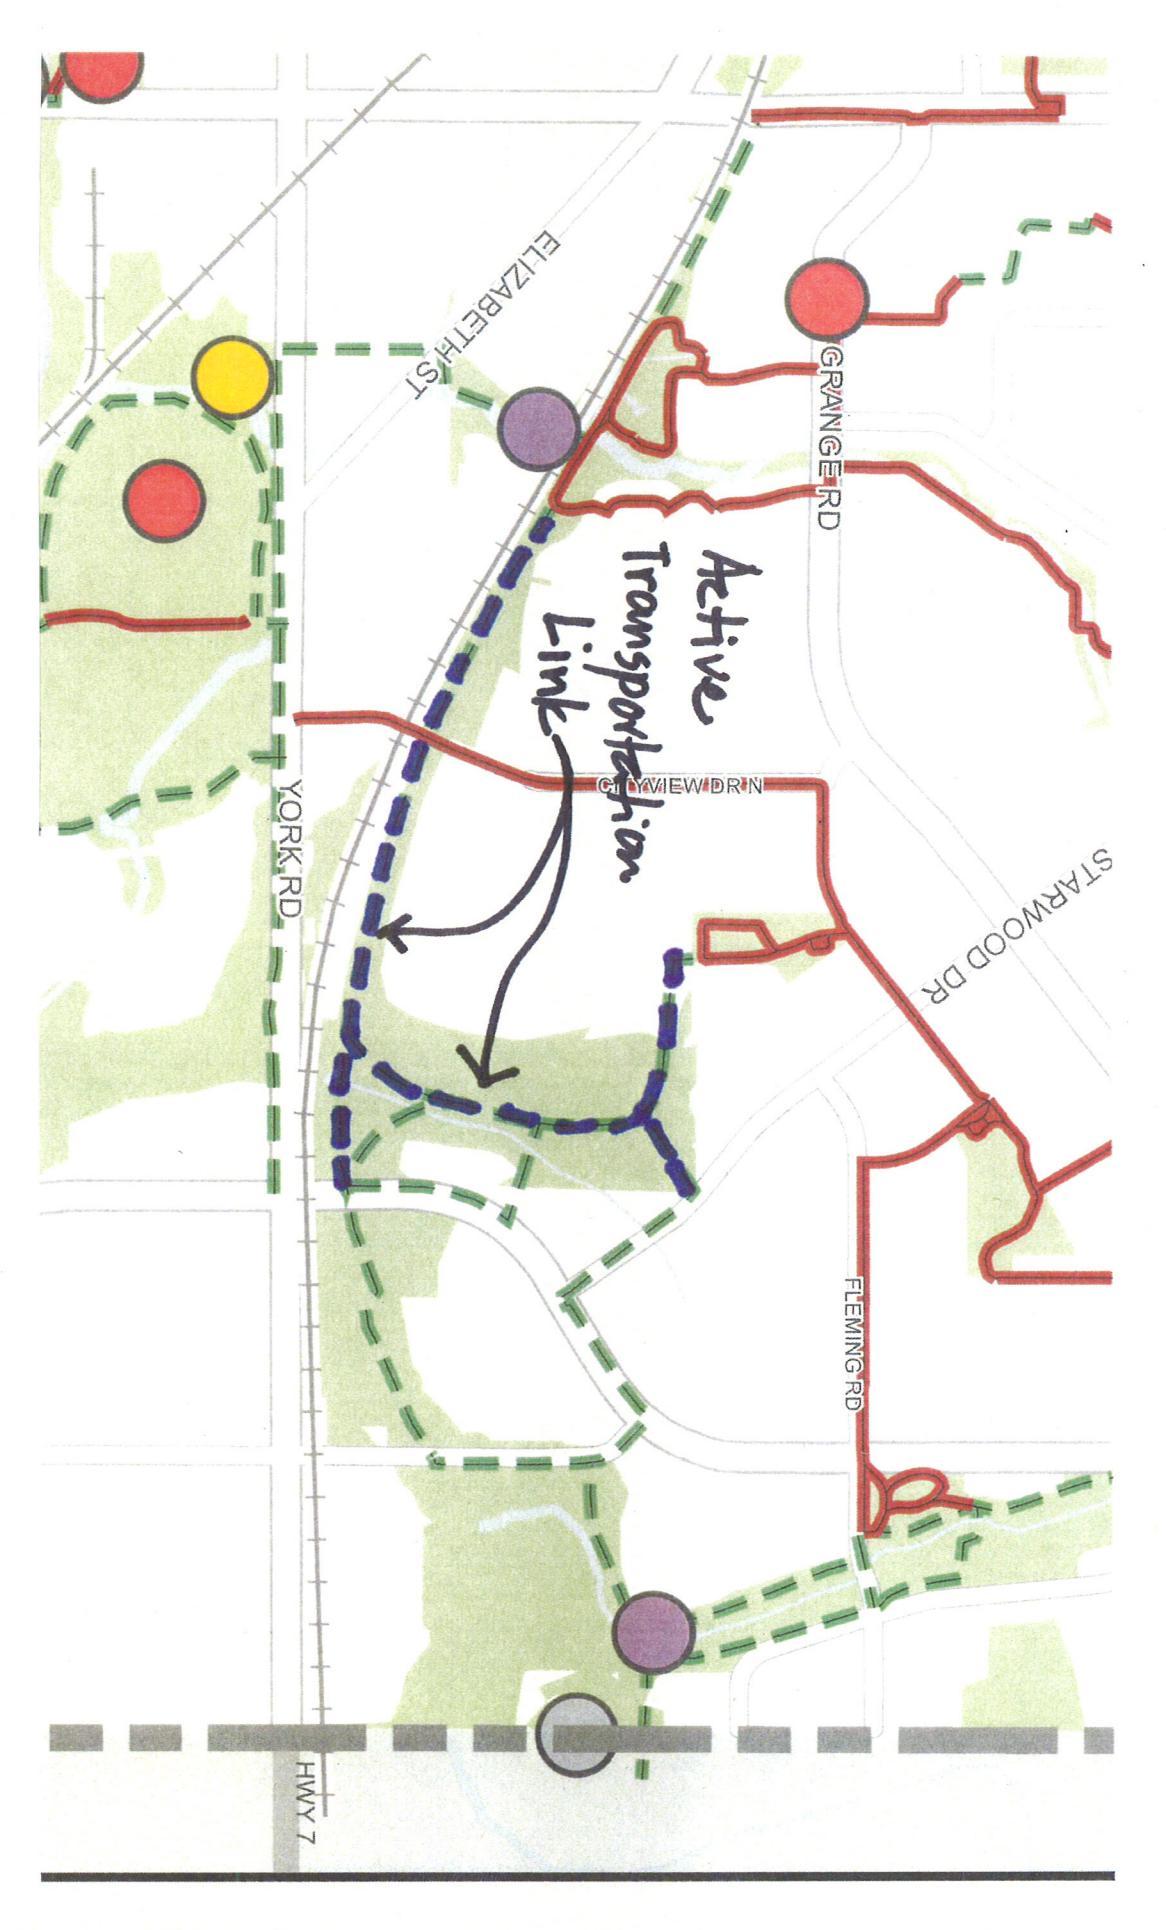
Figure 2: Conceptual Trail Alignment Provided by City of Guelph

The City provided a sketch map (Figure 2 appended) that shows the alignment of the existing trail system to the west of Cityview Drive and a conceptual alignment through the Cityview Ridge Property. West of the study site, the existing trail system runs parallel to the CNR tracks then turns north to connect with an access point on Cedarvale Avenue. The suggestion from the City was to extend the trail along the north side of the tracks to the cul-de-sac at the southern end of Cityview Drive, then continue eastward paralleling the CNR tracks to Watson Parkway, with a link northward through the low-lying lands just west of Watson Parkway which would connect to the proposed subdivision to the north of the Cityview Ridge Lands. Although the intent to provide continuous connection from the existing trail system to Watson Parkway is appealing from a trail system perspective, the concept did not account for the steep wooded slope and sensitive wetland and woodland feature located in the eastern, low-lying part of the Cityview Ridge property.

However, the segment of the conceptual alignment located on and east of the steep slopes associated with the east-facing flank of the drumlin poses substantial issues for trail alignment. These issues include:

- policy conformity related to the section through the significant wetland and significant woodland;
- re-grading of the slope to accommodate two switchbacks for the section through cultural plantation on the drumlin slope;
- removal of a substantial number of trees as a result of the re-grading;
- the loss of trees could result in erosion issues;
- it is less likely that two of three locally significant birds species which have used the cultural plantation in the past will persist, and this would not conform to City policy; and
- a trail connection running northward, to connect to the proposed subdivision to the north of the Cityview Ridge Lands through the wooded area at the bottom of the slope, will not offer users the higher quality of visual experience (long views to the east) that a trail alignment that extends northerly, along the rear of lots 41 to 57 would do.

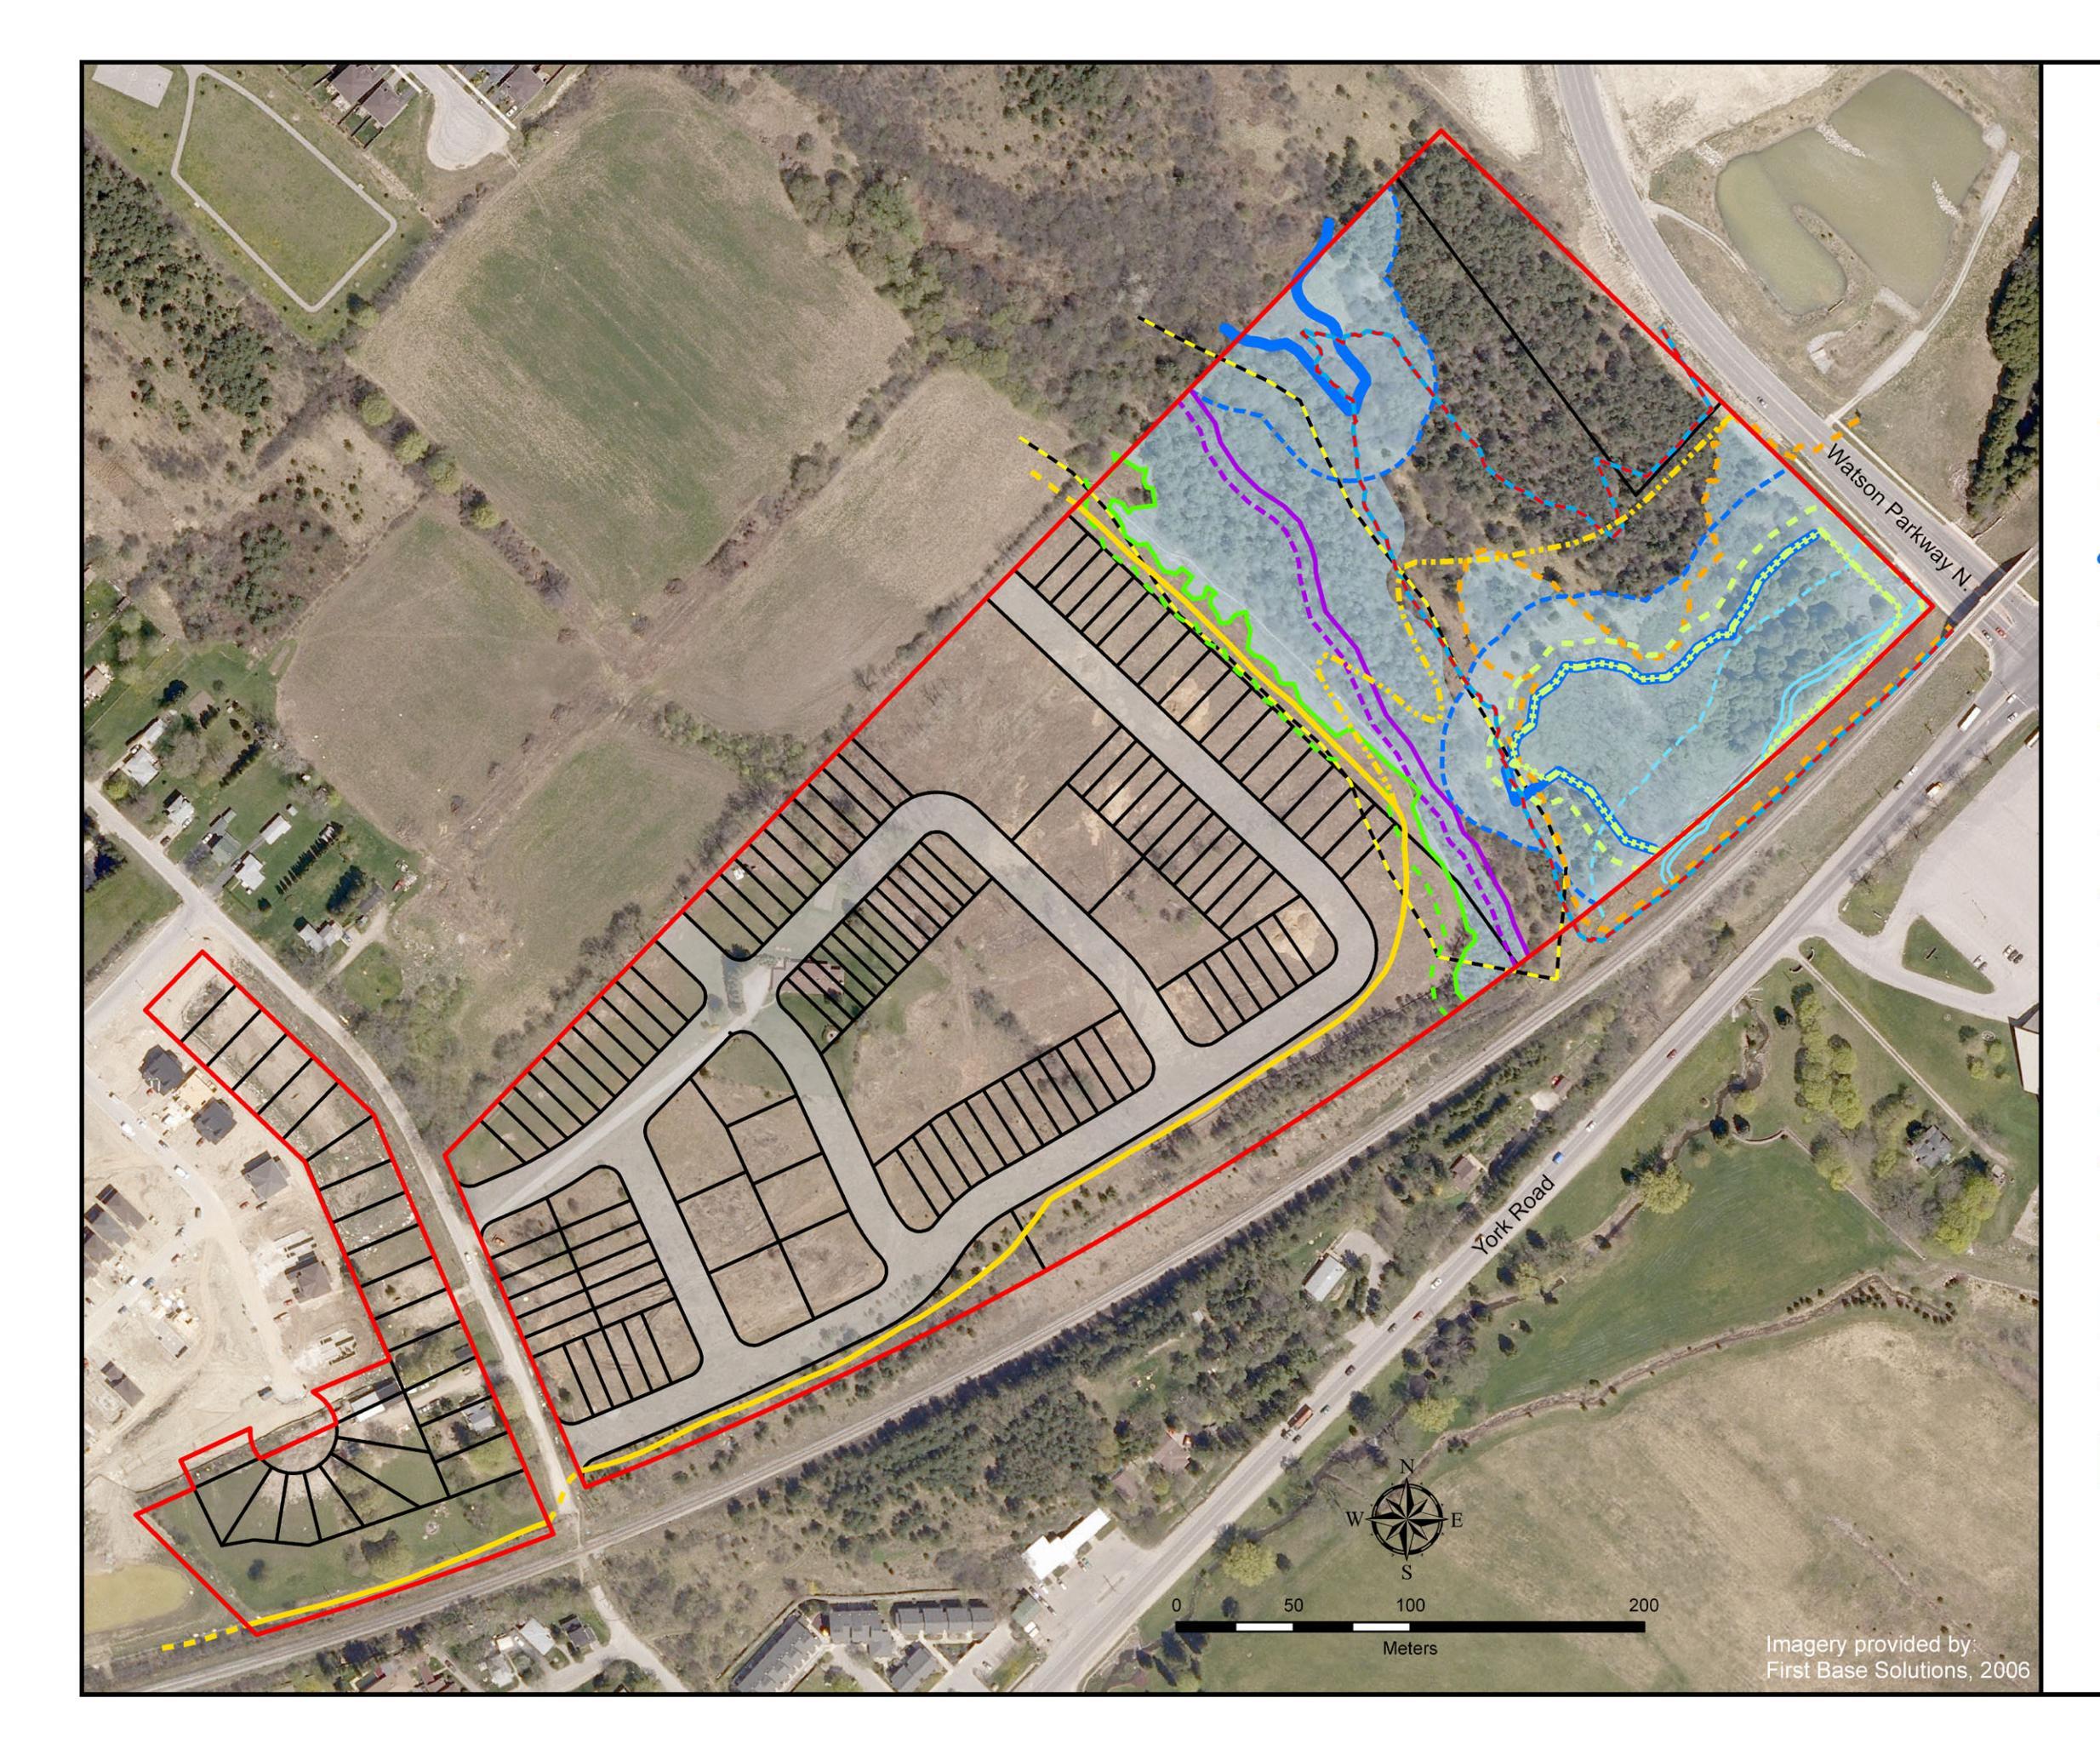
Cityview Ridge EIS Addendum Figure 3: Proposed Trail Alignment

Instead, the consulting team recommends an alignment that extends northerly, along the rear of lots 41 to 57, beyond the edge of the steep slope/cultural plantation, terminating at the boundary with the adjacent lands to the north (Figure 3 appended). It is our expectation that the trail connection can be picked up on the adjacent lands and connect with the road system to the north (decisions on the road alignments on the adjacent property are pending, but there will likely be some connection to Silurian Drive or Starwood Drive). Should the conditions change in the future (*e.g.*, policy changes regarding the locally significant species, the locally significant species no longer occur, or the wooded slope is damaged by major wind storm and requires rehabilitation), then the alignment down the slope could be re-considered. There is nothing in the alignment proposed by the consulting team that precludes re-consideration of an alignment down the wooded slope in the future.

This section of the trail crosses transversely through the open area in the easterly part of the stormwater block (on the outside of the bend on street 6), then parallels the rear lot lines of lots 41 to 57. The portion south of lot 57 is outside the10 m buffer for the cultural plantation and the section lots 41 to 57, is more or less coincident with the outer edge of the buffer. Trails are permitted within cultural plantation (subject to an EIS) and their buffers, thus the proposed alignment conforms to the relevant policies.

Since the trail is proposed to be located outside the cultural plantation and the steep slope, there is no potential for direct impacts. As the trail is in the buffer immediately adjacent to the rear lot lines, it is not expected to generate any additional indirect impact from its long term use than those discussed in the EIS. The EIS predicted that the three locally significant bird species will continue to utilize the site as at present and the proposed trail alignment does not change this conclusion.

- 1. The trail alignment should not be located down the steep slope through the cultural plantation.
- 2. The proposed trail alignment as shown on Figure 4, located through stormwater block 112, then behind lots 41 to 57 within block 114, be accepted as the preferred alignment.
- 3. That rough-grading of the trail be undertaken when the retaining wall behind lots 51 to 57 is constructed.
- 4. The rough-graded trail should be seeded or otherwise stabilized if final trail construction is not going to occur immediately.
- 5. That construction of the trail and retaining wall occur outside the breeding bird season (mid-May to mid-July), unless it is demonstrated through a breeding bird survey that no locally significant species are present or if present are distant enough from the

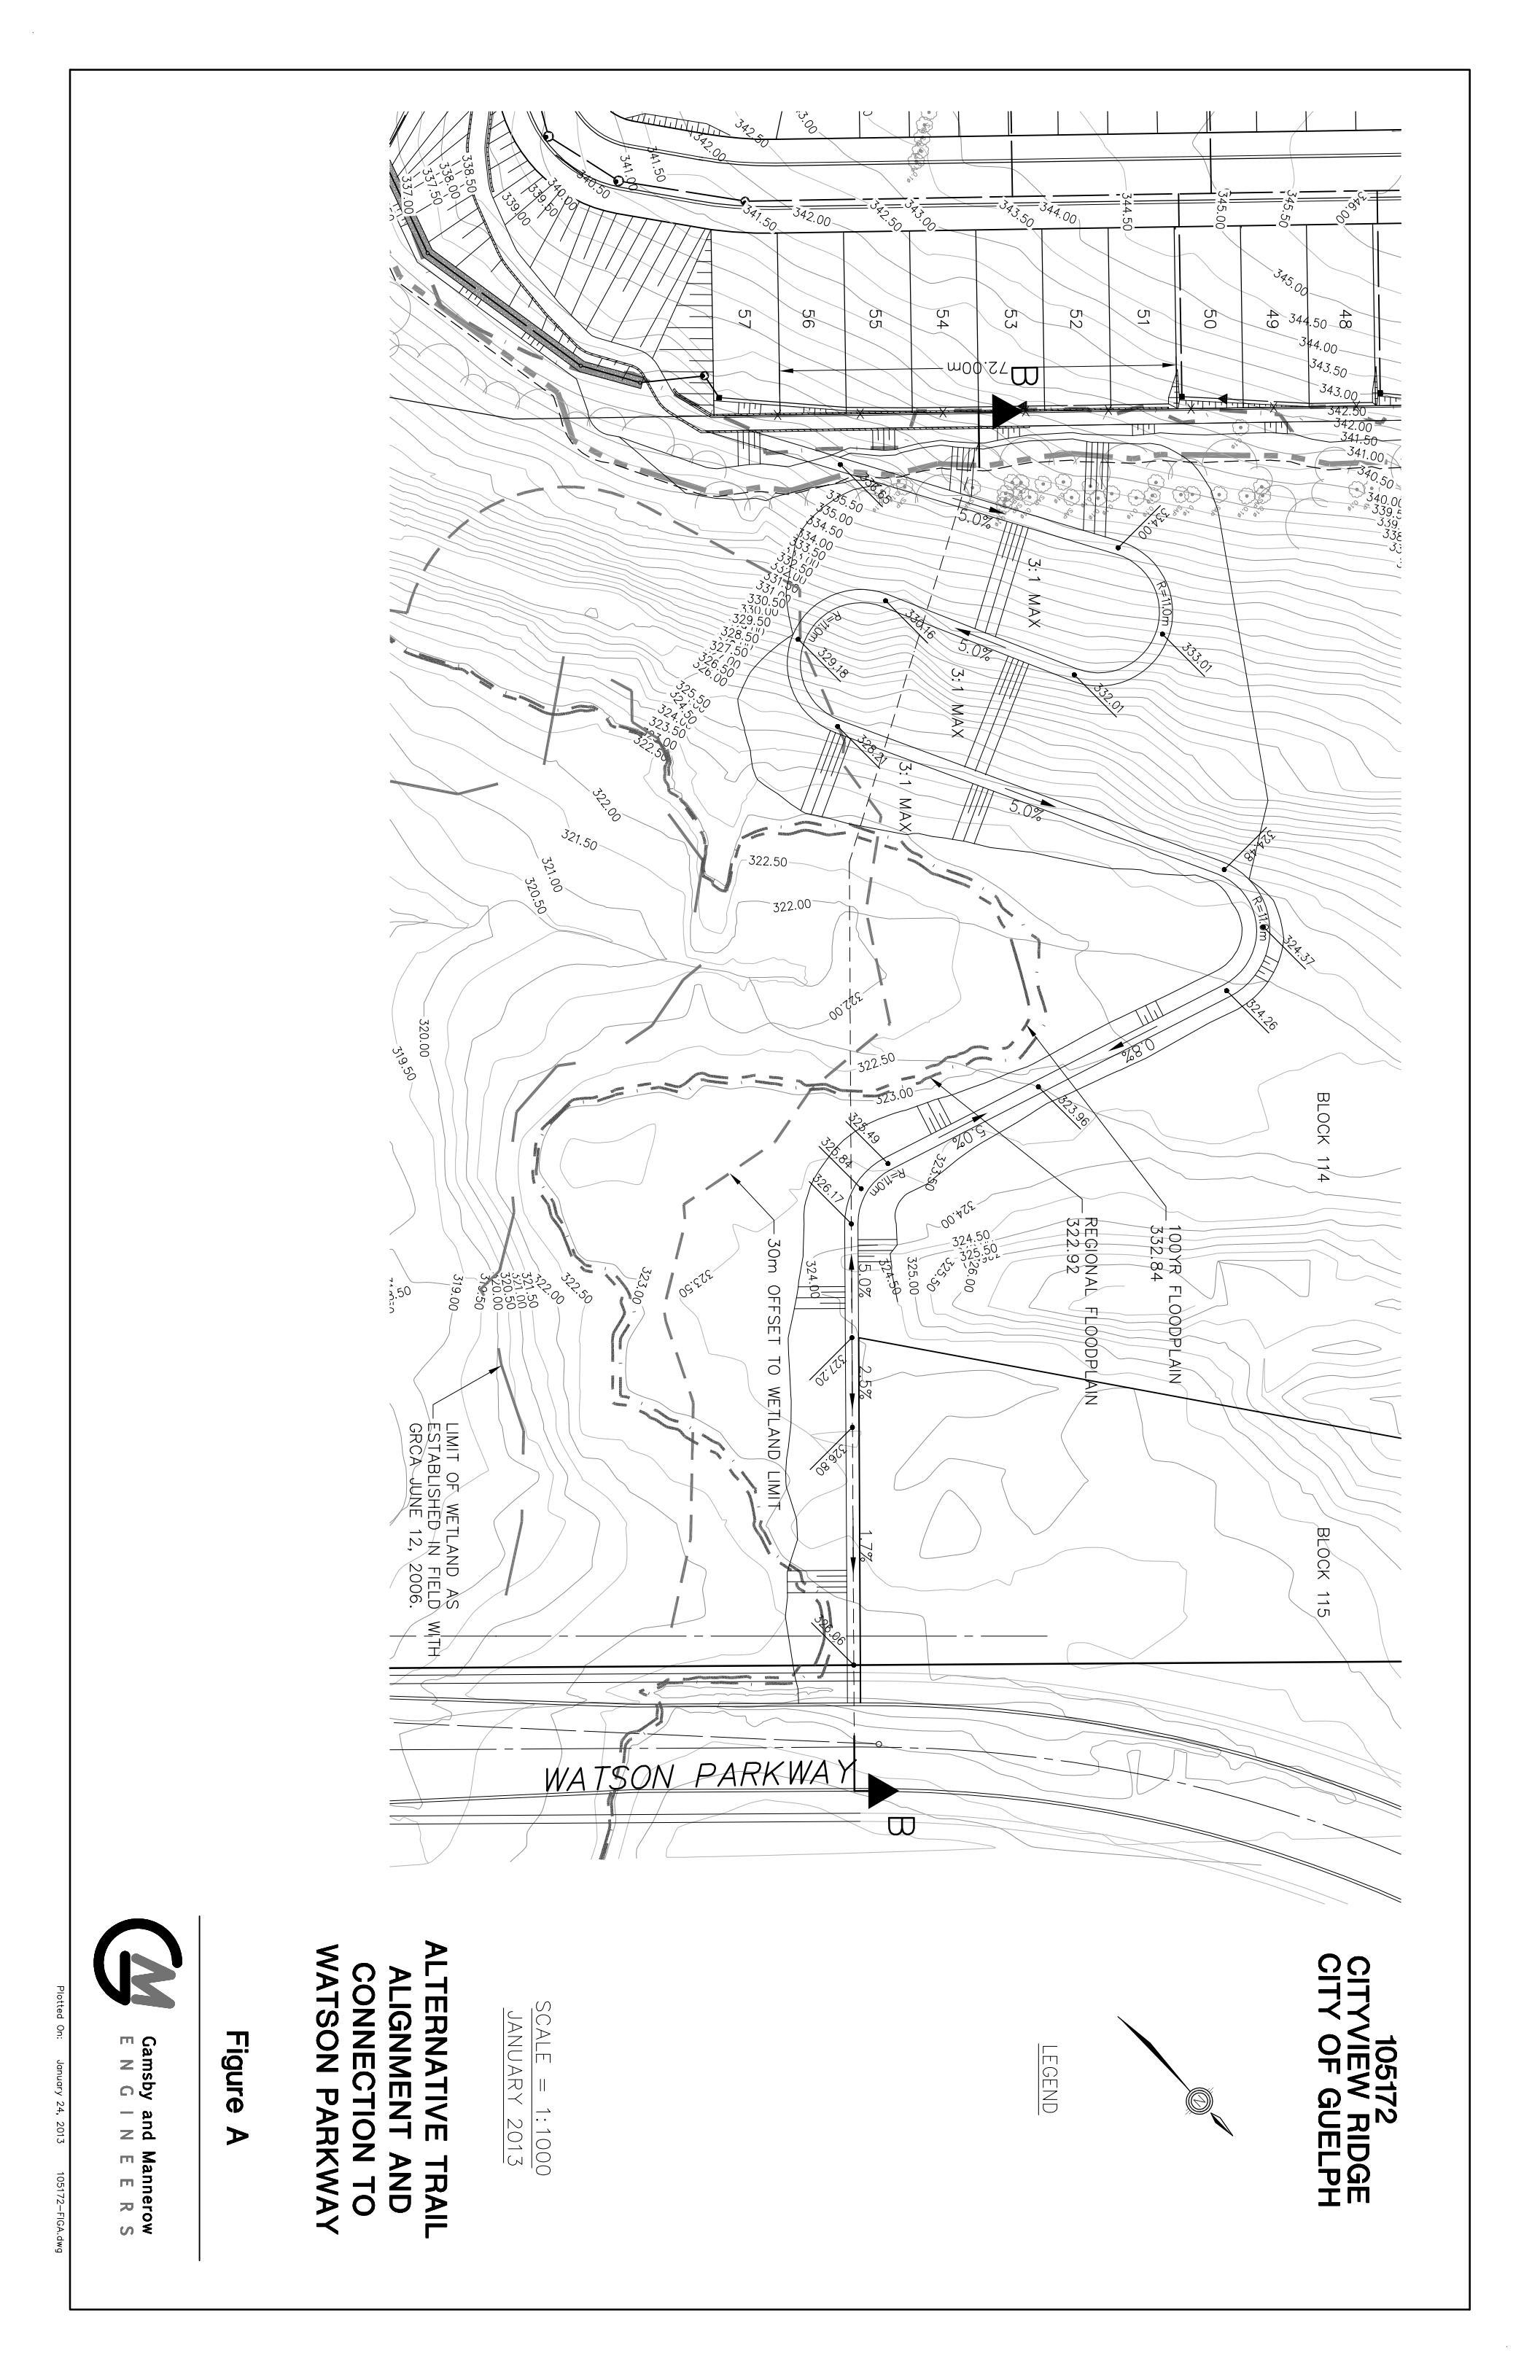
To fully evaluate the consequences of locating the trail on the slope, an alignment was developed to achieve acceptable grades and provide for safe use of the trail per City trail standards. This resulted in a switchback configuration (see Figure "A" appended). Figure "A" indicates the general area that would need to be cleared of trees and graded. A cross-section of the slope and trail was also developed (Figure "B" appended). Figure "B" has a 10 times vertical exaggeration to accommodate page size, and this tends to make the slope look steeper than it is. None-the-less, Figure "B" clearly illustrates the extent of cut and fill required to achieve a 2.4 m wide trail with a maximum gradient of 5%, minimum allowable curve radii and 3:1side slopes to minimize the potential for erosion.

There are no existing *ad hoc* trails in the significant wetland and woodland, and none of the four tests are met, so it is inappropriate to align the trail through this area. As shown in Figure "A", the trail can be re-aligned to avoid conflict with the buffers of the significant wetland and woodland. However, as noted in the EIS, the wetland contains several springs that feed Clythe Creek. These springs and the organic soils along the creek are sensitive and are vulnerable to impact if exposed to increased access. It is likely that providing trail access to the low-lying lands, even if outside the buffer, will increase the probability that trail users will develop unsanctioned, *ad hoc* trails to the creek, as it is an interesting feature. This would constitute an undesirable impact from a natural heritage perspective.

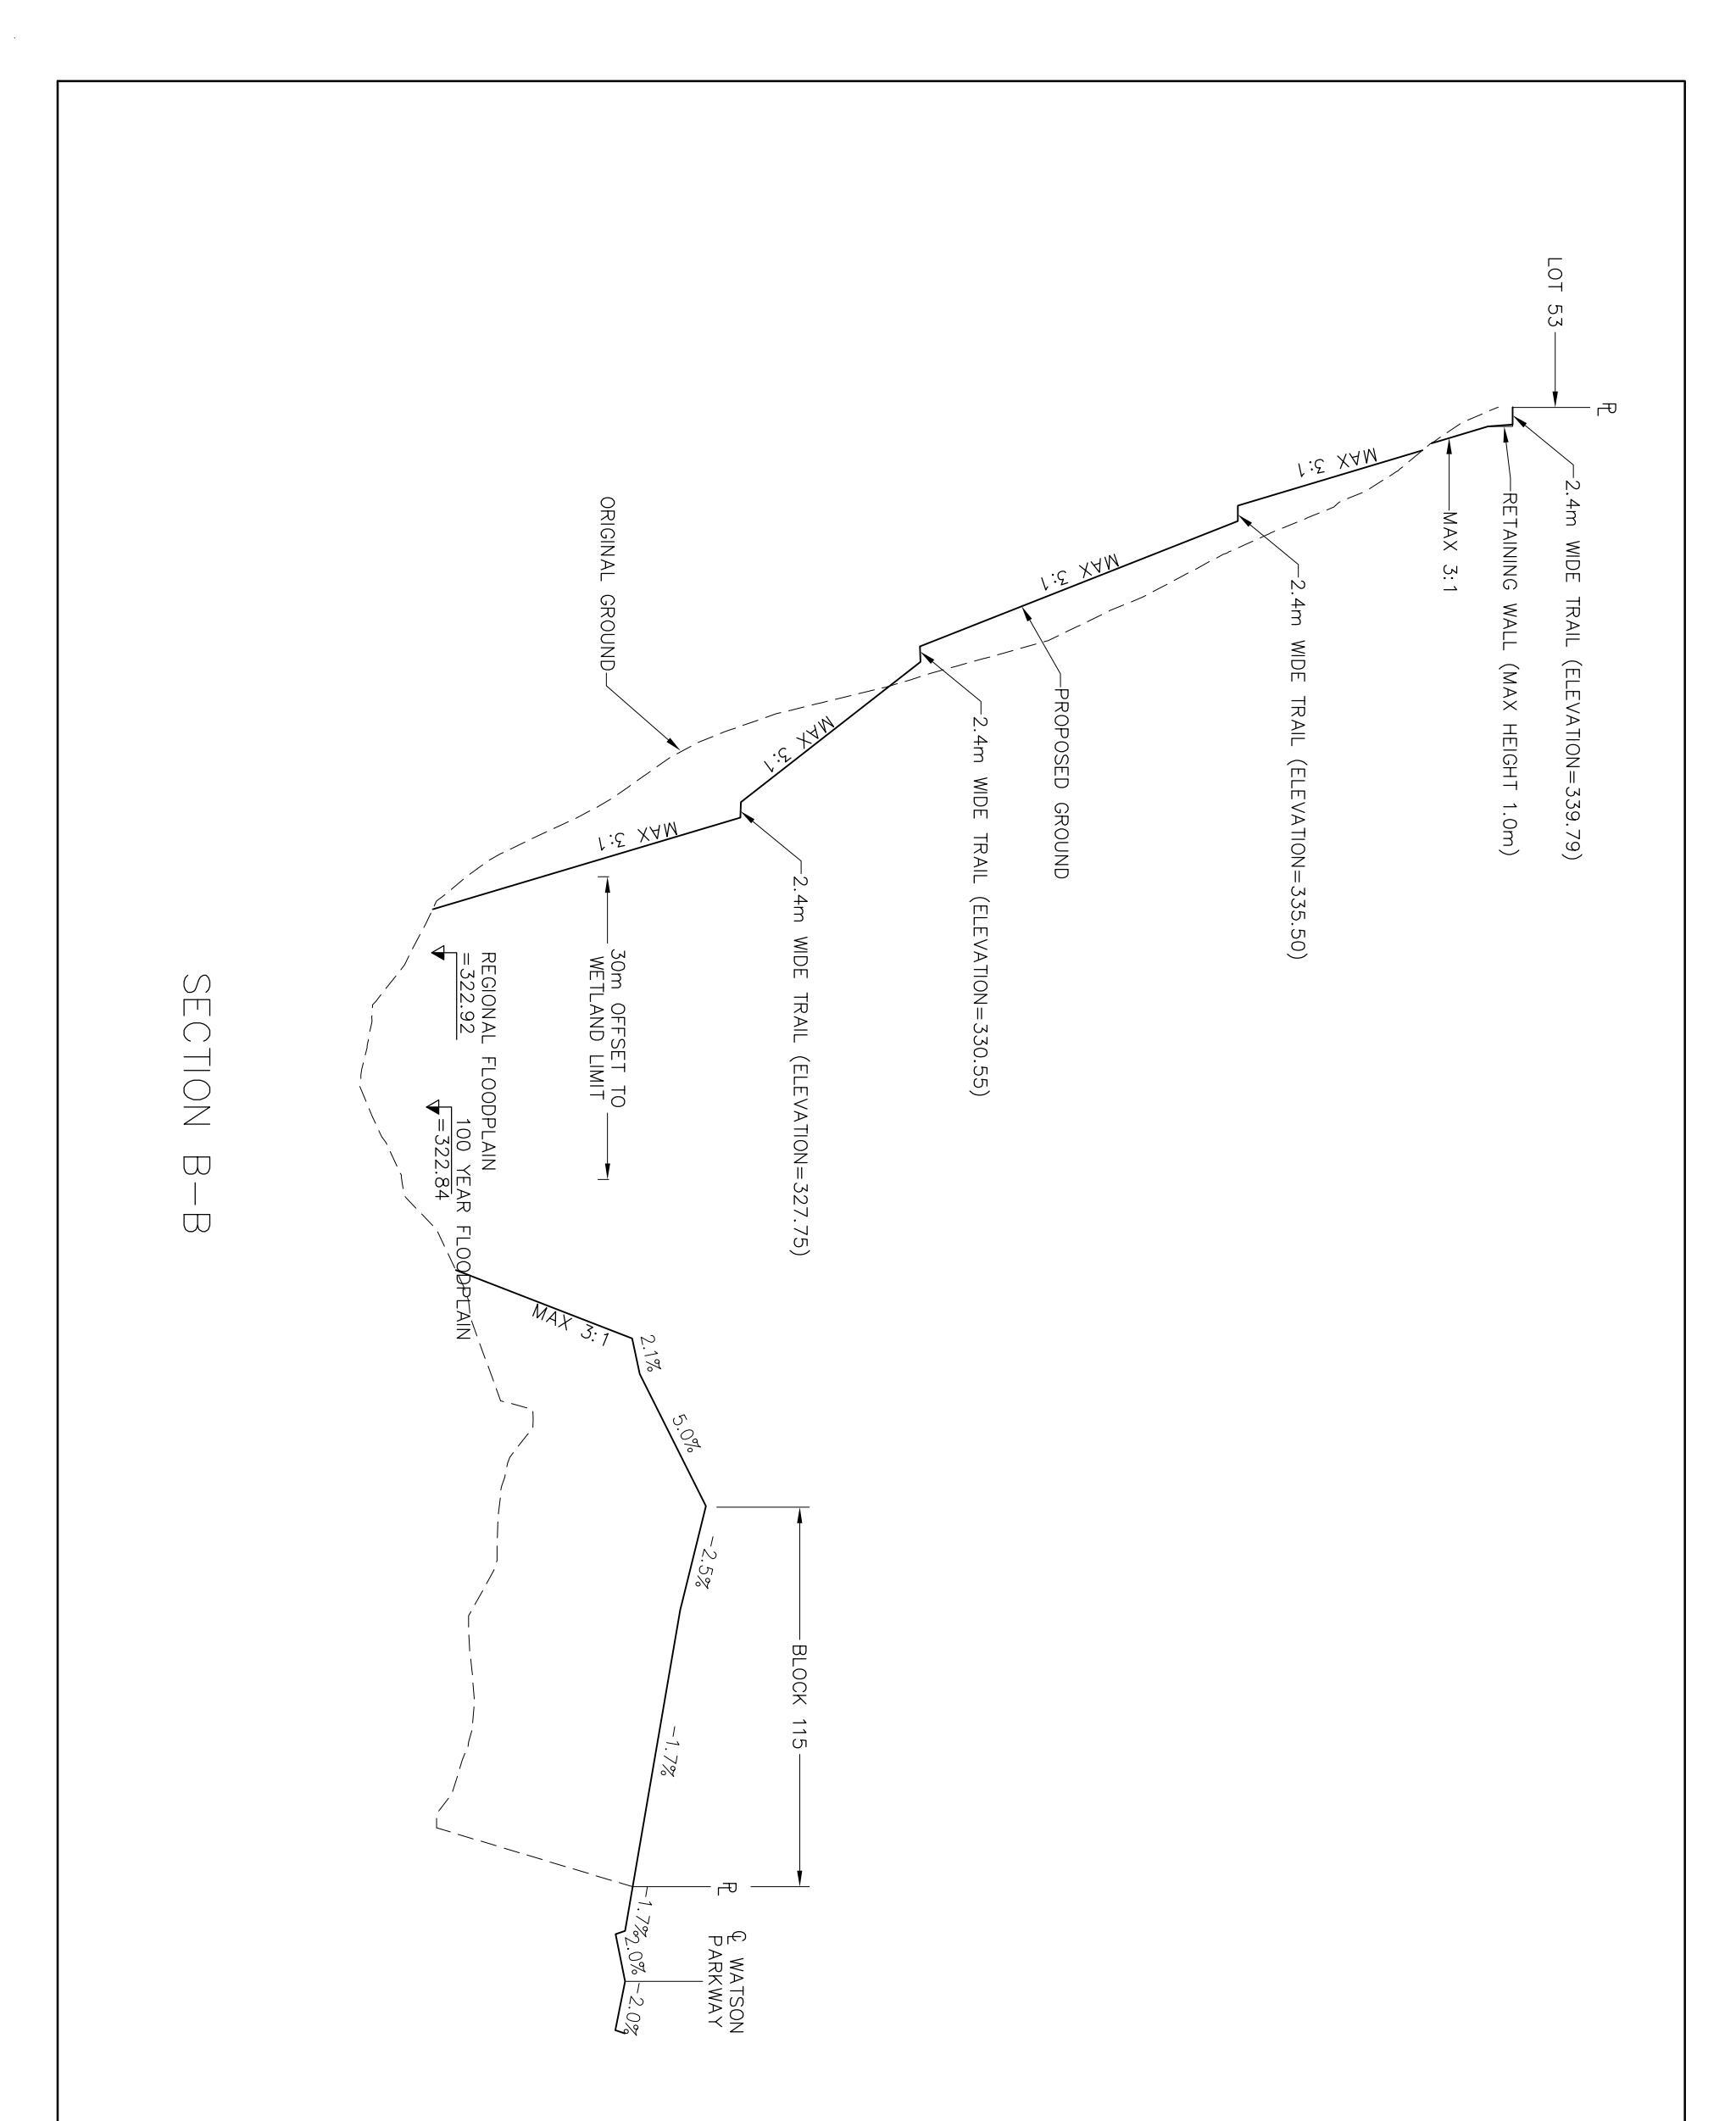
Figure B

ALTERNATIVE TRAIL ALIGNMENT AND CONNECTION TO WATSON PARKWAY

SCALE = H 1:1000 V 1:100 JANUARY 2013
