35, 40 & 55 Silvercreek Parkway South

City of Guelph, Ontario

Scoped Environmental Impact Study

AA16-190B

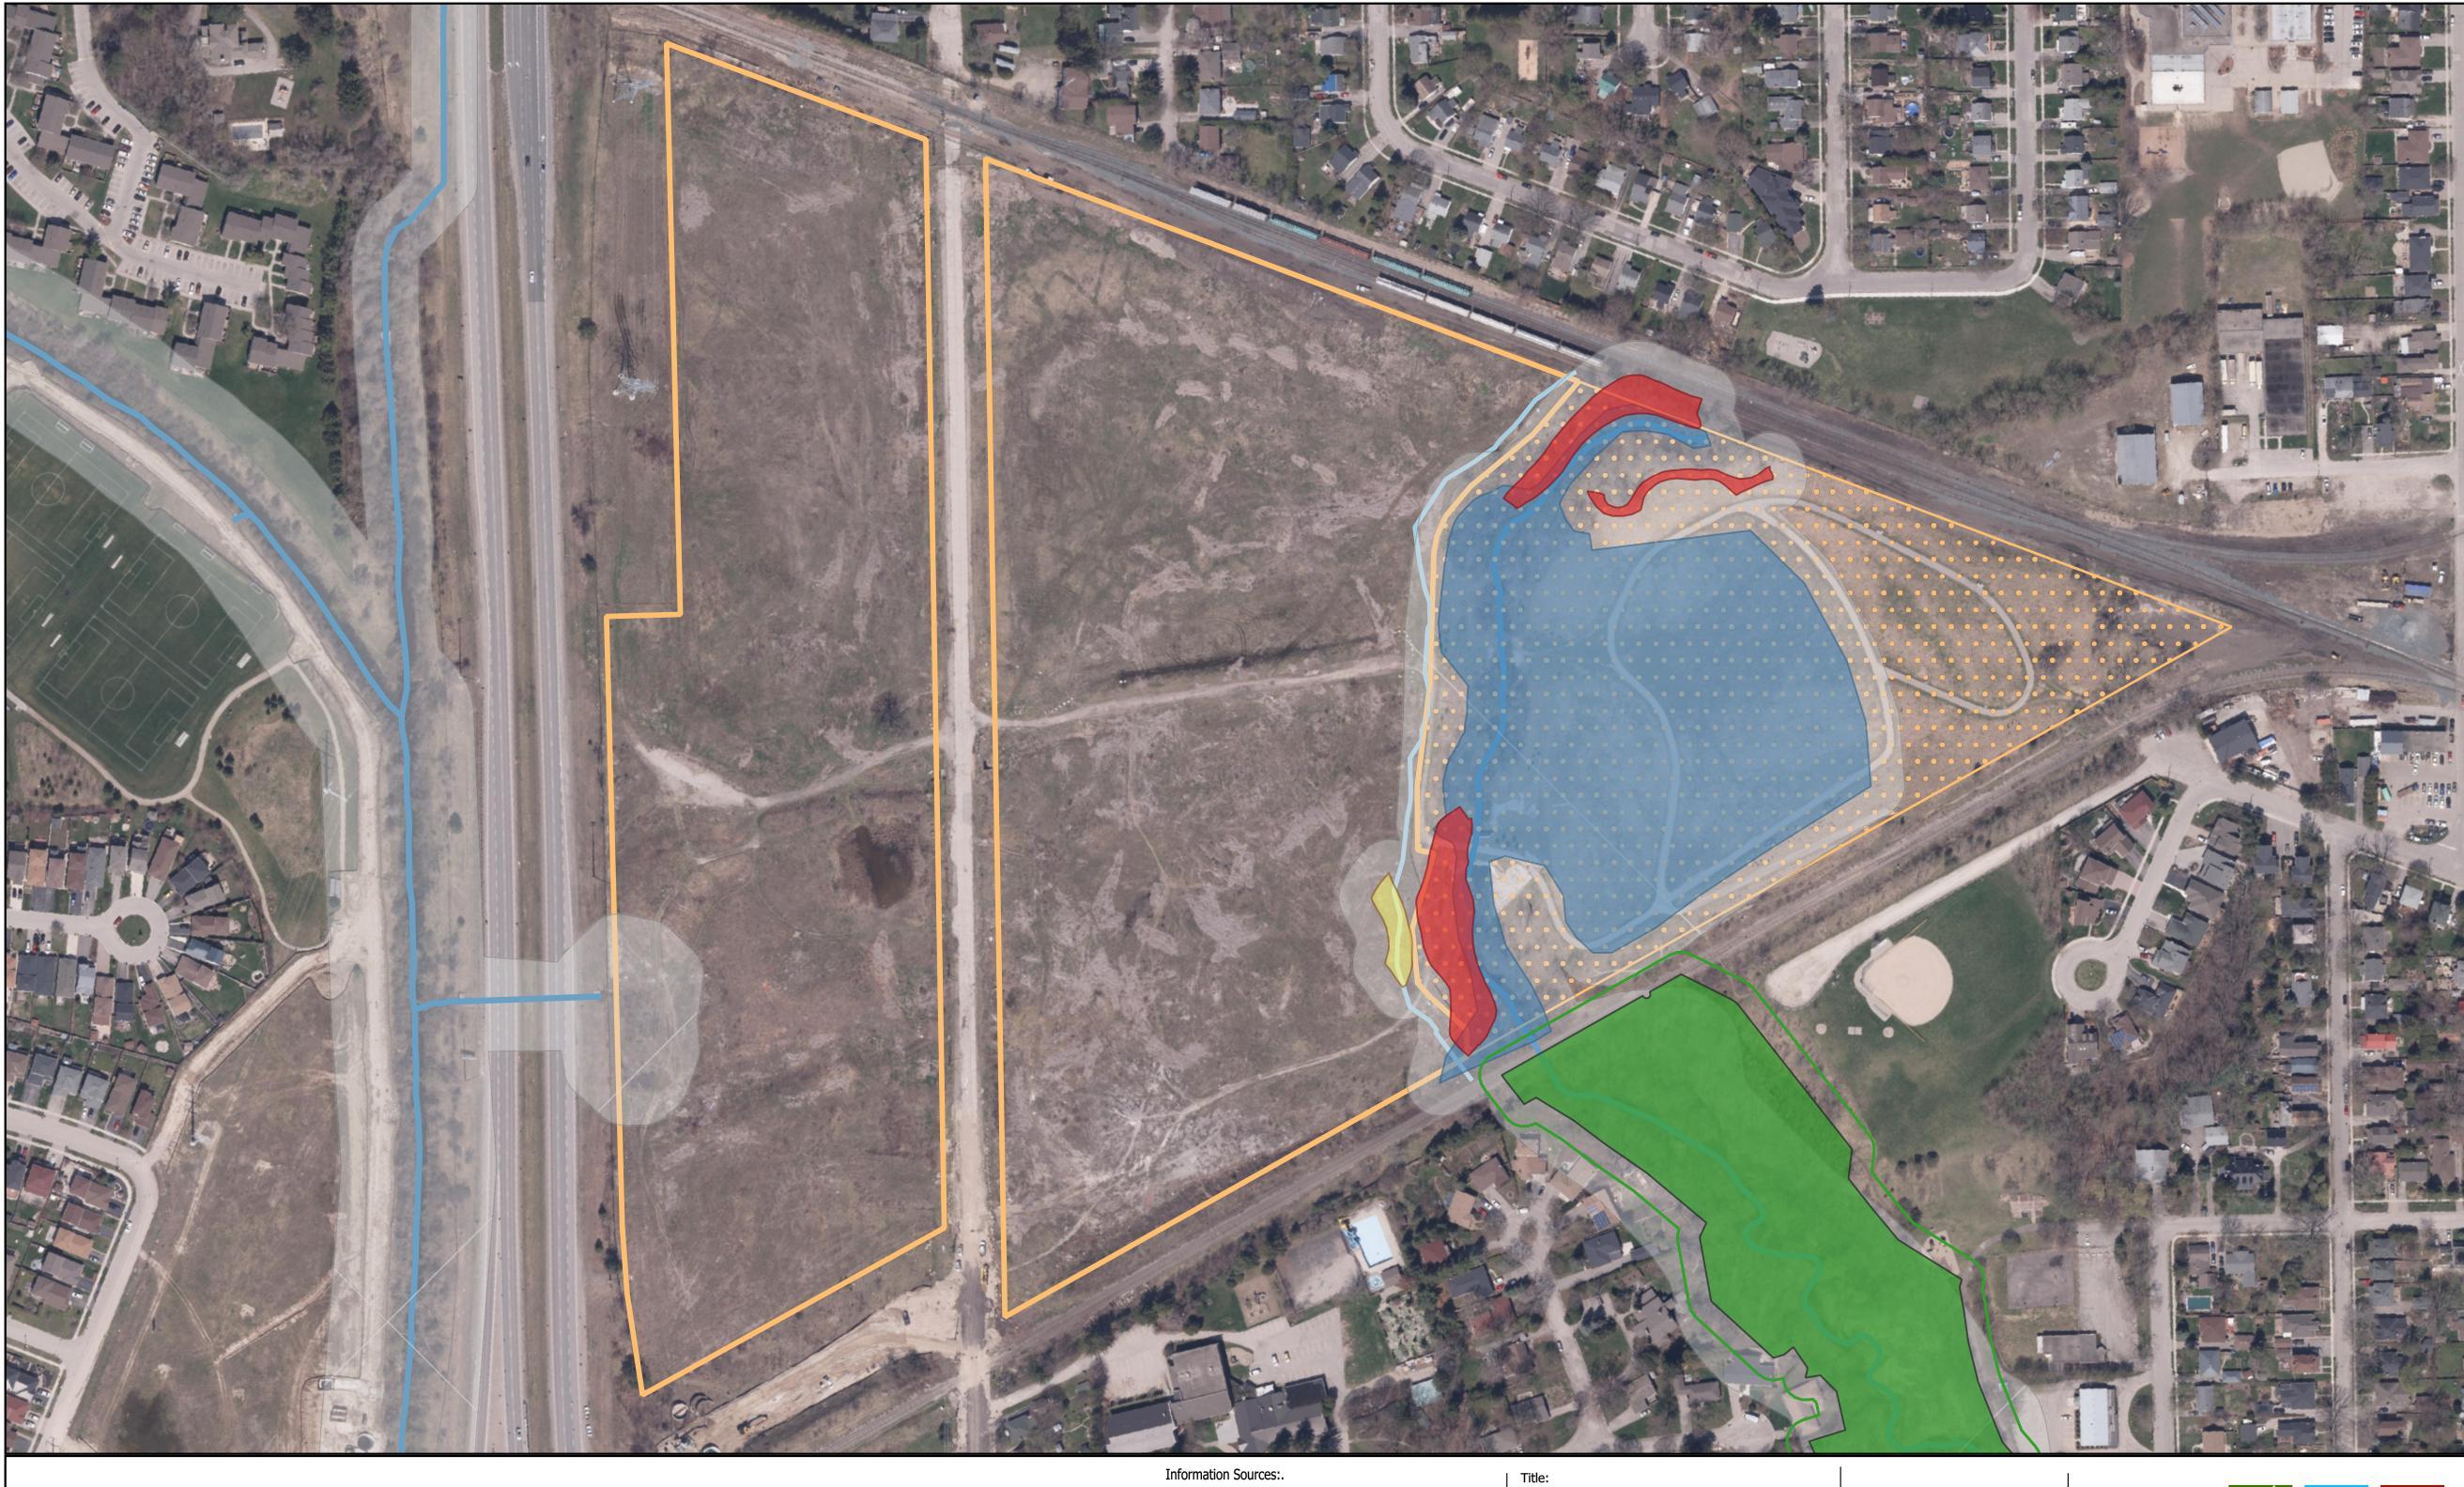
- SUBJECT LANDS
- ------ WATERCOURSE
- REGULATION LIMIT
- **RESTORATION AREA** . . .
- WOODLAND BUFFER

Based on field surveys and background information four classes of natural heritage features, as defined in the City of Guelph Official Plan (OP), are found on or adjacent to the Subject Lands and shown on Figure 1. The four classes of features are:

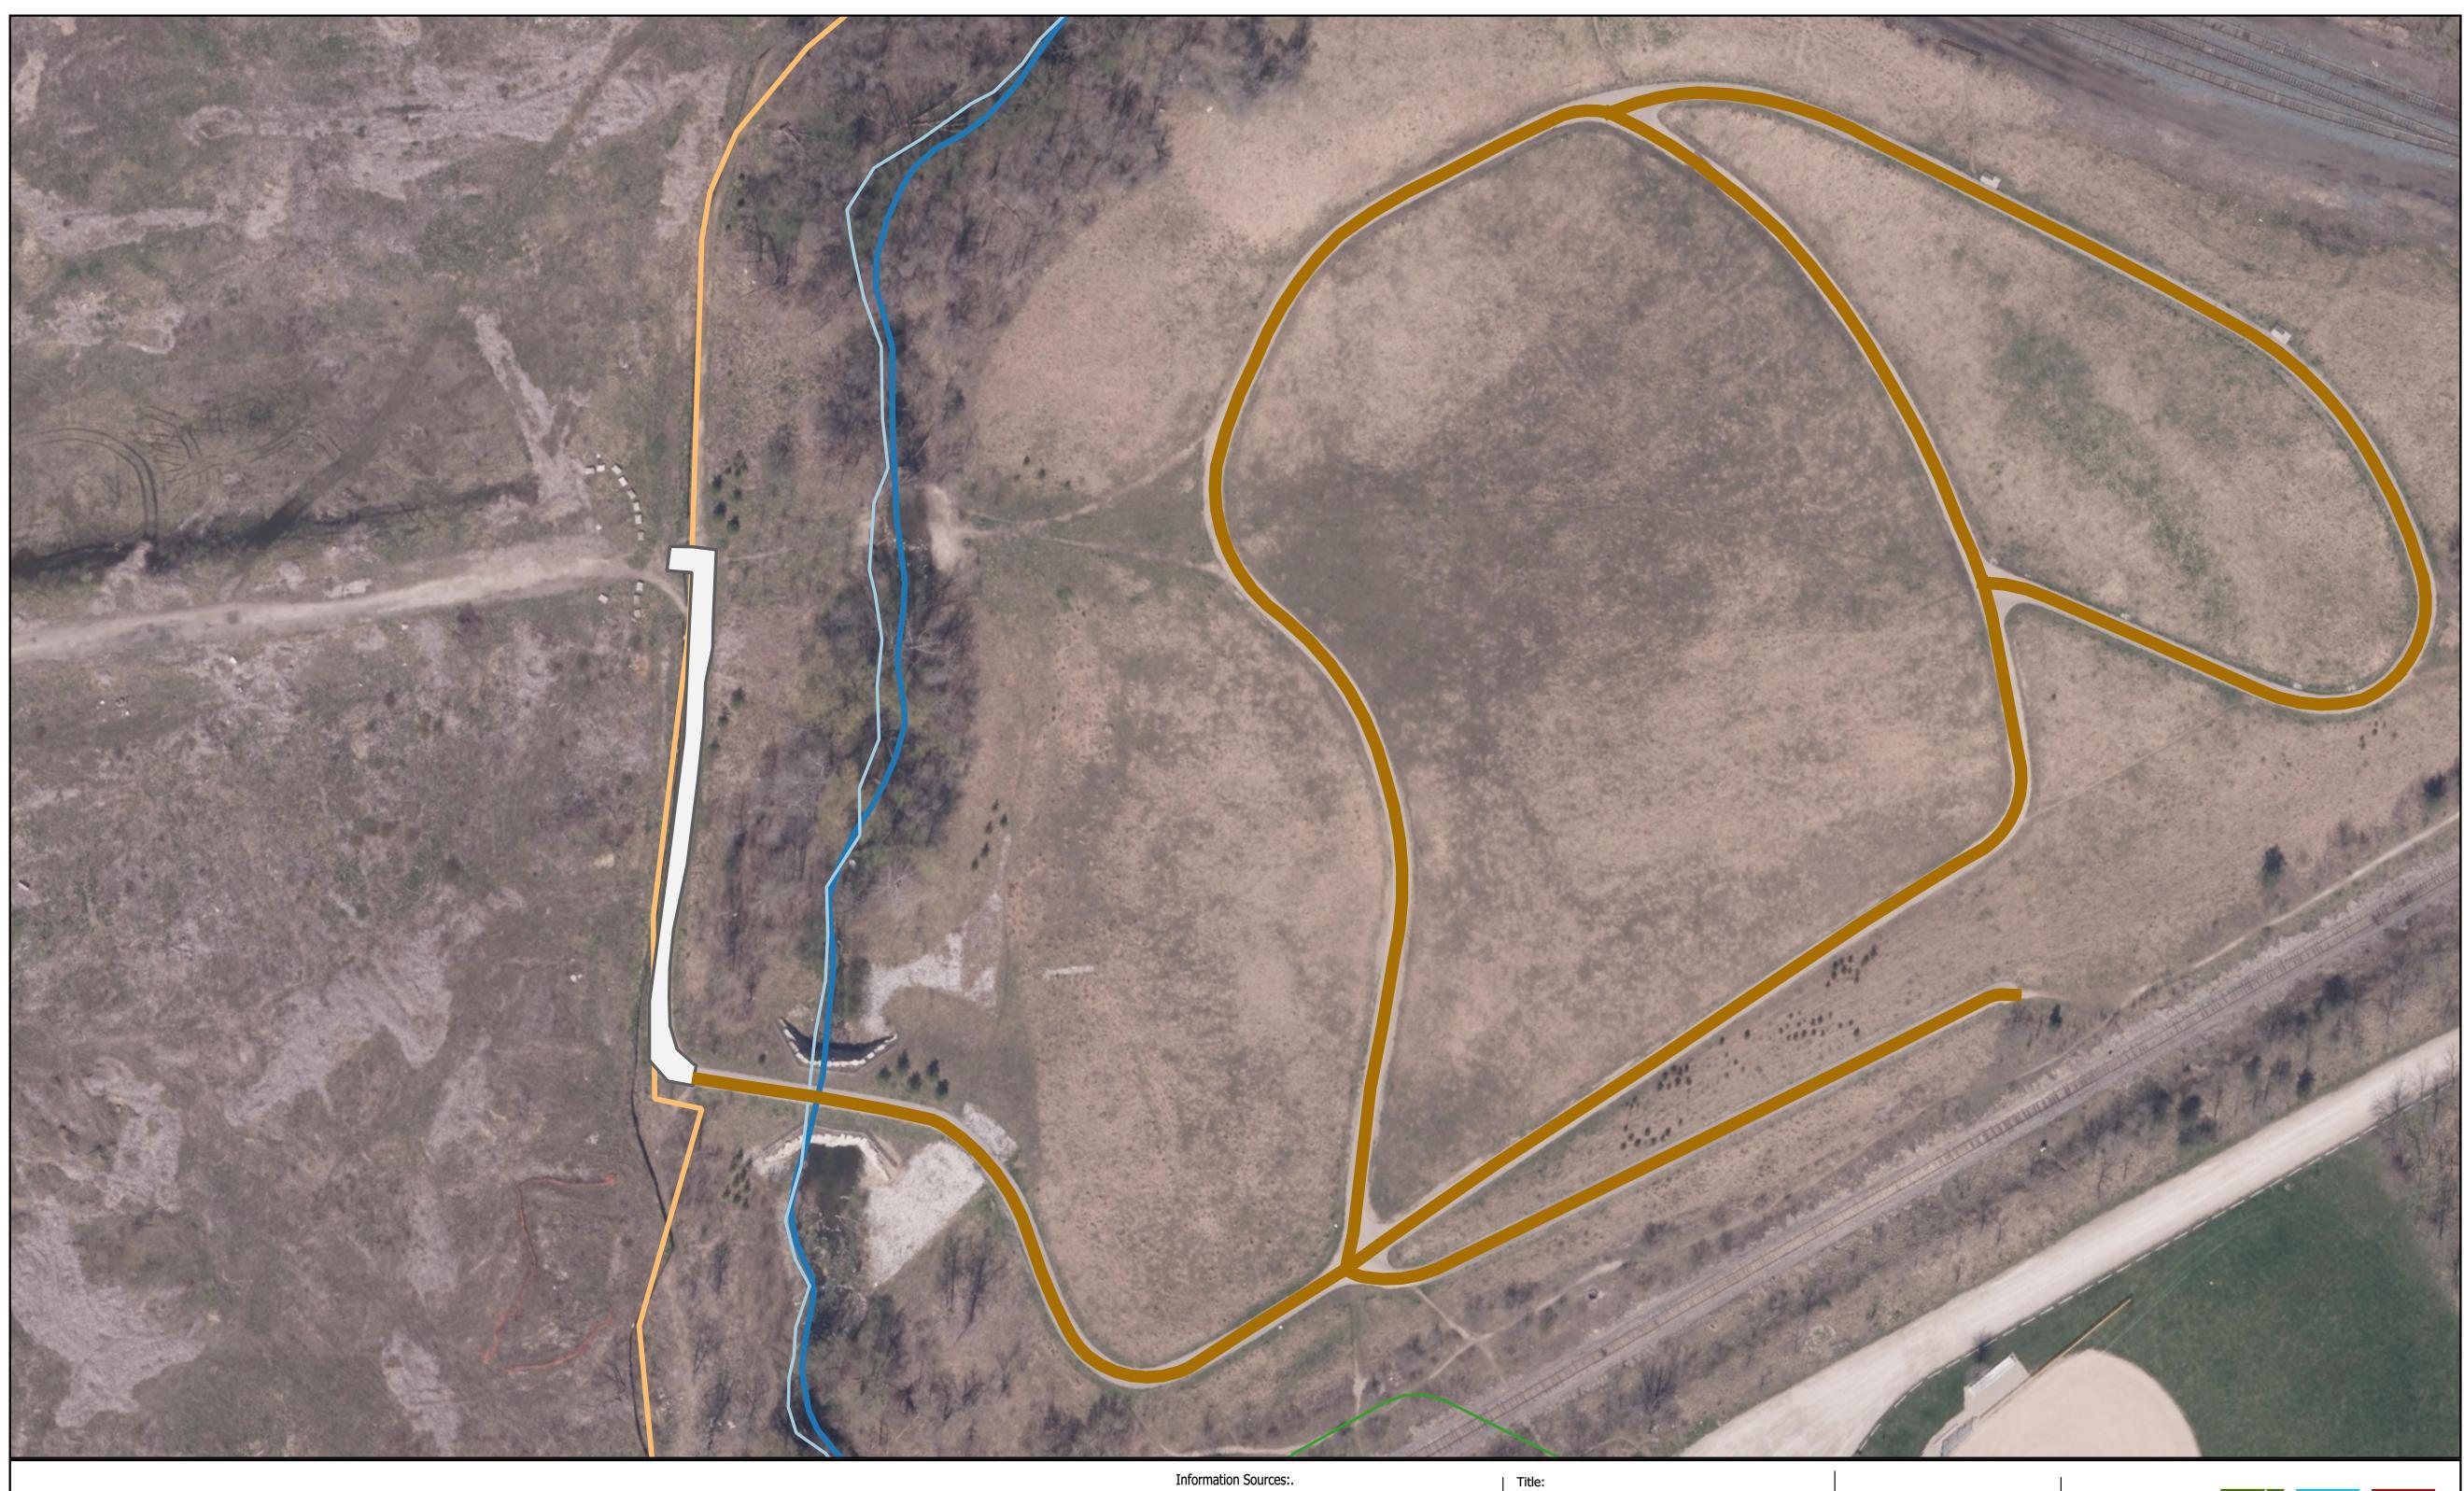
PEDESTRIAN TRAIL AND ASSOCIATED BUFFERS

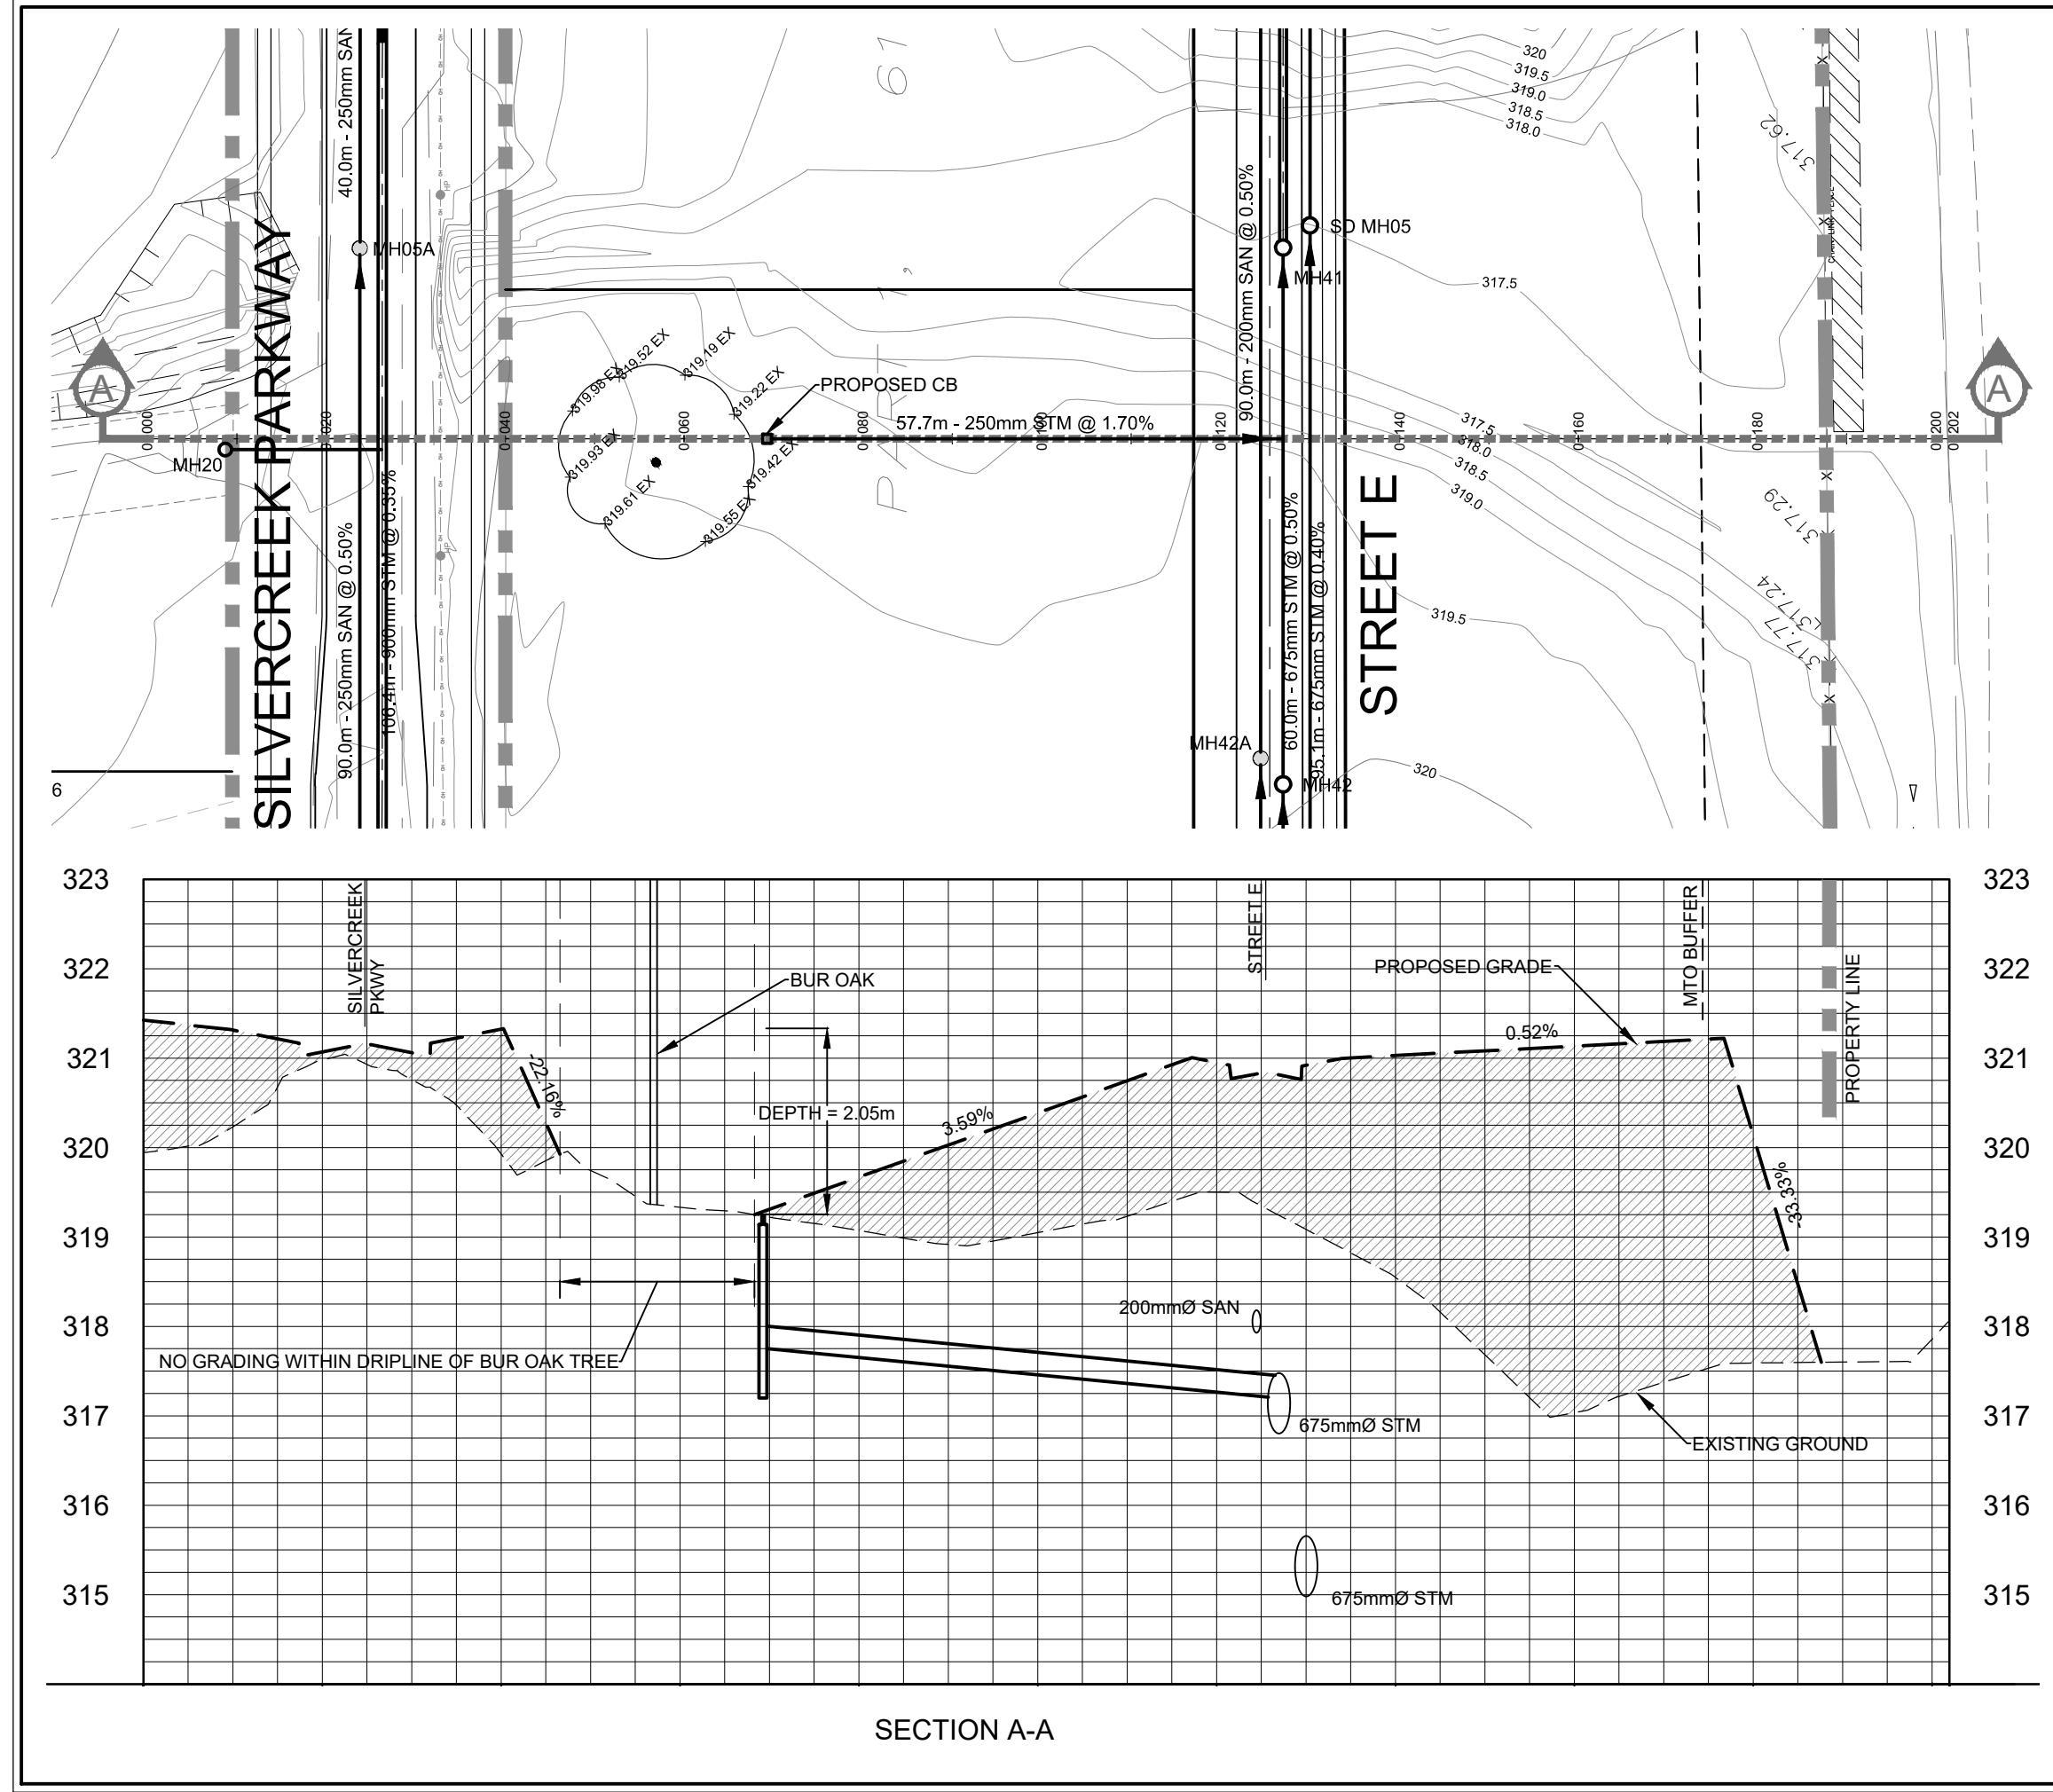
APPENDIX G: Grading Plan Near Bur Oak

0 10 20 40 60
Client Client
Figure Title SILVERCREEK
CROSS SECTION THROUGH PARK
Drawn Checked Date Figure No. BF DN 20/09/25
Scale Project No. FIG
