MEETING River Systems Advisory Committee

DATE November 15, 2017

Item Niska Rd Class EA

Report provides a status update regarding the project and shares new/updated information in relation to the design studies that are proceeding currently.

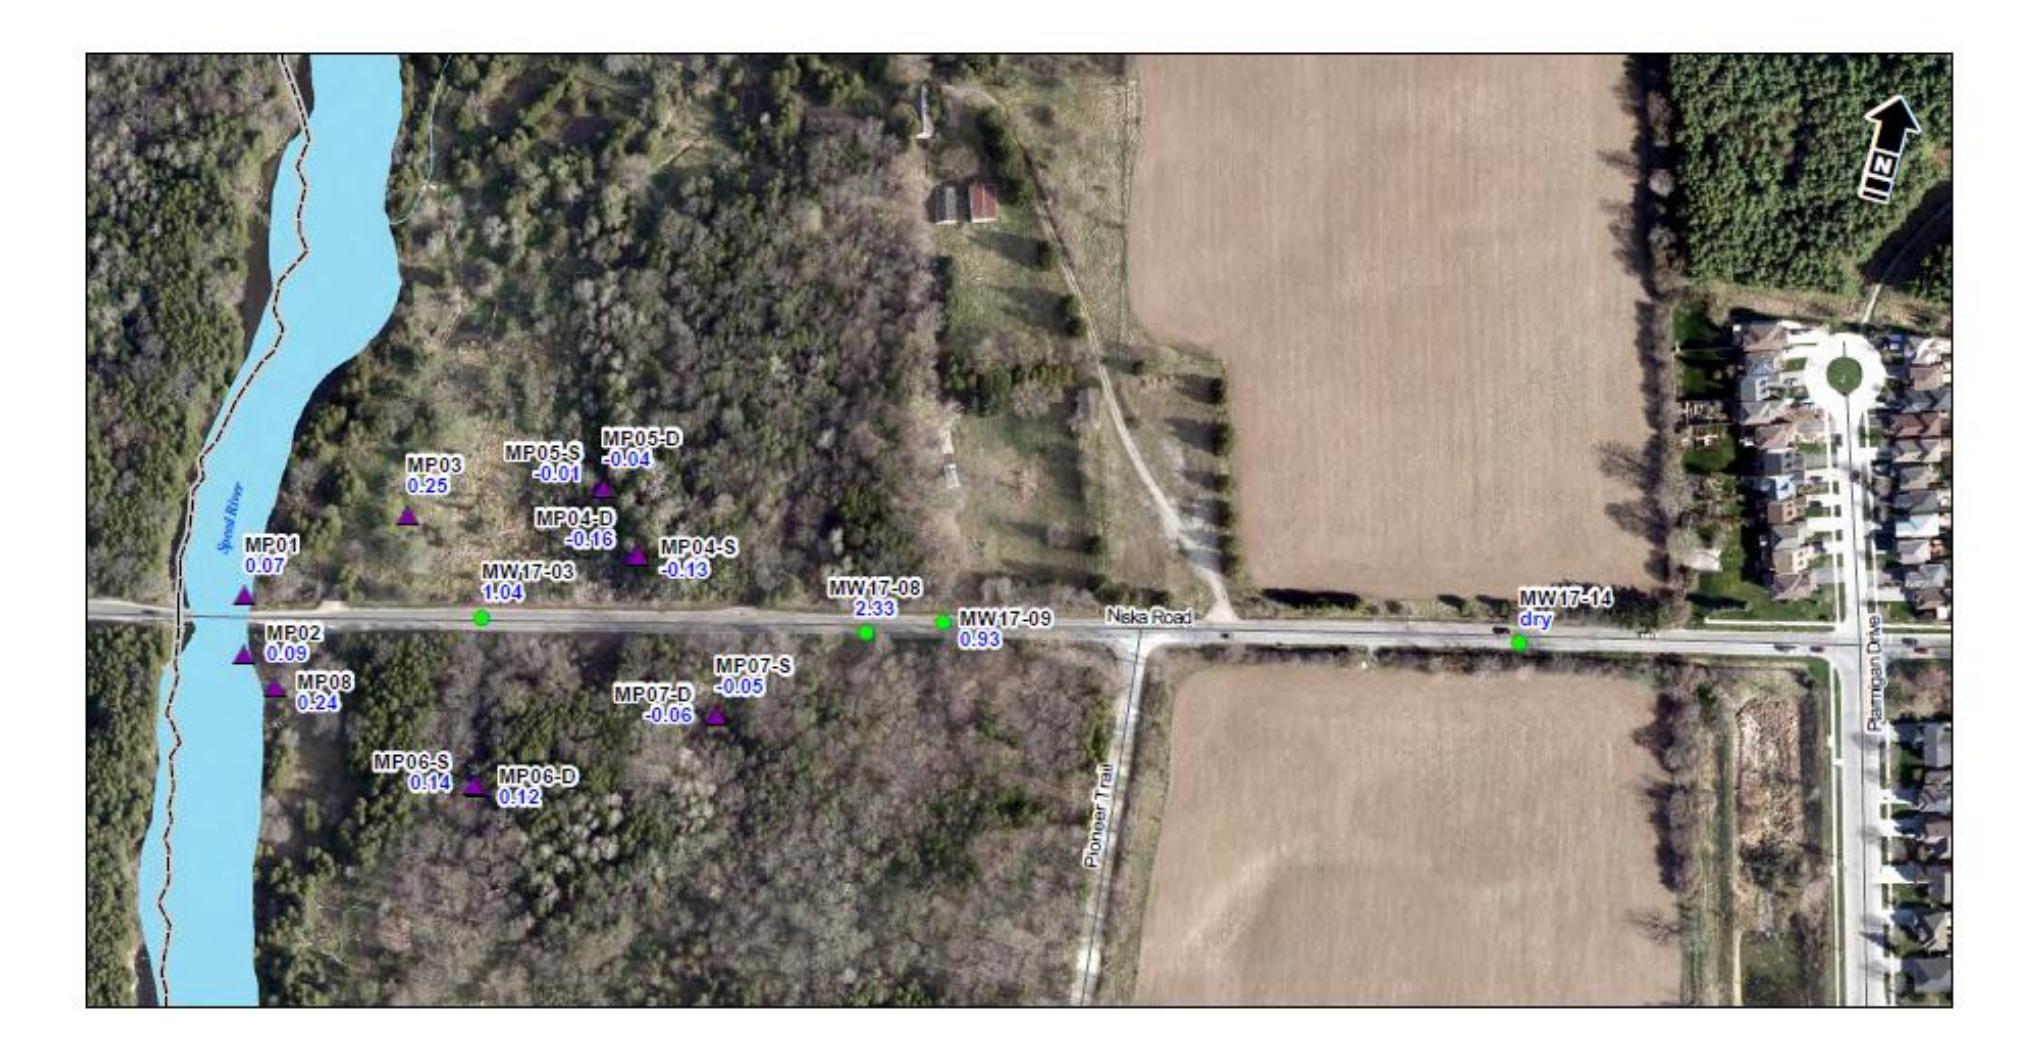
Attachment 4 – Locations of monitoring wells and minipiezometer locations

Water monitoring commenced in the spring of 2017 and the last samples are being collected this month (November). Attachment 4 includes a map of the minipiezometer locations.

Sixteen (16) boreholes were also completed along Niska Rd from Ptarmigan west to the Speed River on May 10 and 11, 2017. Four (4) locations also included water monitoring wells (also shown in attachment 4). Soil and groundwater conditions were observed in the open boreholes throughout the drilling operations.

- Support groundwater movement flowing generally in an east-west direction (generally parallel to the road).
- Confirmed presence of organics (peat) under Niska Rd at boreholes 17-3 & 4 (see attachment 3). Peat was found at a depth of approximately 1.4 m to 2.2 m below the ground surface
- Depth to groundwater becomes increasingly shallow west of Pioneer Trail
