## **Conservation of Heritage Structures & Older Buildings**

Repointing Masonry Walls – Matching the Techniques for Success or Failure

By Paul Jeffs, PJ Materials Consultants Limited

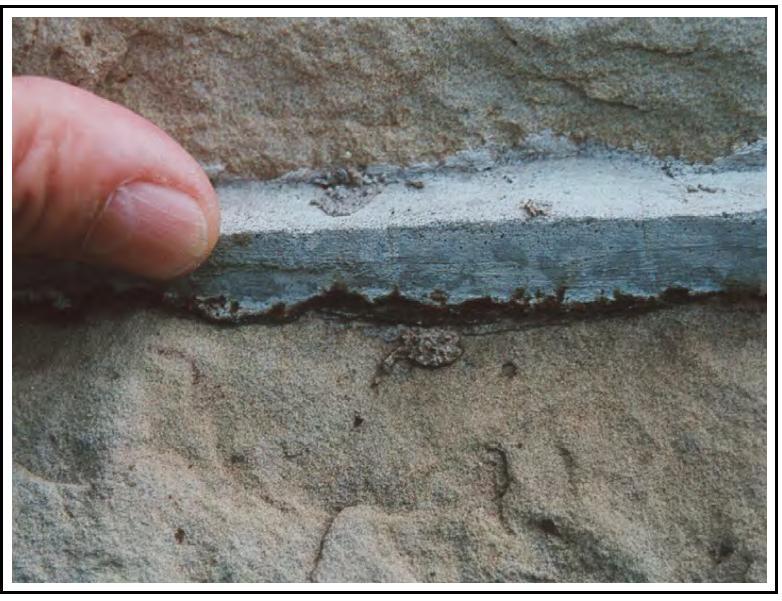
Photo. 1. This hard cement based repointing mortar was applied without cutting out the old mortar and is now causing deterioration to the stone masonry units.

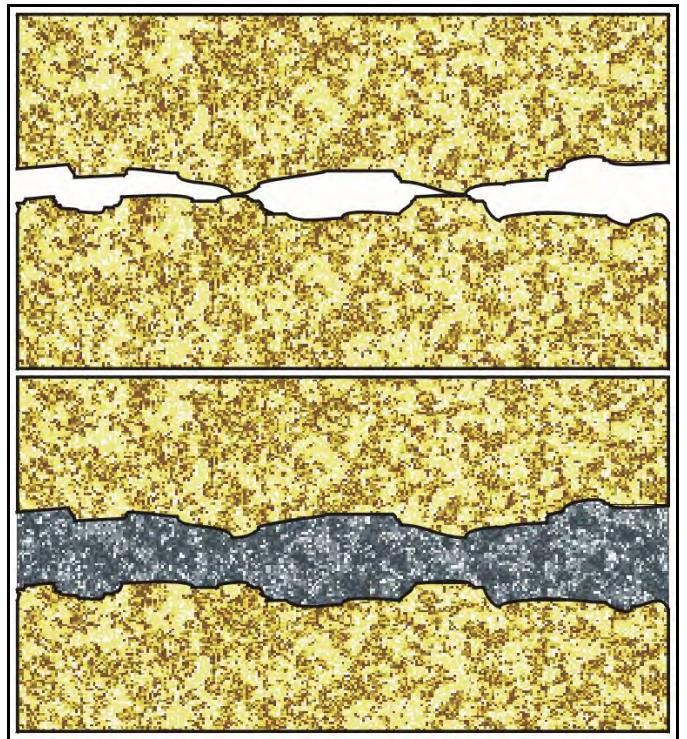
Figure 1& 2: Dry-Laid stones (top) provide point-loading and poor lateral restraint; Mortared joints (bottom) provide uniform load distribution and good lateral restraint.

It is a common but misguided conception that mortar is only used to "glue" the masonry units together and therefore the mortar should be as strong as possible. However, although it is important that individual masonry elements should become a monolithic component of a structure - and obviously this is unlikely to be achieved by dry-laying brick or block units structurally adequate free-standing stone walls can often be constructed without any mortared joints at all. Unfortunately, this can lead to damage of stones due to uneven loading conditions and poor lateral restraint as stresses develop from the natural accommodation of movement caused by temperature change, wind loading, snow, vibration, differential settlement, etc. The major function of mortar, therefore, is to uniformly distribute these stresses and provide restraint against lateral movement. (see Figures 1 and 2.)

In addition to providing uniform support and the avoidance of point-loading conditions, it is important that the mortar absorbs stresses as they develop. If the hardened mortar is too strong, stresses can be transmitted to the weaker units which would then suffer

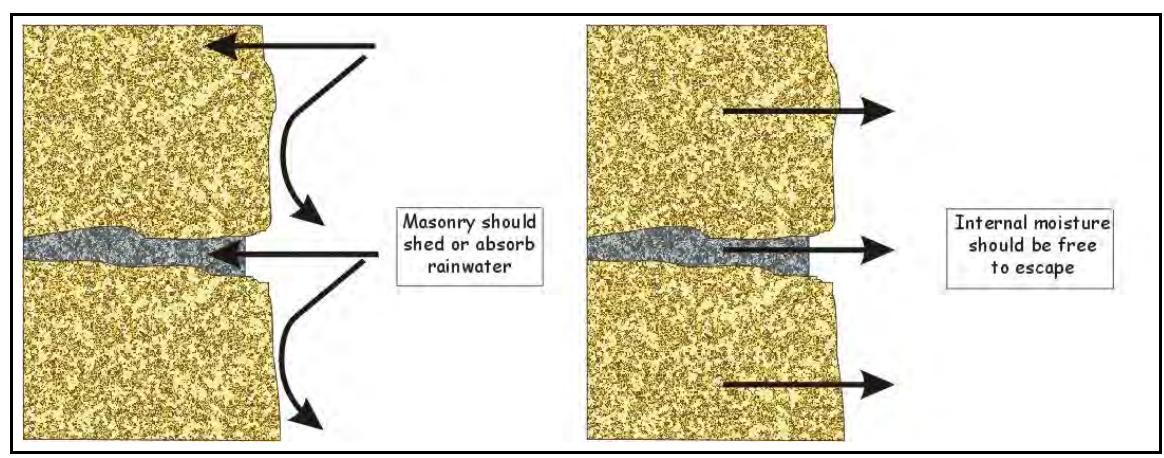
Figure 3 & 4: There are usually no problems with masonry absorbing rain-water - as long as both the mortar joints and the masonry units can uniformly dry before freezing and thawing conditions prevail.

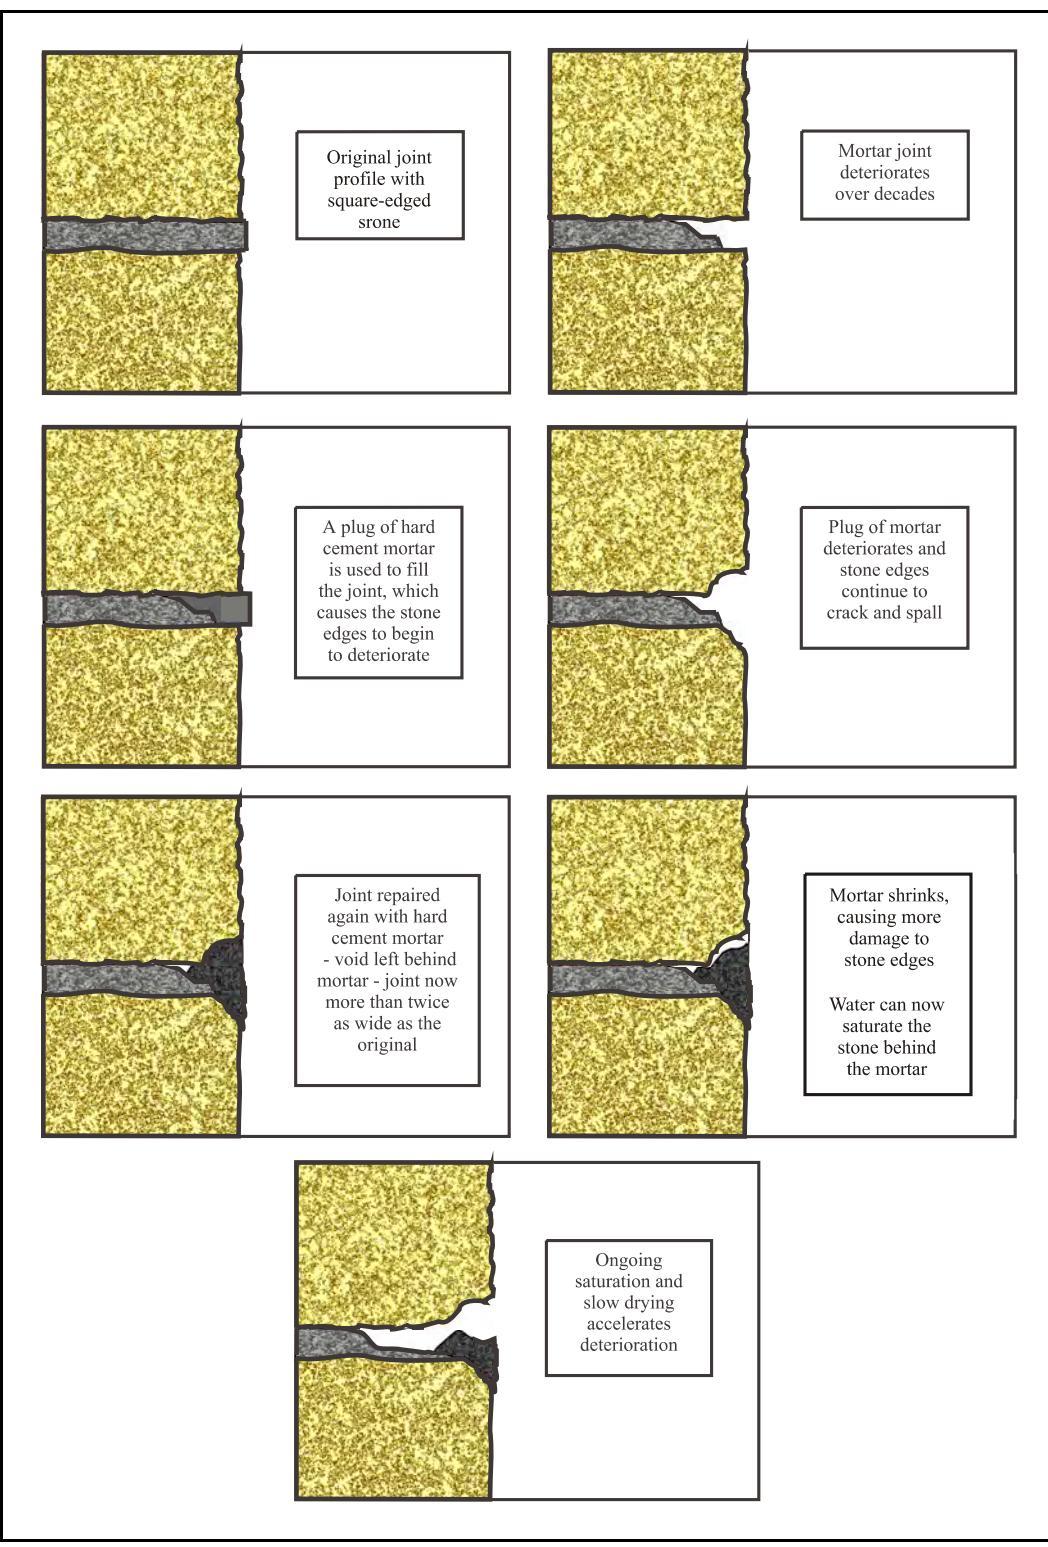
If we are to develop effective repointing strategies, it is important that we learn from past mistakes and avoid repeating them. Figure 5 illustrates a typical sequence of deterioration that can take place over the years.

In order that progressive deterioration already illustrated by Figure 5 can be arrested or slowed, the restoration strategy should consider the technique detailed in Figure 6. This generally preferred technique removes old deteriorated mortar, using the methods described later, and replaces it with a carefully designed mortar (also discussed later). The original joint width is almost restored by recessing the mortar and any lower projections are chamferred to assist in shedding rain water.

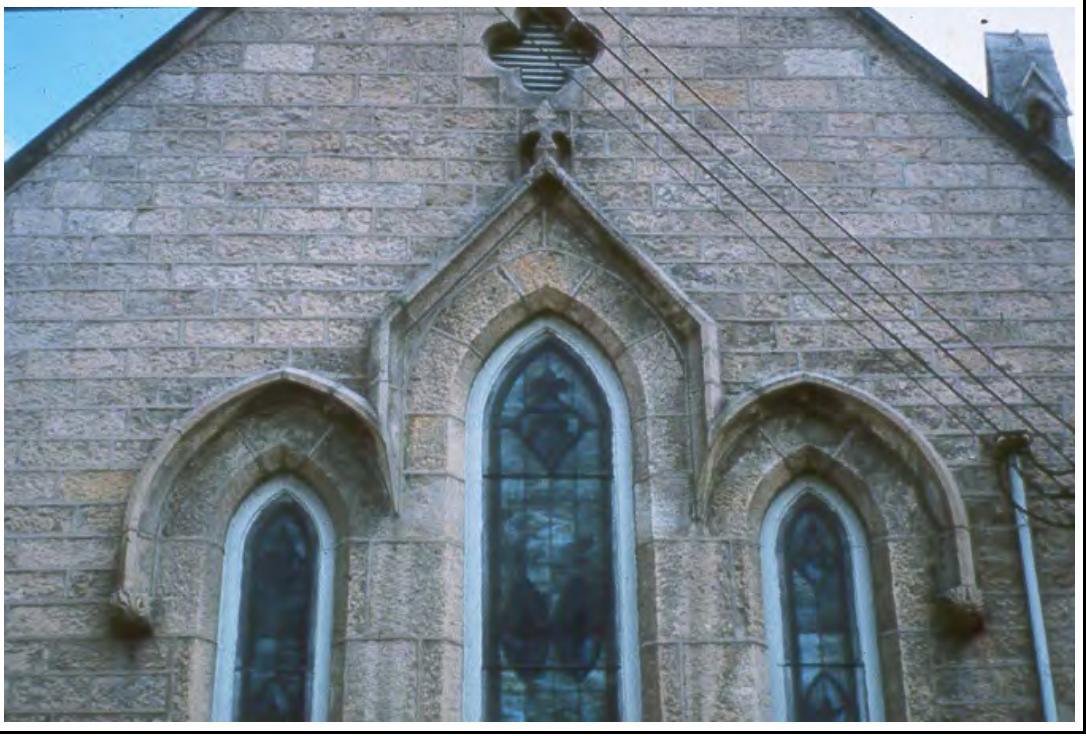
structure that Α exemplifies the illustrated sequence progressive of deterioration is shown in Photos 2 and 3. The first photograph shows a section of stone masonry 16 years major after repointing work was carried out in 1961.

A close examination reveals that the ribbon-jointing style using a cement m o r t a r i s deteriorating quite badly, along with the stone edges.

Photo.2: A section of mortar 16 years after repointing in 1961 By kind permission of the Wellington County Museum Archives, Ontario

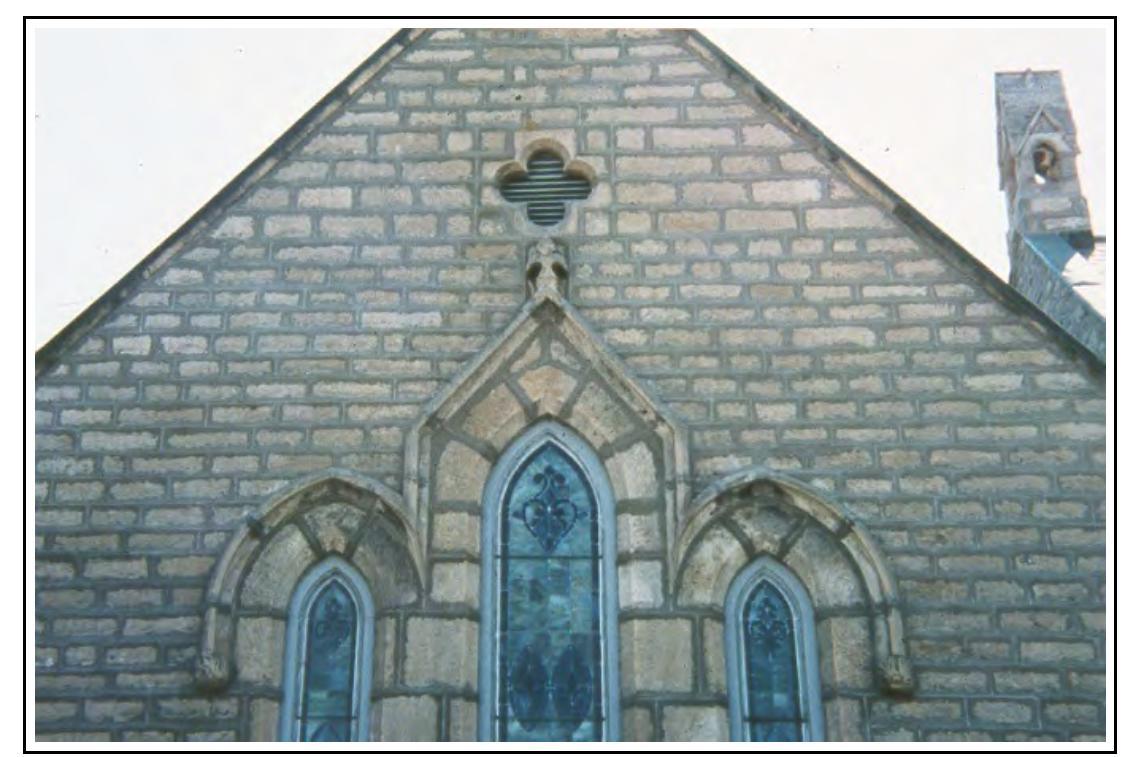
It can only be supposed that this advanced rapidly, as major repointing work was carried out again in 1993 and Photograph 3 illustrates the extent to which a hard cement mortar has been used to maintain a flush joint, increase the joint widths and thereby reduce the visible area of stone.

Photo. 3: After major repointing in 1993

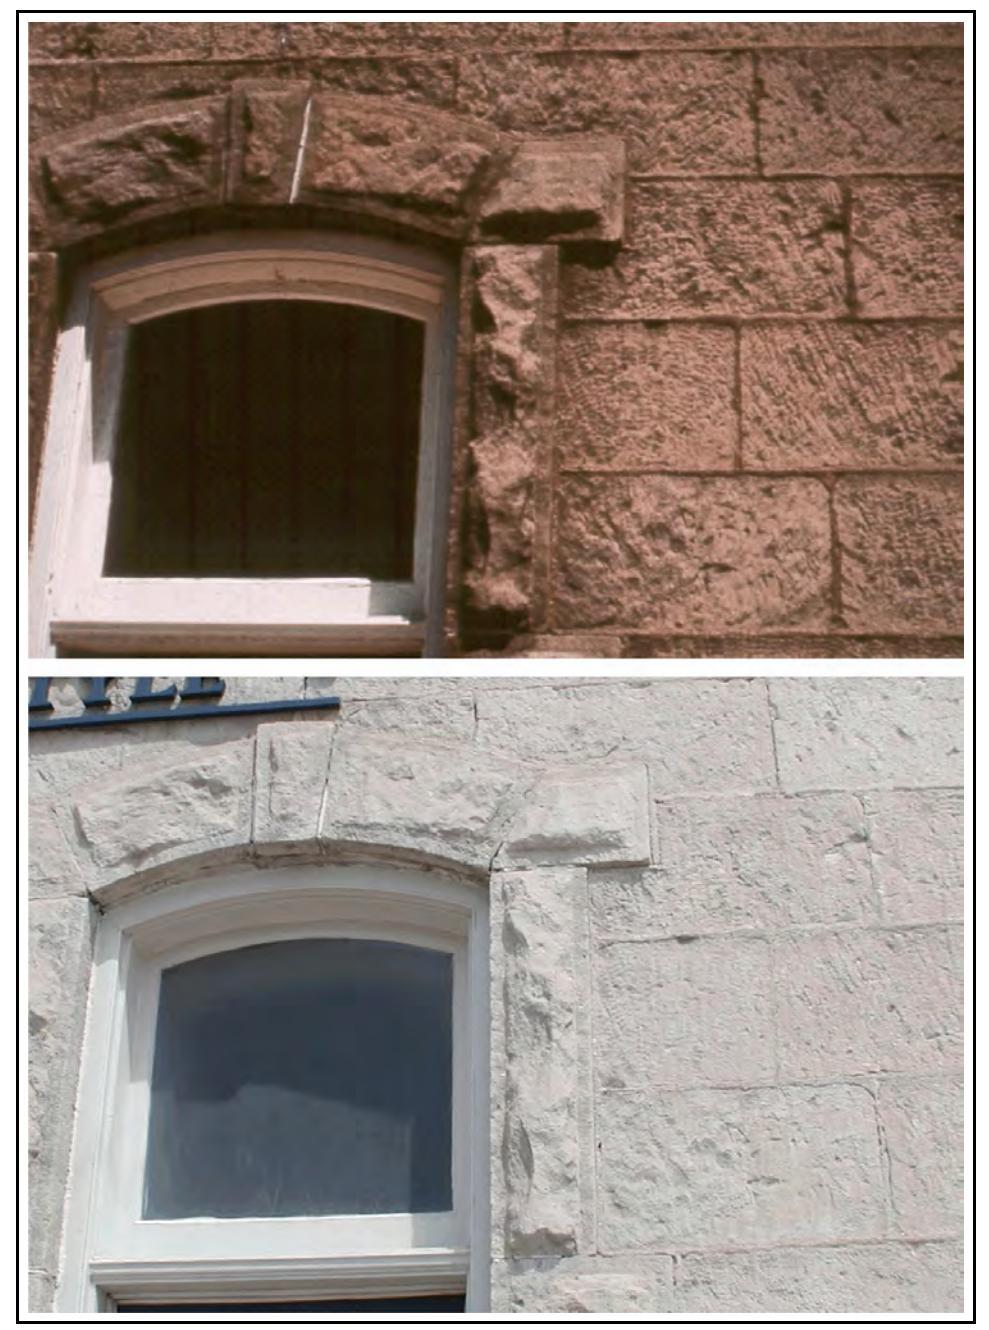
Photograph 4 shows a section of masonry constructed from ashlar limestone in 1853. The original mortar is clearly visible and - apart from some localised repointing work that is required - in general, the condition of the mortar is very good. The photograph was taken in 1974 and, if it is compared with Photograph 5 - which was taken in 2008 - it can be seen that very little deterioration has taken place since that time. While it is fair to state that some partial repointing work is required in other areas of the masonry full joint restoration work is still not required - even after more than one hundred & fifty years.

Photo.4: (Top) Original mid-eighteenth century mortar in 1974 (By kind permission of the Wellington County Museum Archives) Photo. 5. (Bottom) 34-years later, there is little sign of additional deterioration.

With good maintenance practices, it should be possible to repoint a structure to last for more than fifty years. Indeed, many heritage structures can be found with the original mid-tolate-nineteenth century mortared joints still performing well, even though they have been exposed to quite hostile weathering actions. (see Photographs 4 & 5)

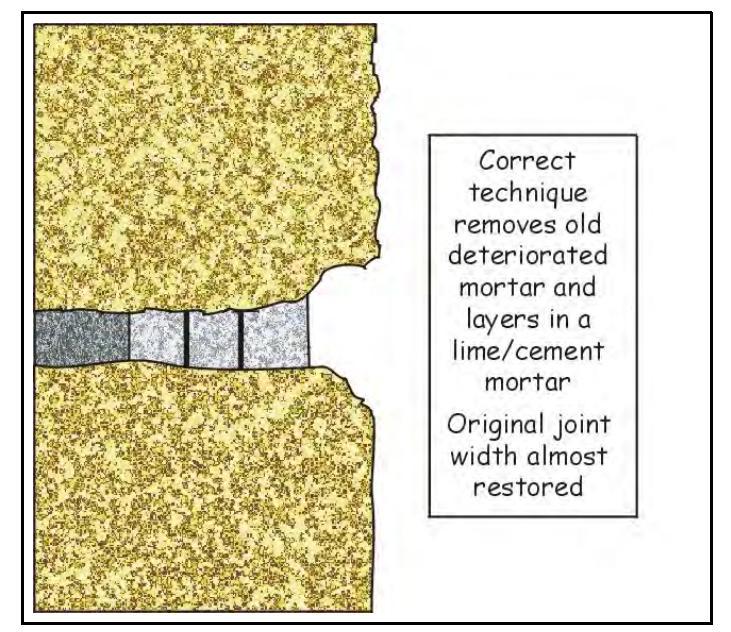
Figure 6

If a return to a straight edged joint is considered essential for authenticity, then a purpose-designed mortar - not the repointing mortar - should be used to re-profile the deteriorated masonry unit. The reprofiling mortar should preferably consist of a lime/sand mortar containing very little cement, if any. A clean, concreting sand chosen for its size distribution and colour can be used to resemble the

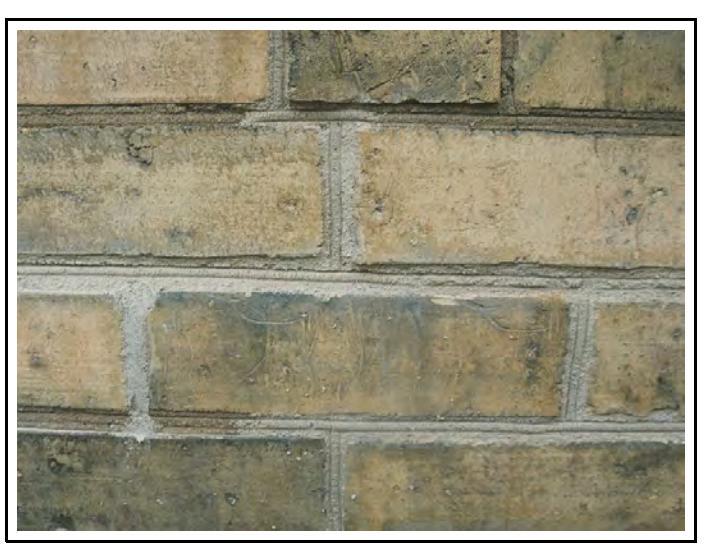
The following five photographs further illustrate how the selection of a pointing style and hard mortar can accelerate deterioration. Photograph 7 was taken in Photo. 6. The repointing of this 100-year old brick masonry 1974 and shows the results of numerous attempts at attempts to match the original pointing style. repointing over at least a forty year period. At one time

- or perhaps originally - mortar was used to change the appearance of the random sized rubble stone to a more expensive, uniform ashlar stone. (A form of the technique originally known as "tuck-pointing".) The repointing techniques applied mortar over the faces of the stone and then used a "tape" or "ribbon" style for repointing. (This is a technique that has been widely adopted in the Wellington County area in Ontario and appears to have grown and spread in popularity during the 1930 - 1940's) Photograph 8 shows the extent of deterioration caused by the poor techniques in 1994.

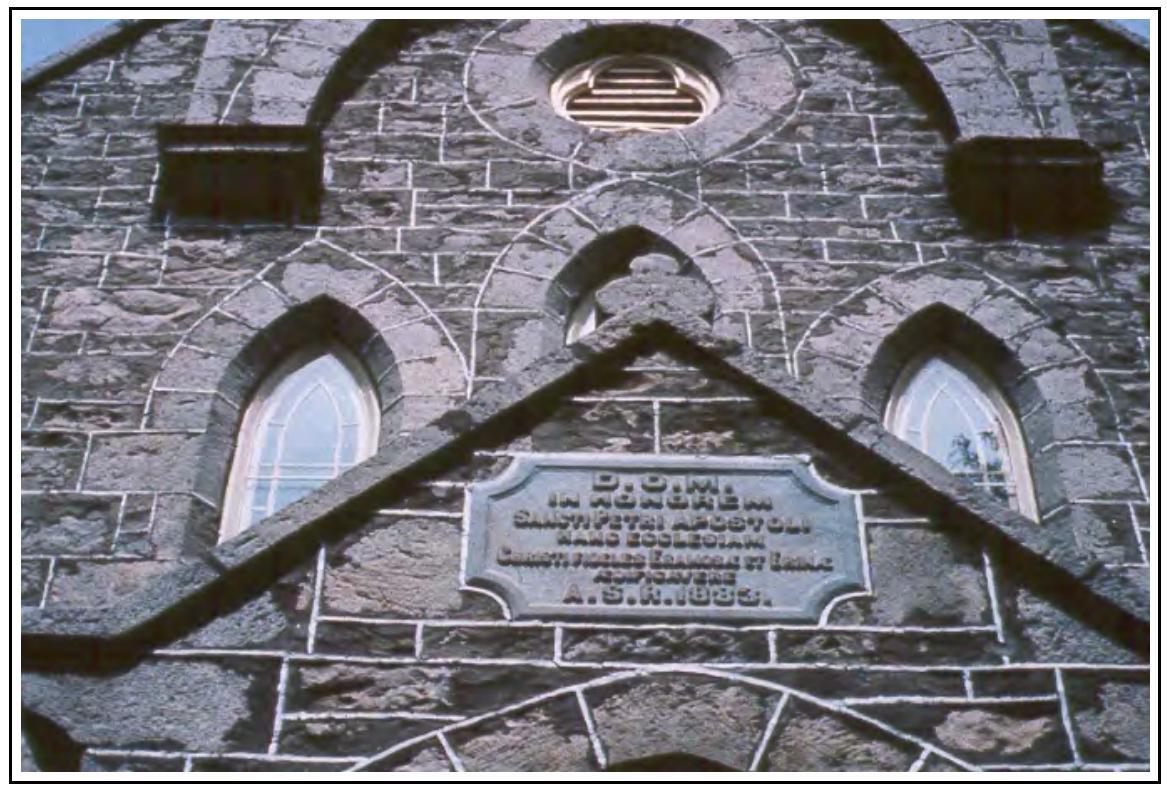
Photo.7: The effects of numerous attempts at repointing (1974) By kind permission of the Wellington County Museum Archives

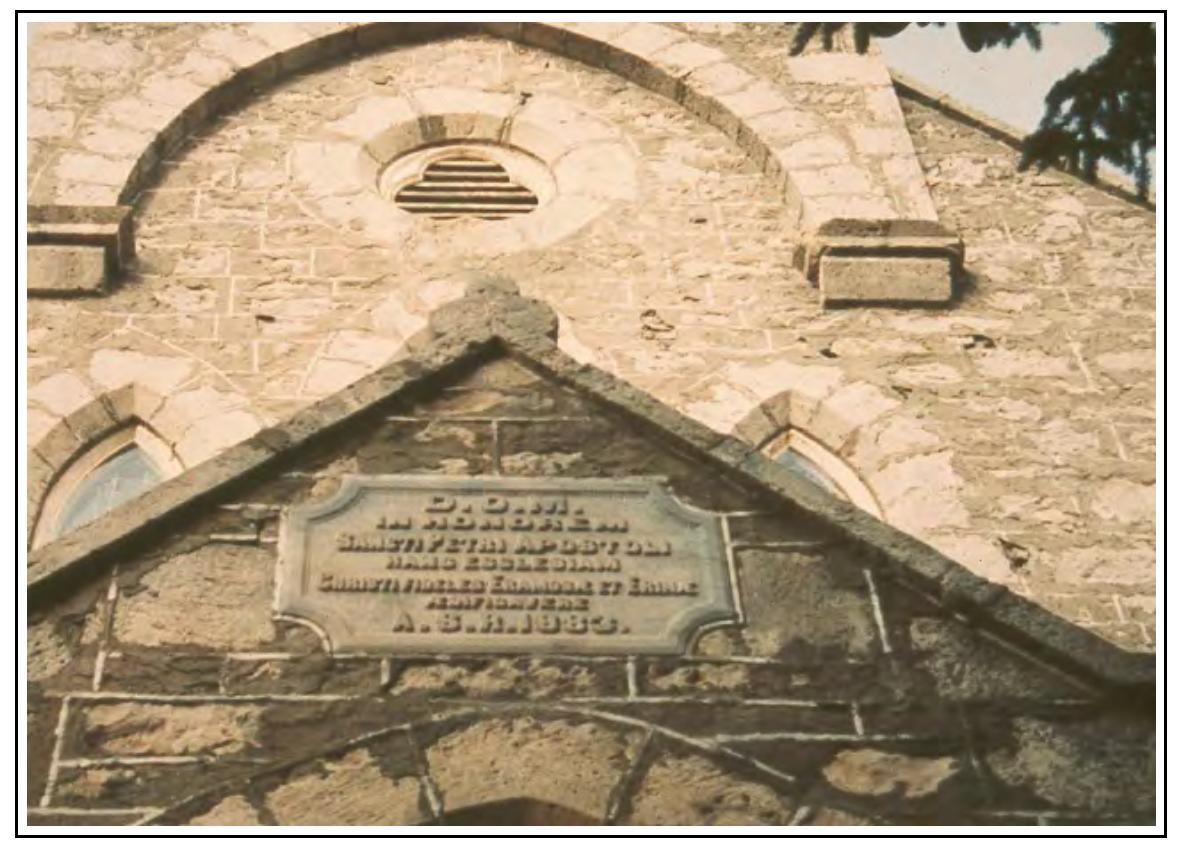
Photo. 8: Further deterioration is evident after 20 years

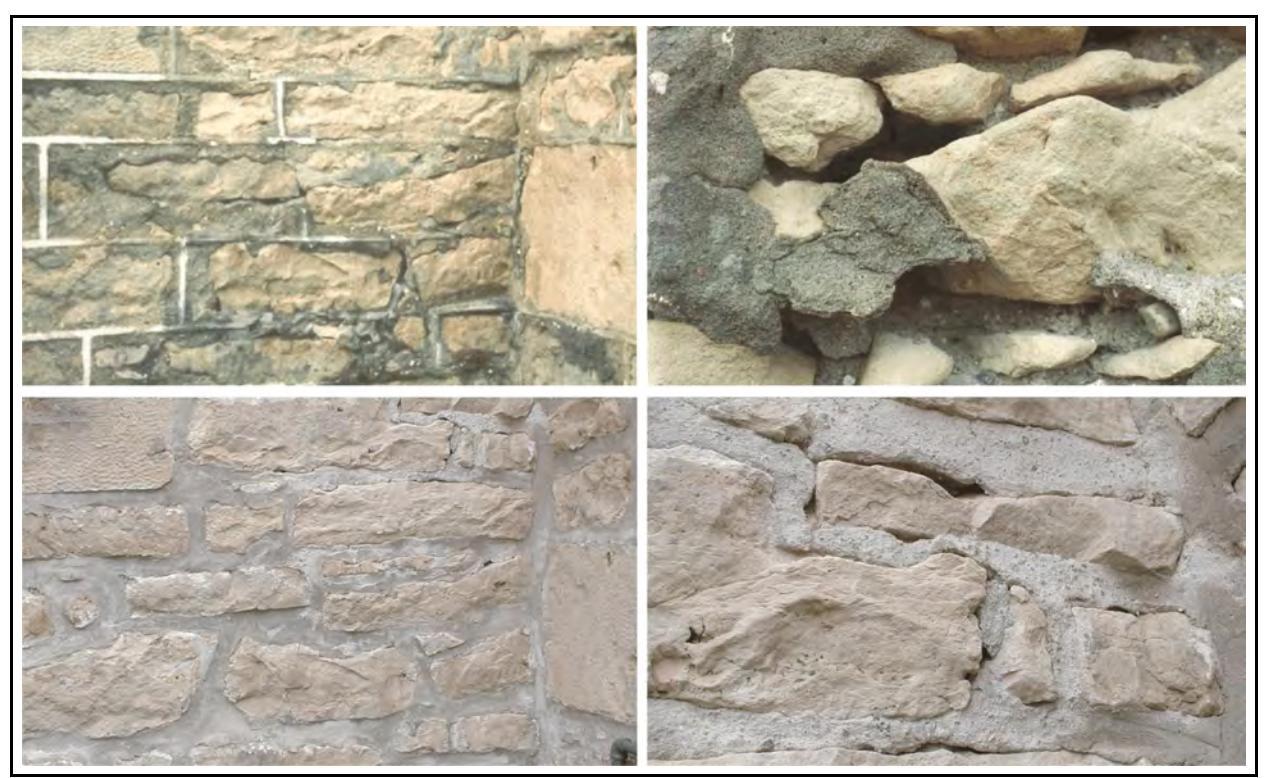
Taken about 1993, Photograph 9 shows an area of the church masonry which more clearly reveals the extent of previous repointing and the deterioration. Photograph 10 further illustrates the extent to which the technique, style and selection of hard cement mortars has accelerated deterioration and damaged the masonry units. In particular, water has soaked into the stone behind the "feather-edged" mortar which covered the stone face. The water has been unable to "breathe" as naturally through the hard mortar as it could through the stone. This has repeatedly caused the development of stresses within both the mortar and the stone during periods of freezing and thawing, until progressive damage occurs to both materials - but the "softer" natural stone suffers more.

Photo.9 through 12.(Upper Left) Natural stone masonry that has been repointed many times - incorrectly, and (Upper Right) a close up view of accelerated deterioration caused by the incorrect repointing techniques - note the damage caused to the natural stone. (Lower Left) The same area of masonry some 10-years after restoration, and (Lower Right) the omission of inner core rubble grouting has resulted in further deterioration.

However, of equal concern is the fact that water has penetrated through to the inner rubble core and signs of leaching out of the binder are also apparent. This raises concerns that the masonry may not be acting completely as a composite structure and loads may not therefore be uniformly distributed and stresses evenly absorbed. Part of a restoration strategy, under similar circumstances, should investigate the seriousness of any inner core deterioration and evaluate the need for grouting techniques to ensure structural stability of the masonry.

Unfortunately, when restoration was carried out about two or three years after Photograph 9 was taken, the work did not include grouting of the inner core rubble. Photograph 11, taken in 2008, indicates that this omission is resulting in further evident deterioration. A close-up inspection of the masonry confirms multiple areas where water which obviously enters the core rubble at higher levels, then gravitates and collects to cause freeze/thaw damage - which subsequently permits the binder from the inner core to percolate and exit the masonry through deteriorated joints. (See Photograph 12.) An unfortunate result of the original poor repointing practices (illustrated in Photograph 9.) is also the damage caused to the masonry units by the subsequent cutting out operations required to remove the hard cement mortar from the face of the stone.

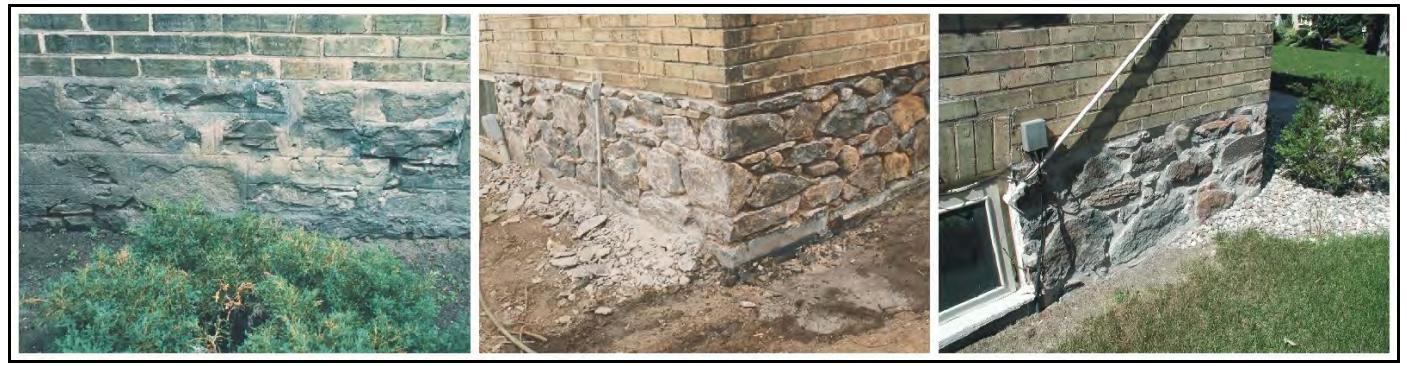
Photos 13 through 15 illustrate repointing a foundation wall that had been poorly repointed over many years.

Photos. 13 through 15: A badly repointed foundation wall before, during and after restoration.

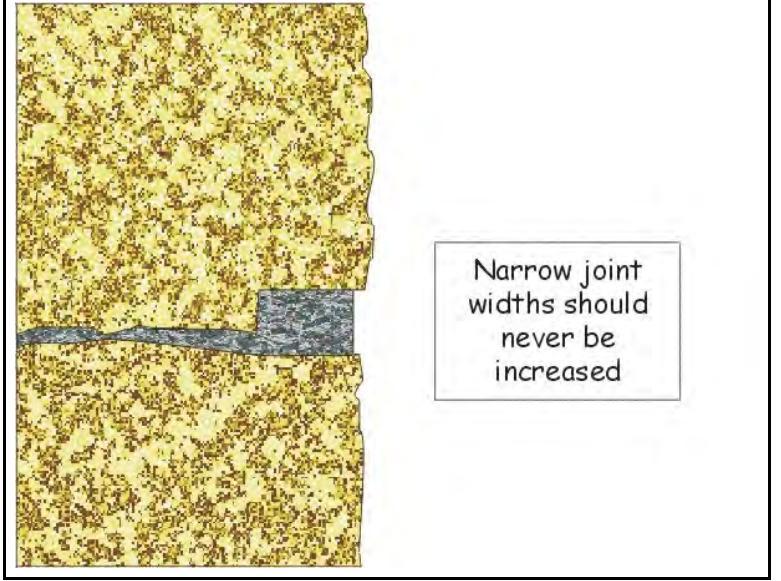
Figure 7

Joints should never be widened to facilitate easier repointing. (see Figure 7.) Very narrow joints can often be raked using pointed industrial hack-saw blades or other suitable instruments. The use of grinders to open up a joint or remove mortar is difficult to control and, whenever possible, should be avoided to prevent damage to masonry units. In fact, on heritage structure restoration projects, it is generally recognized that power tools should only be permitted for mortar removal work in exceptional circumstances. and then only used by experienced operators. (See Photograph 16.) In particular, grinders should never be used as the only means by which mortar is removed - nor should they be permitted to be used on head (vertical) joints (see Photograph 17) Apart from the potential detraction from the visual character

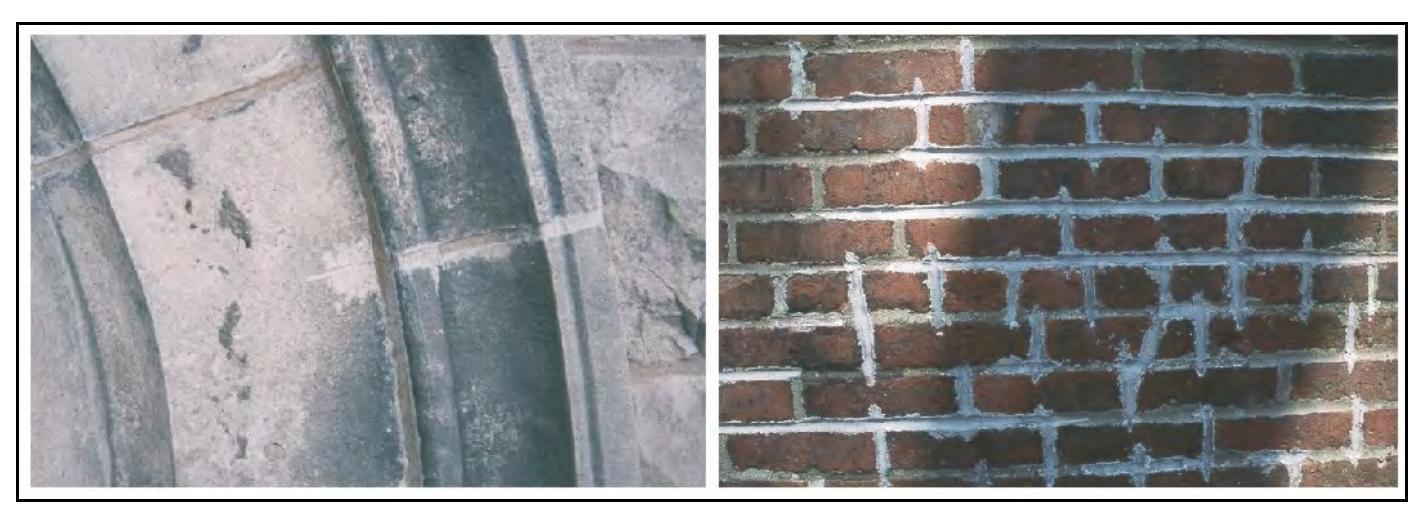
Photos.16 & 17: Damage caused by use of a grinder to remove previous mortar.

If joints are uniform and sufficiently wide, the use of grinders with small diameter blades is often permitted to remove the central portion of mortar in order that easier use of hand tools can be achieved. In this case, the thickness of the grinder blade must be less than half the width of the joint. In addition, removing deteriorated lime mortar is usually no problem using hand tools, but removal of hard cement based mortars is generally more difficult and the avoidance of power tools may not be possible. Unfortunately, when previous repointing work used inappropriate mortars, the use of inappropriate tools (grinders) is often the only solution.

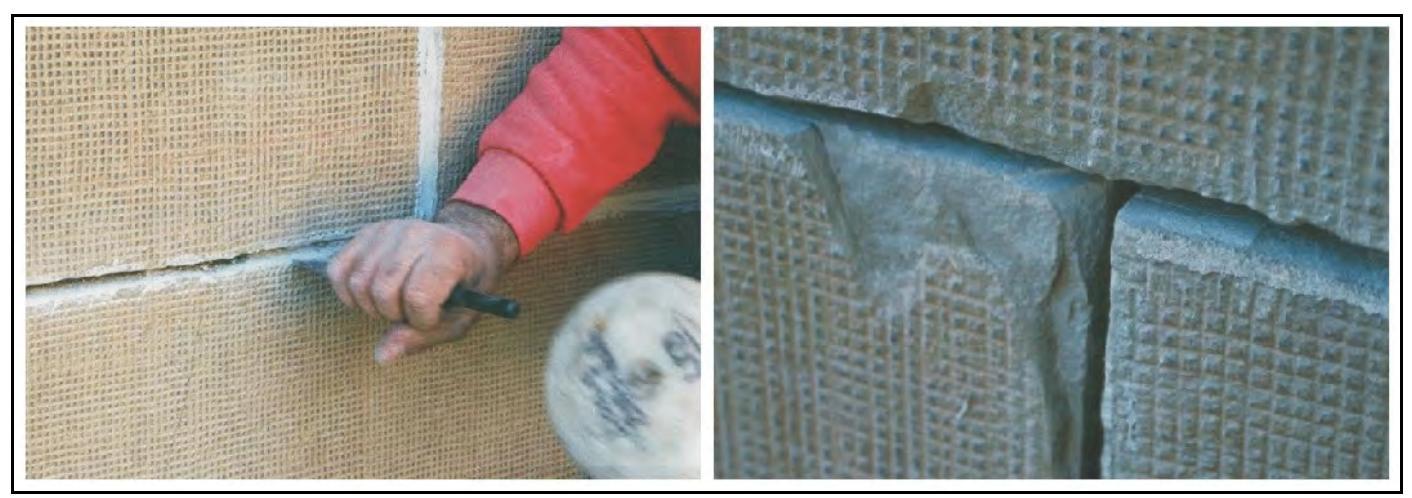
Ironically, in some rare cases, the use grinders will in fact create less damage to some stone masonry units than carving tools or chisels - particularly if the units are under high compression loads due to unusual circumstances, and/or the stone was face-bedded. This latter condition can often cause fracturing or scaling of the joint edges from the release of energy during the cutting out of joint under severe compression. (See Photographs 18 & 19.)

Photos.18 & 19: Cutting out over-loaded face bedded stone mortar joints using hand chisels (left) caused damage to the masonry which was not created when grinders were used. This was due to unusually high loads imposed on the outer wythe of masonry following roof reconstruction work carried out 30-years previously.

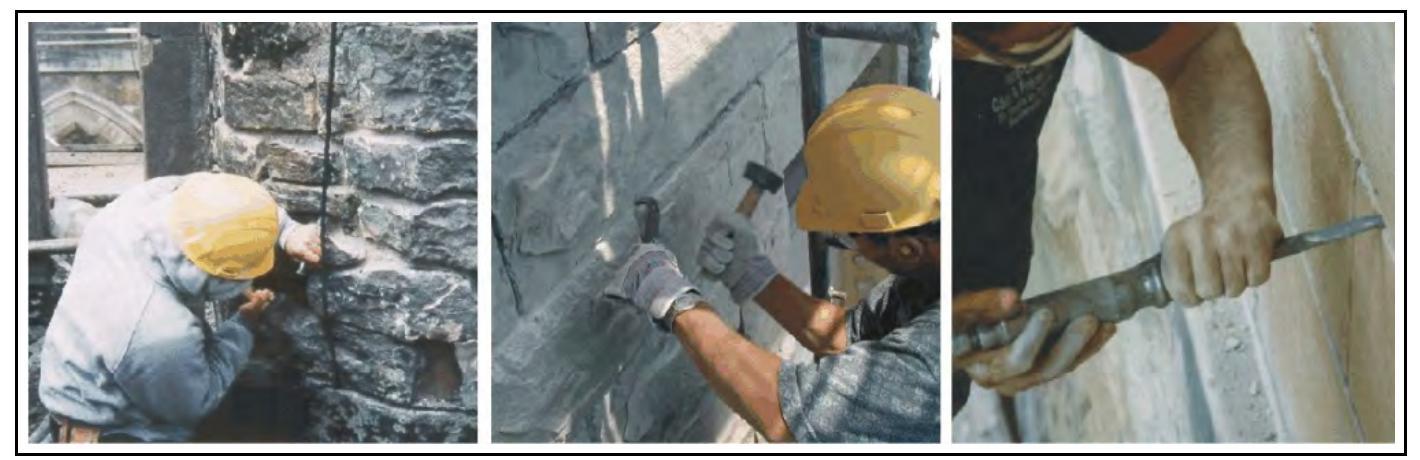
However, damage to masonry units can usually be better controlled by use of hand tools. (see Photographs 20 through 22) Chisels should be used that have point thicknesses that are no wider than half the width of the joint.

Photo.20, 21 & 22: Removing deteriorated mortar with chisel (left) rake (middle) and lightweight stone carving tool (right).

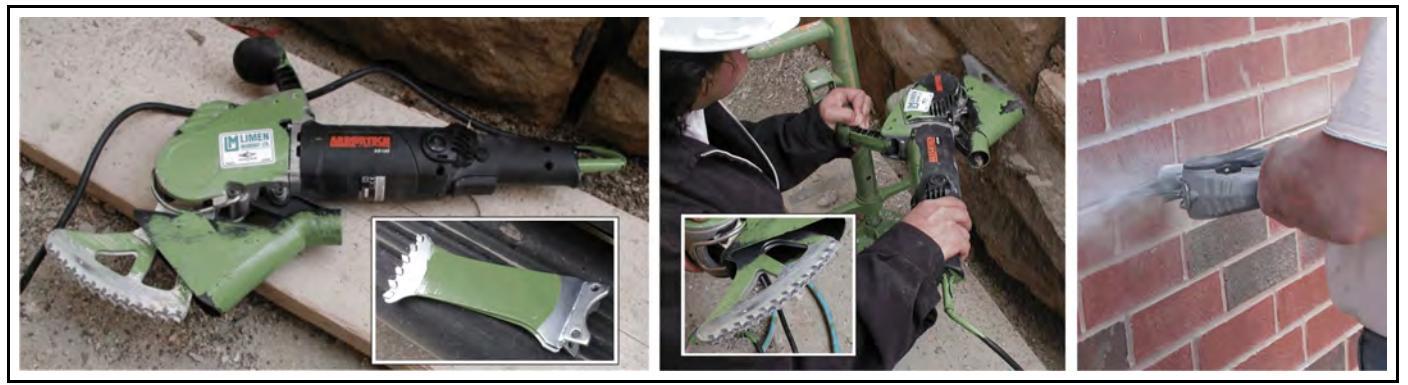
A reasonably recent innovation within the masonry restoration industry is a power tool that is claimed to be more controllable than a grinder - and has a purpose designed dual blade configuration that can be used for a variety of circumstances - including cutting out head joints. (See Photographs 23 through 25.) However, the correct use of the tool should be assured with trials and training - particularly when hard mortars are present. The formation of a short length of a centre slot using a grinder is typically advisable to ensure the blades can get a 'purchase' into the mortar within horizontal courses. The dual blades can then be inserted into the slot and moved horizontally. This technique will typically avoid potential damage to masonry units from 'chattering' of the blades on the surface of the mortar. At the moment, there is only one manufacturer supply a proprietary tool of the type described and illustrated.

Photos.23 through 25.A new cutting out tool (left) that can be used for stone (centre), brick (left) and other types of masonry unit - and can be used for head joints (left inset). The dual blade configuration (right inset) reduces the possibility of causing damage to masonry units during cutting out operations.

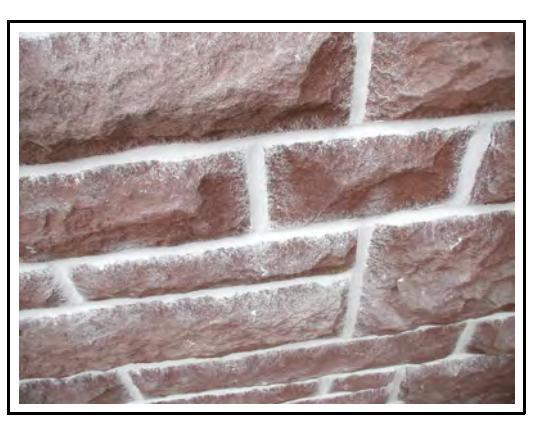
Cut out joints should finally be cleaned of dust and debris by gentle flushing with clean water. If it is possible for this to be carried out just prior to filling the joints, the dampness will prevent the rapid loss of mixing water from the new mortar which could otherwise reduce bond. However, the joints should not be wetted with free water at the time of application as this may cause undesirable reductions in the strength of the bond or an increase in shrinkage. It is also important that the face of the masonry units be damp to dry not wet - at the time of repointing work, or mortar runs and "streaking" may occur. (See Photograph 26.) This also means that repointing work should be suspended during rainfall and freshly applied mortar protected from getting wet.

Photos.26. The result of repointing while the face of the masonry is wet.

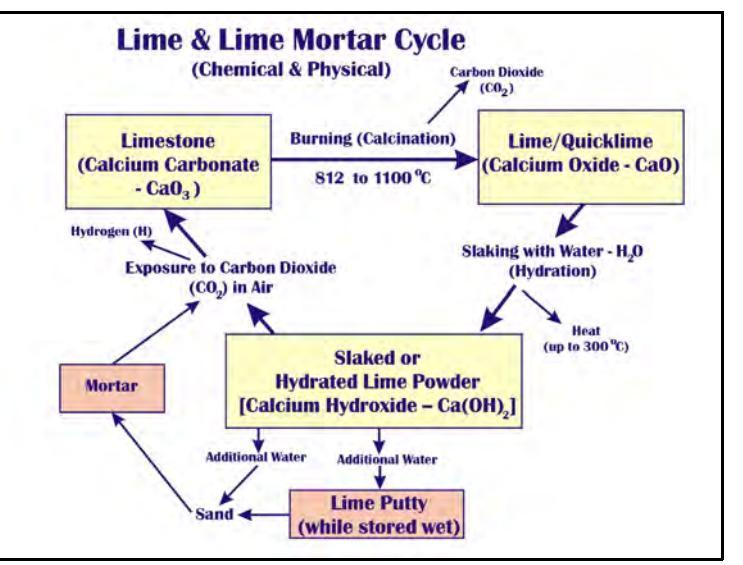
Until the late 1800's, pointing mortars used lime as the only binder, and this largely acquired its hardened properties by a slow process known as carbonation. (See Figure 8 for an explanation of the chemical and physical cycles of lime.) Traditionally, the quicklime was delivered fresh to the construction site in a sealed wooden barrel. The quicklime was then transferred to a pit or a large wooden box and mixed with water - a process known as slaking - to produce a lime putty which would be left to mature for several months.<sup>8</sup> Once the slaked lime reached maturity, the excess surface water was then removed and sand mixed to produce the mortar at the proportions 1-part lime putty to 3-parts sand by volume.

Figure 8. Lime and lime mortar cycle

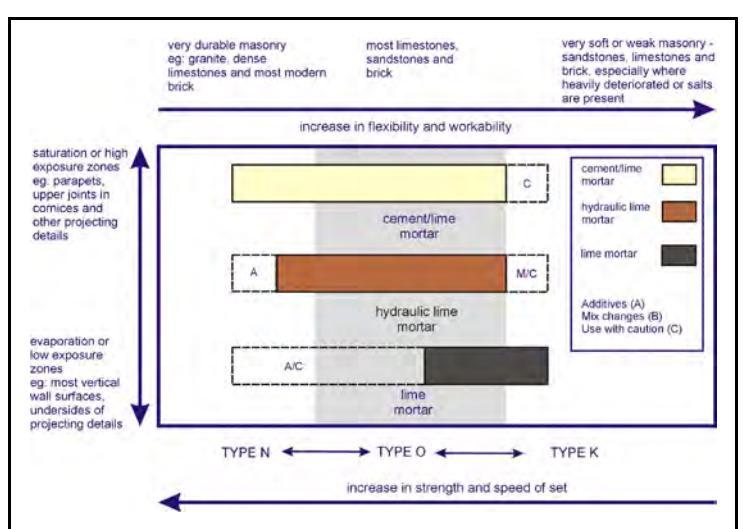
Figure 9. Mortar Selection Chart for Historic Masonry Structures

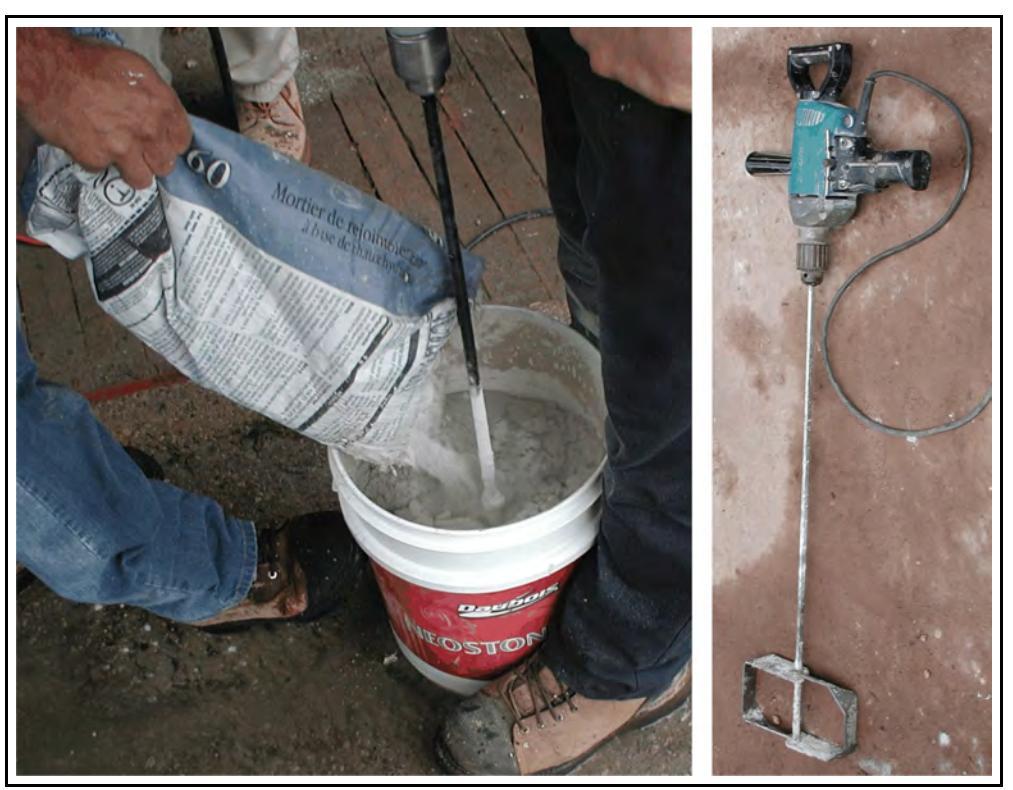
When using prepackaged repointing mortars, it is essential that the manufacturer's recommendations be followed for mixing. Many products have different peculiarities that may require some training to overcome potential problems. In particular, if a mixing head within a drill is the chosen method, the power and adjustable speed

Photos.27 & 28 (Left) Mixing a prepackaged repointing mortar. (Right) A drill and inserted mixing head.

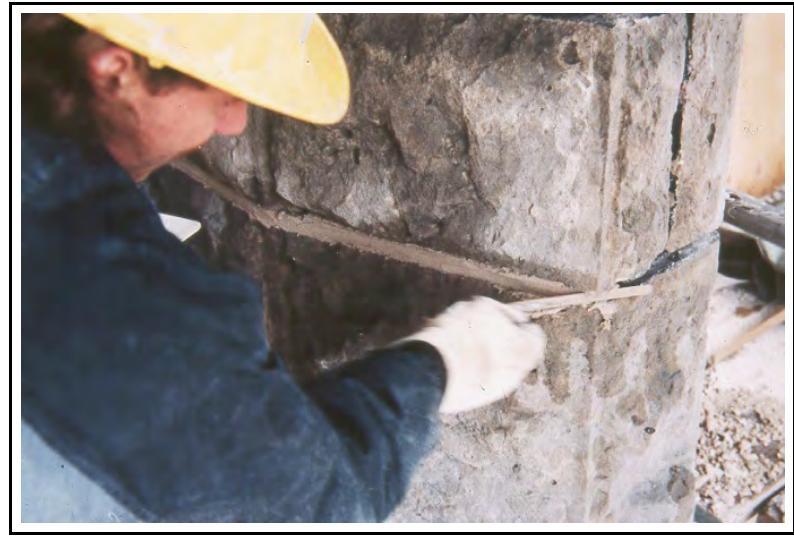
Photo.29: Applying the final layer of mortar

mortar should be produced with a stiff consistency and well compacted. The final layer is usually left flush or slightly proud of the final required finish and a period allowed for the mortar to stiffen to the desired degree for final joint finishing. (See Photograph 29.)

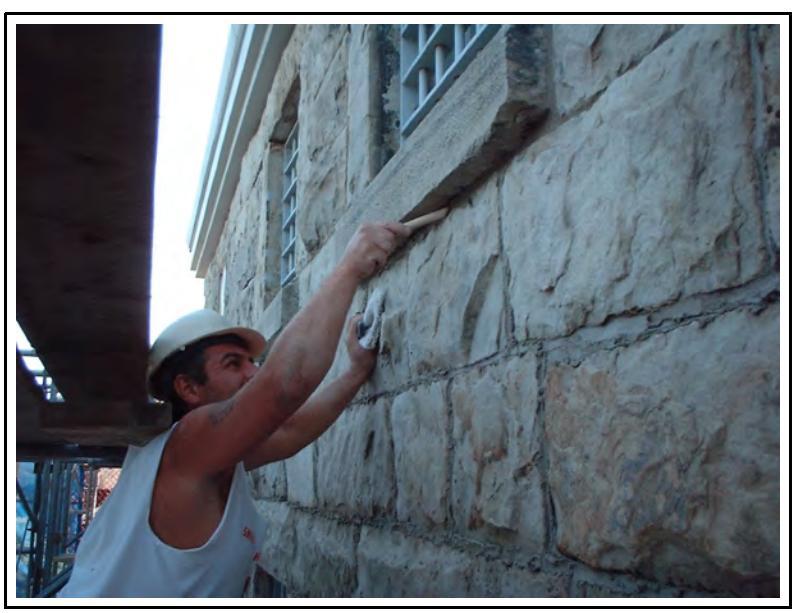
Simply using the trowel to smooth the filled joint is not a recommended practice. The preferred practice is to "tool" the filled joint with a purpose-designed finishing tool, known as a "slicker" to the finished profile. (See Photograph 30.) Pulling the slicker over the surface compresses the filled joint to improve durability and strength. The process usually brings binder to the surface and this is often removed by gently brushing with a soft-bristled paint brush. (See Photograph 31.) This helps to produce a more weathered appearance, but care should be taken to avoid dislodging or loosening embedded aggregate particles.

Proper timing is important or colour changes can result. Also, hairline cracking can occur if Photo. 30. "Slicking" the stiffened mortar to the desired profile. the mortar is too soft. Dark streaks, known as

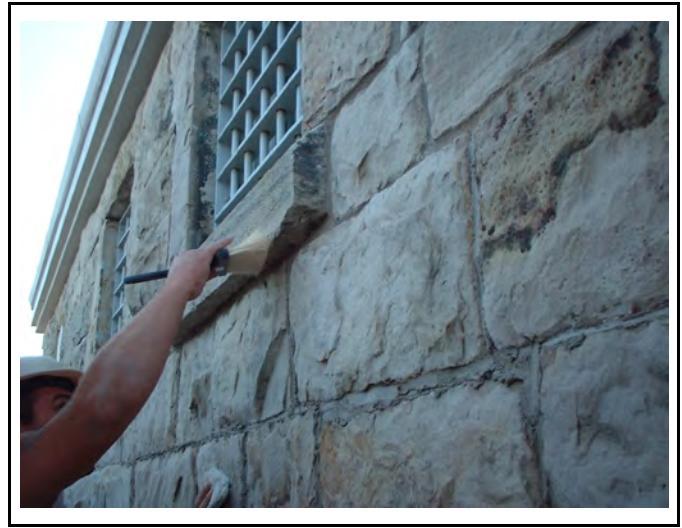
Photo.31: Brushing the joint to remove binder and to produce final finish

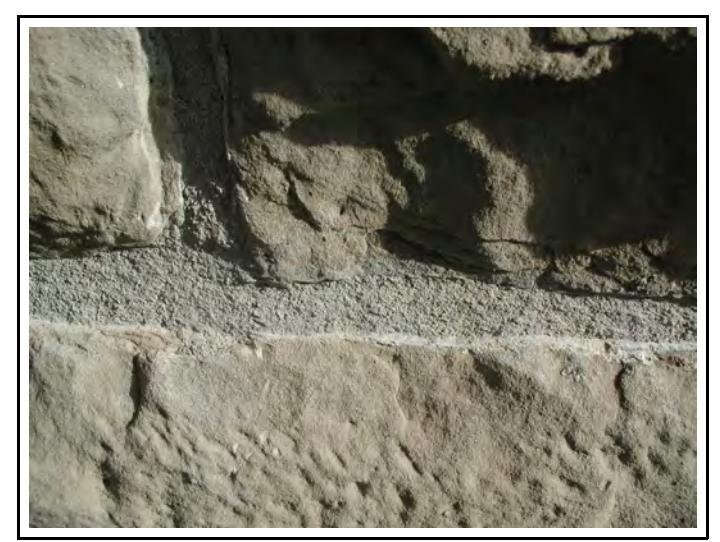
Photo.32. The finished joint

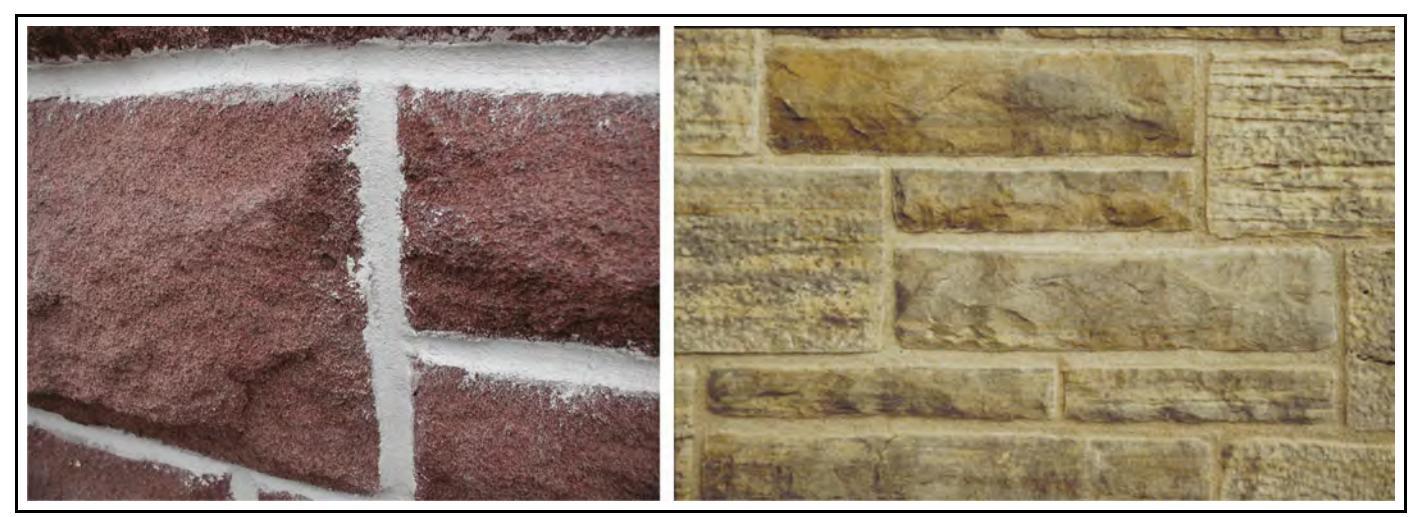
While there will always be a need to clean the masonry prior to completion of the restoration work, one of the largest challenges facing the consultant or inspector is to ensure that mortar droppings, splatters, smears, etc., created during the repointing operations are removed and the face of the masonry washed to prevent the residue from hardening. A modern trend in masonry construction - particularly for bricklaying operations - is to permit the use of a "brick cleaner" or other cement-removing solution to remove hardened mortar deposits at the end of the work. Although modern masonry units may be able to withstand the chemical reactions that have to take place to remove the cement mortar, this may not be the case with traditional masonry, particularly limestone and sandstone. Specifiers are cautioned to ensure specifications require cleaning residual mortar immediately they are created - and inspectors/consultants should rigidly enforce this during repointing operations. Preventing repointing mortar smears over the face of the masonry units from the joints must also be discouraged, but the occurrence or otherwise of this will depend on the skills and diligence of the mason. (See Photographs 33 & 34.)

Photos. 33 & 34. The difference between the degrees of skill and diligence exhibited by the two masons requires no comment!
