## **Conservation of Heritage Structures & Older Buildings**

Repointing Masonry Walls – Matching the Techniques for Success or Failure

By Paul Jeffs, PJ Materials Consultants Limited

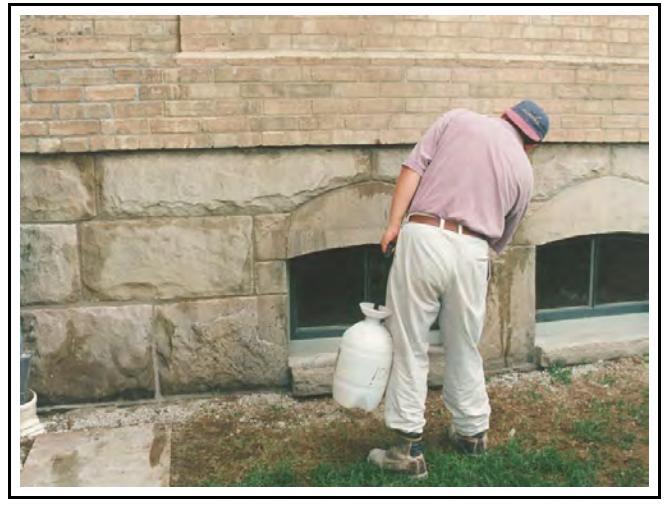
The result of desiccation is typically a weak, friable hardened mortar which has lower strength than Photo.35. Curing repointed joints using desirable. Generally, hardened mortar that has become techniques. desiccated will also be more porous, leading to less

mist-spraying

Typically, recommendations to prevent rapid drying include a two to four day damp cure for cement/lime mortars and three to seven days for pure lime mortars.
