**Supplementary to August 8, 2013
Cultural Heritage Impact Assessment
170 and 178 Elizabeth Street
Guelph, ON**

October 15, 2013

This supplement to the *Cultural Heritage Impact Assessment* has been prepared to provide further information to verify the recommendation in the August 8th *Assessment* for 178 Elizabeth Street. That recommendation was 'salvage mitigation' be employed by "recognizing the site through an interpretive plaque in nearby Franchetto Park coupled with a photographic inventory of the houses and any historic photos of the Franchetto era that can be found."

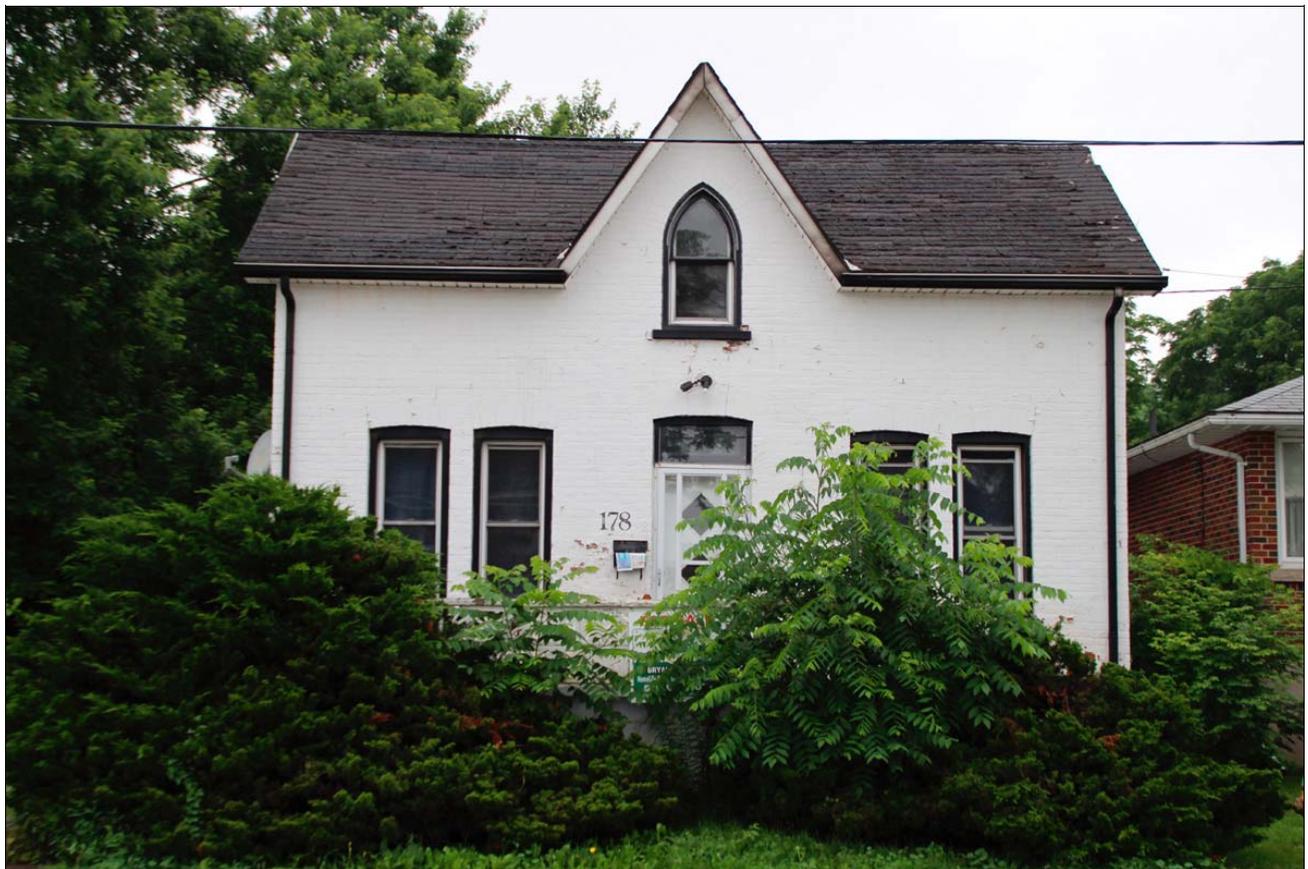
Figure 1

front (south) elevation

The front elevation (Figure 1) of this c. 1889 house is symmetrical with a small gable complete with gothic window, paired (coupled) windows with rounded buff brick headers, flanking a central door with glazed transom. The original red and buff brick has been painted white and is spalling from water damage in an number of areas. (Figures 2, 3 & 4)

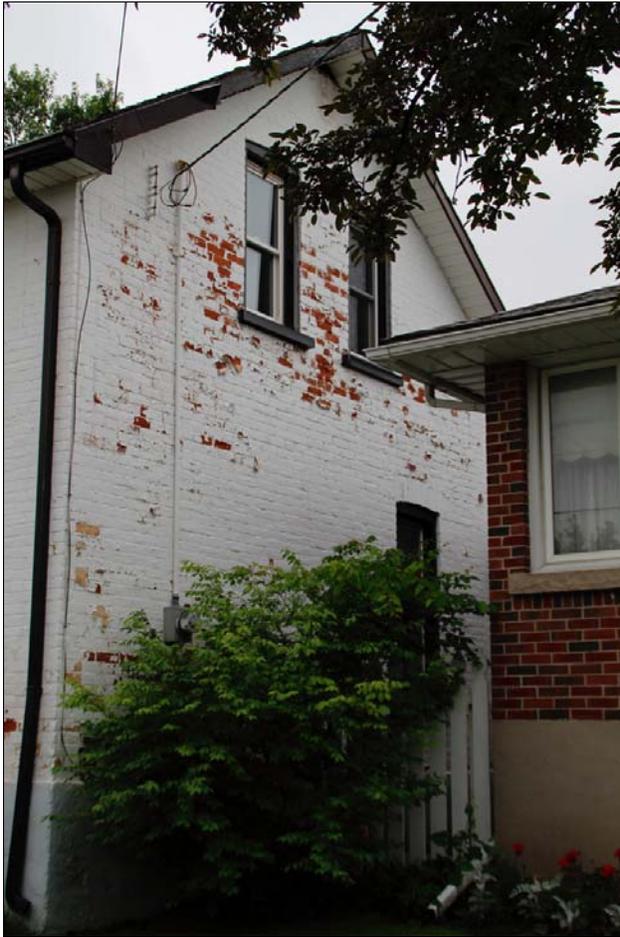
Figure 2 east facade

With respect to the painted brick, there has been a suggestion that chemical means can be used to strip the paint. While this is feasible (and the author has first hand experience with this method on 2 similar buildings), it is not a particularly environmentally-friendly procedure and requires that the brick be in good condition. 178 Elizabeth Street was painted because the brick had spalled and its glaze was already compromised. Paint stripping by any method will not repair the spalled glaze and will exacerbate the situation further.

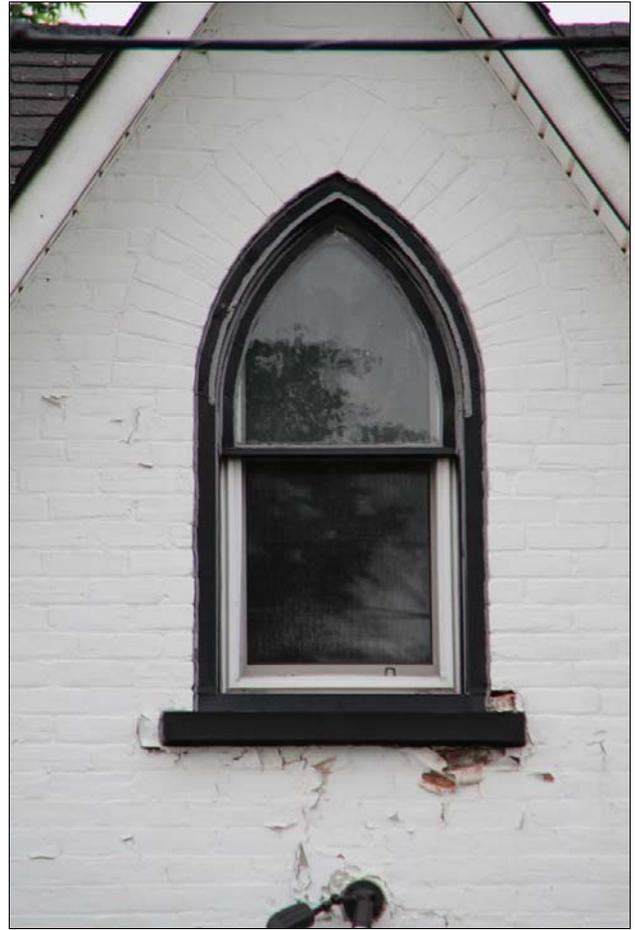
Figure 3 upper front facade

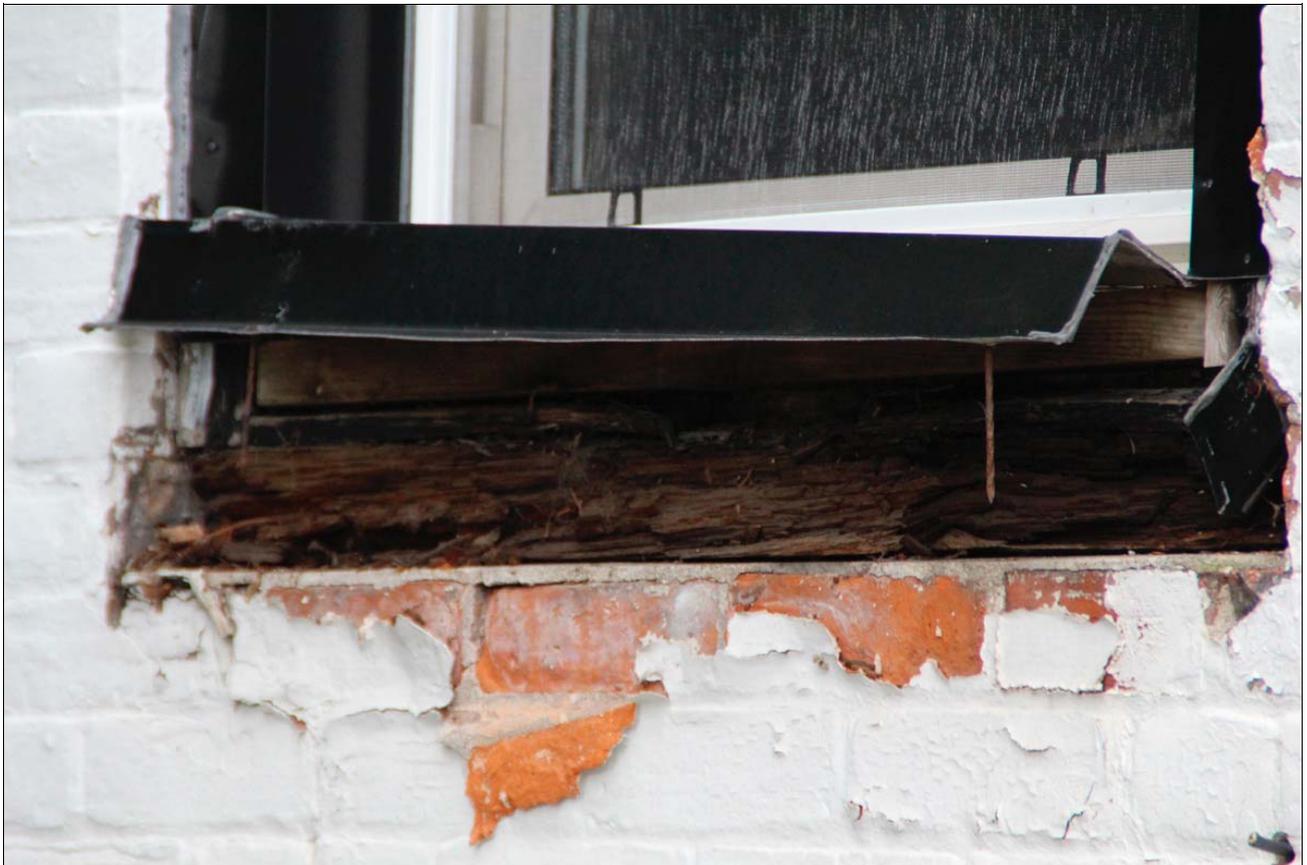
Figure 4 west facade

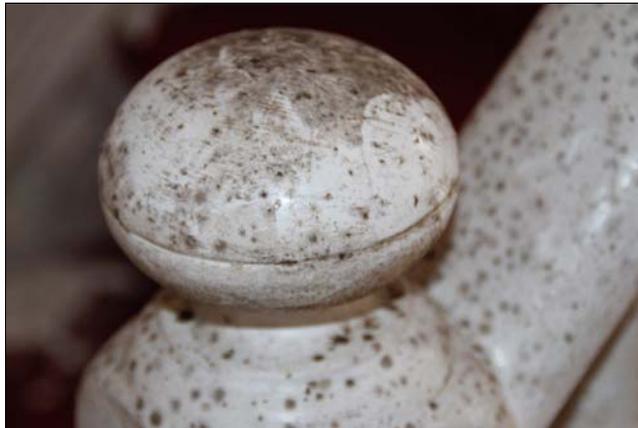
The interior has been altered and is in very poor condition, having been without heat for a number of years. Water pipes froze and there is considerable water damage and mould throughout. (Figures 5 & 6).

Figure 5 mould on newel post

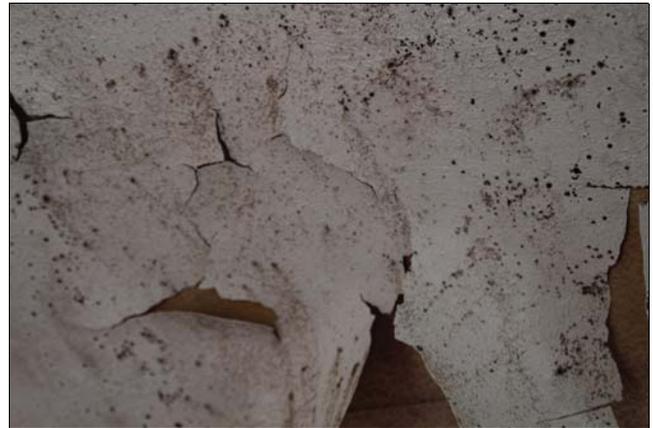
Figure 6 mould on peeling wallpaper
