# Technical Memorandum

15 February 2012

Re: Hydrogeological Investigation, Proposed Cityview Ridge Development, City of Guelph

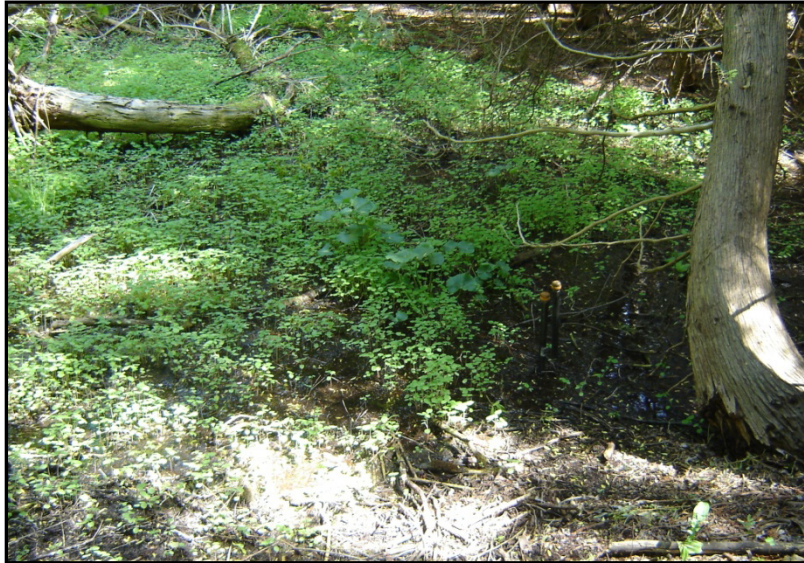
Plate 1: Piezometer Station 1

To confirm the occurrence of groundwater flow and discharge to the wetland located in the southeast area of the site, shallow piezometers were installed at two locations (Refer to Plates 1 and 2). Shallow piezometers were also installed at a third location to determine if shallow groundwater discharge was occurring adjacent to Clythe Creek along the southern boundary of the

At each site the piezometers were installed in pairs, with one set at a shallow depth (about 0.5 m) and another at an intermediate depth (about 1.1 m), to provide for measurement of the vertical hydraulic gradient at various times. Groundwater levels were measured in each piezometer and recorded relative to adjacent ground surface on three occasions: 13 and 25 May, and 4 June 2009.

On each occasion the monitoring confirmed groundwater discharge conditions adjacent to the wetland and upgradient. Confirmation of local groundwater discharge to the wetland is based on the observation of groundwater seeps along the upgradient slope on the north edge of the wetland on each monitoring occasion. Shallow groundwater flow to the wetland is also confirmed by the groundwater levels in piezometers that were observed at or just above ground surface. An upward gradient was not observed, as the groundwater level in the intermediate piezometer was below the adjacent groundwater level in the shallow piezometer. This would indicate that the upgradient

groundwater seeps, combined with shallow groundwater flow along the fringe of the wetland are both important in terms of maintaining water levels in the wetland. These observations demonstrated the wetland's dependence on groundwater flow during this monitoring period.

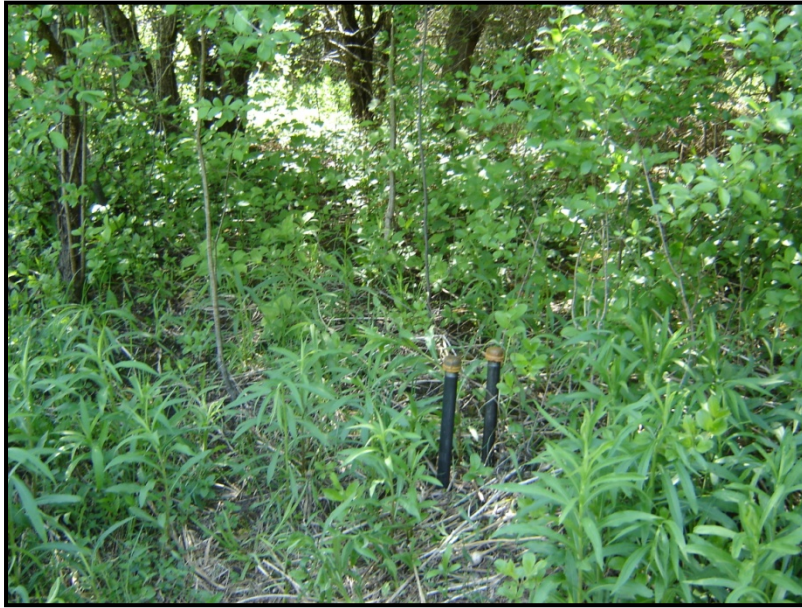
Plate 3: Piezometer Station 3

site (Refer to Plate 3). The locations were selected during a site reconnaissance in early May 2009, when the groundwater seeps were visible and the area upgradient of the wetland was saturated.

The third pair of shallow piezometers located along the southern edge of the site, just west of the Clyde Creek culvert under the railway, indicated groundwater was at a depth of 1.2 m on 13 May, but declined below the intermediate piezometer soon after. The shallow piezometer was dry on each occasion. The monitoring confirmed there was no shallow groundwater discharge at this location on these occasions. It is however possible that groundwater is discharging directly to Clyde Creek in this area.
