Clair-Maltby

Comprehensive Environmental Impact Study (CEIS)
Phase 1 and 2 Characterization Report

September 26, 2018

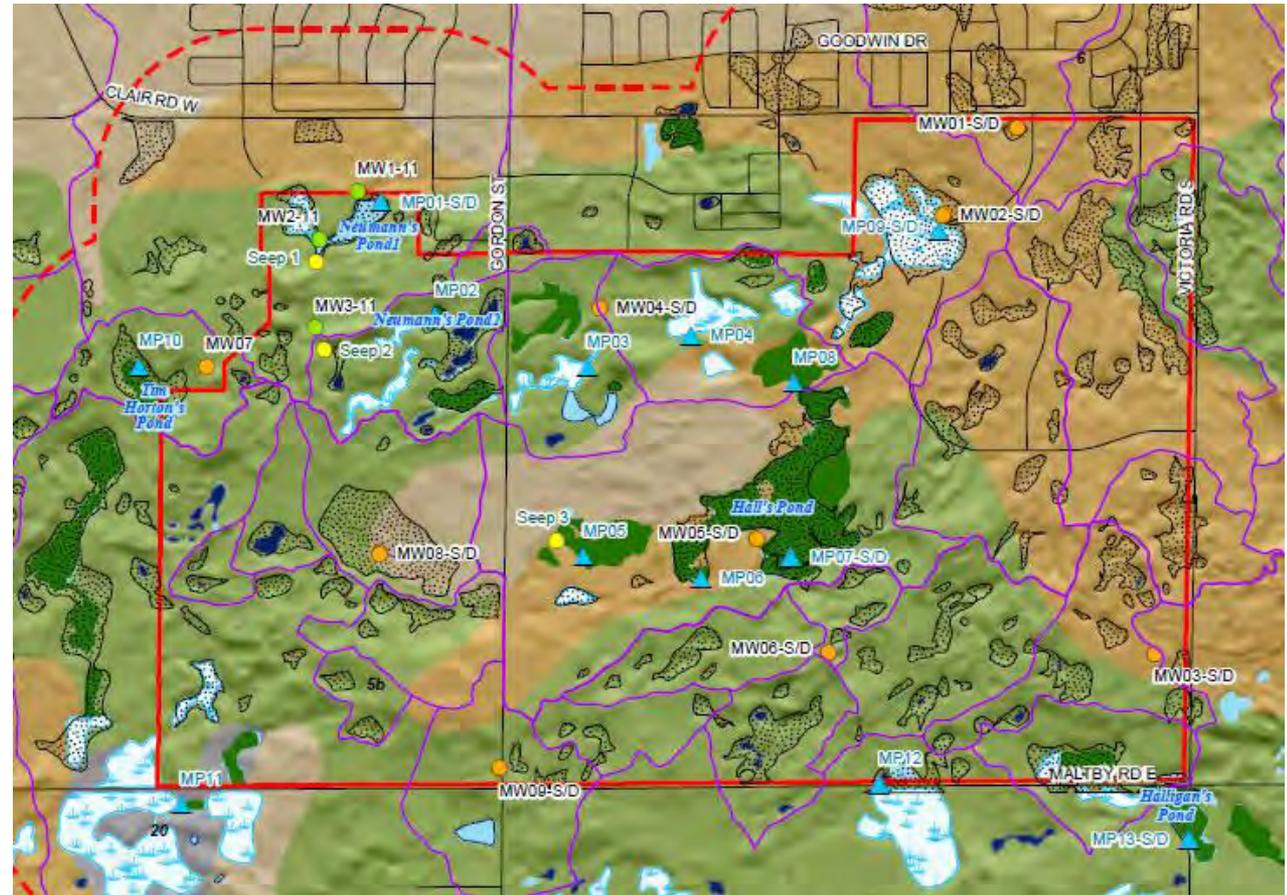
4. CEIS Phase 1/2 Characterization Report: Hydrogeology: Project Specific Field Work

17 boreholes/wells
(9 locations)

18 drivepoint wells
(14 locations)

Groundwater levels
(continuous/manual)

Water quality
(3 events)

Baseflow
(27 locations)

Seeps and springs

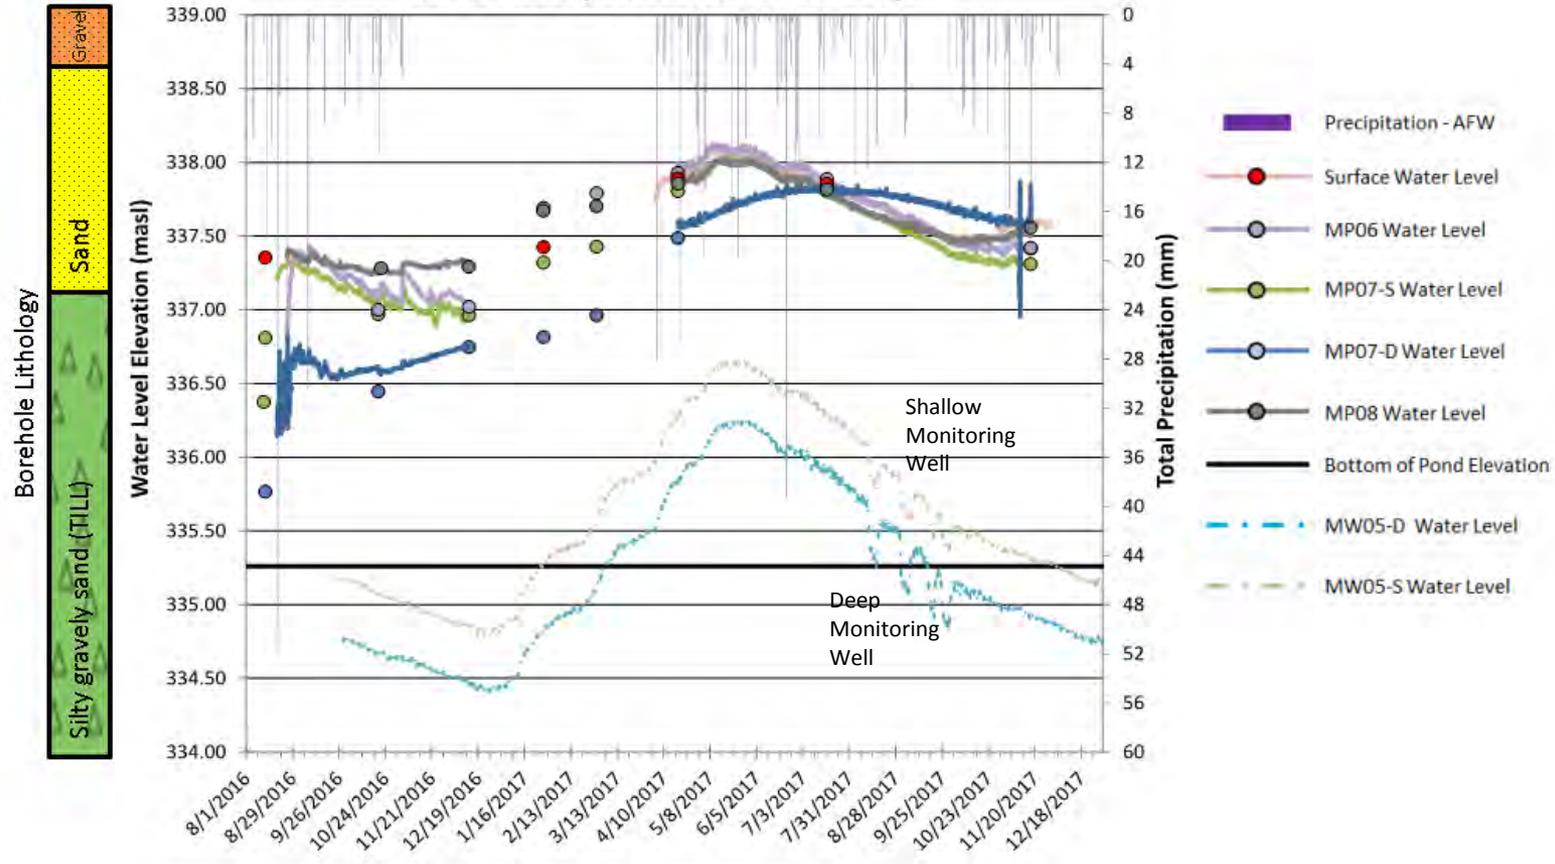
**Clair-Maltby Secondary Plan
Long Term Water Level Monitoring
Hall's Pond (Stations Combined)**

Precipitation - AFW: Data set from rain gauge installed by AMEC Foster-Wheeler at 500 Maltby Rd. E.

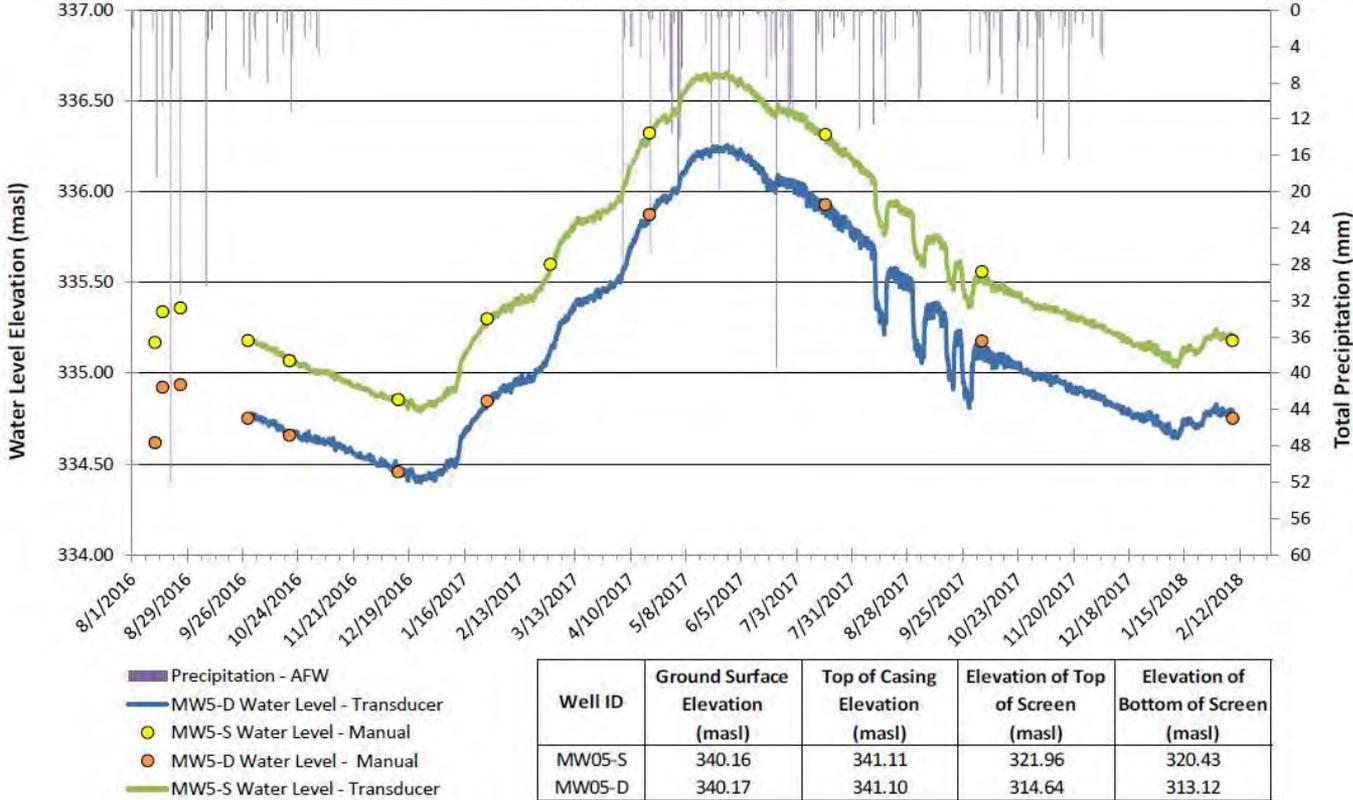
**Clair-Maltby Secondary Plan
Long Term Groundwater Level Monitoring
MW5-D & MW5-S**

Precipitation - AFW: Data set from rain gauge installed by AMEC Foster-Wheeler at 500 Maltby Rd. E.

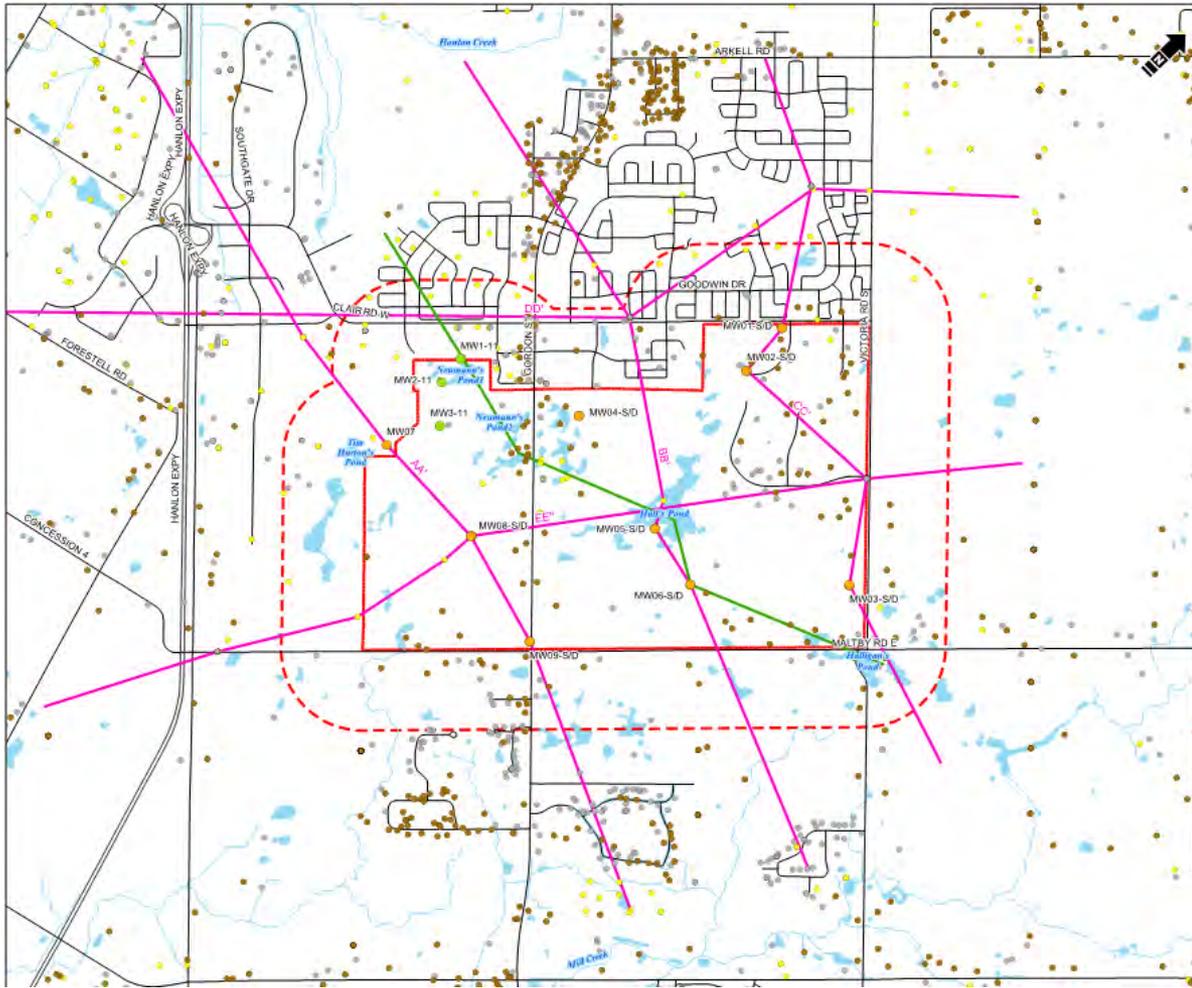
All Available Borehole Information

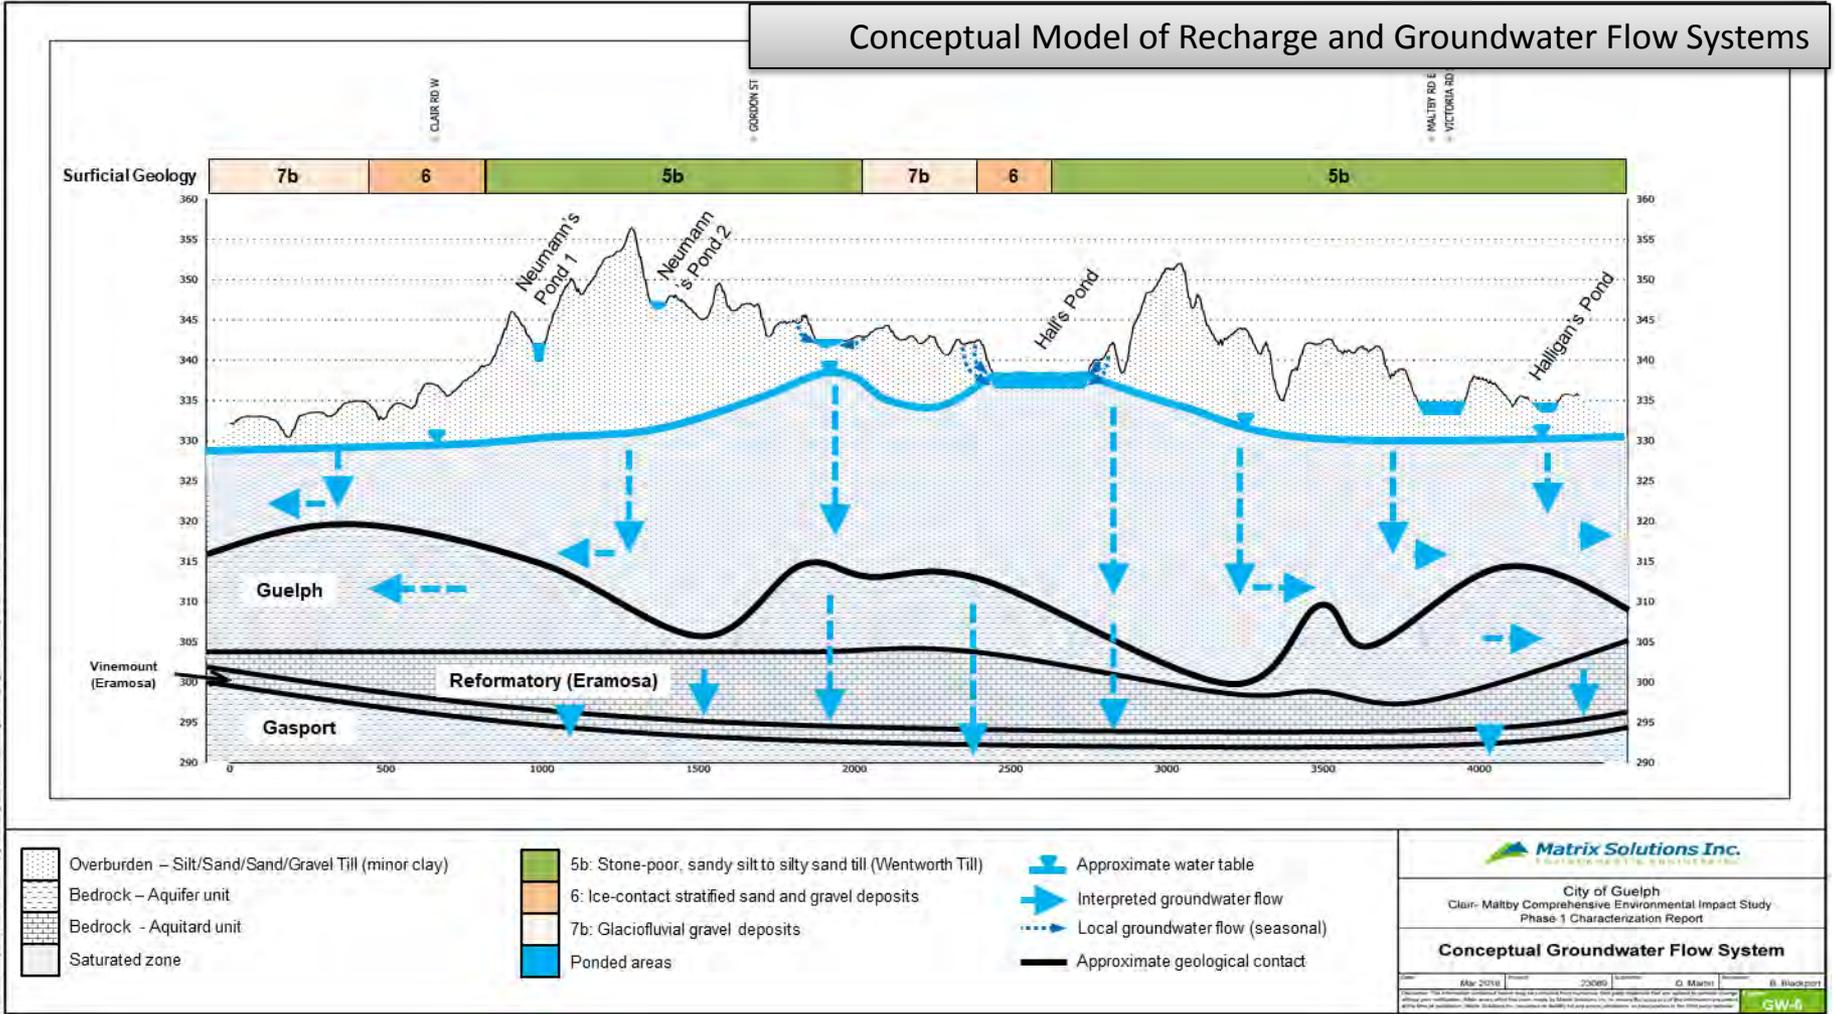
Conceptual Model of Recharge and Groundwater Flow Systems

- Conceptual Model provides functional context and linkages between surface water, groundwater and NHS
 - Key Characteristics
 - Thick unsaturated zone away from wetlands
 - Moderate to High Permeability
 - Moderate to High Infiltration Capacity
 - Key Functions
 - Groundwater discharge to creeks (regionally)
 - Wetland recharge to groundwater system
 - Recharge to bedrock production aquifer

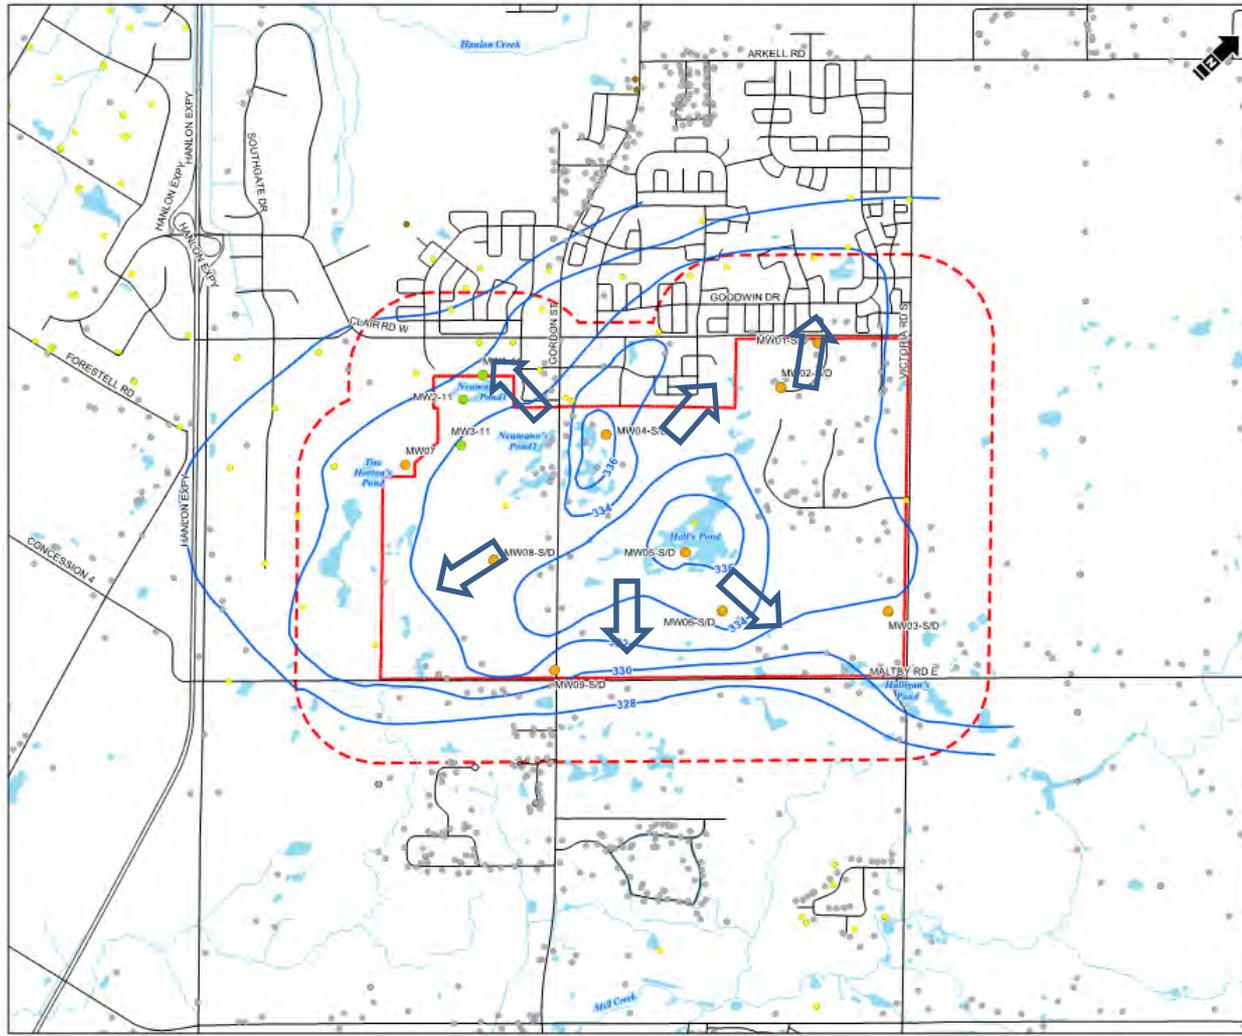
Interpreted Water Table and Generalized Groundwater Flow Directions

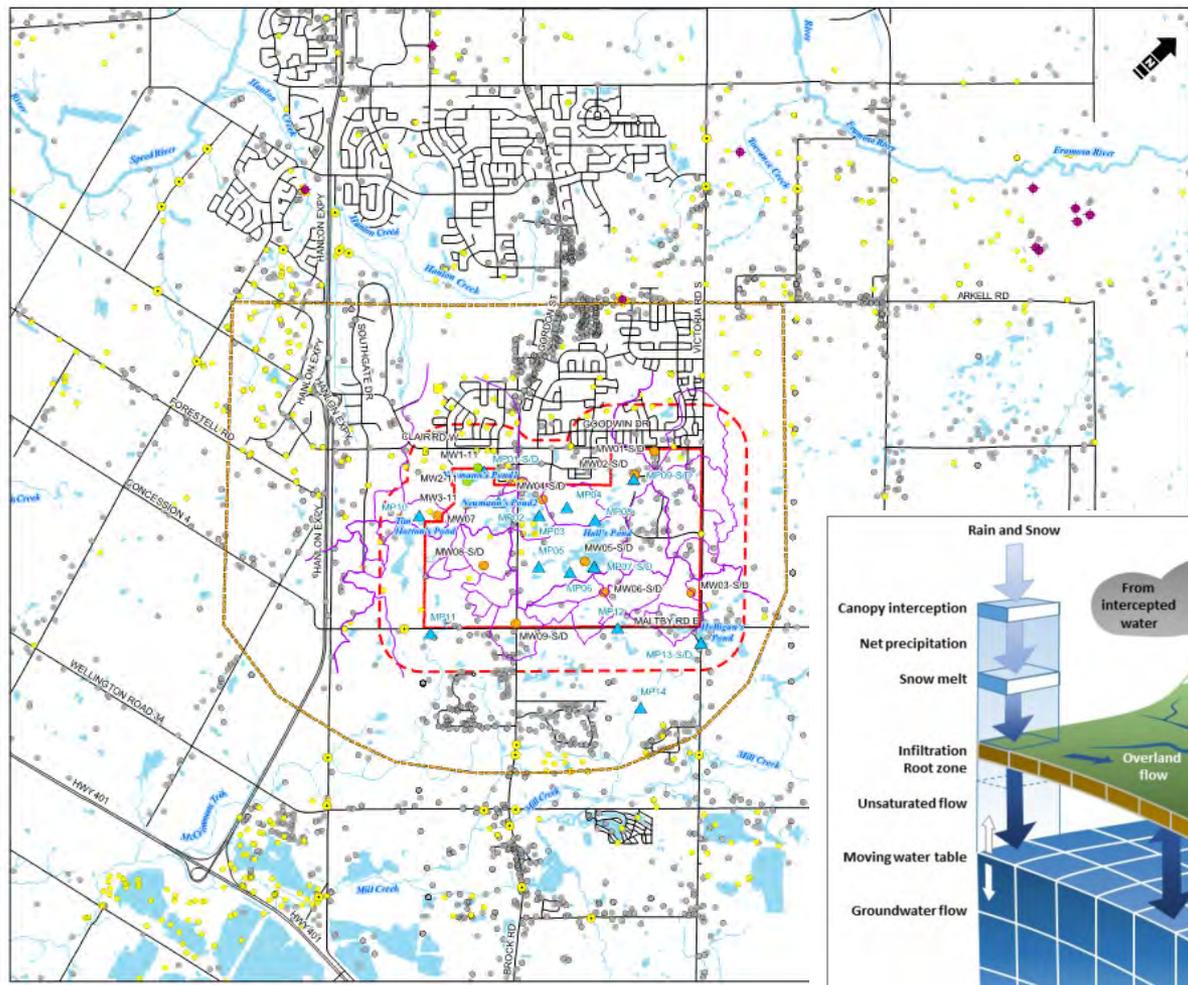
Integrated Surface Water-Groundwater Model Domain

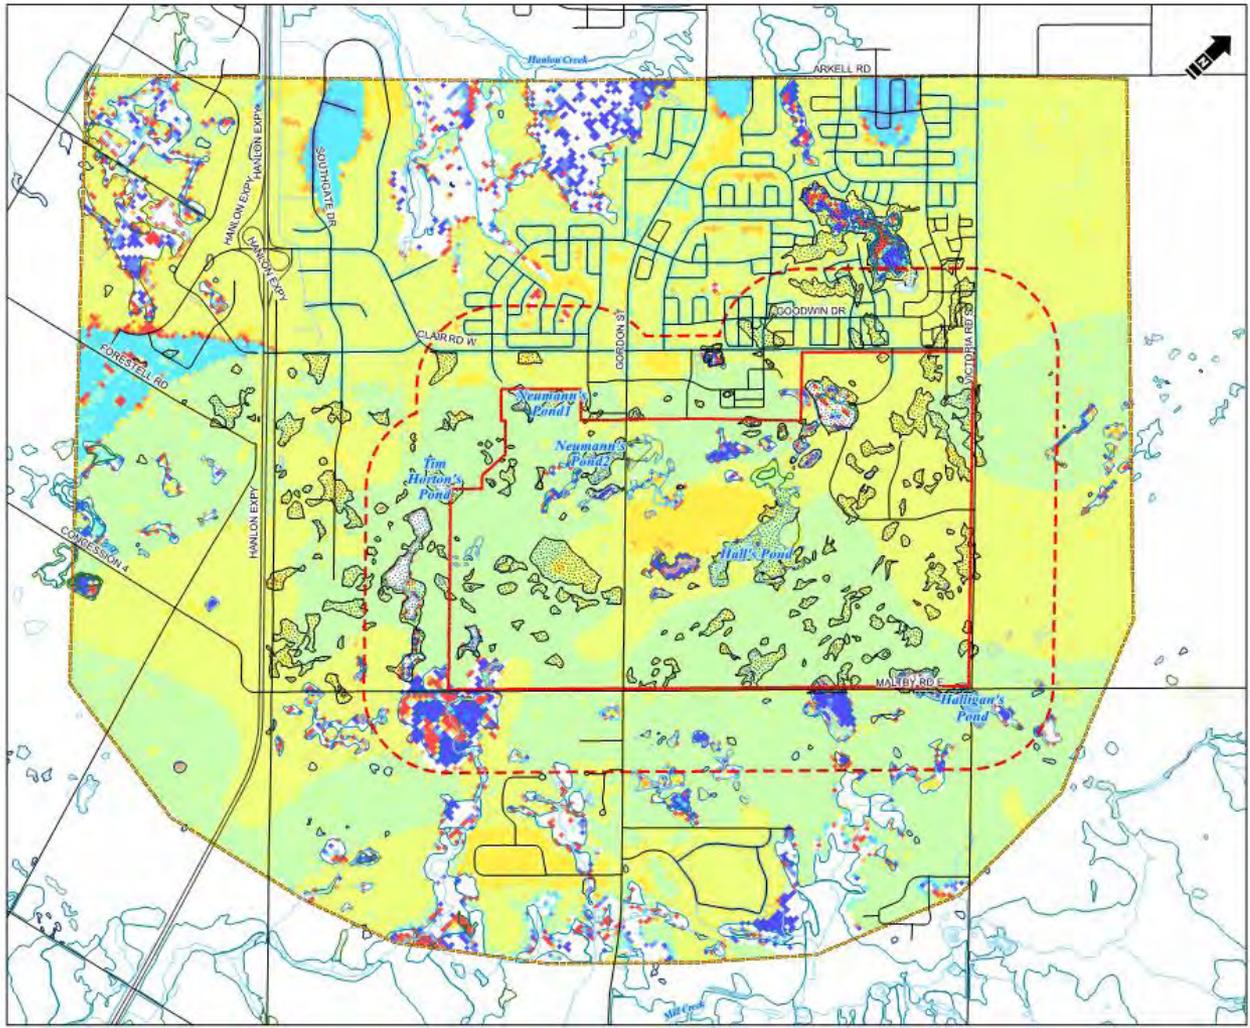
Simulated Average Annual Recharge

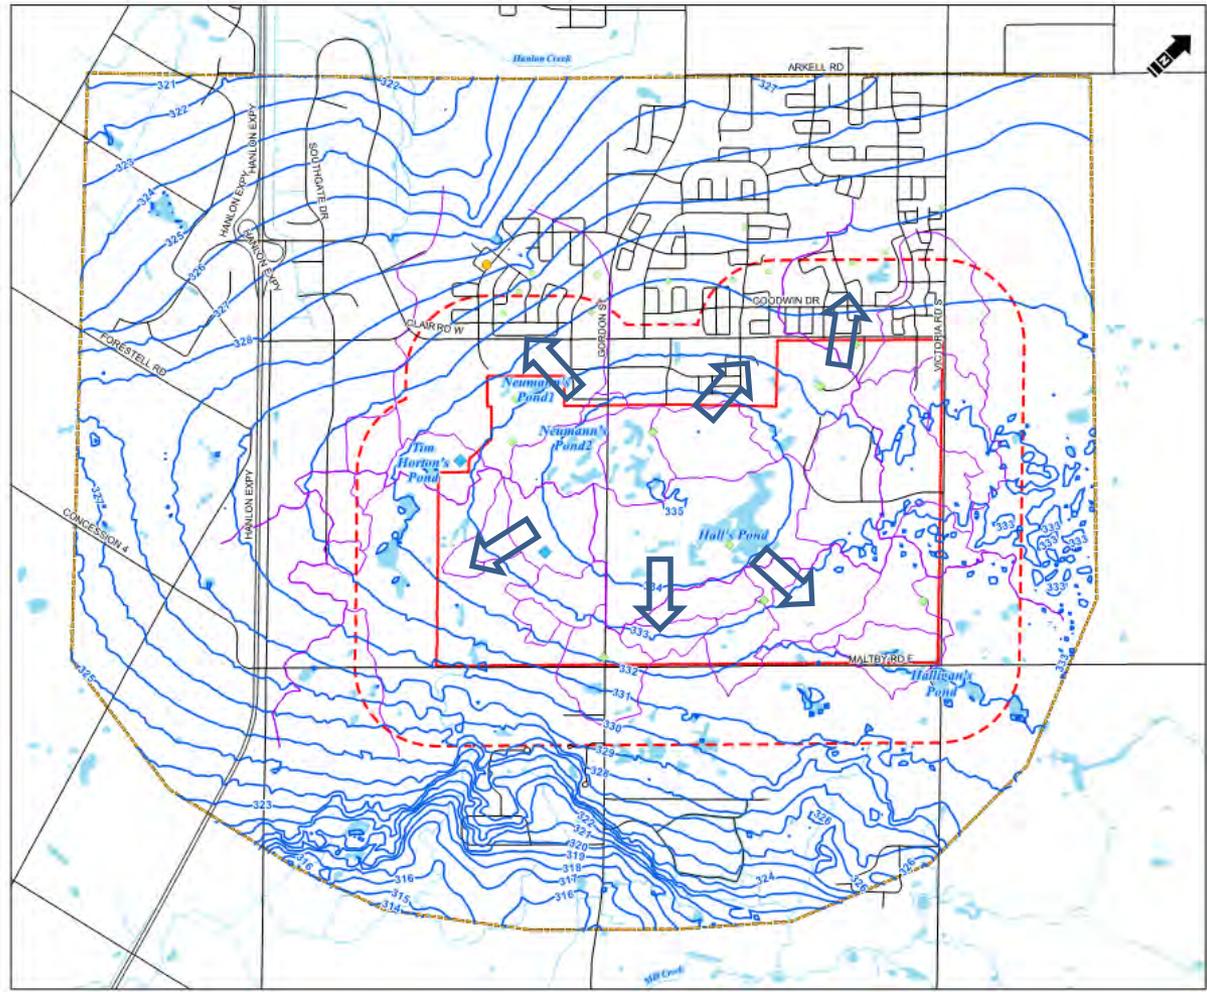
Simulated Water Table & General
Flow Directions

↘
General simulated
groundwater flow
direction

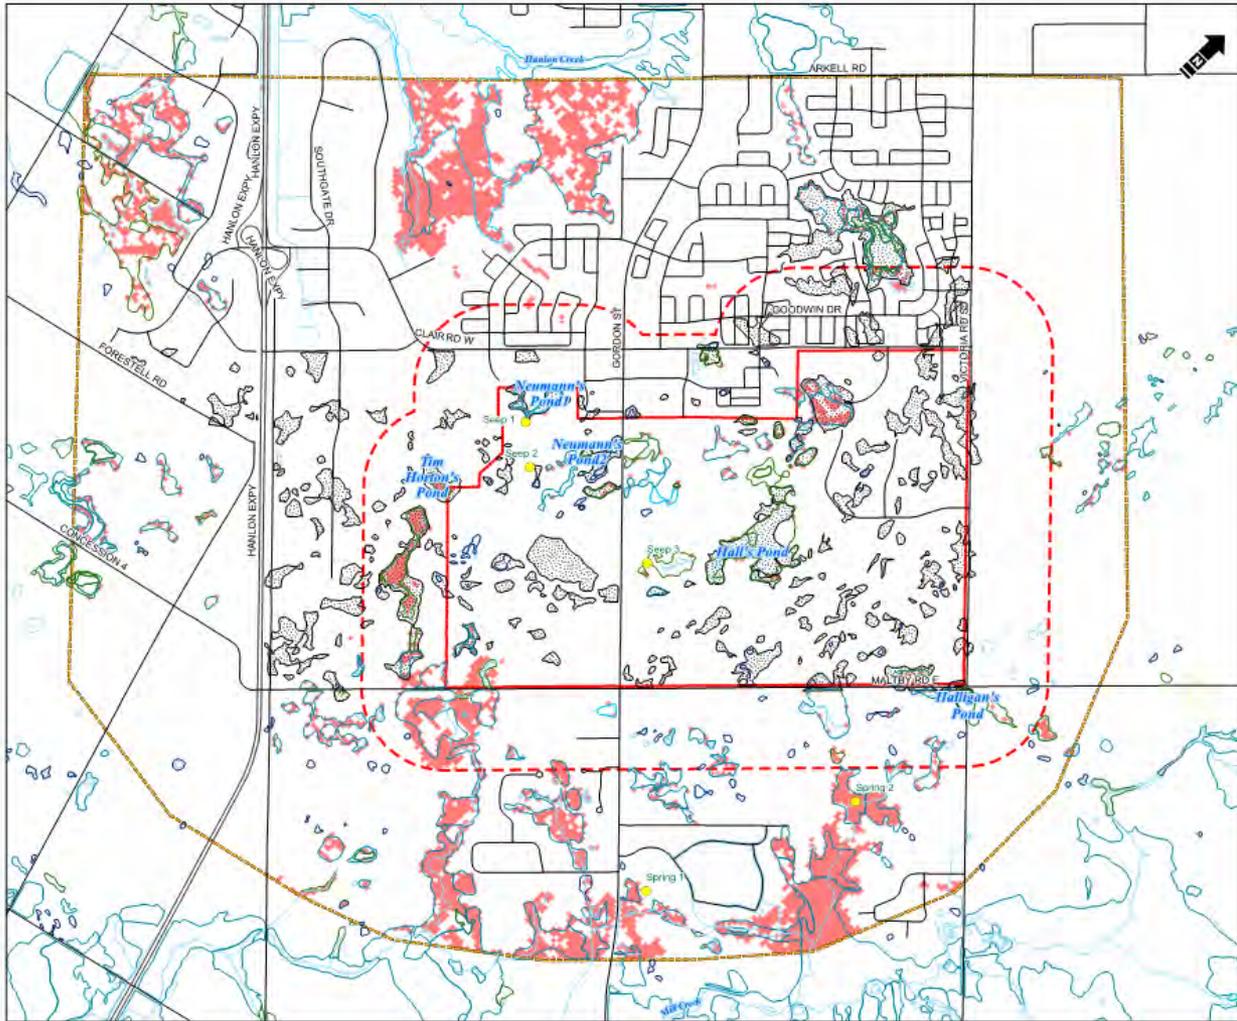
Simulated Average Annual Discharge to Surface Water

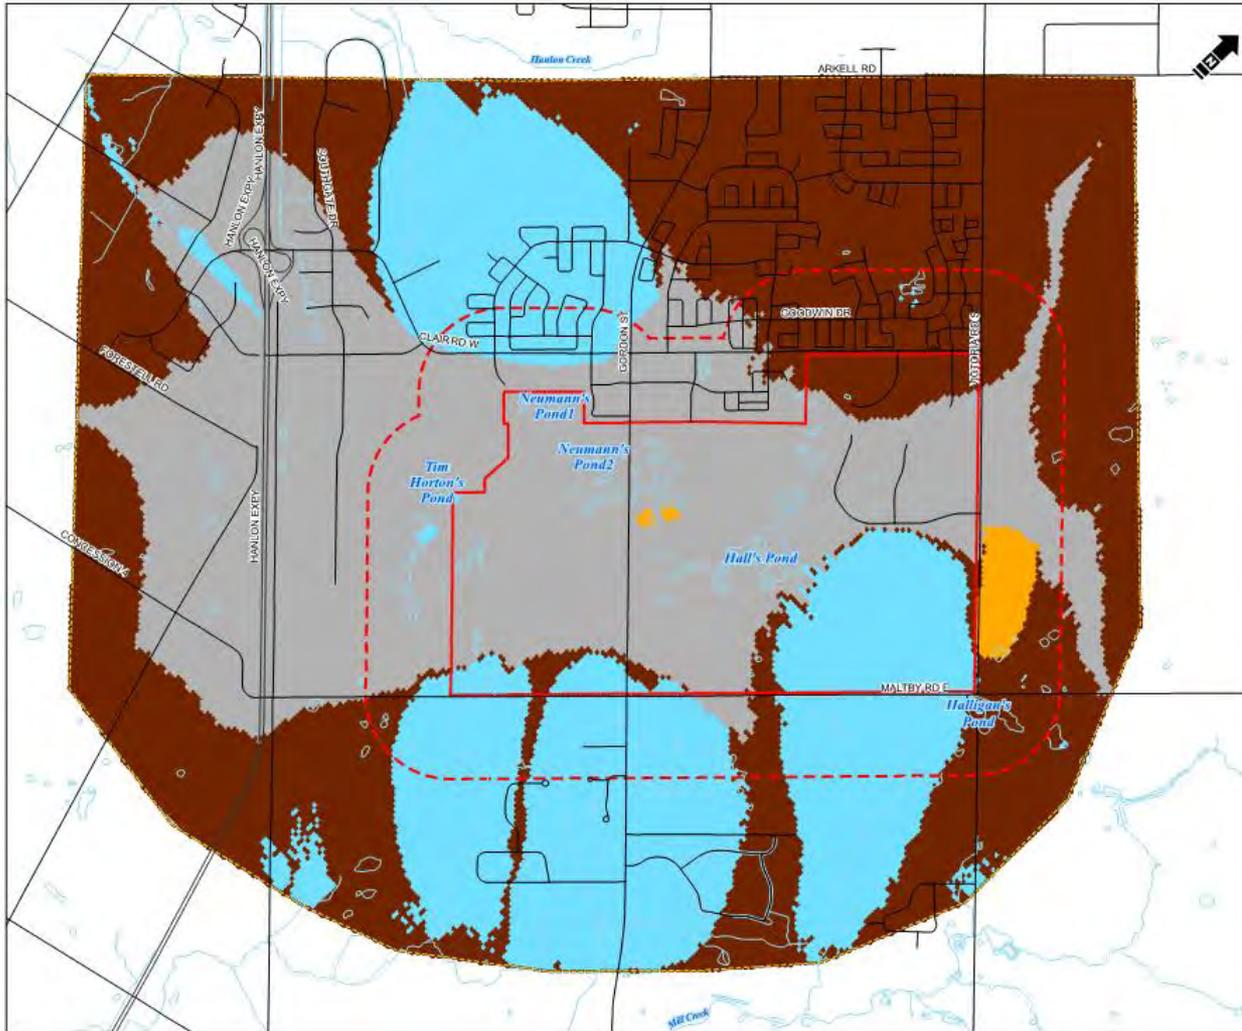
Simulated Recharge – Discharge
Linkage – Where does recharge go?

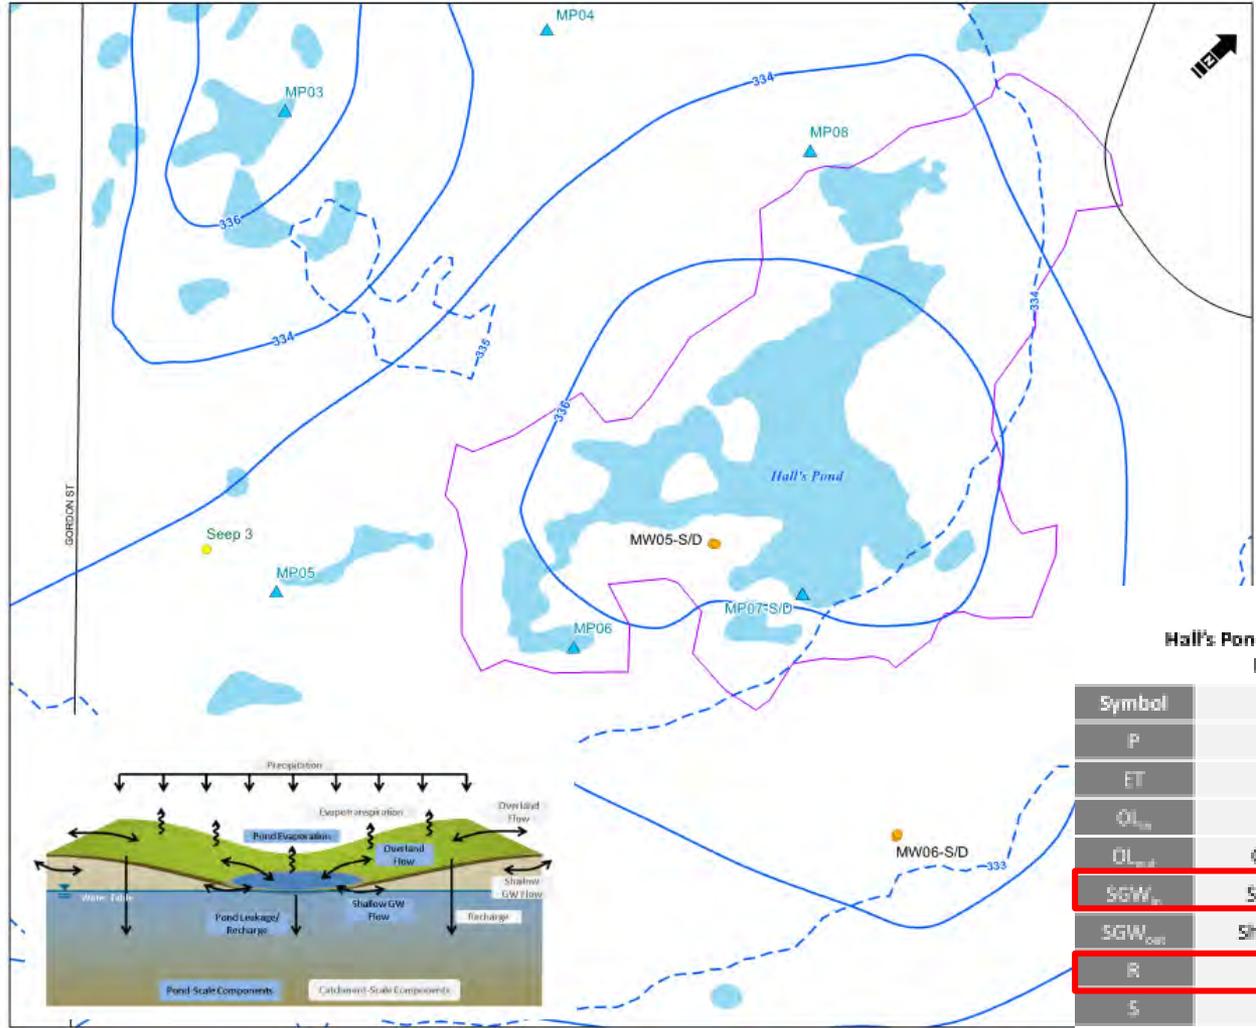
Hall's Pond Water Balance

Hall's Pond Average Annual Simulated Water Balance (2003-2017)
 $P - ET + (OL_{in} - OL_{out}) + (SGW_{in} - SGW_{out}) - R = S$

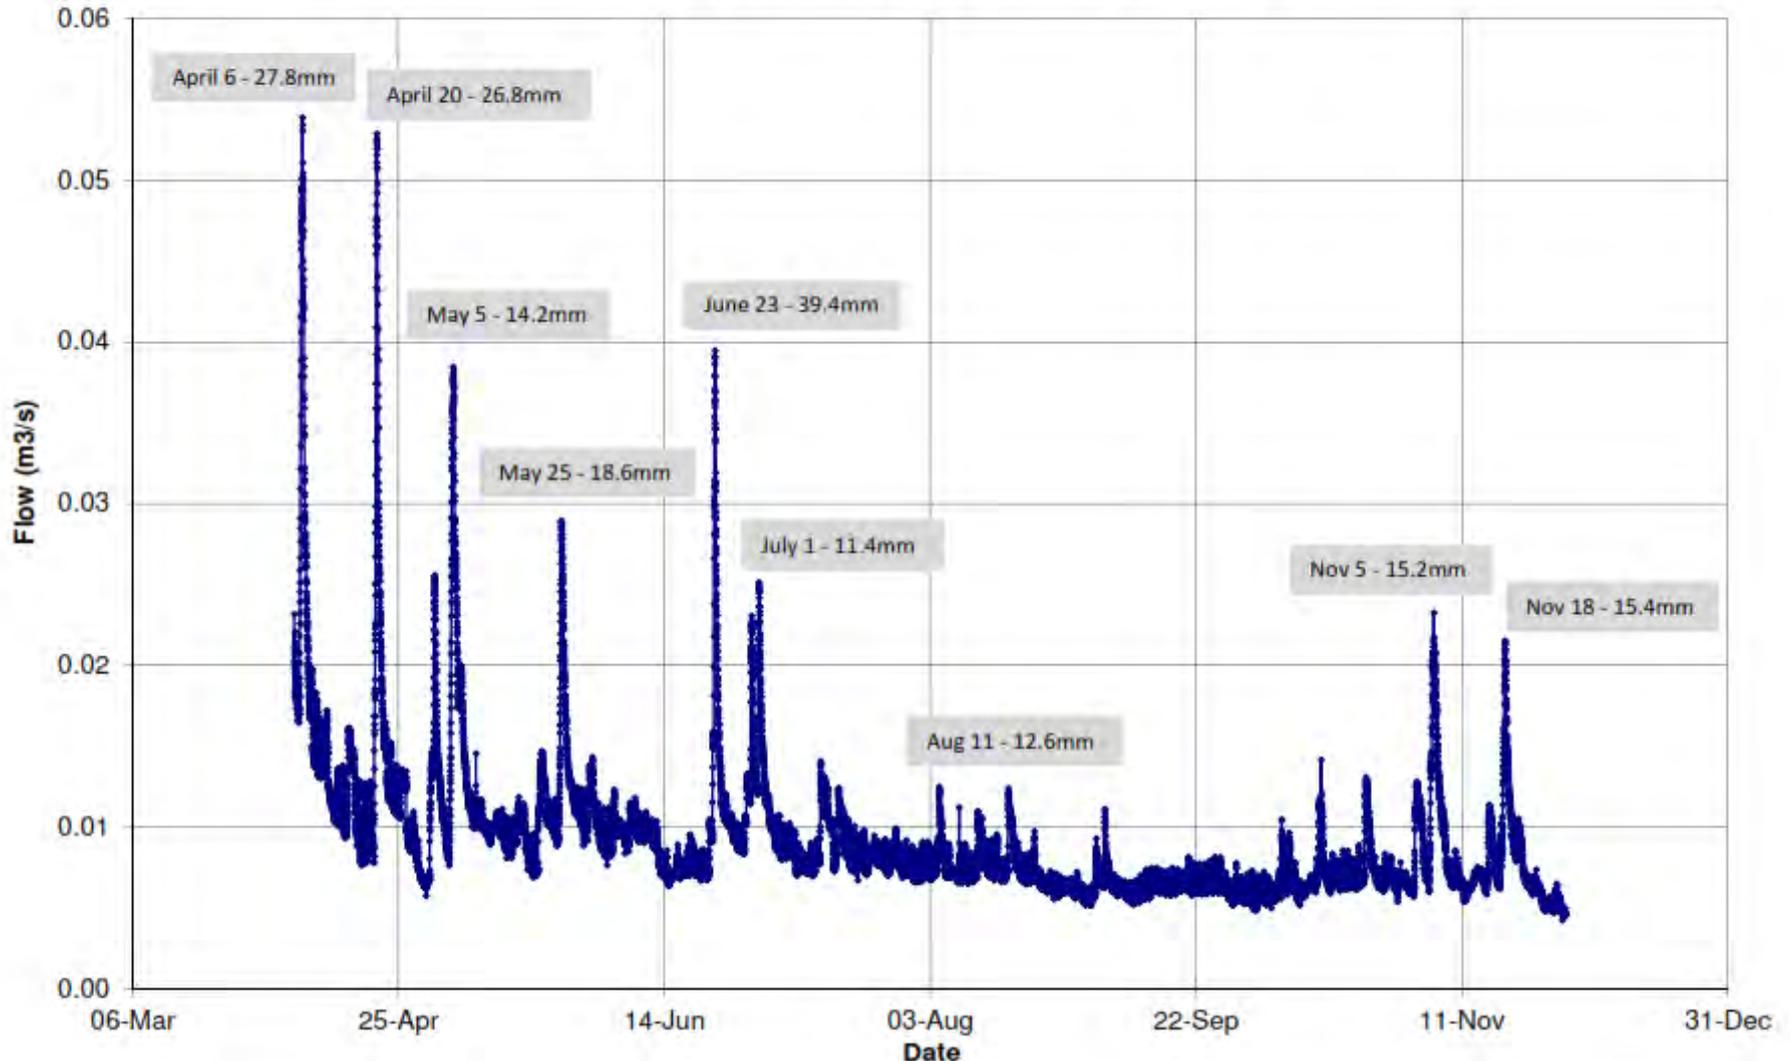
Station 14 (Hammersley) Estimated Flows for 2017

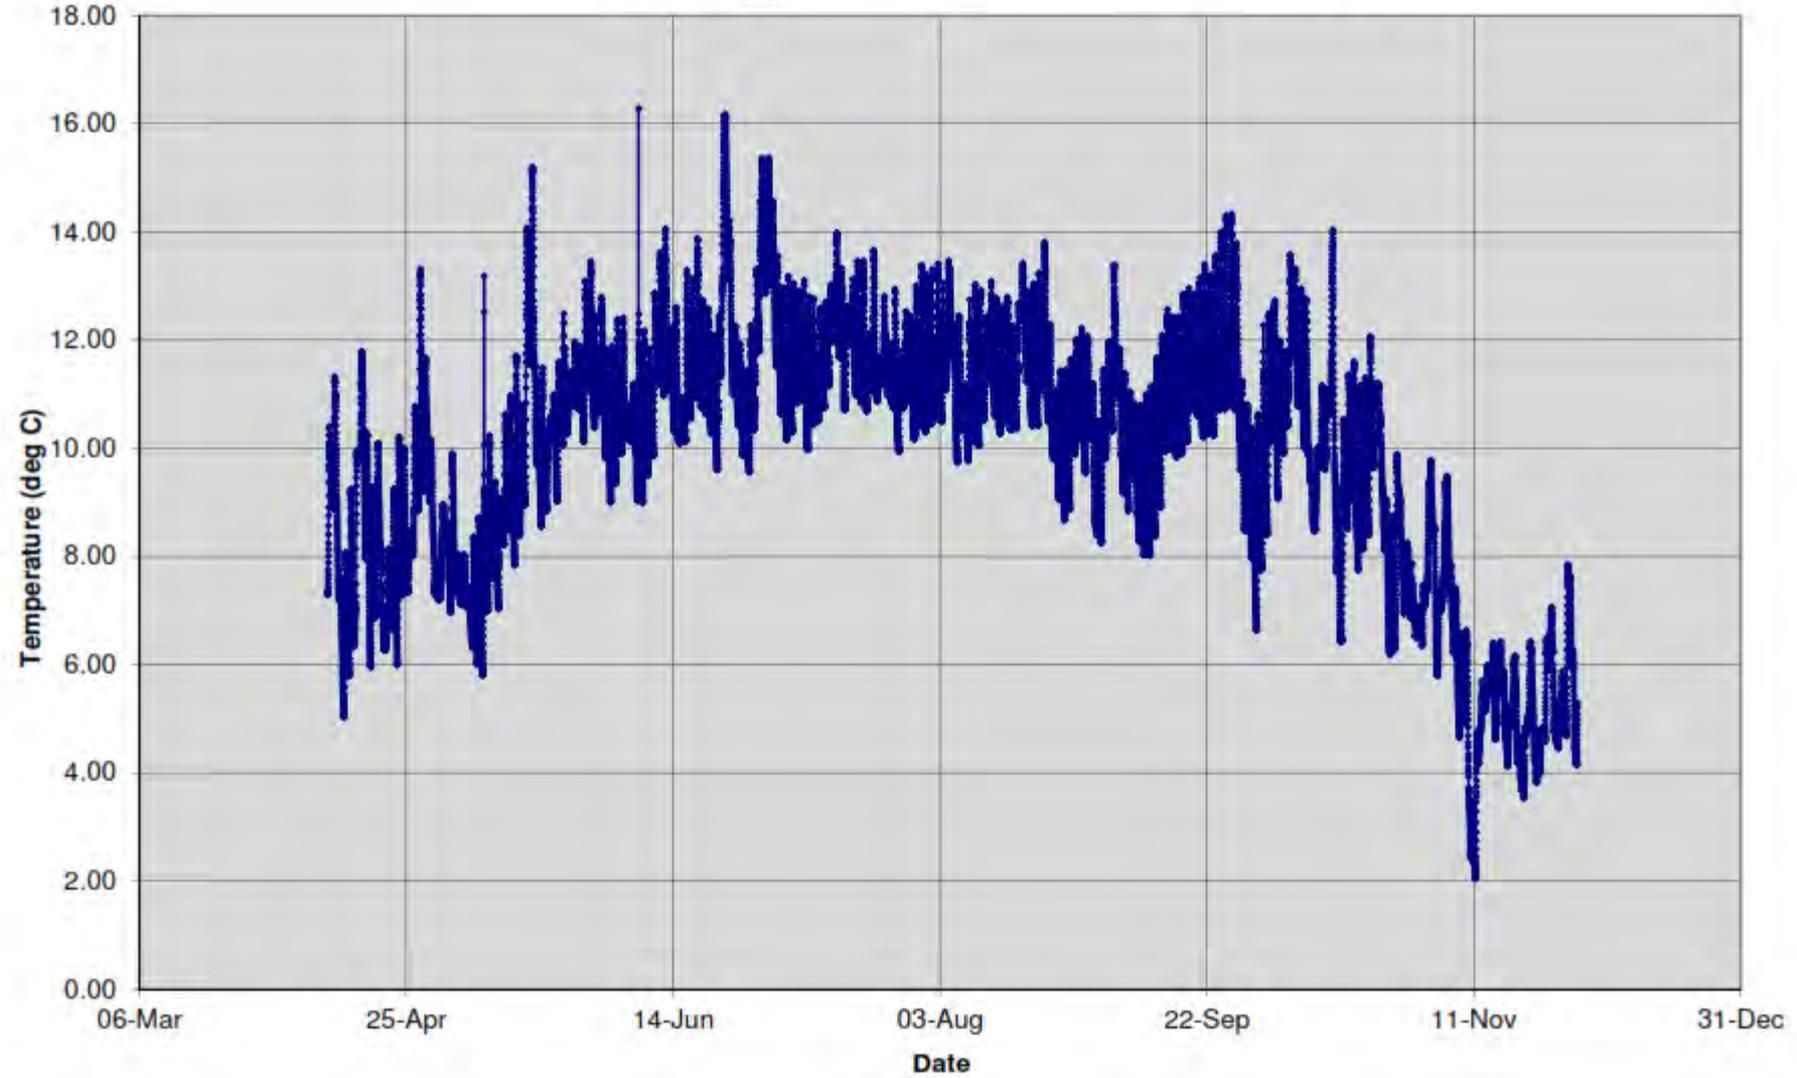
Station 14 (Hammersley) Recorded Temperature for 2017

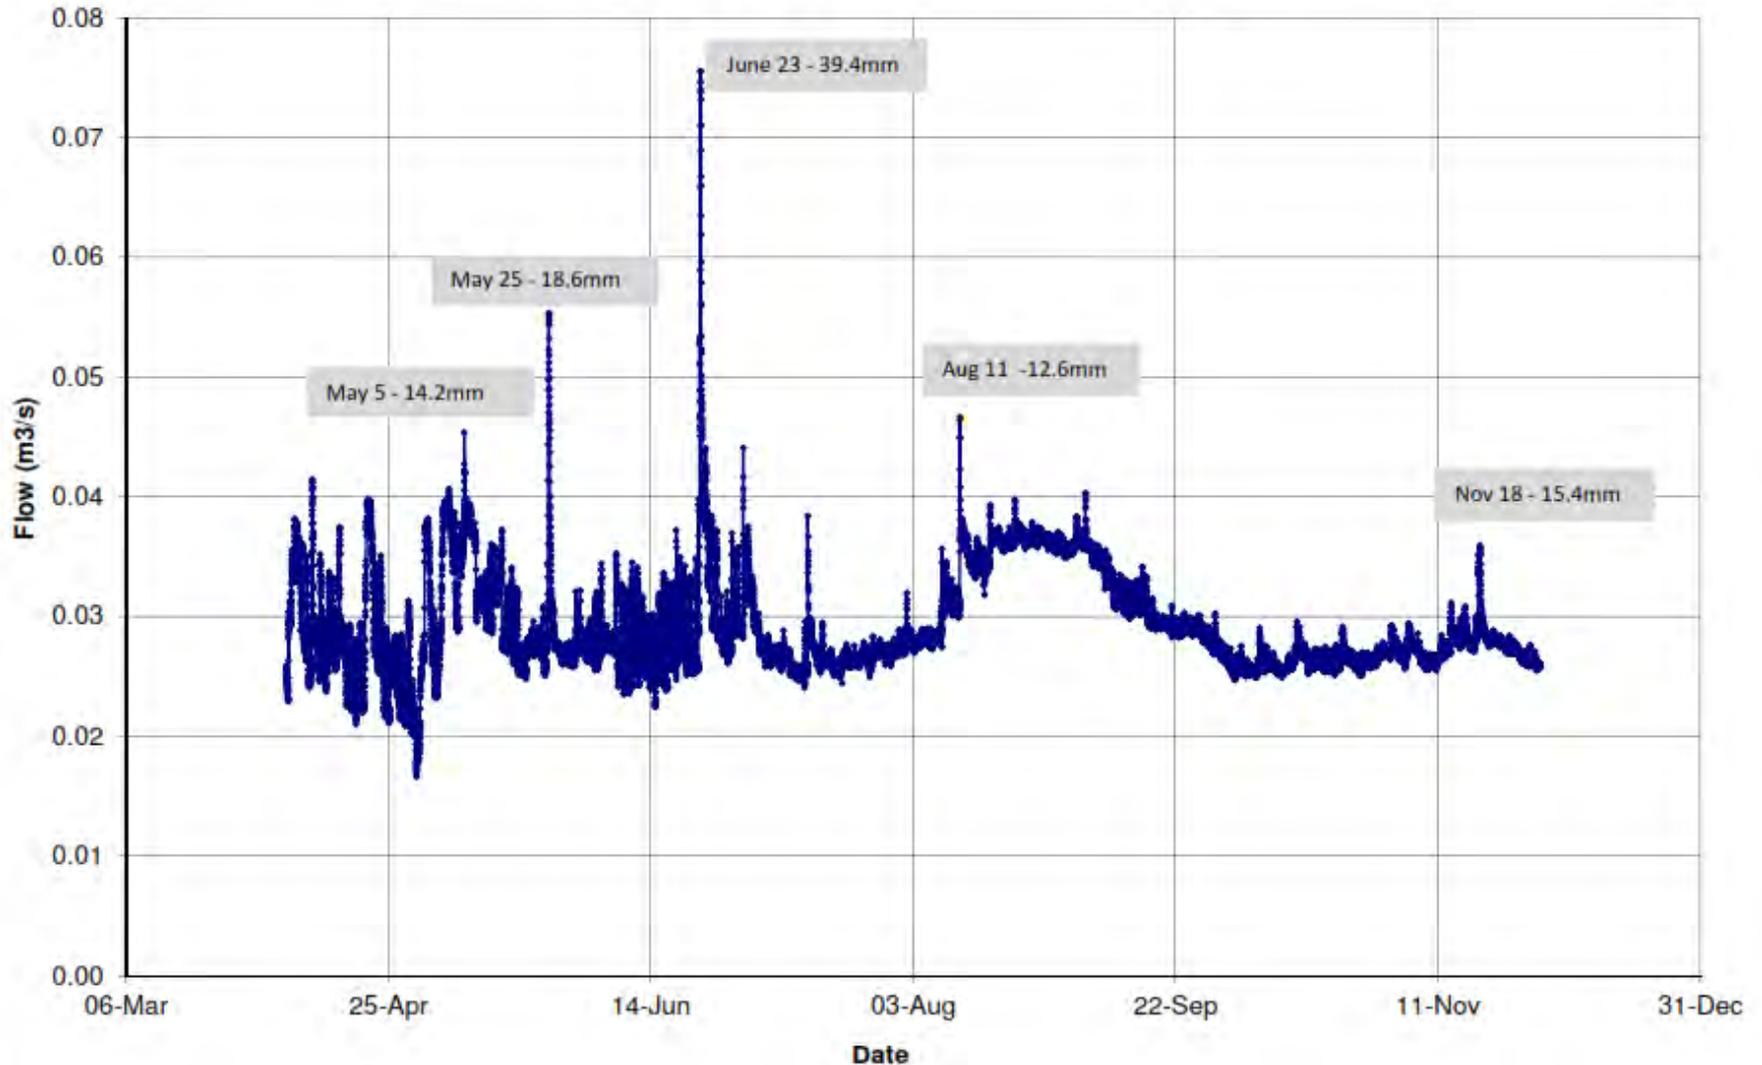
Station 15 (Hanlon) Estimated Flows for 2017
