Clair-Maltby

Comprehensive Environmental Impact Study (CEIS)
Phase 1 and 2 Characterization Report

September 26, 2018

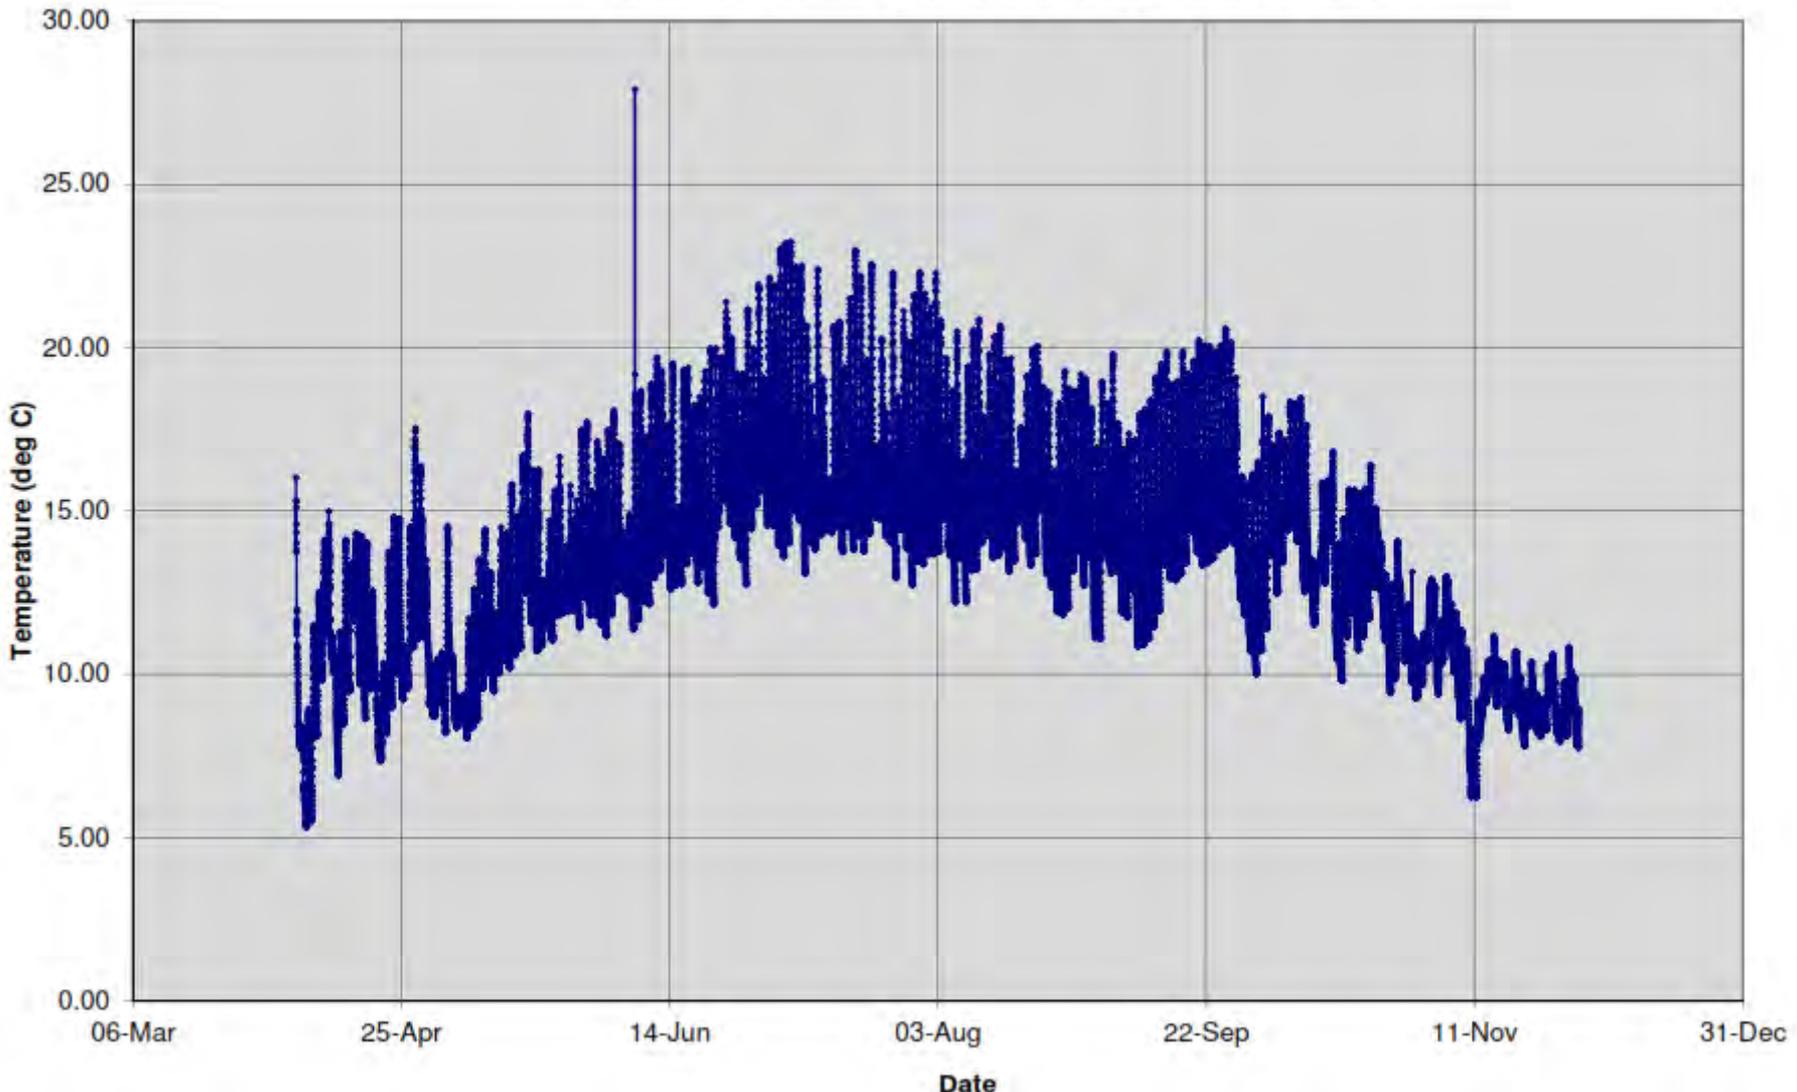
Station 15 (Hanlon) Recorded Temperature for 2017

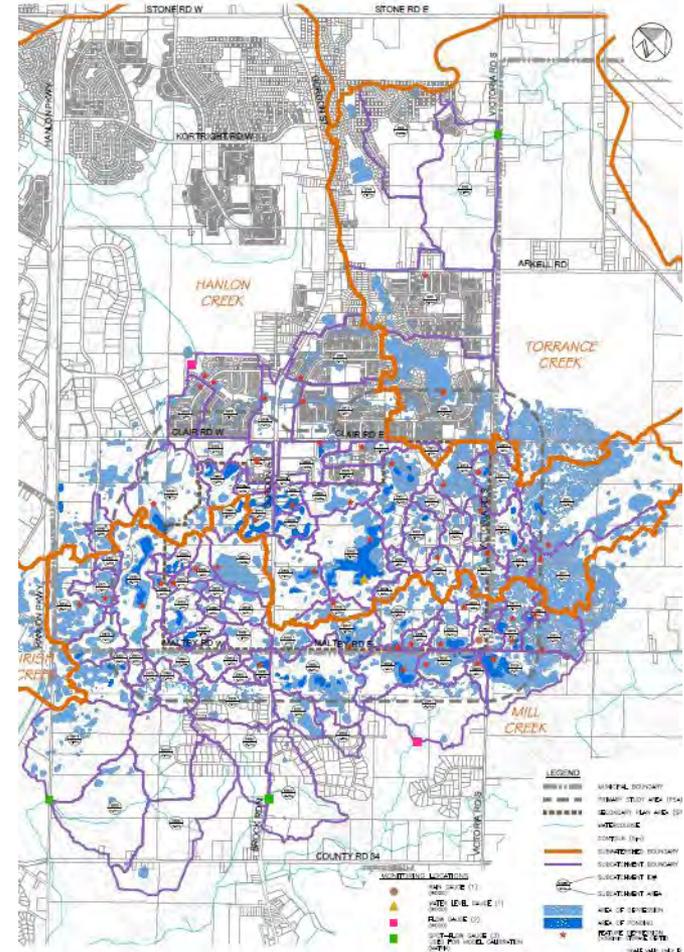
- PCSWMM hydrologic model built on 2012 digital elevation model
- Subcatchments developed to Hanlon Creek, Mill Creek and Torrance Creek to the monitoring locations
- Depressional features (<300mm capture) incorporated into subcatchment depression storage; (>300 mm capture) used storage elements with overflow.
- Model validation to the 2016 to 2017 monitoring period results, requiring changes to baseflow, impervious coverages and increased infiltration in greenways

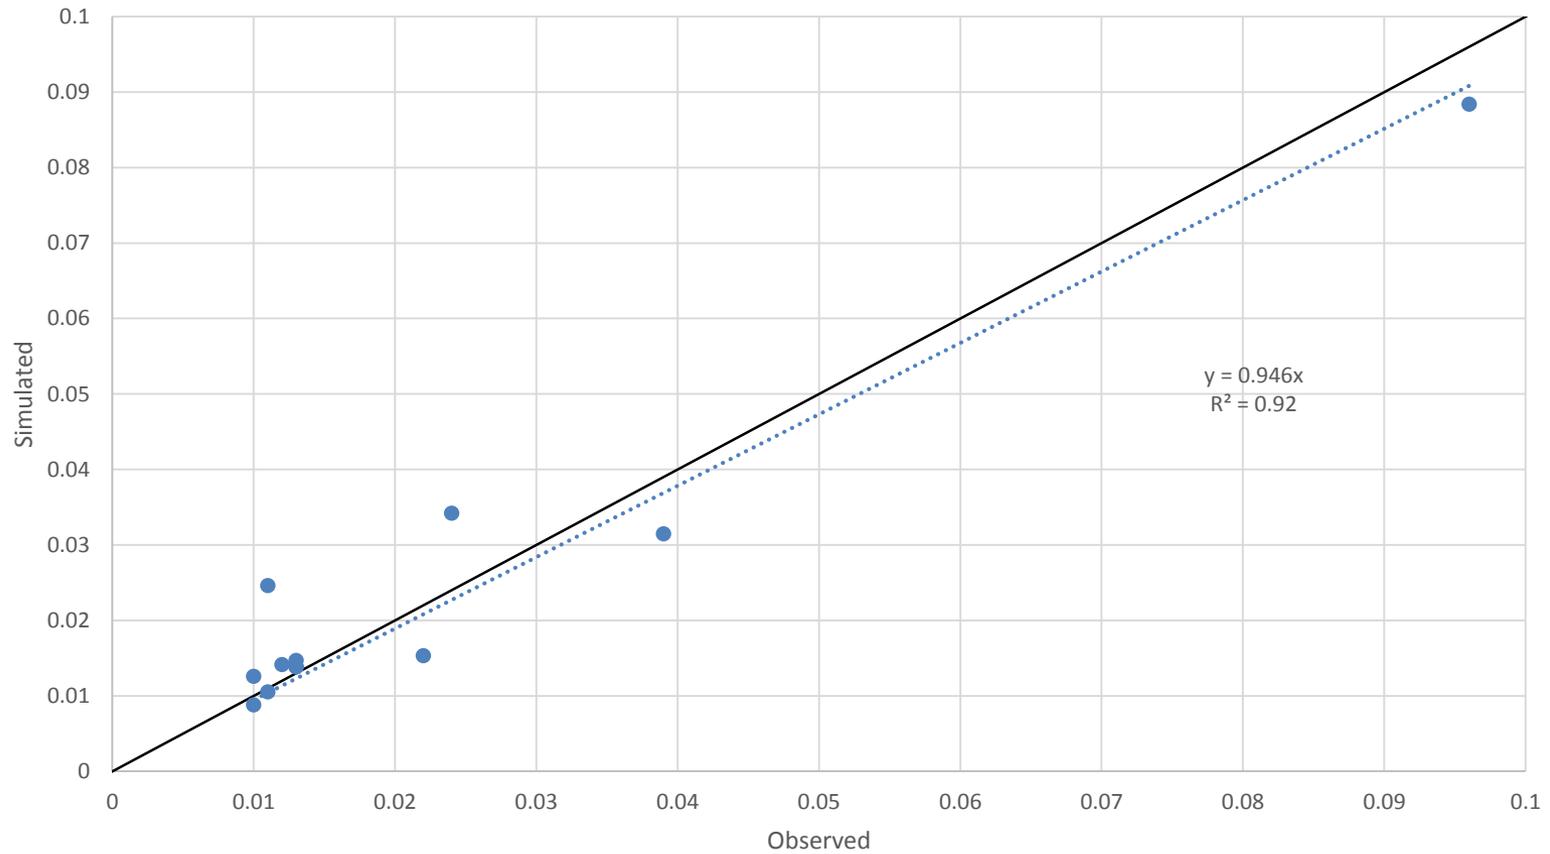
Hamersley Road Gauge - Maximum Flow (m³/s)

- Validated PCSWMM hydrologic model used to determine:
 - Design and frequency peak flows and water balance (surface based)
 - 100 Year frequency flows 1.55 m³/s and 0.48 m³/s for Hanlon Creek and Mill Creek monitoring sites (flows are extremely low)
 - Flows within Hanlon and Mill Creek are low, but have baseflow from contributing groundwater discharge
 - 93% to 97% precipitation either infiltrates or evaporates
 - 95% +/- infiltration within depressional features
 - Only 7 out of 47 significant depressional features (>300 mm capture) exhibited a discharge over 67 years of simulation period

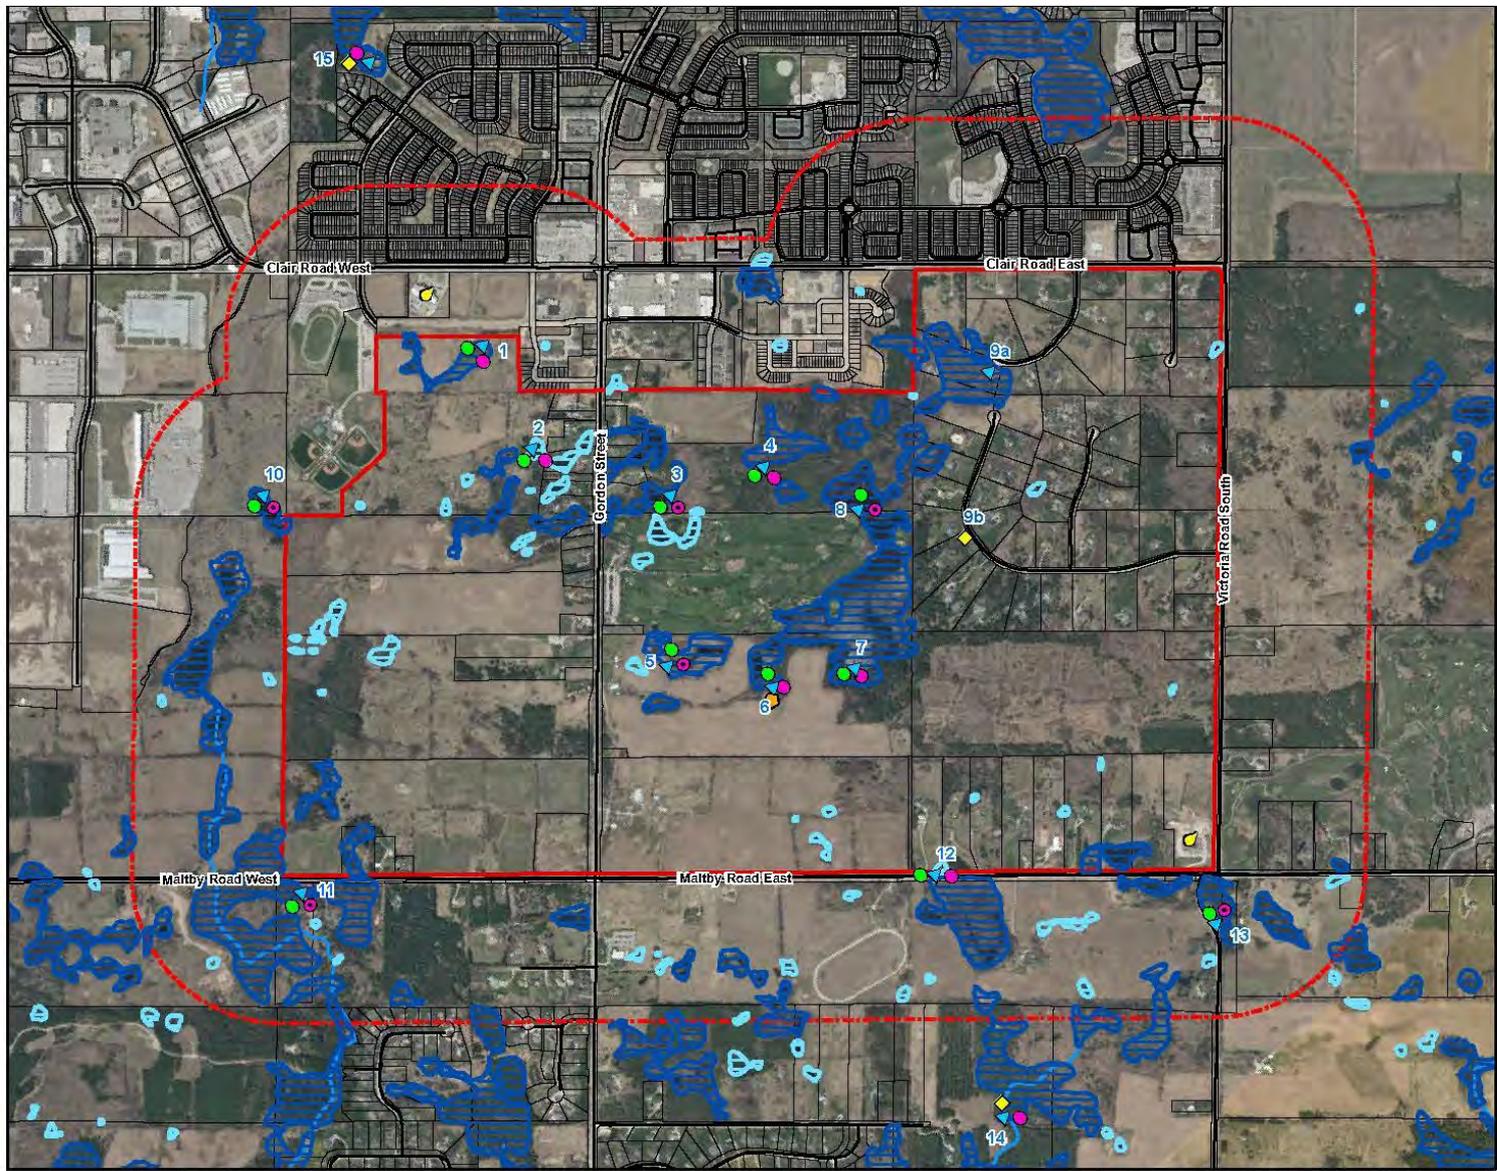
Map SW-1

Surface Water Monitoring Locations

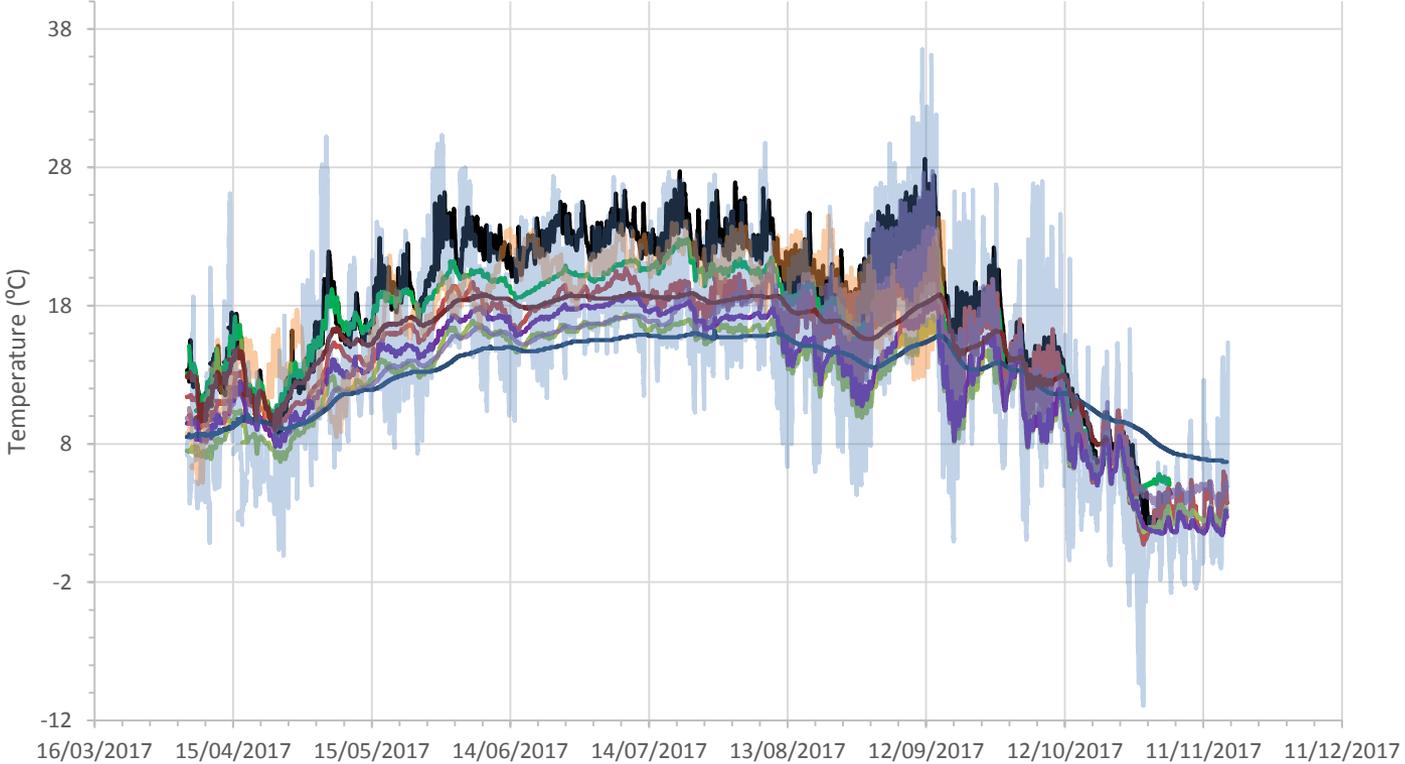
Wetland Station Surface Water Temperatures - Hanlon Creek SWS

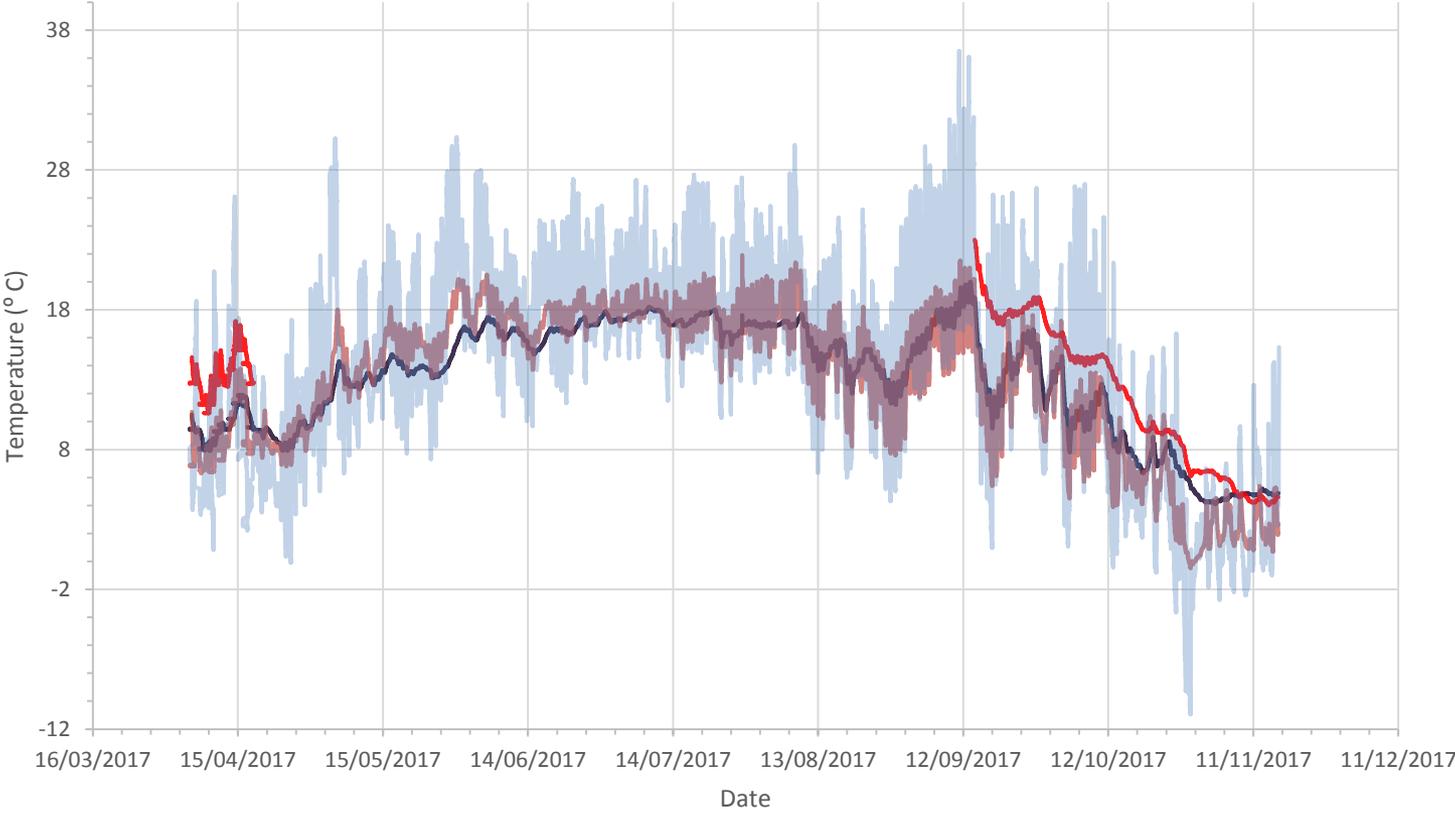
Wetland Station Surface Water Temperatures - Mill Creek SWS

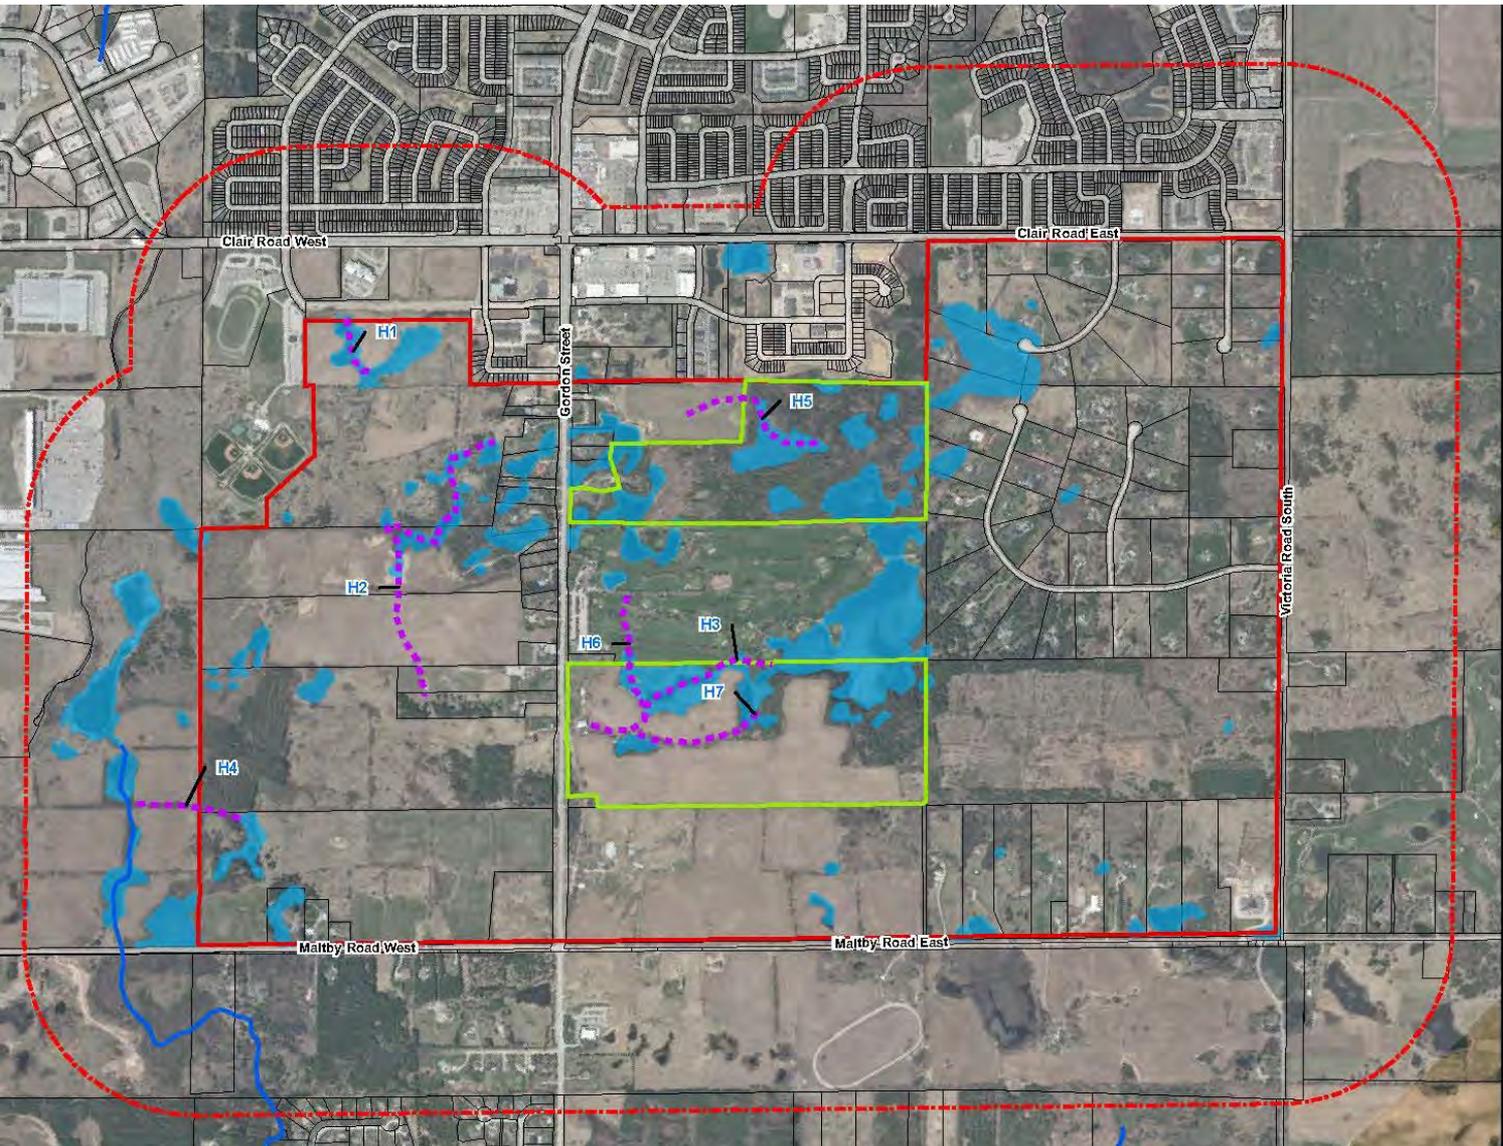
Map NH-4A

Scoped Headwater Drainage Feature Assessment (Potential HDFs)

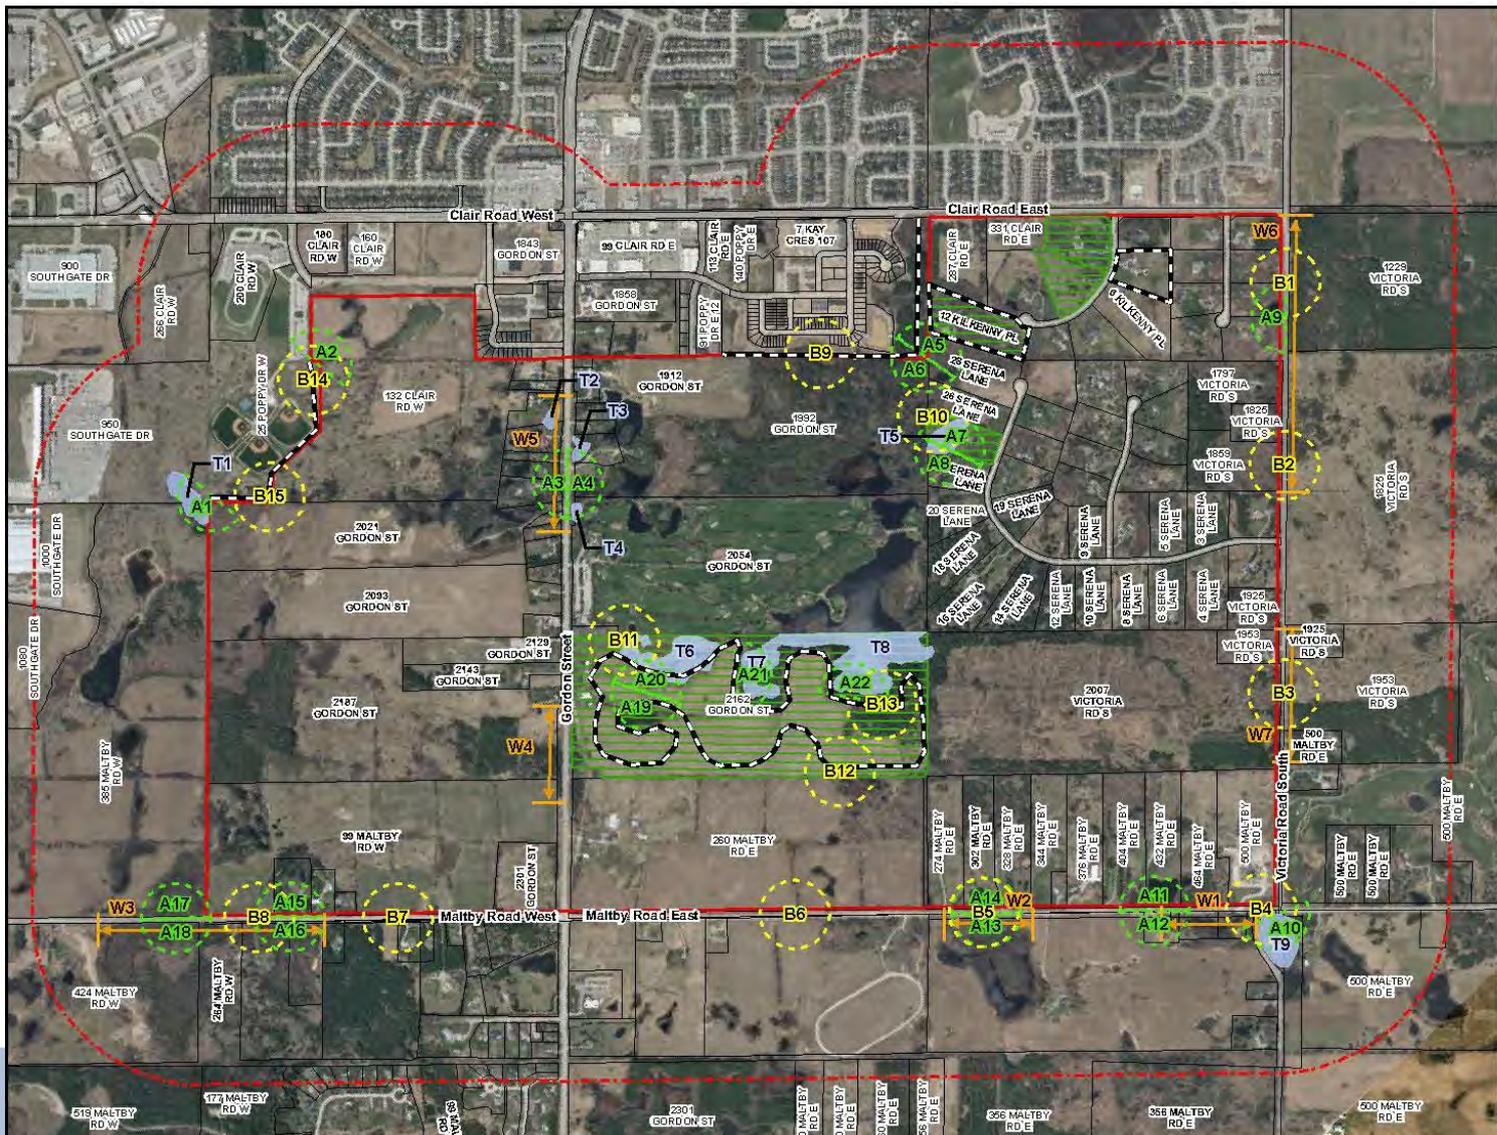
Terrestrial Monitoring Locations	
Map NH-2	
Clair-Malby Secondary Plan 2017 Monitoring Report	
Legend	
	Secondary Plan Area Boundary
	Primary Study Area Boundary
	Site Specific Vegetation Assessments
	A1 Amphibian Monitoring Stations (22)
	B1 Breeding Bird Stations (15)
	Basking Turtle Monitoring Stations (8)
	Winter Wildlife Transects (5)
	Road Wildlife Transects (7)
<small>Beacon Environmental: Watercourse, Amphibian Monitoring Stations, Breeding Bird Stations, Basking Turtle Monitoring Stations, Winter Wildlife Transects, Wildlife Road Transects, Primary Study Area Boundary, 2016; City of Guelph: Secondary Plan Area Boundary, Parcel Fabric, 2016; Ministry of Natural Resources and Forestry: Wetland, 2016</small>	
Contains information licensed under the Open Government License – Ontario	
First Base Solutions Web Mapping Service 2017	
UTM Zone 17 N, NAD 83	
0 150 300 600 Metres

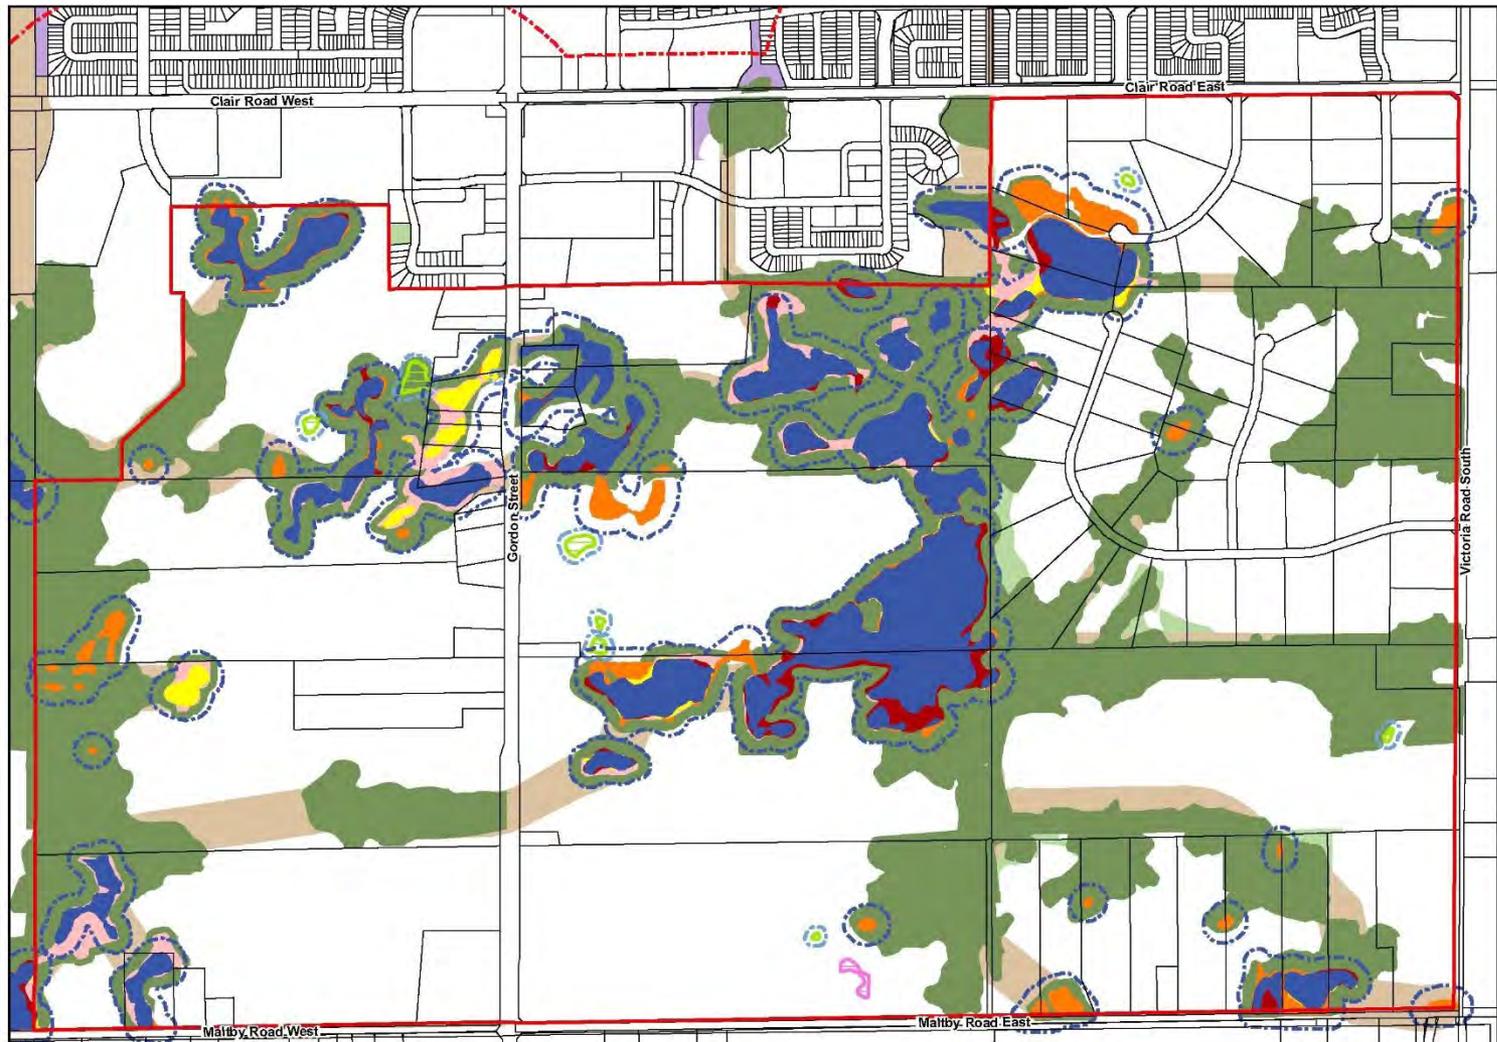
Refinements to City Significant Wetland Mapping	
Map NH-6	
Clair-Maltby Secondary Plan Phase 1 and 2 Characterization Report	
Legend	
<ul style="list-style-type: none"> Primary Plan Area Boundary Secondary Study Area Boundary Parcel Fabric 	
MNR Provincial Wetlands	
<ul style="list-style-type: none"> Proposed MNR Provincial Wetlands to Remain (Beacon, 2018) Proposed Additions to MNR Provincial Wetlands (Beacon, 2018) Proposed Other Wetlands >0.5 ha to MNR Provincial Wetlands (Beacon, 2018) Proposed Removals from MNR Provincial Wetlands (Beacon, 2018) 	
Other Wetlands ≤ 0.5 ha	
<ul style="list-style-type: none"> Proposed Additions from Other Wetlands ≤ 0.5 ha (Beacon, 2018) Proposed Removals from Other Wetlands ≤ 0.5 ha (Beacon, 2018) Proposed Removals from LIO Unevaluated Wetlands ≤ 0.5 ha (Beacon, 2018) 	
Wetland Buffers	
<ul style="list-style-type: none"> MNR Provincial Wetland 30 m Buffer Locally Significant / Other Wetlands 15 m Buffer

1. Consulted with MNRF and GRCA
2. Reviewed MNRF wetland mapping, GRCA wetland mapping and City wetland mapping
3. Updates based on current vegetation mapping
4. Wetlands recommended to be added as Provincially Significant where they (a) are in the 2014 NHS and/or (b) have a surface hydrologic connection to an existing PSW
5. Other ponds / wetlands identified for future review
6. Mapping from previous OPA 42 settlements respected
7. Refinement work still in progress where access has been provided in 2018

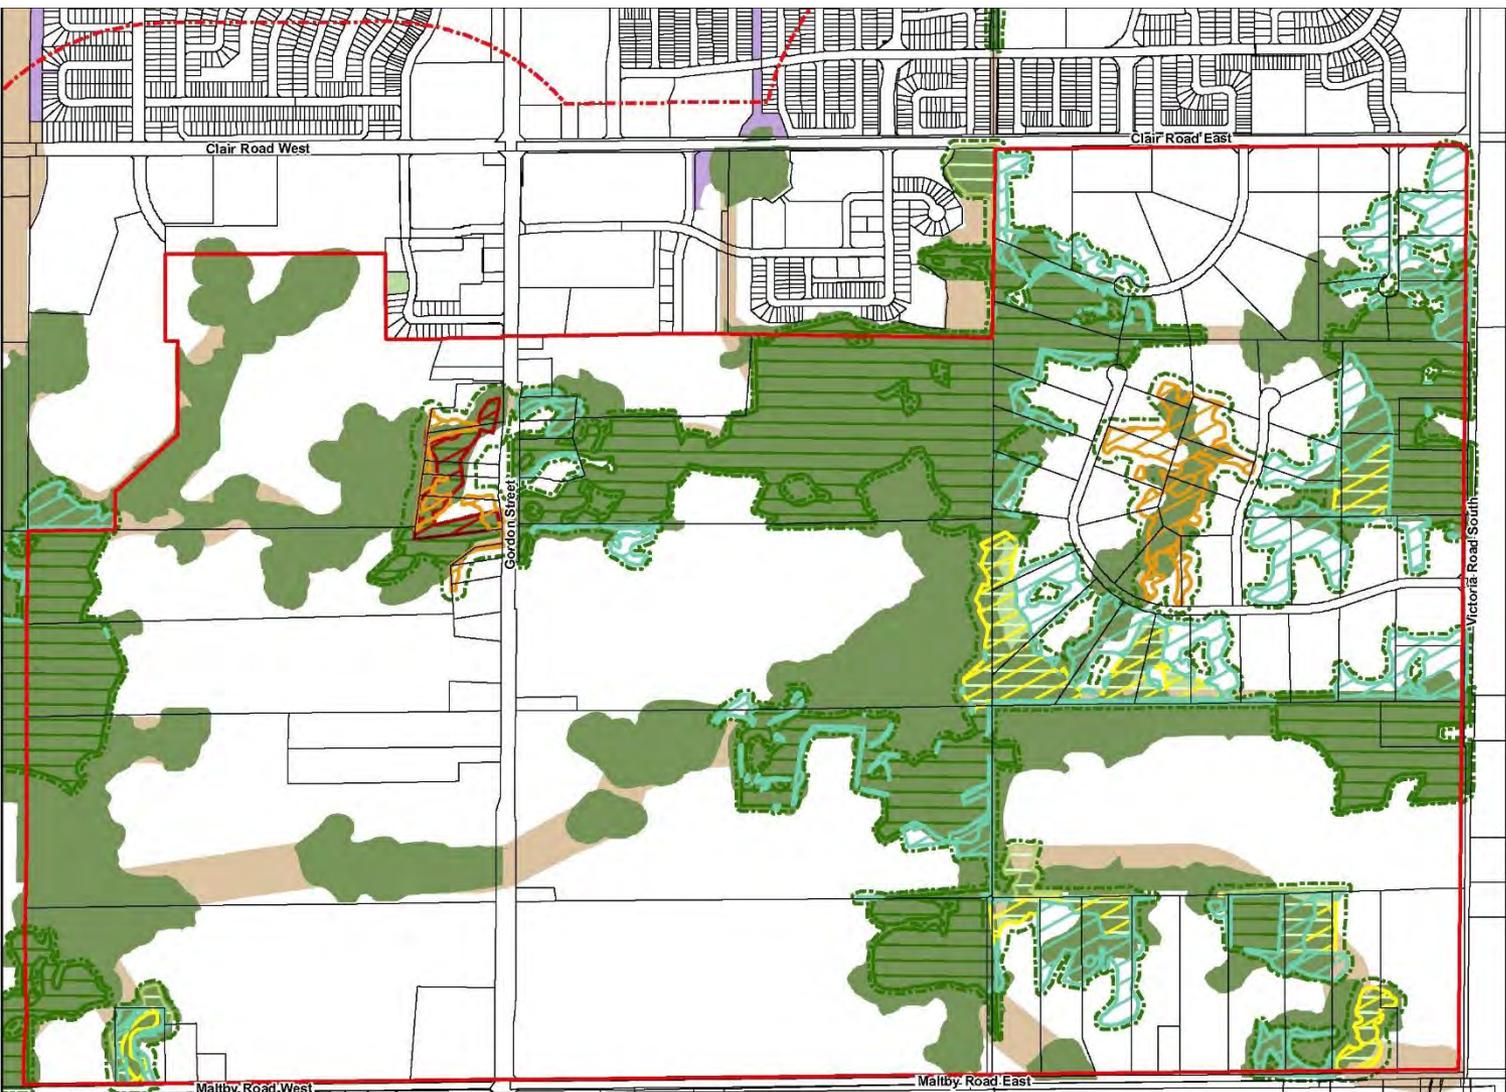
**Refinements to
City Woodlands Mapping
and Current City NHS**

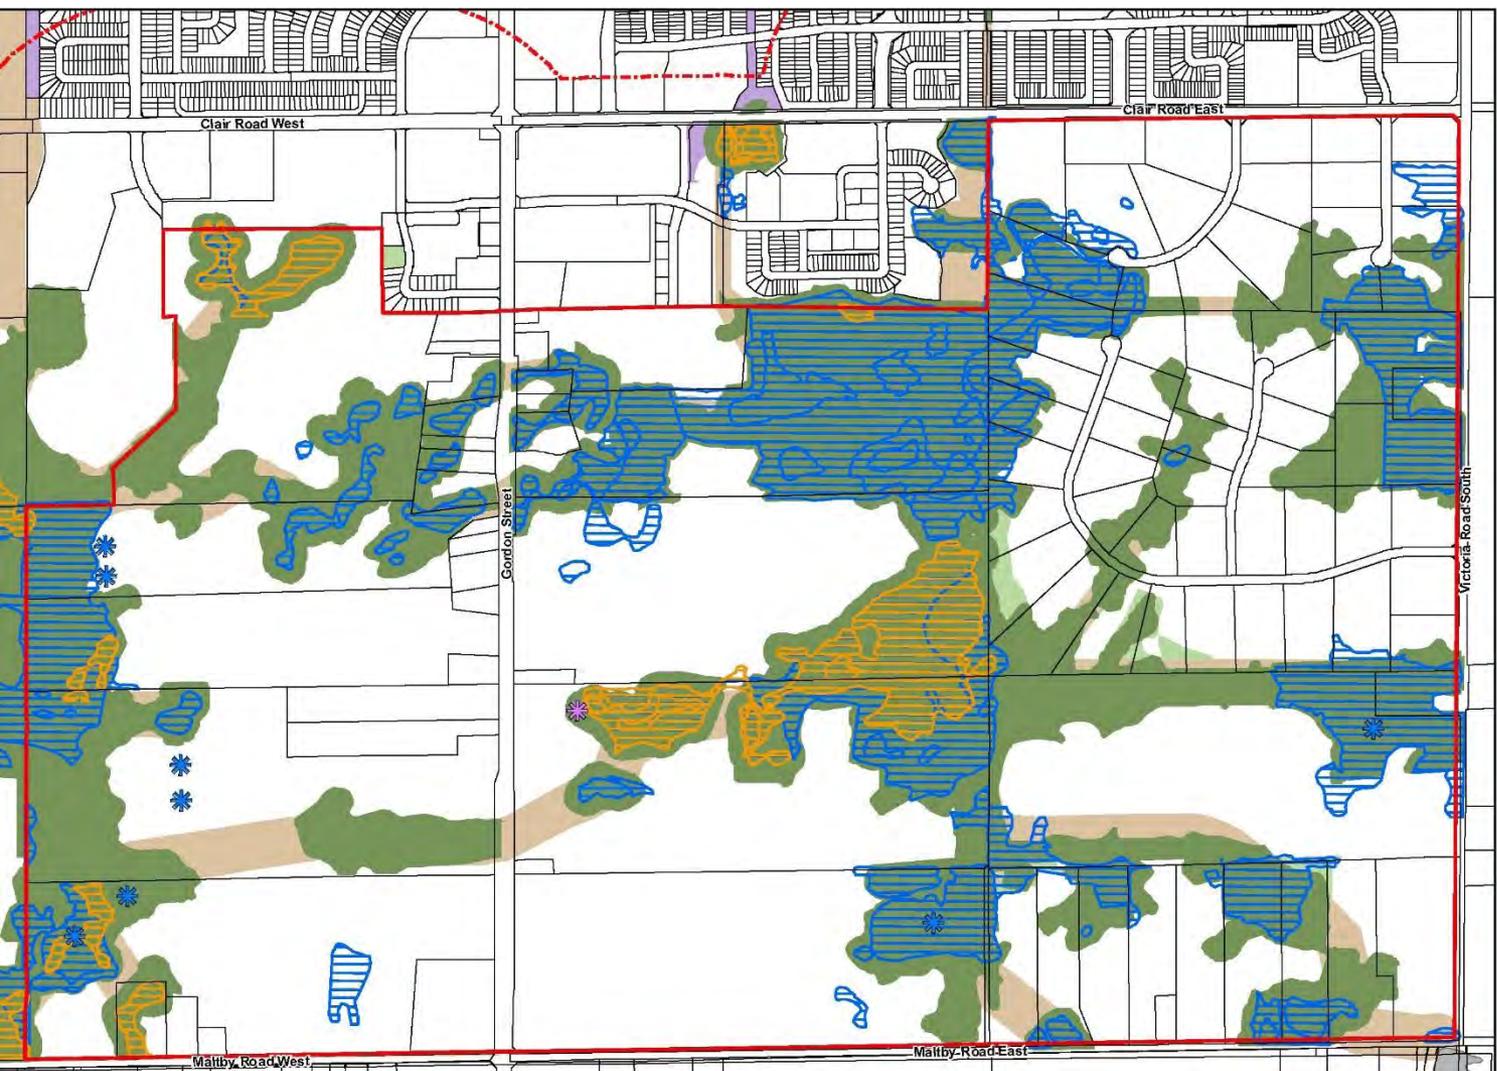
Preliminary Significant Wildlife Habitat (SWH) and Current City NHS	
Map NH-10	
Clair-Maltby Secondary Plan Phase 1 and 2 Characterization Report	
Legend	
	Secondary Plan Area Boundary (SPA)
	Primary Study Area Boundary (PSA)
	Candidate Amphibian Breeding Habitat (Wetland)
Significant Wildlife Habitat	
	Candidate SWH – Presence and Extent To Be Verified *
	Confirmed SWH
	Candidate SWH – Presence To Be Verified
	Confirmed SWH (based on ELC polygon(s))
	Halligan's Pond**
City of Guelph Natural Heritage System (2014)	
	Significant Natural Areas
	Natural Areas
	Ecological Linkages
	Restoration Areas

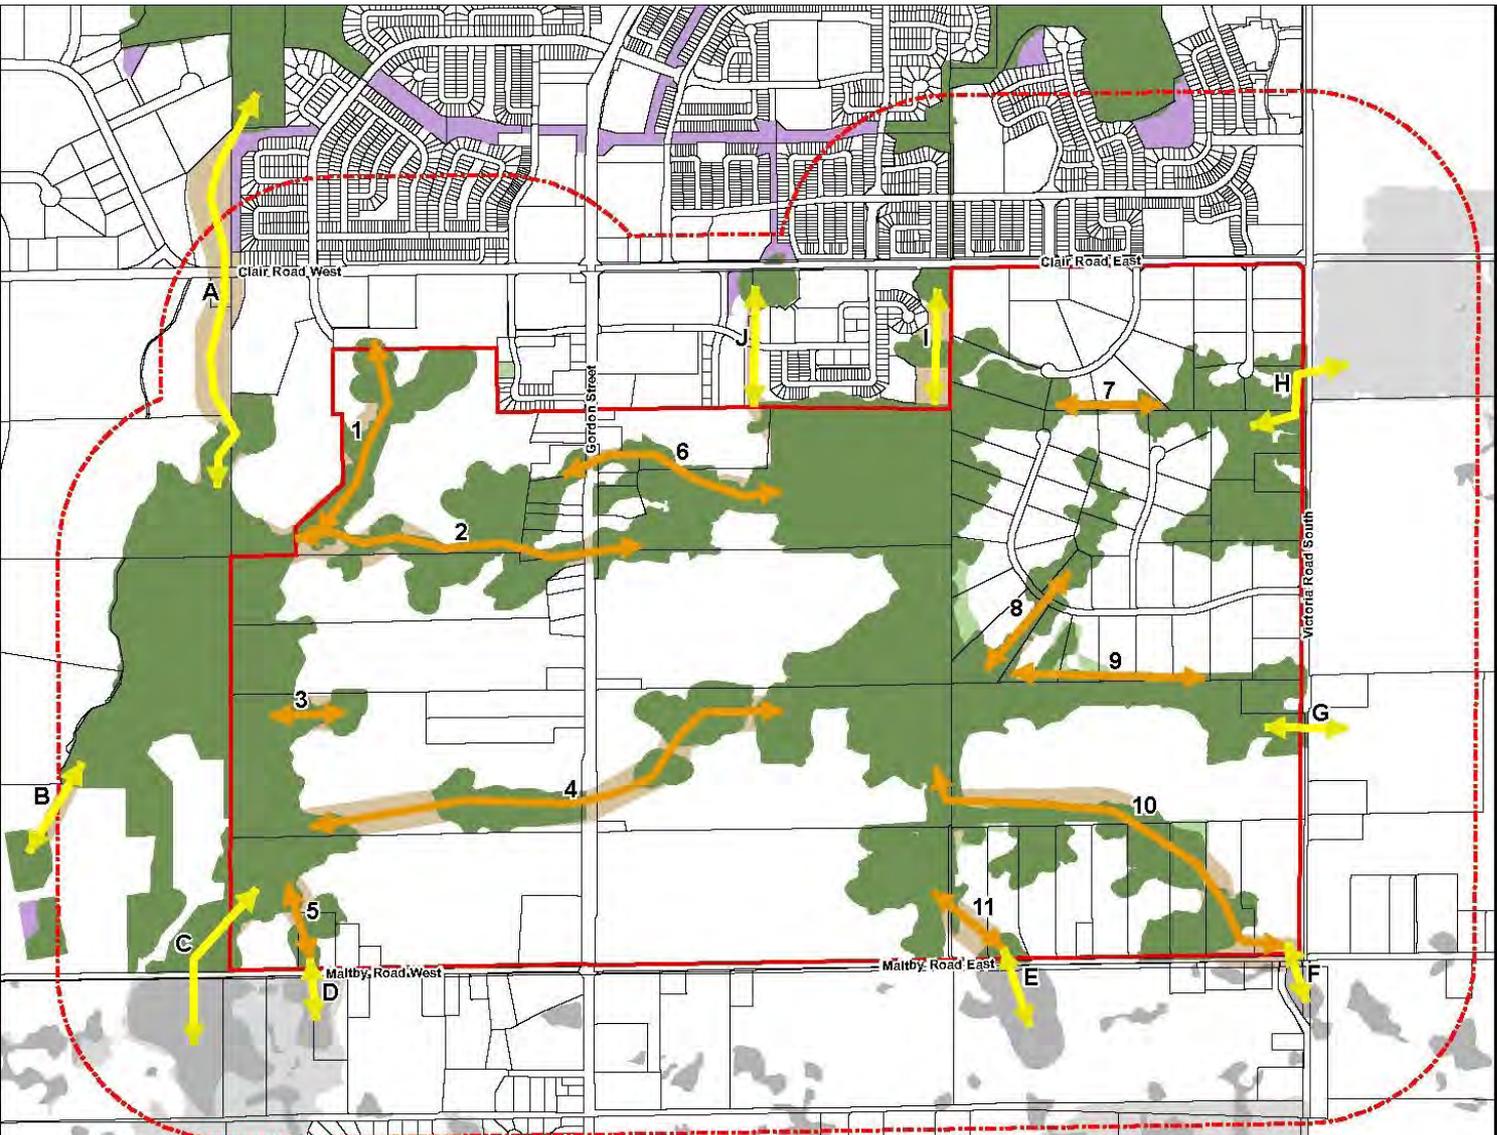
Ecological Linkages	
Map NH-11	
Clair-Maltby Secondary Plan Phase 1 and 2 Characterization Report	
Legend	
	Secondary Plan Area Boundary
	Primary Study Area Boundary
	Ecological Linkages within the PSA
	Ecological Linkages within the SPA
City of Guelph Natural Heritage System (2014)	
	Ecological Linkages
	Significant Natural Areas
	Natural Areas
	Restoration Areas
Wildlife Crossings	
	Amphibian Crossings
	Deer Crossings
	Other Wildlife Crossing Opportunities
<small>* Several Candidate SWH areas are shown approximately with asterisks. Site-specific study will be needed to capture the best and most representative area(s) in the SPA.</small>	
<small>** Halligan's pond could be considered Candidate SWH for amphibian breeding, waterfowl stopover and turtle wintering but has not been mapped as such as it is outside the City of Guelph.</small>	
<small>City of Guelph: Secondary Plan Area Boundary, Parcel Fabric, 2016.</small>

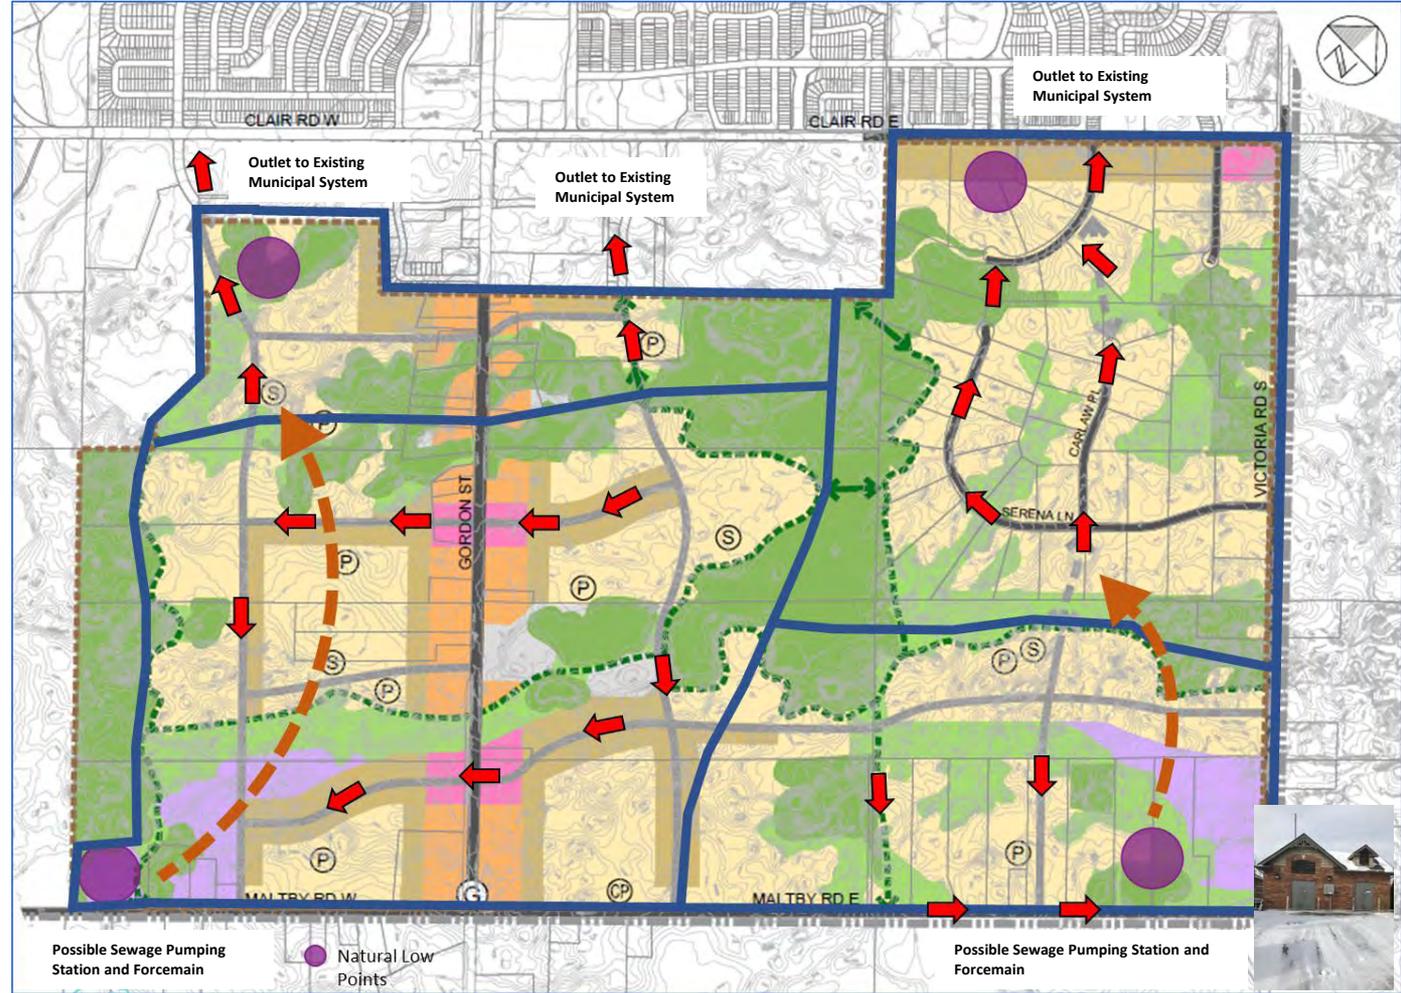
External Servicing Upgrades will be required to provide Capacity from CMSP lands to Guelph WWTP
