# Phase One Environmental Site Assessment

303, 309 and 317 Speedvale  
Avenue East  
Guelph, Ontario

Habitat for Humanity Wellington  
Dufferin Guelph  
Final Report | Version 00  
Reference no. 02302109.000

January 22, 2024

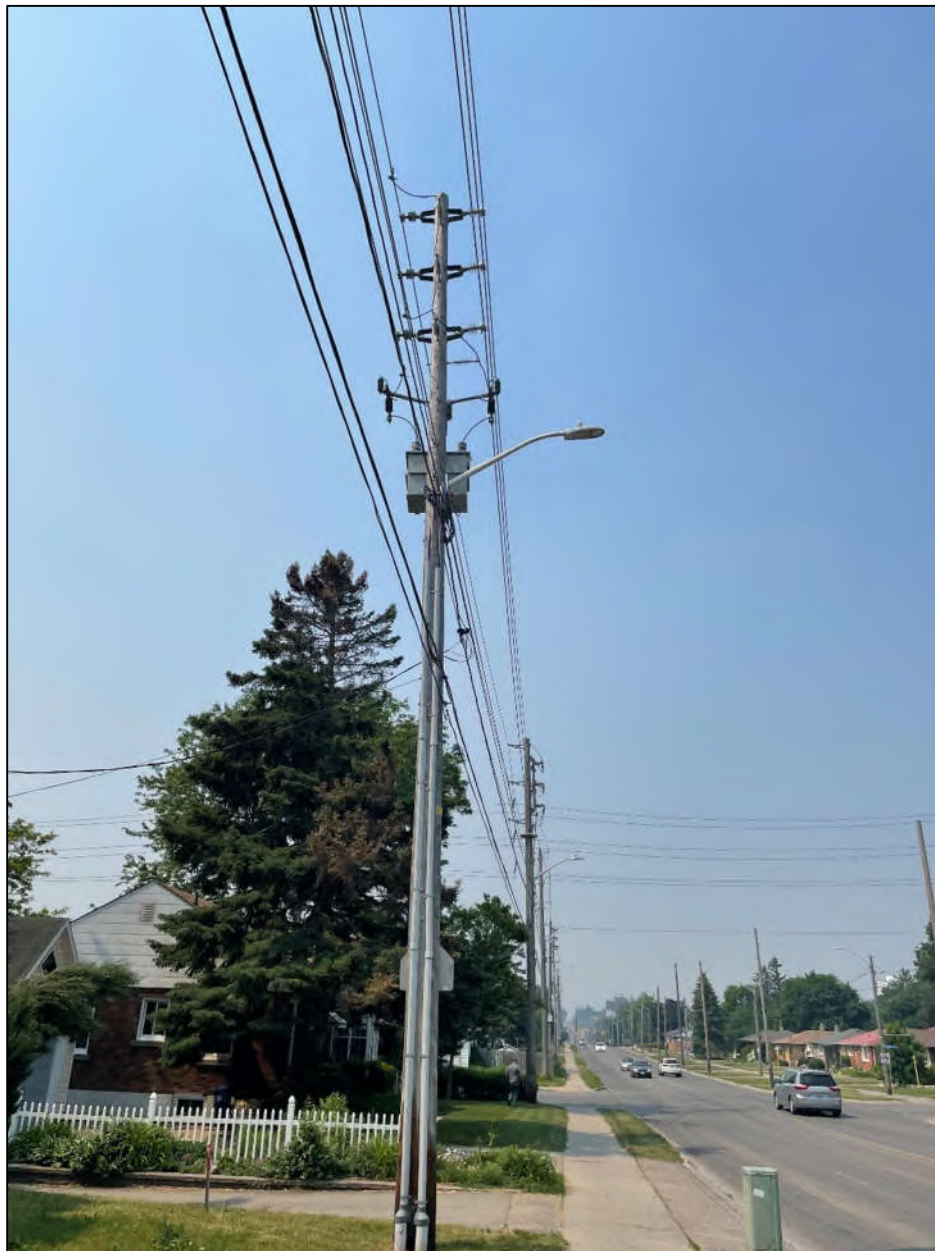
**Figure 3** View of Speedvale Avenue East and a pole mounted transformer in front of 303 Speedvale Avenue East, facing southwest.

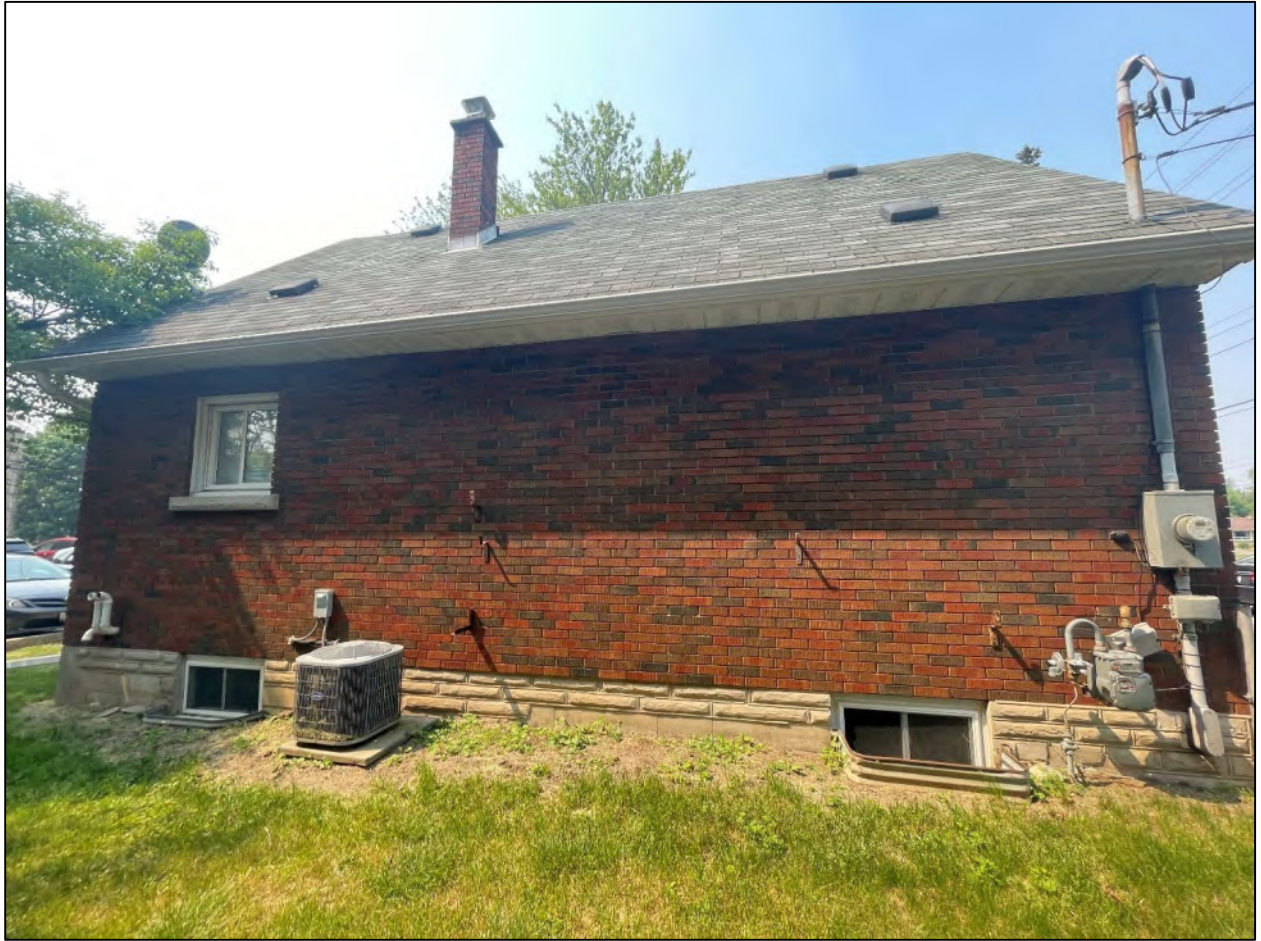
**Figure 5** View of northeast elevation of 309 Speedvale Avenue East, showing natural gas service and AC unit on northeast wall, facing southwest.

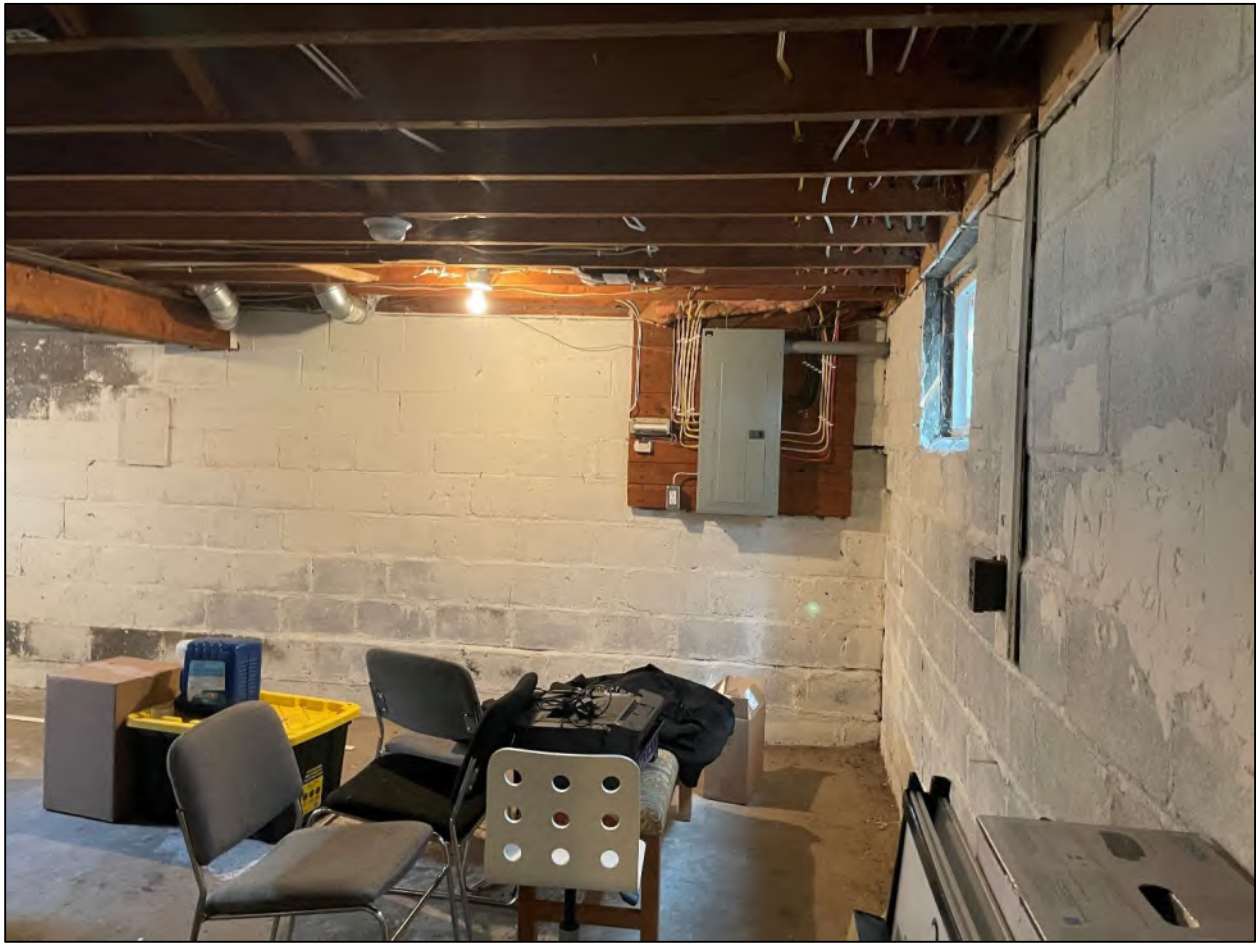
**Figure 12** View of the electrical panel in the northern corner of the basement in 309 Speedvale Avenue East, facing northwest.

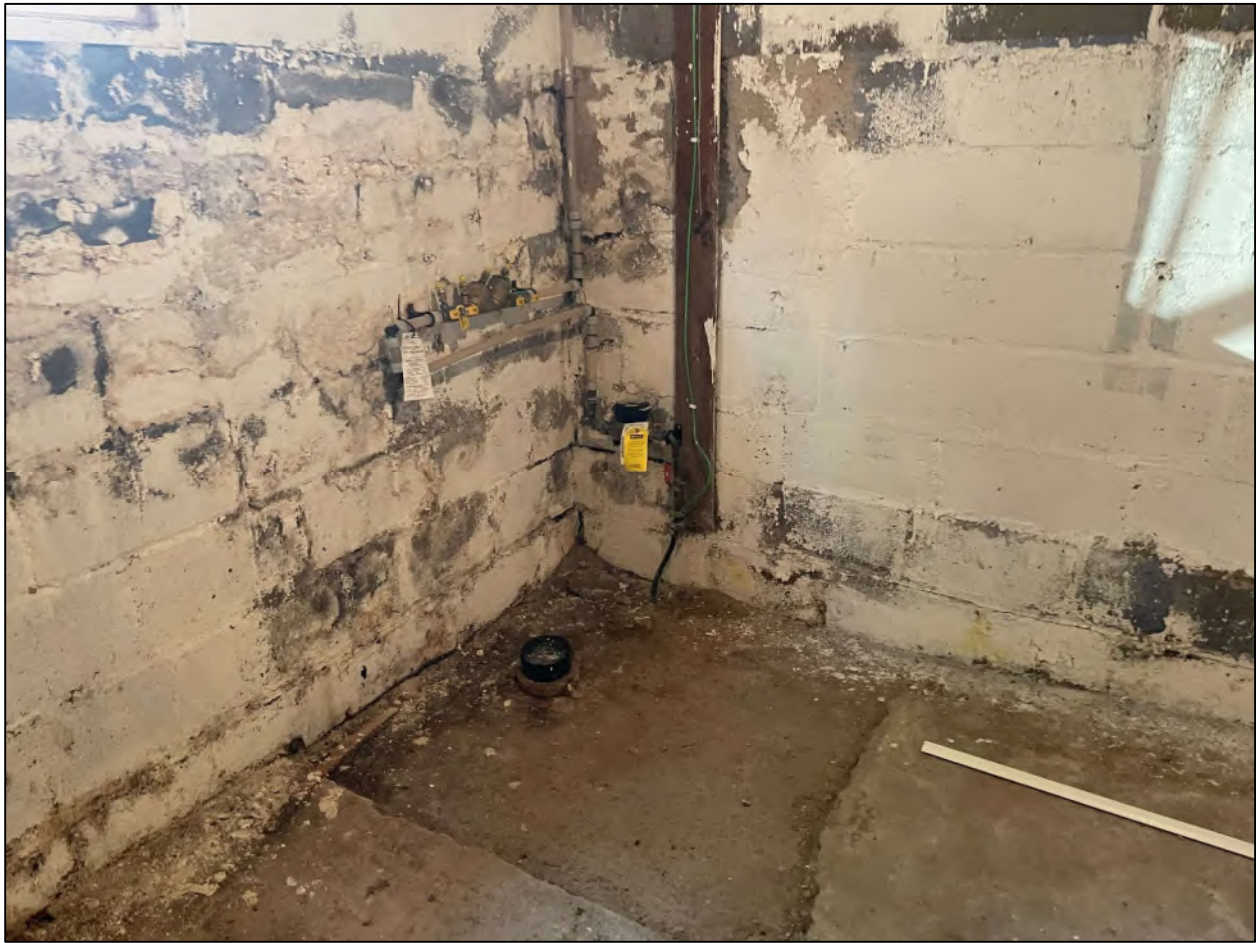
**Figure 14** View of the west corner of the basement in 309 Speedvale Avenue East showing sump location, facing west.

No pits were observed during the Site visit. Sump pumps were observed in the basements of 303 and 309 Speedvale Avenue East. One floor drain was observed in the mechanical room of 317 Speedvale Avenue East.

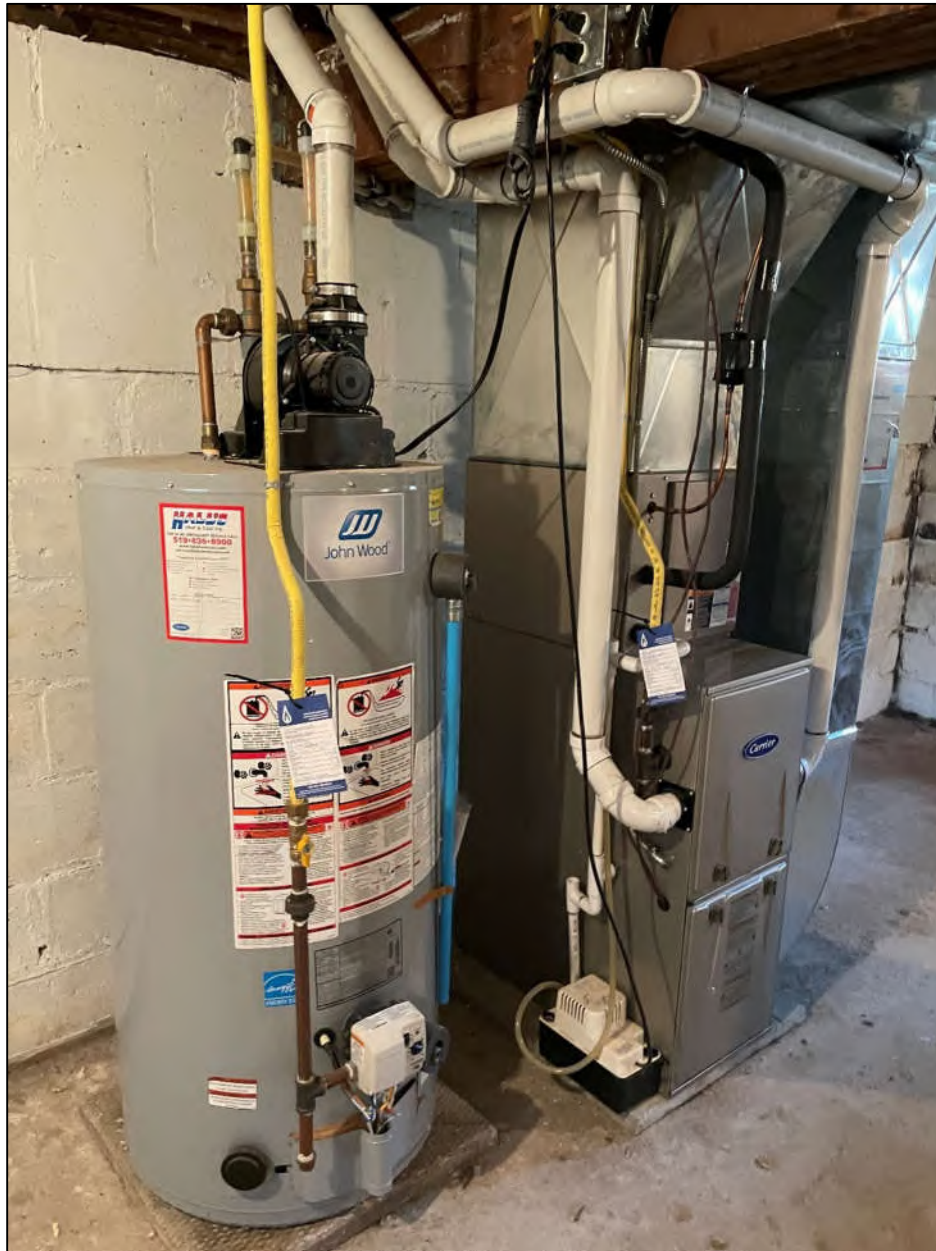
**Figure 15** View of the furnace and water heater on the southeast wall of the basement in 309 Speedvale Avenue East, facing southeast.

The three (3) Site buildings are heated using natural gas and cooled via central air conditioning. According to the Site representative, the building located at 317 Speedvale Avenue East was previously heated with forced air electric heat pumps; the current Heating Ventilation and Air Conditioning system has been located on the roof since at least 2015. The Site representative also identified that 309 Speedvale Avenue East has been forced air natural gas heat since at least 2015. According to the Site representatives, there is no knowledge of the buildings 303, 309 and 317 Speedvale Avenue East being previously heated by fuel oil or having oil tanks.

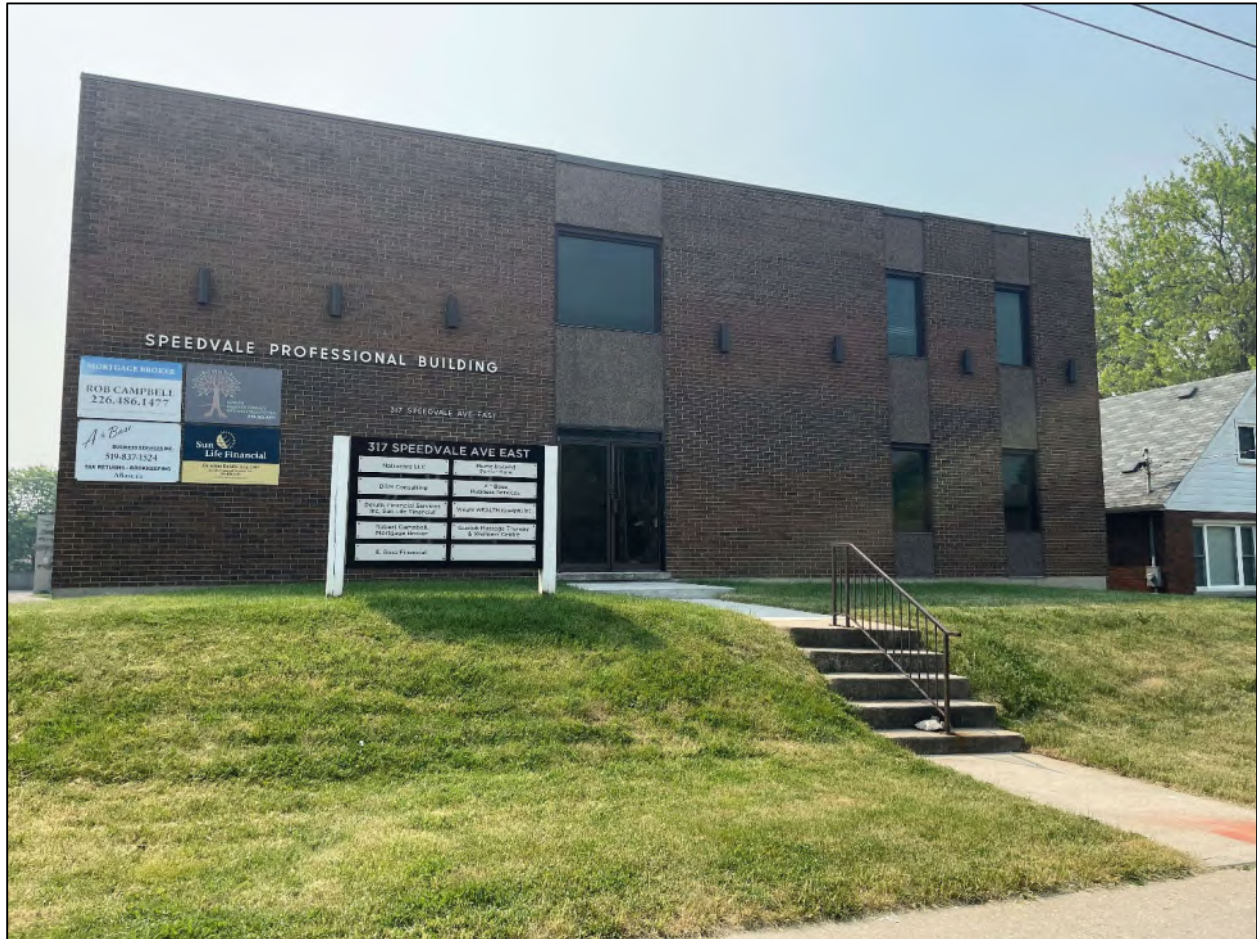
**Figure 16** View of the northwest elevation and main entrance of 317 Speedvale Avenue East, facing southeast.

The topography at the property was observed to be generally flat and graded slightly from east to west. The northwest exterior of 317 Speedvale Avenue East is built up toward the building with a fill of unknown quality. The driveway on the property of 303 Speedvale Avenue East slopes from north to south. The Site representative indicated fill materials of unknown quality were likely imported to the Site for development and purposes. (PCA #5)

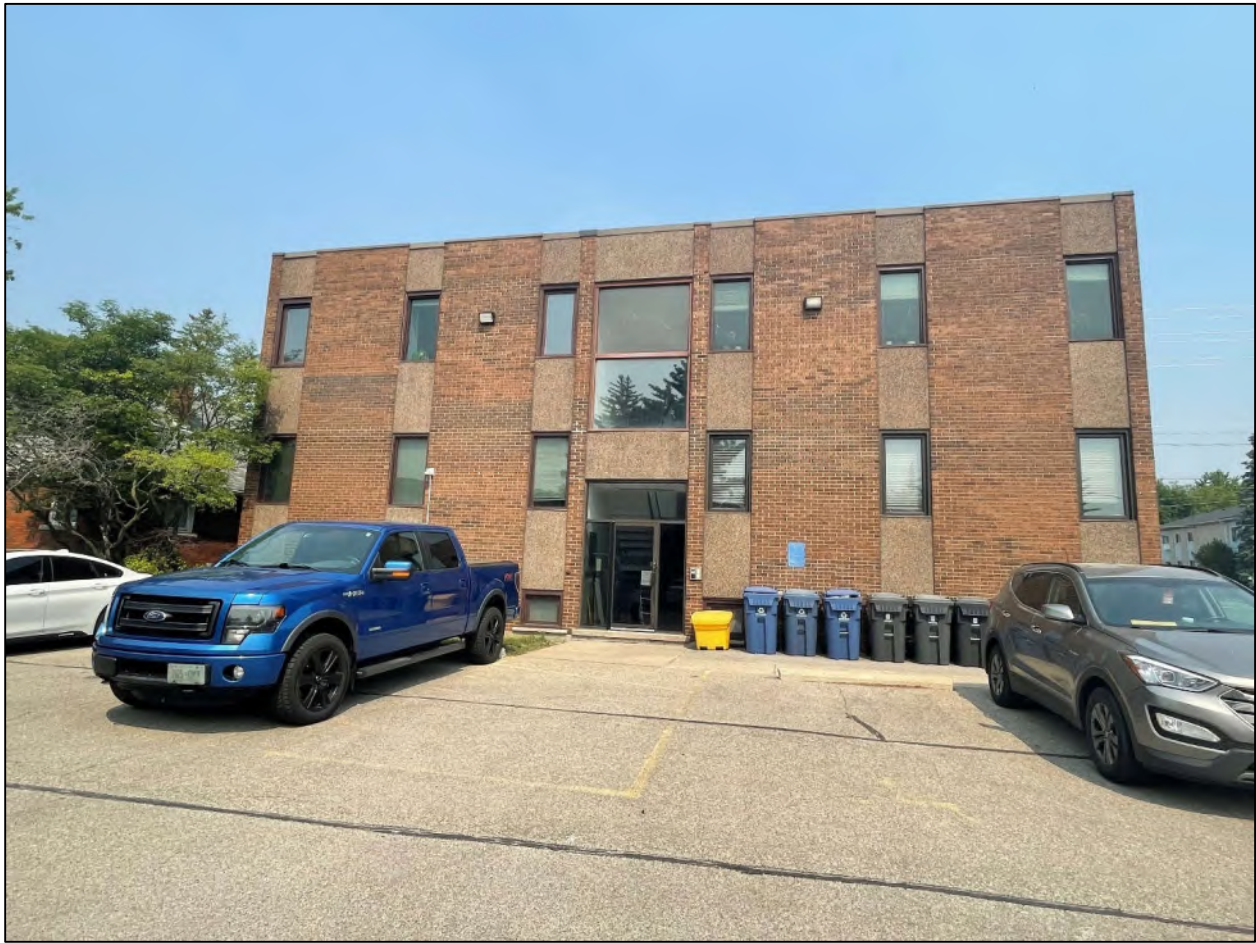
**Figure 19** View of the southeast elevation and secondary entrance of 317 Speedvale Avenue East, facing northwest and showing waste bin storage location.

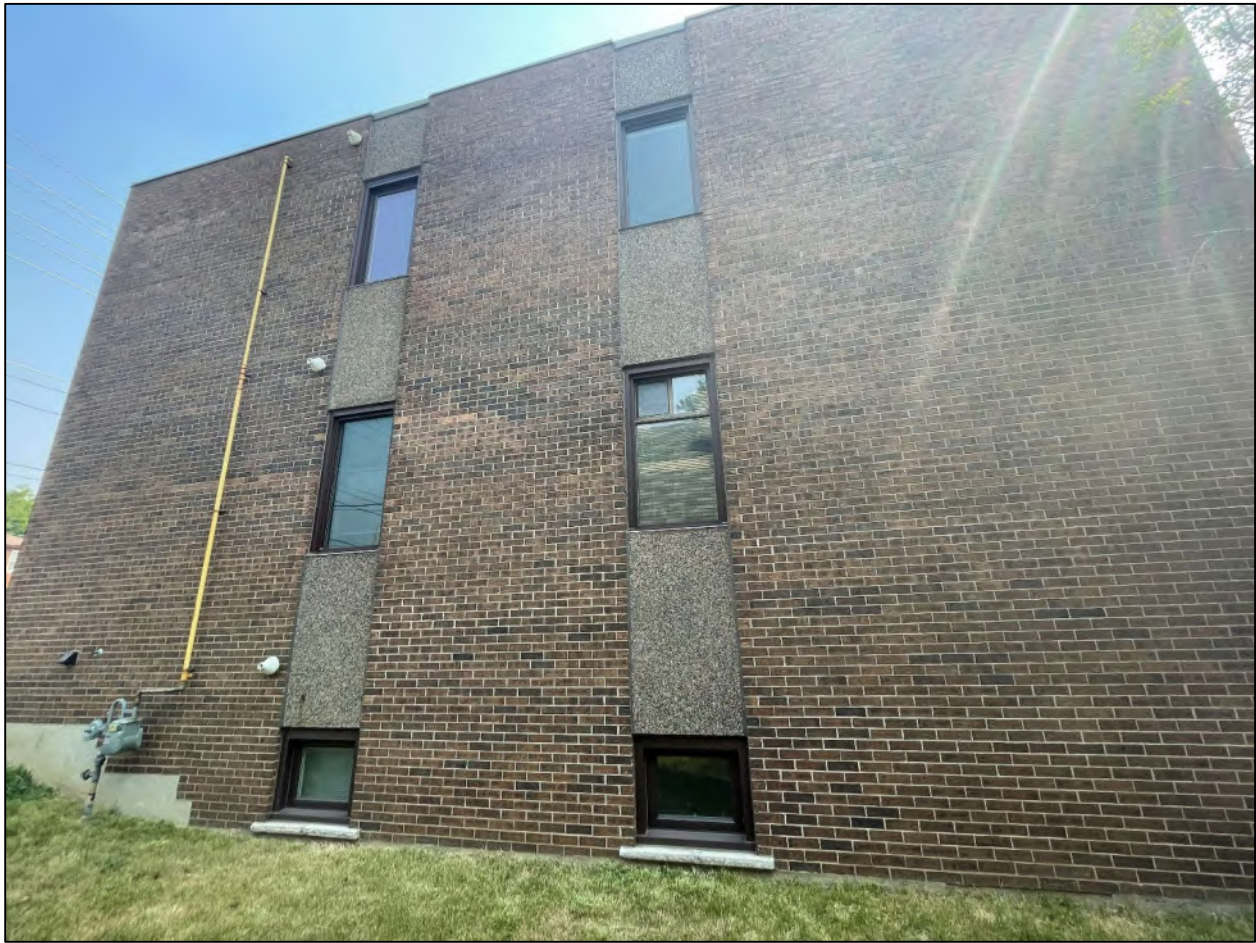
**Figure 20** View of the southwest side and natural gas service for 317 Speedvale Avenue East, facing northeast.

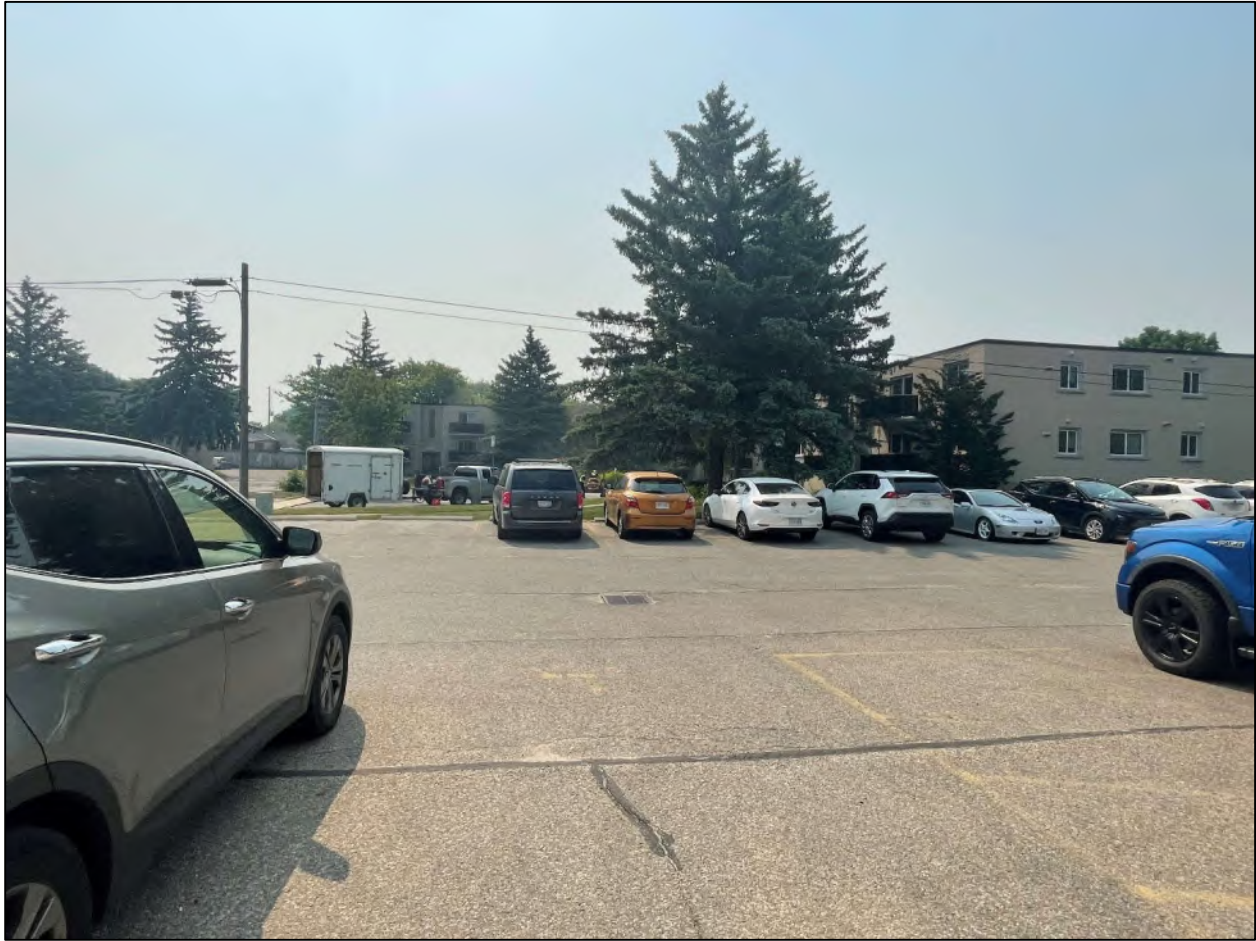
**Figure 21** View of the parking lot and one of the catch basins located on the southeast side of 317 Speedvale Avenue East, facing southeast. Overhead lines running parallel to the property boundary are also visible.

| <p>Describe and assess the potential for underground utilities, if any, to affect contaminant distribution and transport</p> | <p>Two catch basins were observed in the parking lot located behind 309 and 317 Speedvale Avenue East during the Site visit on June 7, 2023. A sanitary service line is likely to run down Manhattan Court, but no utility mapping has been completed as part of this investigation to confirm the locations of municipal sanitary service lines.</p> |

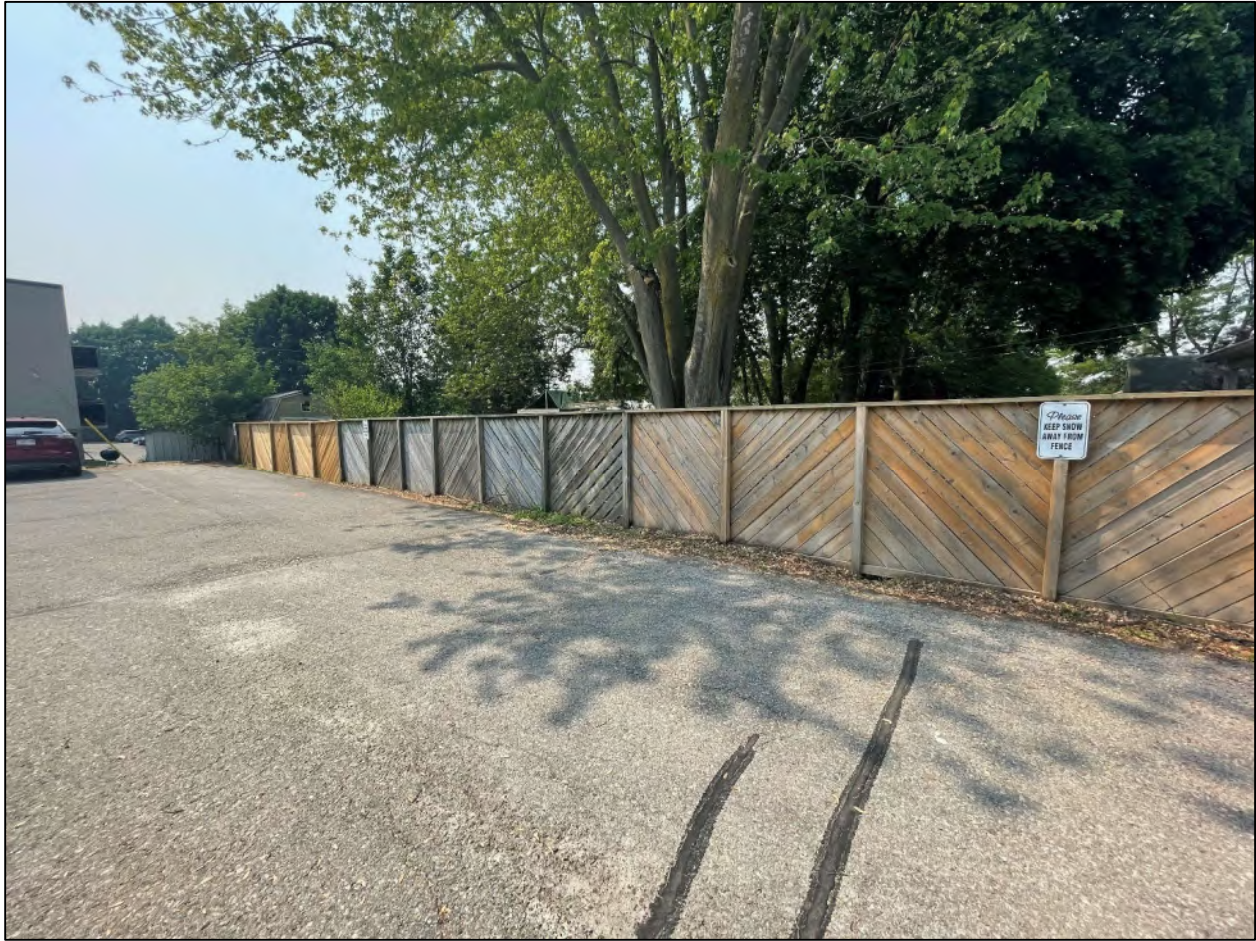
**Figure 22** View of the parking lot and fence along the property boundary of 303 and 309 Speedvale Avenue East and located on the south side of the parking area behind 317 Speedvale Avenue East, facing south.

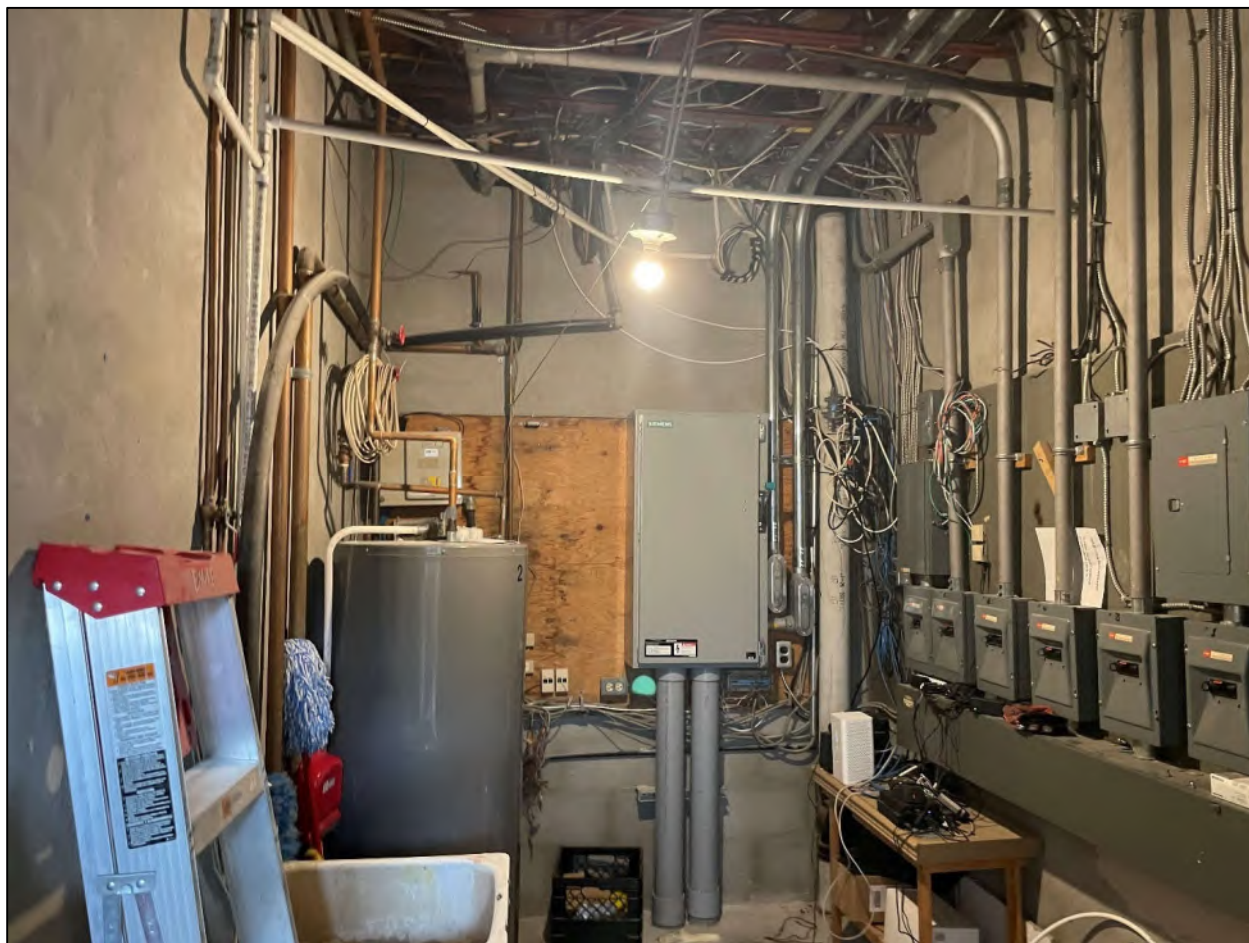
**Figure 23** View of the mechanical room in the basement of 317 Speedvale Avenue East.

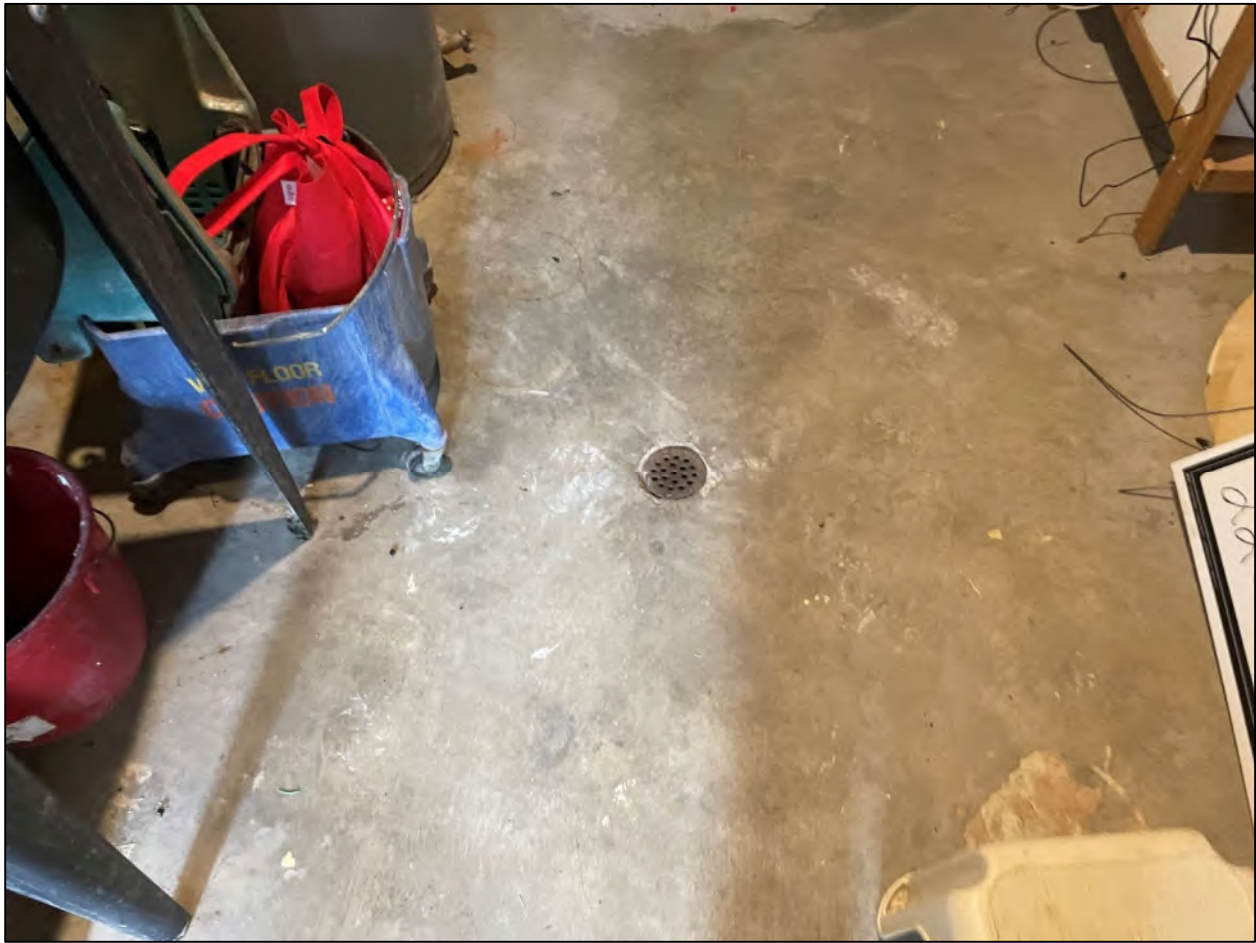
**Figure 24** View of a floor drain in the center of the mechanical room in the basement of 317 Speedvale Avenue East.

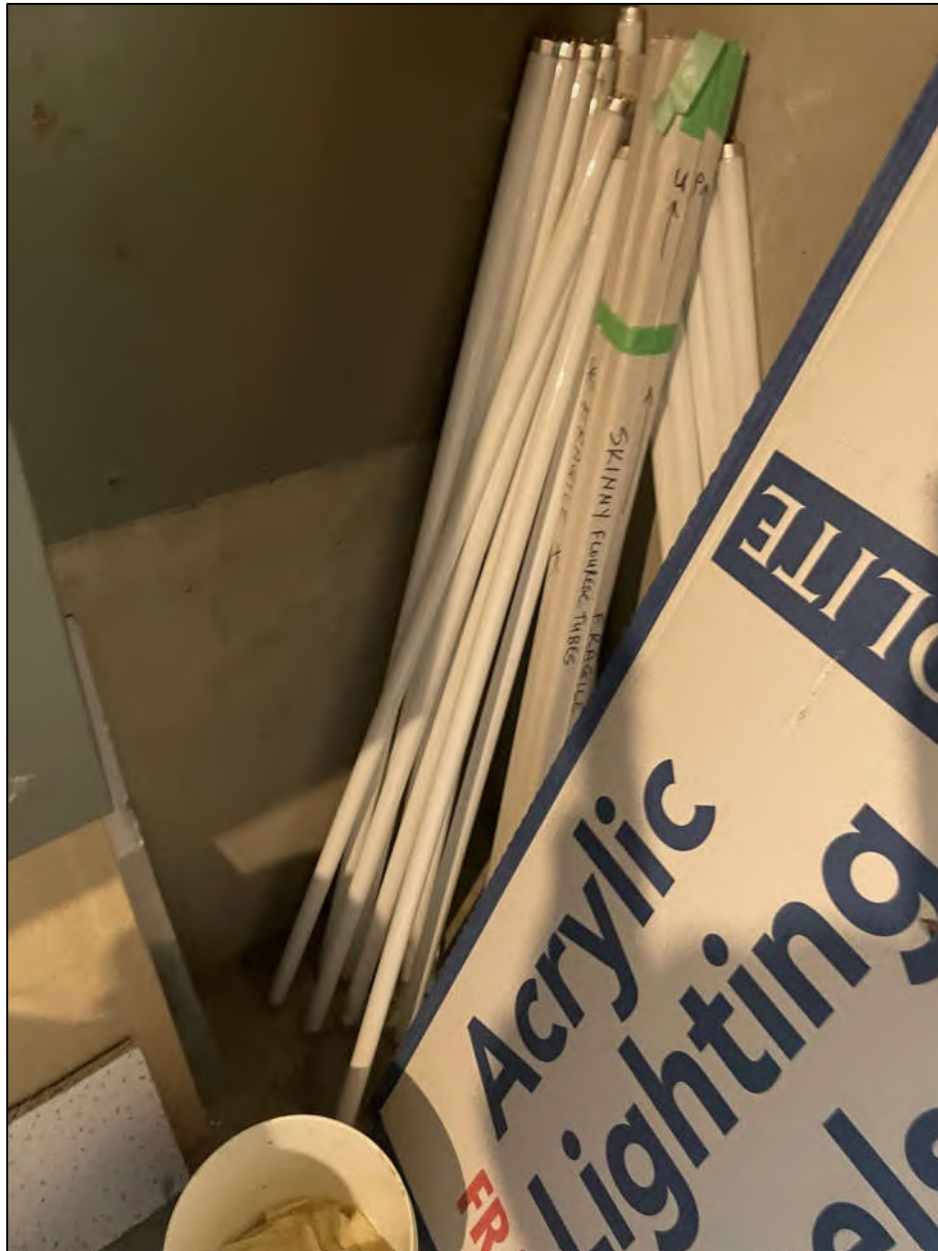
**Figure 26** View of storage of additional fluorescent lighting tubes in the front right corner of the mechanical room in the basement of 317 Speedvale Avenue East.

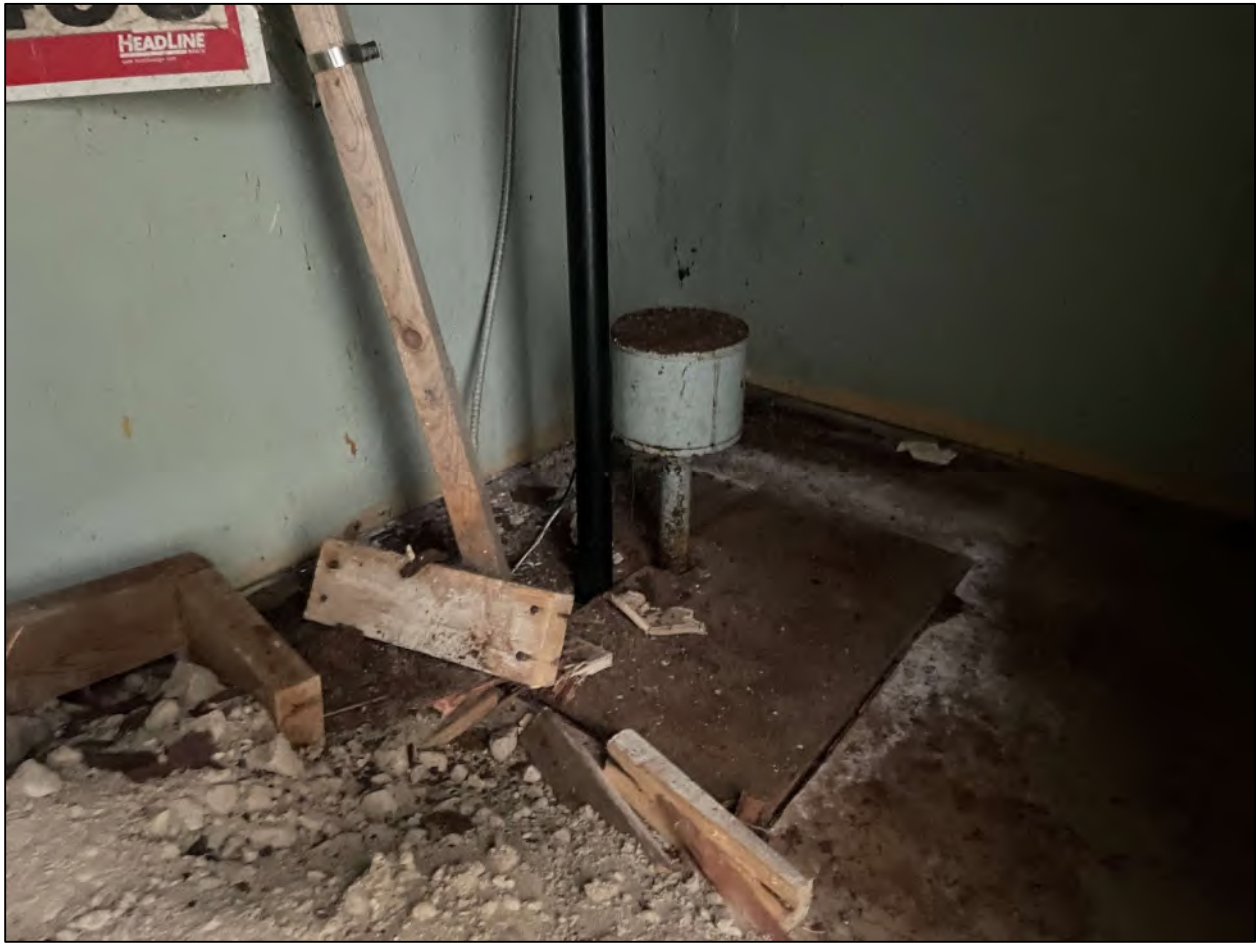
**Figure 27** View of the sump in the basement of 317 Speedvale Avenue East.

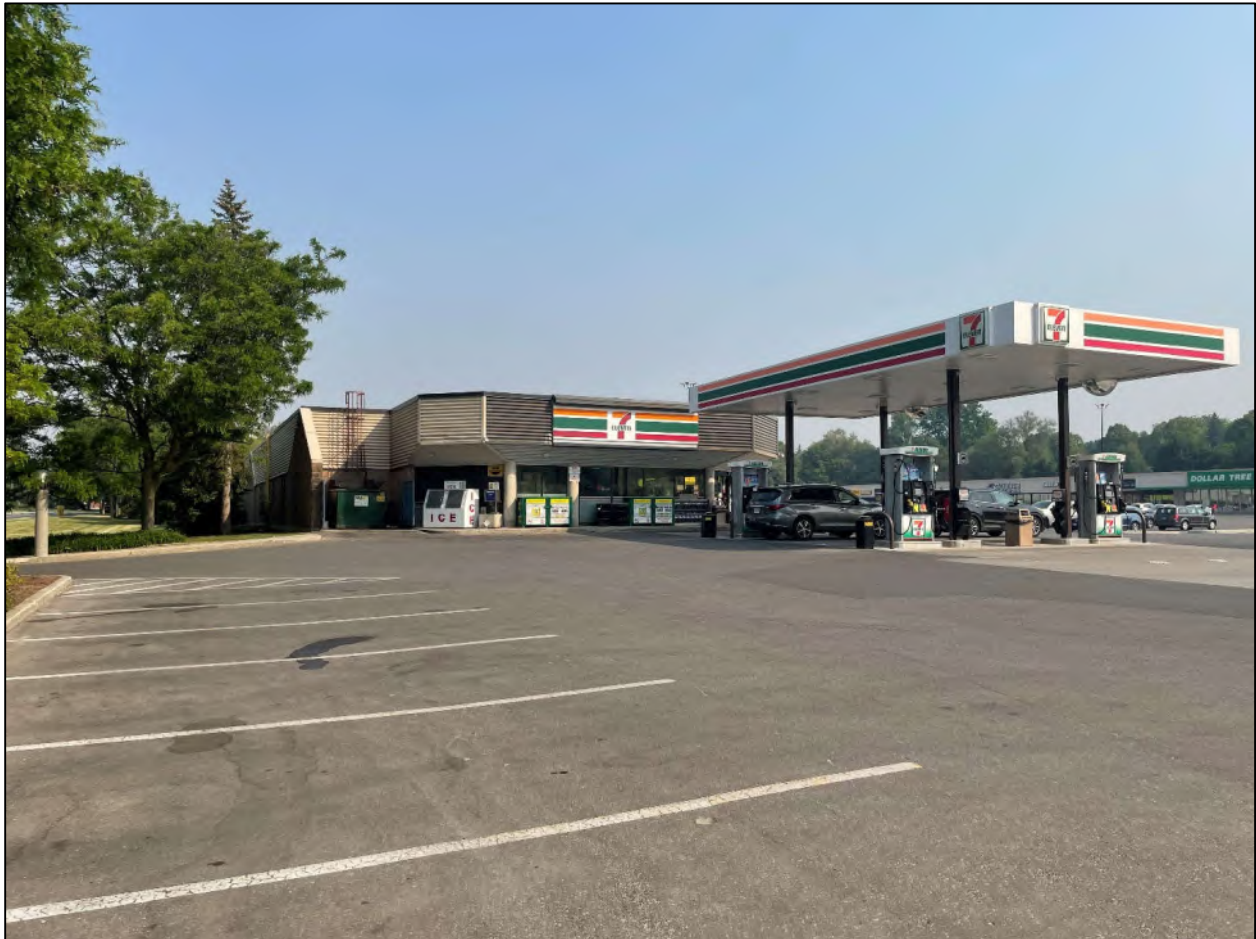
**Figure 32** View of the neighbouring 7-Eleven gas station on the north corner of Speedvale Avenue East and Stevenson Street North (328 Speedvale Avenue East), facing north.

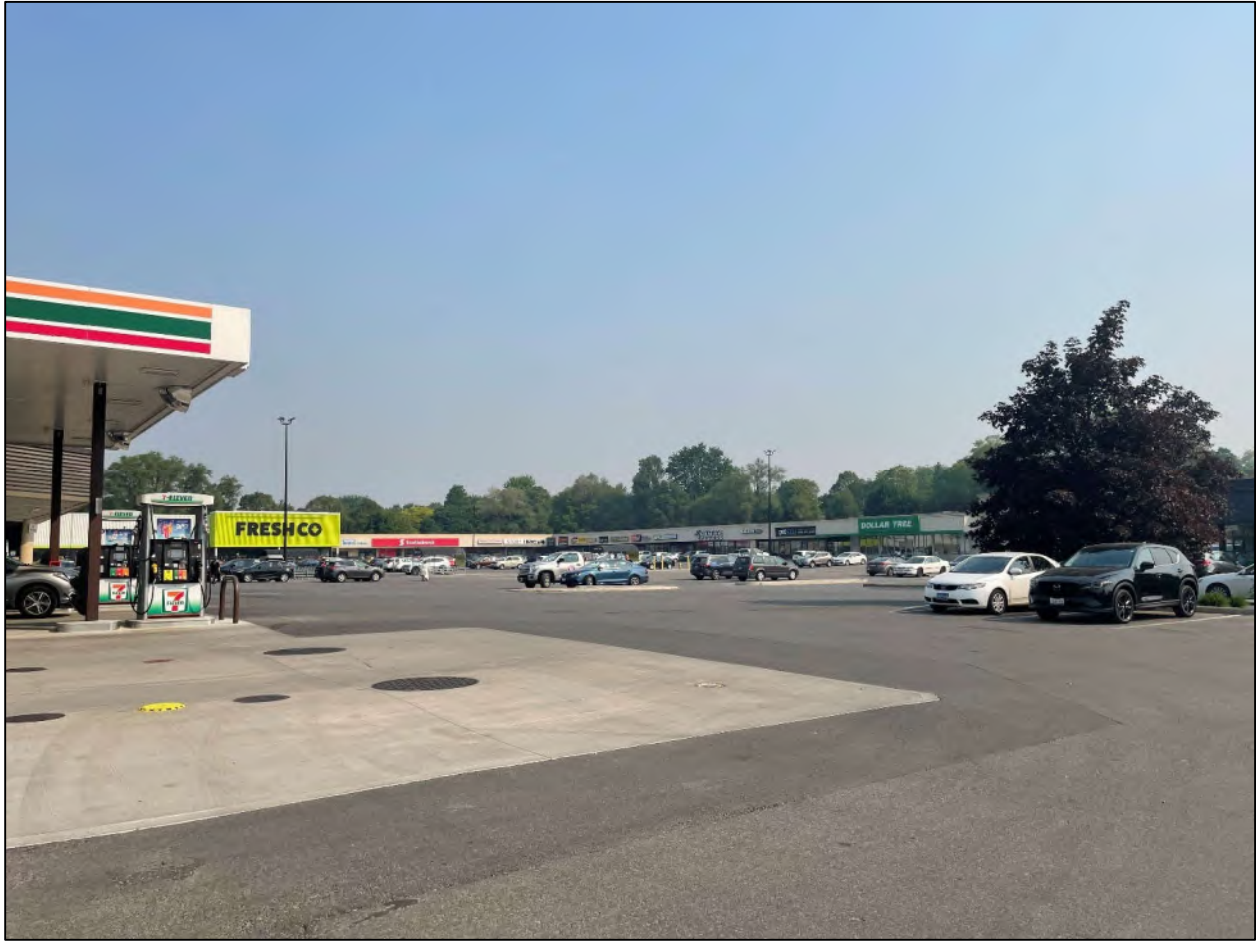
**Figure 33** View of the commercial shopping plaza on the north corner of Speedvale Avenue East and Stevenson Street North (328 Speedvale Avenue East), facing north.

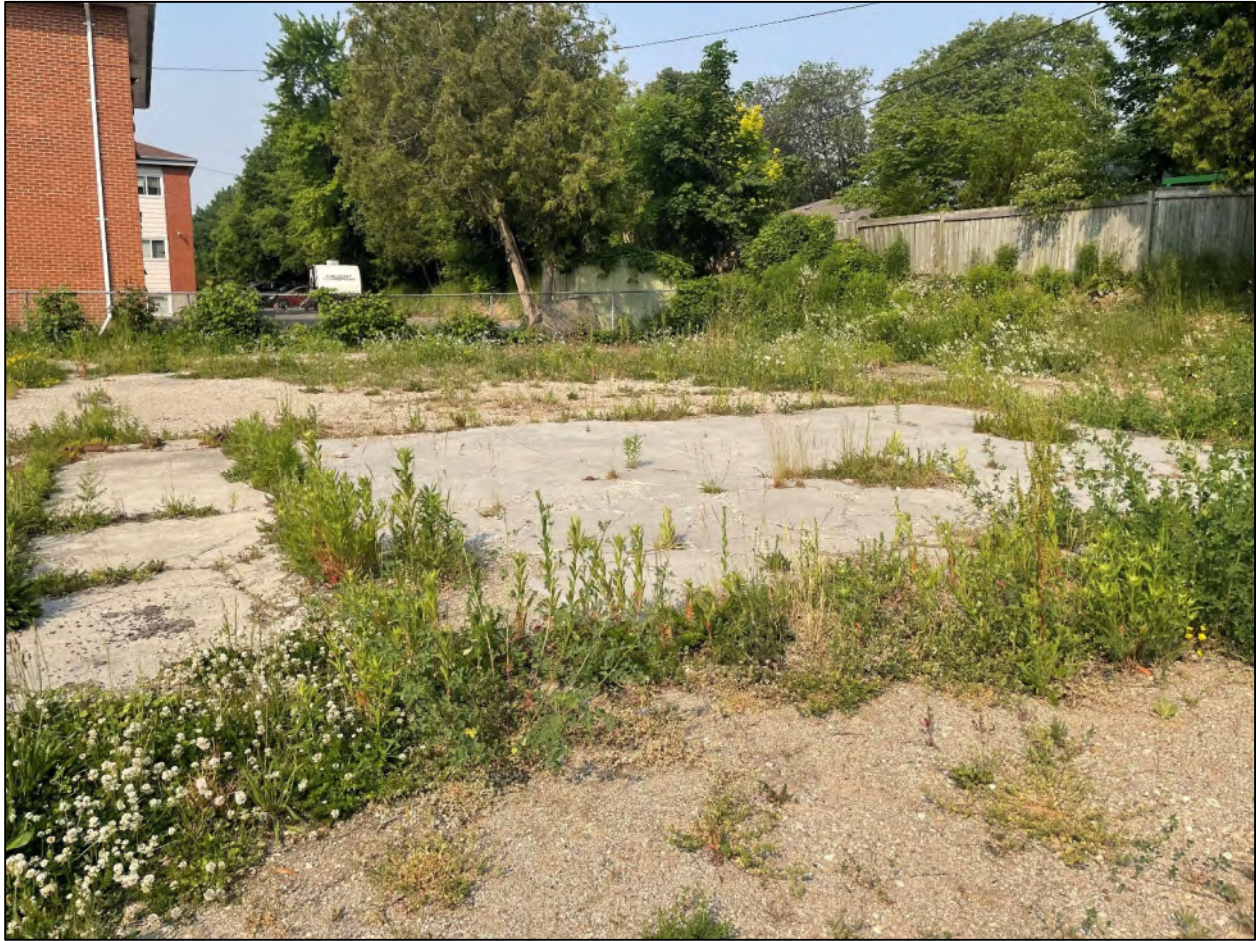
**Figure 34** View of a vacant lot on the west corner of Speedvale Avenue East and Stevenson Street North (324 Speedvale Avenue East), facing west.

| <p>Identify and locate any APECs</p> | <p>Five (5) APECs identified at the Site, as shown on <b>Figure 4</b> in <b>Appendix A</b>.</p> <ul style="list-style-type: none"> <li><b>APEC 1</b> - North portion of Site - former retail fuel outlet at 324 Speedvale Avenue East</li> <li><b>APEC 2</b> - North portion of Site - Historic dry cleaning facility at 358 Speedvale Avenue East</li> <li><b>APEC 3</b> - North portion of the Site - current retail fuel outlet at 328 Speedvale Avenue East</li> <li><b>APEC 4</b> - North Portion of the Site - Use of halogenated solvents at 328-378 Speedvale Avenue East</li> <li><b>APEC 5</b> - Northwest corner of the Site in front of 317 Speedvale Avenue East - Importation of Fill Material of Unknown Quality</li> </ul> |

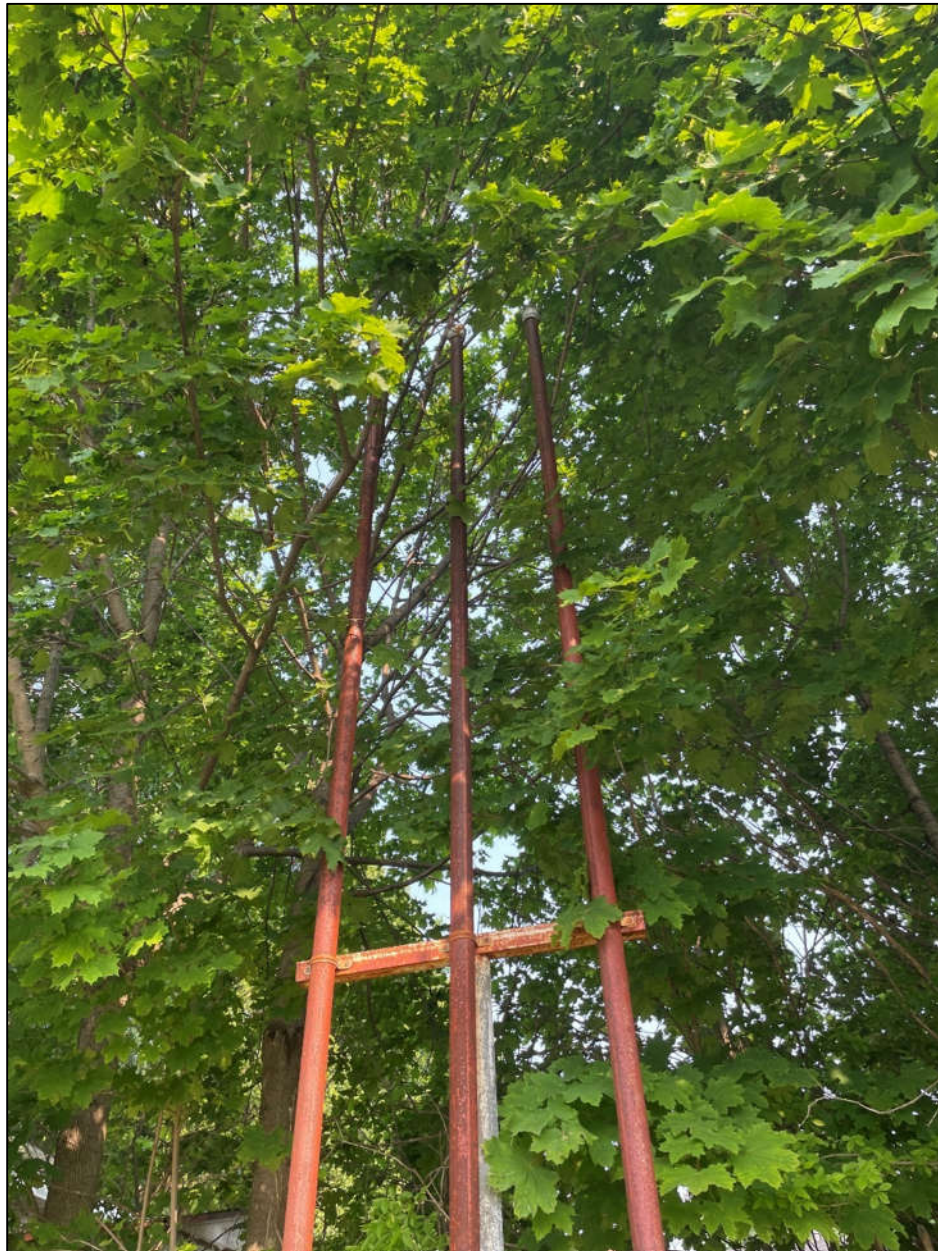
**Figure 35** View of vents indicating historical underground storage tanks on the northwest property boundary of the vacant lot located on the west corner of Speedvale Avenue East and Stevenson Street North (324 Speedvale Avenue East), facing west.
