# Phase One Environmental Site Assessment

303, 309 and 317 Speedvale  
Avenue East  
Guelph, Ontario

Habitat for Humanity Wellington  
Dufferin Guelph  
Final Report | Version 00  
Reference no. 02302109.000

January 22, 2024

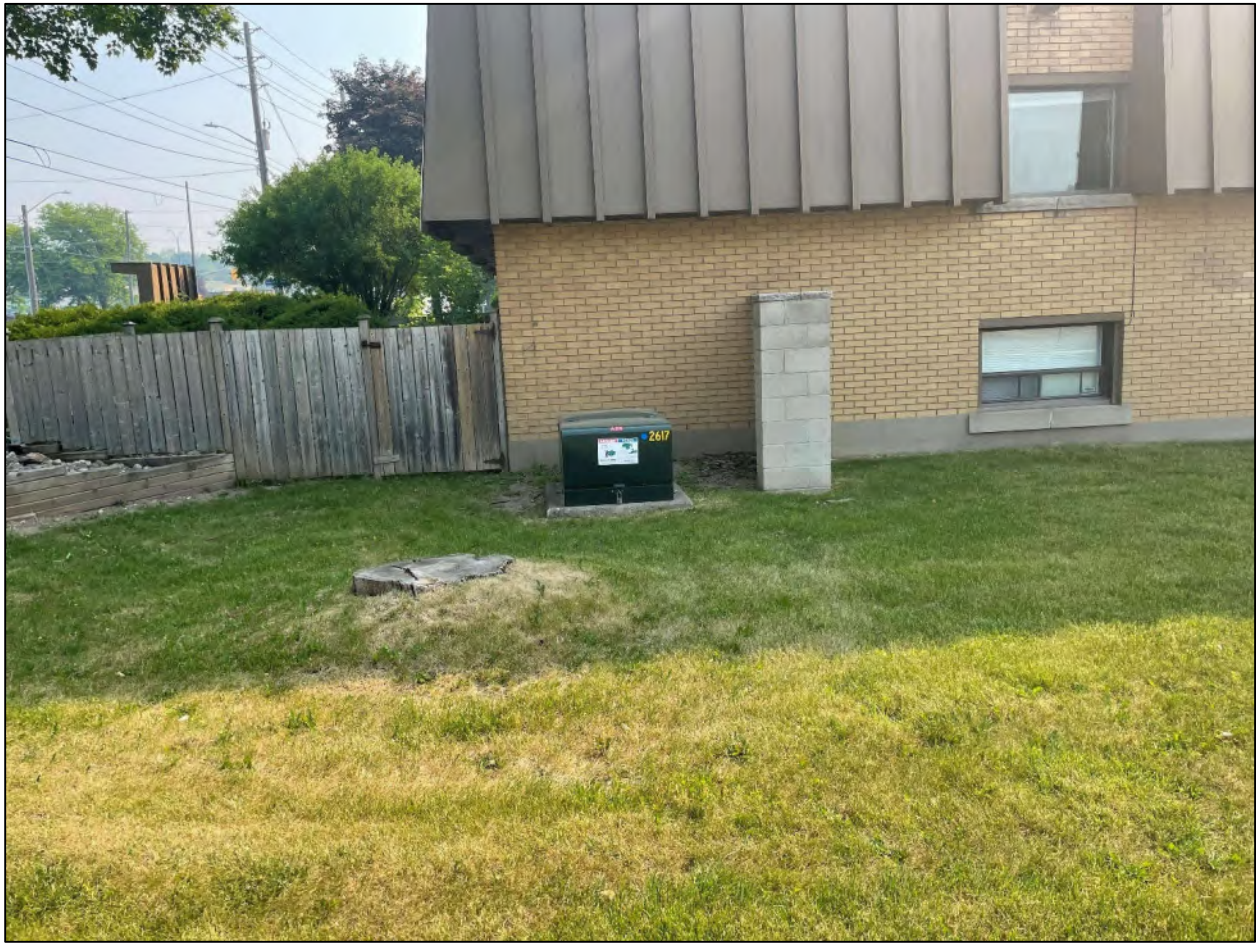
**Figure 37** View of a pad mounted transformer on the southwest side of the neighbouring dentist office to the northeast Site boundary, across Manhattan Court, facing northeast.

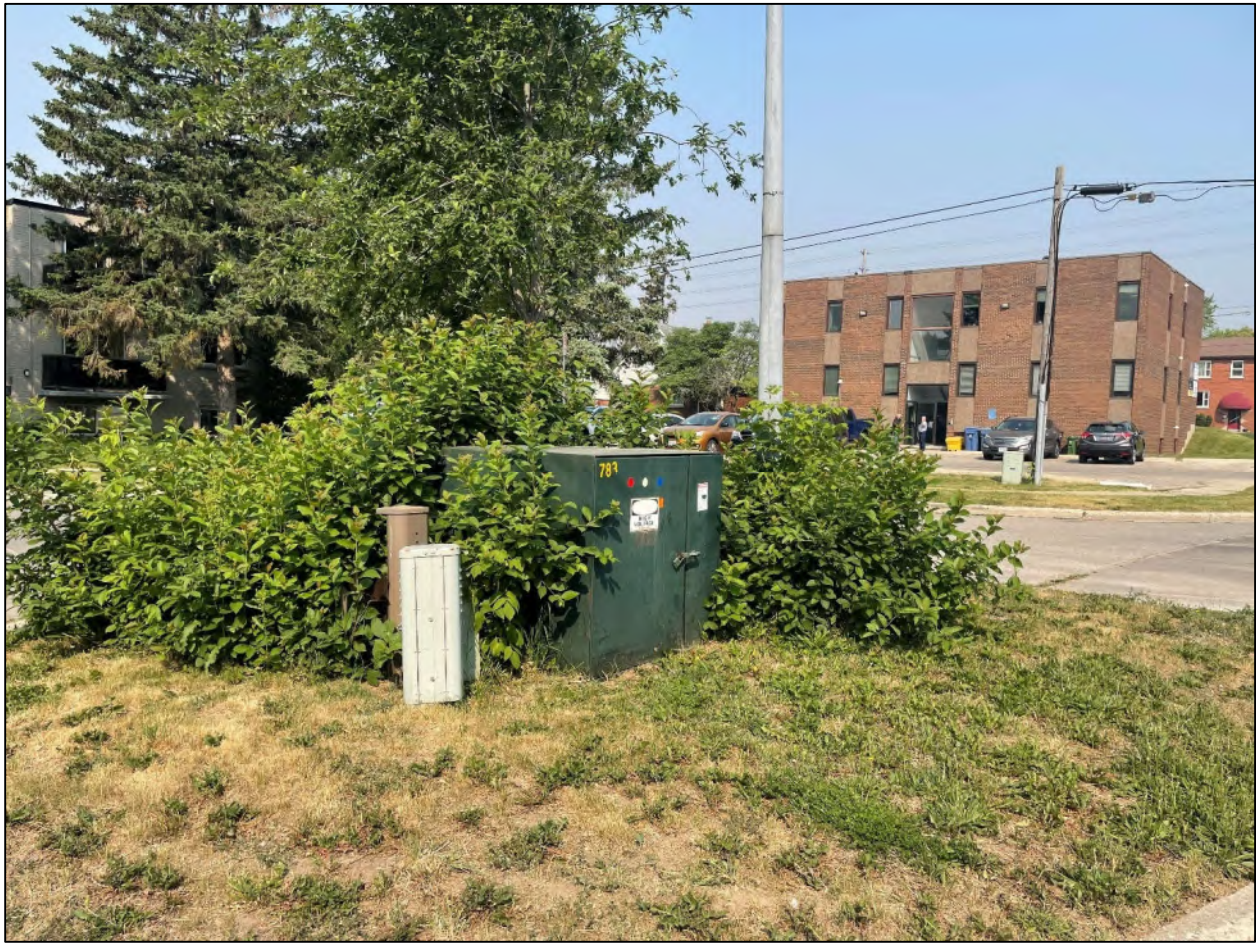
**Figure 39** View of a communications box and a pad mounted transformer located in the center of Manhattan Court adjacent to the east Site boundary, facing west.

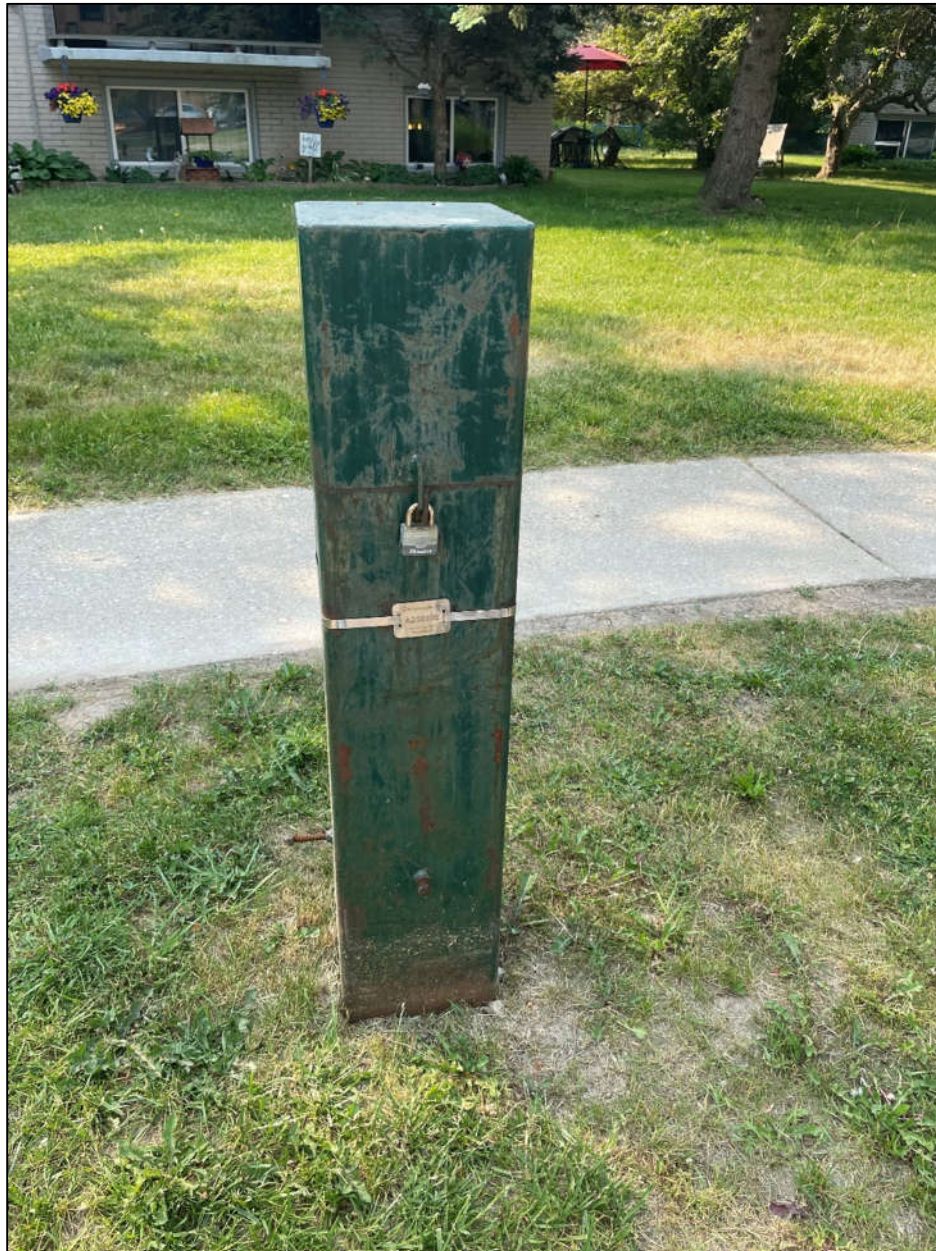
**Figure 40** View of a monitoring well located on the south edge of Manhattan Court southeast of the Site, facing south.

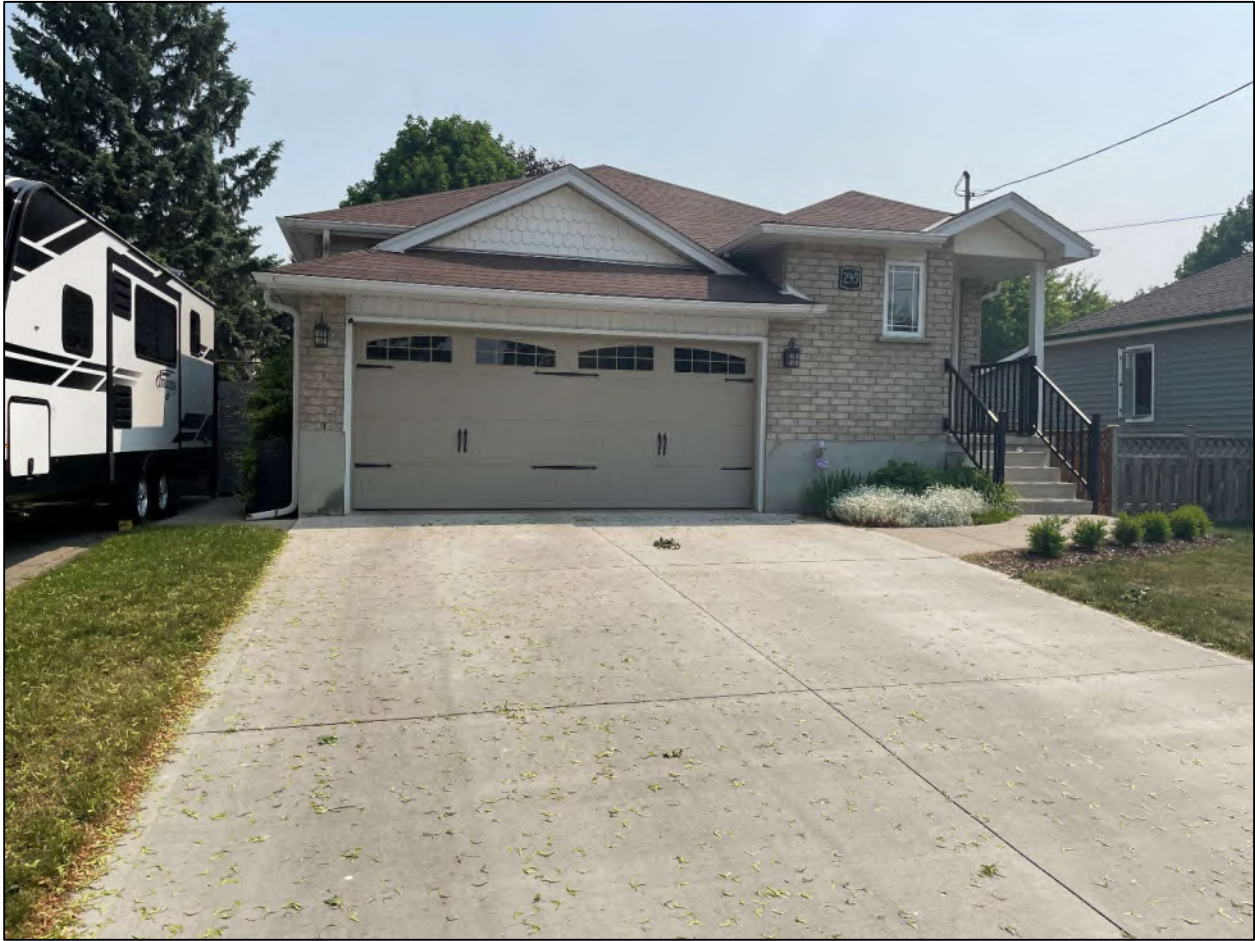
**Figure 46** Example of the residential properties south of the Site on Metcalfe Street, facing northeast.
