ALMA Guelph Phase 2

Preliminary Hydrogeological Investigation

601 Scottsdale Drive, Guelph, ON

September 22, 2023

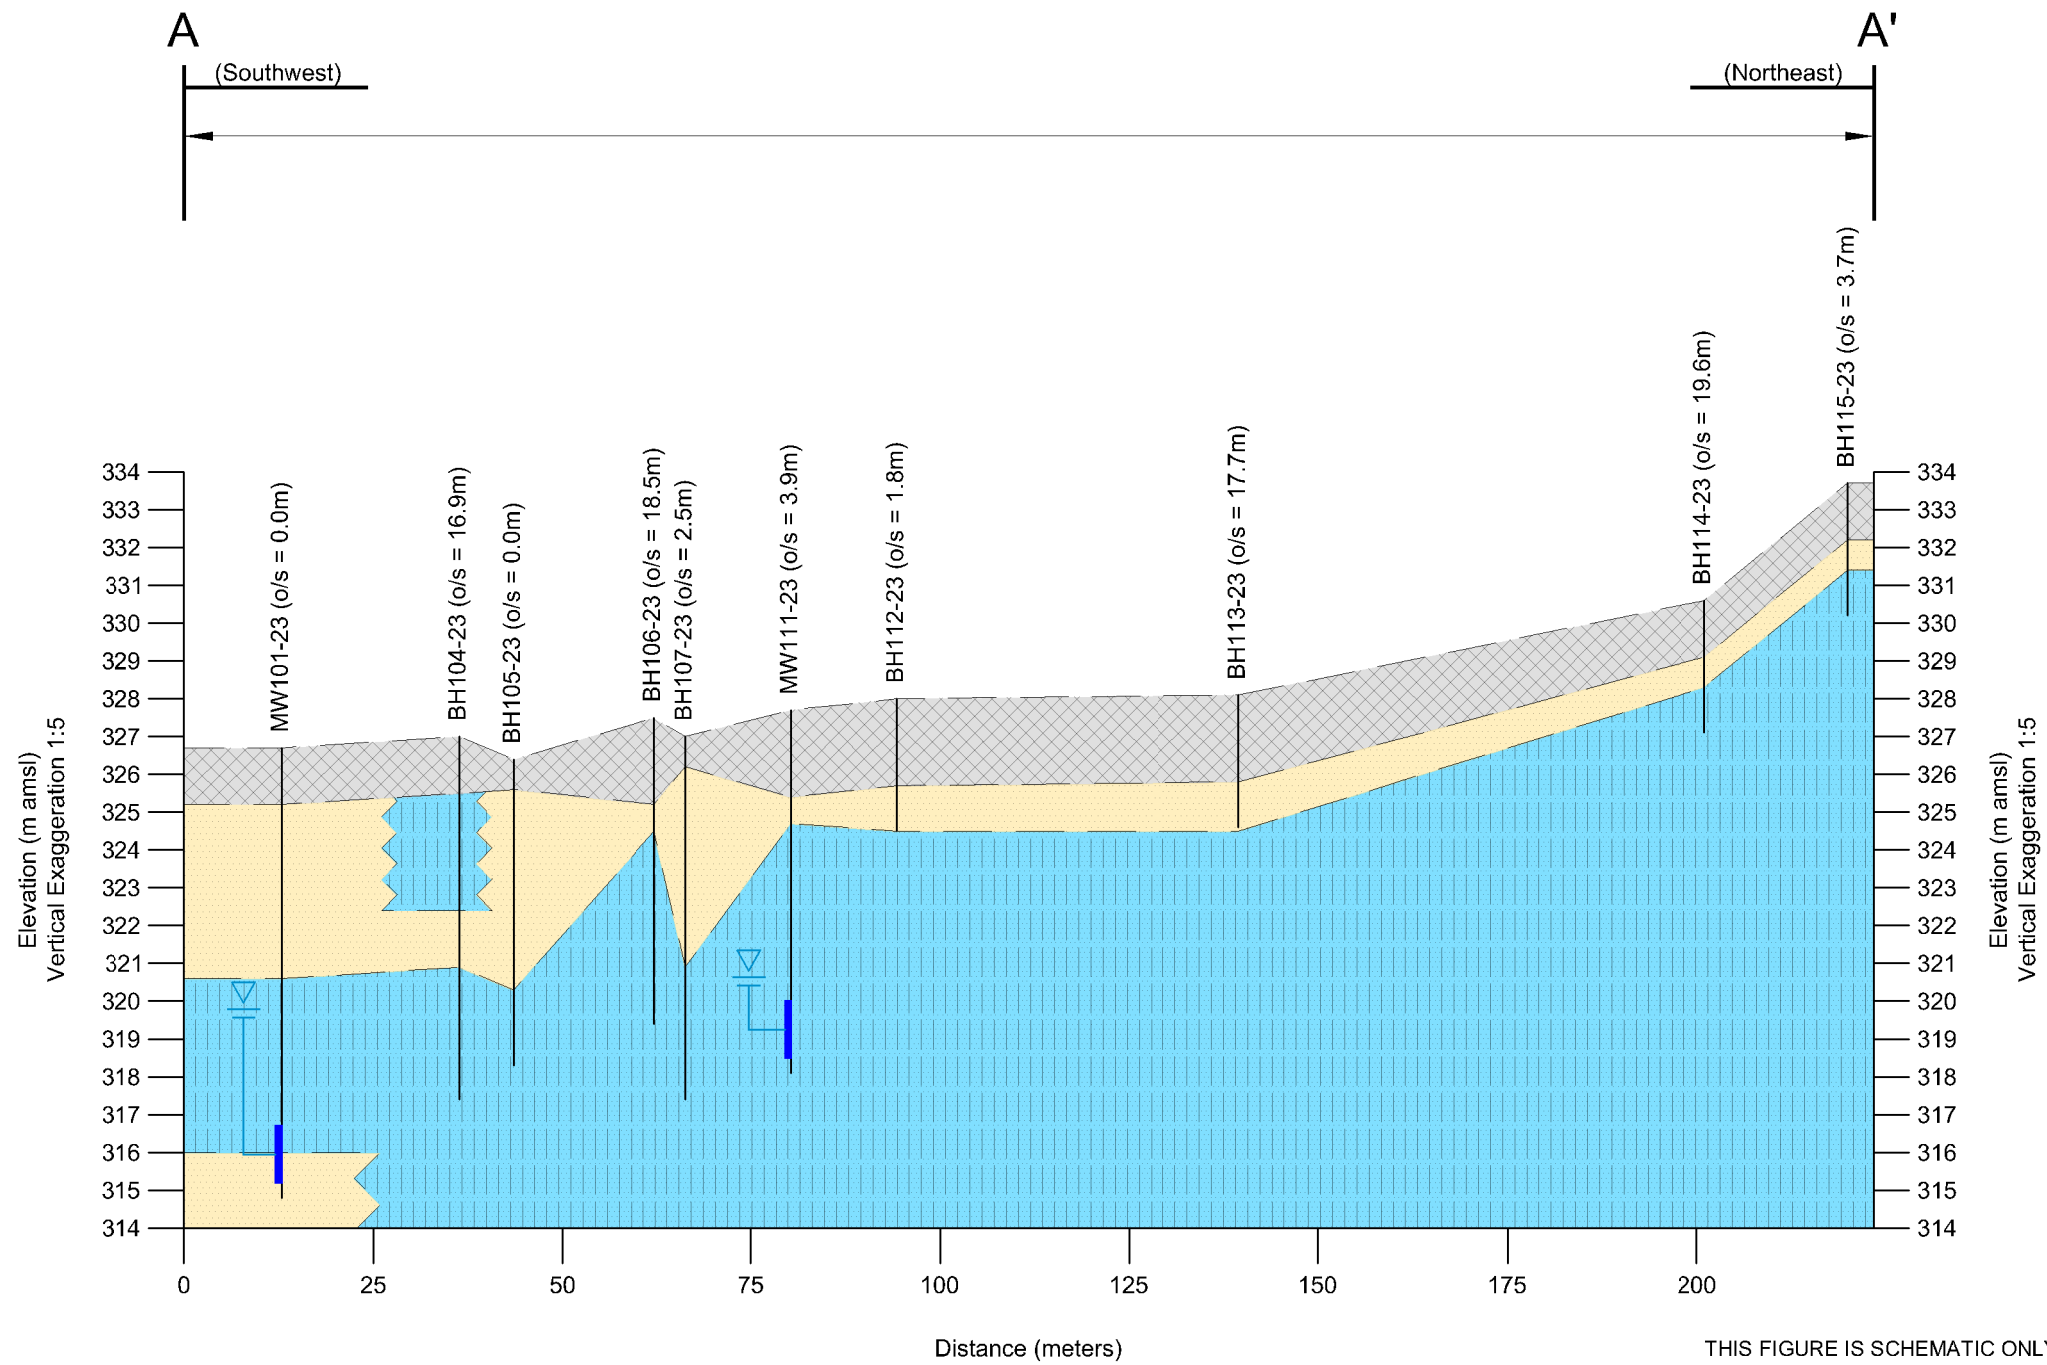
Geological Cross-Section A-A' (Figure 7):

- Extends approximately 225 m from southwest to northeast.
- Topography slopes from southwest to northeast from approximately 327 to 334 m amsl.
- The Site is underlain by fill materials that range in thickness from approximately 1 to 3 m.
- The fill material is underlain by a sand deposit, consisting of gravelly sand to silty sand, extending to approximately 320 m amsl on the southwest and 331 m amsl on the northeast.
- The sand deposit is underlain by sandy silt deposits extending to the depth of the investigation.

The stratigraphy consists of a surficial layer of shallow fill above sand and sandy silt deposits. Bedrock was not encountered in the boreholes to the depths explored (up to 12 m bgl). The sand and sandy silt deposits are consistent with glaciofluvial outwash deposits.

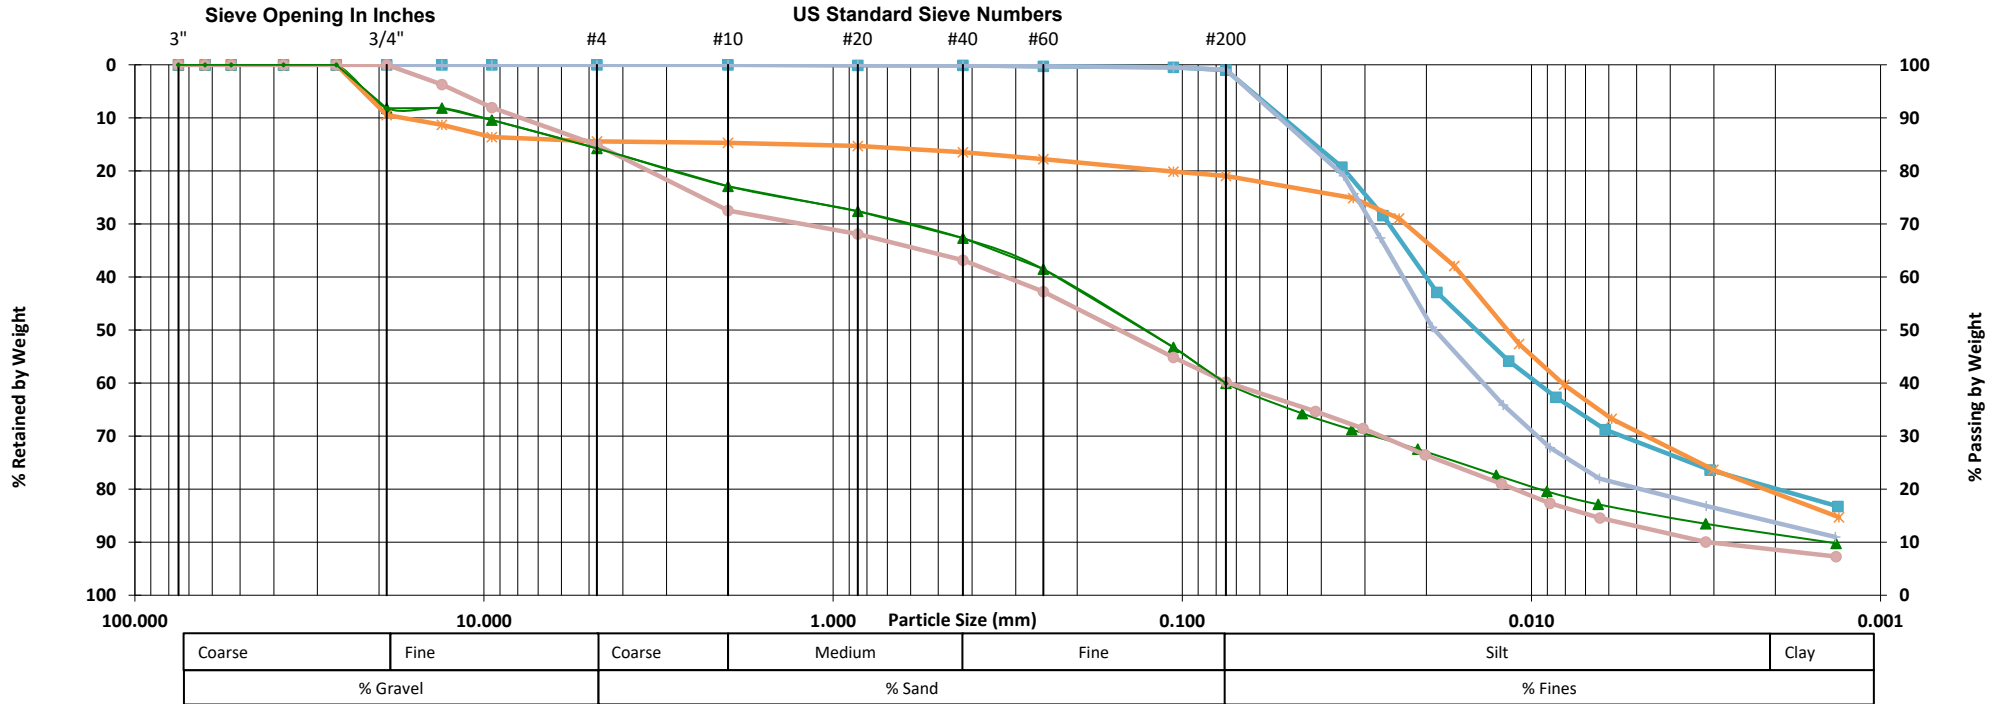
Unified Soil Classification

Symbol	Borehole ID	Sample #	Sample Depth	Description
▲	MW101-23	SS-11	10.7 - 11.1 mbgs	Gravelly Silty SAND, some Clay
■	MW108-23	SS-8	9.1 - 9.8 mbgs	SILT, some Clay, trace Sand
✱	MW111-23	SS-5	3.0 - 3.7 mbgs	SILT, some Clay and Gravel, trace Sand
◆	MW111-23	SS-9	7.6 - 8.2 mbgs	SILT, some Clay, trace Sand
●	BH115-23	SS-3	1.5 - 2.1 mbgs	Gravelly Silty SAND, trace Clay
