**Guelp Lake Subdivision  
Stormwater Management  
Report**

**TYPICAL INFILTRATION  
GALLERY  
SECTION 'B-B'**

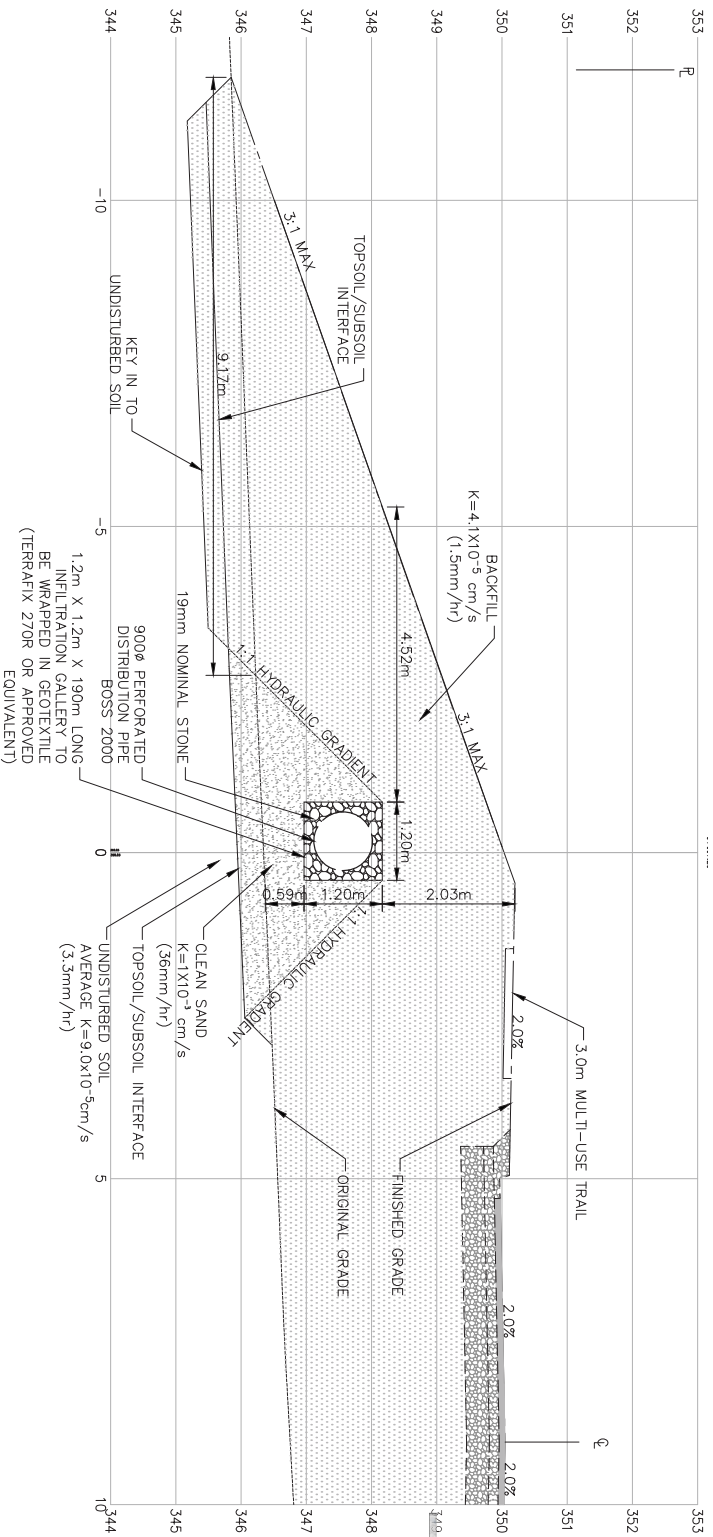
**Figure No. 9c**

FOR STRUCTURE  
OVERFLOW DETAIL,  
SEE P.P.1.

SCALE 1:75  
JULY 2015
