City Of Guelph

Structure 112 Mcdonell Street Soffit Inspection Report

GMBP File: 123117

February 29, 2024

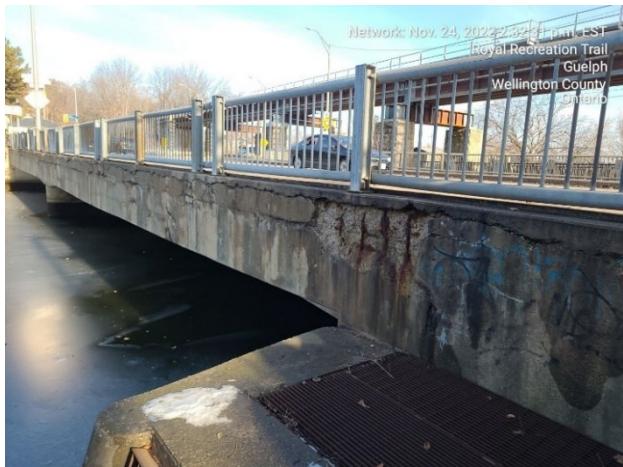
Photo 1: December 7, 2022 Inspection

North Fascia showing severe delamination, exposed corroded rebar and spalls:

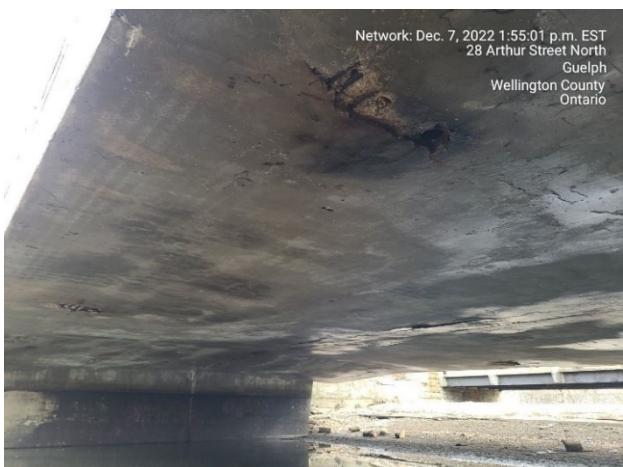
Photo 3: December 7, 2022 Inspection

Northwest deck drain showing severe delamination and rust stains:

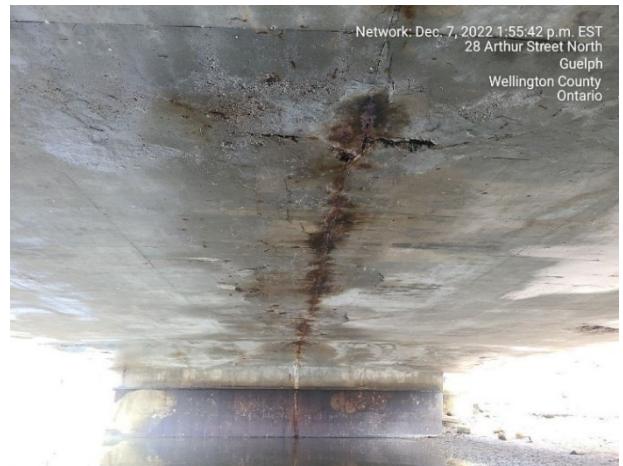
Photo 5: December 7, 2022 Inspection

West span soffit showing wide crack with moisture staining, efflorescence and rust staining on centerline:

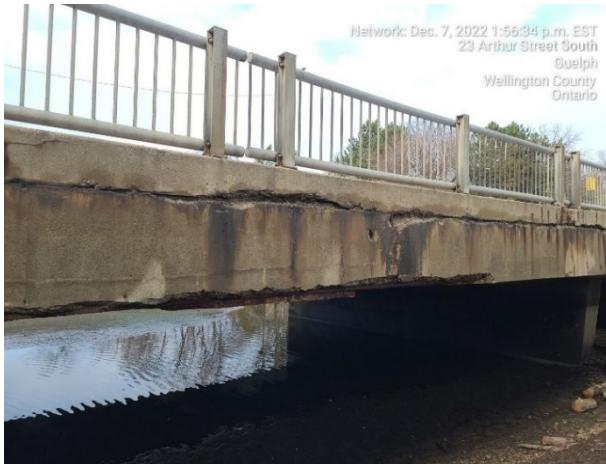
Photo 7: December 7, 2022 Inspection

South fascia showing spalls and exposed corroded rebar:

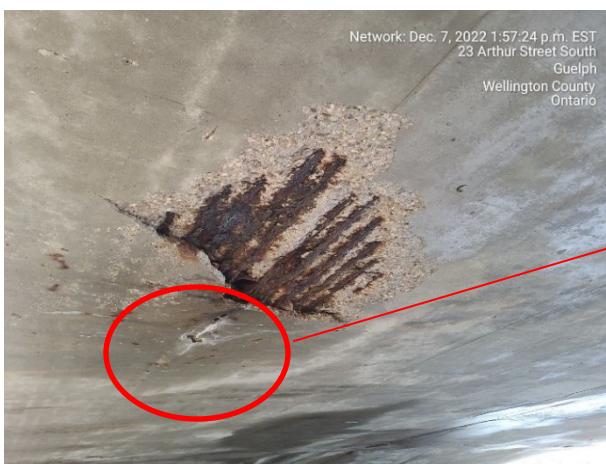
Photo 9: December 7, 2022 Inspection

South soffit showing spalls and exposed corroded rebar:

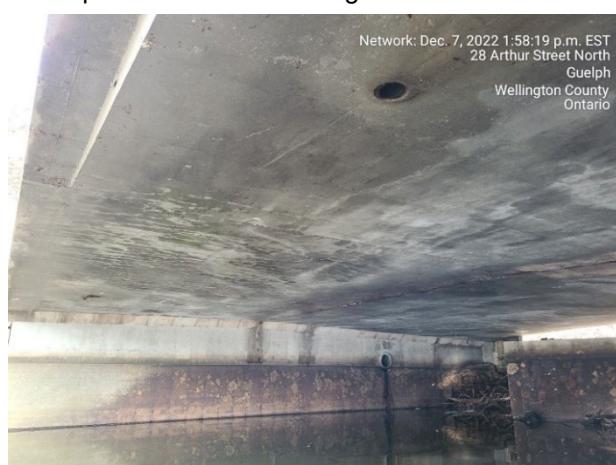
Photo 11: December 7, 2022 Inspection

East span deck soffit showing wide crack with moisture staining, efflorescence and rust staining on centerline:

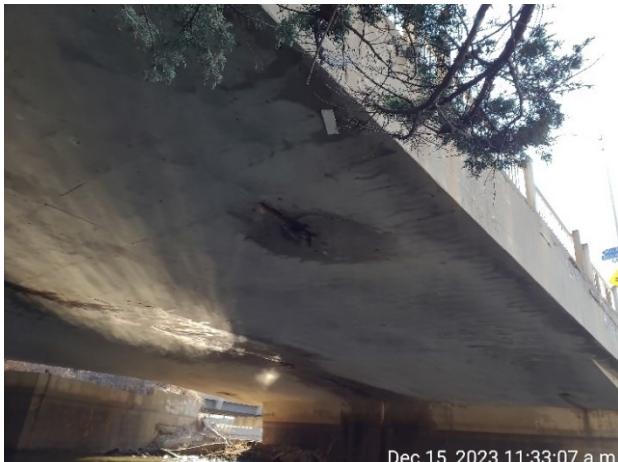
Photo 13: December 7, 2022 Inspection

Northeast deck drain showing severe delamination:

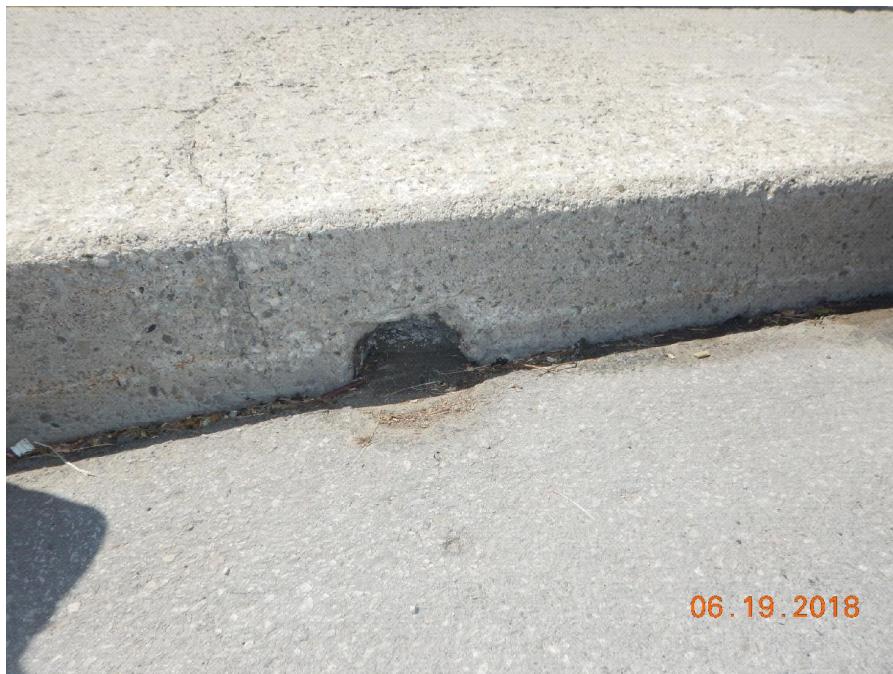
Plugged curb drains

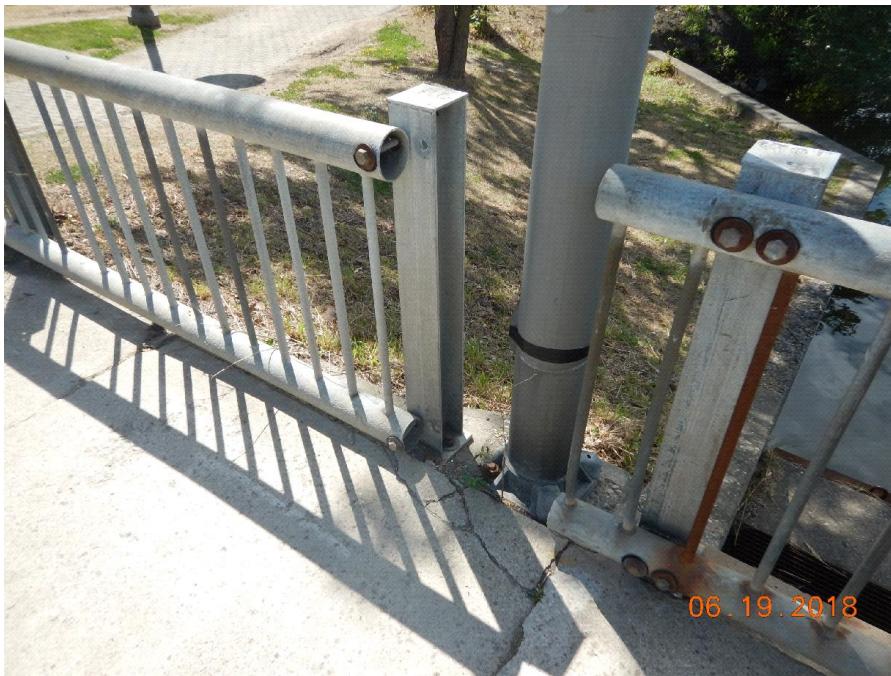
Northwest railing, missing end cap

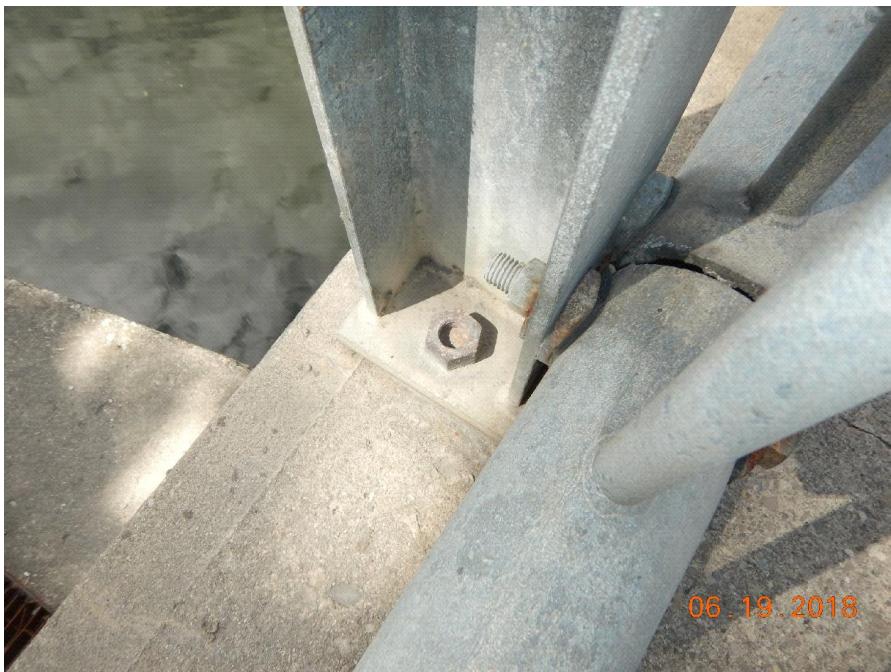
Insufficient bolt length on northwest railing

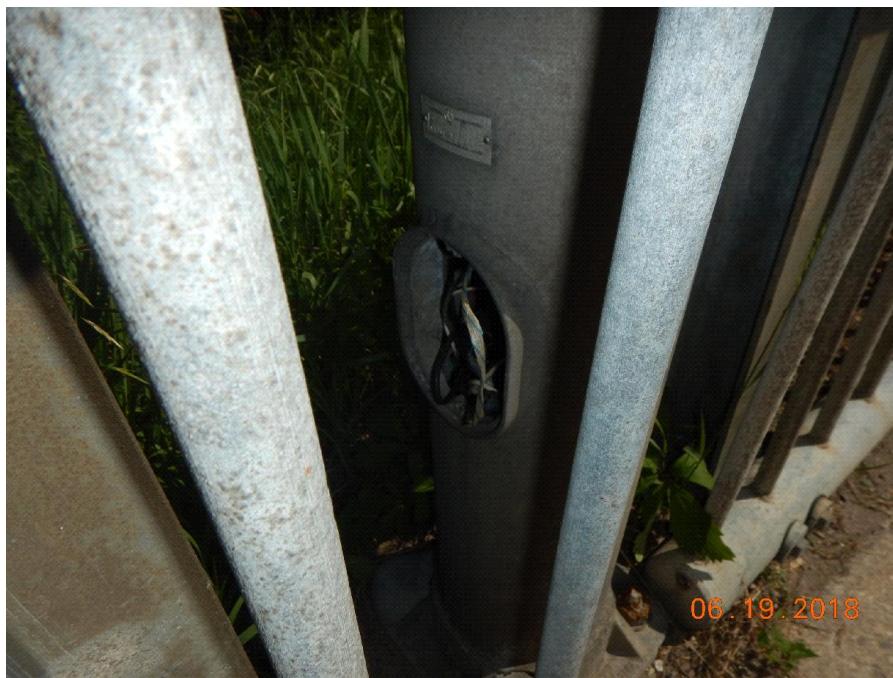
Southwest light post, missing electrical cover

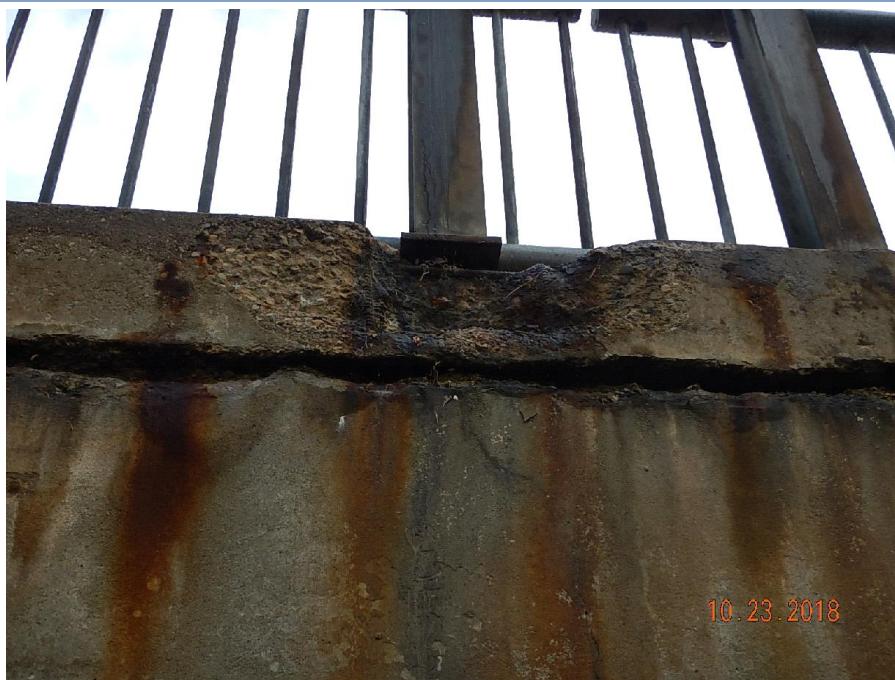
Southeast exterior soffit, spall at post base

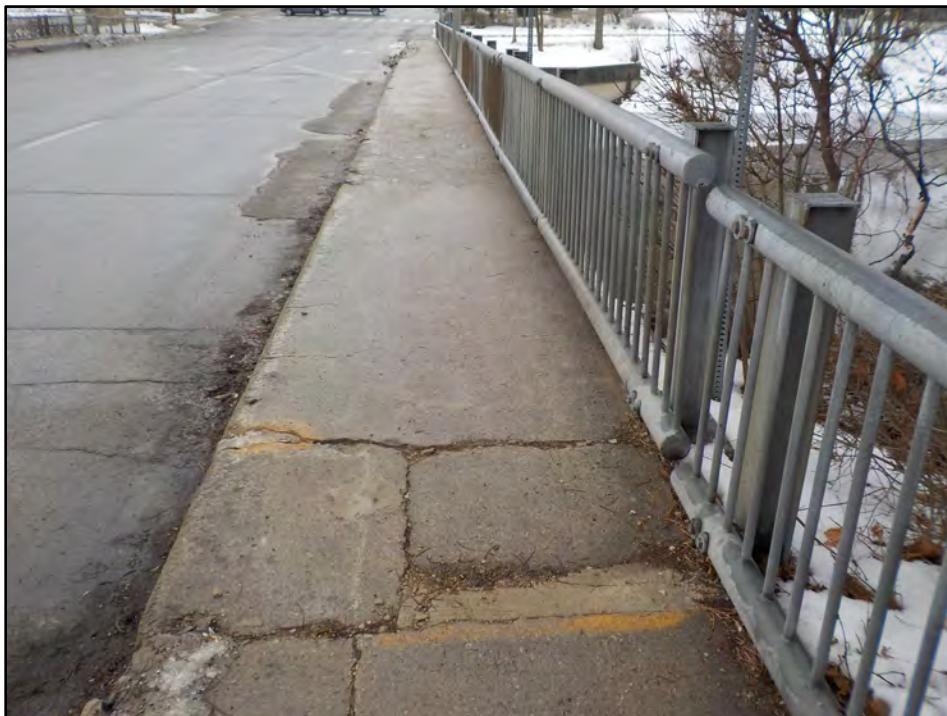
Photo 8: Wide Cracks on North Sidewalk at East End of Deck

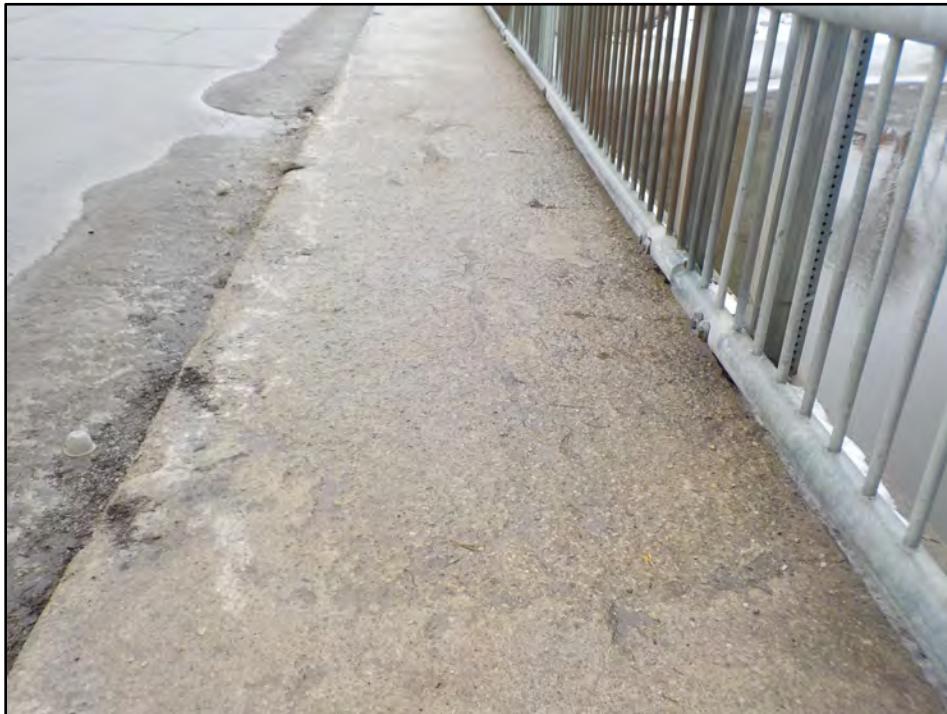
Photo 9: Light to Moderate Scaling on North Sidewalk

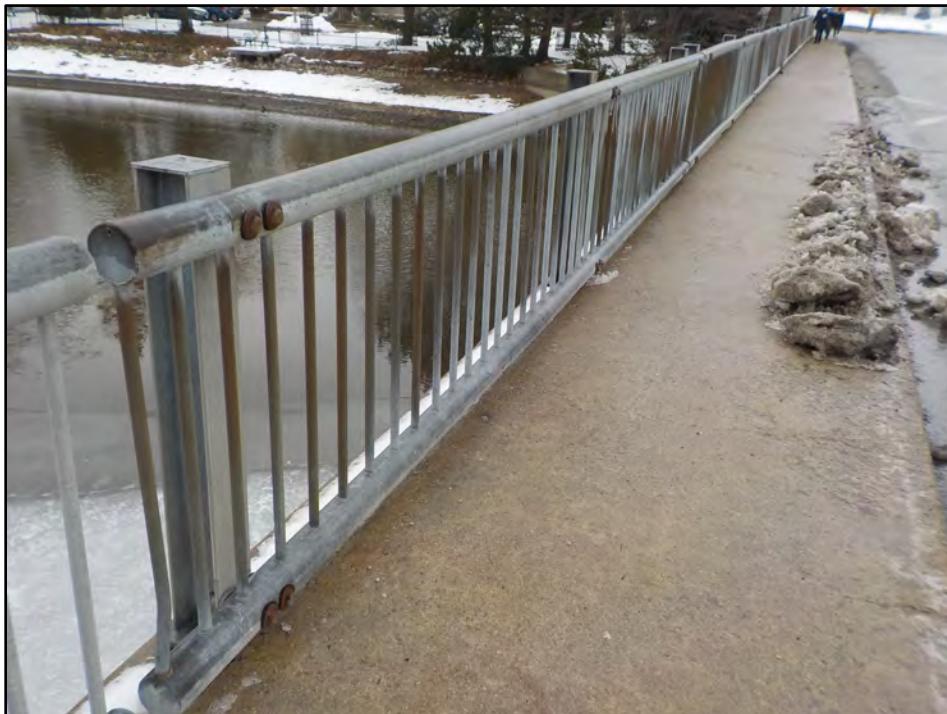
Photo 10: Light to Localized Moderate Corrosion on Steel Barrier

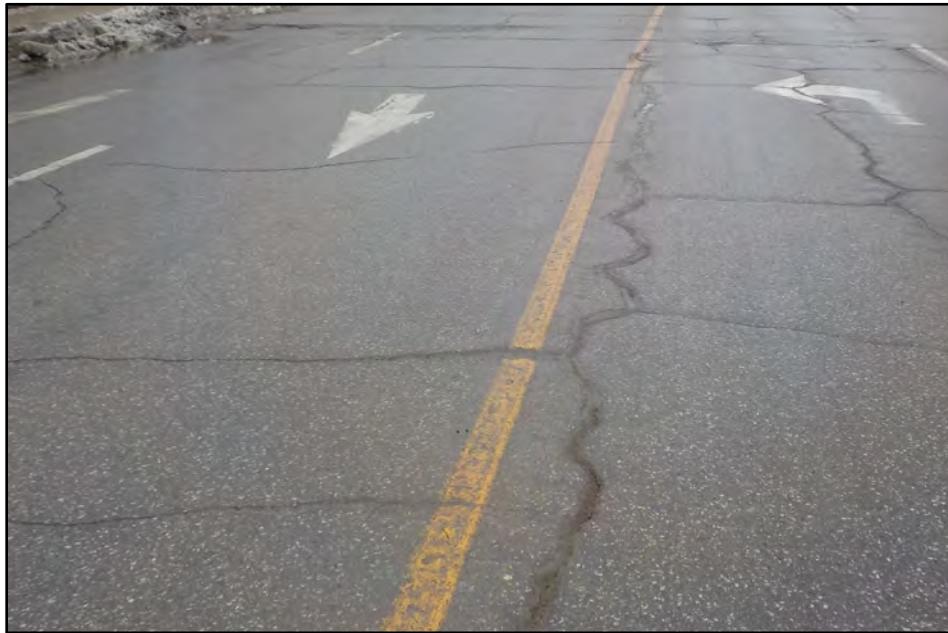
Photo 11: Wide Transverse and Longitudinal Cracks on Deck Wearing Surface

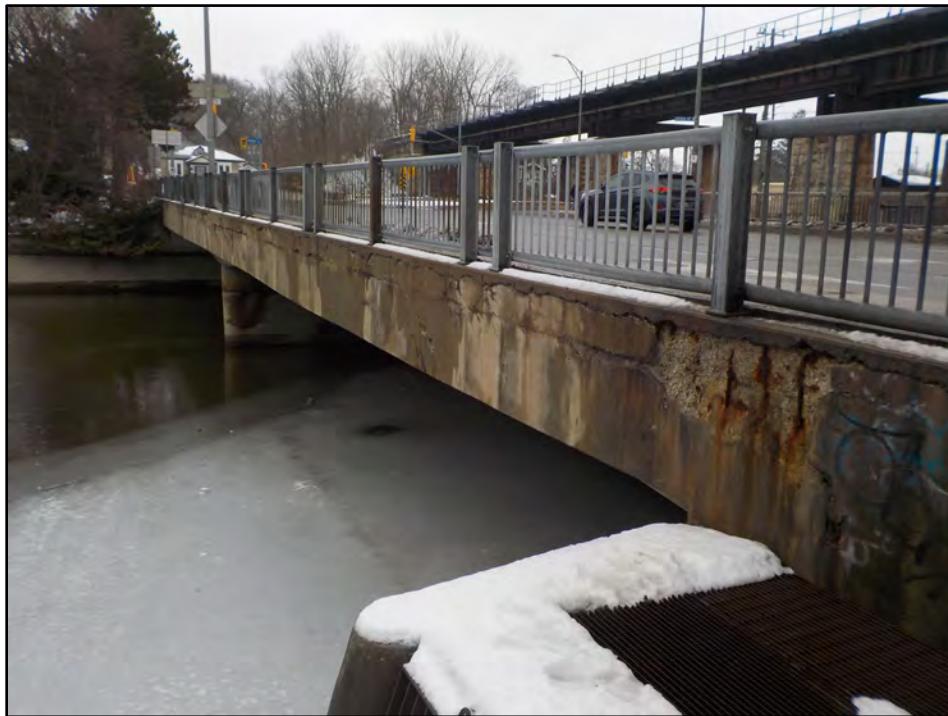
Photo 12: Medium Cracks and Large Spall with Exposed Corroded Reinforcing Steel on North Soffit Fascia

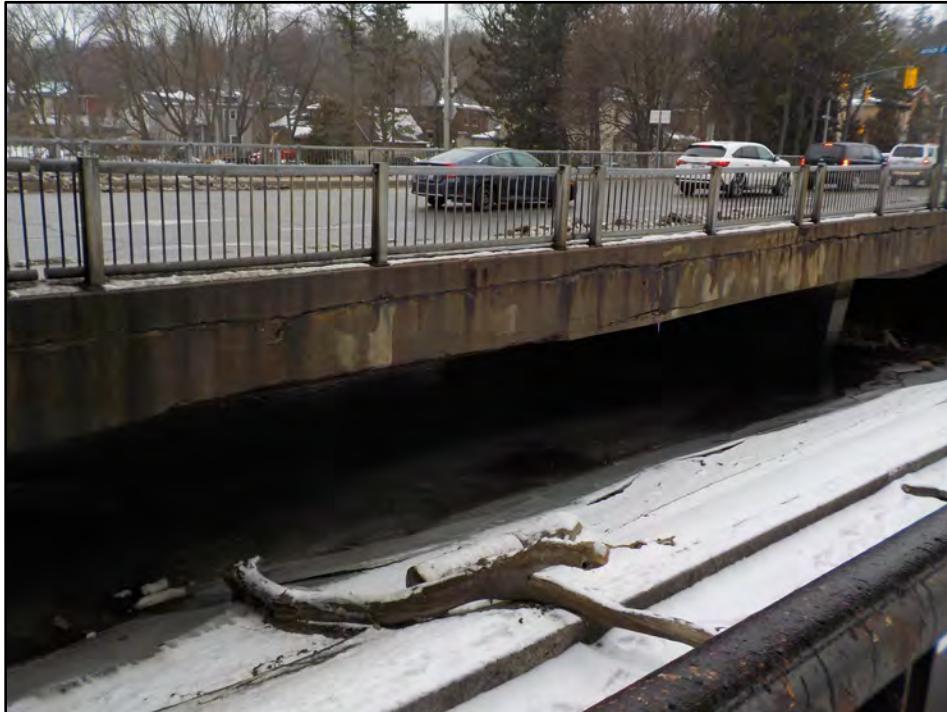
Photo 13: Wide Cracks and Delaminated Concrete on South Soffit Fascia

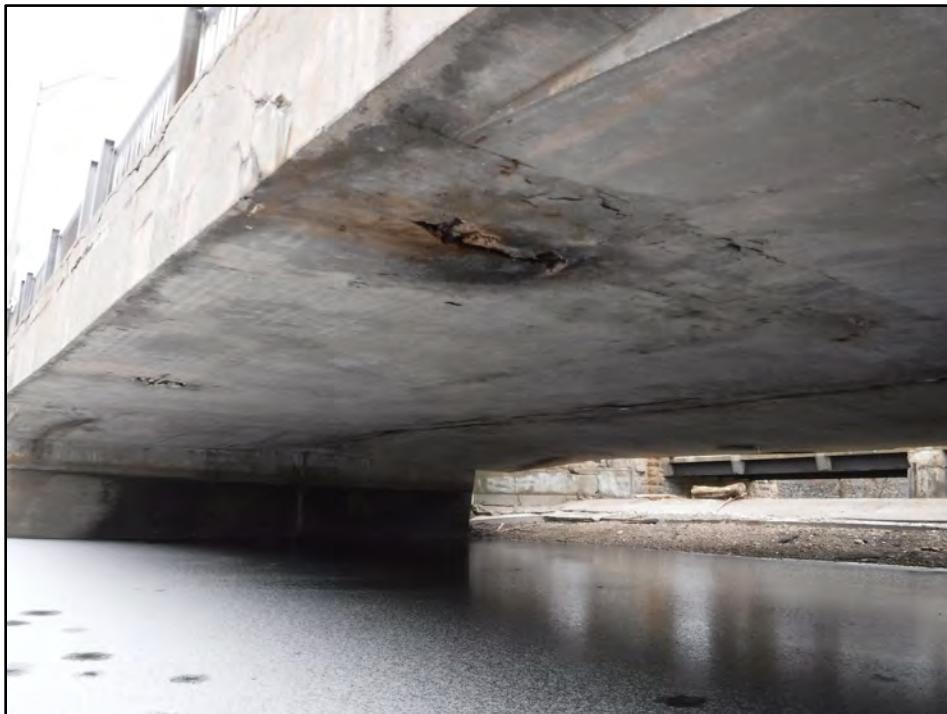
Photo 14: Spall with Exposed Corroded Reinforcing Steel and Delaminated Concrete on Soffit, West End of West Span

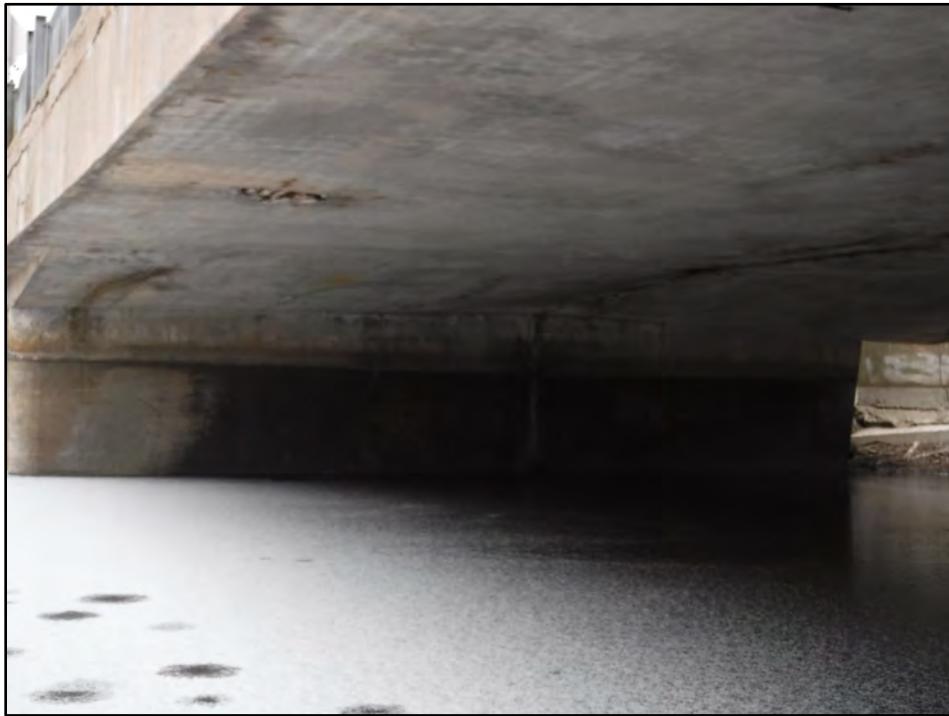
Photo 15: Spall with Exposed Corroded Reinforcing Steel and Delaminated Concrete on Soffit, Center of West Span

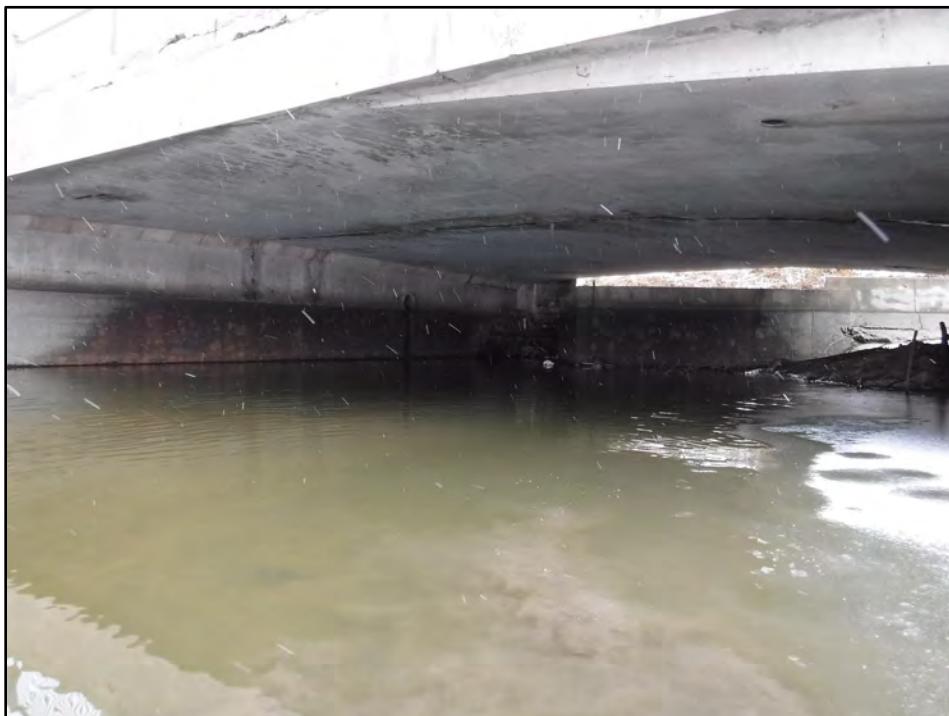
Photo 16: Wide Longitudinal Crack with Damp Staining, Full Length of East Span Soffit

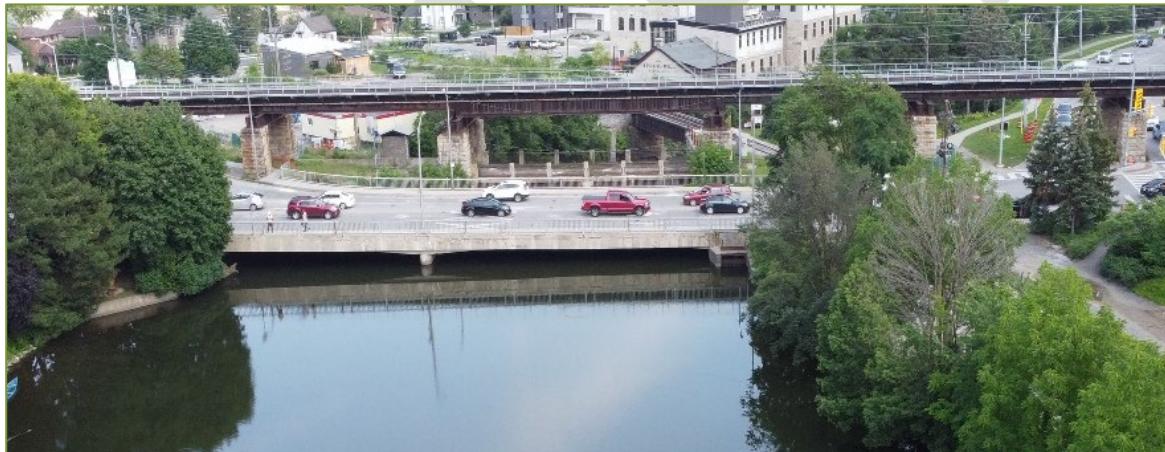
North Elevation of Site No. 112, Macdonell Bridge

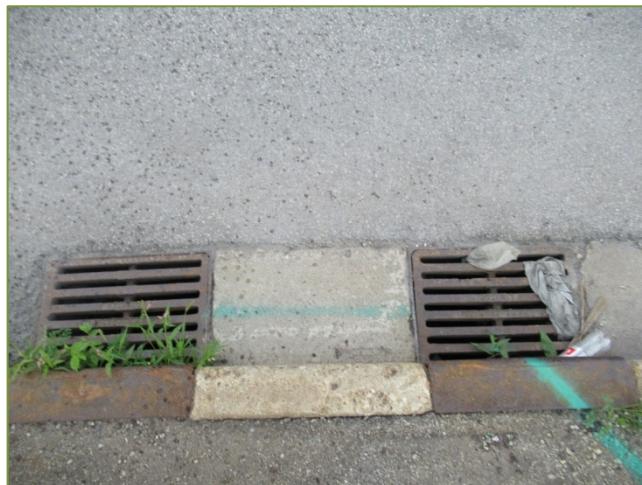
Typical Condition of Catch Basin @ Southeast

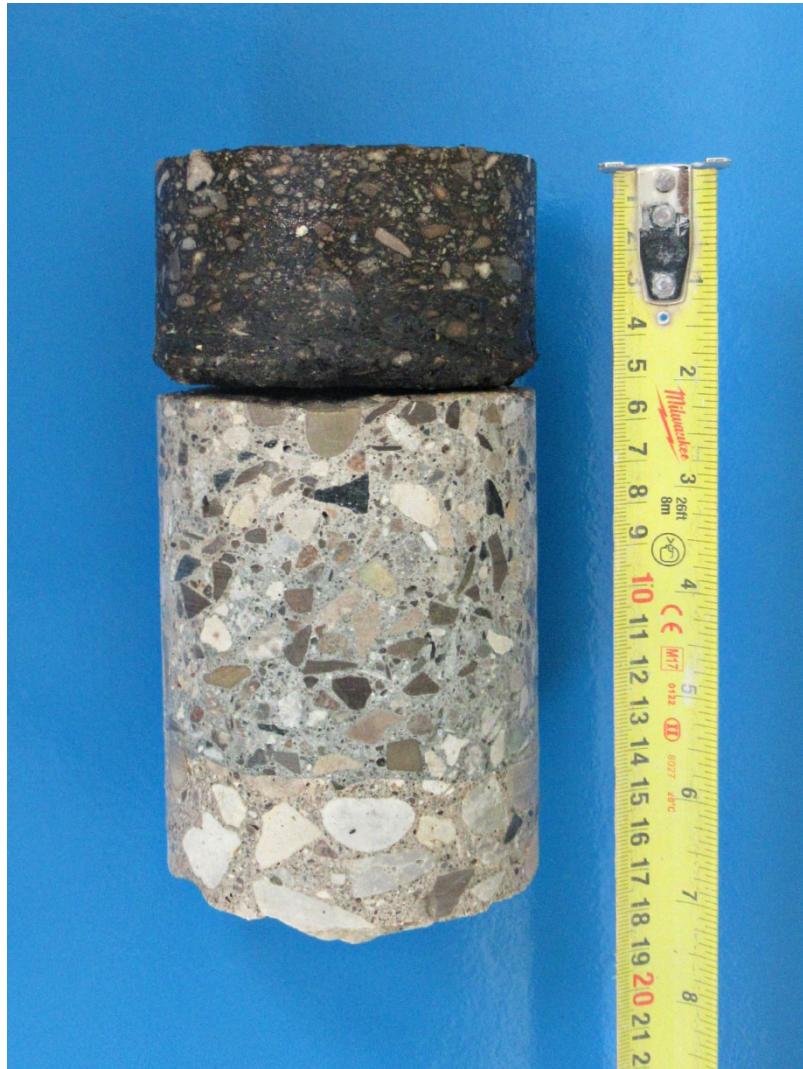
Core C5

The concrete overlay, encountered in the coreholes, varied in depth from 55 mm to 130 mm. The concrete cover on the upper rebar layer was found to range from 75 to 135 mm with an average cover of 111 mm. Light rusting of the reinforcement steel was found in core C20. Severe rusting of the reinforcement was noted in core C5.

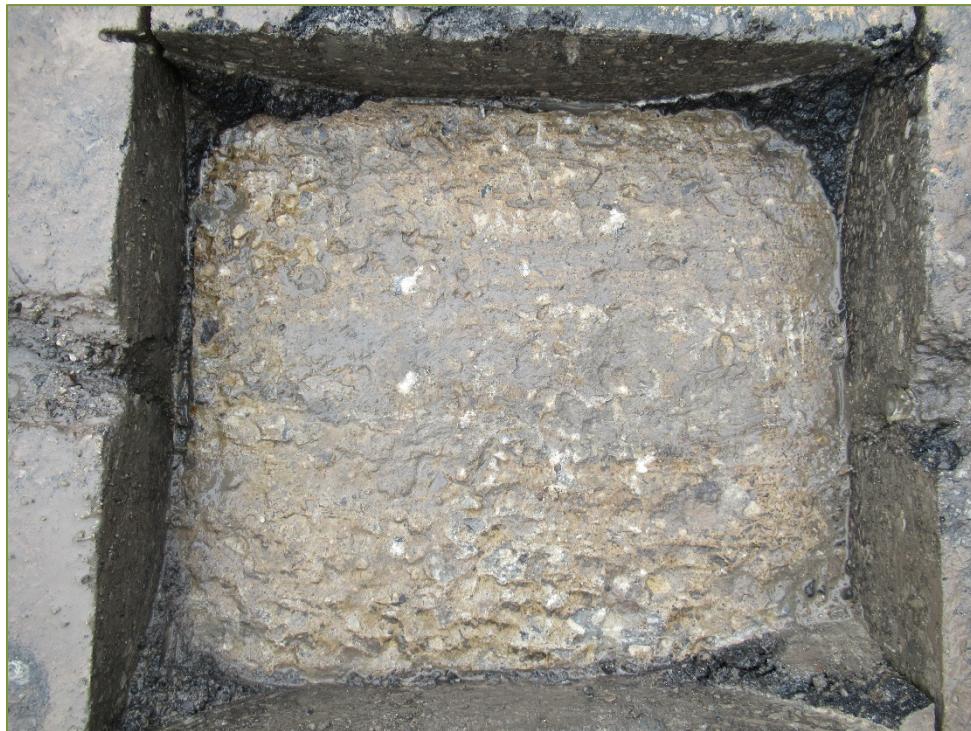
Photo S1 – Sawn Sample SS1 (medium scaling)

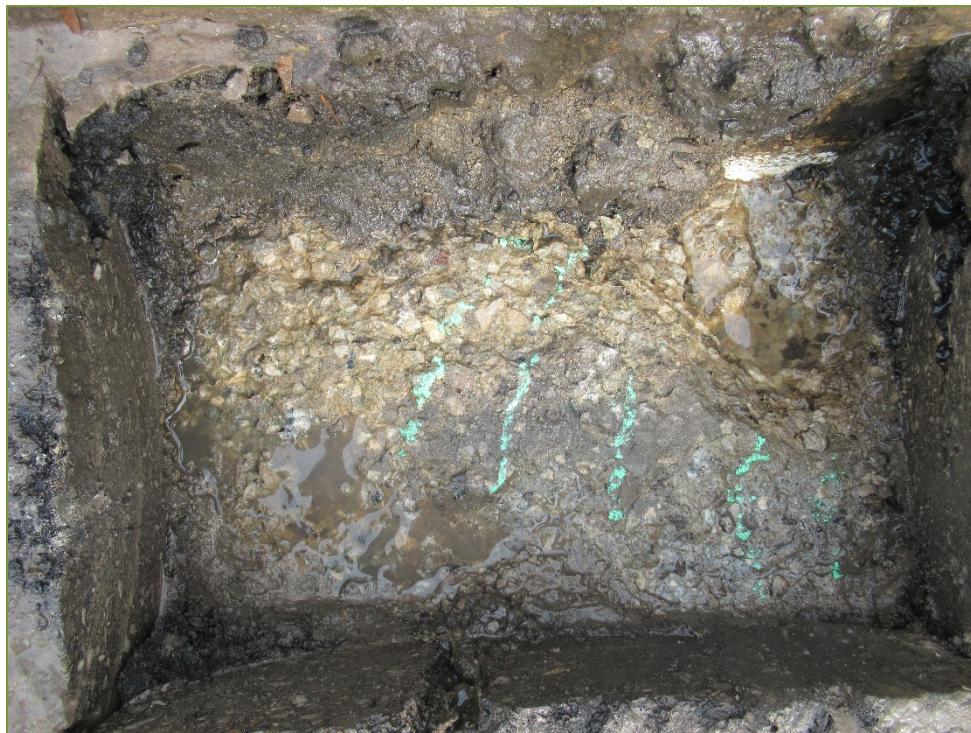
Photo S2 – Sawn Sample SS2 (delamination, and severe scaling)

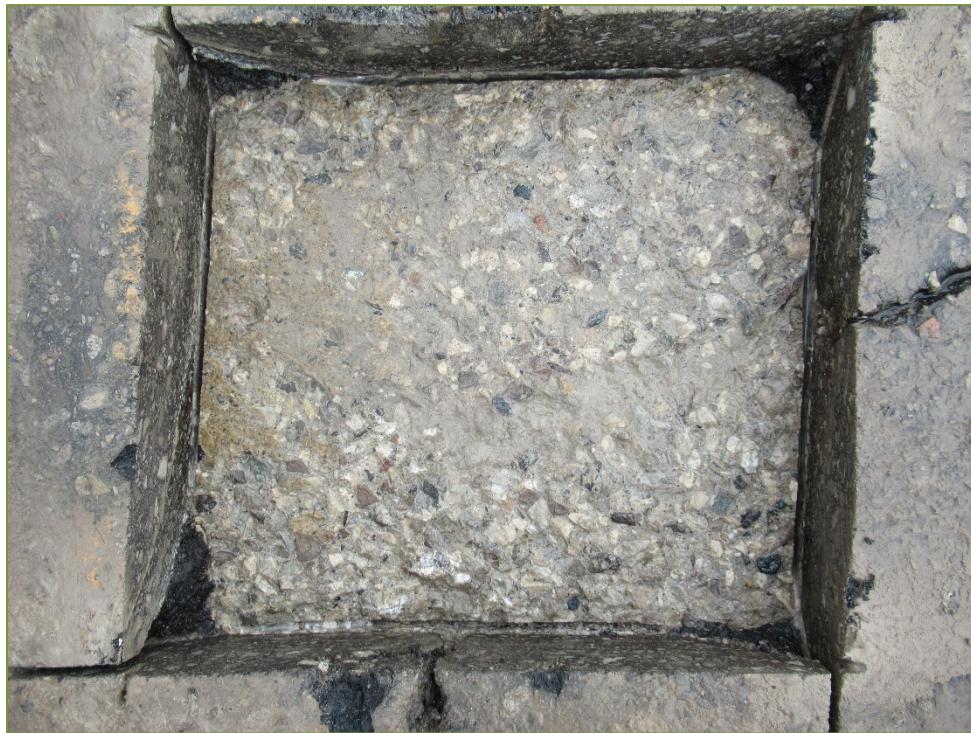
Photo S3 – Sawn Sample SS3 (medium scaling)

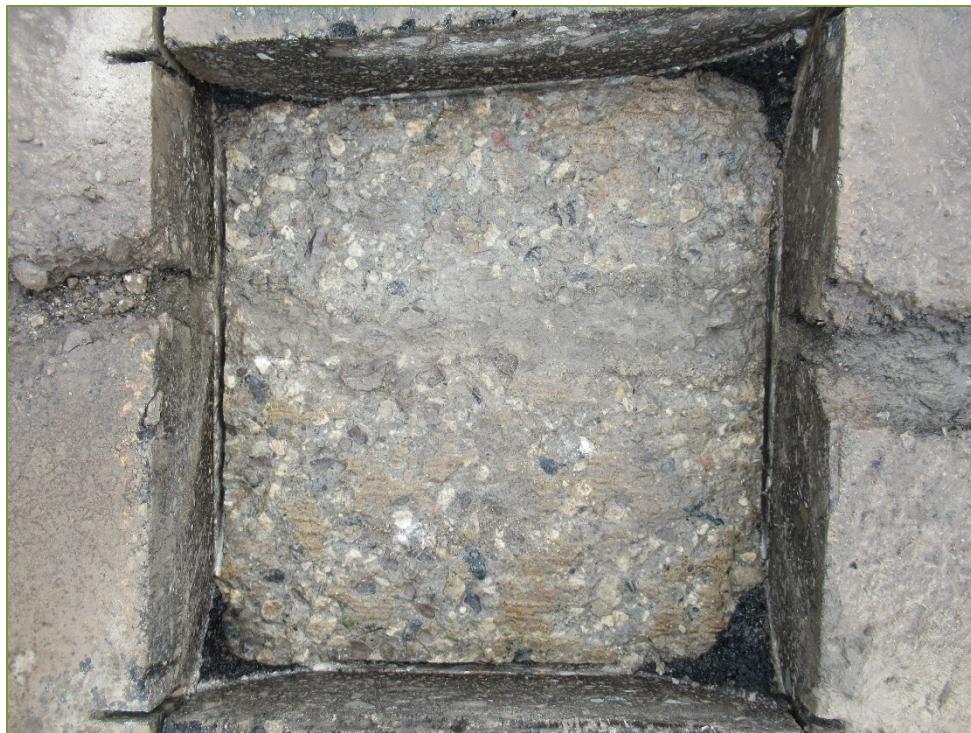
Photo S4 – Sawn Sample SS4 (medium scaling)

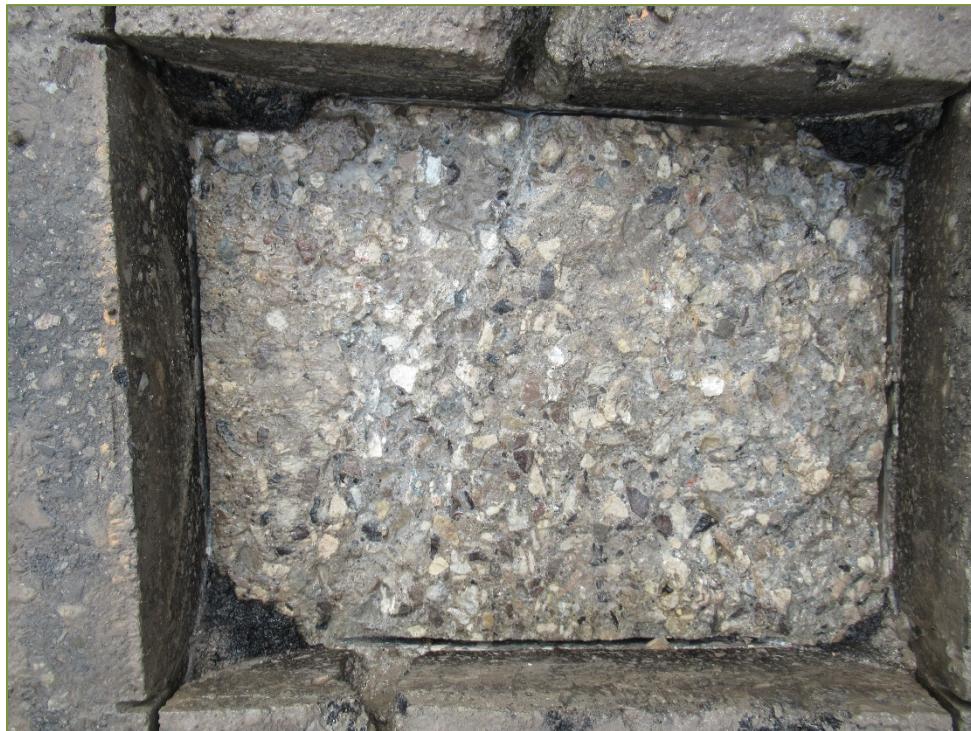
Photo S5 – Sawn Sample SS5 (severe scaling)

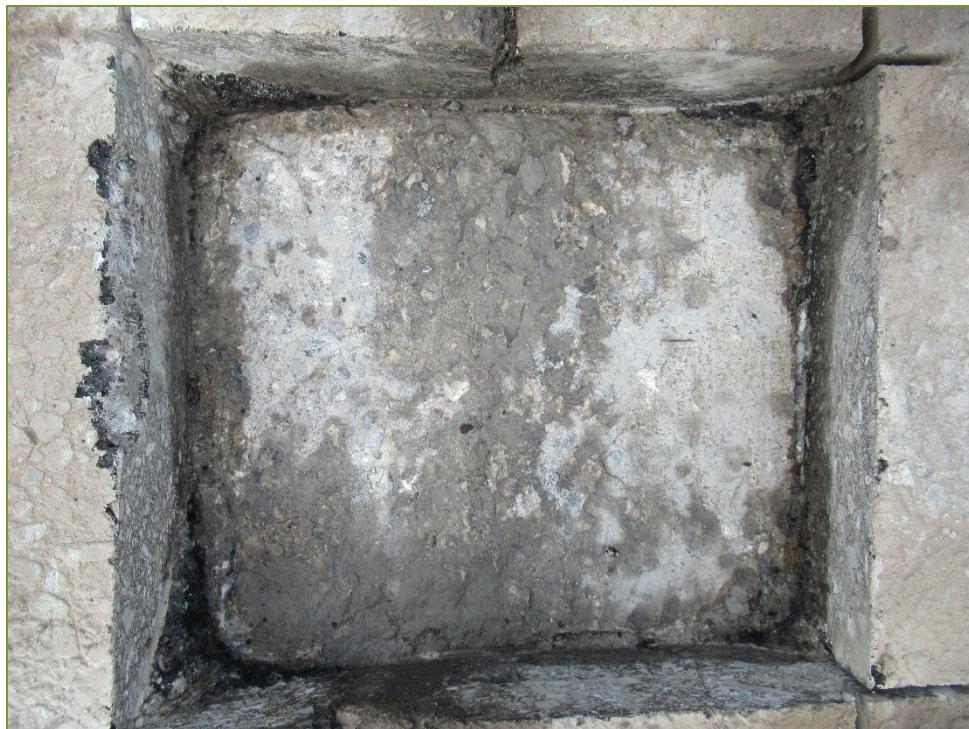
Photo S6 – Sawn Sample SS6 (medium scaling)

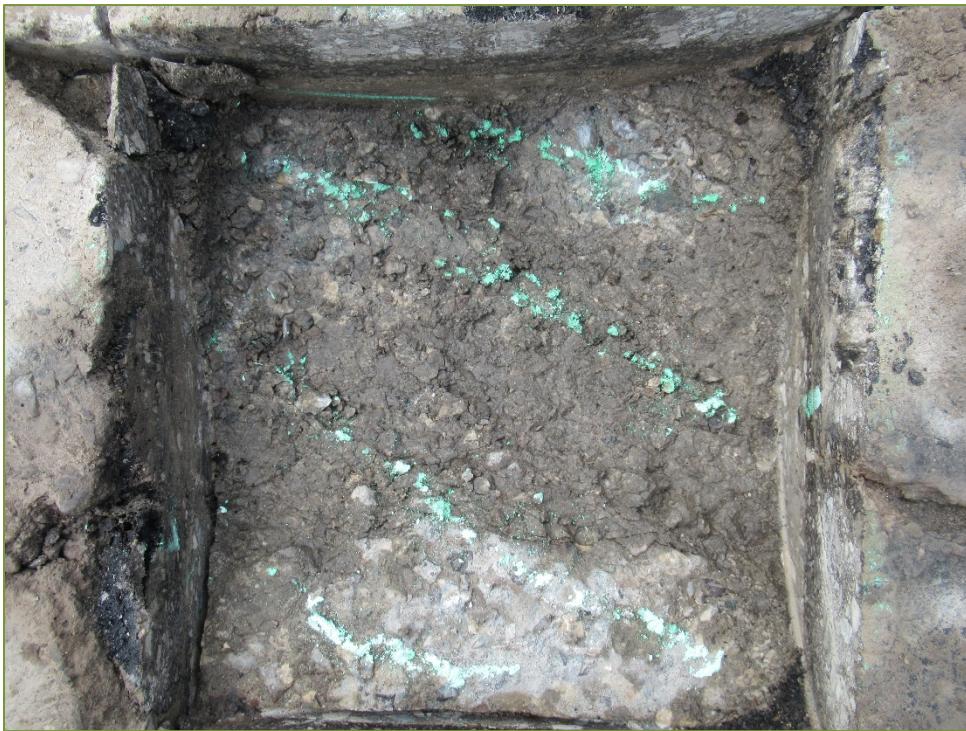
Photo S7 – Sawn Sample SS7 (delamination, and severe scaling)

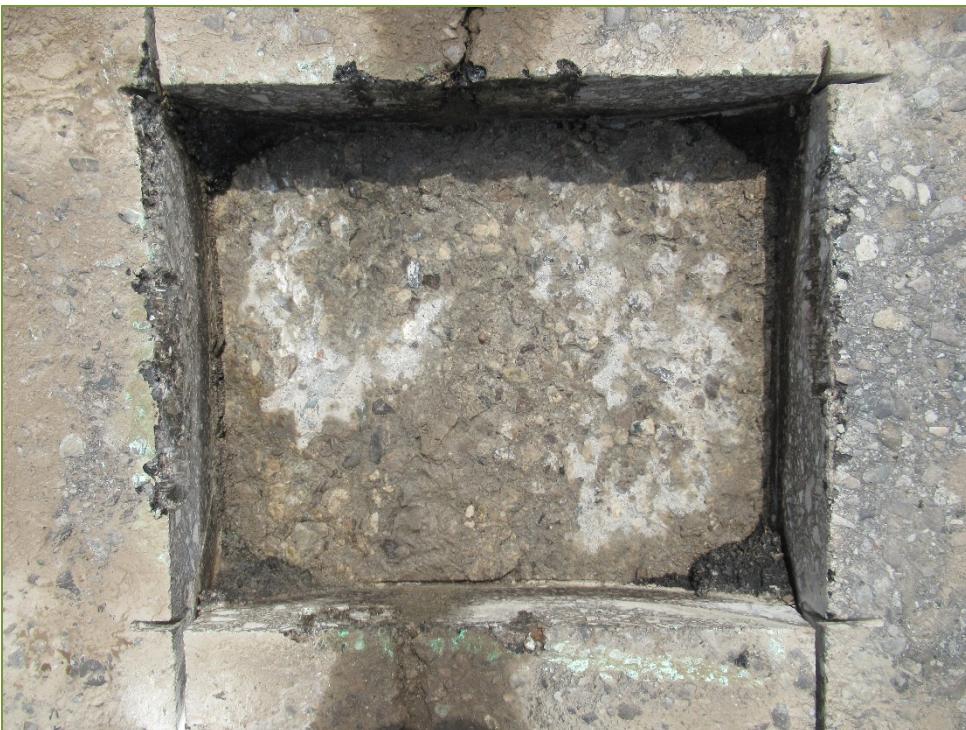
Photo S8 – Sawn Sample SS8 (medium scaling)

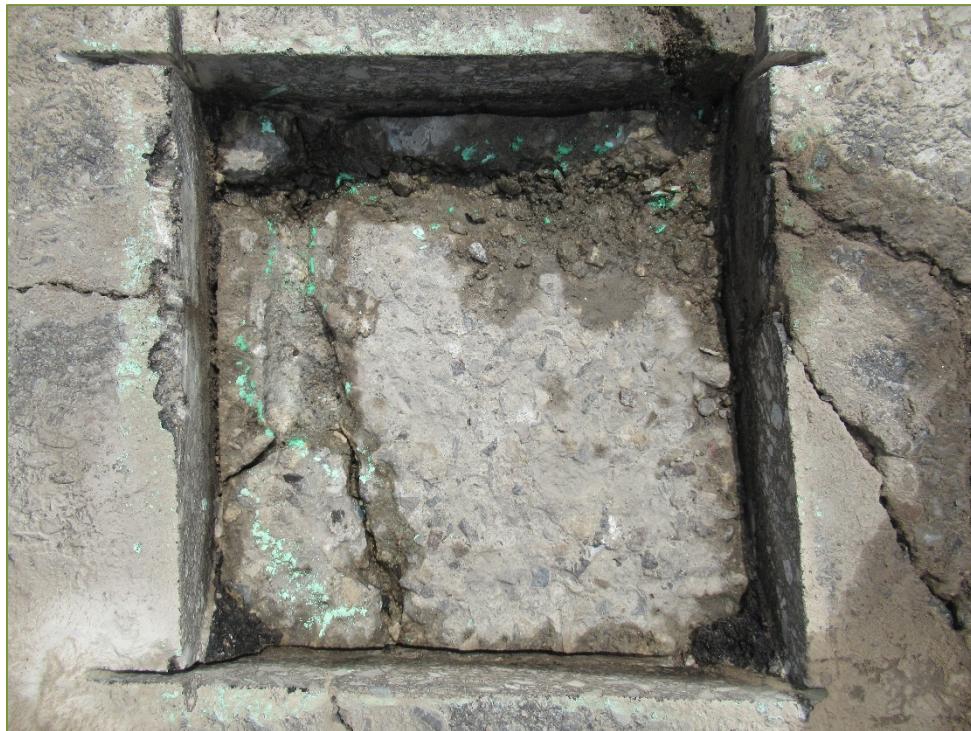
Photo S9 – Sawn Sample SS9 (delamination, and severe scaling)

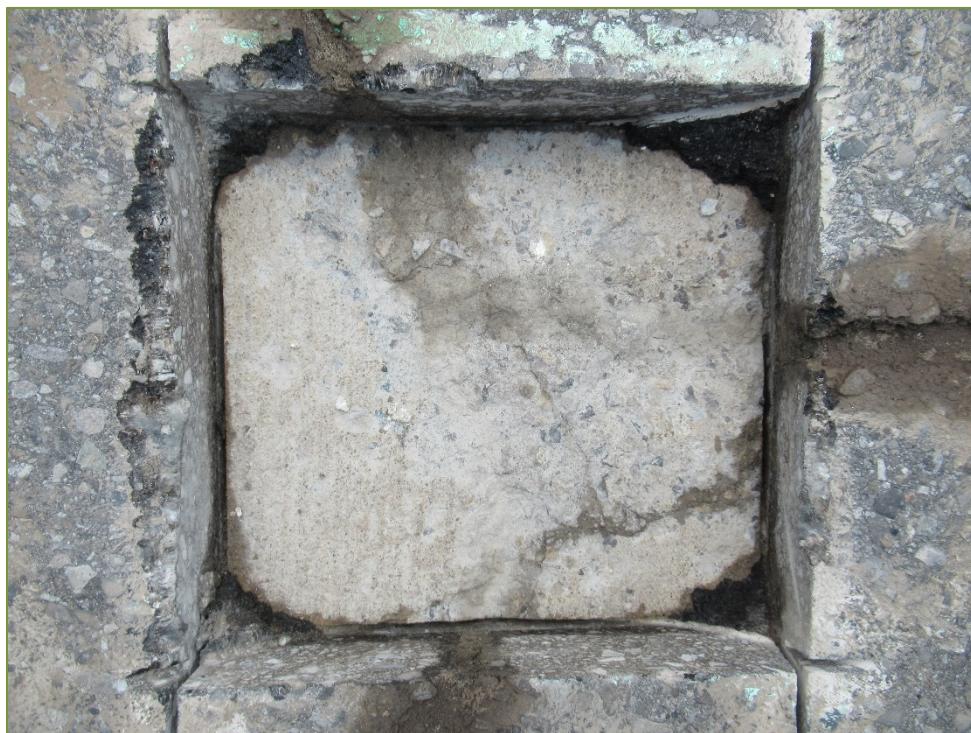
Photo S10 – Sawn Sample SS10 (crack, and medium scaling)

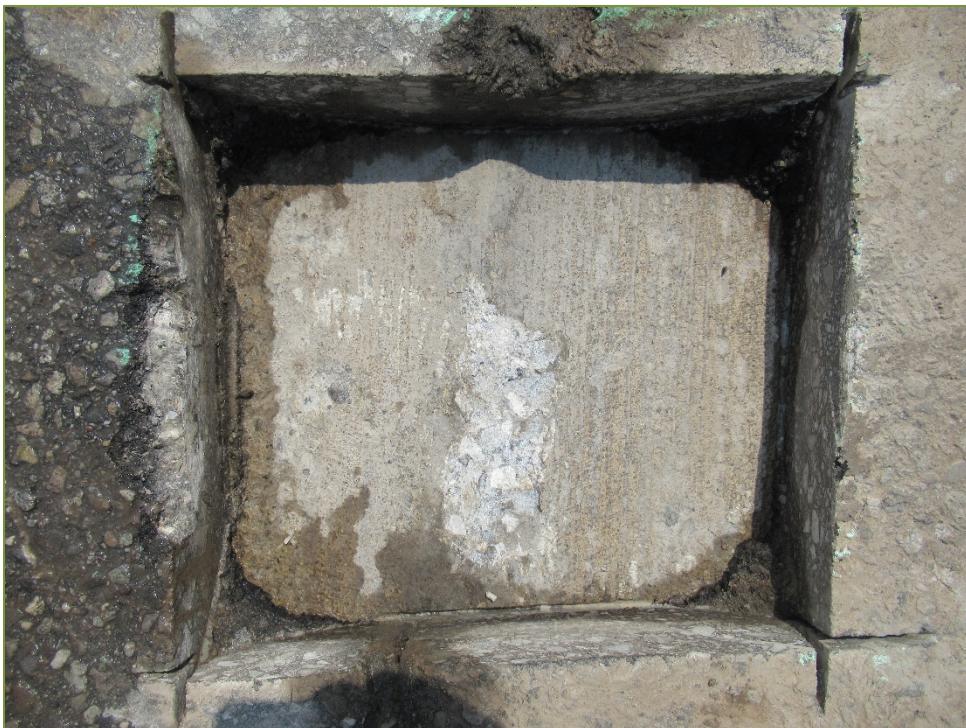
Photo S12 – Sawn Sample SS12 (light scaling)

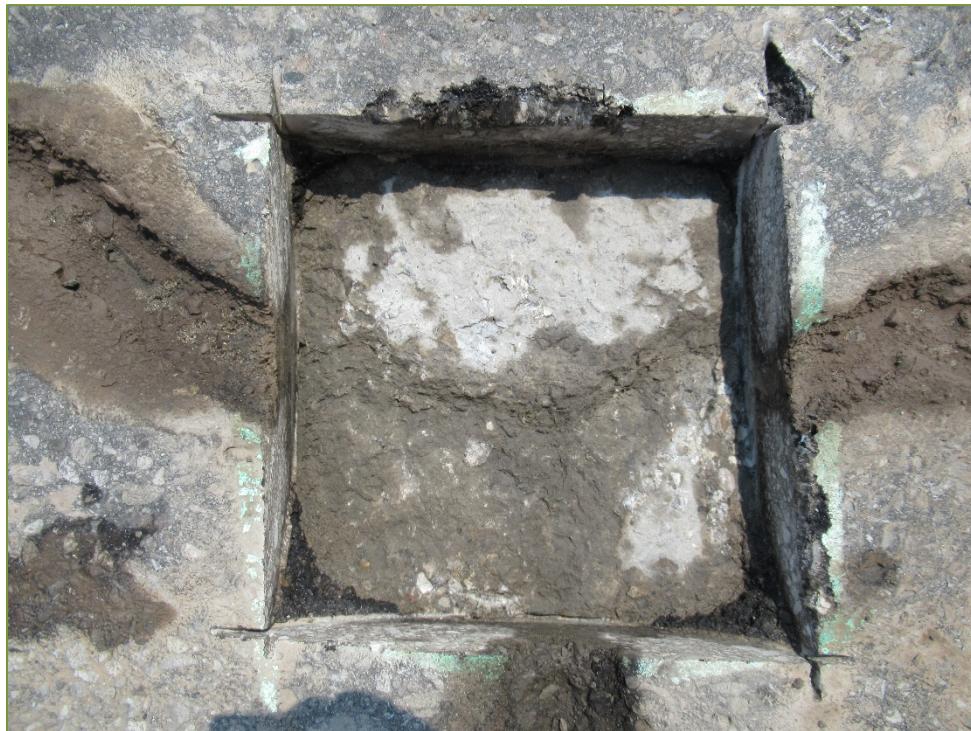
Photo S13 – Sawn Sample SS13 (severe scaling)

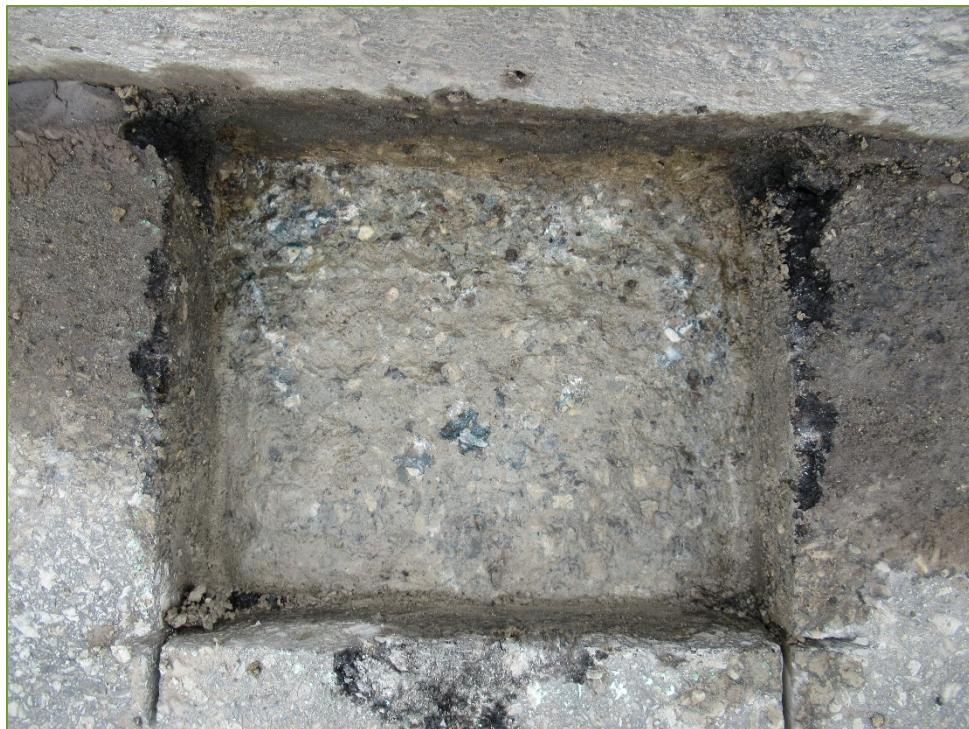
Photo S14 – Sawn Sample SS14 (severe scaling)
