City Of Guelph

Structure 112 Mcdonell Street Soffit Inspection Report

GMBP File: 123117

February 29, 2024

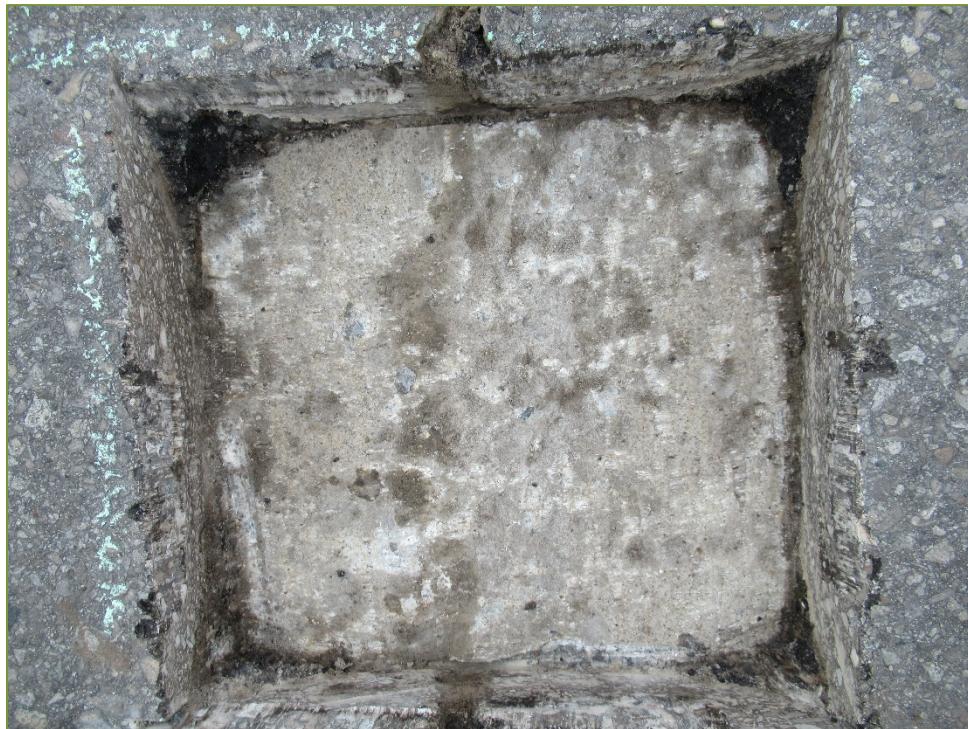
Photo S15 – Sawn Sample SS15 (light scaling)

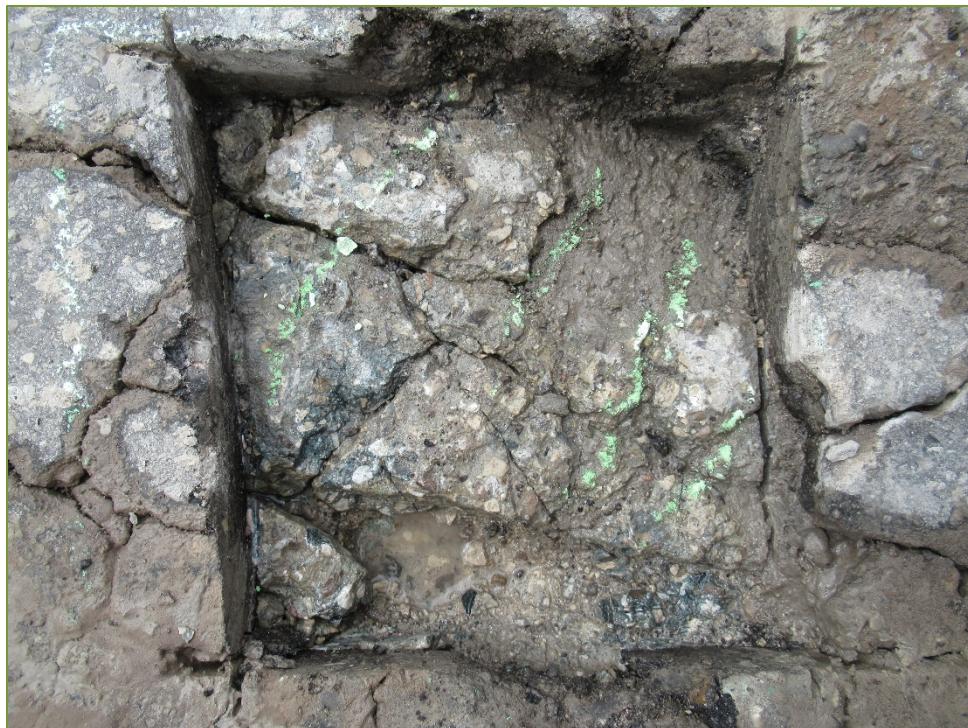
Photo S16 – Sawn Sample SS16 (cracks, delamination, and severe scaling)

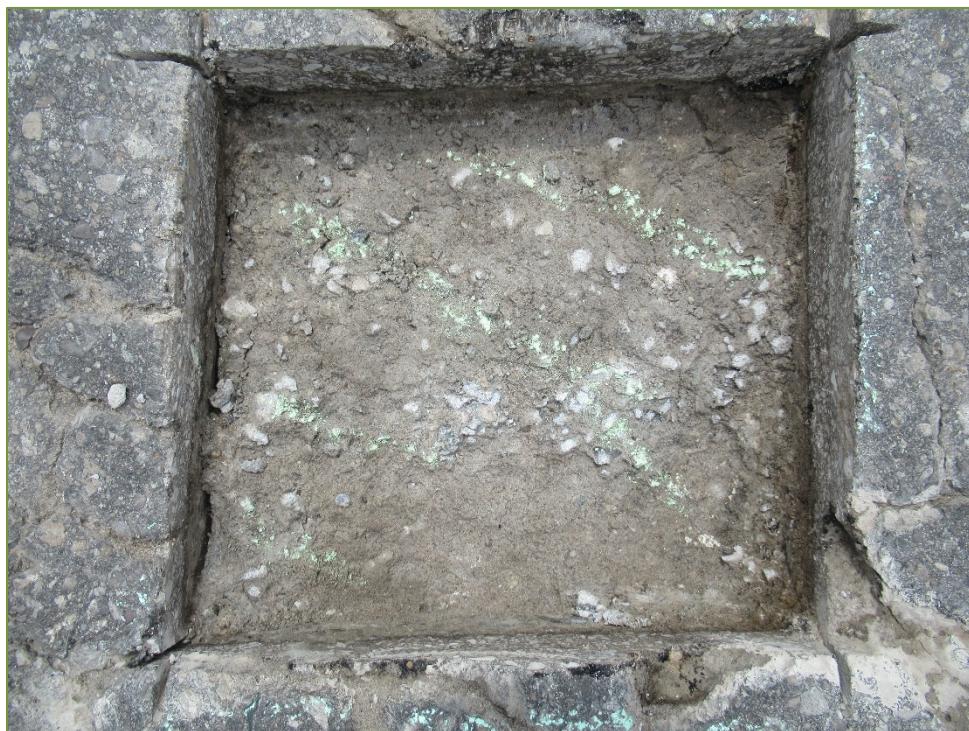
Photo S18 – Sawn Sample SS18 (delamination, and severe scaling)

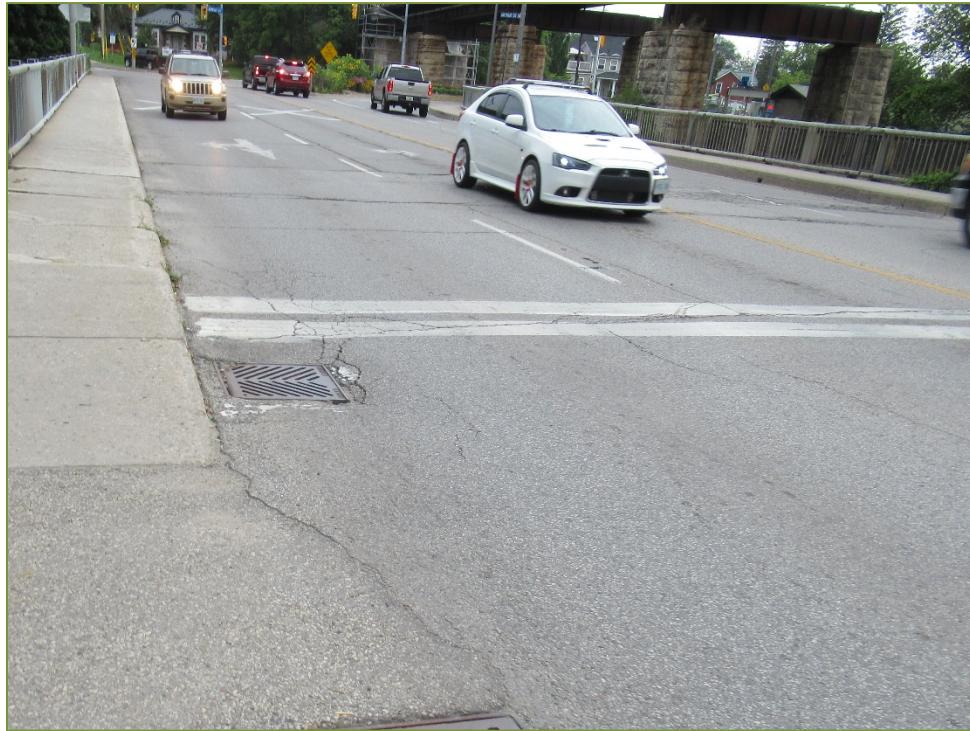
Photo P3 Deck General View, looking east

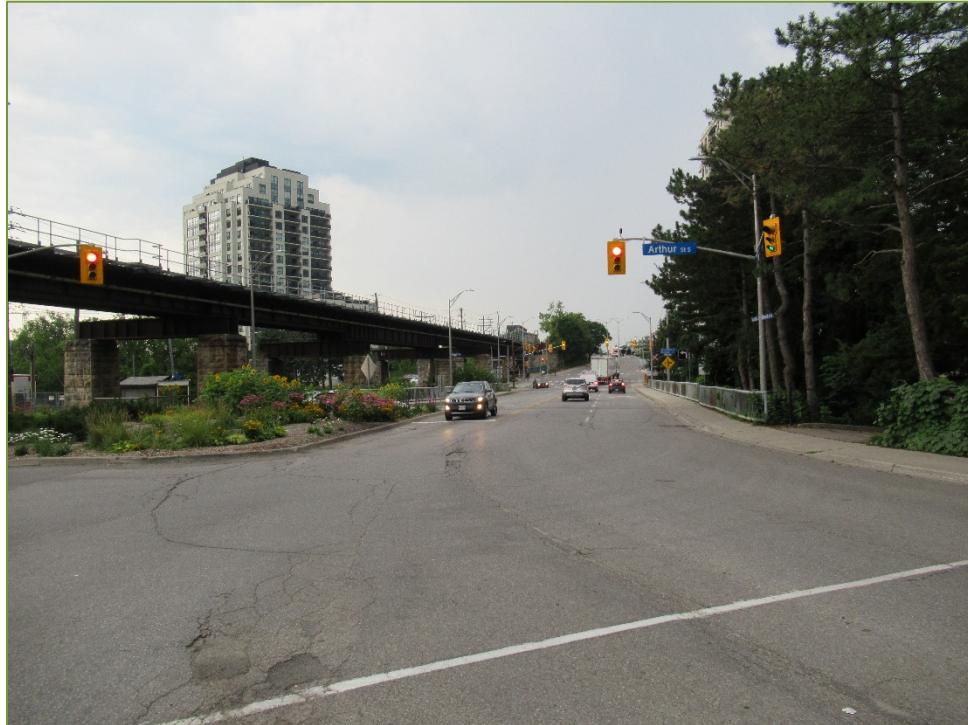
Photo P4 Deck General View, looking west

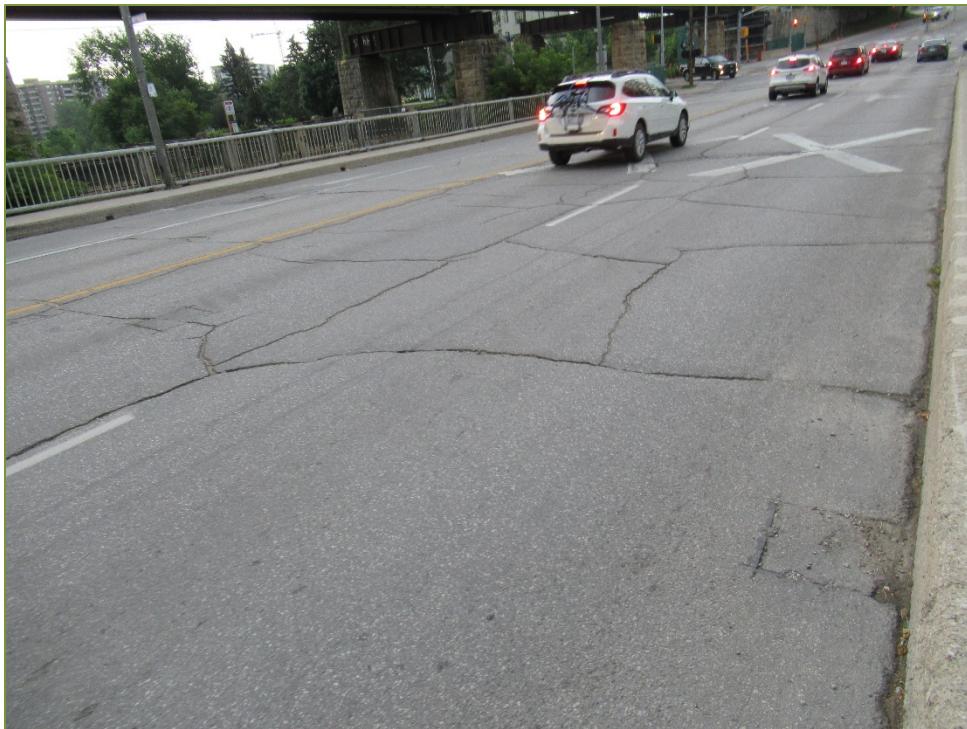
Photo P5 Deck Wearing Surface (fair to poor condition – unsealed cracks, alligator cracks, pot holes, ravelling and rutting)

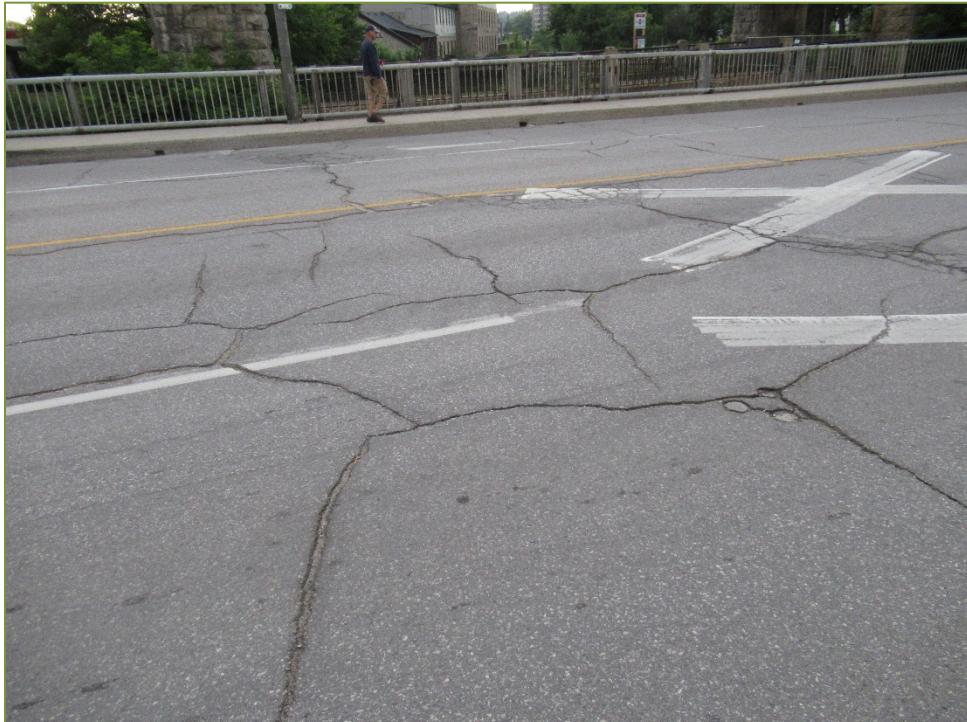
Photo P6 Deck Wearing Surface (unsealed cracks)

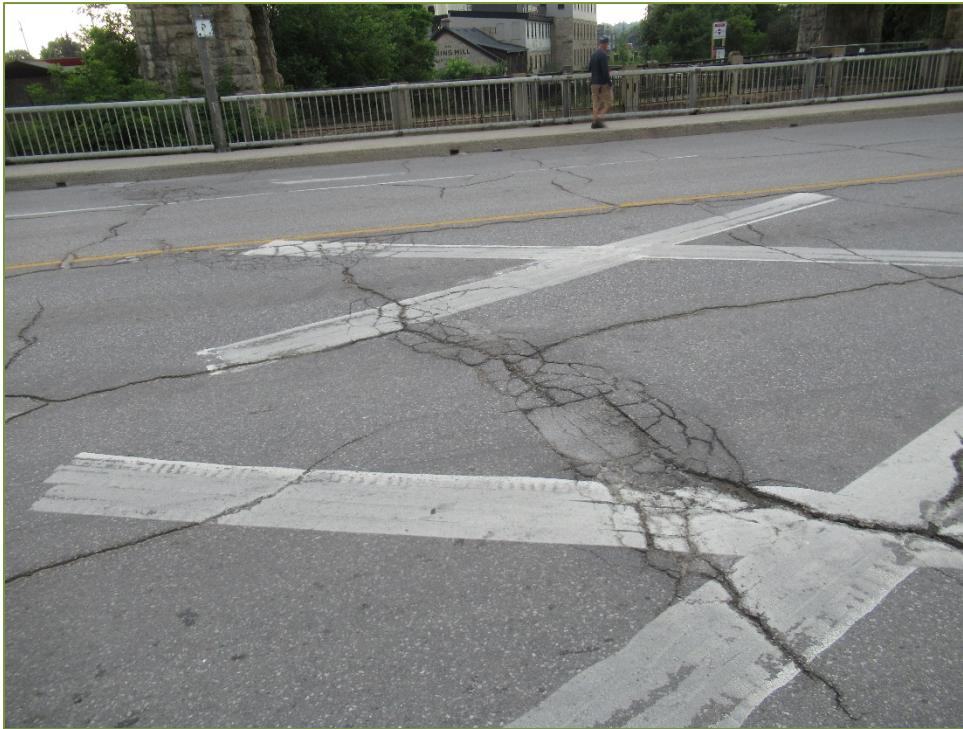
Photo P7 Deck Wearing Surface (unsealed cracks, alligator cracks)

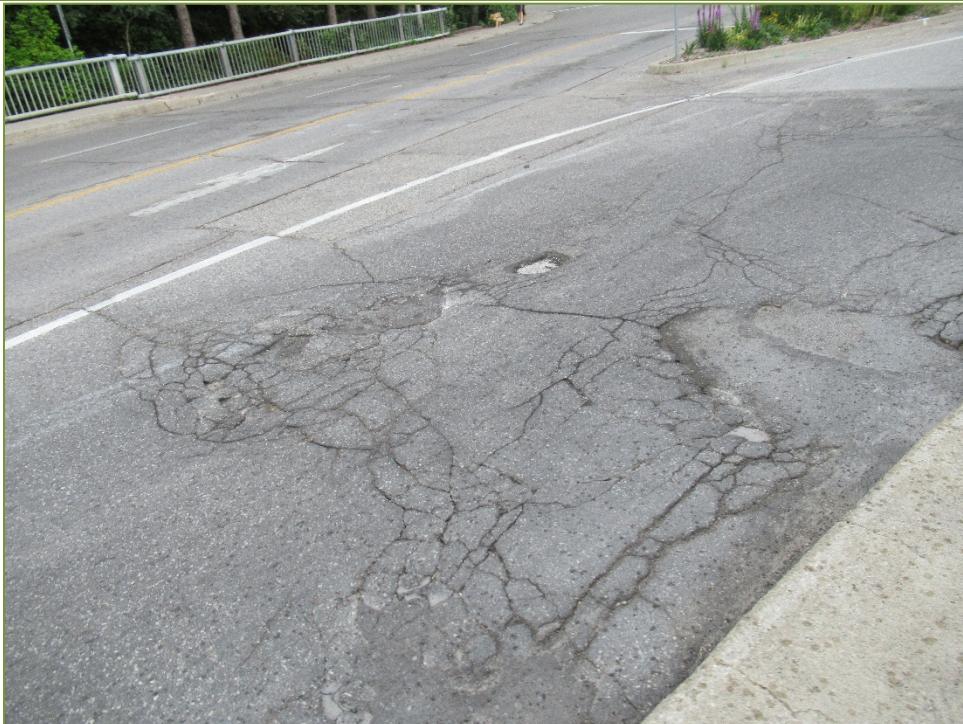
Photo P8 Deck Wearing Surface (unsealed cracks, alligator cracks and pot holes and rutting)

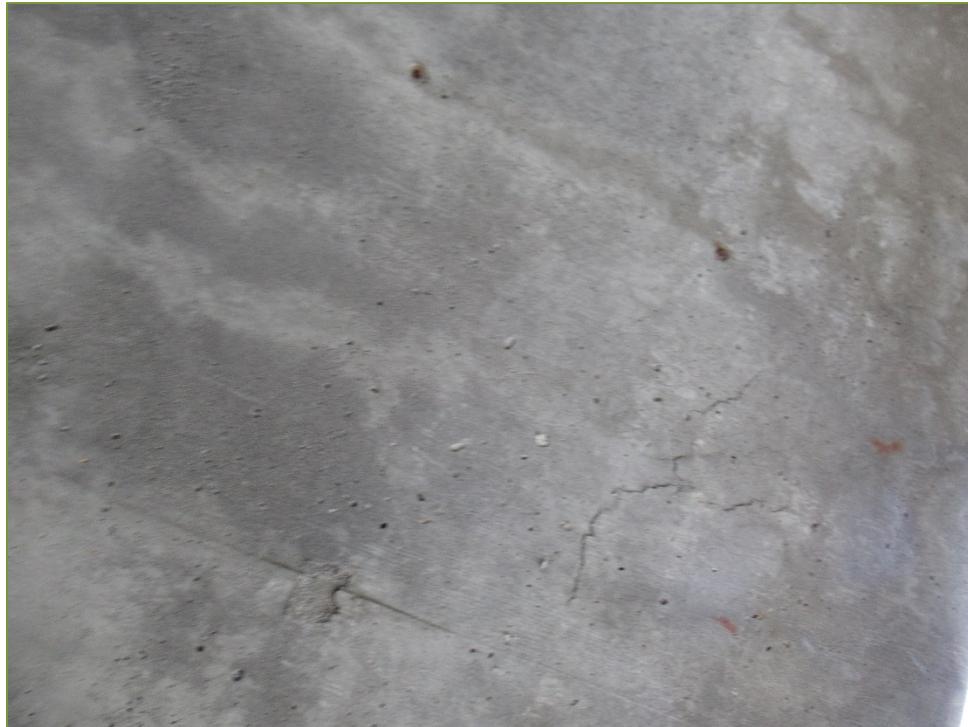
Photo P13 Soffit between East Abutment and Pier (cracks, delamination, and wet area)

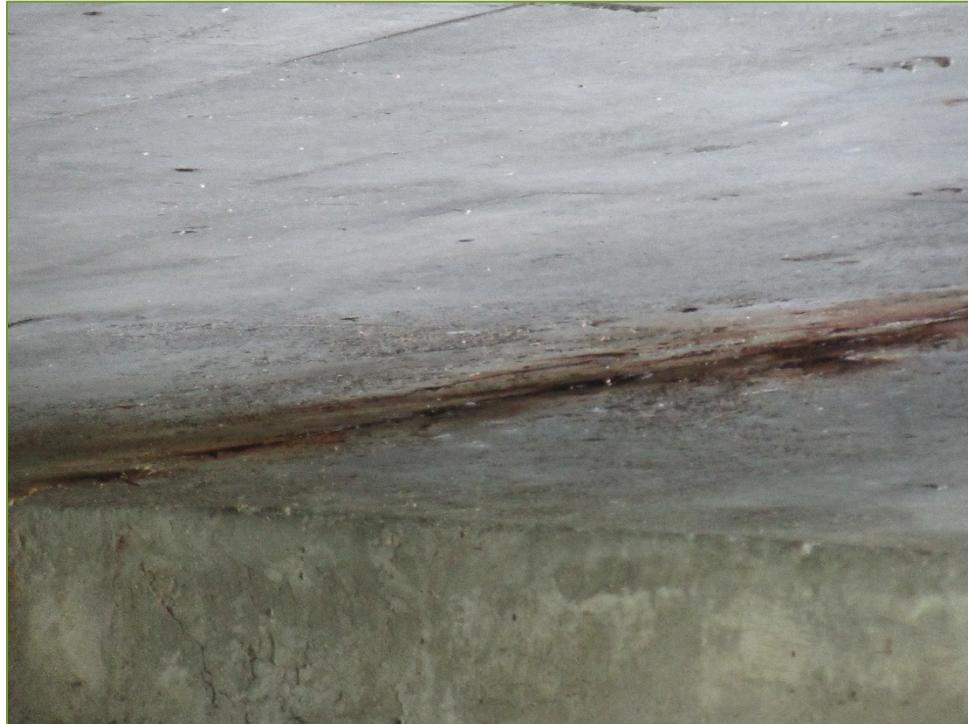
Photo P14 Soffit at Pier (cracks, spall, delamination, and wet area)

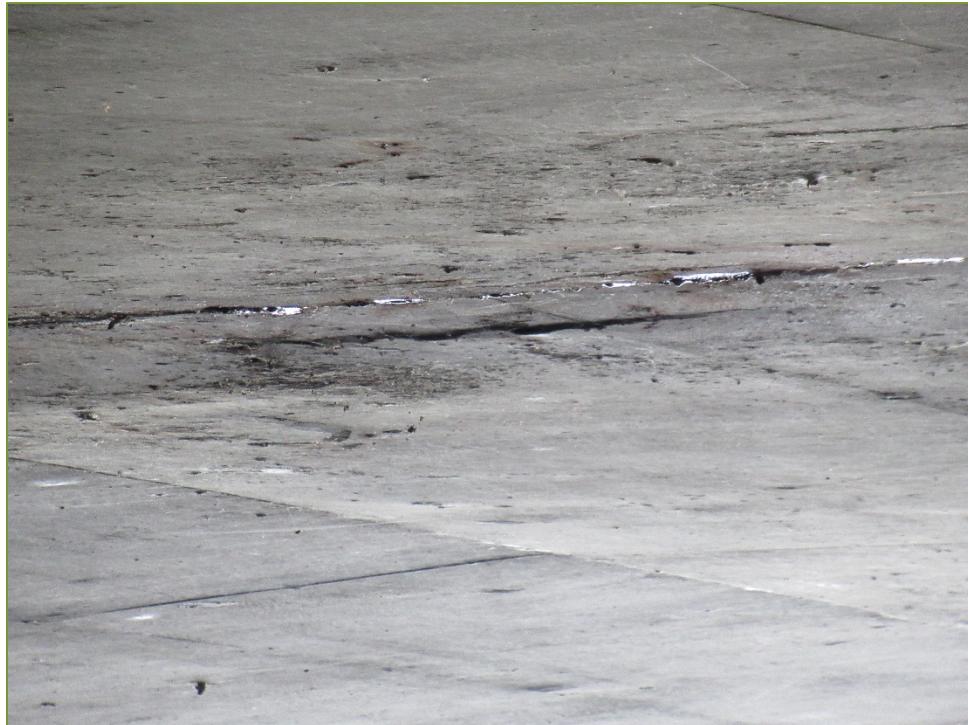
Photo P15 Soffit between East Abutment and Pier (cracks, spall, delamination, and wet area)

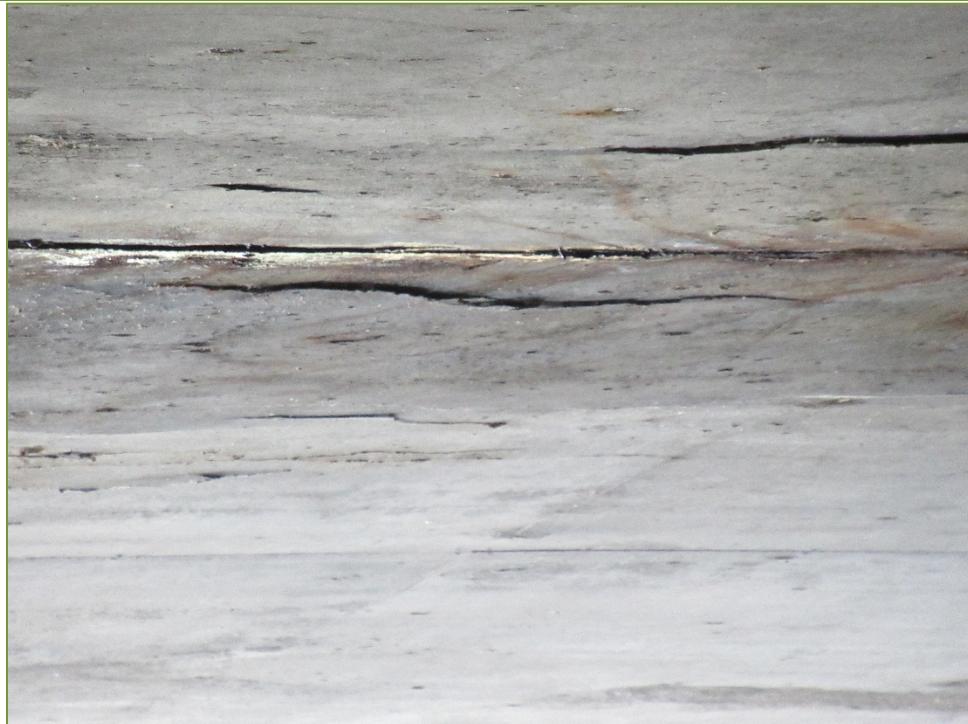
Photo P16 Soffit between East Abutment and Pier (cracks, spall, delamination, and wet area)

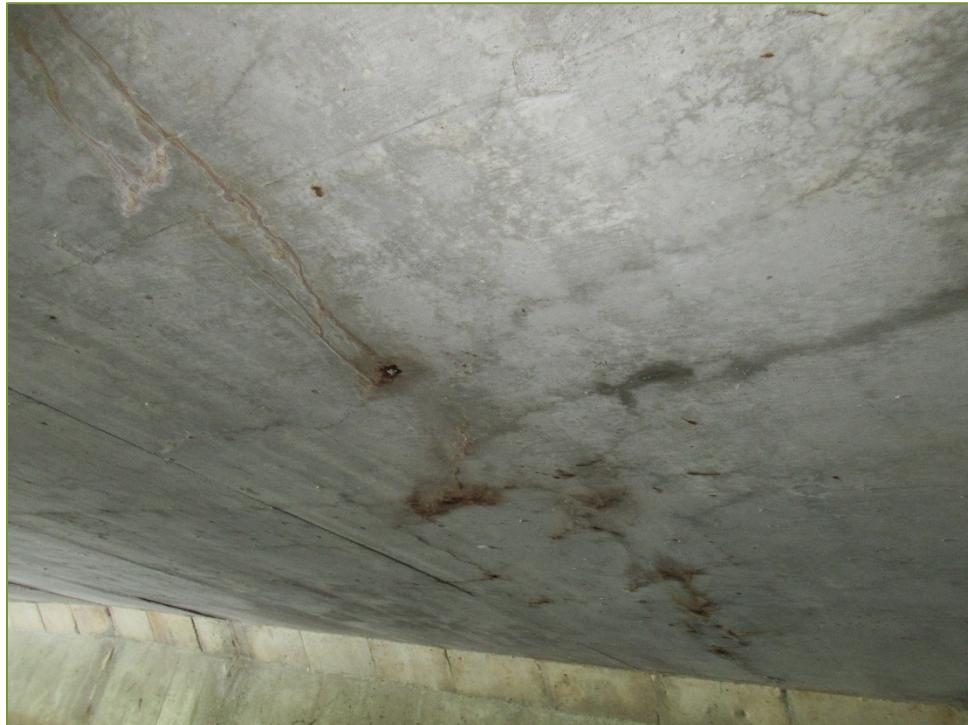
Photo P18 Soffit between East Abutment and Pier (cracks and wet area)

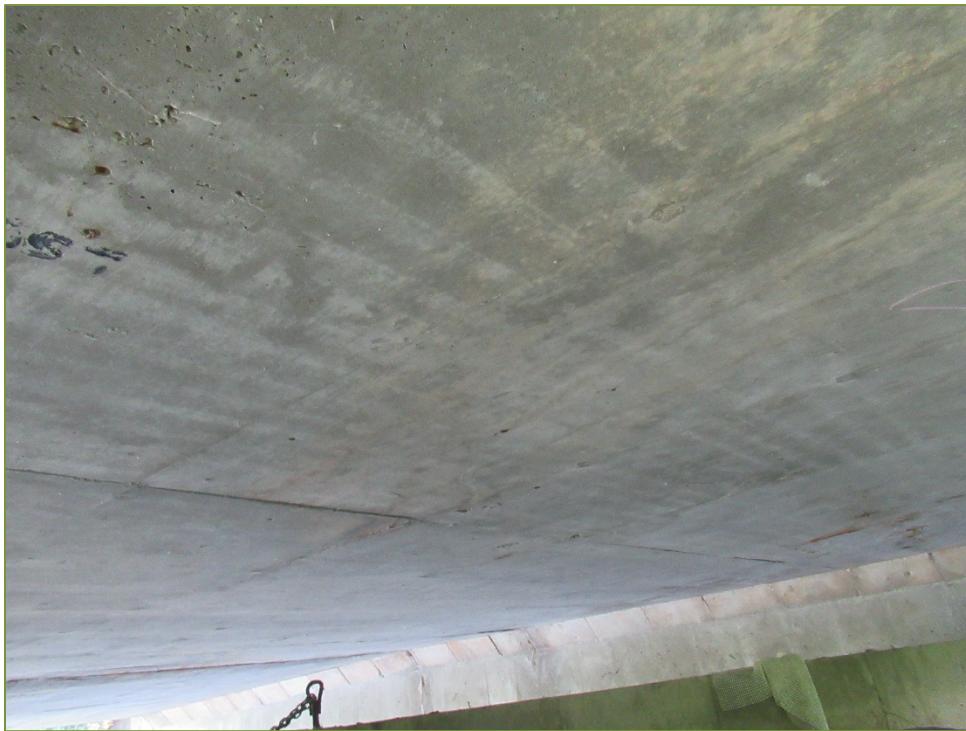
Photo P19 Soffit between East Abutment and Pier, south side (cracks)

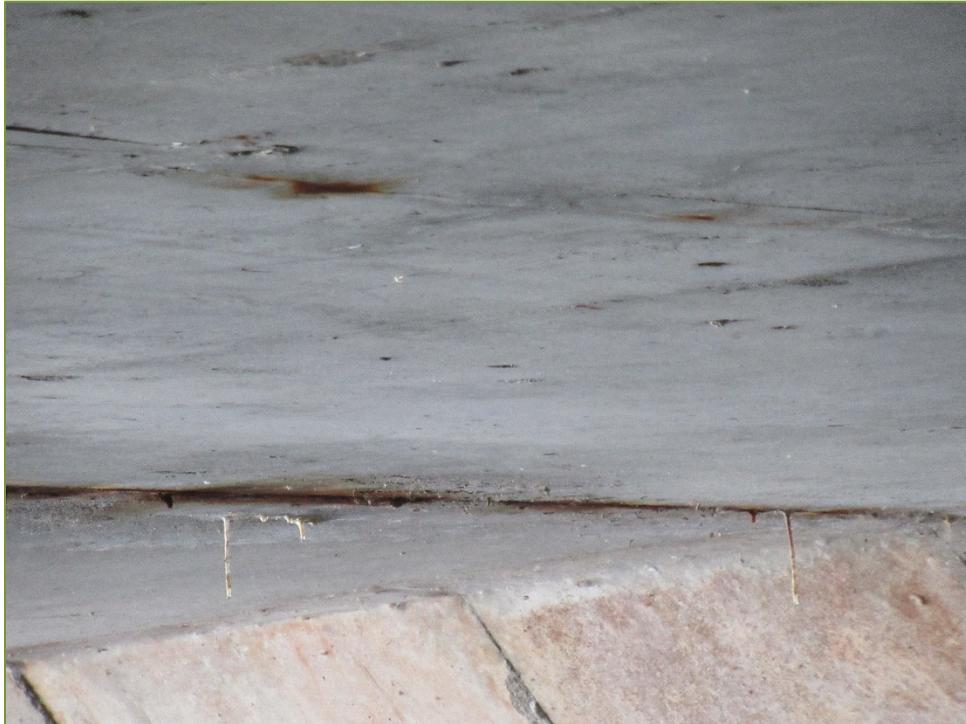
Photo P20 Soffit at East Abutment (cracks, and spall)

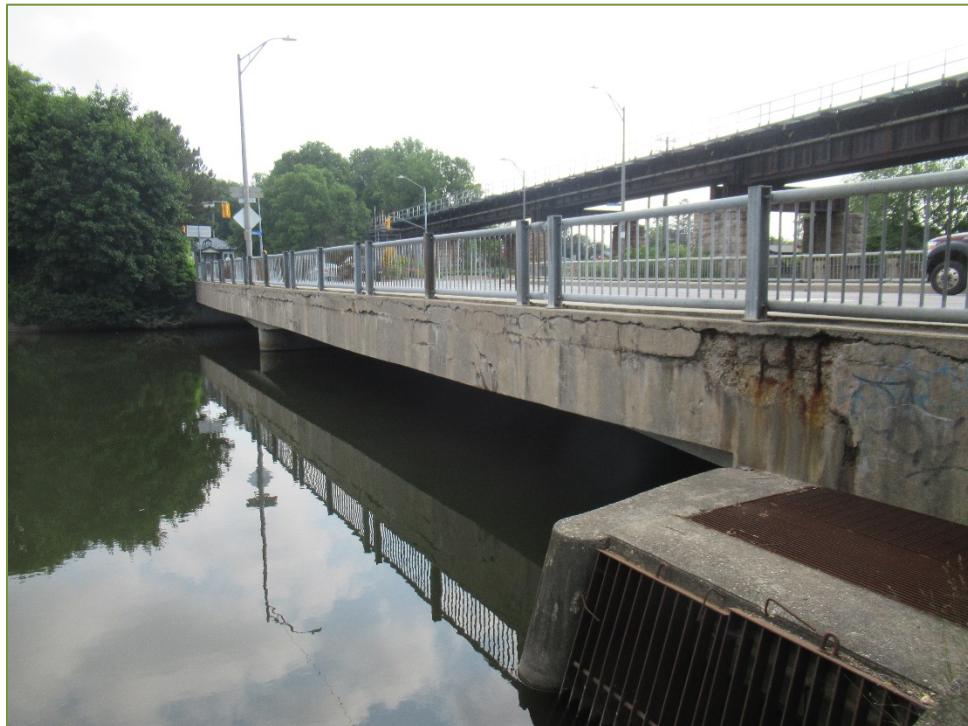
Photo P22 North Elevation – Fascia (wide cracks, spall and delamination) note, exposed rebar

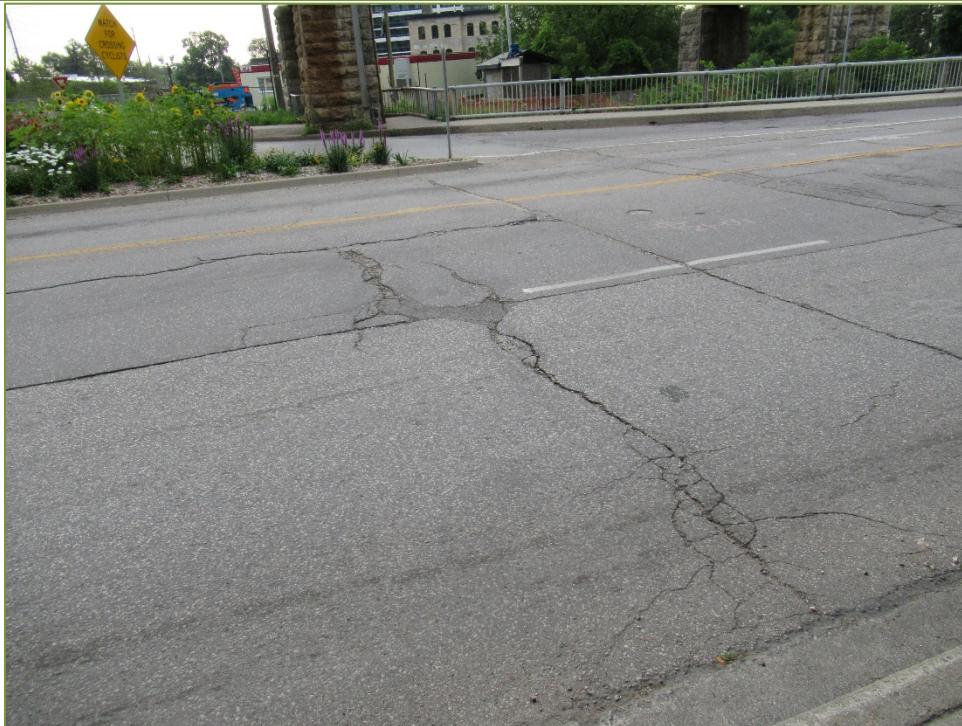
Photo P26 East Approach Wearing Surface (fair condition - unsealed cracks, and pot holes)

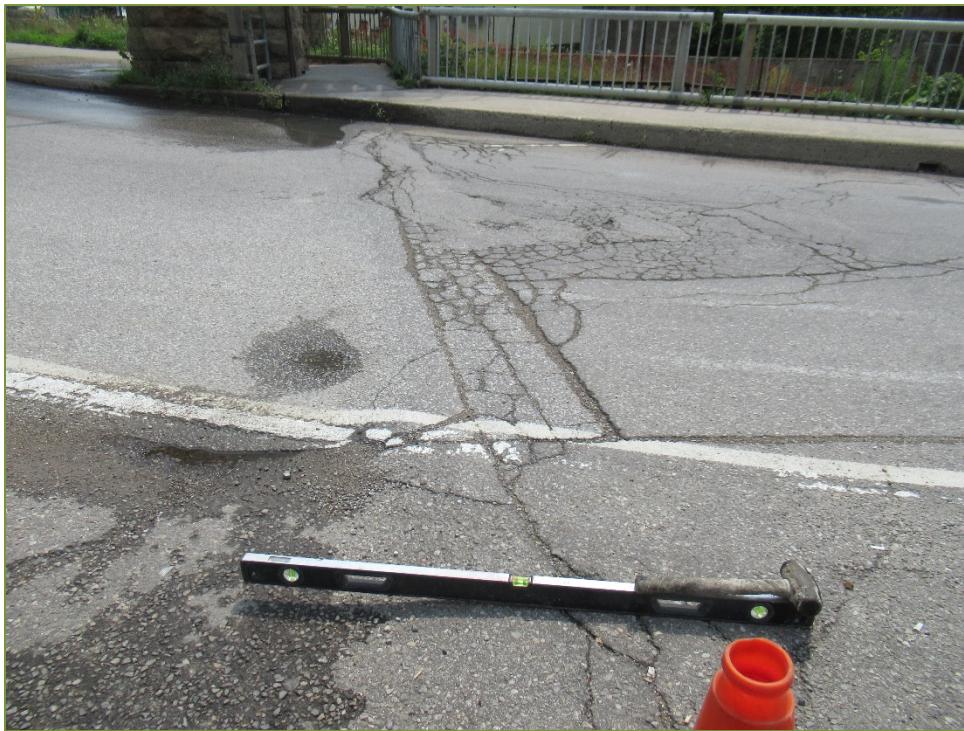
Photo P33 East Joint (settlement and water ponding)

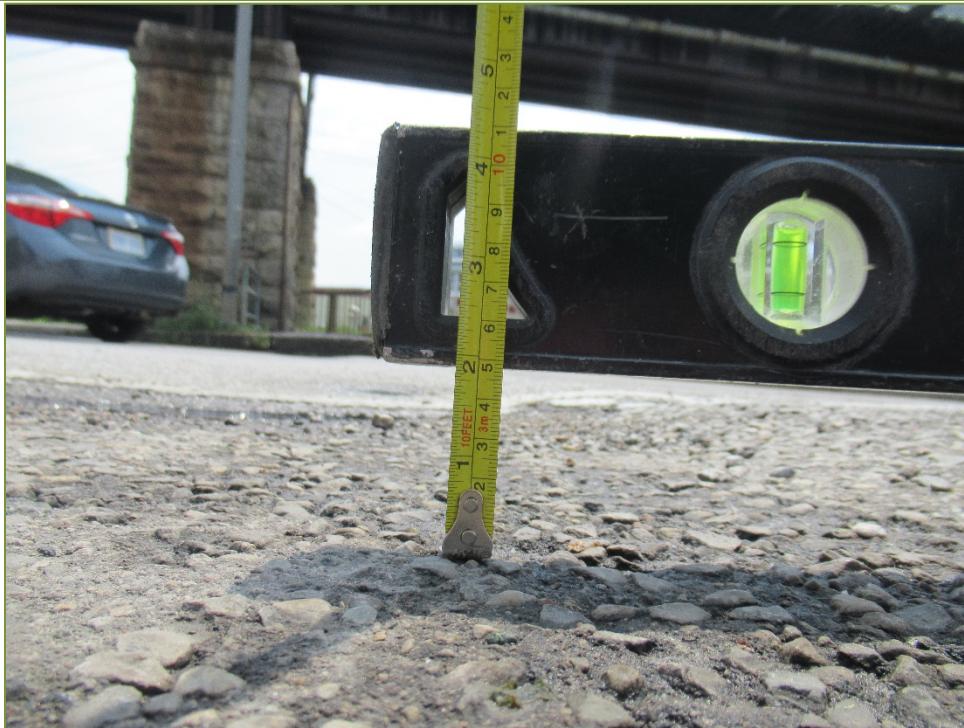
Photo P34 East Joint (settlement)

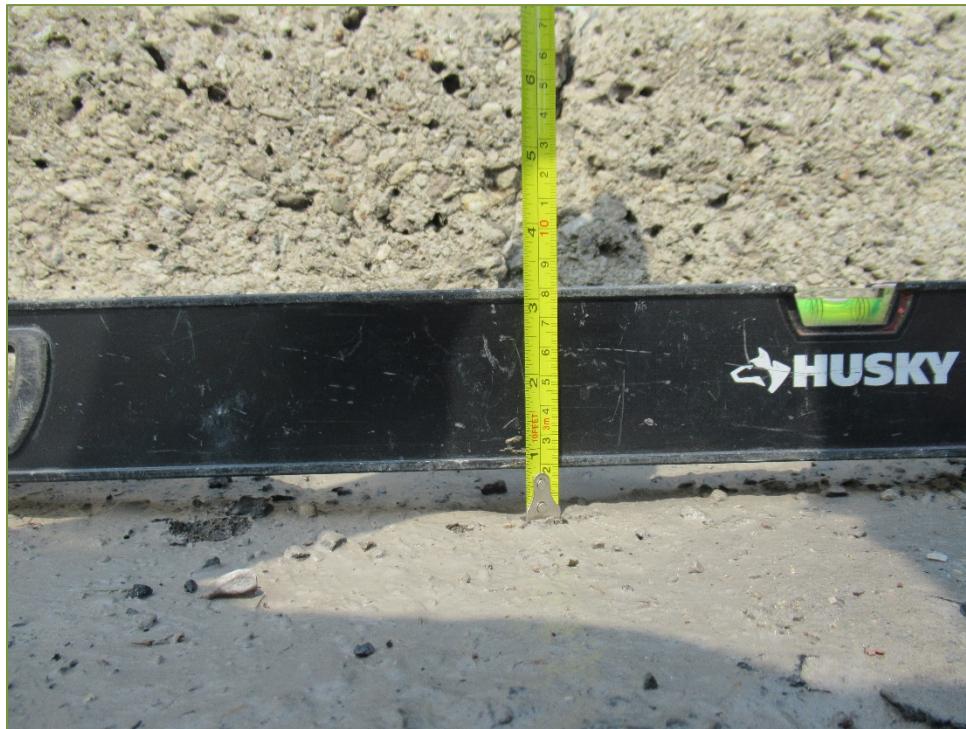
Photo P35 West Joint (settlement)

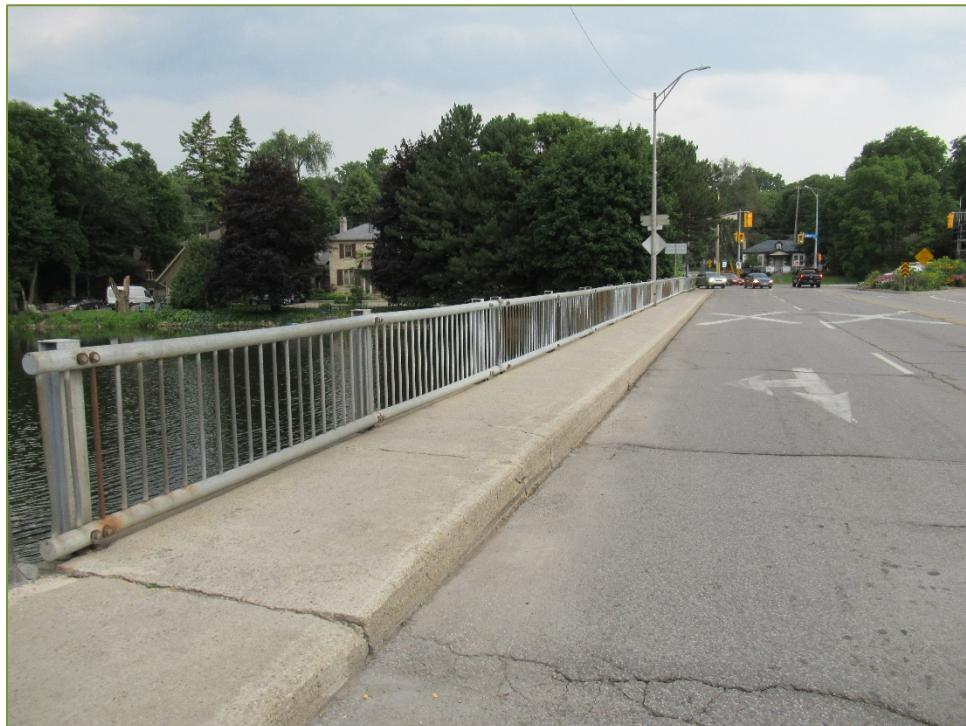
Photo P36 North Sidewalk (fair to poor condition - cracks, spall, delamination, and light to severe scaling) **and Handrail** (fair condition - light corrosion)

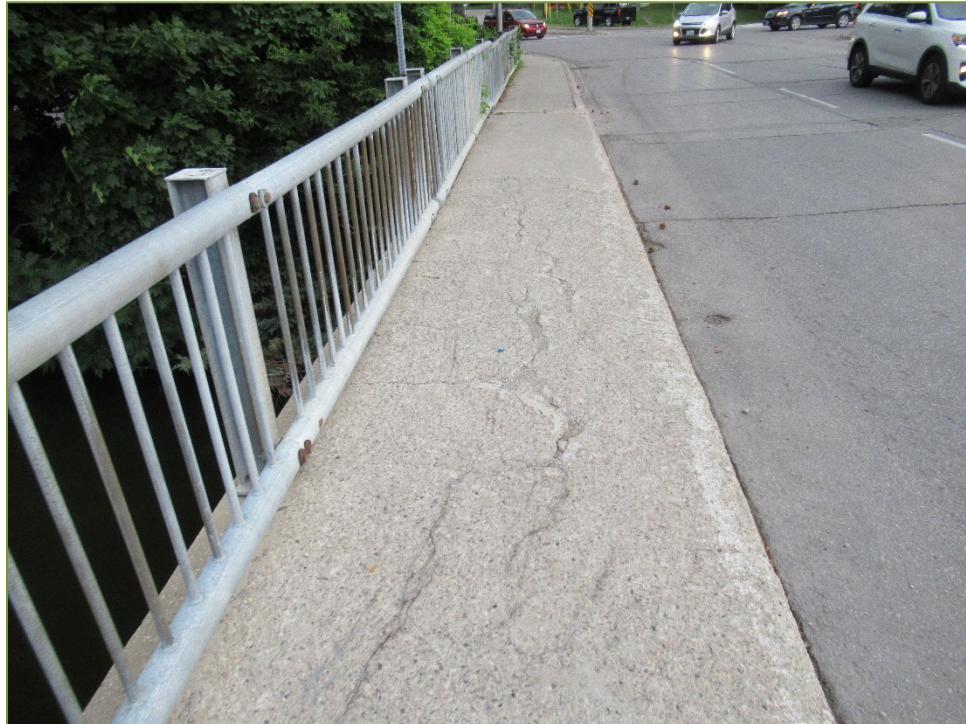
Photo P38 **North Sidewalk** (cracks, spall, delamination, and severe scaling) and **Handrail** (light corrosion)

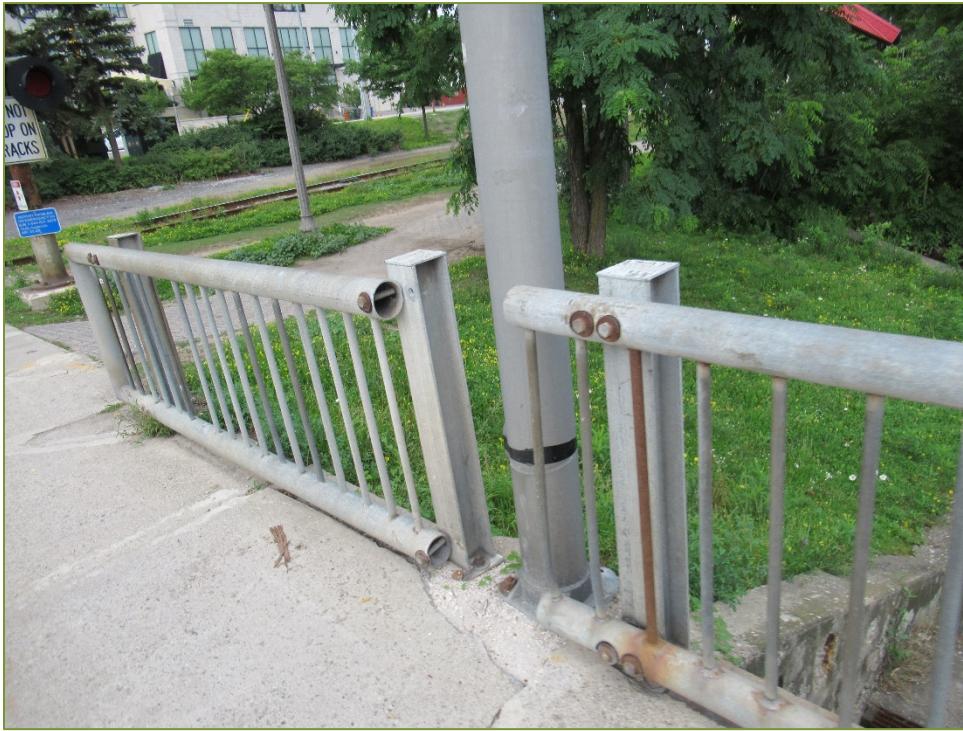
Photo P39 North Handrail (light corrosion)

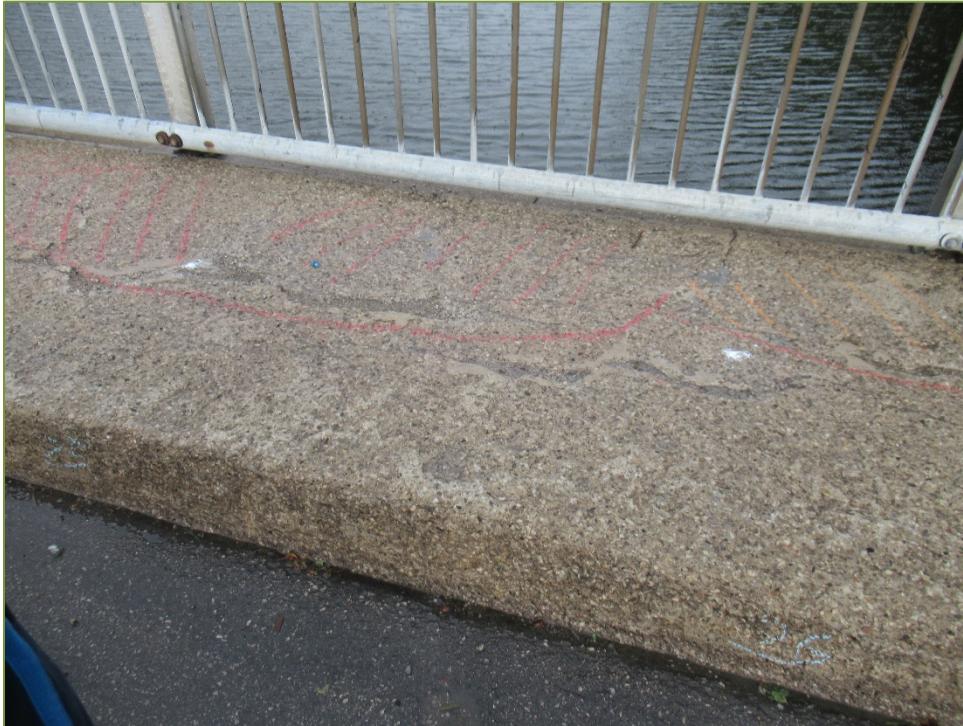
Photo P40 North Sidewalk (cracks, spall, delamination, and severe scaling) and Handrail (light corrosion)

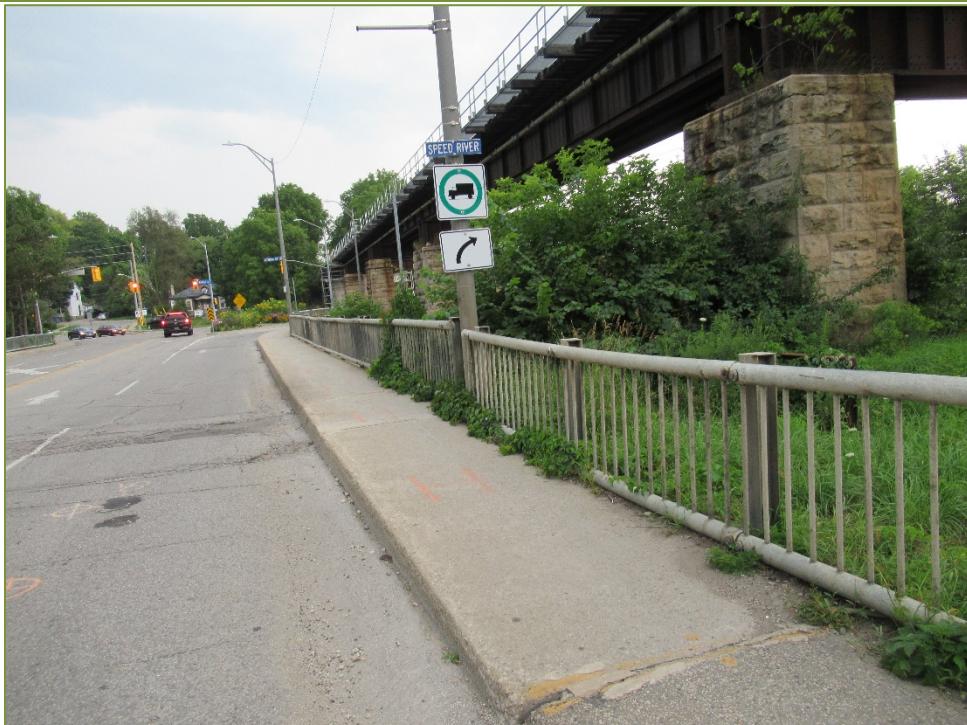
Photo P42 South Sidewalk (fair condition – wide cracks and light to medium scaling) and Handrail (fair condition - light corrosion)

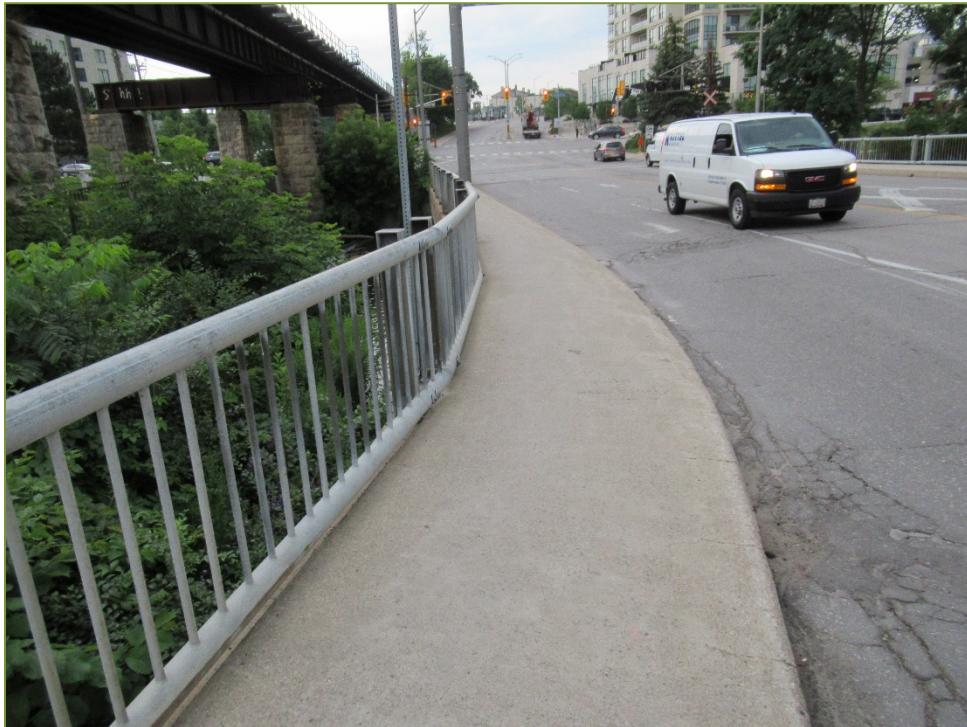
Photo P44 South Sidewalk (cracks and light to medium scaling) and Handrail (light corrosion)

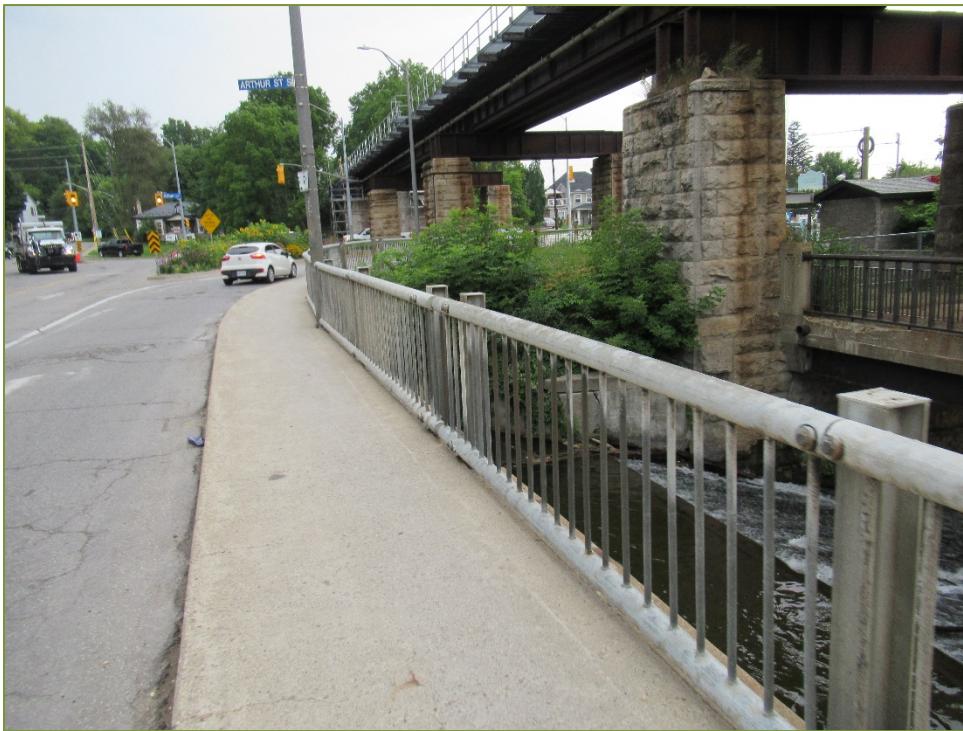
Photo P45 South Sidewalk (cracks and light to medium scaling) and Handrail (light corrosion)

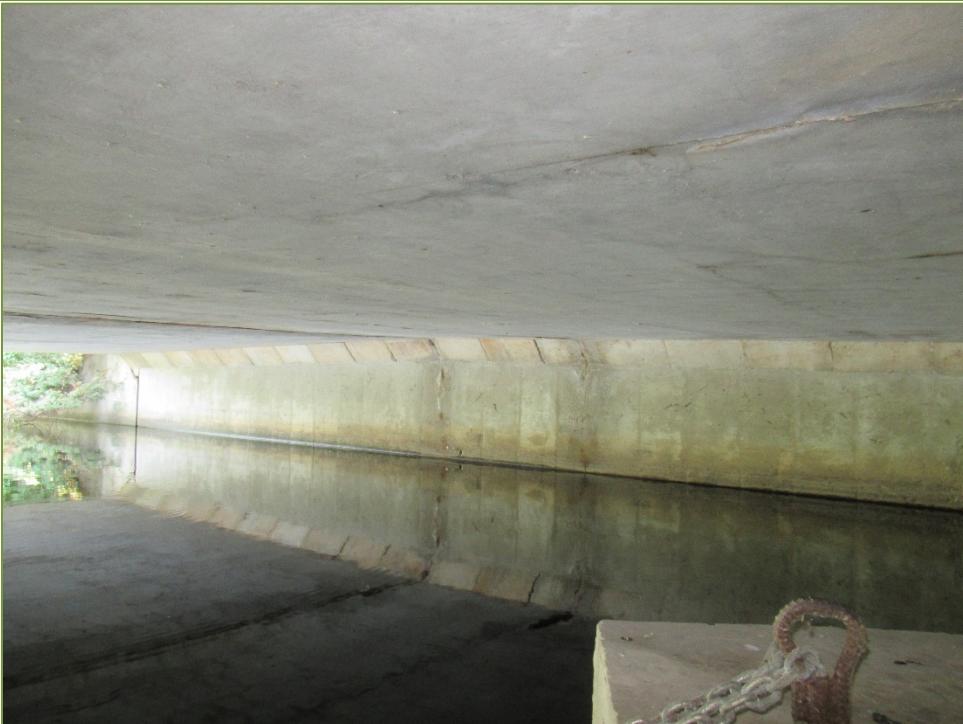
Photo P46 East Abutment (fair condition – cracks, spall, light to medium scaling, and wet area)

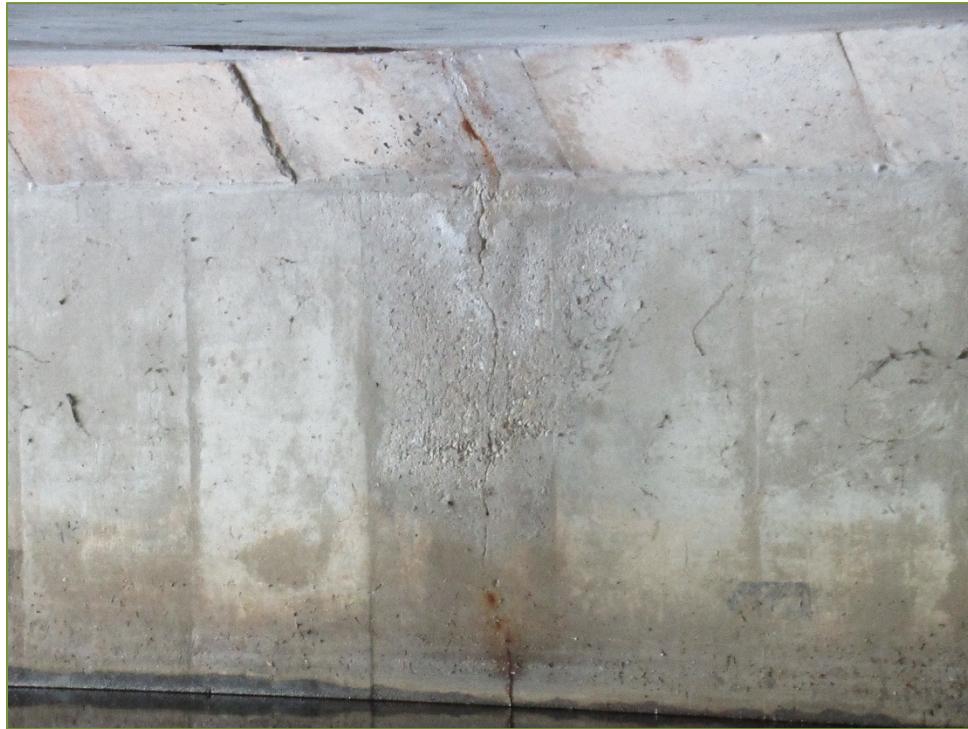
Photo P47 **East Abutment** (cracks, light to medium scaling, and wet area)

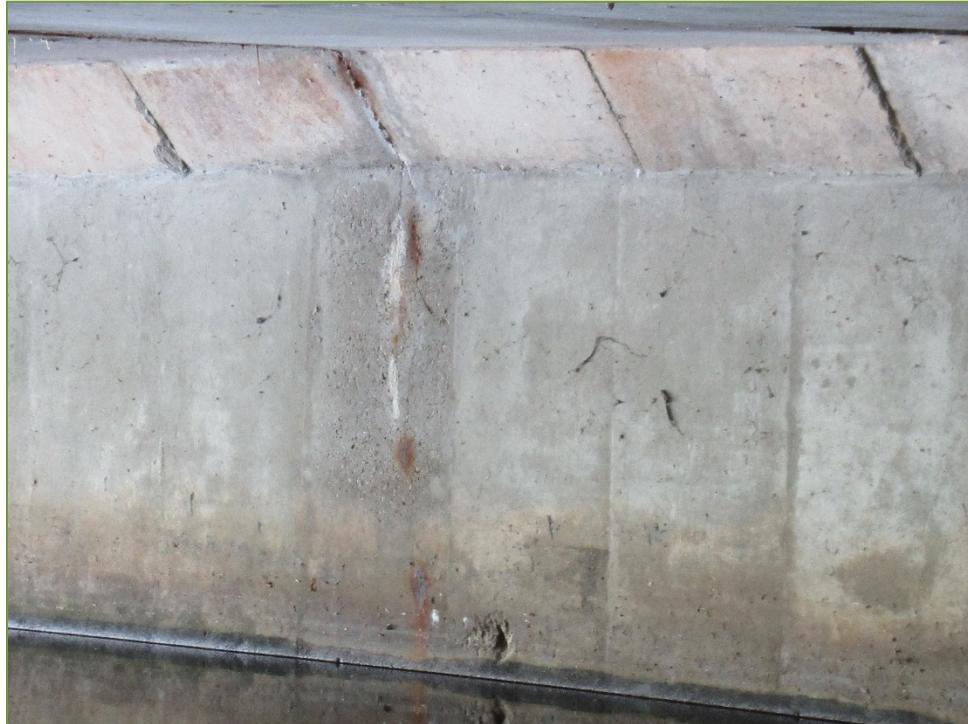
Photo P48 **East Abutment** (cracks, spall, light to medium scaling, and wet area)

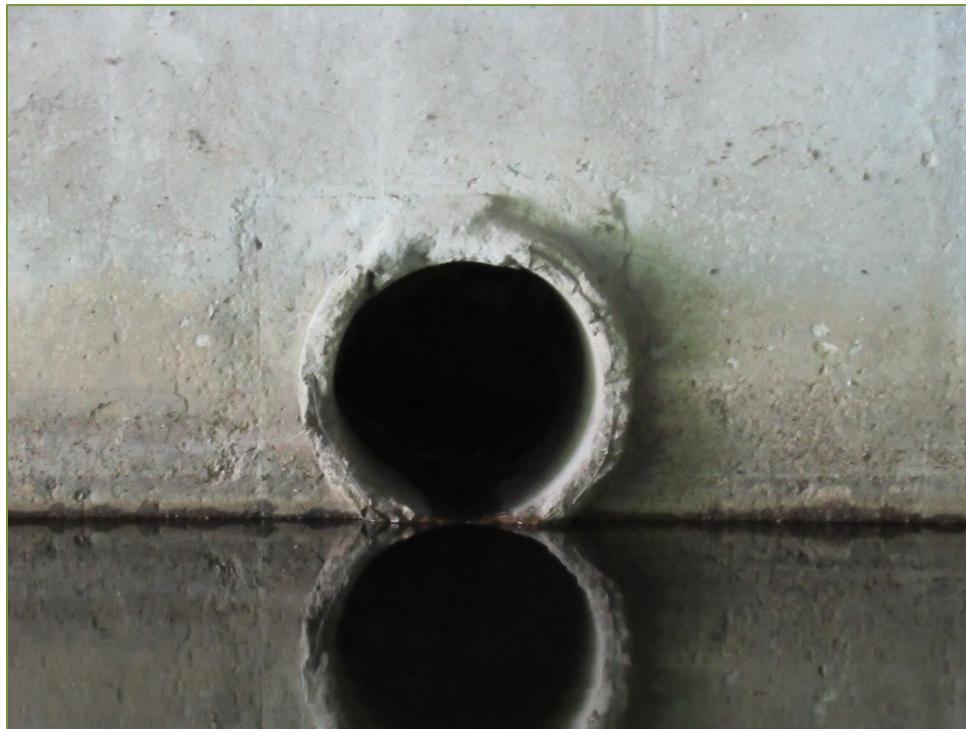
Photo P49 East Abutment (cracks, and medium scaling) note, drain
