City Of Guelph

Structure 112 Mcdonell Street Soffit Inspection Report

GMBP File: 123117

February 29, 2024

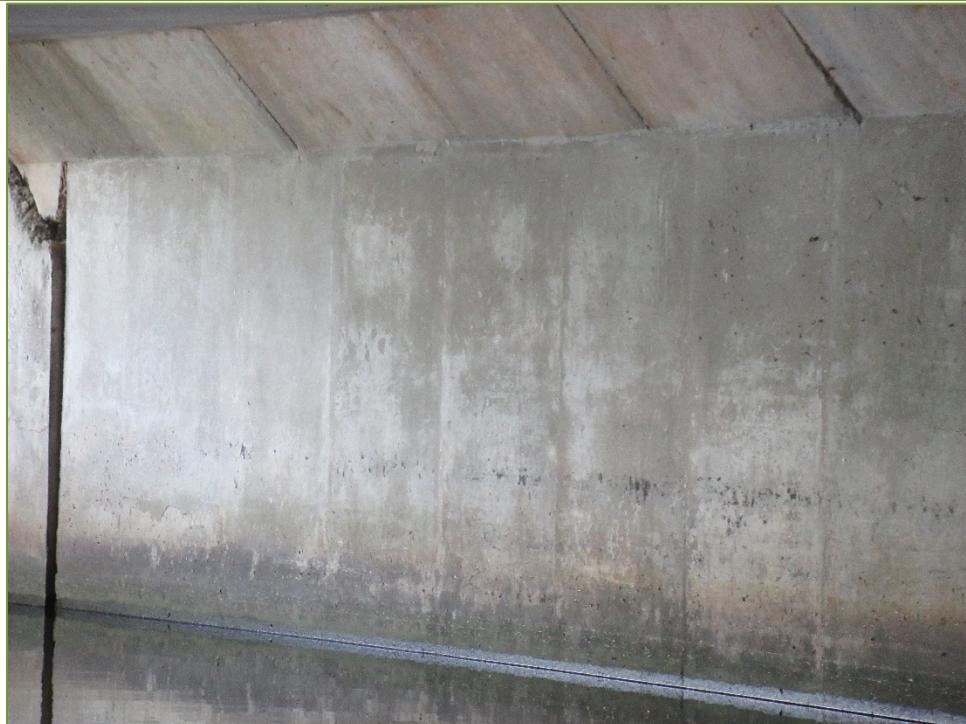
Photo P50 East Abutment, north side (cracks)

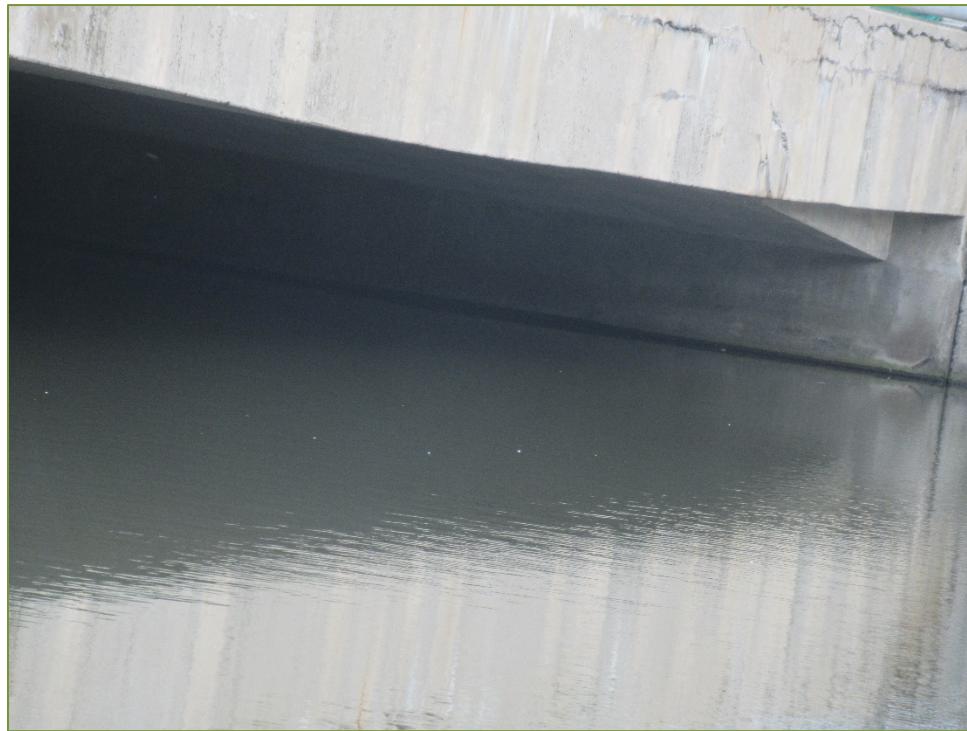
Photo P51 West Abutment (cracks)

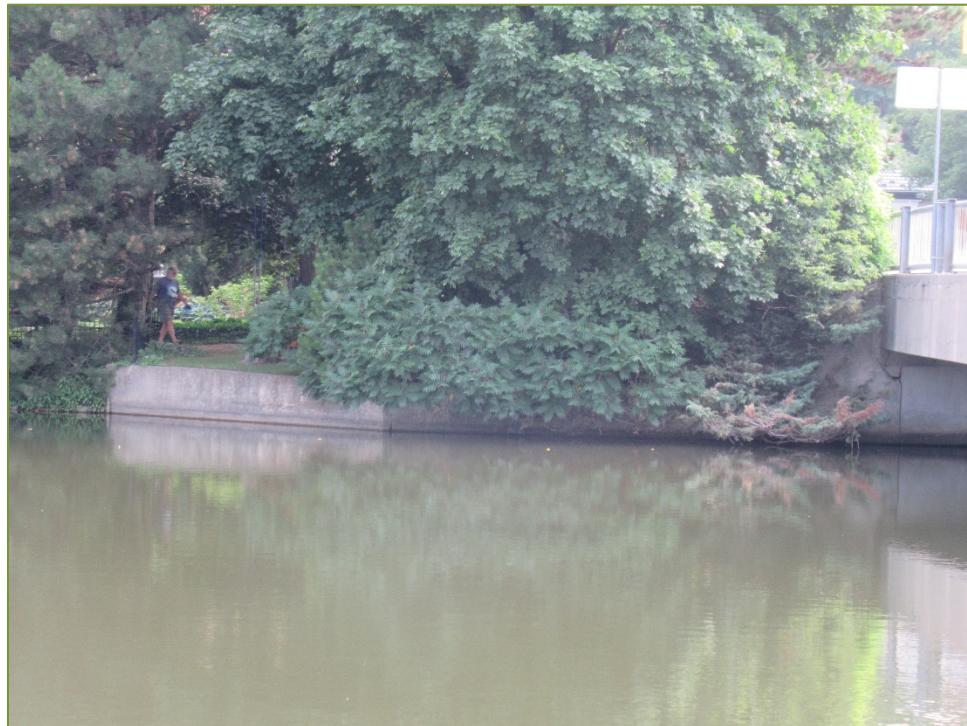
Photo P52 Northeast Retaining Wall (fair condition – wide cracks, spall, delamination, and light scaling)

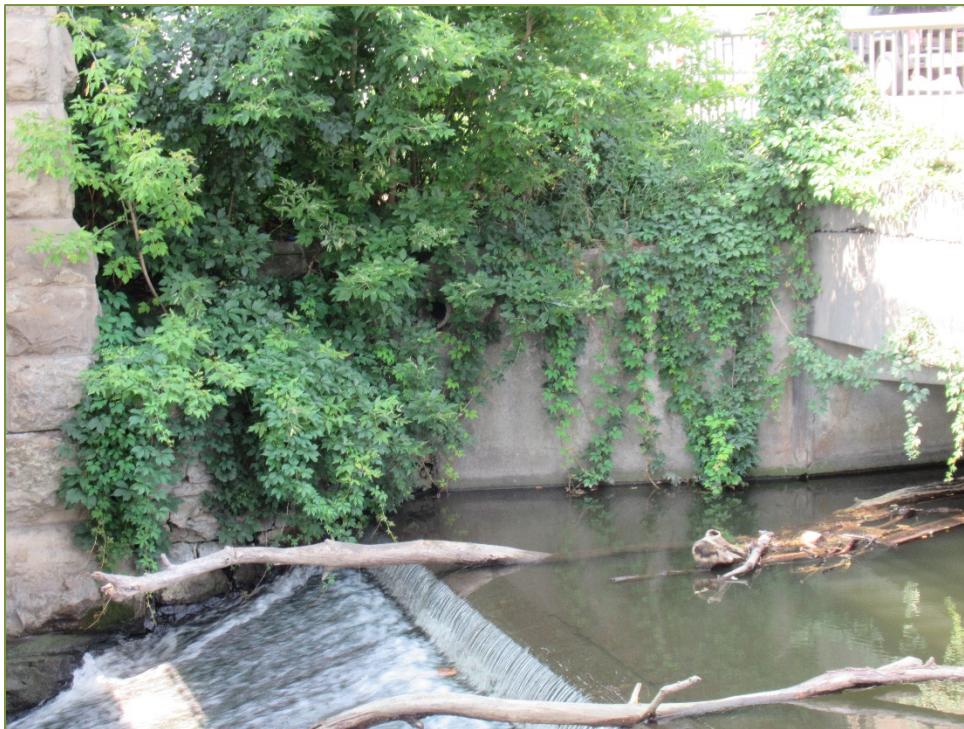
Photo P55 Southwest Retaining Wall (good condition - cracks and light scaling)

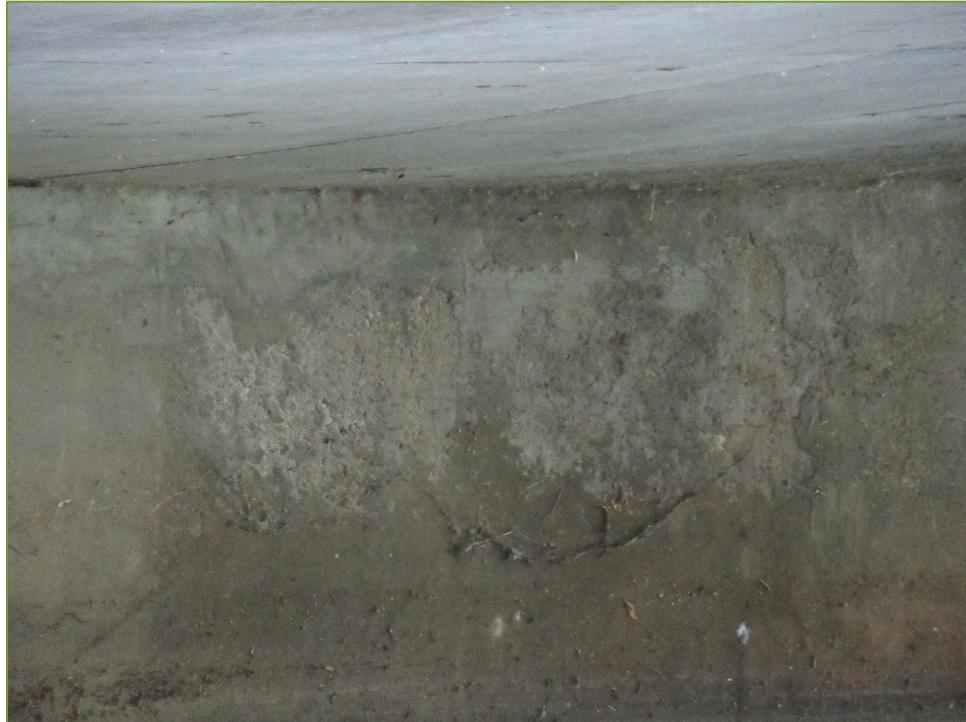
Photo P57 Pier - East Face (fair to good condition - crack and light scaling)

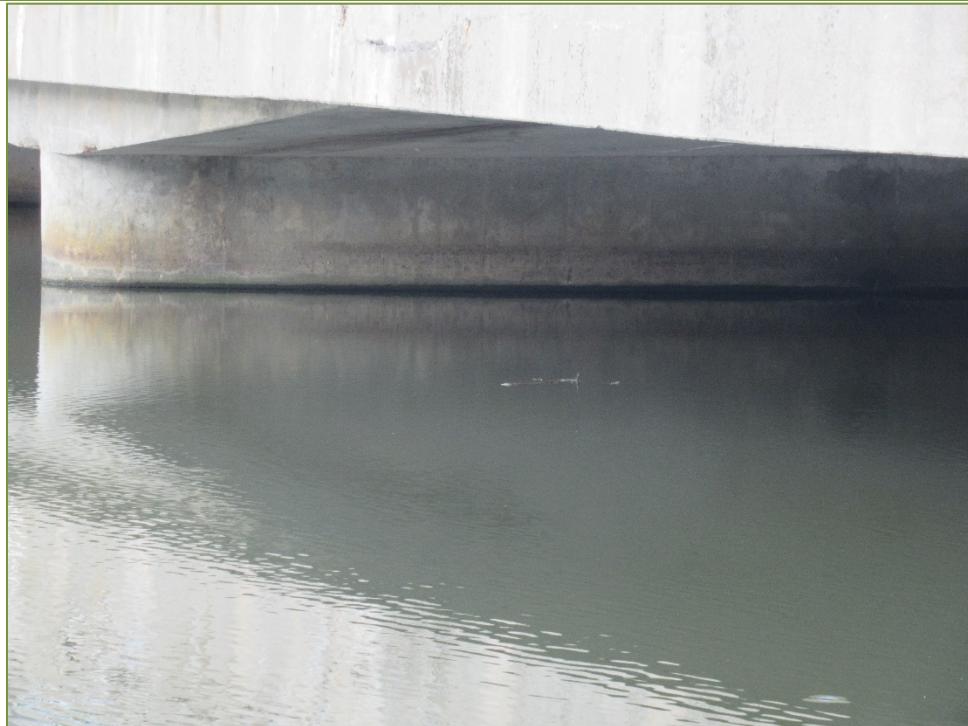
Photo P59 Pier - East Face (cracks, spall, and wet area)

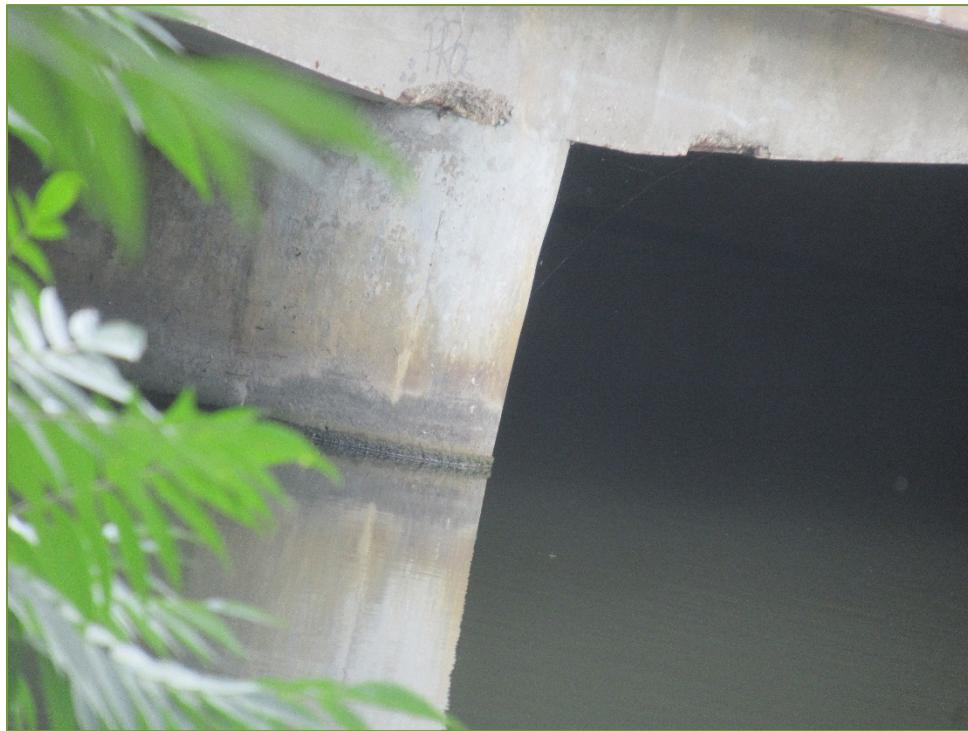
Photo P60 Pier - West Face (cracks, and light scaling)

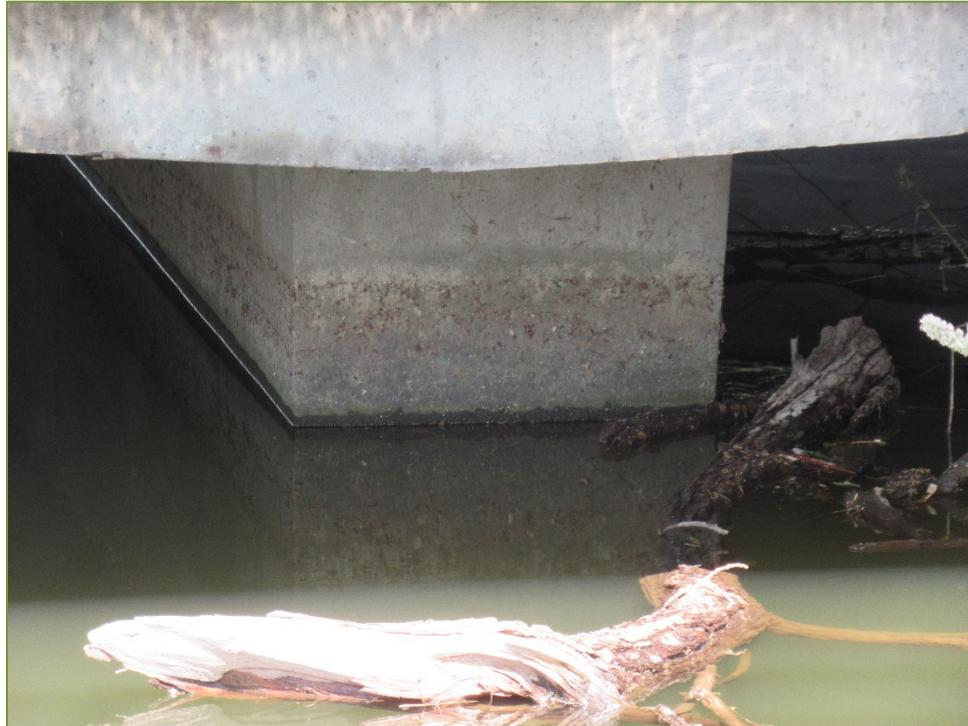
Photo P61 Pier - North Face (crack)

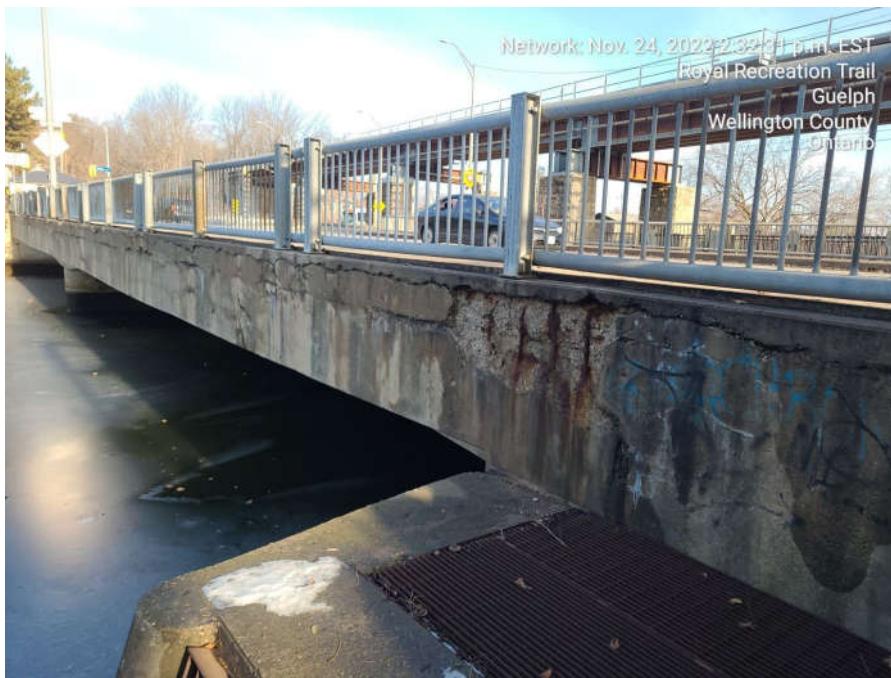
North soffit exterior shows severe delamination and exposed corroded rebar throughout

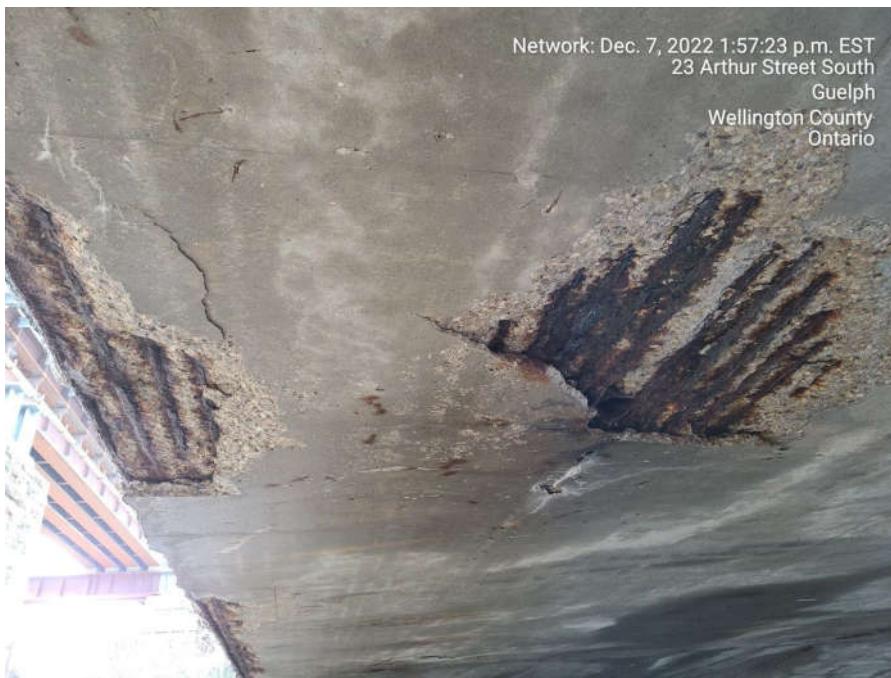
South soffit exterior and interior showing spalls and exposed corroded rebars

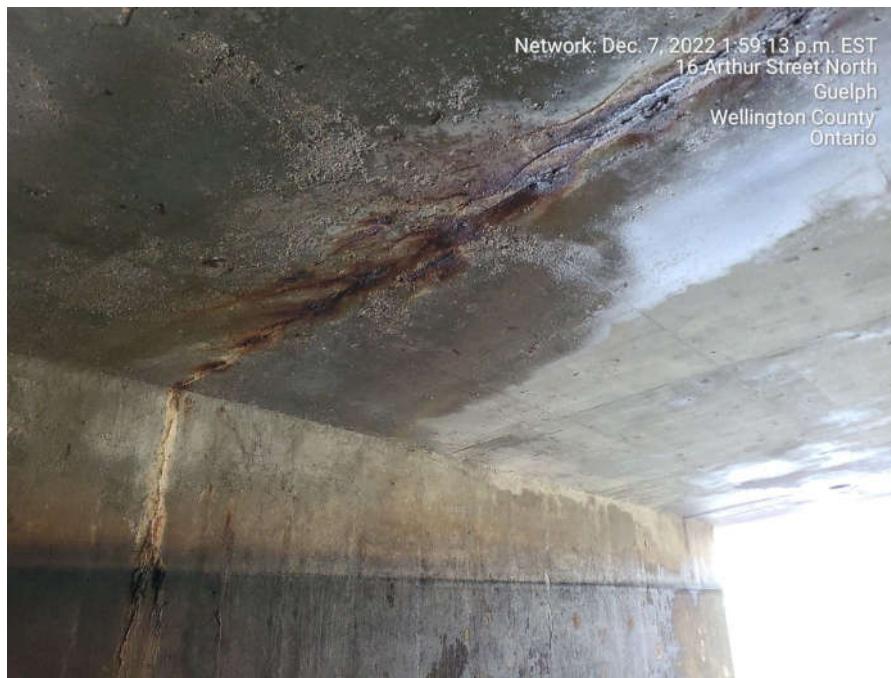
Medium full length crack with rust stains showing on east abutment wall and soffit

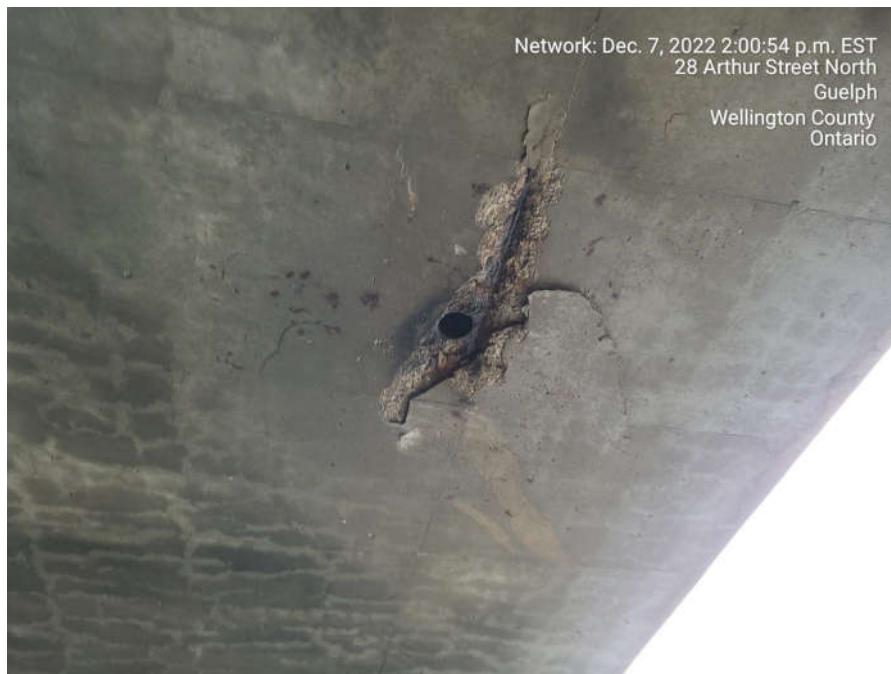
Drainage system outlet showing spalls

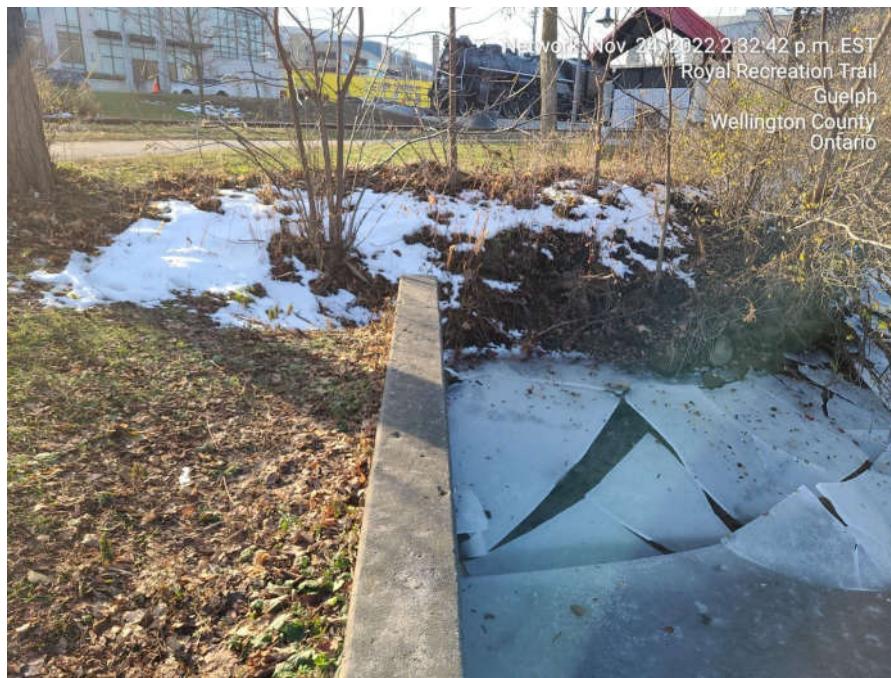
Northwest embankment showing overgrown vegetation

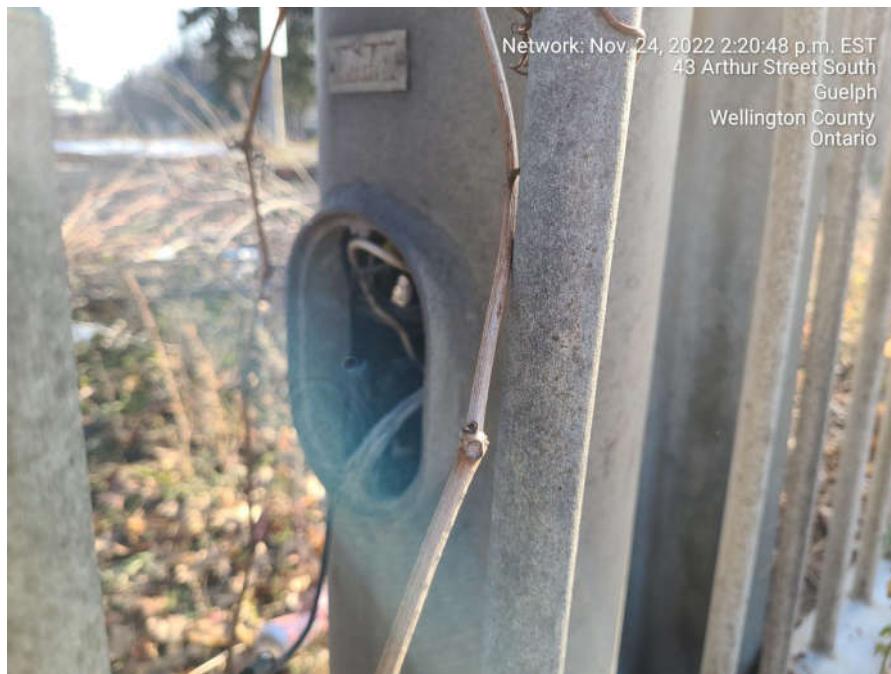
Missing light cap

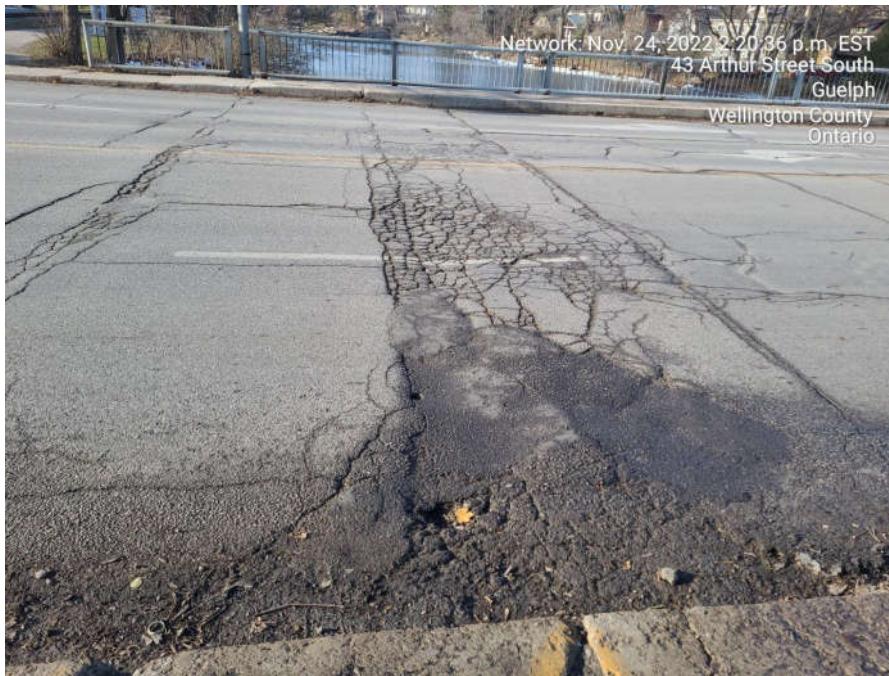
Severe alligator cracking and severe transverse and longitudinal cracks throughout wearing surface

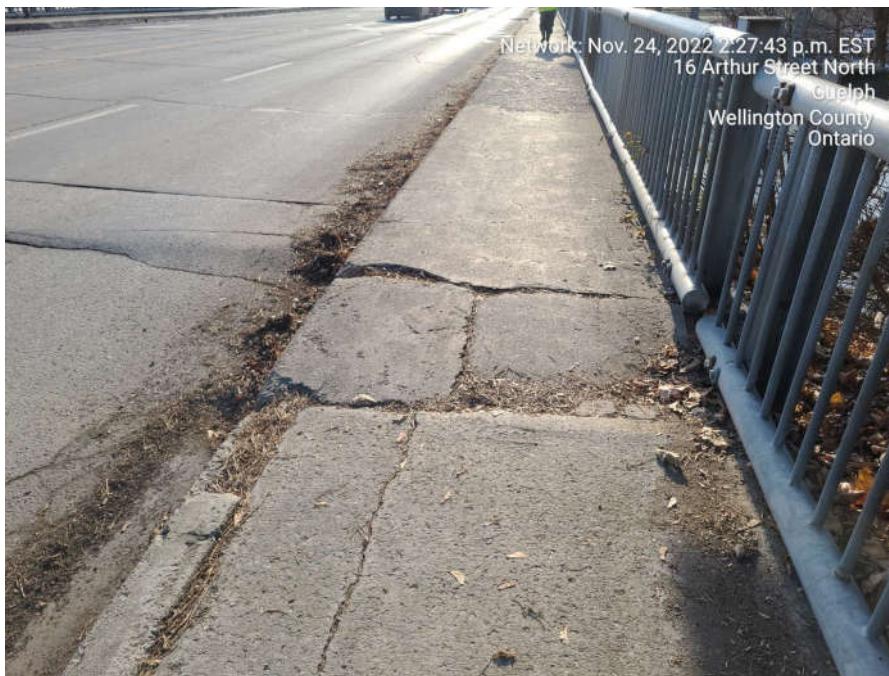
North sidewalk should wide cracks and settlement

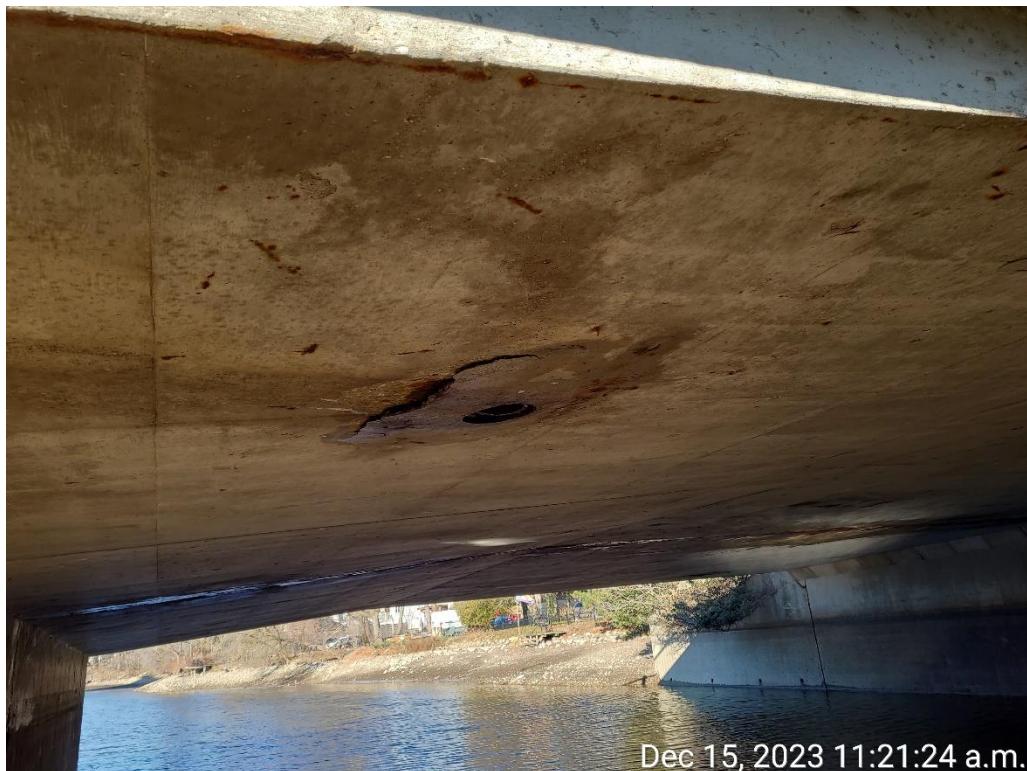
Photograph 18: Southwest deck drain on east span showing delamination around opening

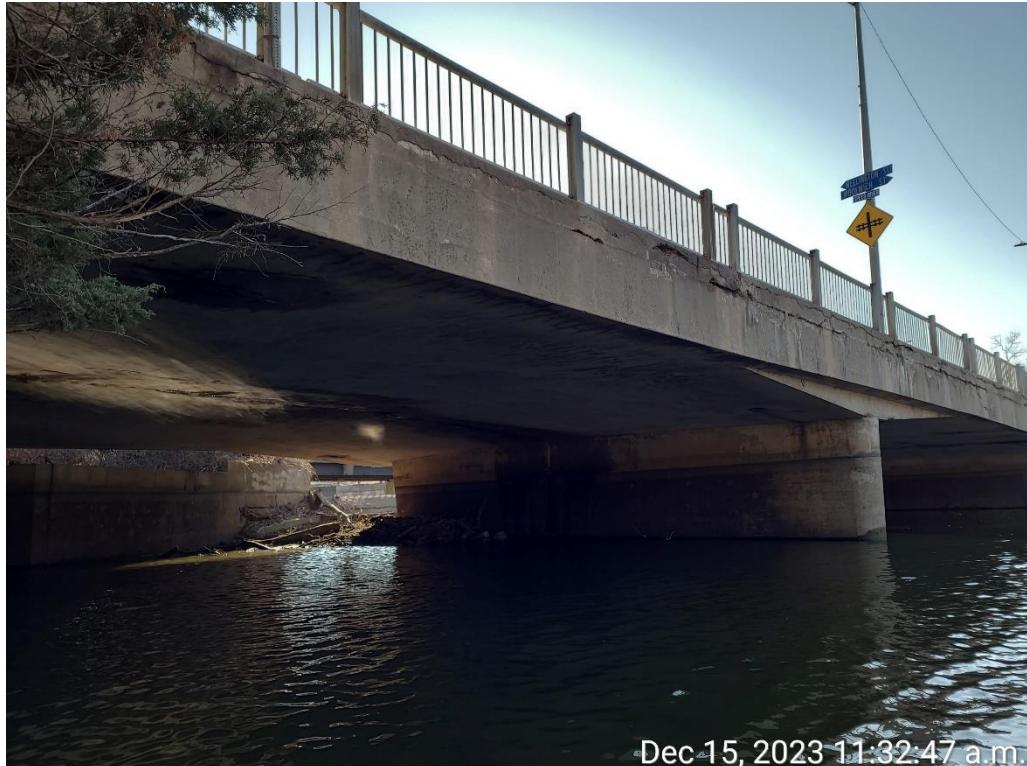
Photograph 19: Nort fascia, looking south

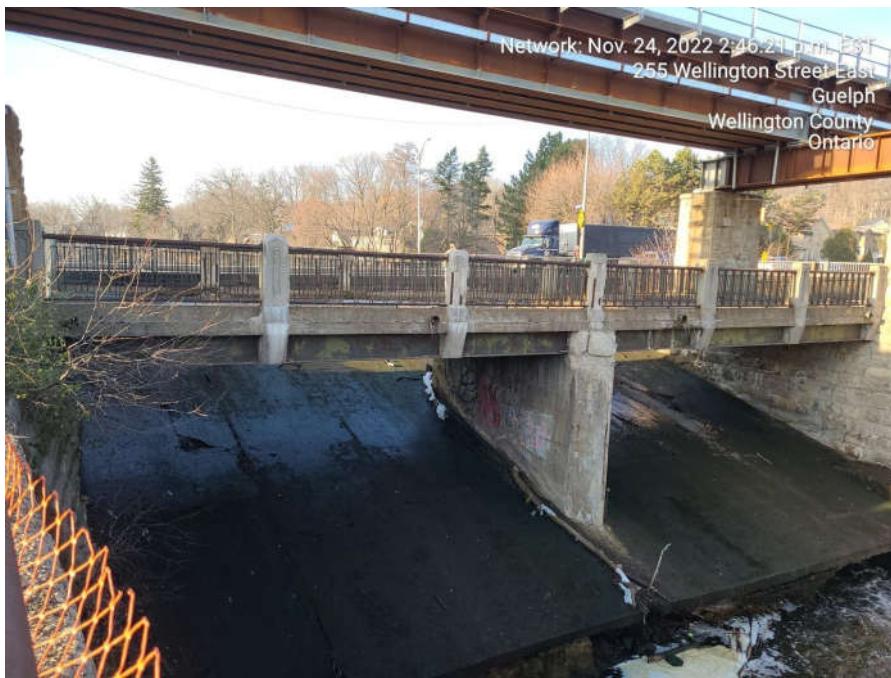
South elevation, showing possible undermining under southeast foundation

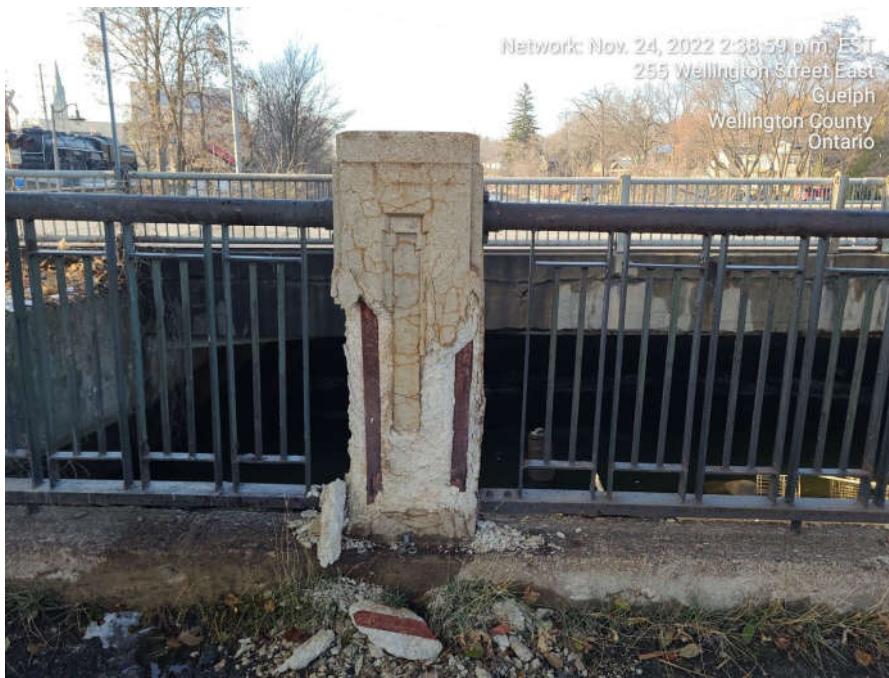
Severe spalls and exposed corroded steel on barrier posts

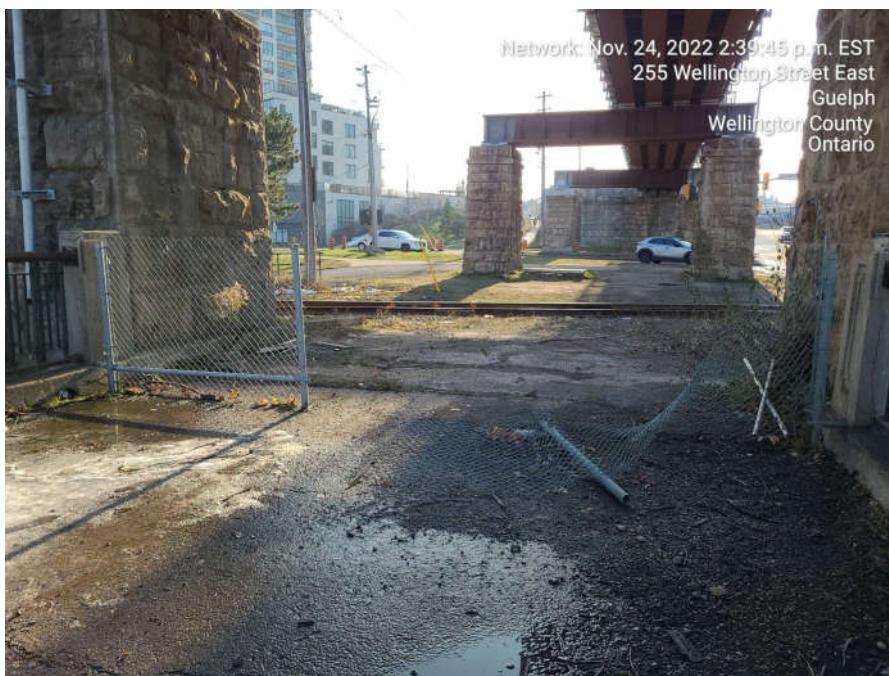
Removed chainlink fence on east approach

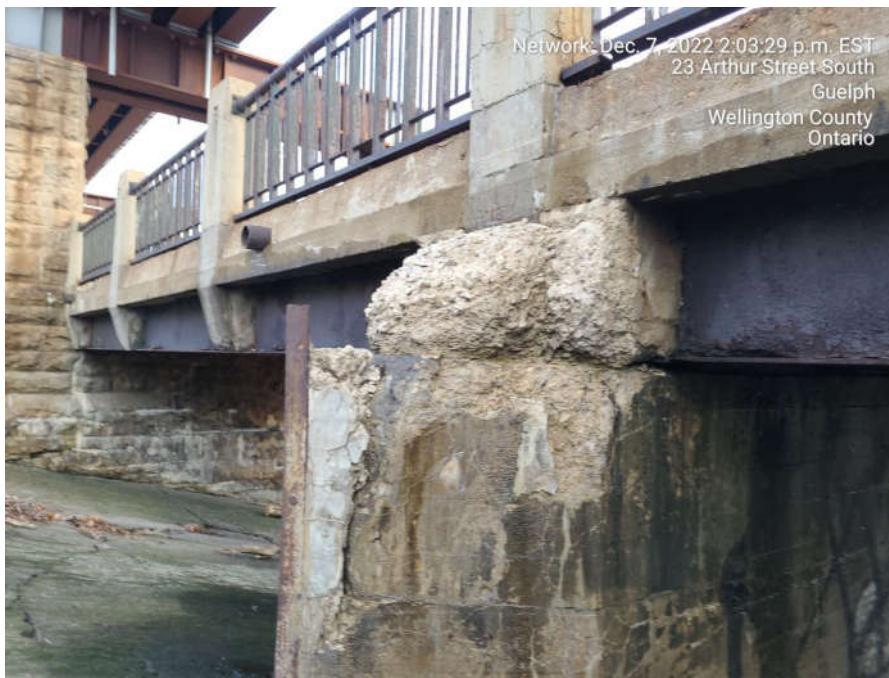
Very severe deterioration of concrete on top of pier cap, north side of structure

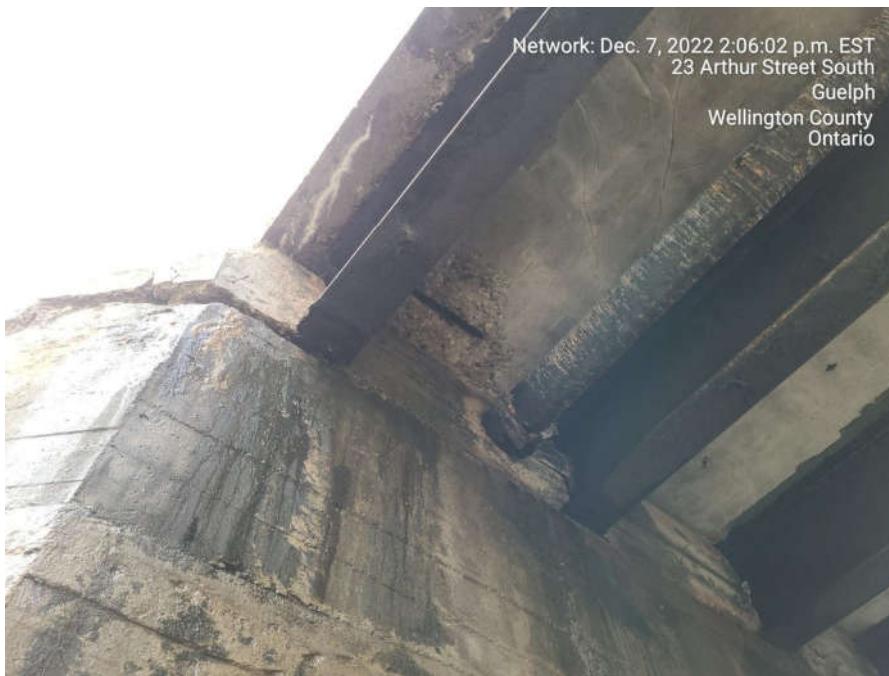
Spalls and exposed corroded rebar on soffit interior on east abutment

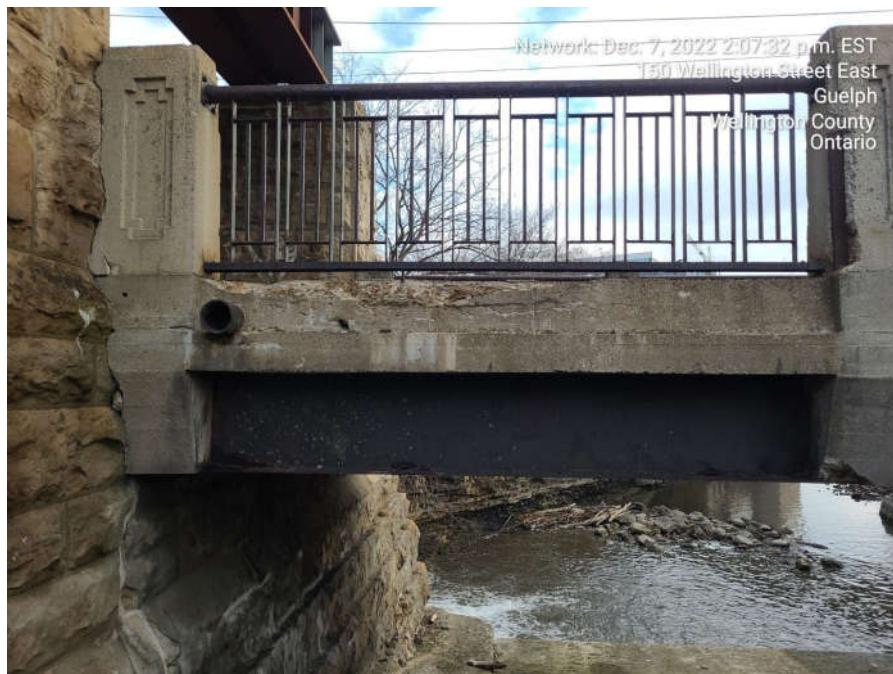
Deck drain and spalls on soffit exterior

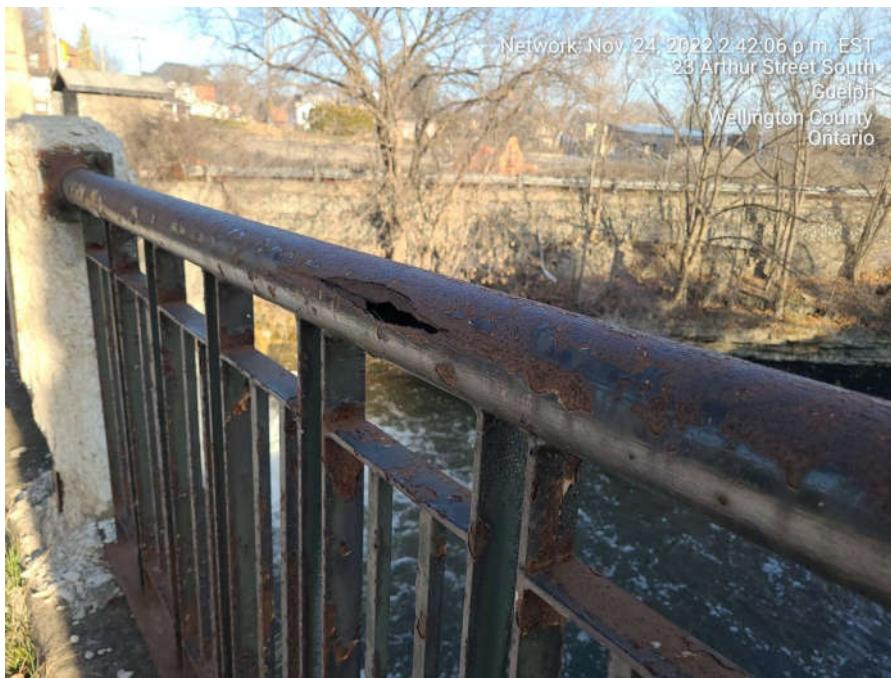
South barrier showing section loss on top rail

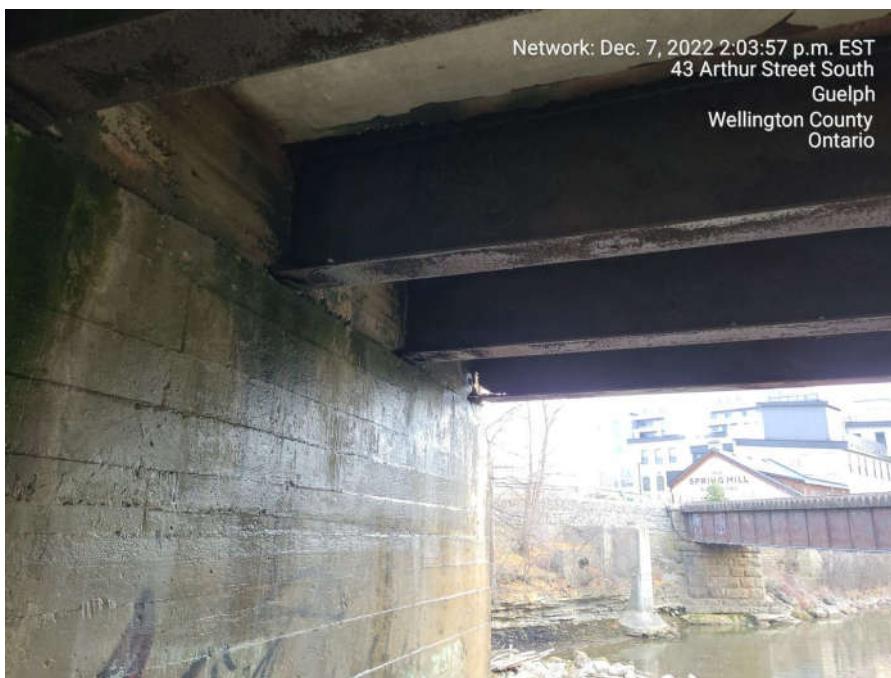
Southwest girder ends showing section loss at the flange

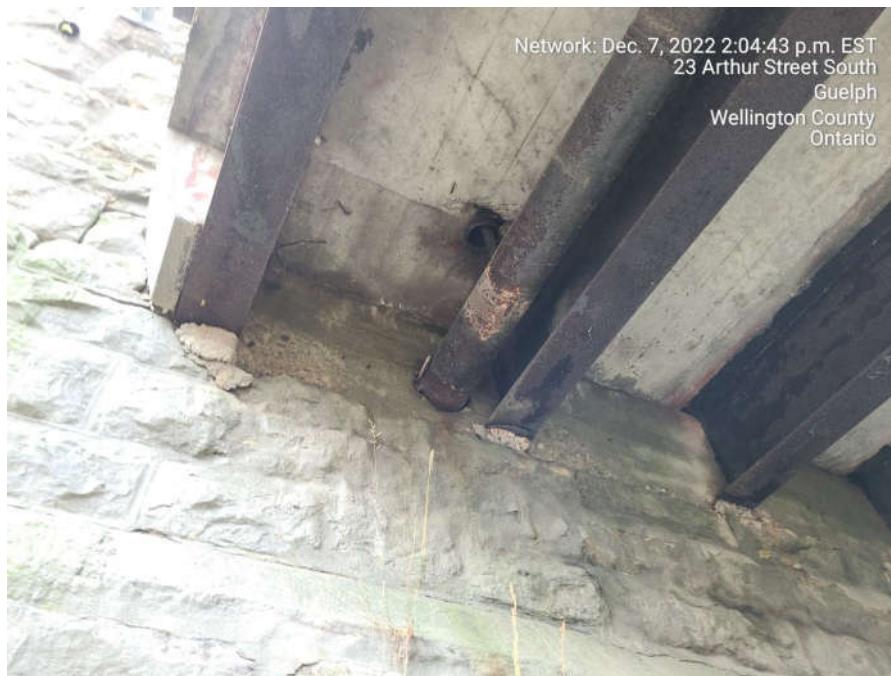
Medium to severe corrosion on deck drains
