DETAILED CONDITION SURVEY REPORT

Structure ID 112, Macdonell Bridge, Guelph, ON

BCC Project No.: BCC21015
Report Date: March 25, 2025

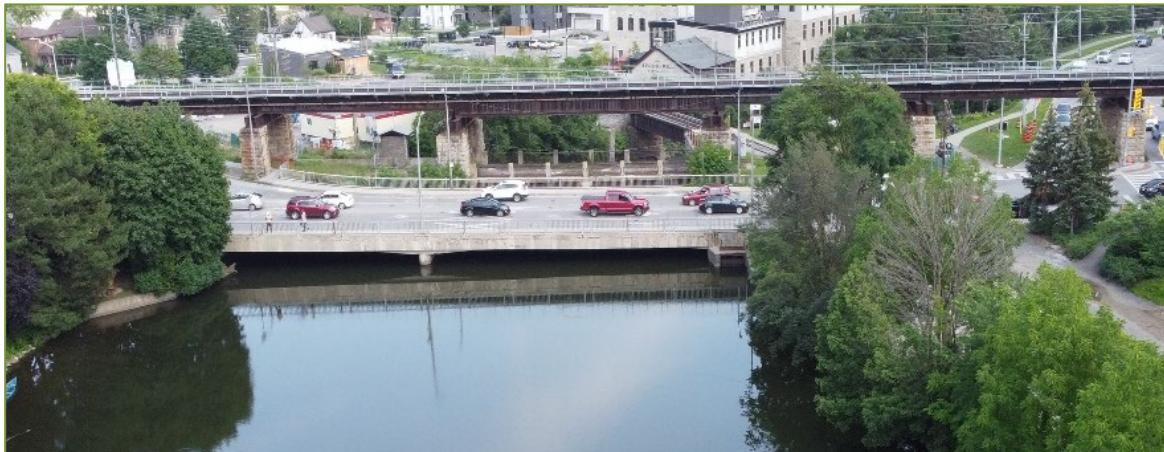
North Elevation of Site No. 112, Macdonell Bridge

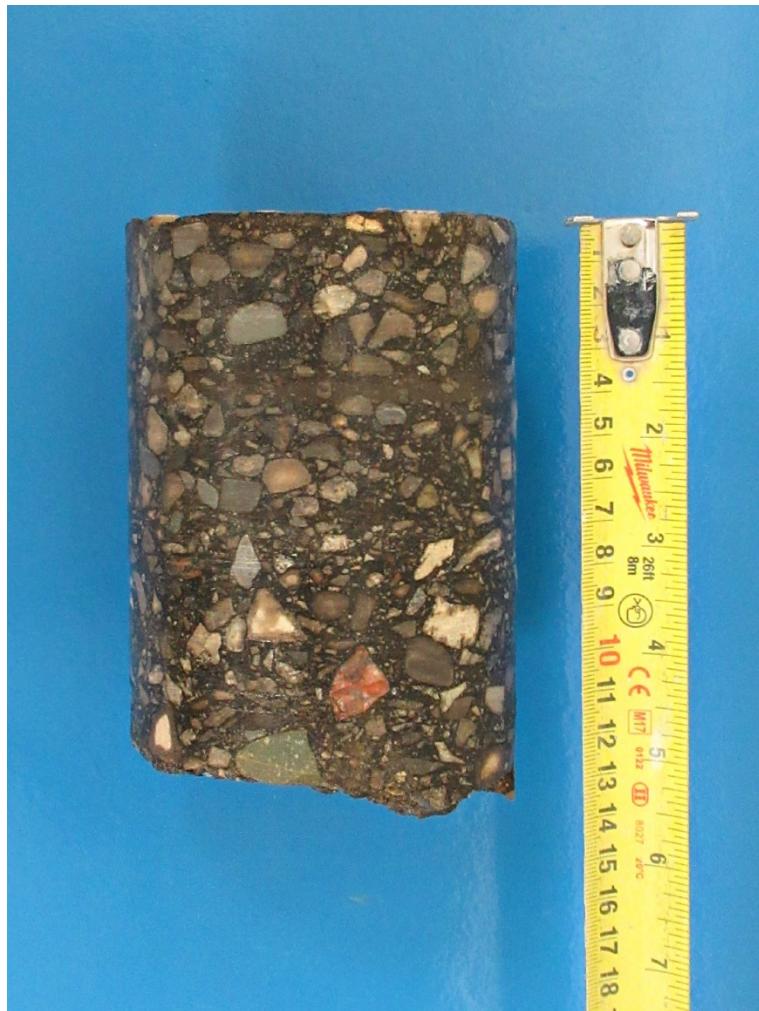
The asphalt wearing surface on the bridge approaches was generally in fair-to-poor condition with unsealed cracks and potholes. Photos P26 and P27 show the general pavement condition on the east and west approaches, respectively. Core C1 was taken from the west approach, where granular materials were encountered beneath 140 mm of asphalt. Photo P63 shows the inside of the corehole C1.

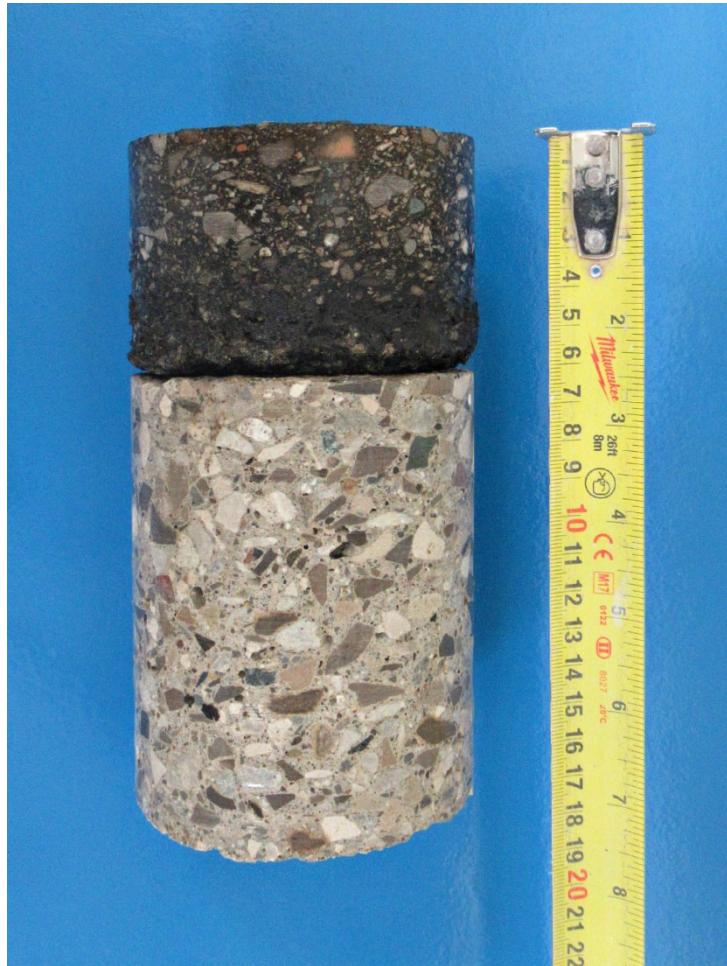
Core C3 was tested to determine the air void system of the hardened concrete in accordance with ASTM C457 using the Modified Point Count Method. Test results are summarized below:

Core No.	Air Content (%)	Specific Surface (mm^{-1})	Spacing Factor (mm)
C3	4.7	39.70	0.139

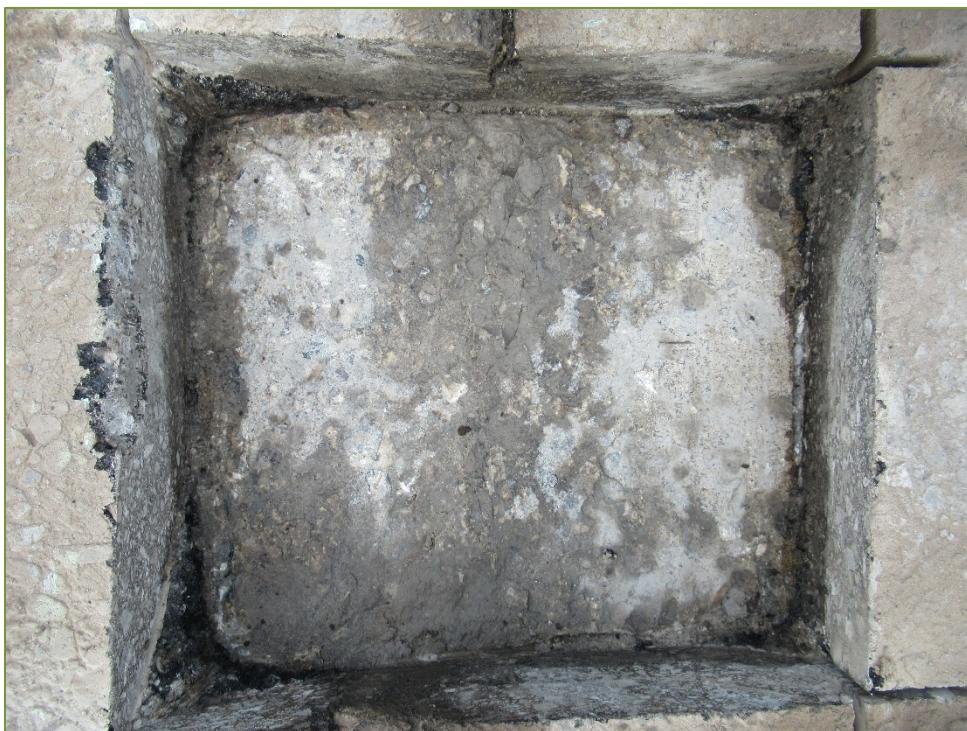
Photo S6 – Sawn Sample SS6 (medium scaling)

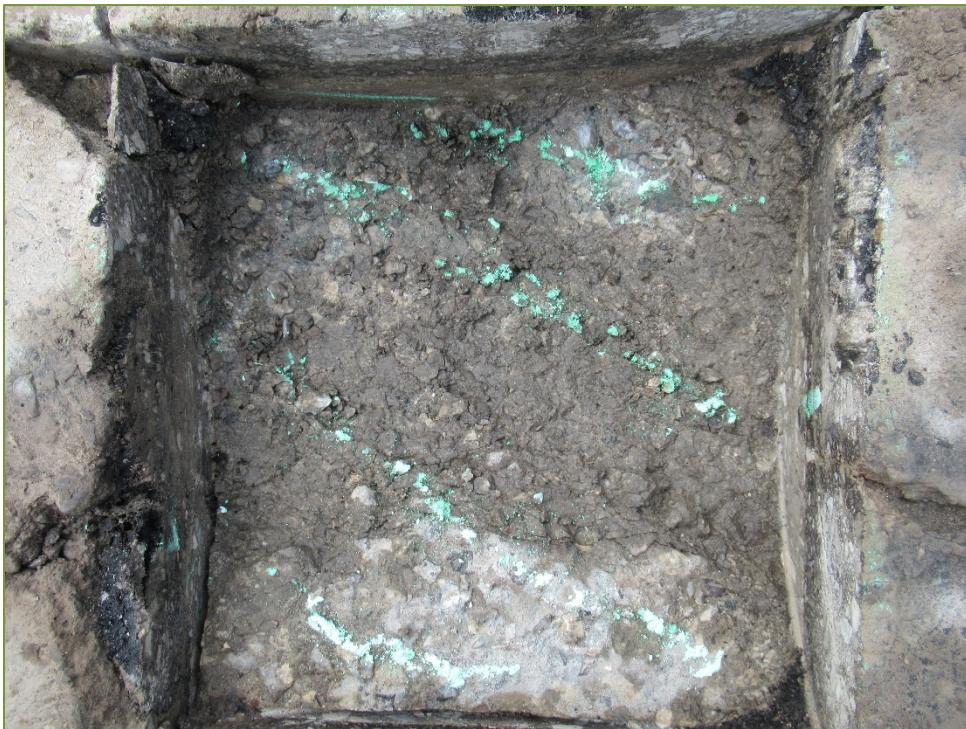
Photo S7 – Sawn Sample SS7 (delamination, and severe scaling)

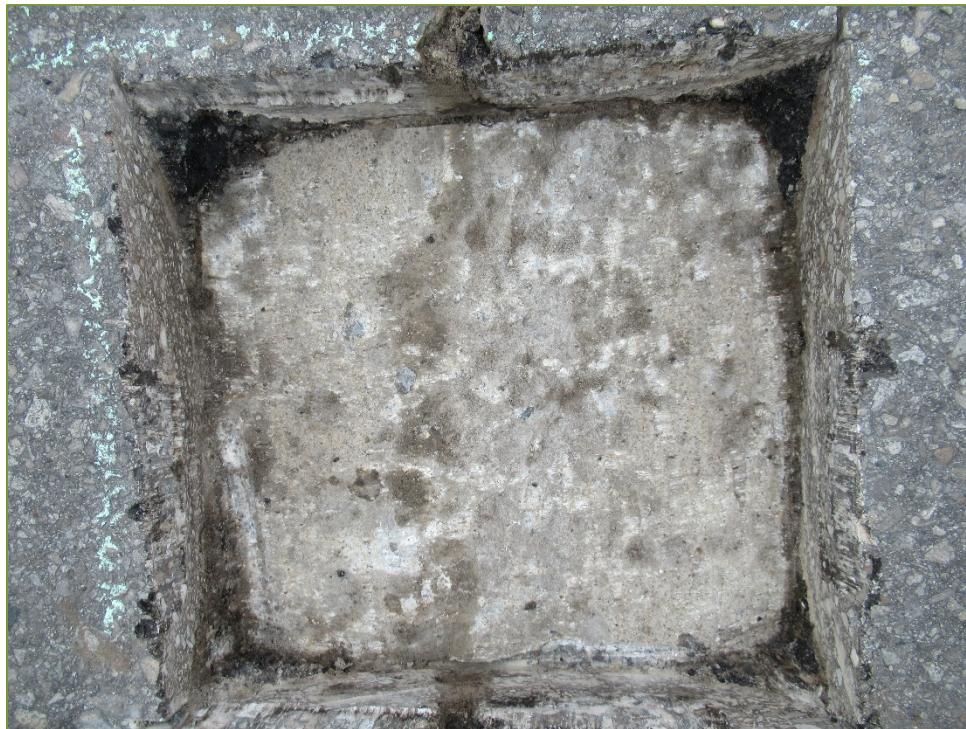
Photo S15 – Sawn Sample SS15 (light scaling)

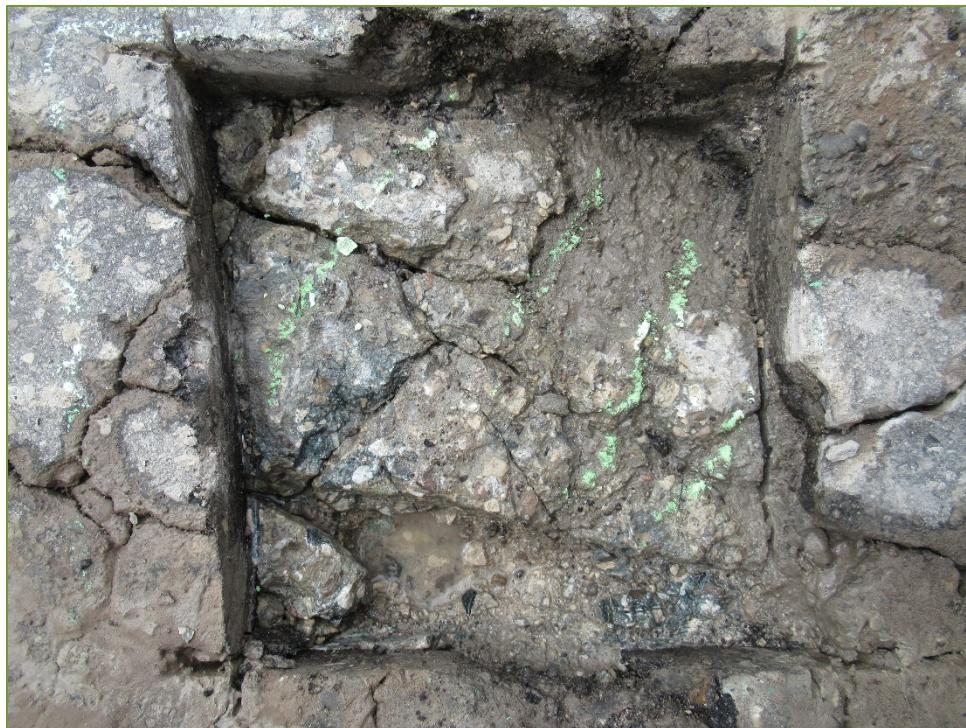
Photo S16 – Sawn Sample SS16 (cracks, delamination, and severe scaling)

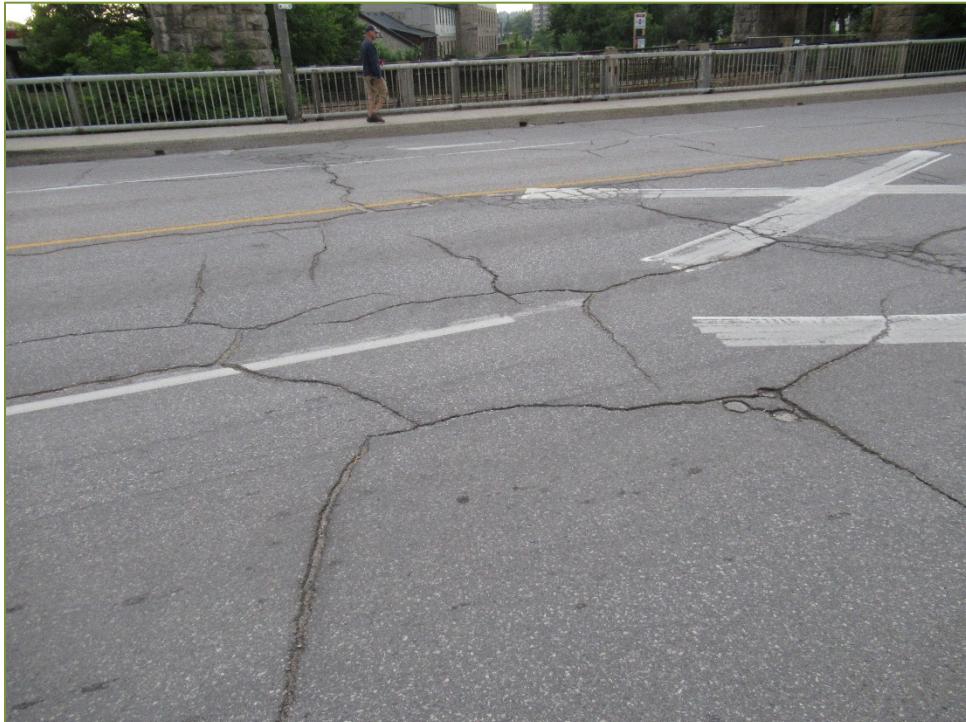
Photo P6 Deck Wearing Surface (unsealed cracks)

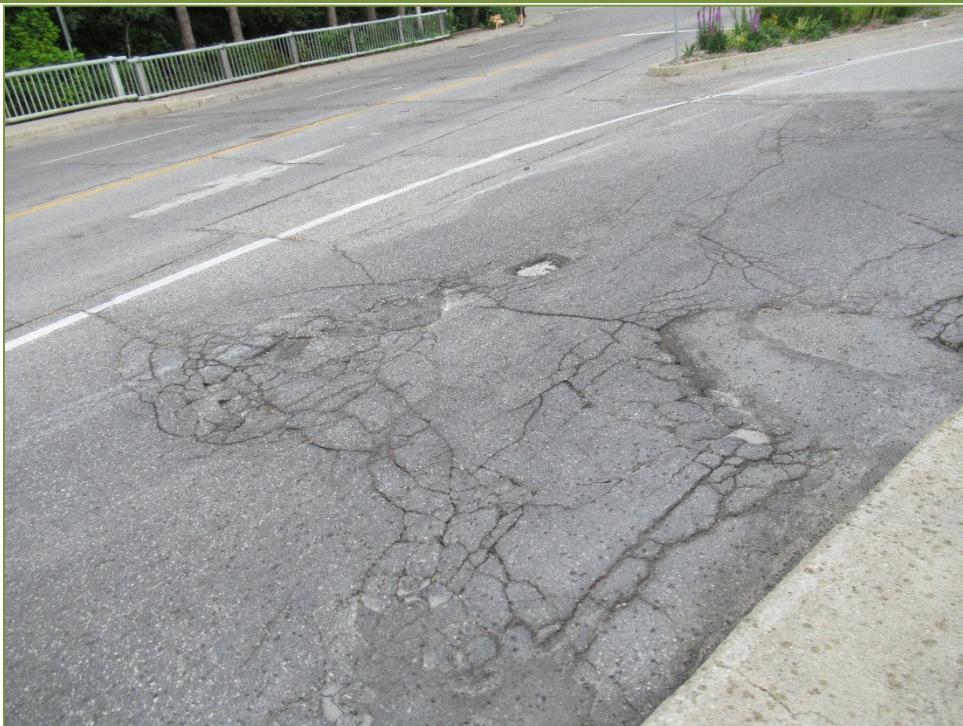
Photo P8 Deck Wearing Surface (unsealed cracks, alligator cracks and pot holes and rutting)

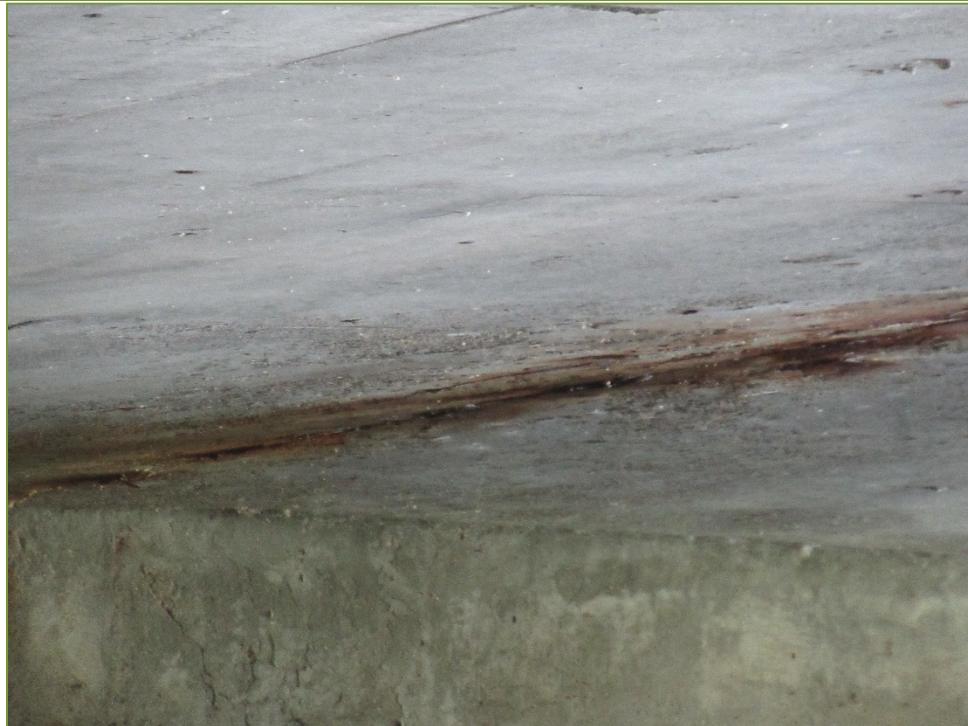
Photo P14 Soffit at Pier (cracks, spall, delamination, and wet area)

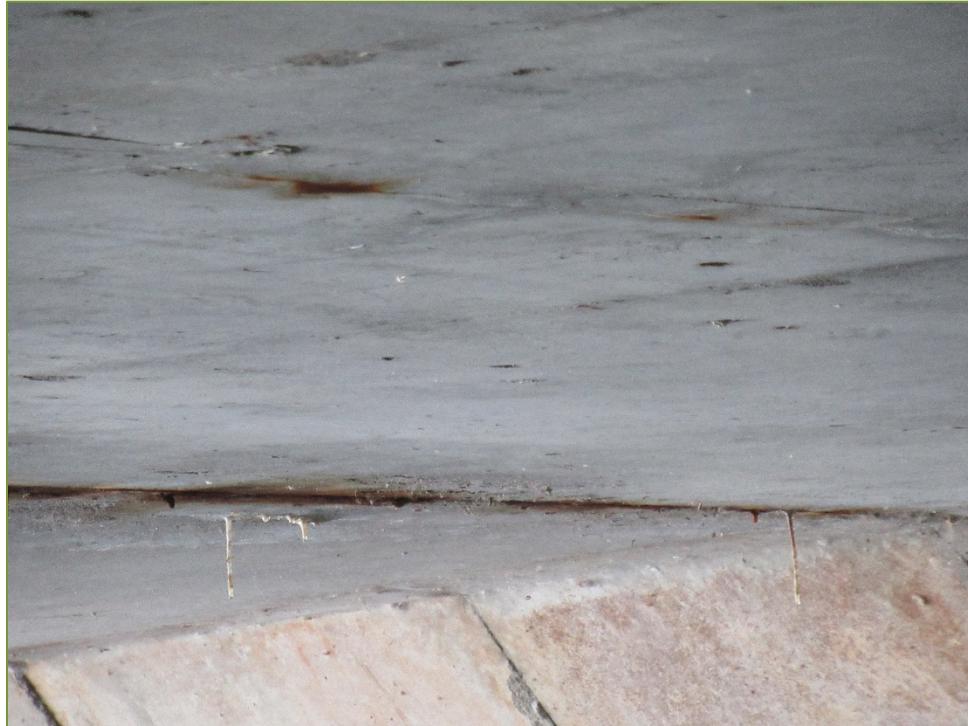
Photo P20 Soffit at East Abutment (cracks, and spall)

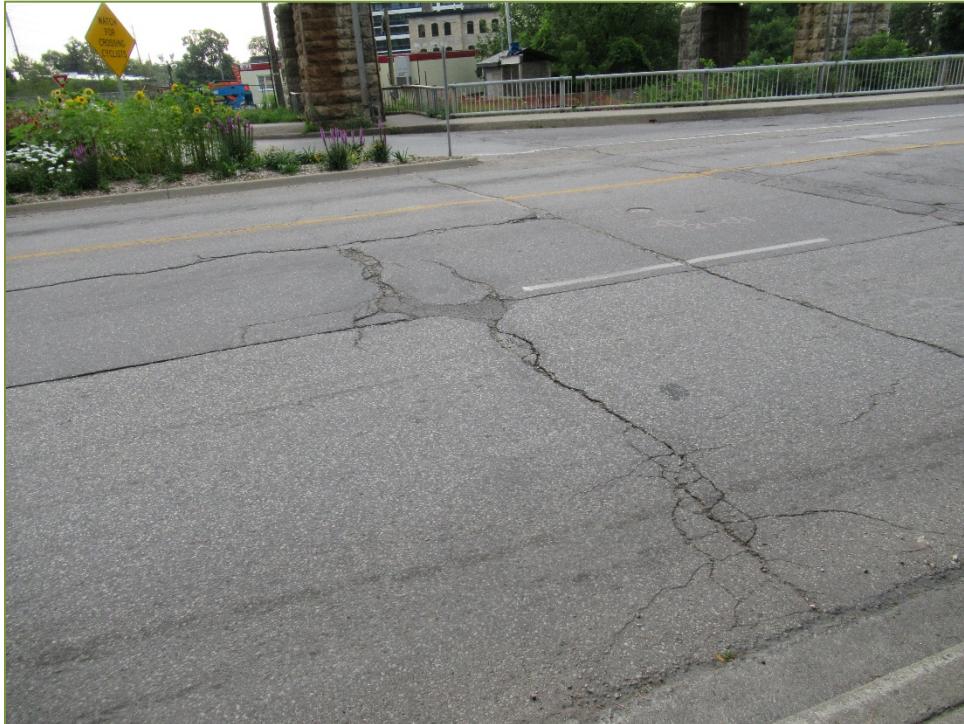
Photo P26 East Approach Wearing Surface (fair condition - unsealed cracks, and pot holes)

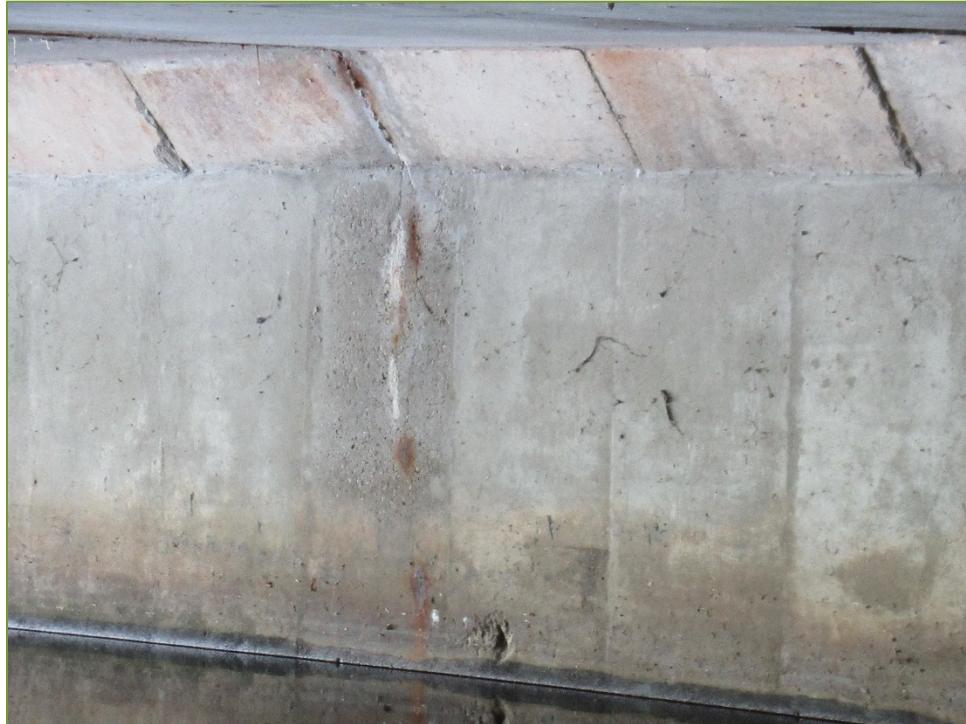
Photo P48 **East Abutment** (cracks, spall, light to medium scaling, and wet area)

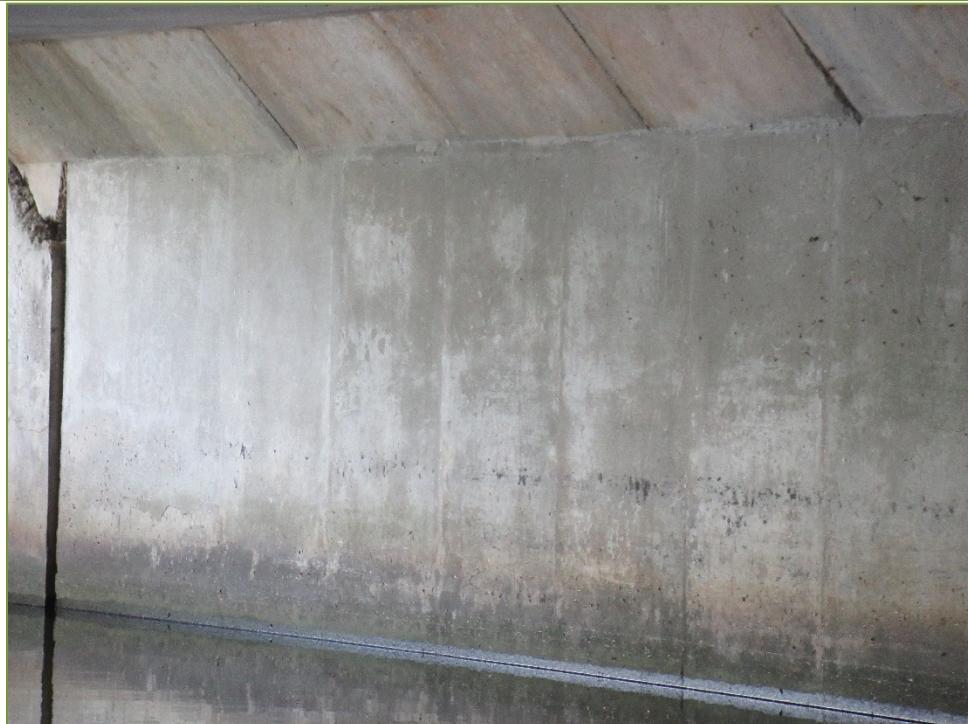
Photo P50 East Abutment, north side (cracks)

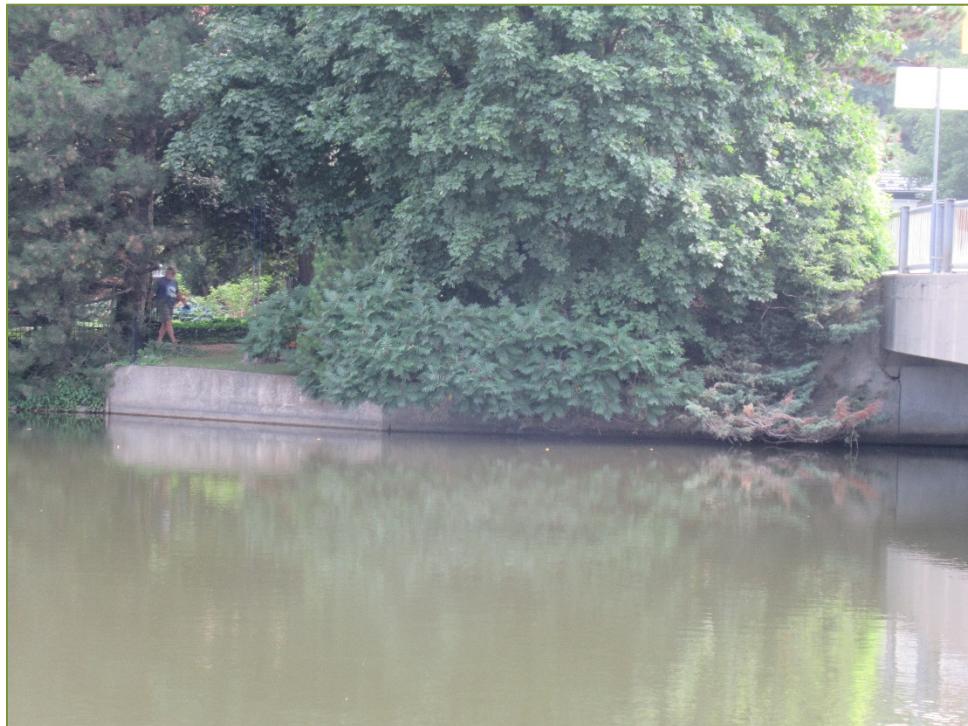
Photo P52 Northeast Retaining Wall (fair condition – wide cracks, spall, delamination, and light scaling)

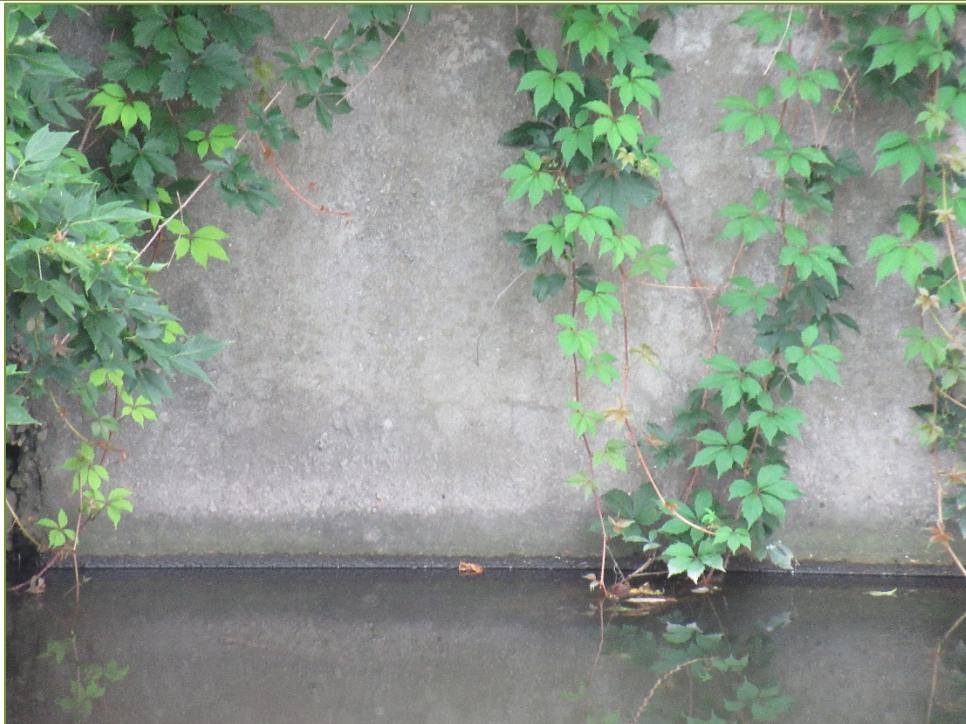
Photo P56 Southwest Retaining Wall (cracks and light scaling)

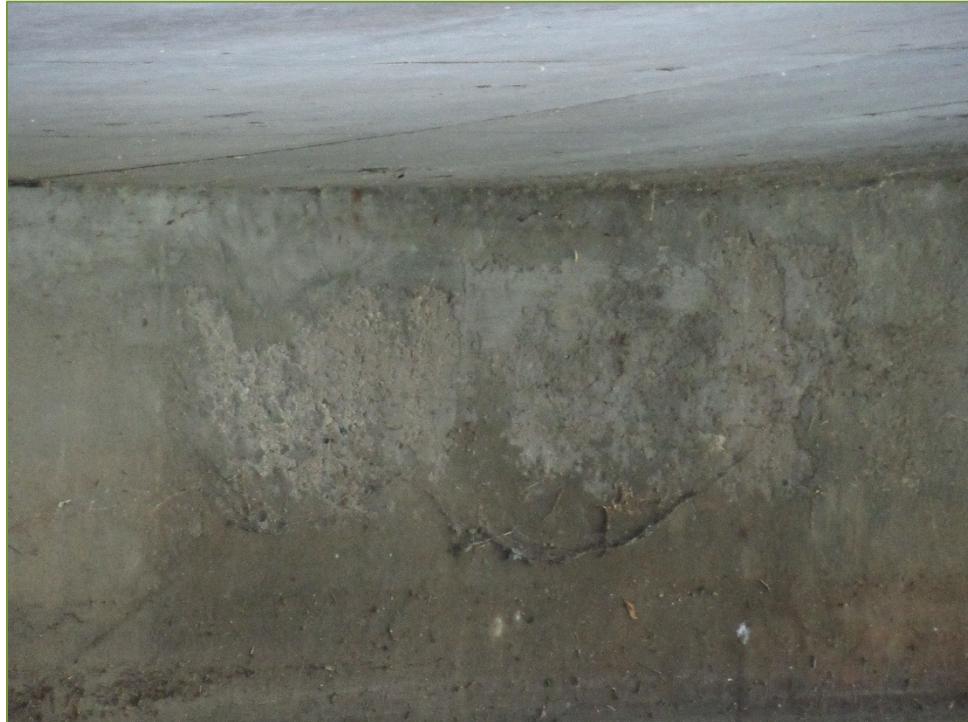
Photo P58 Pier - East Face (light scaling)

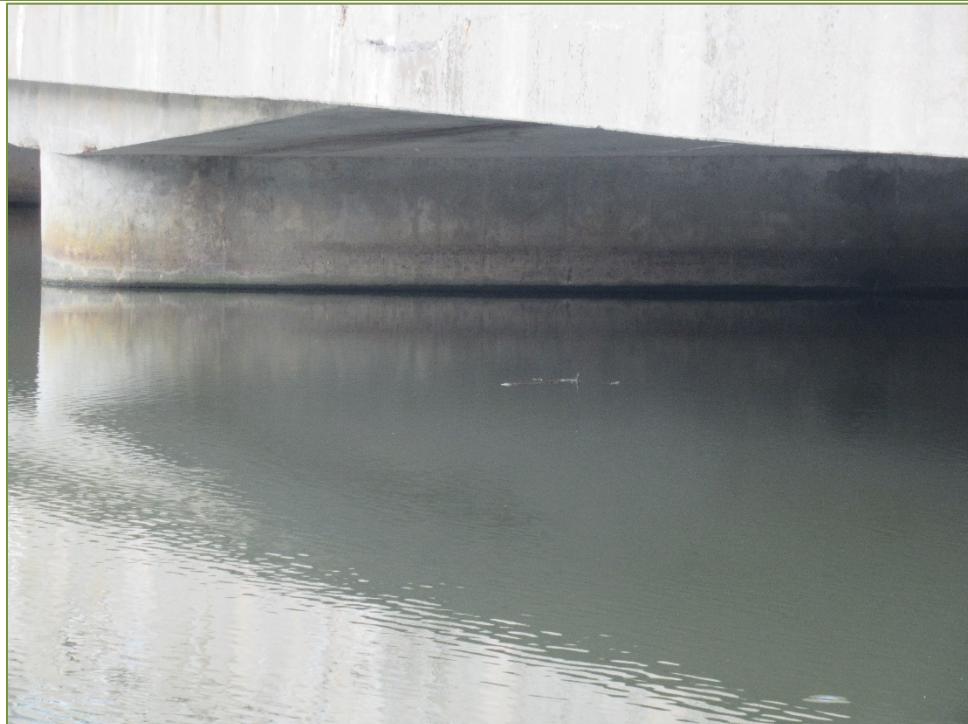
Photo P60 Pier - West Face (cracks, and light scaling)

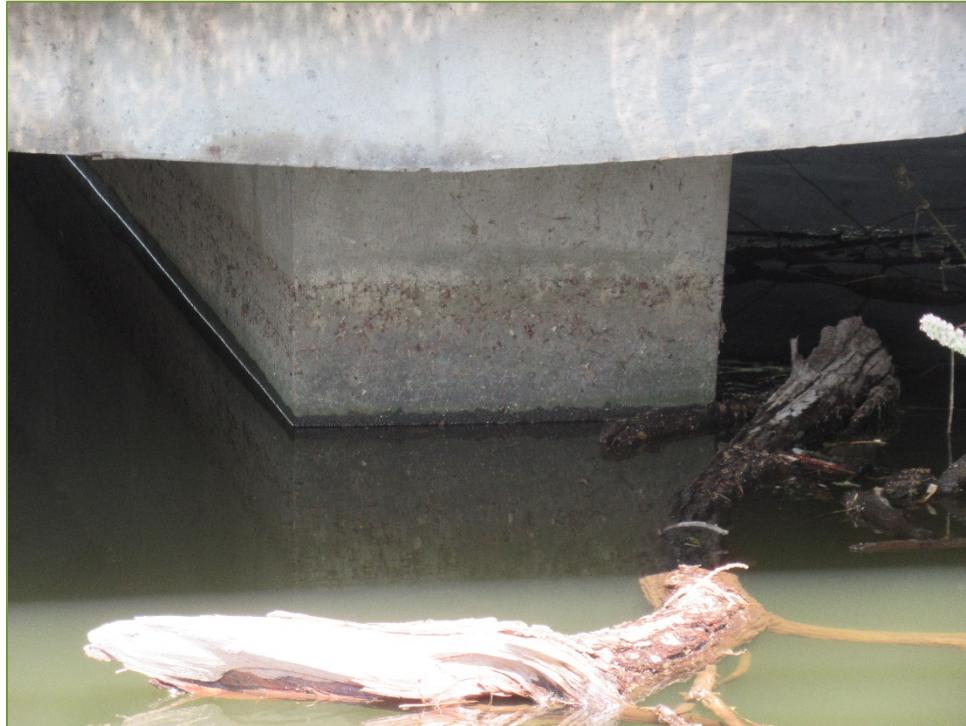
Photo P62 Pier - South Face (medium scaling)

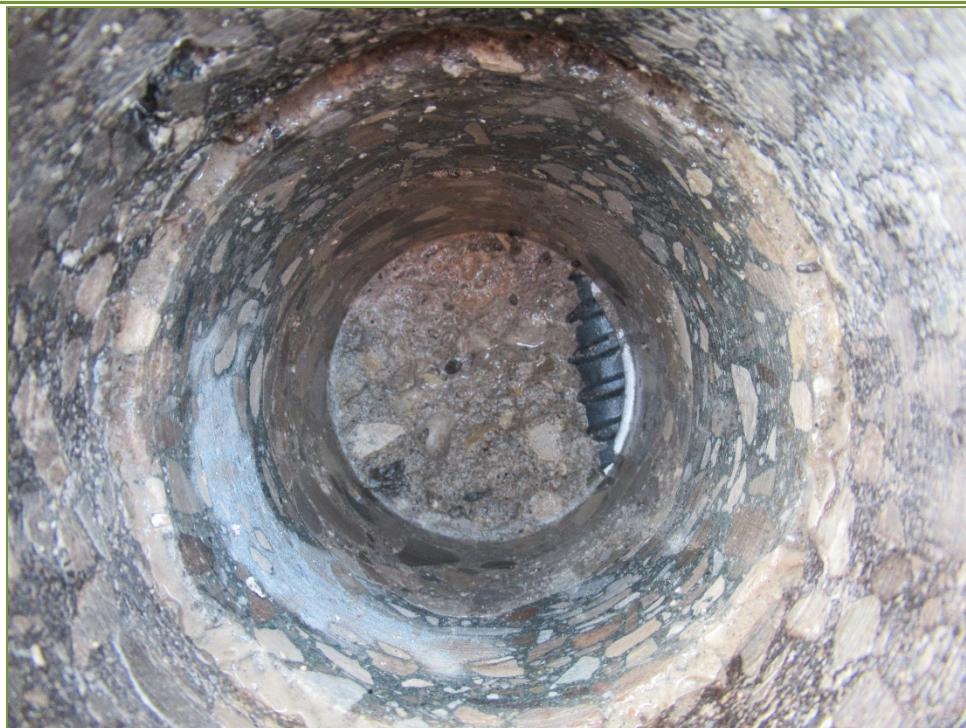
Photo P73 Typical Condition of Inside Core – C20

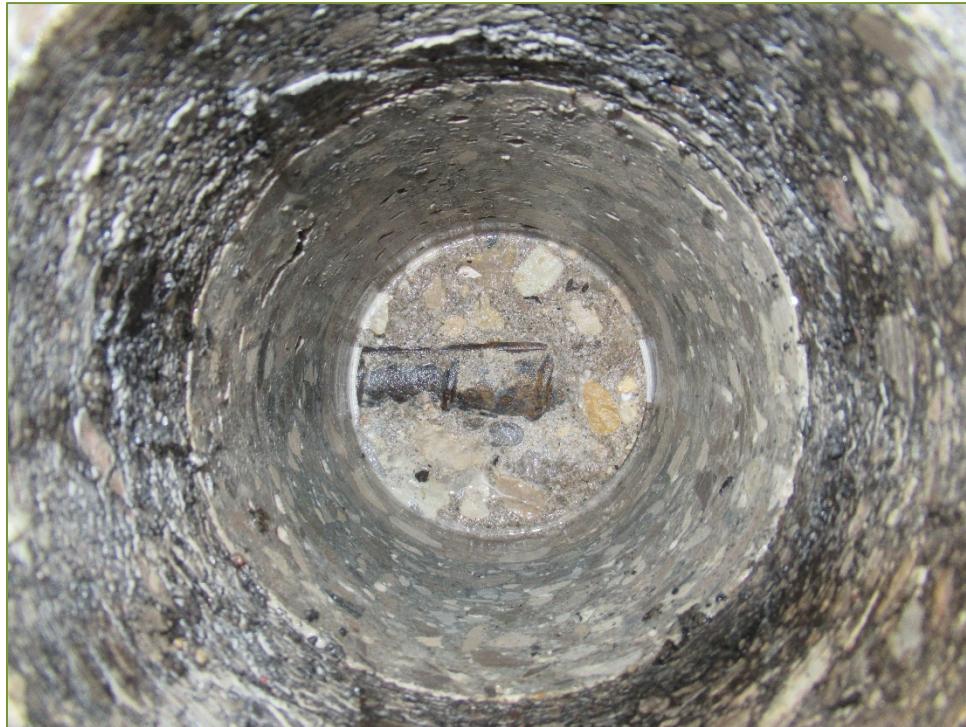
Photo P74 Typical Condition of Inside Core – C21

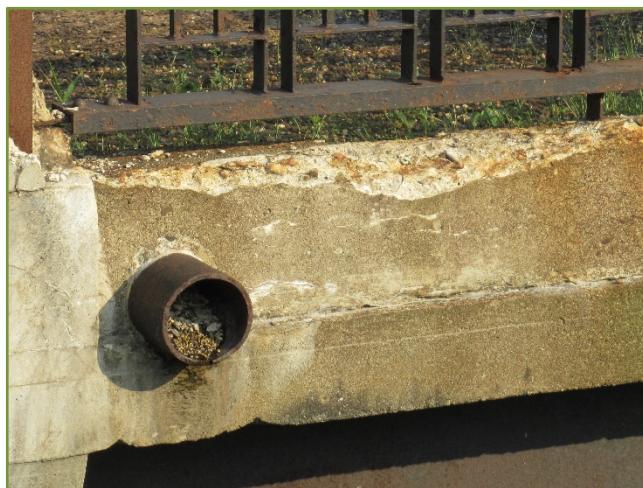
A total of eight drain pipes were located on deck, all of which were found to be blocked with debris. No catch basins were found in the vicinity of the structure.

Typical Condition of North Deck Drainage

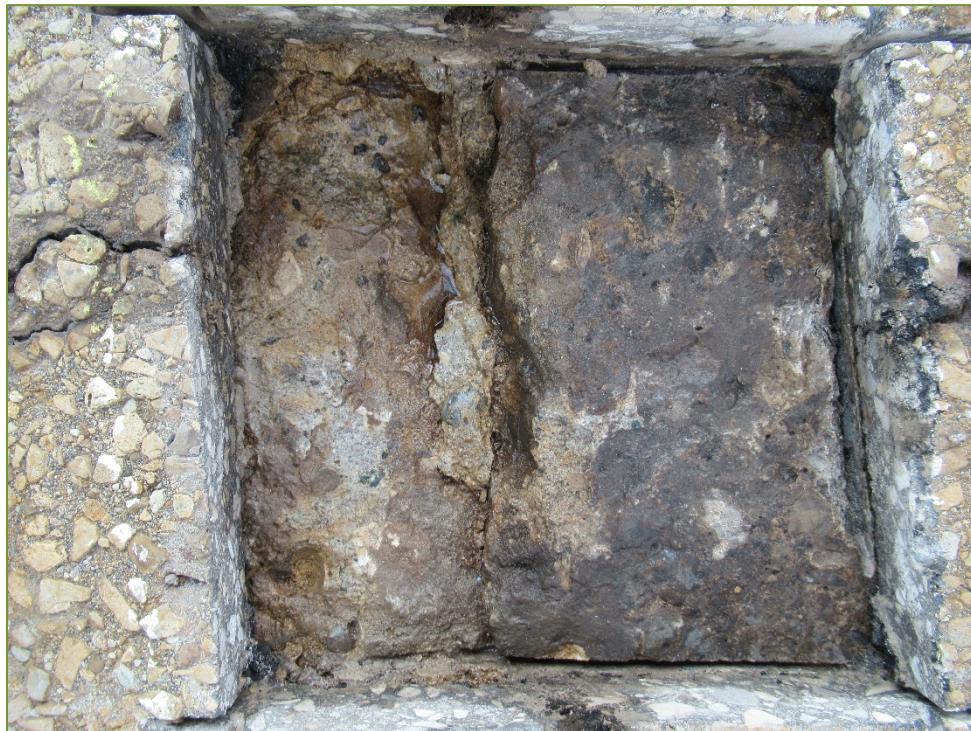
Photo S1 – Sawn Sample SS1 (crack, spall, and rough surface)

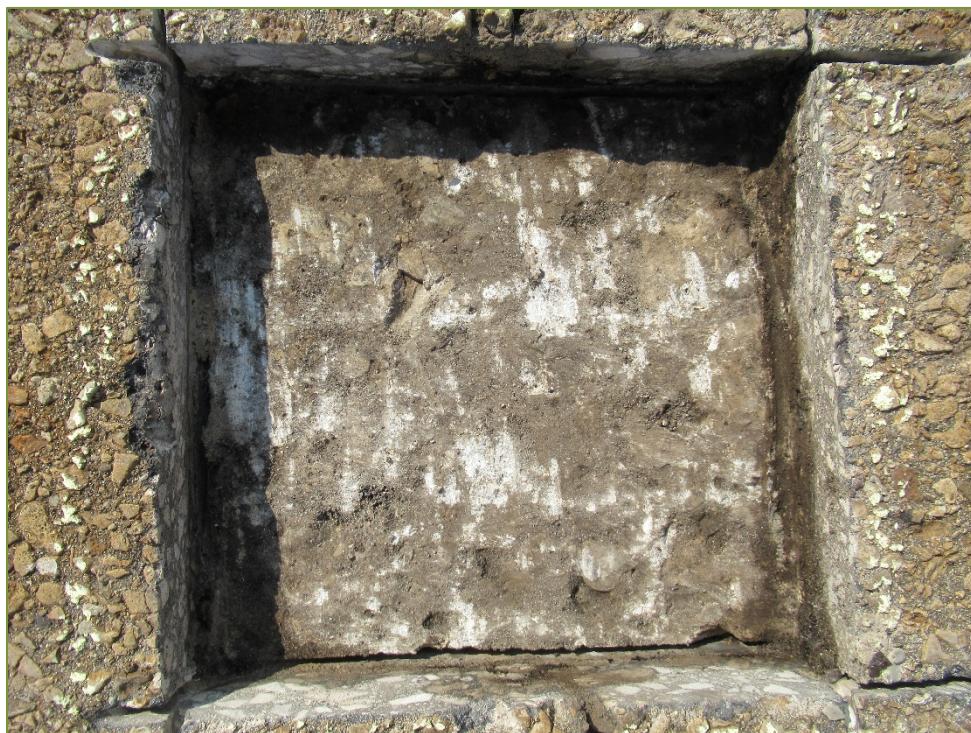
Photo S2 – Sawn Sample SS2 (rough surface)

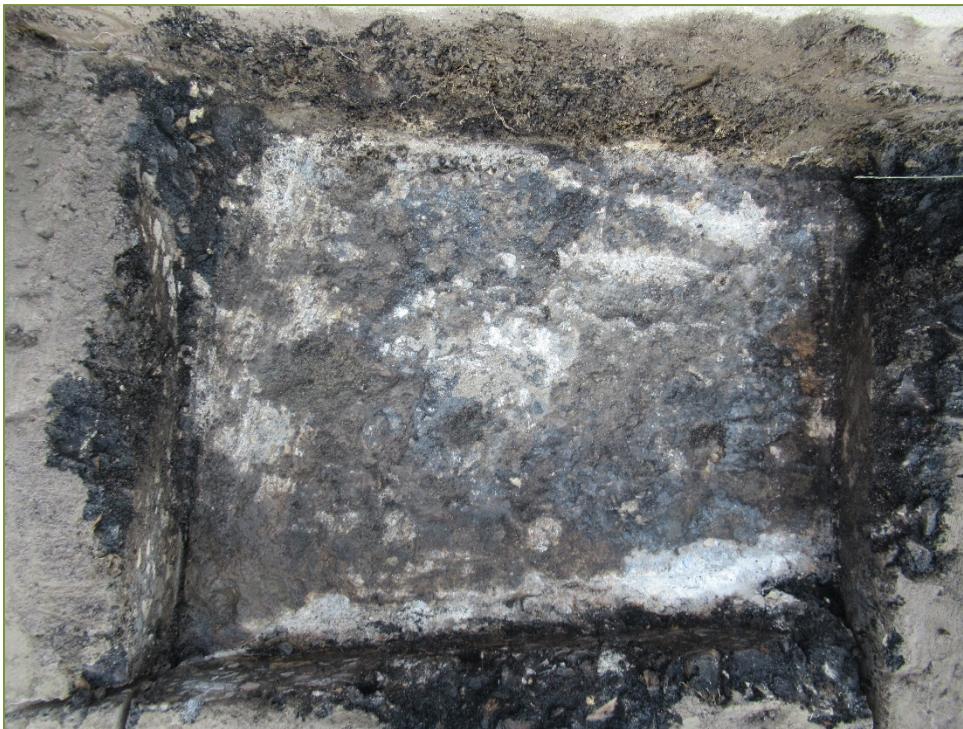
Photo S3 – Sawn Sample SS3 (rough surface)

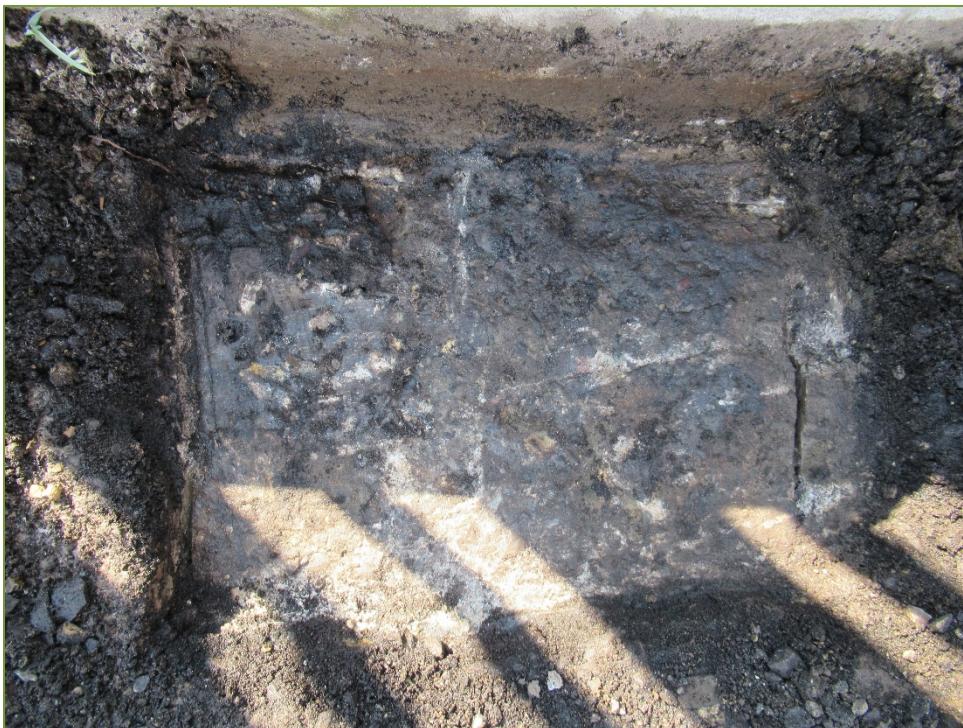
Photo S4 – Sawn Sample SS4 (rough surface)

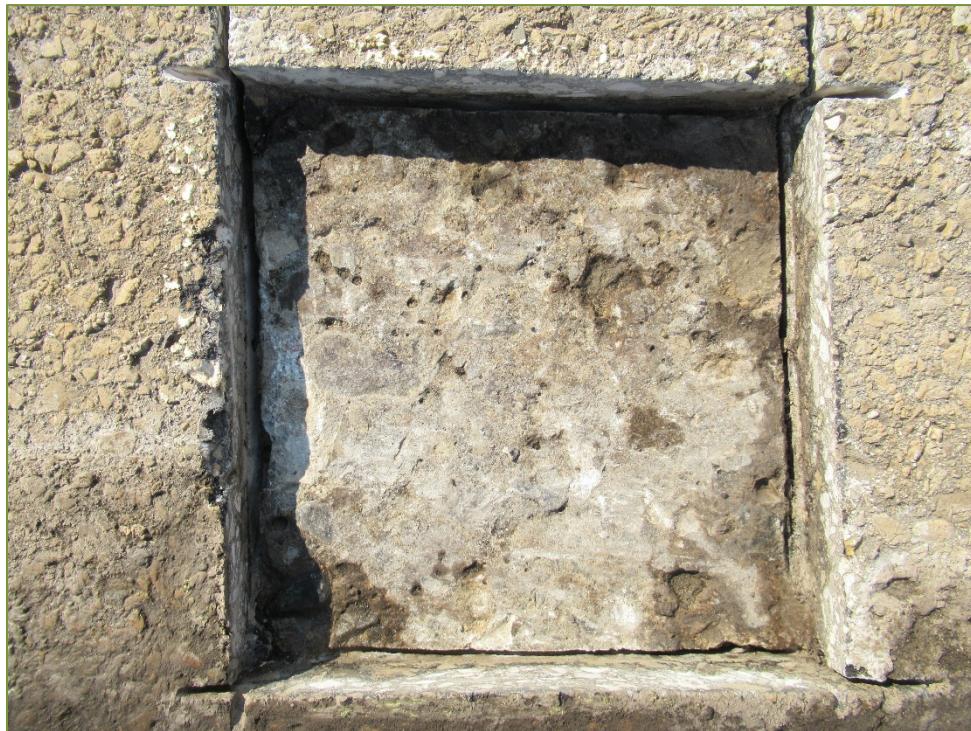
Photo S5 – Sawn Sample SS5 (rough surface)

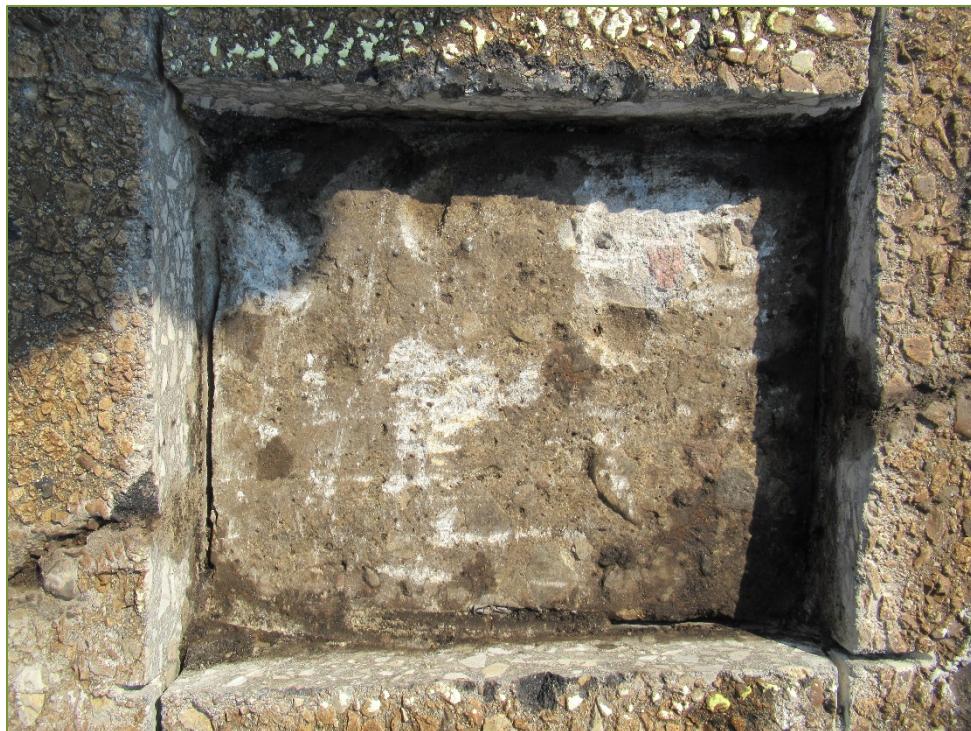
Photo S6 – Sawn Sample SS6 (rough surface)

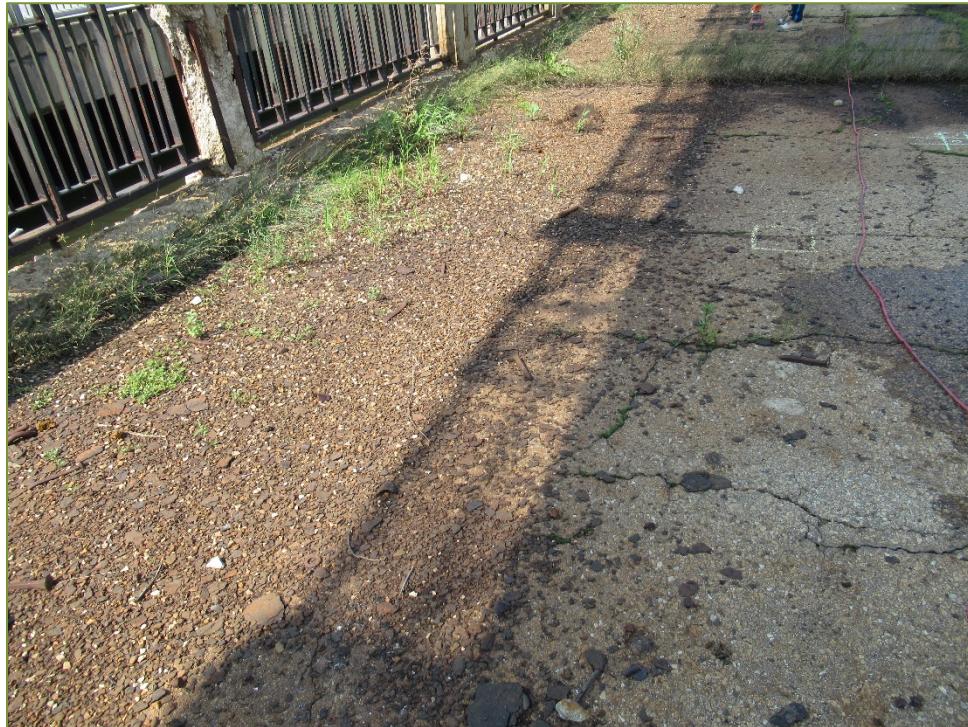
Photo P6 Deck Wearing Surface (unsealed cracks, and ravelling) note vegetation growth and debris

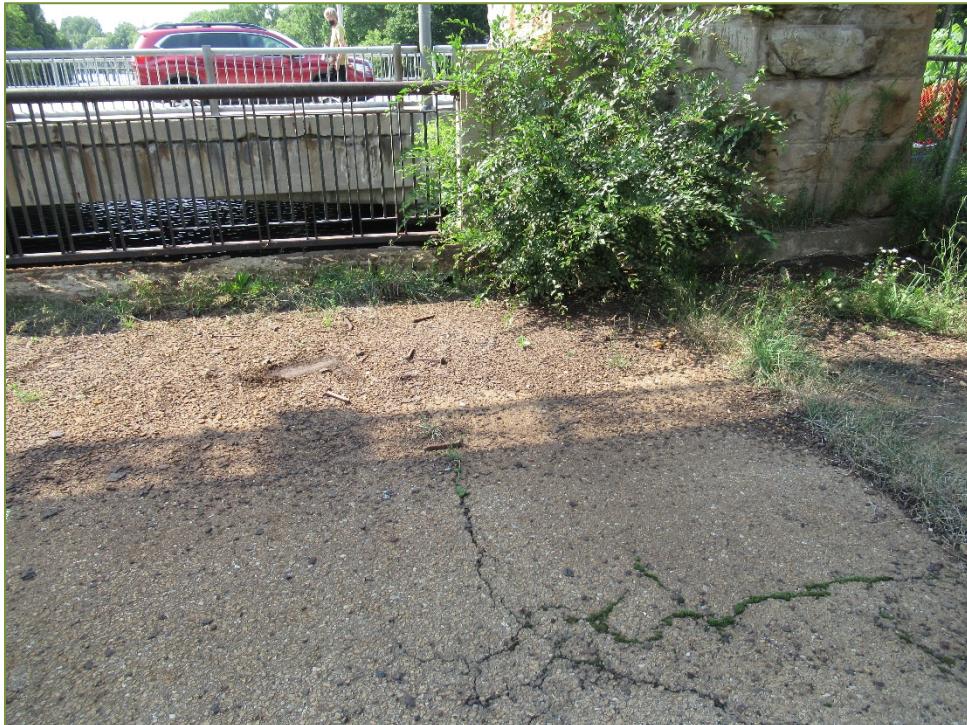
Photo P8 Deck Wearing Surface (unsealed cracks, and ravelling) note vegetation growth and debris

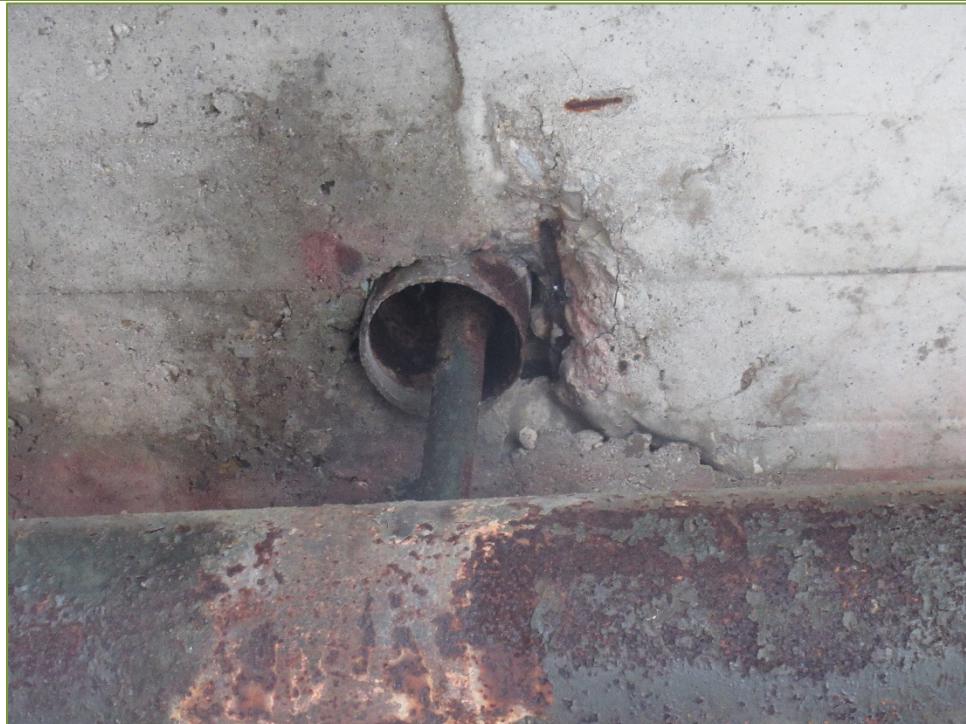
Photo P10 Soffit at West Abutment, south edge (spall, and delamination) note, light corrosion on utility duct

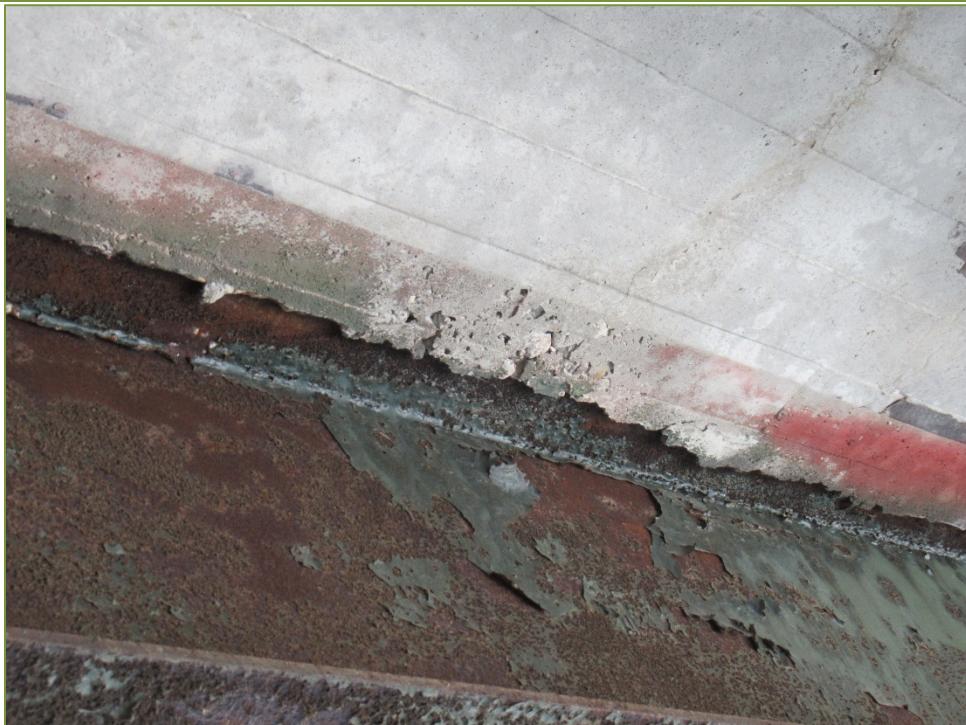
Photo P12 Soffit at West Abutment (honeycombing) and Girder (light corrosion)
