DETAILED CONDITION SURVEY REPORT

Structure ID 112, Macdonell Bridge, Guelph, ON

BCC Project No.: BCC21015
Report Date: March 25, 2025

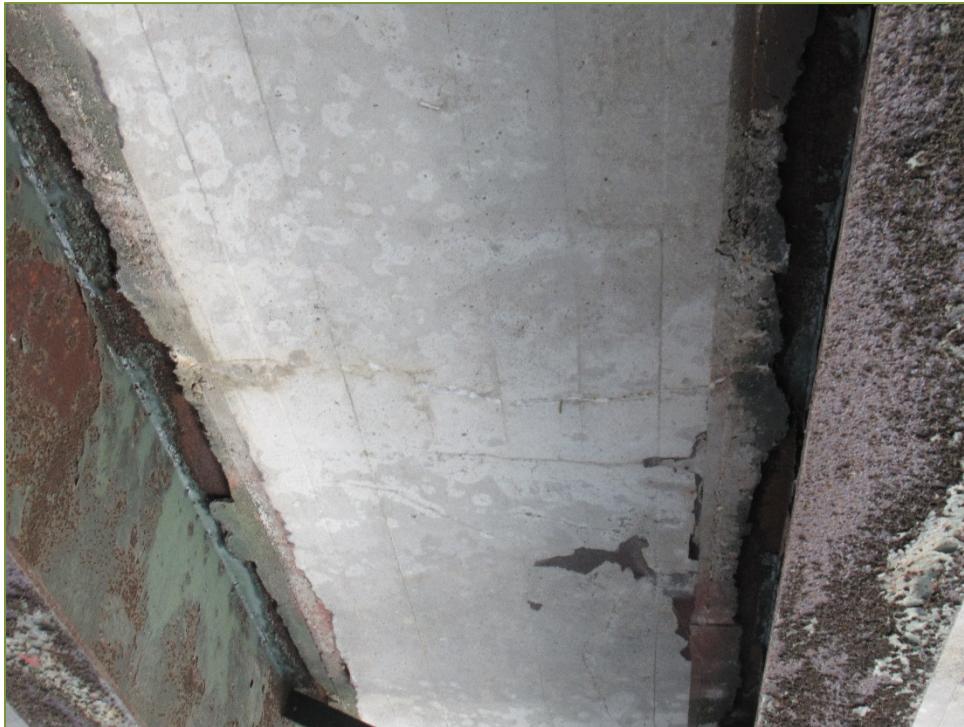
Photo P13 Soffit at West Abutment between 3rd and 4th Girder from North (cracks) and Girders (light corrosion)

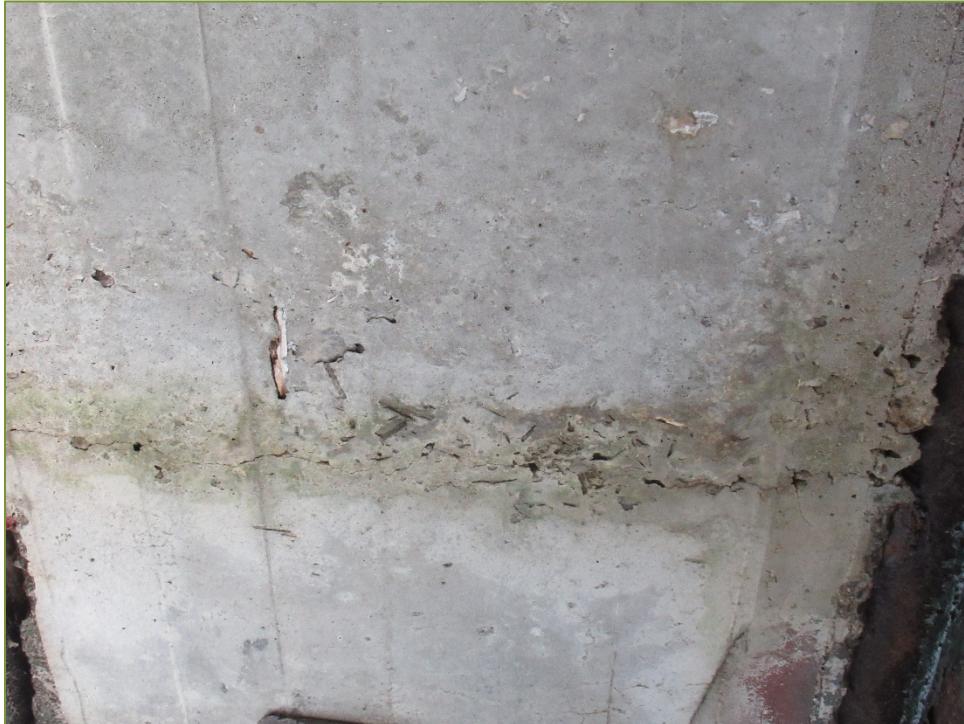
Photo P14 Soffit at West Abutment between 2nd and 3rd Girder from North (cracks, honeycombing, and wet area)

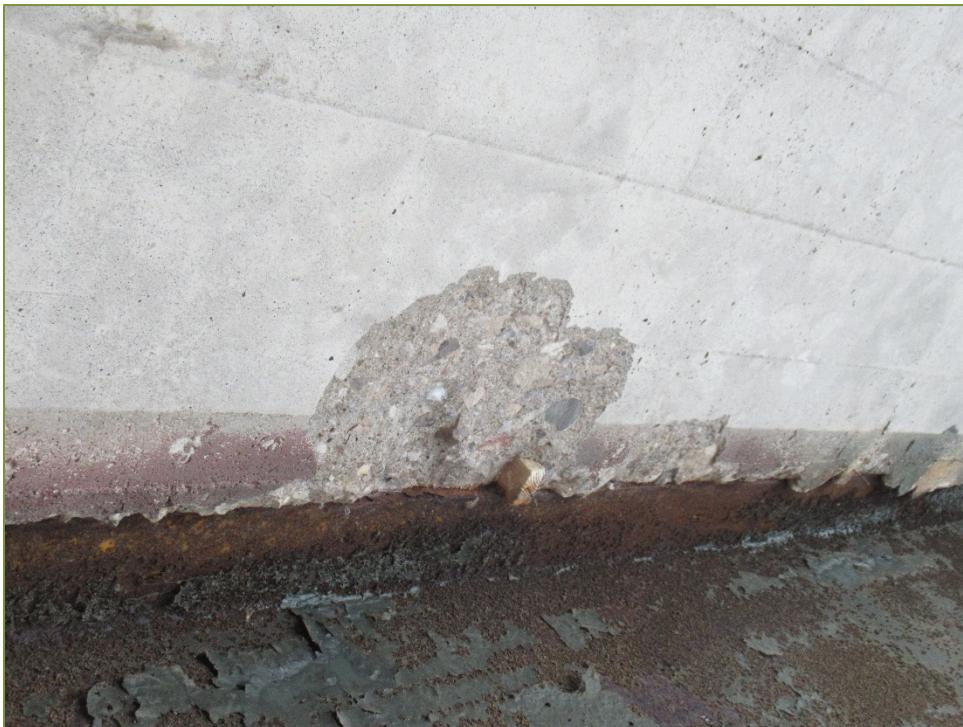
Photo P15 Soffit at West Abutment, north edge (spall) and Girder (light corrosion)

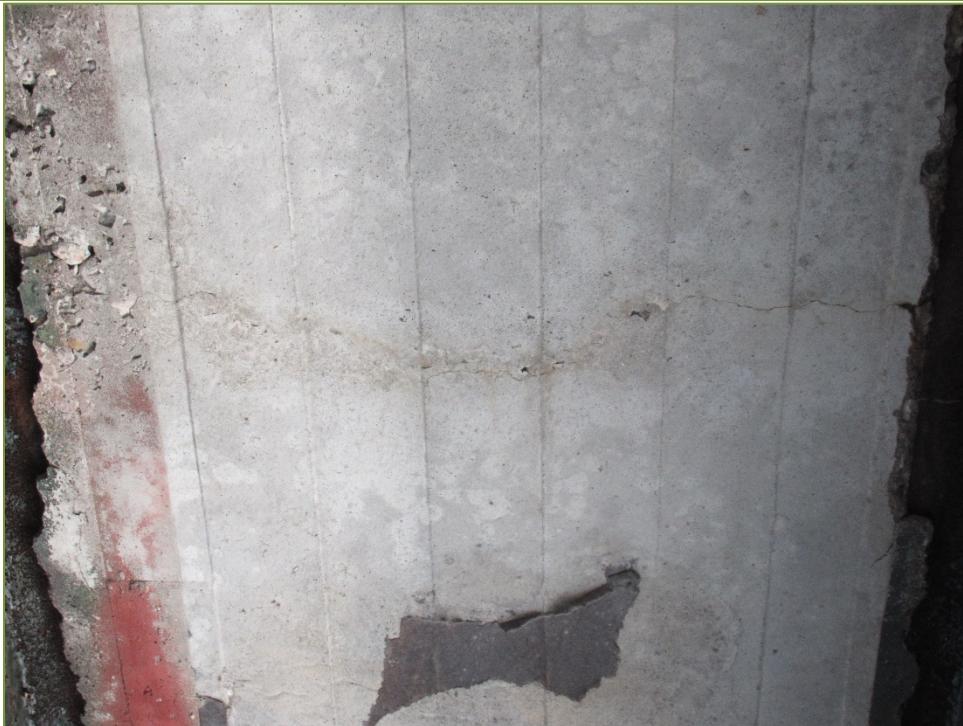
Photo P16 Soffit between West Abutment and Pier between 4th and 5th Girder (crack, and honeycombing)

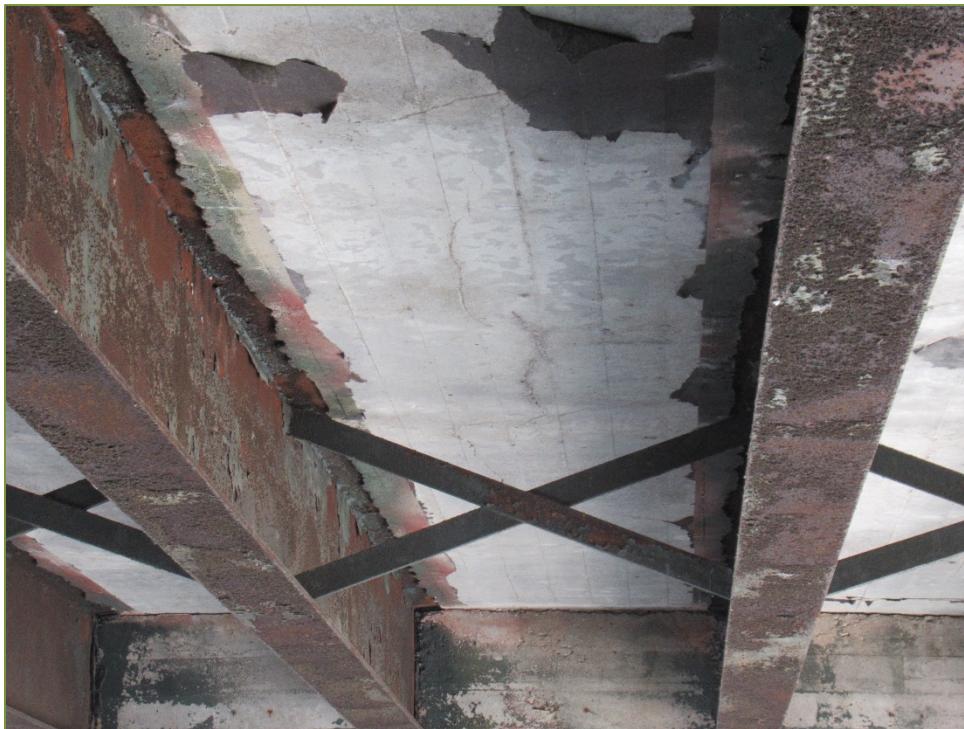
Photo P17 Soffit between West Abutment and Pier between 3rd and 4th Girder from North (cracks and light scaling) and Girders (light corrosion)

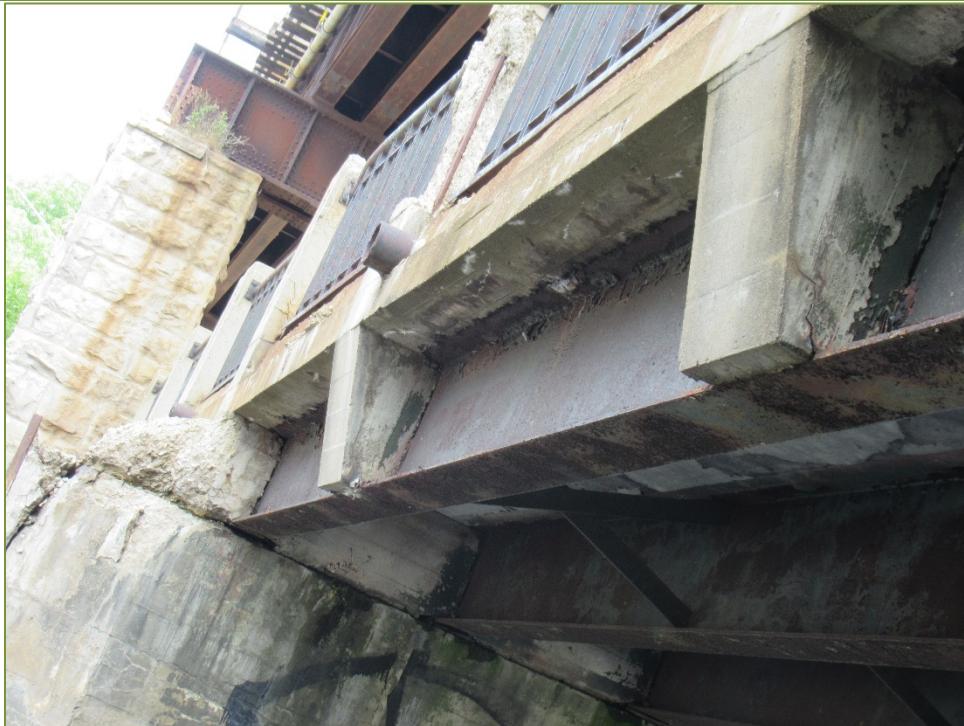
Photo P18 Soffit between West Abutment and Pier, north edge (cracks, and delamination) and Girders (light corrosion)

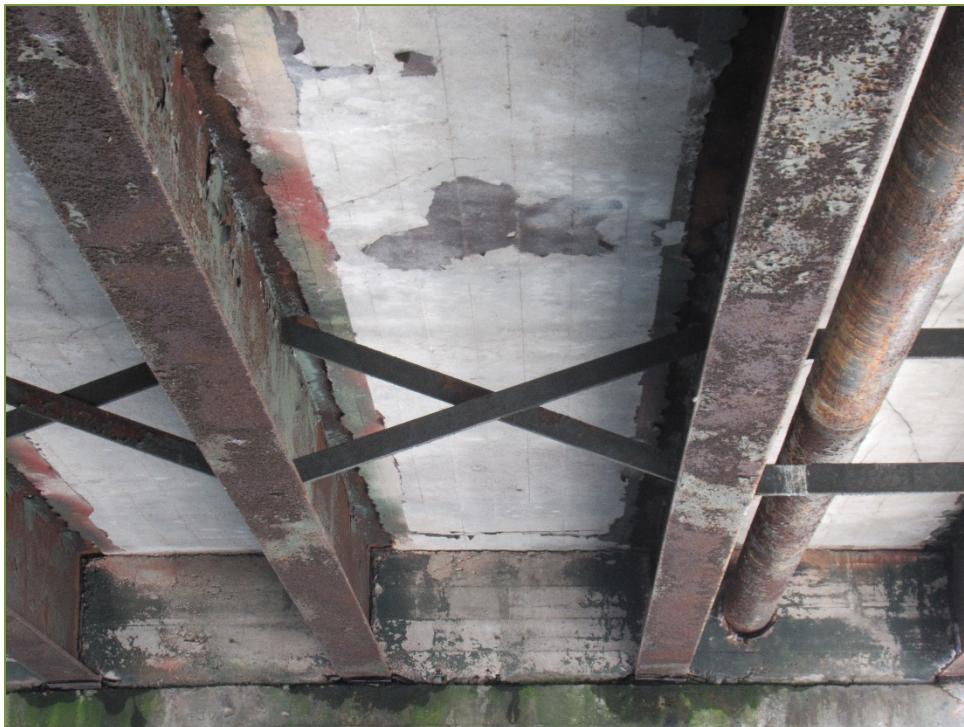
Photo P19 Soffit at Pier (cracks) and Girders (light corrosion)

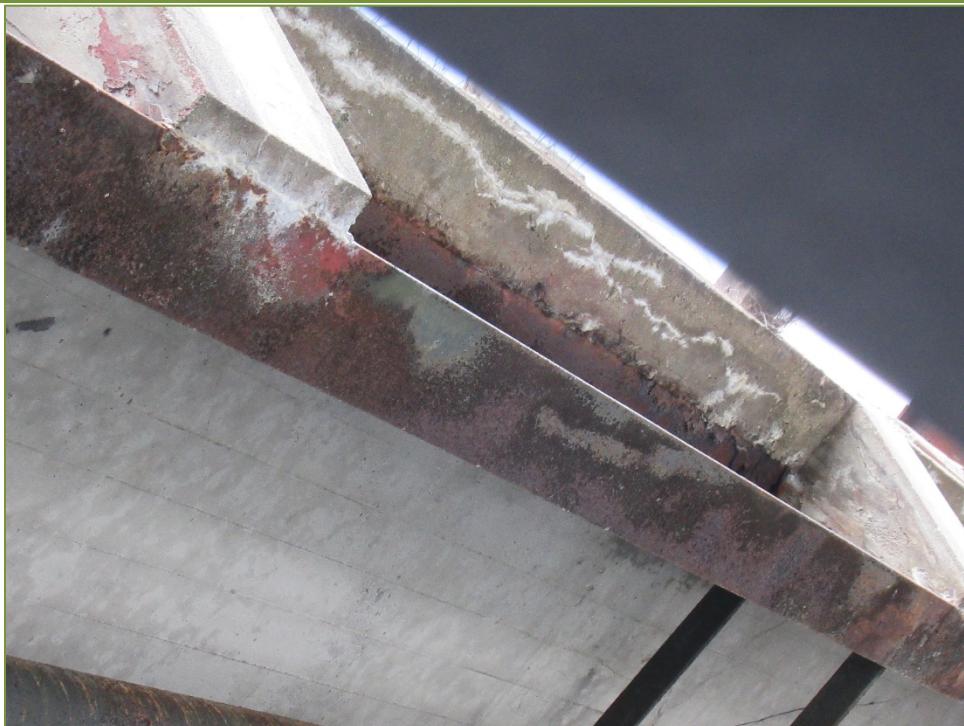
Photo P20 Soffit between West Abutment and Pier, south edge (cracks, and delamination) and Girders (light corrosion)

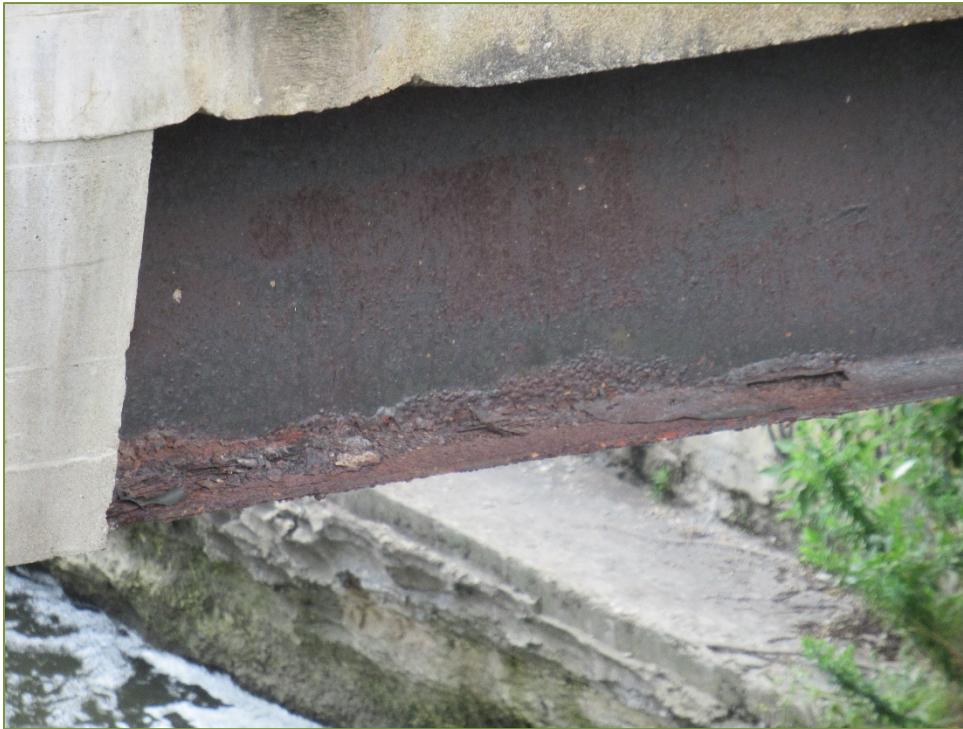
Photo P21 1st Girder from North at Pier (severe corrosion on flange)

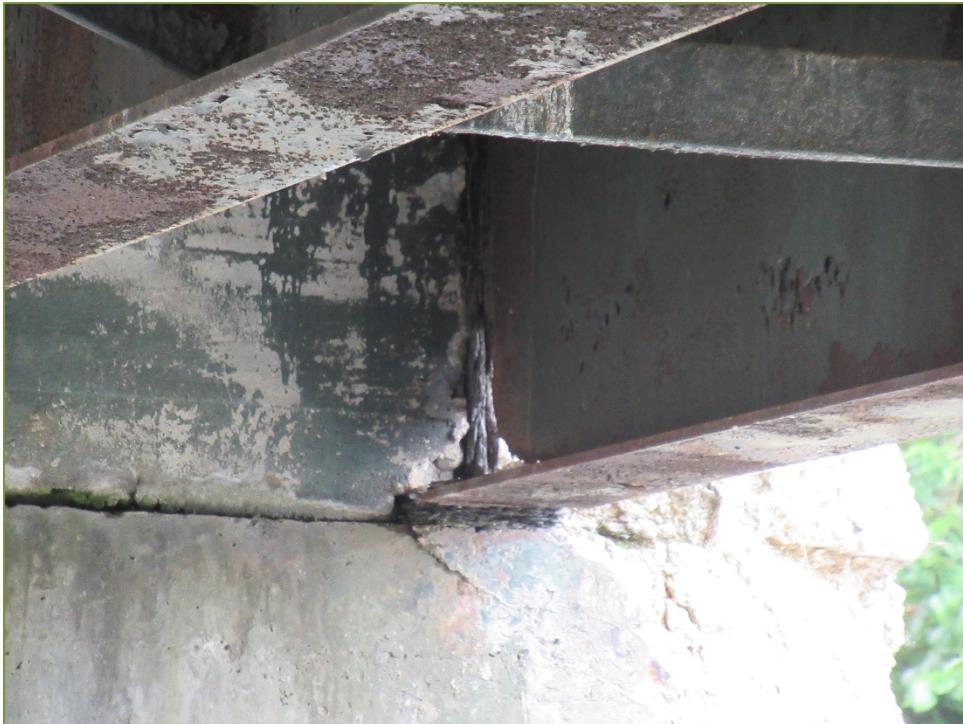
Photo P22 6th Girder from North at Pier (severe corrosion, and section loss)

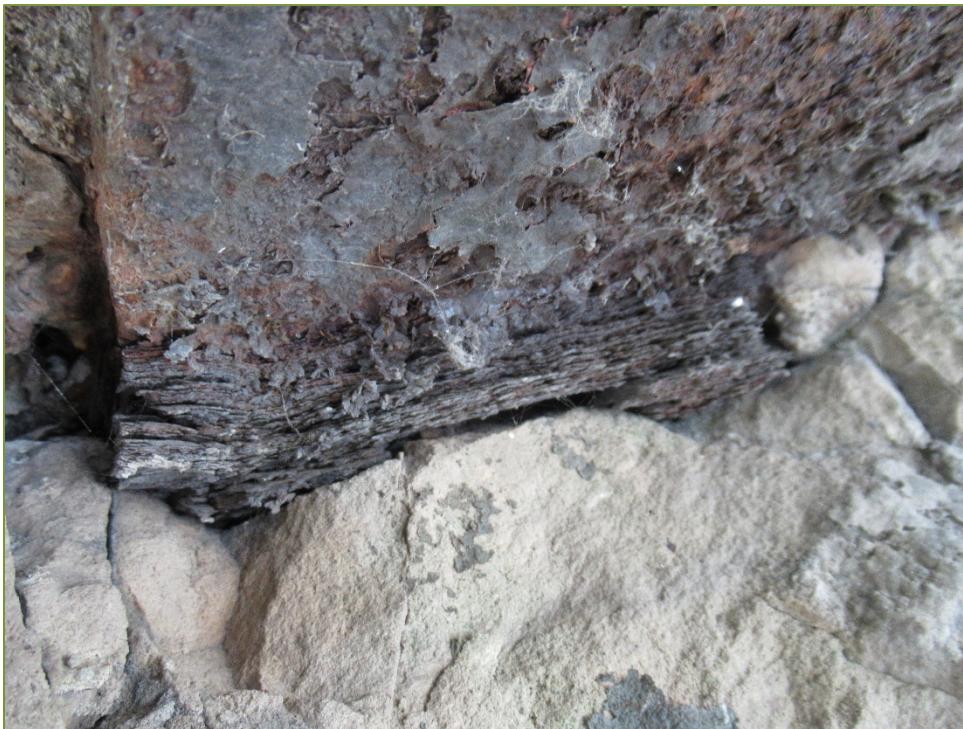
Photo P23 1st Girder from North at West Abutment (severe corrosion)

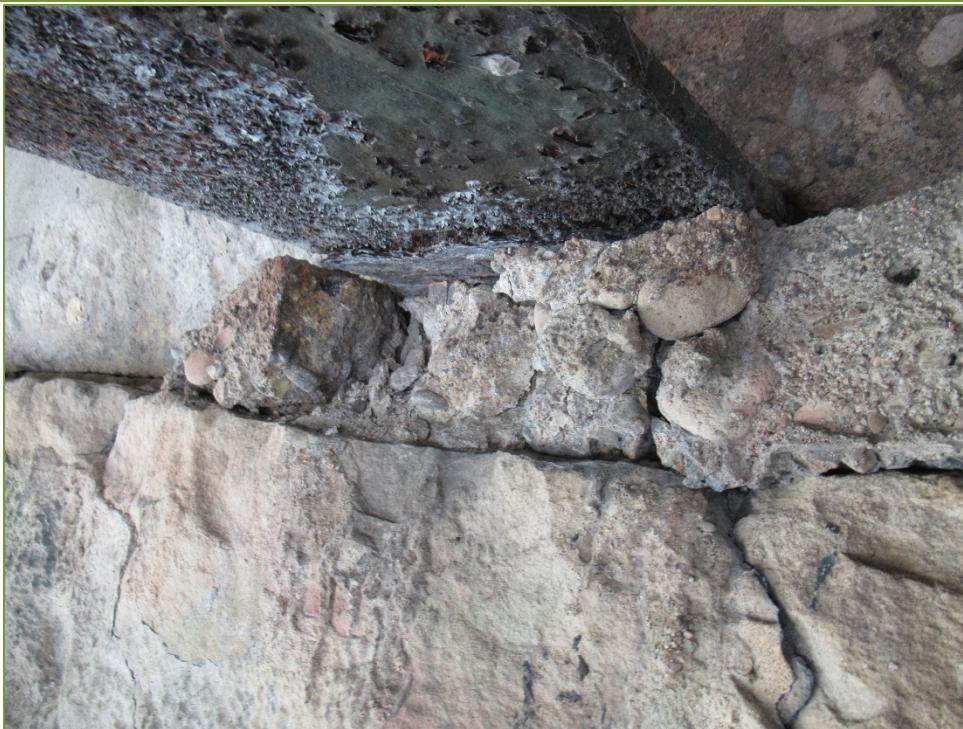
Photo P24 2nd Girder from North at West Abutment (severe corrosion)

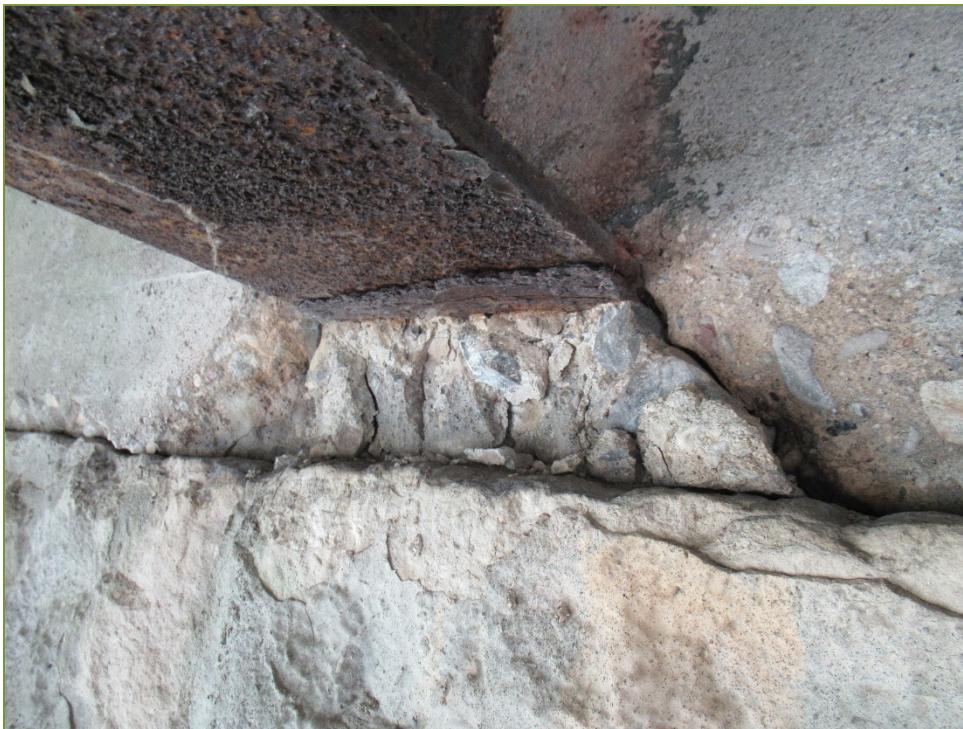
Photo P25 4th Girder from North at West Abutment (severe corrosion)

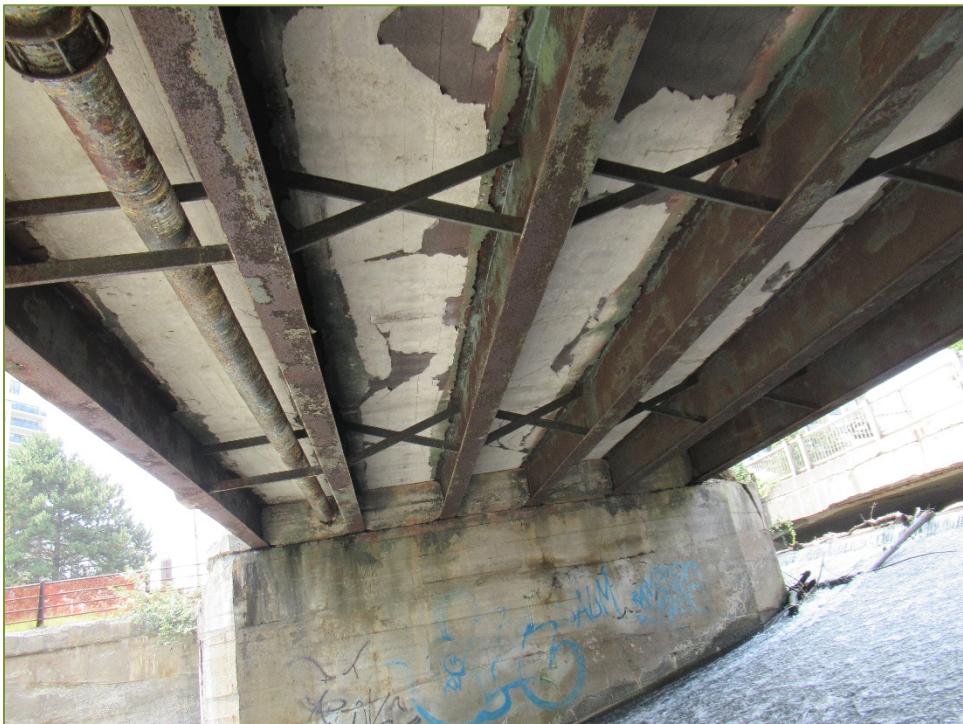
Photo P26 Soffit between Pier and East Abutment (fair condition – cracks, spall, delamination and honeycombing) **and Girders** (fair condition – light to severe corrosion)

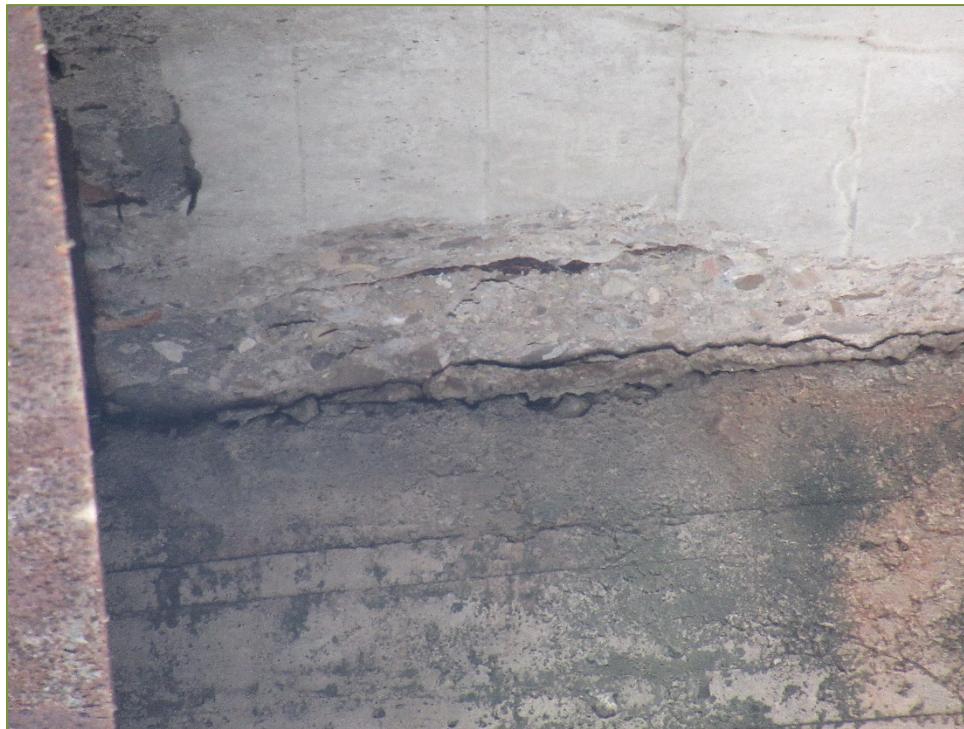
Photo P27 Soffit at Pier, south edge (spall)

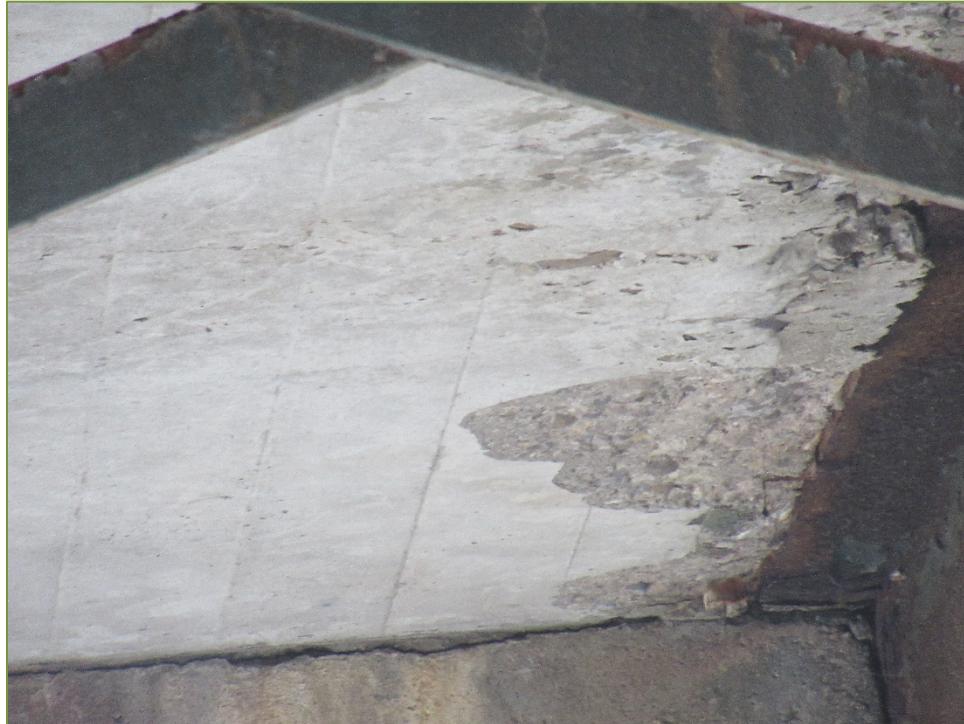
Photo P28 Soffit at Pier, north edge (crack, spall, and delamination)

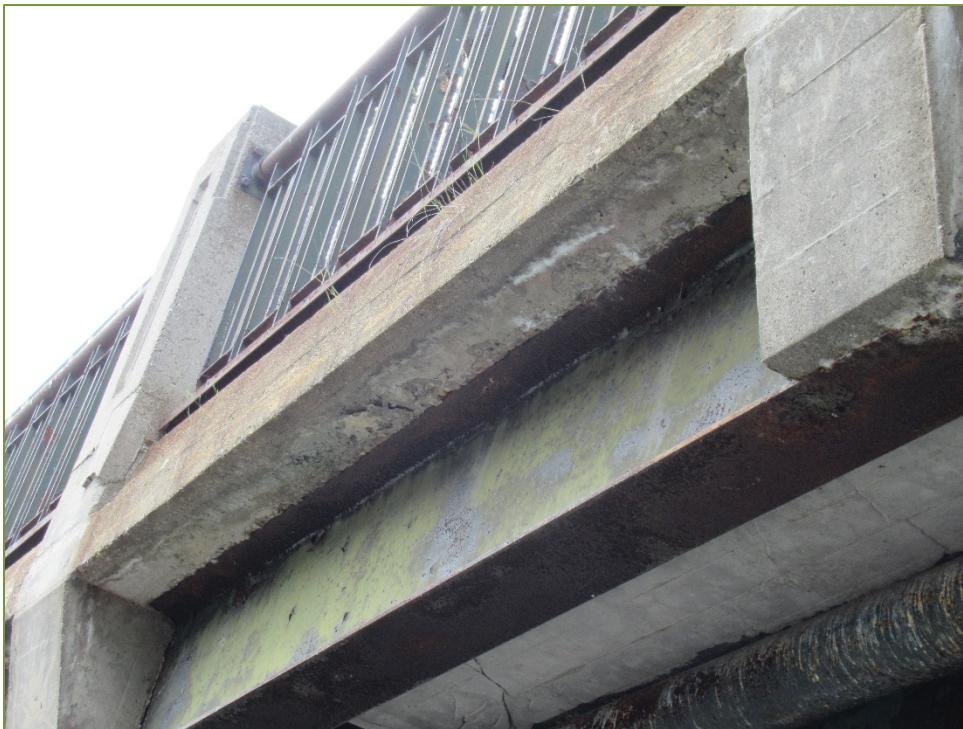
Photo P29 Soffit between Pier and East Abutment, south edge (crack, spall and delamination) and Girders (light corrosion)

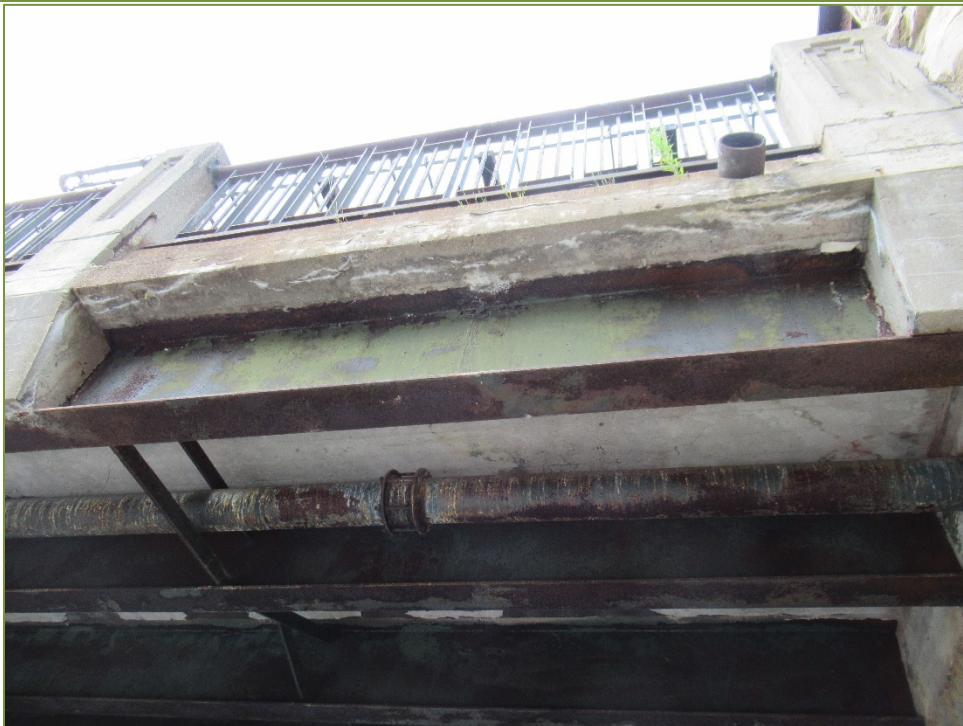
Photo P30 Soffit between at East Abutment, south edge (cracks) and Girders (light corrosion)

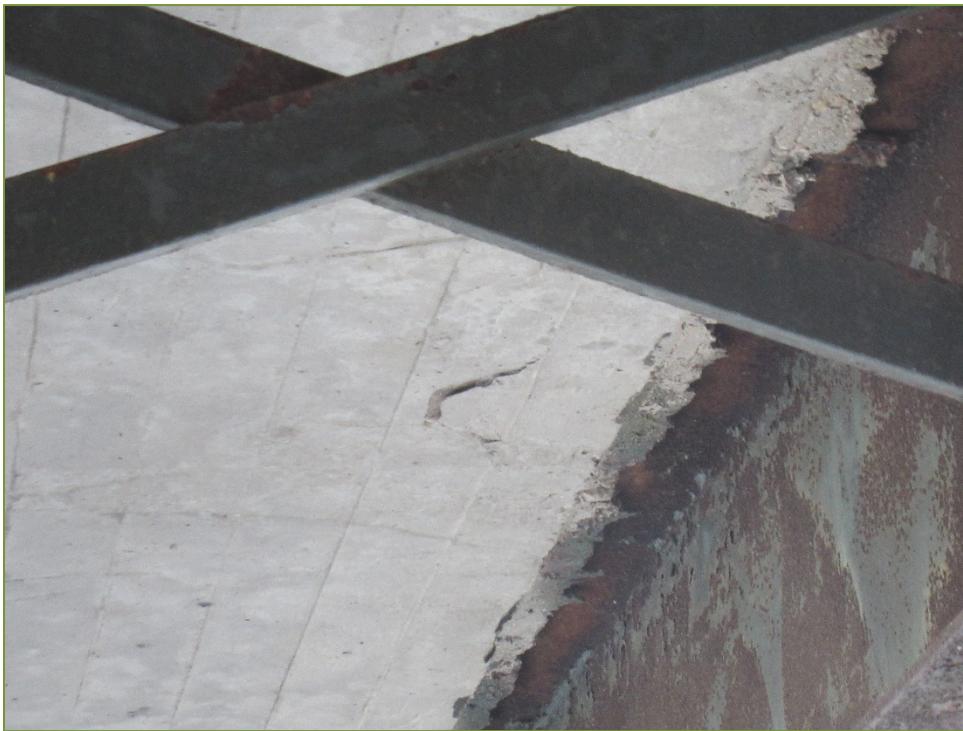
Photo P31 Soffit between Pier and East Abutment between 1st and 2nd Girder from North (delamination) and Girders (light corrosion)

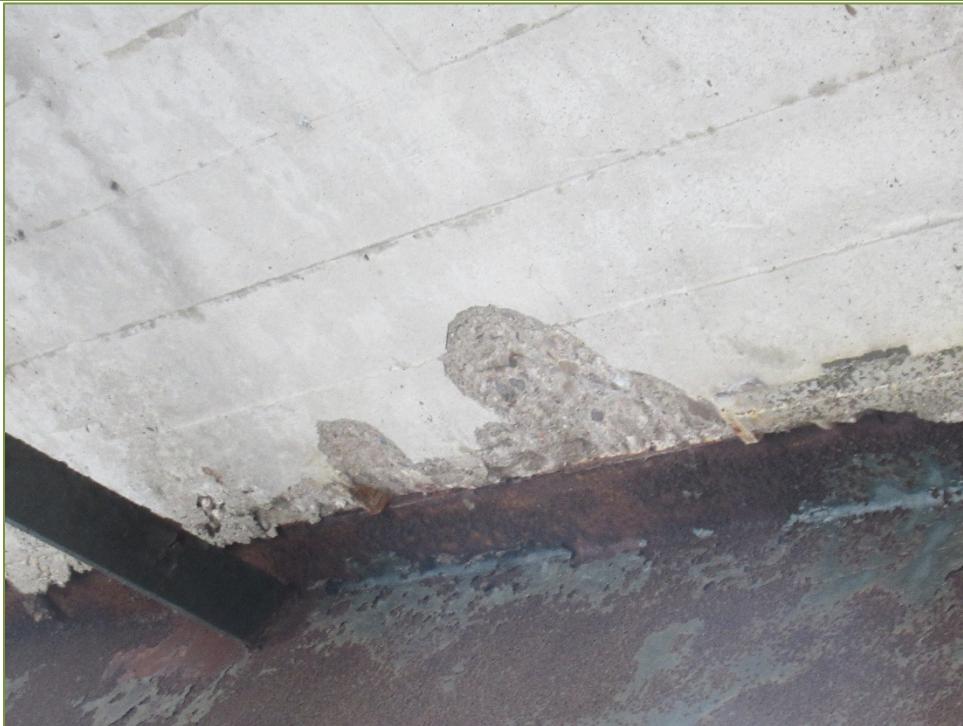
Photo P32 Soffit between Pier and East Abutment, north side (crack, spall, and delamination) and Girders (light corrosion)

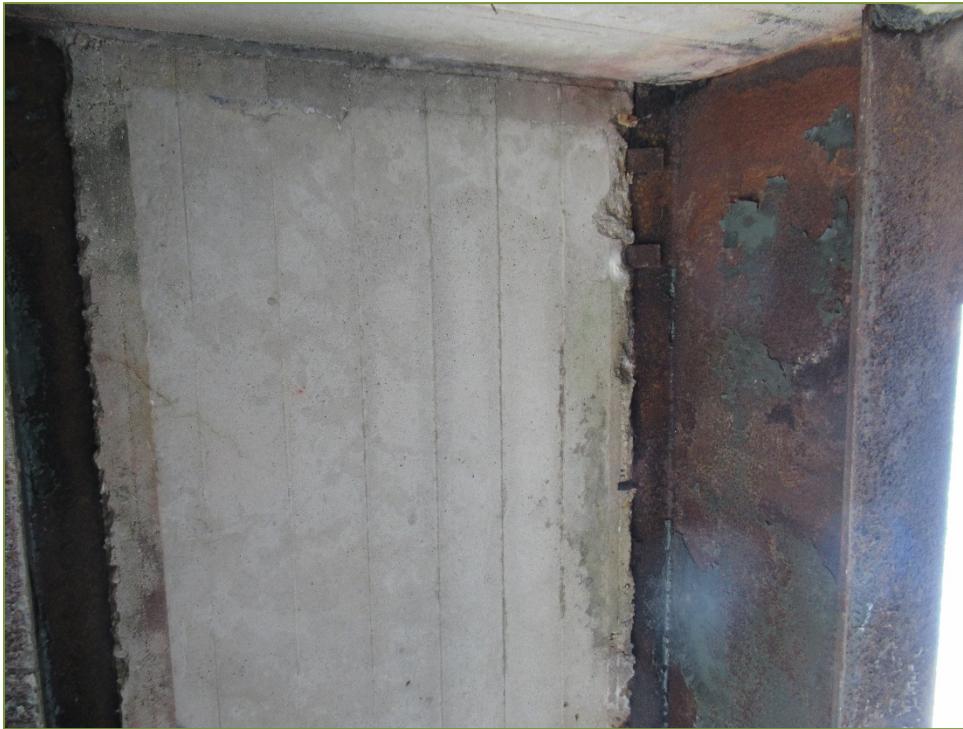
Photo P33 Soffit between at East Abutment (crack, spall, and delamination) **and Girders**
(light to medium corrosion)

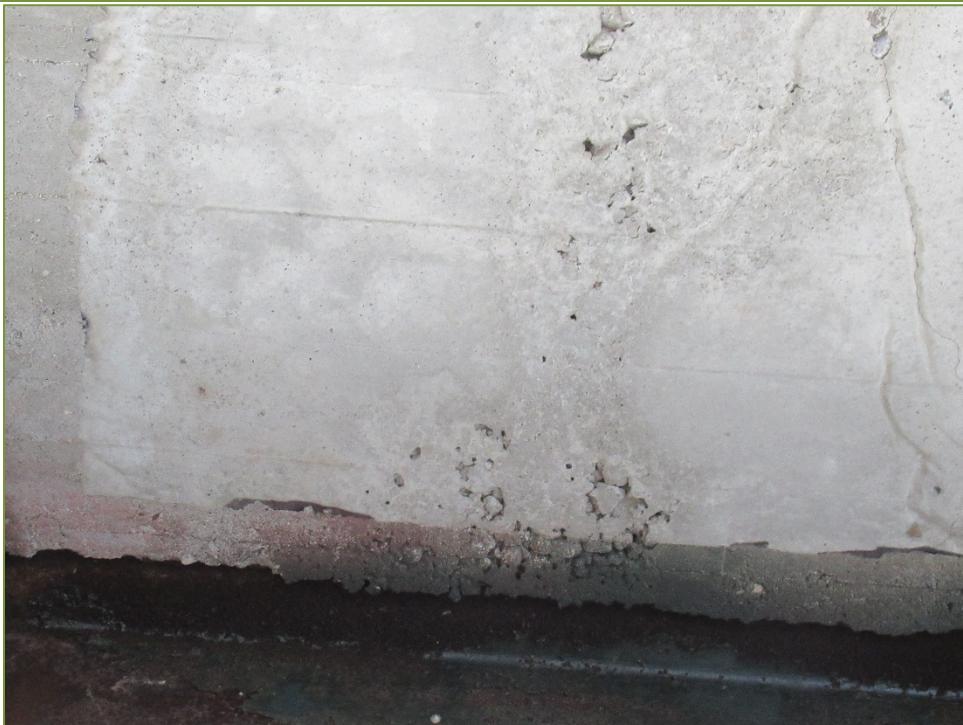
Photo P34 Soffit between at East Abutment (crack and honeycombing)

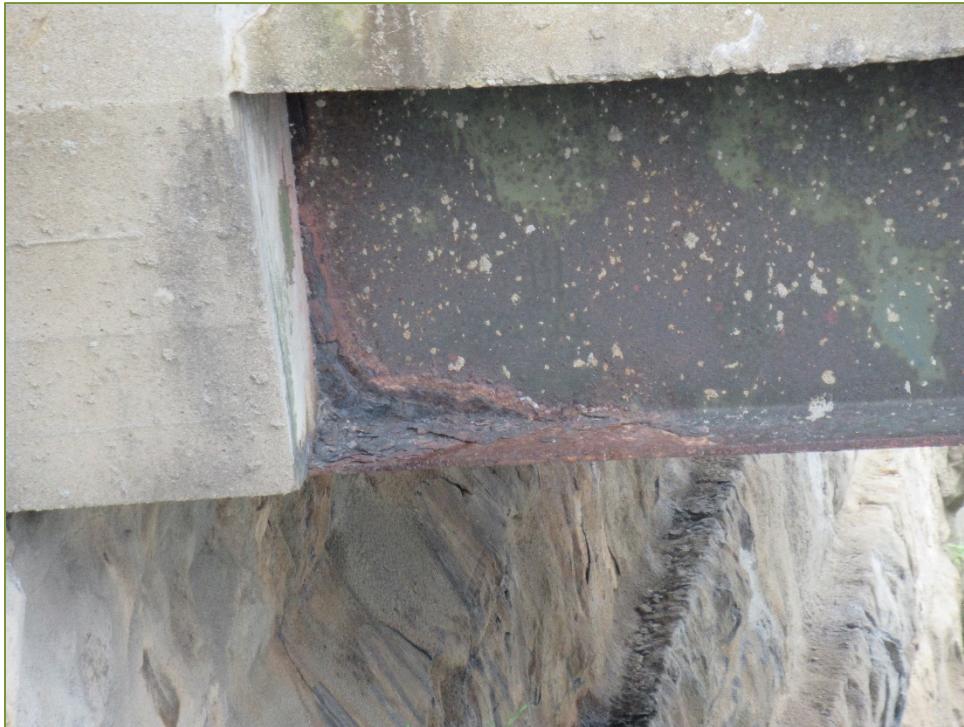
Photo P35 1st Girder from North at East Abutment (severe corrosion on top flange)

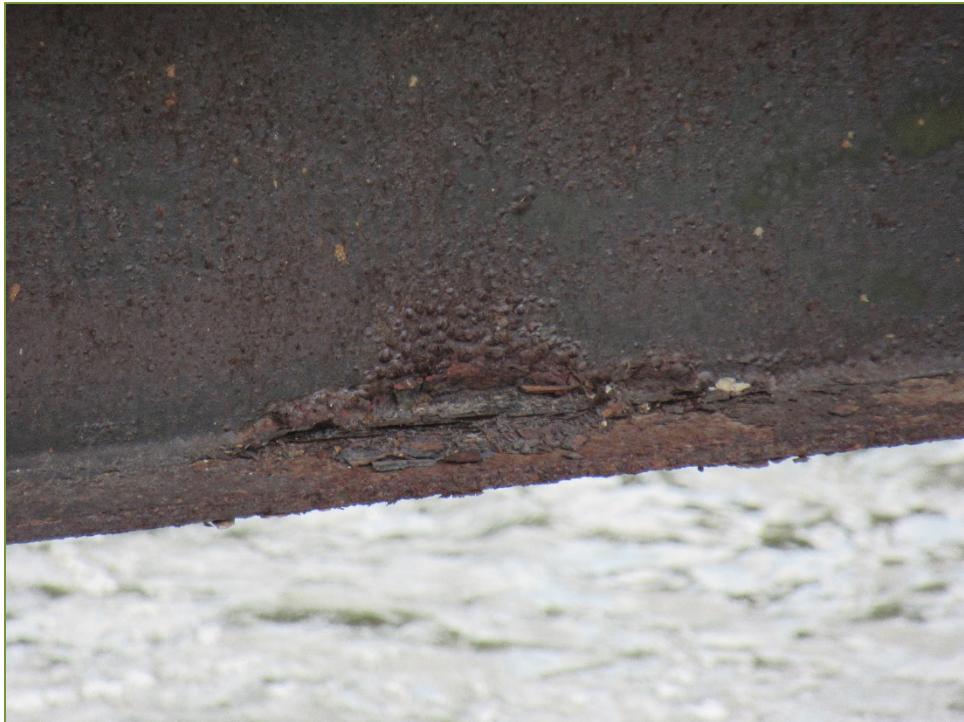
Photo P36 1st Girder from North between Pier and East Abutment (severe corrosion on top flange)

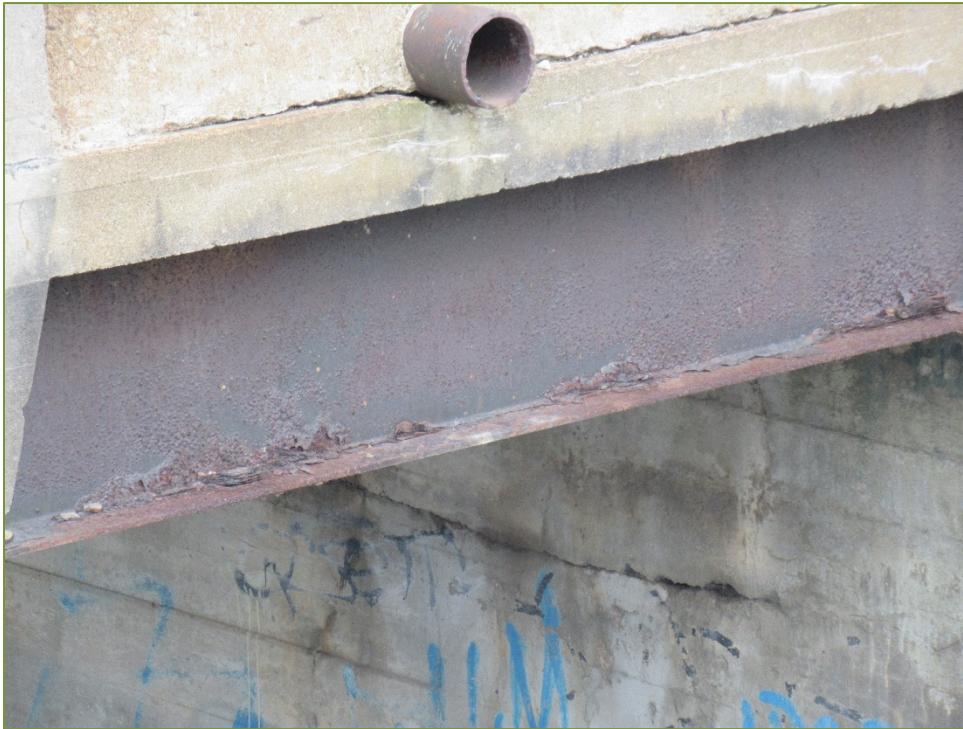
Photo P37 1st Girder from North at Pier (severe corrosion on top flange)

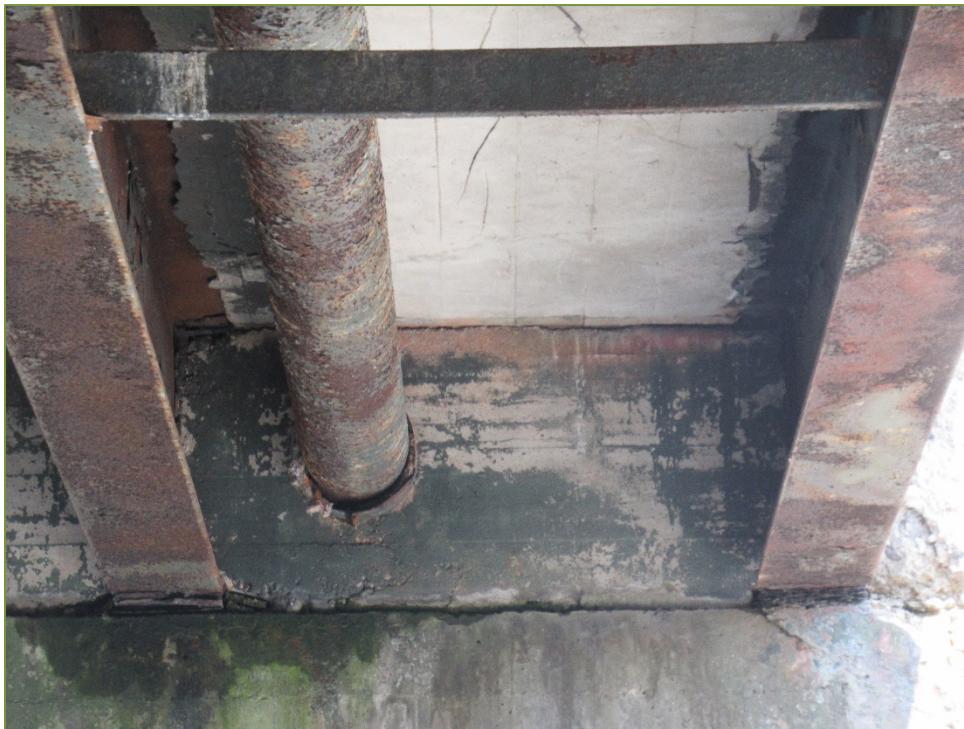
Photo P39 Typical Diaphragm at Pier – West Face (spall and honeycombing)

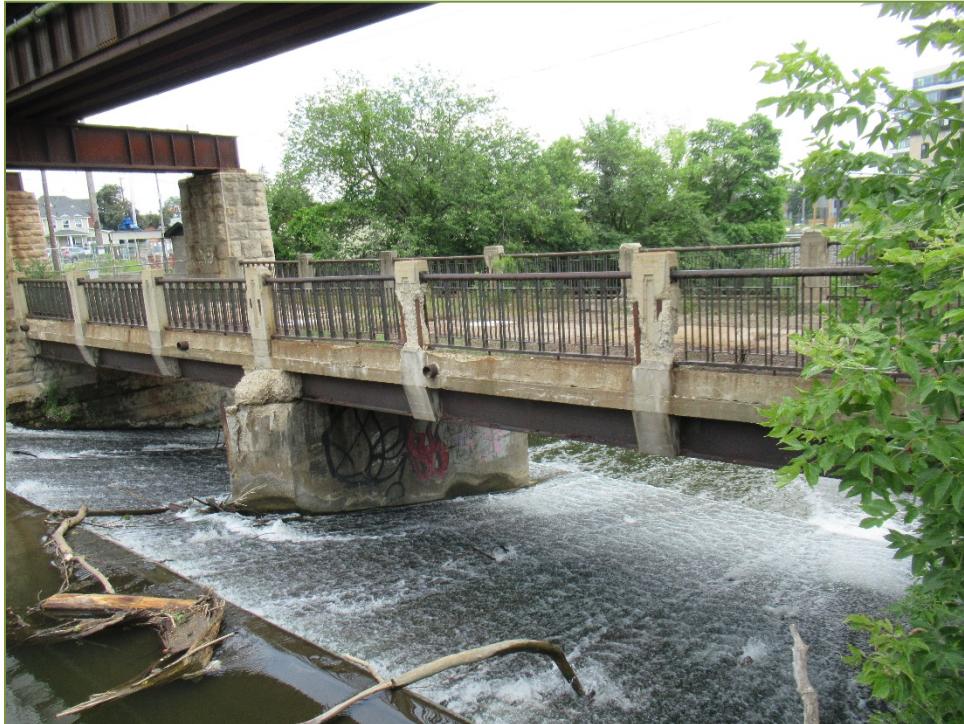
Photo P40 North Elevation – Fascia (cracks, spall, delamination, and light scaling)

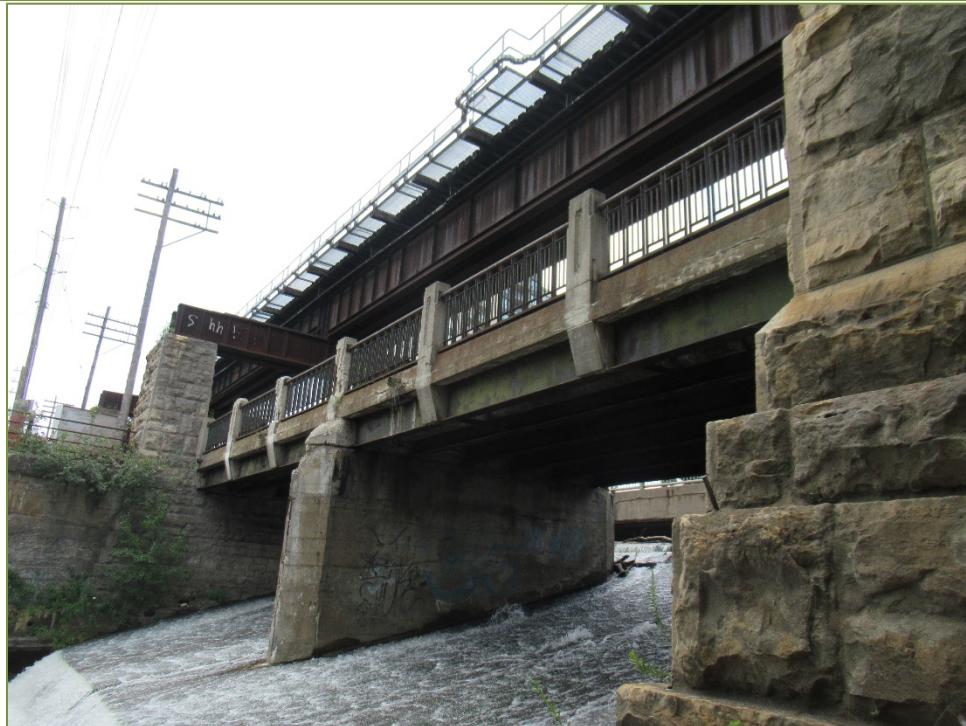
Photo P42 South Elevation – Fascia (cracks, spall, delamination, and light scaling)

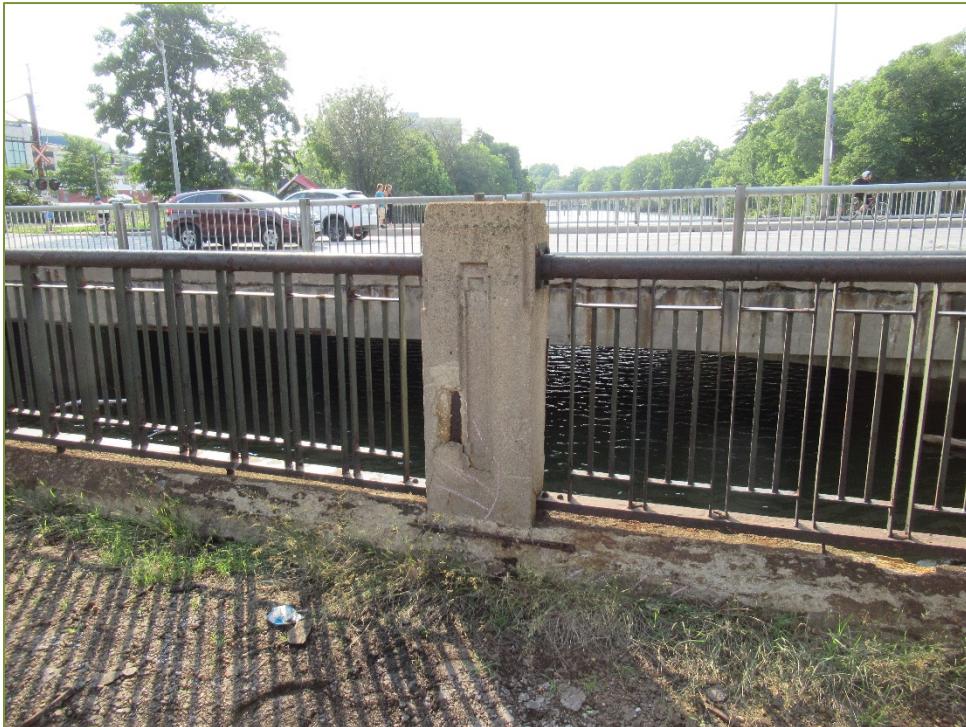
Photo P46 North Curb (poor condition – cracks, spall, delamination, and medium to severe scaling) **Concrete Posts** (fair to poor condition – cracks, spall, delamination, and light scaling) **and Handrail** (fair condition – light corrosion)

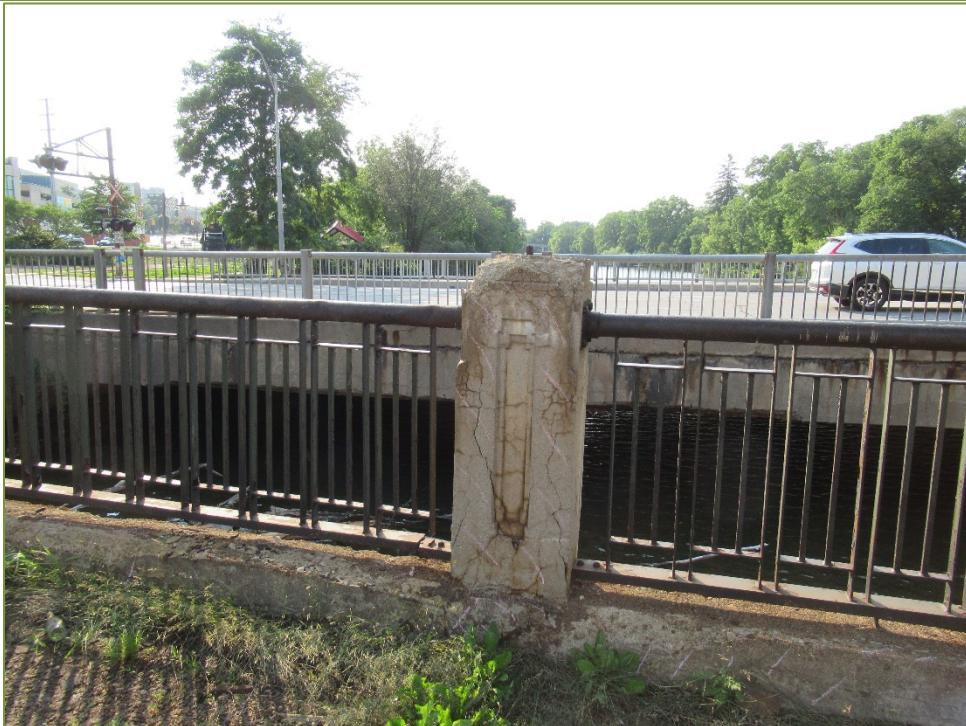
Photo P47 **North Curb** (cracks, spall, delamination, and medium to severe scaling) **Concrete Posts** (cracks, spall, delamination, and light scaling) **and Handrail** (light corrosion)

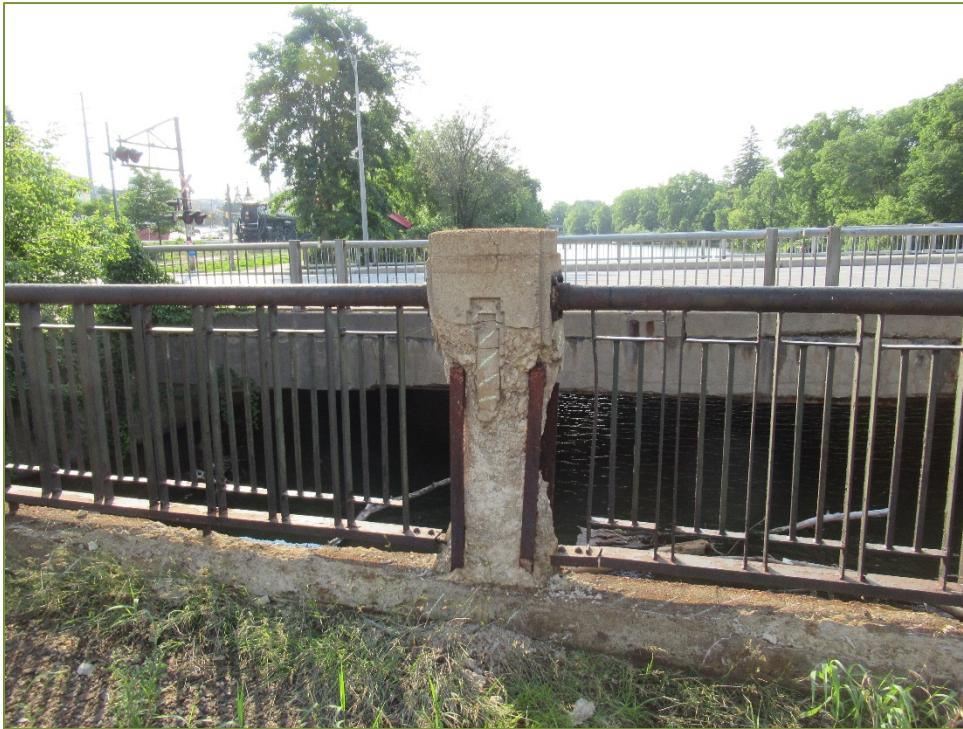
Photo P48 **North Curb** (cracks, spall, delamination, and medium to severe scaling) **Concrete Posts** (cracks, spall, delamination, and light scaling) **and Handrail** (light corrosion)
