DETAILED CONDITION SURVEY REPORT

Structure ID 112, Macdonell Bridge, Guelph, ON

BCC Project No.: BCC21015
Report Date: March 25, 2025

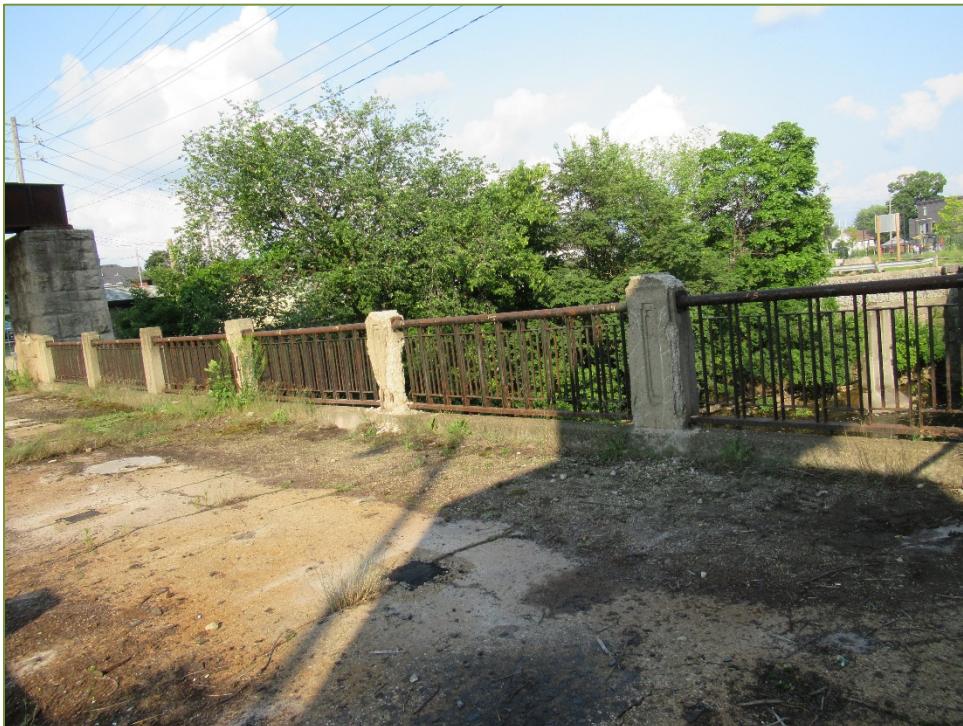
Photo P49 **North Curb** (cracks, spall, delamination, and medium to severe scaling) **Concrete Posts** (cracks, spall, delamination, and light scaling) **and Handrail** (light corrosion)

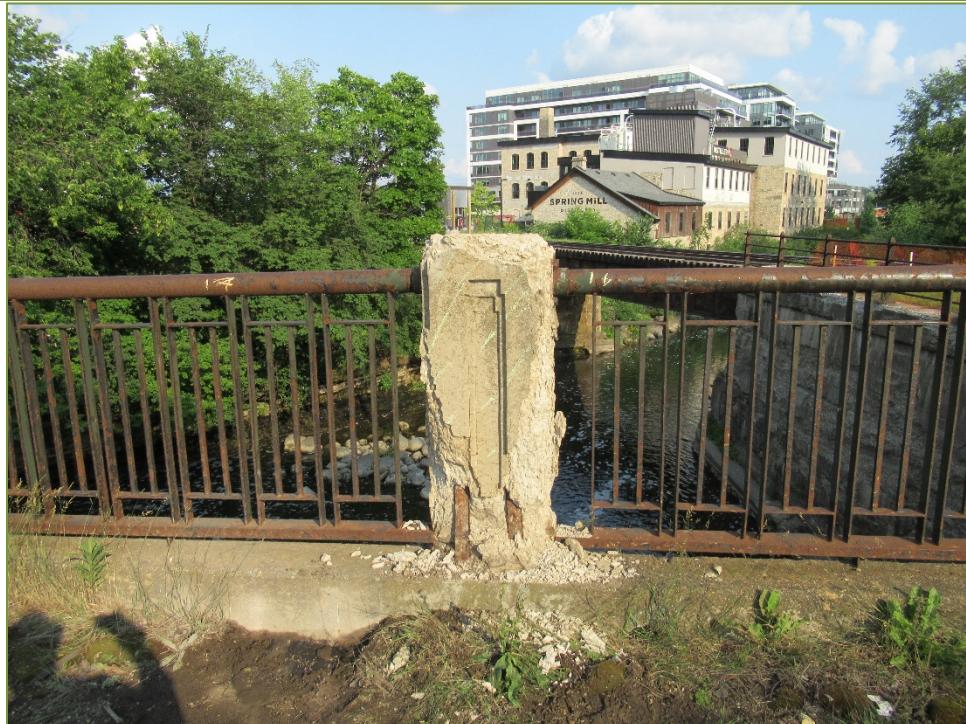
Photo P51 **South Curb** (medium scaling) **Concrete Posts** (cracks, spall, delamination, and light scaling) **and Handrail** (light corrosion)

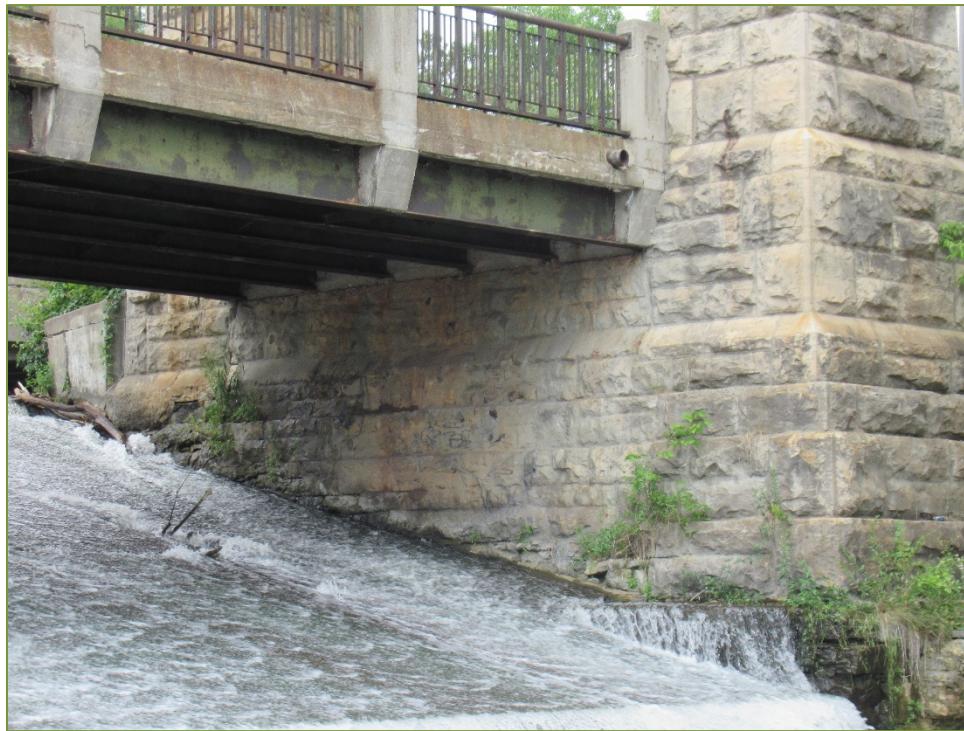
Photo P54 **East Abutment – Masonry Wall** (cracks, spall and wet area)

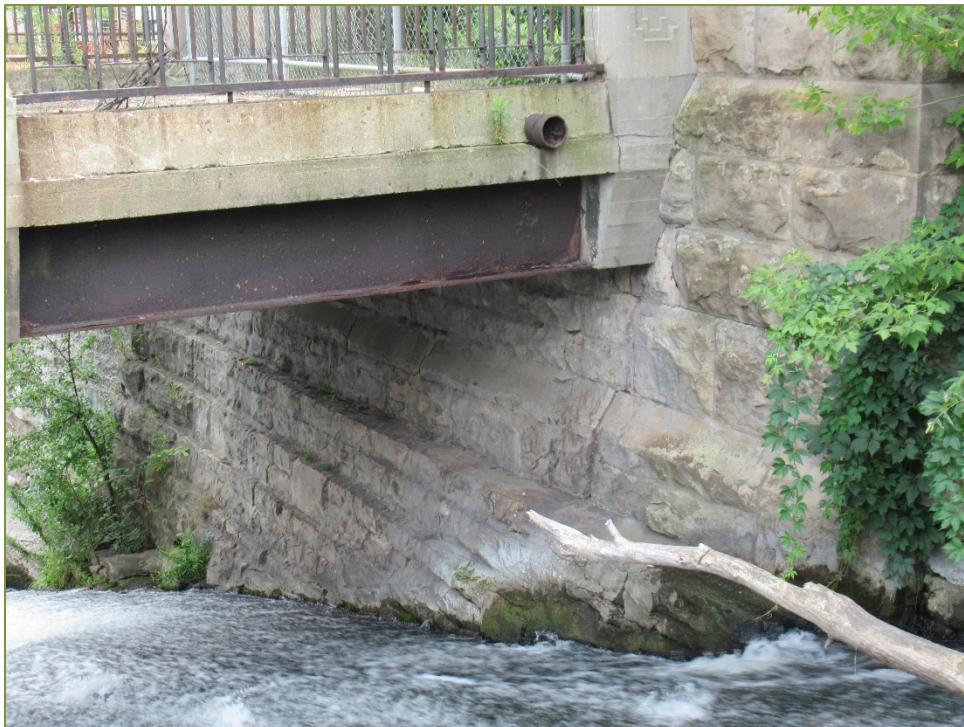
Photo P56 West Abutment – Masonry Wall (cracks, and spall)

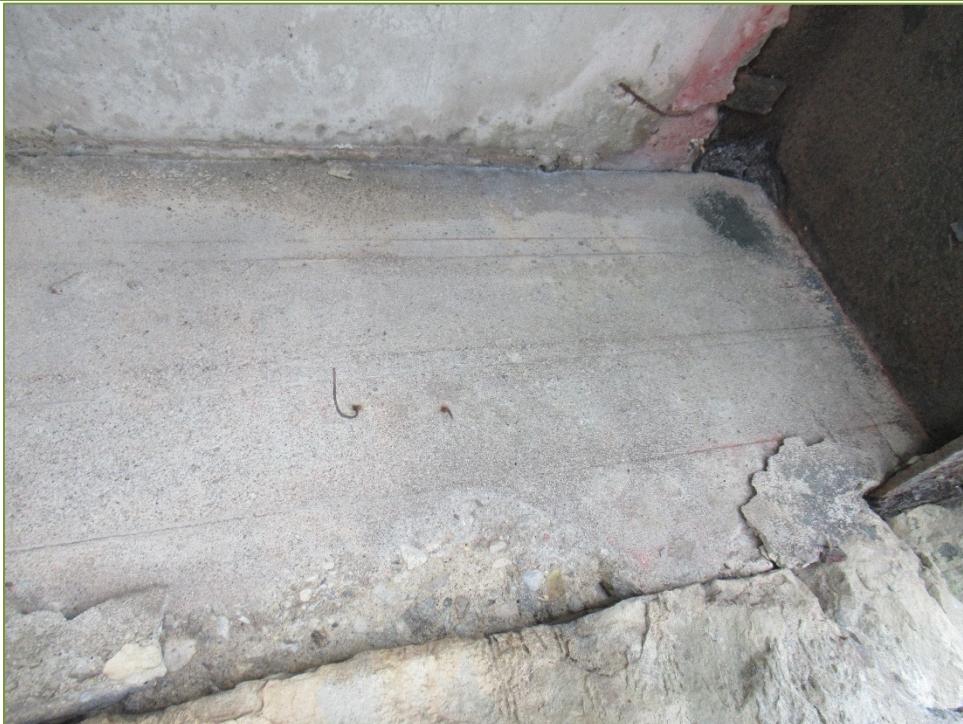
Photo P59 West Abutment – Masonry Wall (spall)

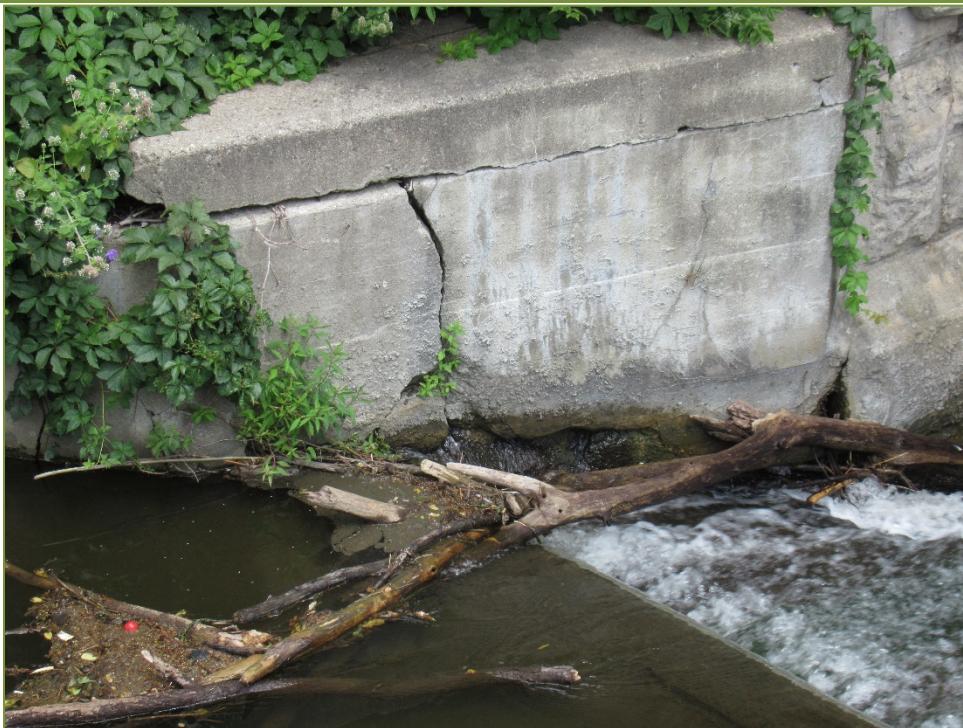
Photo P65 Northeast Retaining Wall (fair to poor condition – wide cracks, spall, and light scaling)

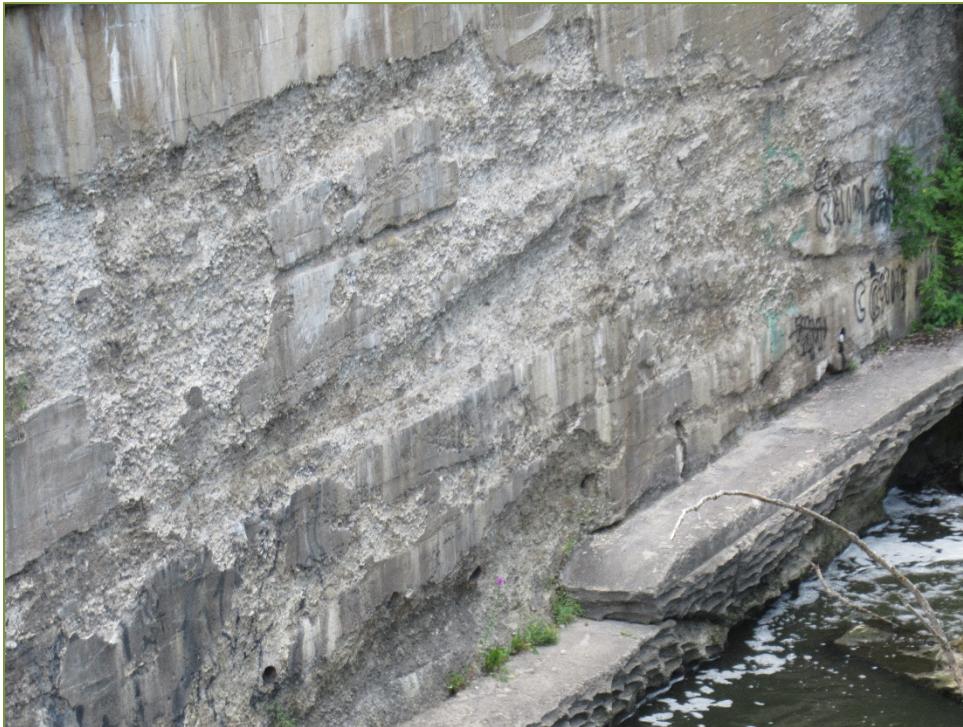
Photo P68 Southwest Retaining Wall (spall and severe scaling)

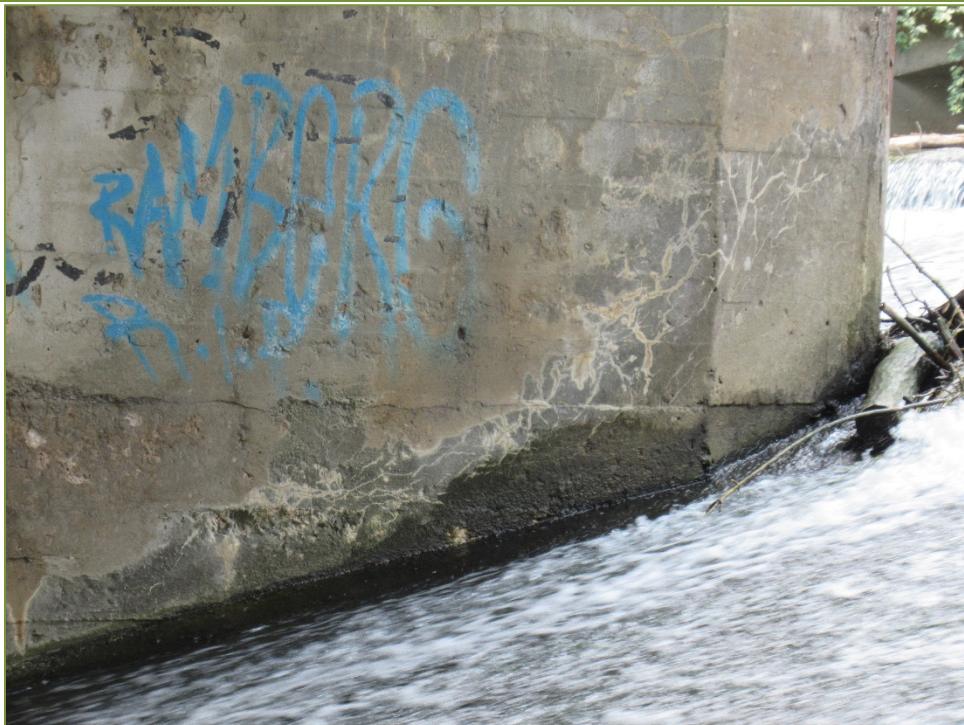
Photo P71 Pier - East Face, north side (cracks, spall, delamination, light to medium scaling, and wet area)

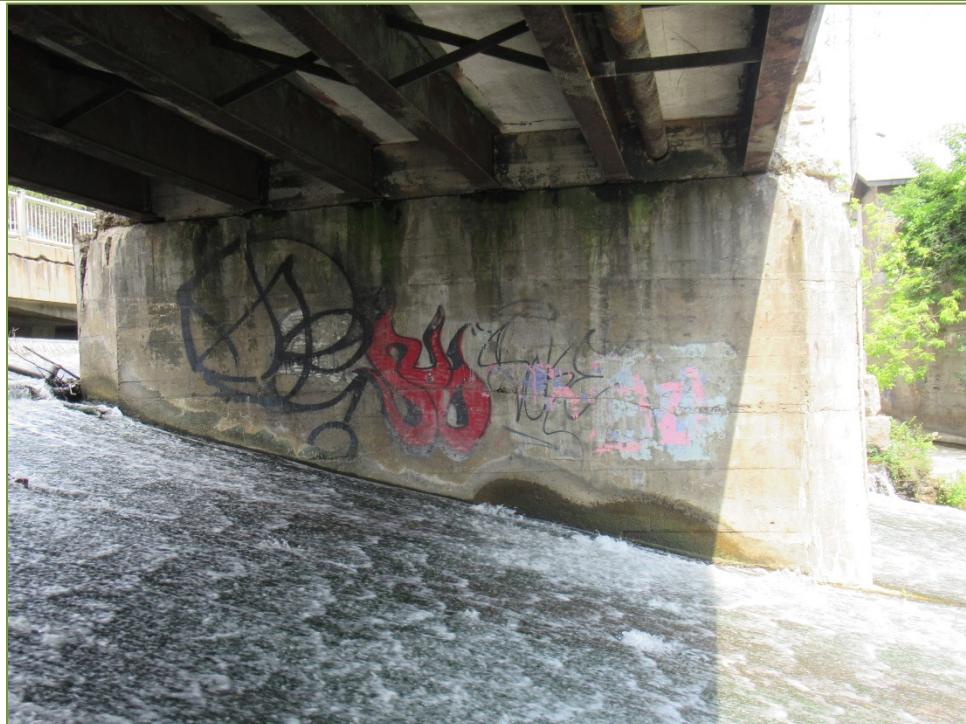
Photo P73 Pier – East Face, south side (cracks, spall, delamination, light to medium scaling, and wet area)

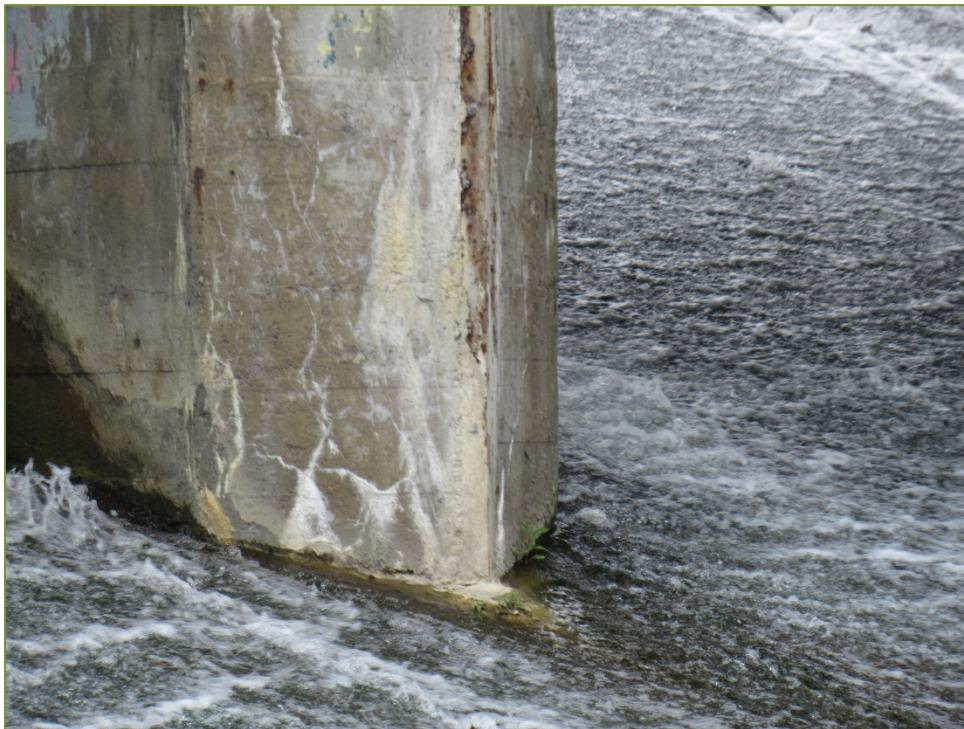
Photo P74 Pier - West Face (fair to poor condition - cracks, spall, delamination, light to medium scaling, and wet area)

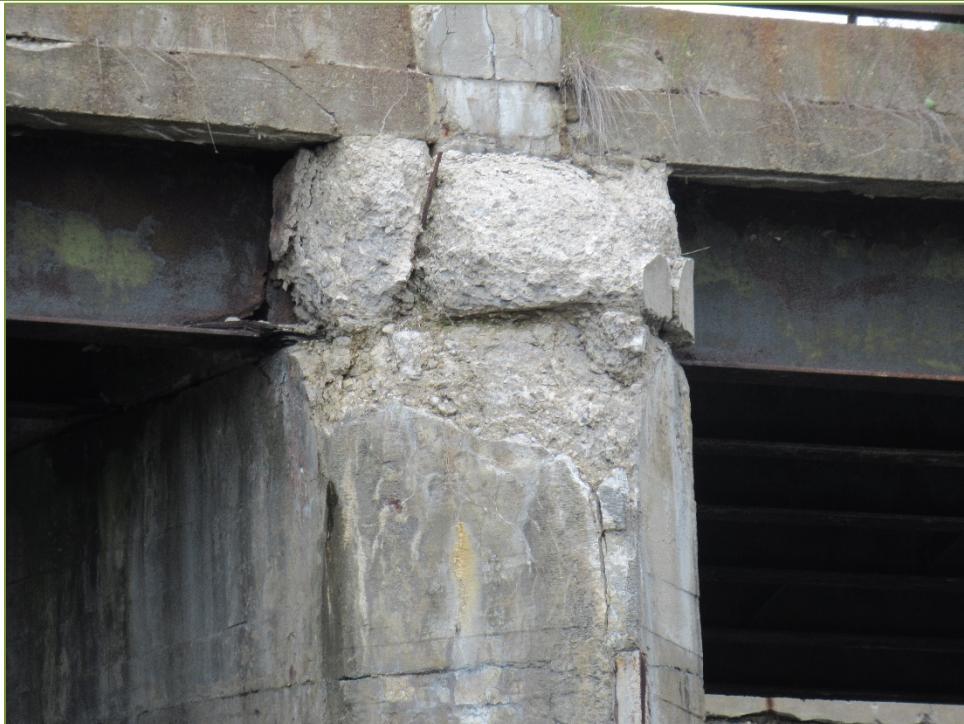
Photo P75 Pier - West Face, south side (cracks)

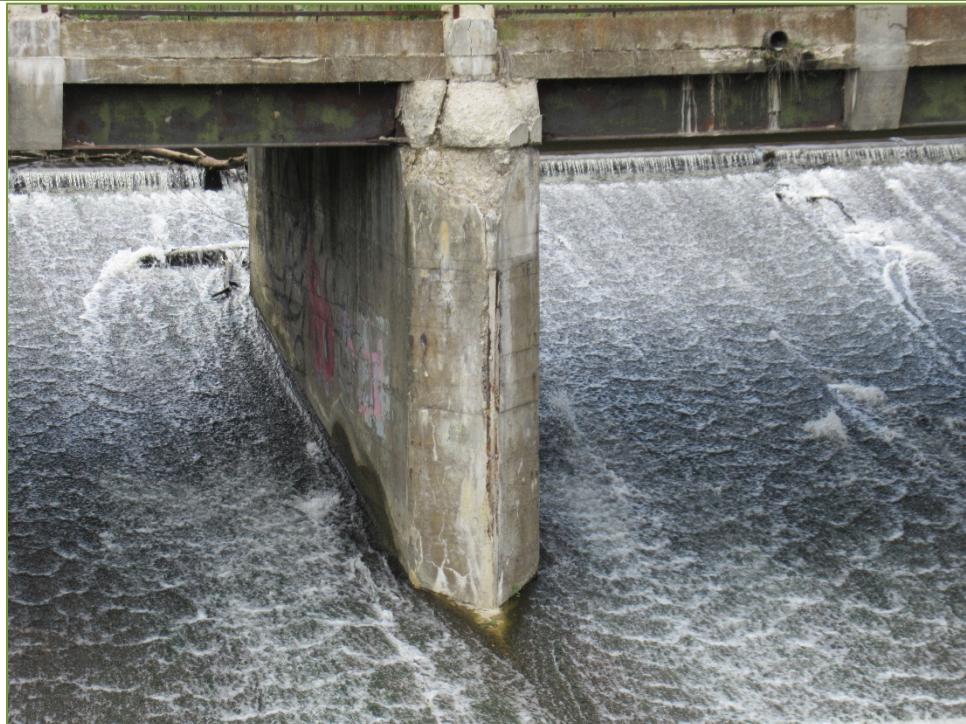
Photo P77 Pier - West Face, north side (cracks, spall, and delamination) note, exposed rebar)

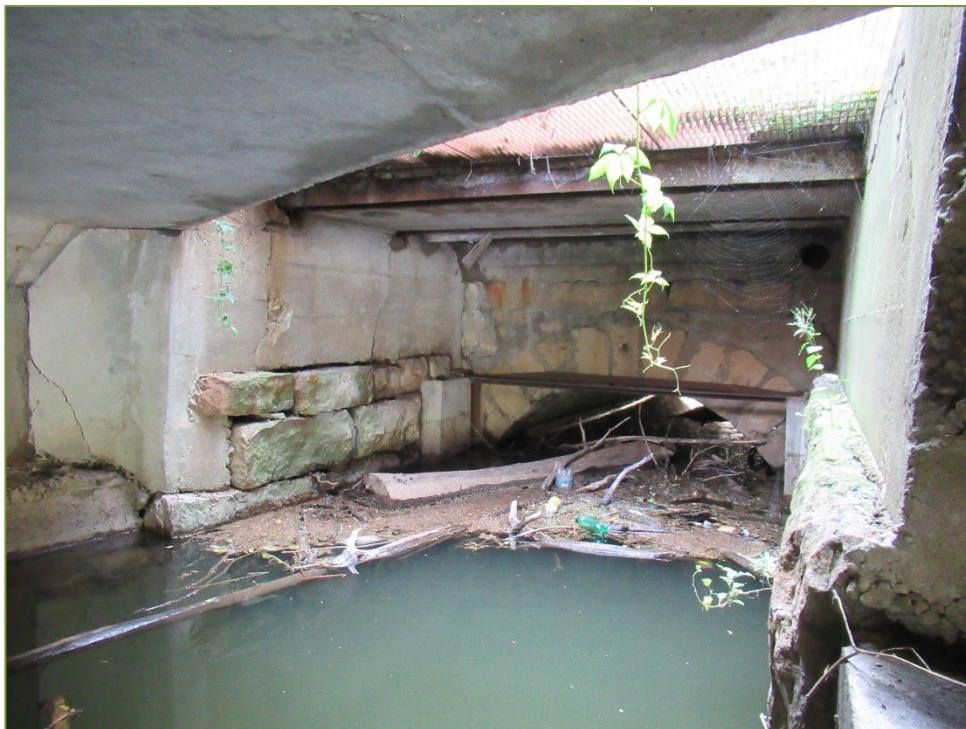
Inlet – North Elevation

The site consists of reinforced cast-in-place concrete slab and walls. The Allan Spillway forms a weir that created headwaters for the removed Allan's Mill. The sluice gate was closed at the time of inspection and water level was high. Photo P1 shows a view of the inlet- north elevation. Photo P8 shows a view of the outlet-west elevation.

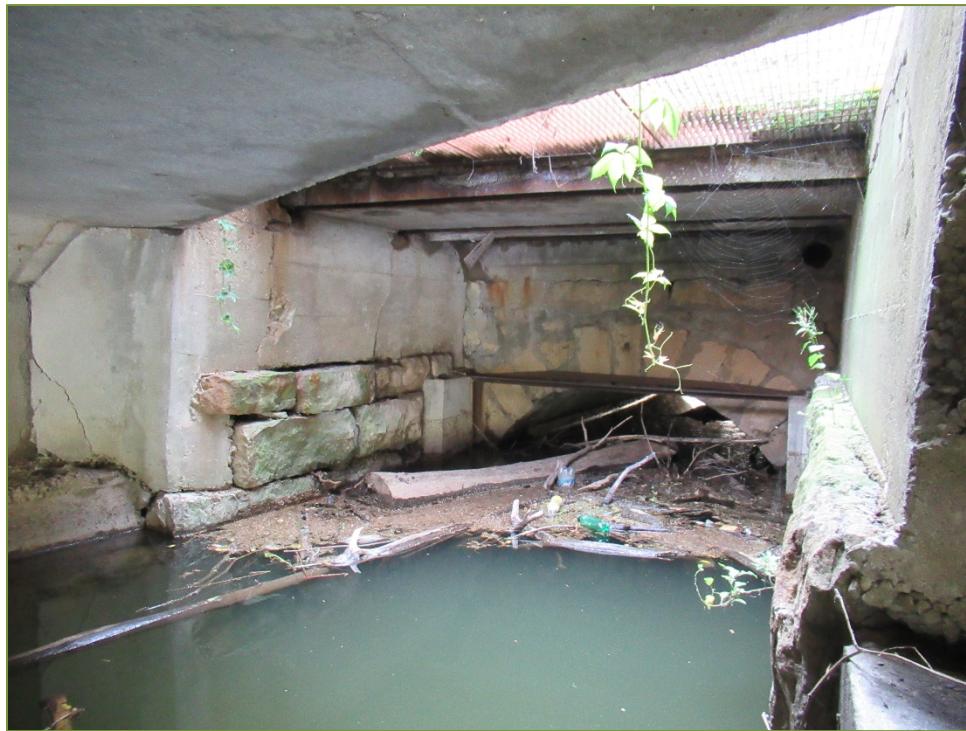
Photo P1 Inlet - North Elevation

The inlet components included the north elevation, west wall, and east wall. The deteriorations are shown on Drawing 1 and in Photos P1 to P7. The inlet components, with a total surveyed area of 13.30 m², were in fair condition with clean medium width cracks (2.0 m), clean wide width cracks (5.0 m), delaminations (0.95 m²), spalls (0.85 m²), light scaling (0.55 m²), medium scaling (1.12 m²), honeycombing (0.10 m²), wet areas (0.45 m²), and exposed reinforcement. The inlet was partially blocked with tree branches and debris.

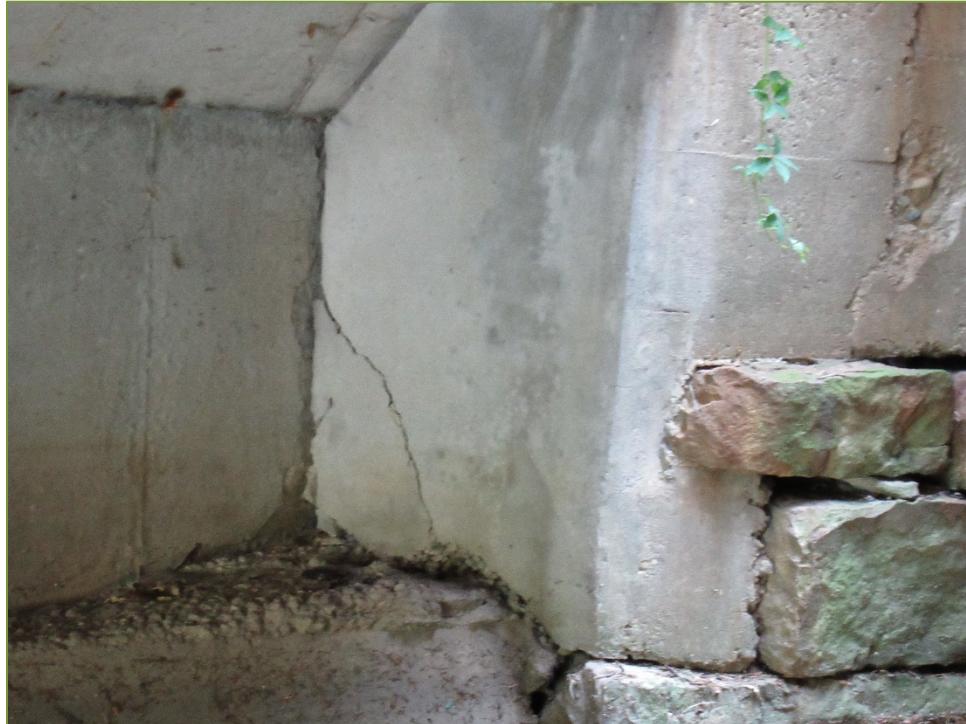
Photo P2 Inlet – North Elevation, East Wall (wide crack)

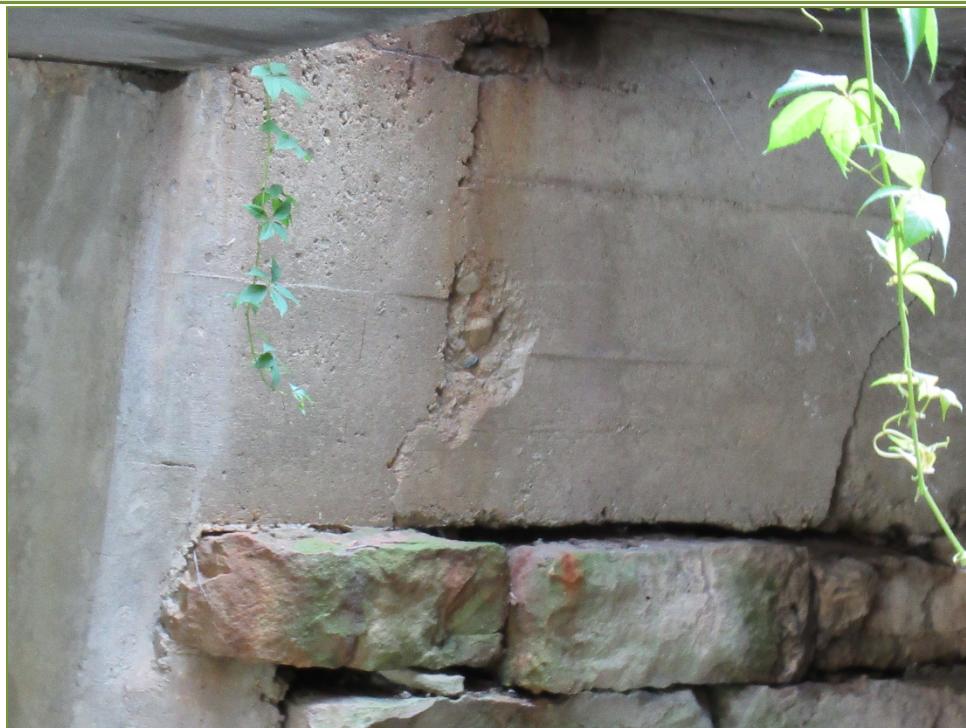
Photo P6 Inlet- East Wall, North side (wide crack, spall, delamination, and light to medium scaling)

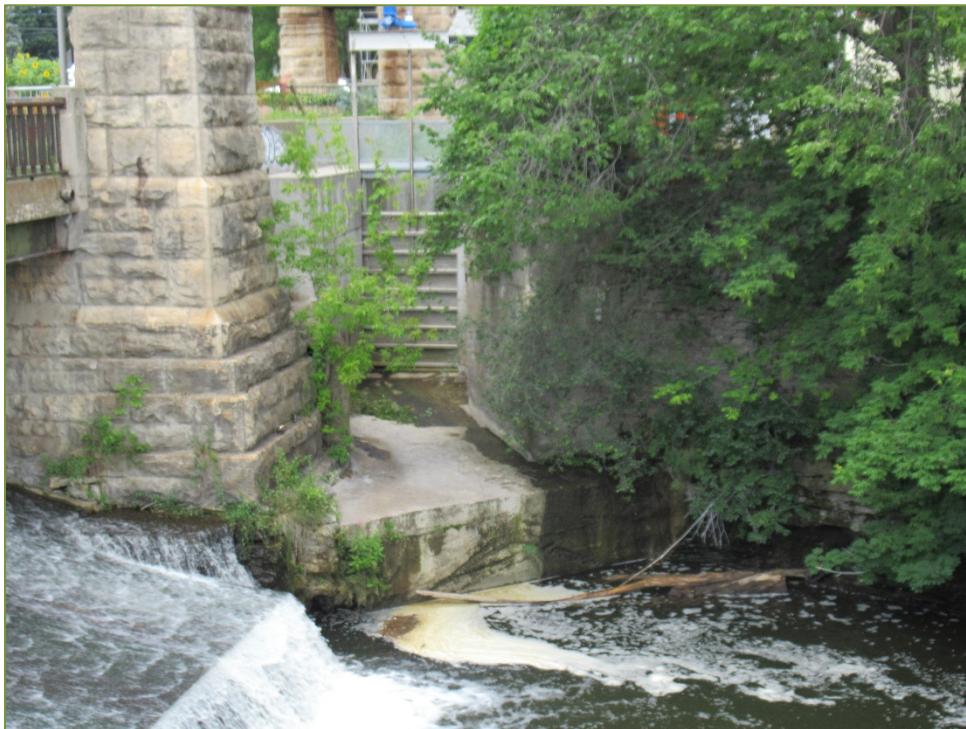
Photo P8 Outlet – West Elevation

The outlet components included the north wall, south wall, top face, west elevation, and floor slab. The deteriorations are shown on Drawing 1 and in Photos P8 to P22. The outlet components, with a total surveyed area of 104.00 m², were in fair condition with clean/stained medium width cracks (46.0 m), delaminations (3.10 m²), spalls (4.10 m²), light scaling (46.70 m²), medium scaling (14.10 m²), severe scaling (8.50 m²), wet areas (1.82 m²), and exposed reinforcement in spalled areas. Photo P16 depicts a cavity behind the north wall-old structure at west end.

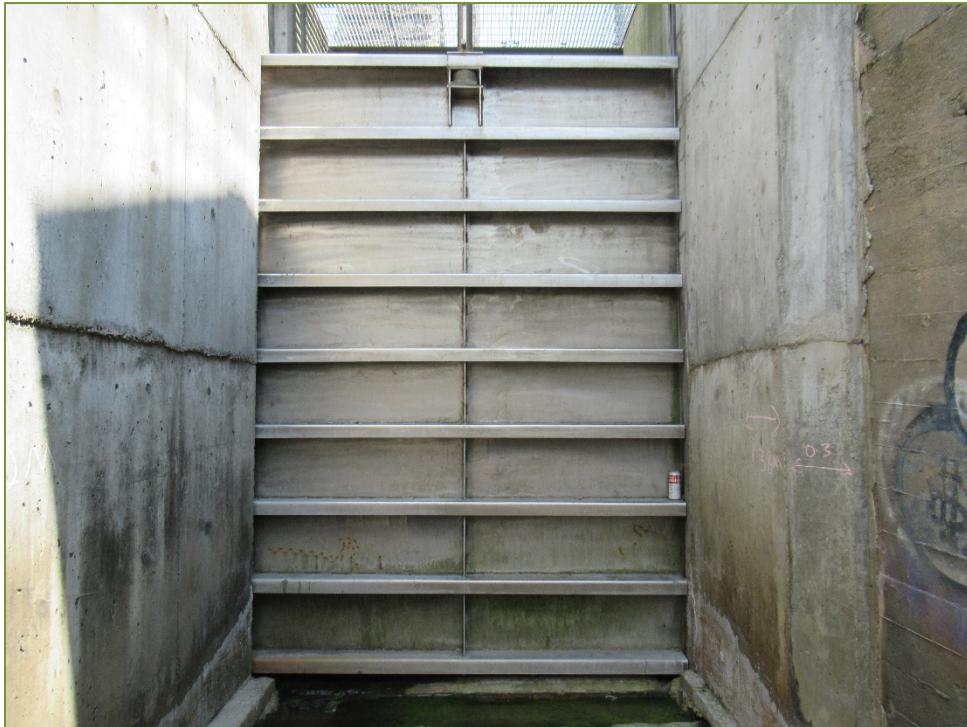
Photo P12 **Outlet – West Elevation**, note, shutter

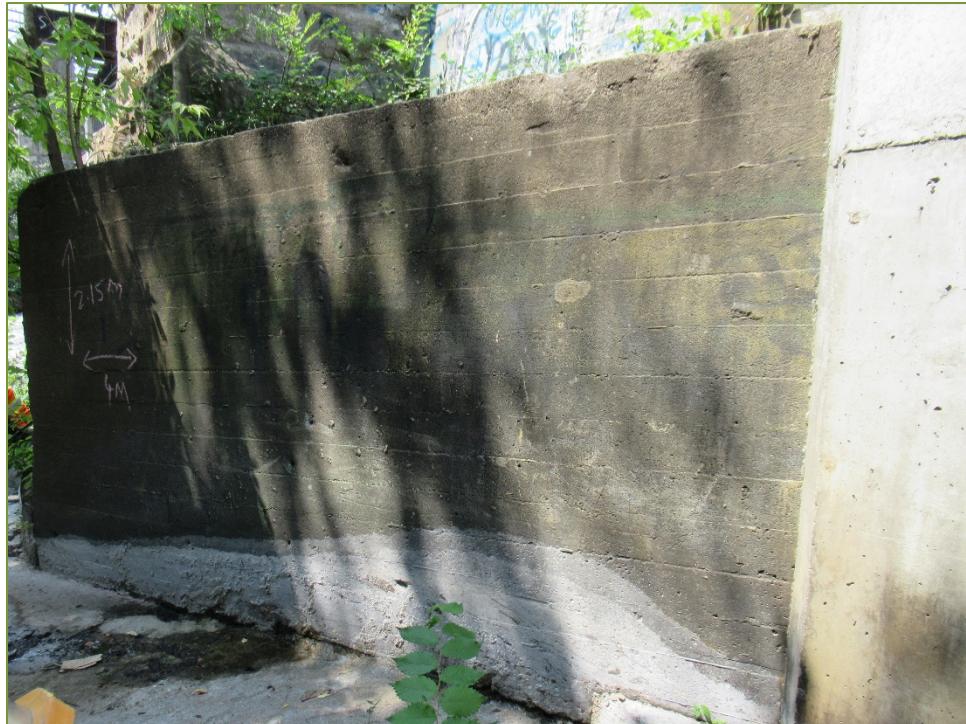
Photo P14 Outlet – North Wall, old structure (crack, spall, delamination, and light scaling)

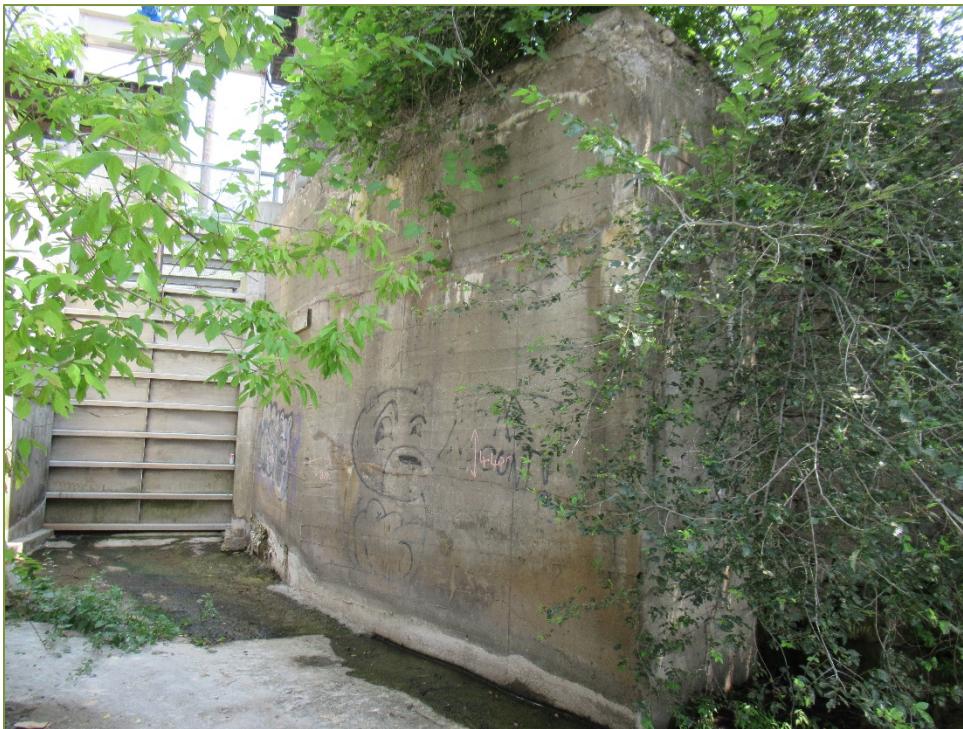
Photo P17 **Outlet – South Wall** (cracks, spall, delamination, light to medium scaling, and wet area)

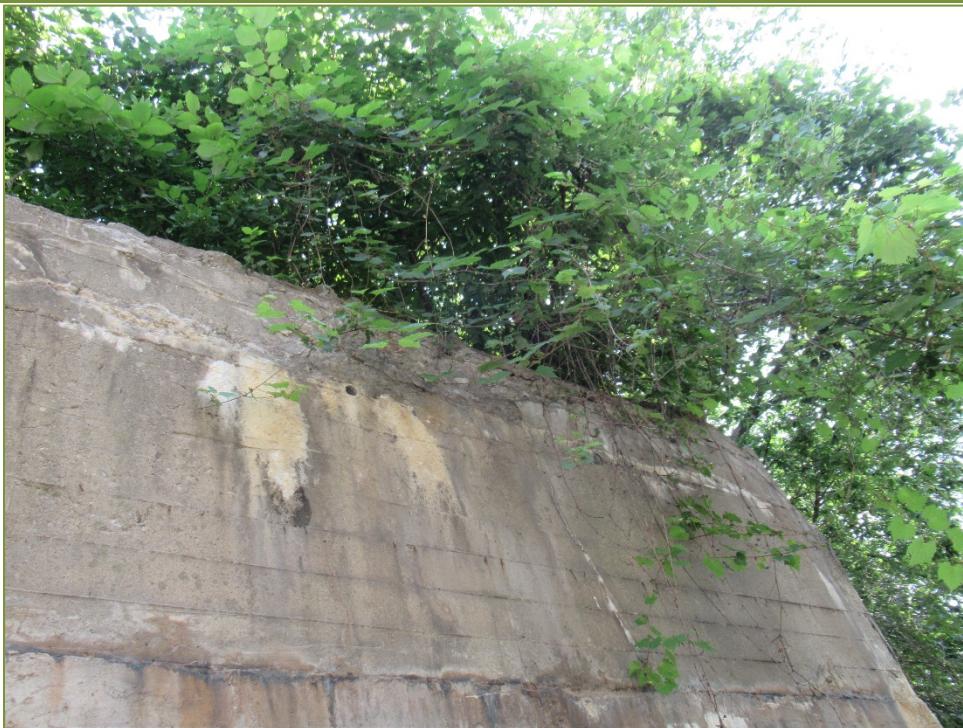
Photo P18 **Outlet – South Wall** (cracks, spall, delamination and medium scaling)

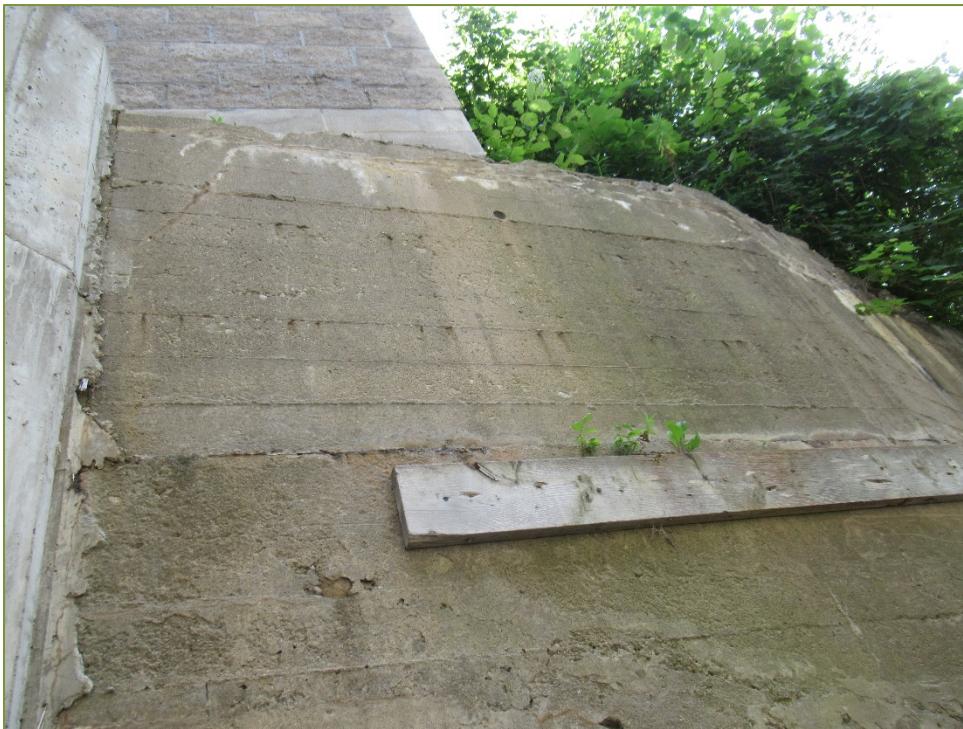
Photo P19 **Outlet – South Wall** (cracks, spall, delamination, and medium scaling)

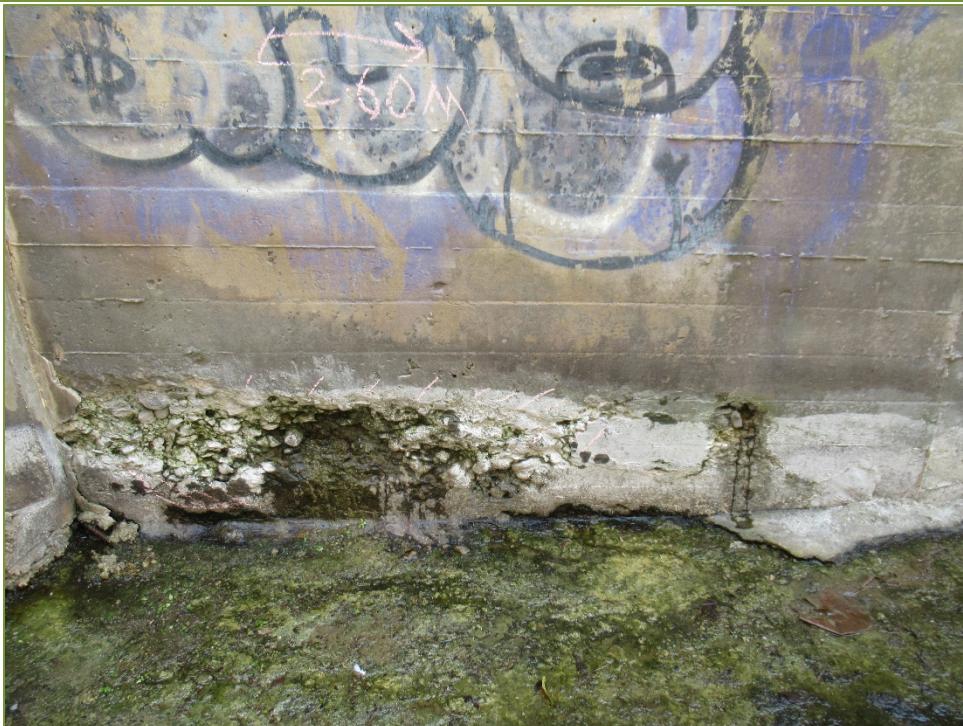
Photo P20 **Outlet – South Wall** (spall and delamination) note, exposed rebar

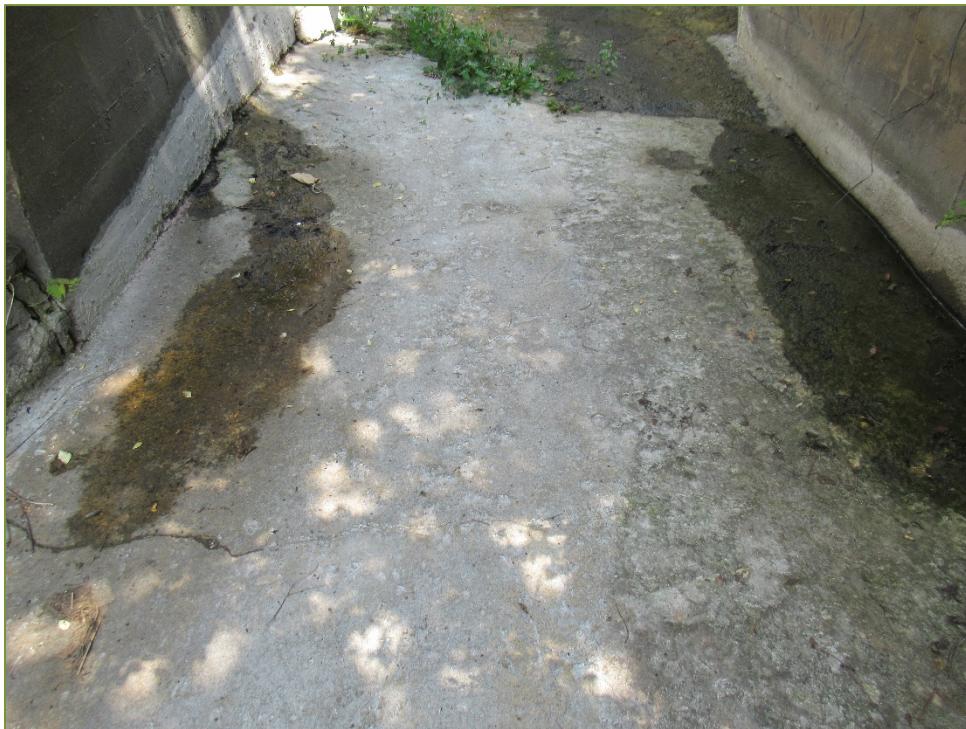
Photo P21 Outlet – Floor (cracks, and medium to severe scaling)

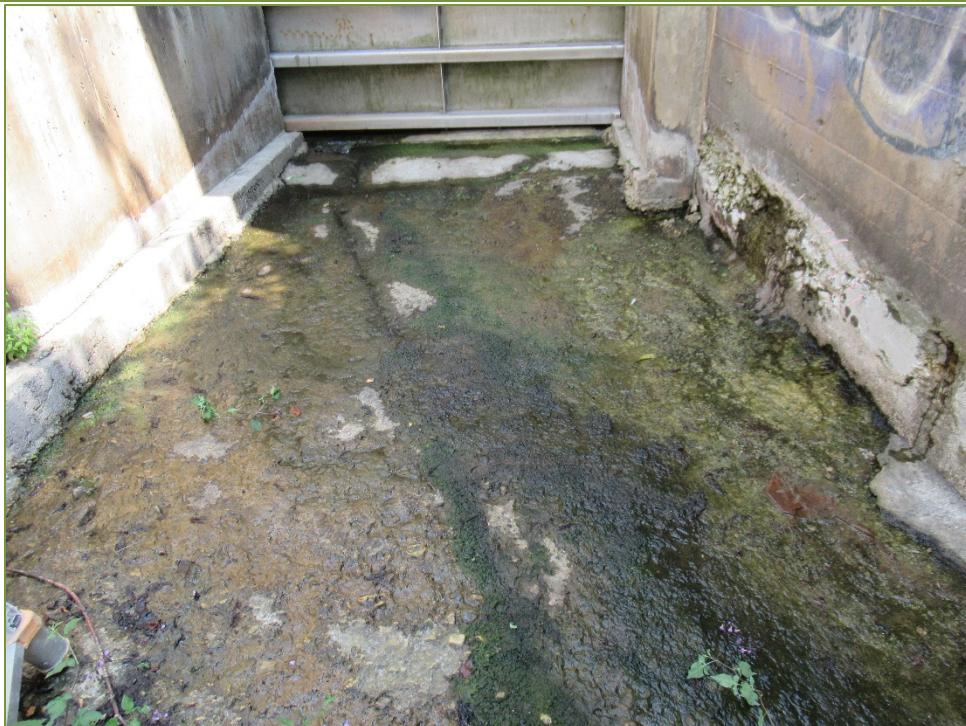
Photo P22 Outlet – Floor (cracks, and medium to severe scaling)
