**City of Guelph**

## **Stormwater Management Master Plan**

## Appendix H: Stormwater Management Facility Maintenance Inspection Summary

Prepared by:  
**Aquafor Beech Ltd.**

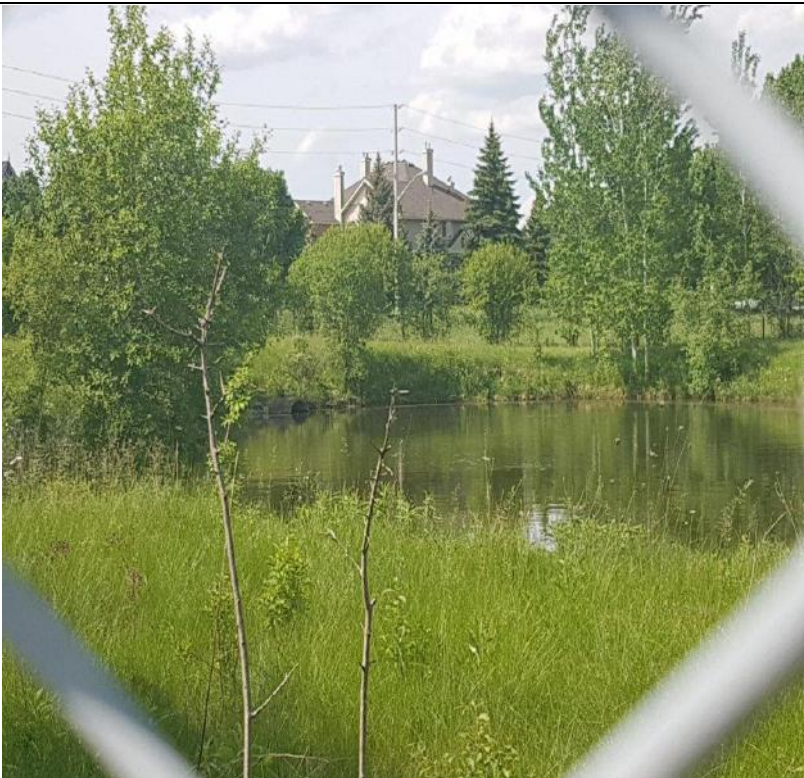
Inspection Summary Table		
Immediate	Moderate	Low
<ul style="list-style-type: none"> <li>Pond has high levels of permanent standing water (Photo B.)</li> <li>Located within NHS</li> </ul>	<ul style="list-style-type: none"> <li>900mm inlet pipe is 50% submerged and potentially clogged with sediment and debris (Photo B.)</li> </ul>	<ul style="list-style-type: none"> <li>Outlet weir channel showing sediment deposition (Photo A.)</li> <li>Minor sediment accumulation in outfall channel and establishment of grassy vegetation that may cause minor flow restriction</li> </ul>

B. 900mm Inlet pipe 50% submerged in permanently standing water

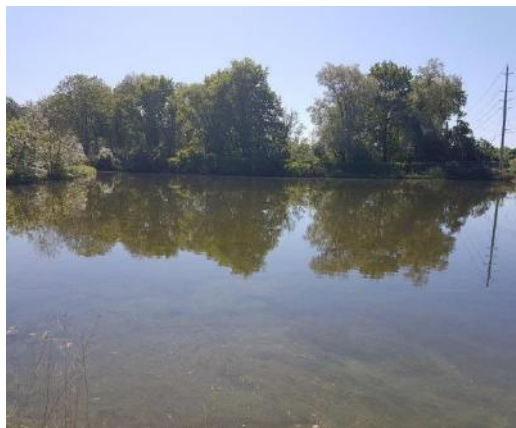
<div>A. Infiltration cell with permanent standing water</div>

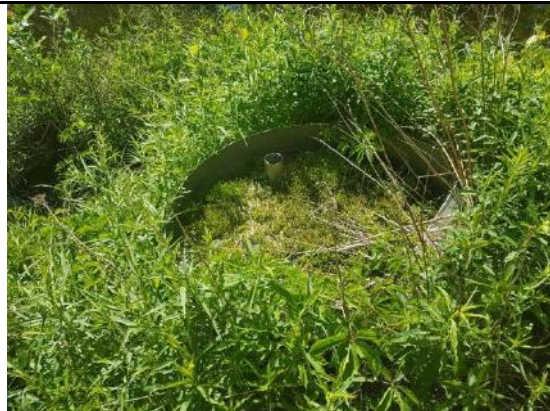
Inspection Summary Table		
Immediate	Moderate	Low
<ul style="list-style-type: none"> <li>Pond has high levels of permanent standing water (Photo B.)</li> <li>450mm riser 90% buried and surrounded by vegetative overgrowth and sediment accumulation (Photo D.)</li> </ul>	<ul style="list-style-type: none"> <li>Outlet spillway has concrete fractures and features sediment and vegetative accumulation (Photo G,H,I)</li> </ul>	<ul style="list-style-type: none"> <li>Early stages of algae growth in pond (Photo B.)</li> <li>Poor access to pond/structures due to dense vegetation</li> <li>Buckthorn present in facility</li> </ul>

<div>D. Riser Structure 90% buried</div>

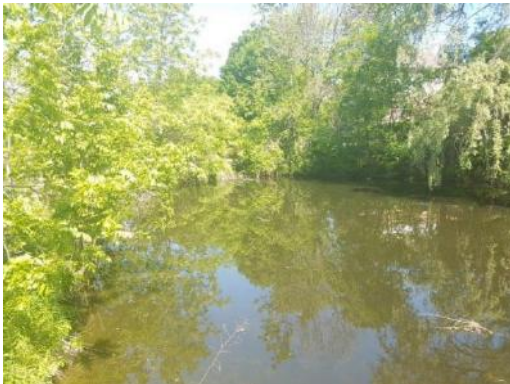
<div>E. Forebay looking towards inlet</div>

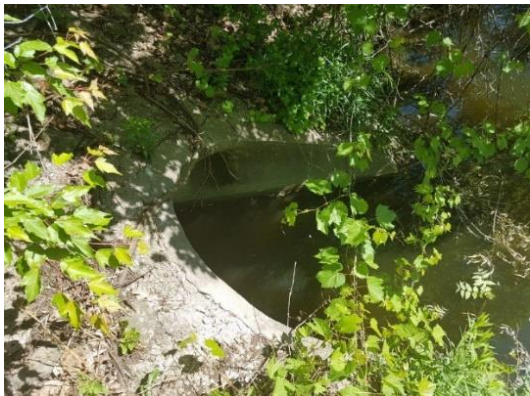
<div>F. Concrete inlet pipe and structure</div>

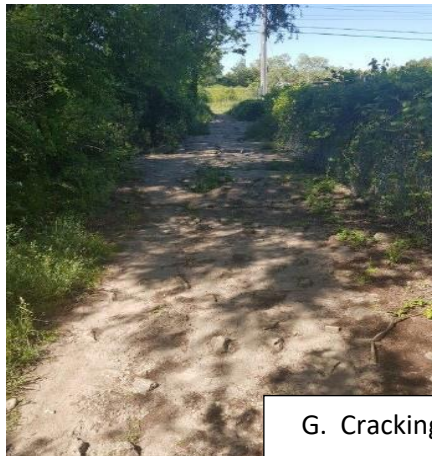
<div>G. Cracking Spillway</div>

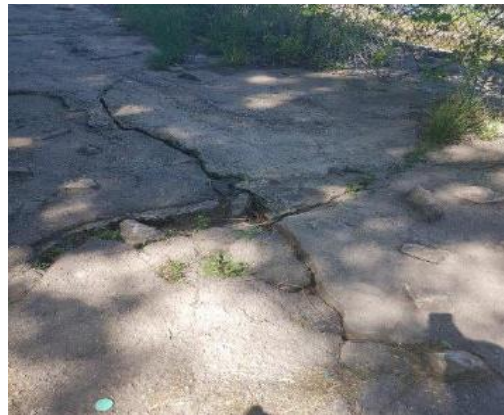
<div>H. Cracking concrete spillway structure</div>

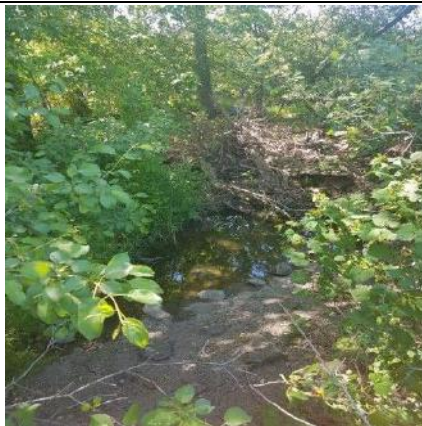
<div>I. Downstream from weir to outlet channel</div>

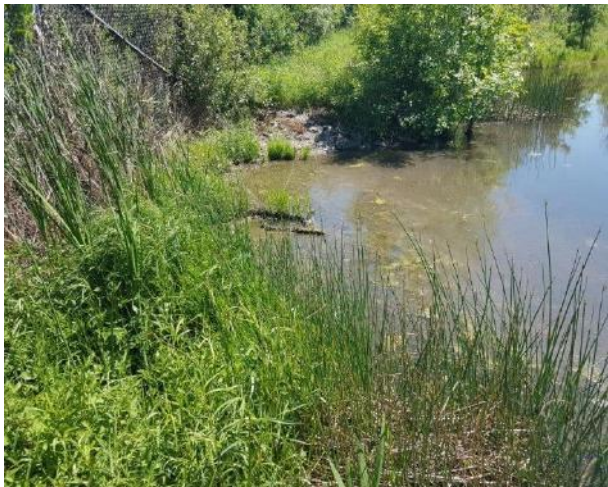
Inspection Summary Table		
Immediate	Moderate	Low
<ul style="list-style-type: none"> <li>Recharge pond cell has high levels of permanent standing water (Photo E.)</li> </ul>	<ul style="list-style-type: none"> <li>Water in forebay found with oily sheen (Photo C.)</li> <li>Weedy undergrowth in permanent water (Photo. F)</li> </ul>	<ul style="list-style-type: none"> <li>Residents with ladder access (Photo G.)</li> <li>No facility signage</li> <li>Buckthorn and dense shrubs growing around perimeter</li> <li>Forebay spillway showing minor vegetation establishment (Photo D.)</li> </ul>

F. Outlet Weir with weedy undergrowth

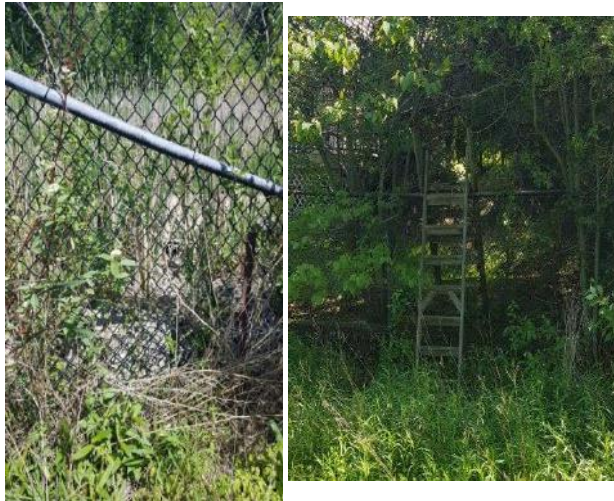
G. Outlet Channel/ Residential access ladder

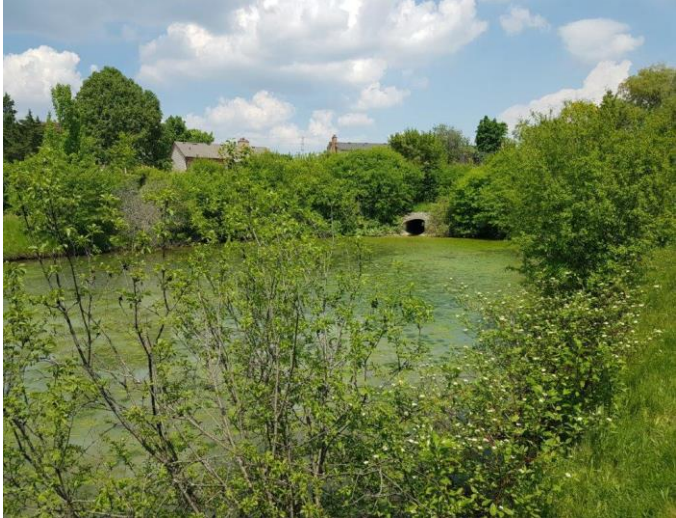
B. Forebay looking at inlet pipe

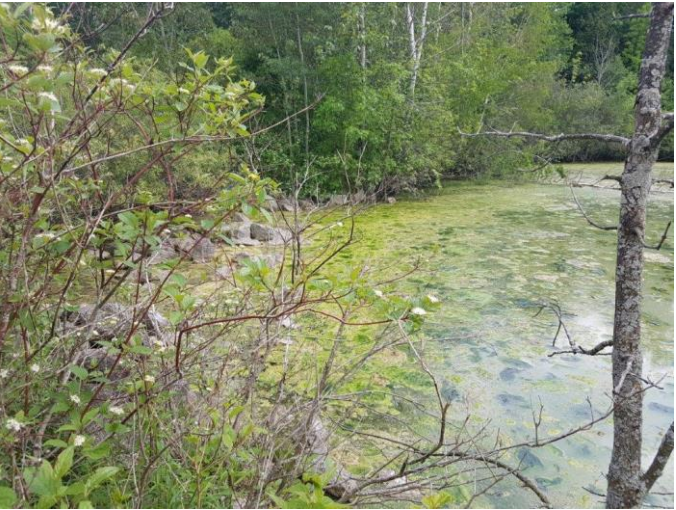
C. Forebay looking towards overflow weir

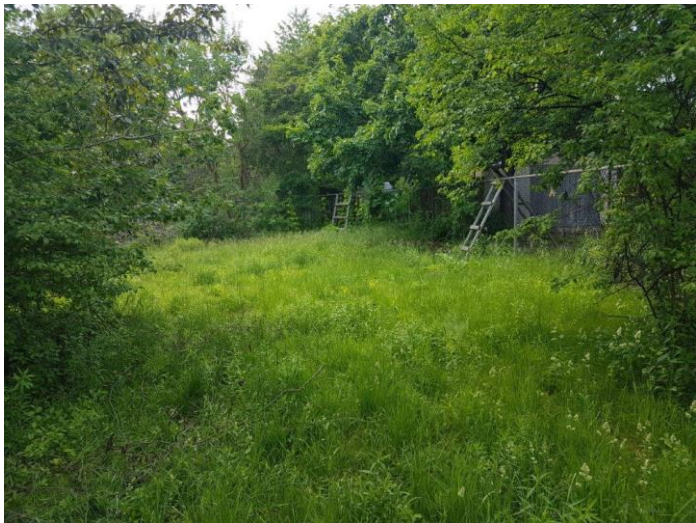
E. Resident access ladder

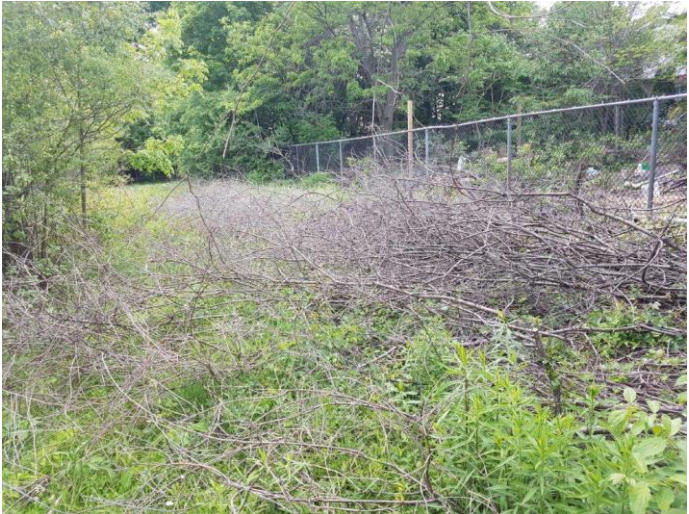
Inspection Summary Table		
Immediate	Moderate	Low
<ul style="list-style-type: none"> <li>• Infiltration basin has high levels of permanent standing water (Photo D.)</li> <li>• Very poor water quality: eutrophication evident from dense algae growth at surface, high turbidity and water odor (Photo D.)</li> <li>• Trash rack in forebay is submerged and appears to be damaged (Photo I)</li> <li>• Forebay outlet pipe blocked by sediment and forcing water to outlet over the weir to the main cell (Photo I)</li> </ul>	<ul style="list-style-type: none"> <li>• Weir dividing forebay and infiltration pond has heavy tree overgrowth and sediment accumulation due to increased use with riser outlet blocked (Photo C, J.)</li> <li>• Sediment accumulation at base of infiltration pond overflow weir (Photo M.)</li> <li>• Incision evident in outlet channel downstream of weir (Photo O.)</li> </ul>	<ul style="list-style-type: none"> <li>• Mosquitos prevalent</li> <li>• Poor access to inlet structure</li> <li>• Odor complaints from residents</li> <li>• Steep banks</li> <li>• Invasive plant species (buckthorn) causing very dense vegetation and reduced access to structures</li> <li>• Residents with access ladders (Photo E.)</li> <li>• Tree and vegetative deadfall (Photo F.)</li> <li>• Vegetation growing through fence (Photo G.)</li> </ul>

F. Tree deadfall

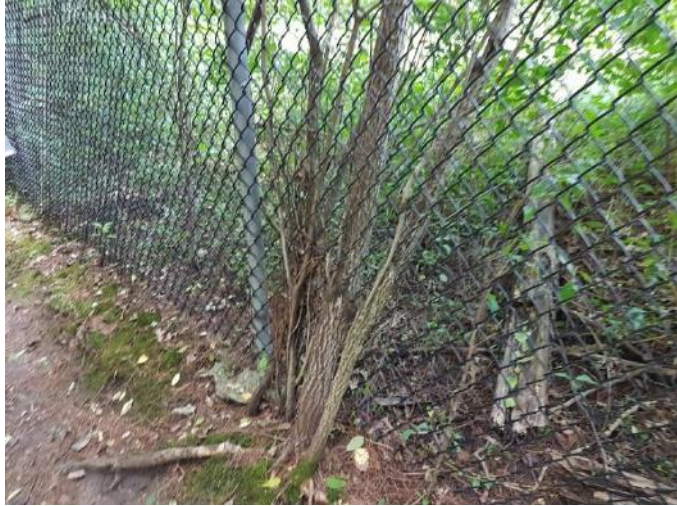
G. Trees growing through facility perimeter fence.

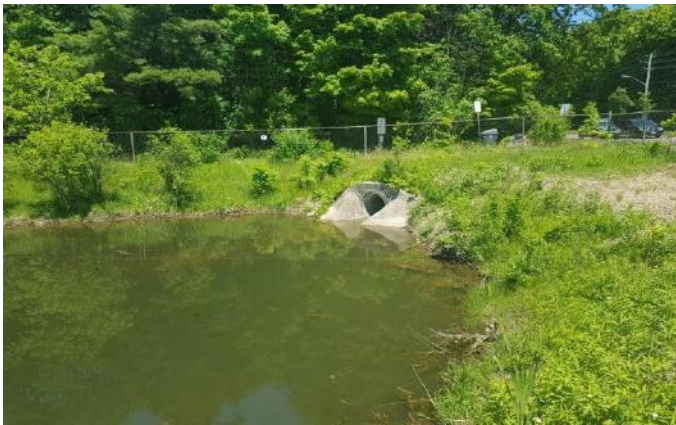
A. Looking at Inlet structure on forebay

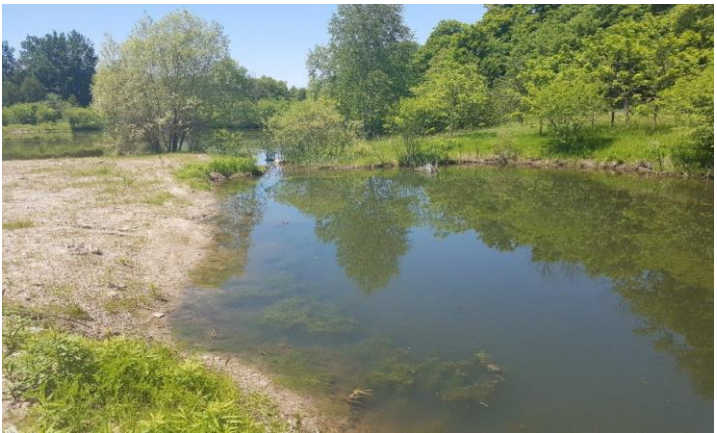
B. Looking at forebay at spillway to main cell

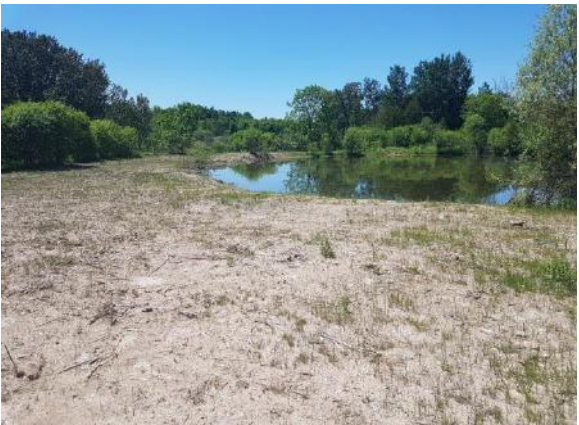
C. South East embankment lacking vegetation

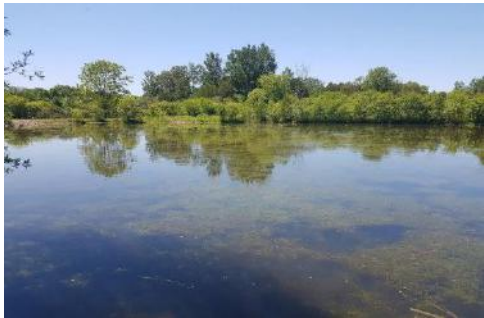
F. Main cell of pond with algae and weed growth

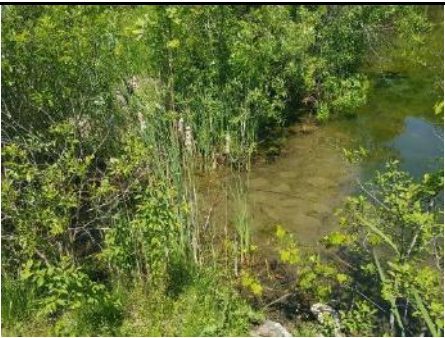
F. Outlet spillway

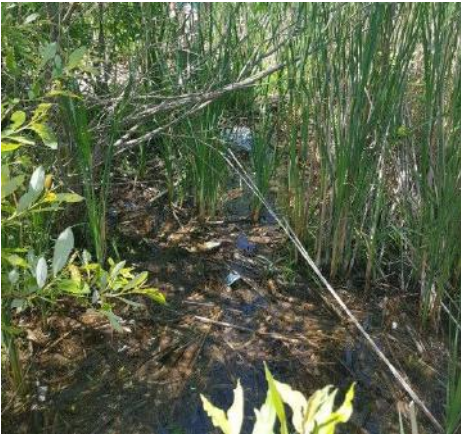
G. Outlet channel with sediment accumulating

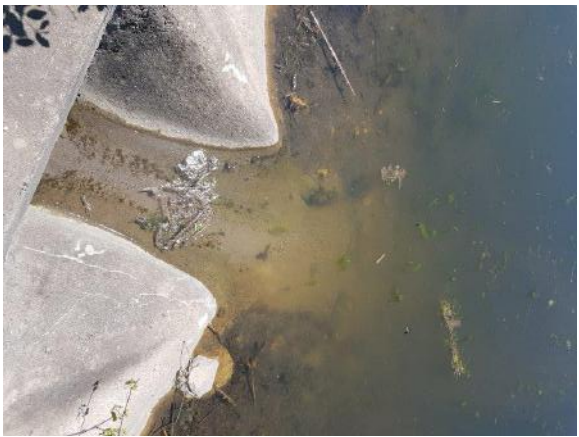
I. Concrete inlet pipe and structure

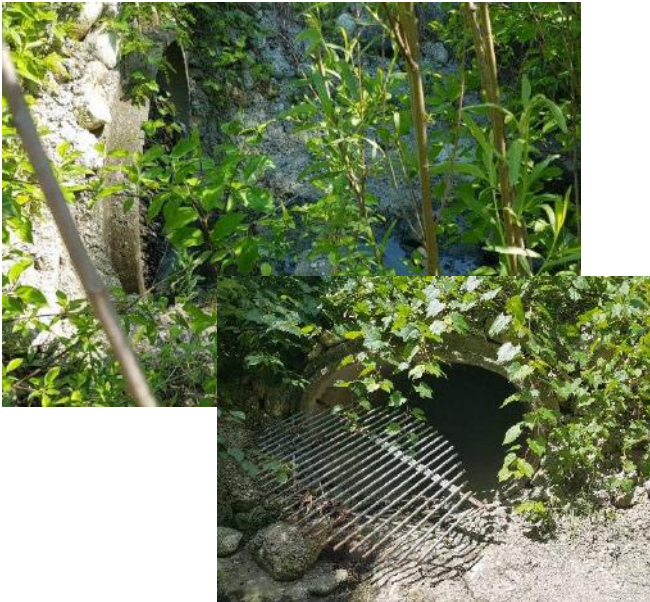
<p>A. Concrete inlet pipe inlet with knocked out trash grate and inlet channel</p>

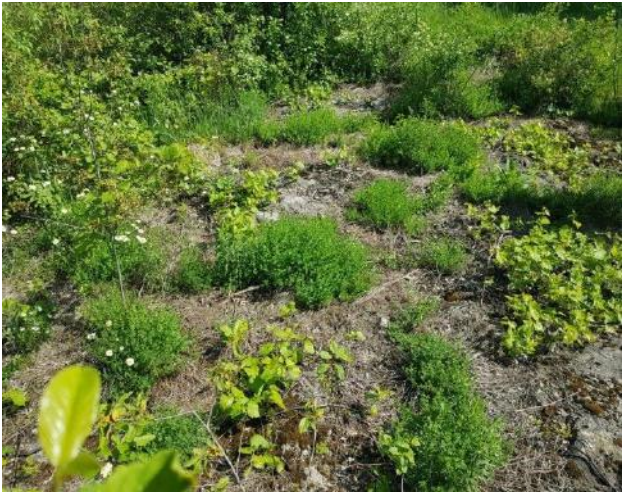
Inspection Summary Table		
Immediate	Moderate	Low
<ul style="list-style-type: none"> <li>Pond has high levels of permanent standing water with significant algae growth (Photo B.)</li> <li>Outlet pipe under a rooted tree, and estimated to be 95% submerged in water (Photo F.)</li> <li>Ditch inlet CB structure about 10% submerged in water, as well as grate heavily matted in sediment at normal water level (Photo E.)</li> </ul>	<ul style="list-style-type: none"> <li>Outfall densely vegetated and sediment prevalent (Photo D, F.)</li> <li>Inlet pipe trash grate has popped out from a high flow event and is now attached by one side and leaves pipe open (Photo A1 to A2.)</li> </ul>	<ul style="list-style-type: none"> <li>Mosquitos present</li> <li>Buckthorn prevalent</li> <li>Residents using access ladders, and benches/chairs inside gated area</li> <li>Emergency overflow weir (South East corner) showing vegetation coverage (Photo C.)</li> </ul>

<p>C. Emergency overflow weir with dense vegetation coverage</p>

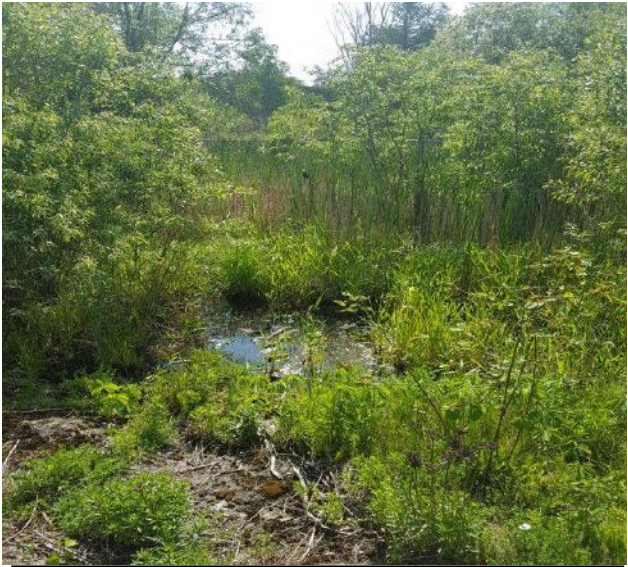
<p>D. Downstream receiving wetland</p>

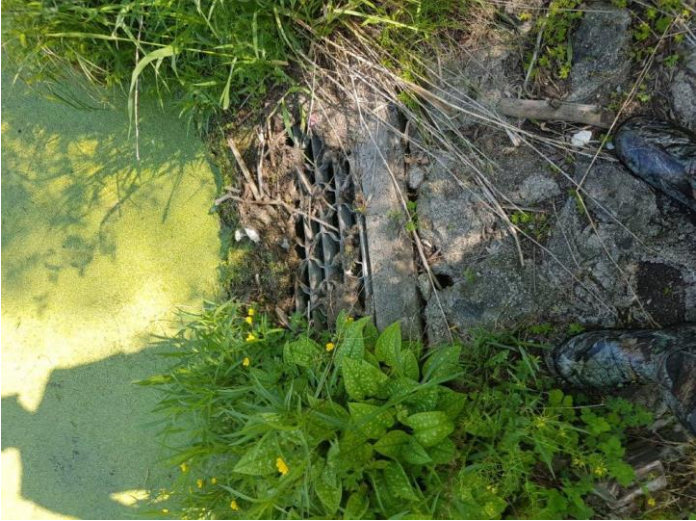
<p>E. Ditch inlet structure heavily submerged (visually estimated as 60%) and matted with sediment</p>

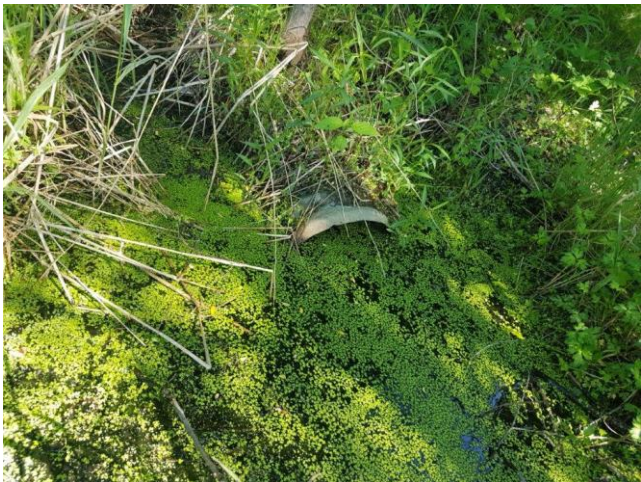
<p>F. Downstream outlet pipe about 95% submerged in water</p>

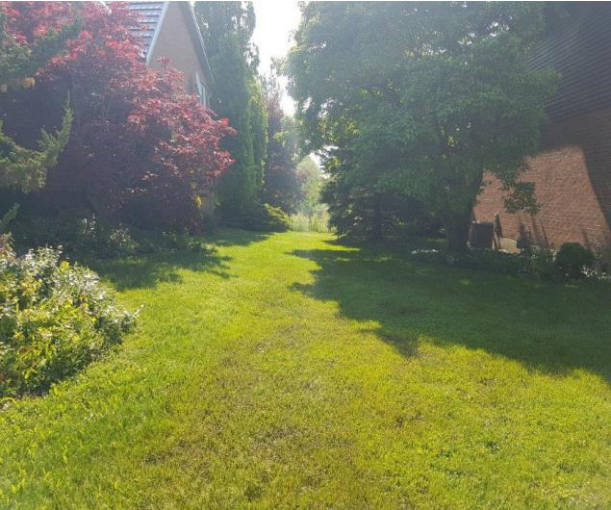
<p>G. Easement looking toward gate from road</p>

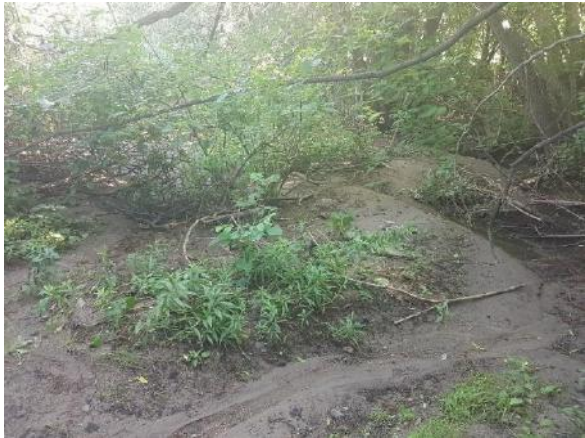
Inspection Summary Table		
Immediate	Moderate	Low
<ul style="list-style-type: none"> <li>Infiltration cell has high levels of permanent standing water (Photo A.)</li> <li>Forebay is becoming clogged with dense vegetation and sediment deposition approximately 1m deep based on design drawings (Photo B.)</li> <li>Trash rack found submerged in forebay, becoming clogged/blocked by extensive build up from woody debris, sediment, and nearby vegetation growth around grate (Photos K, L)</li> </ul>	<ul style="list-style-type: none"> <li>Forebay weir accumulating sediment and has some displaced riprap due to increased use as outlet to main cell (Photo C.)</li> </ul>	<ul style="list-style-type: none"> <li>Mosquitos from standing water</li> <li>Upstream and downstream channels showing partial flow restriction due to garbage, clogging from sediment and vegetative over growth</li> <li>Buckthorn and Phragmites presence extensive (Photo E.)</li> <li>Piles of vegetative deadfall</li> <li>Outlet pipe headwall structure has several pieces of rip-rap from pond and dense vegetation in receiving channel (Photo M,N.)</li> </ul>

<div>B. Forebay showing dense vegetation and significant sediment build up (80% full by visual assessment).</div>

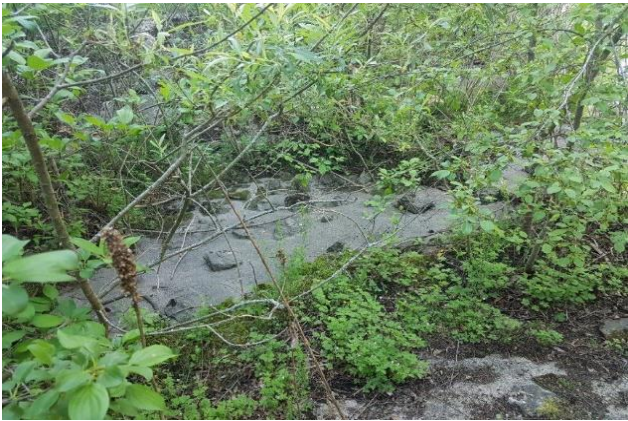
<div>C. Forebay weir with loose riprap and showing signs of sediment accumulation, vegetation establishment</div>

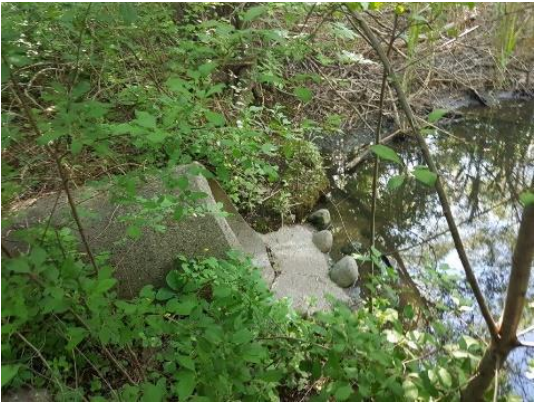
<div>D. Northern 600mm concrete inlet pipe</div>

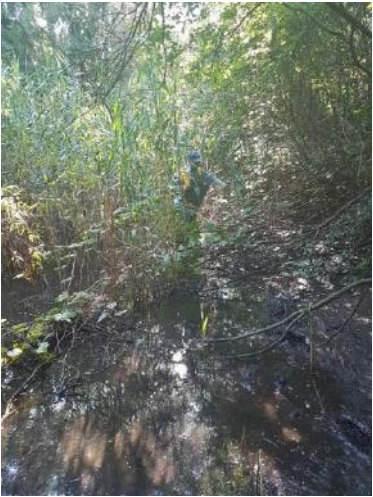
<div>E. Phragmites and standing water in forebay.</div>

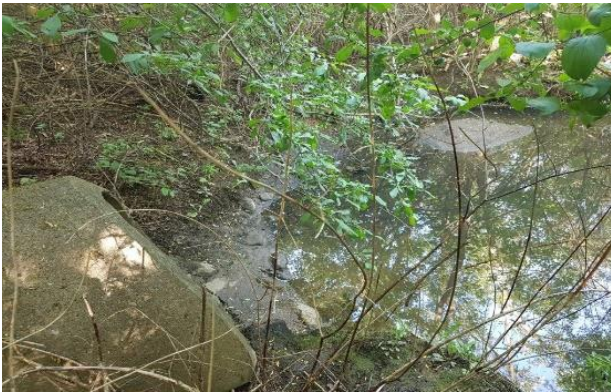
<div>F. 900mm concrete inlet pipe south end of forebay</div>

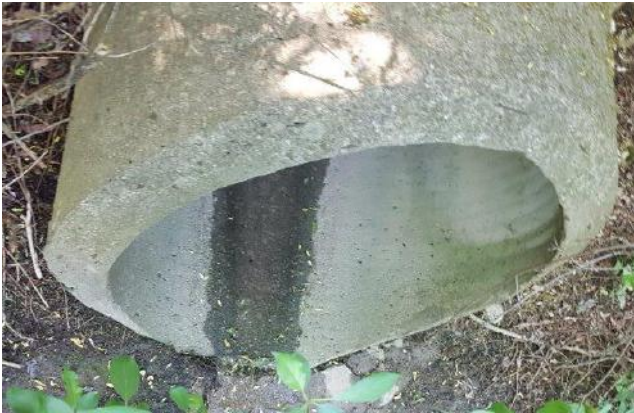
<div>G. 900mm forebay inlet pipe in good condition</div>

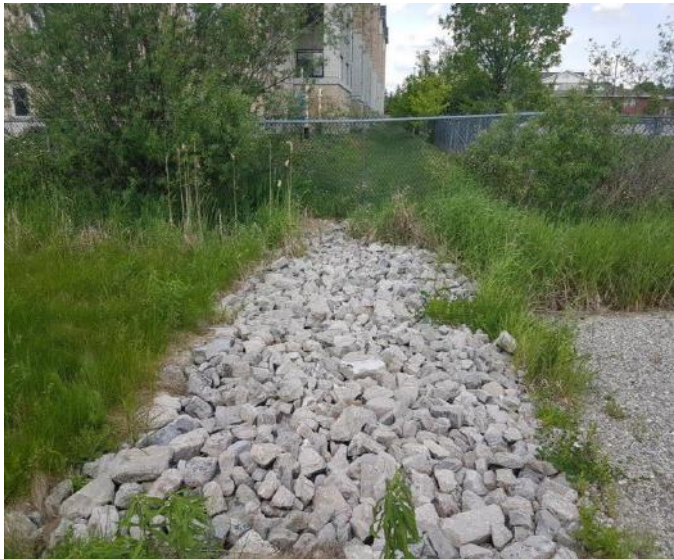
D. Rip-rap inlet channel looking upstream

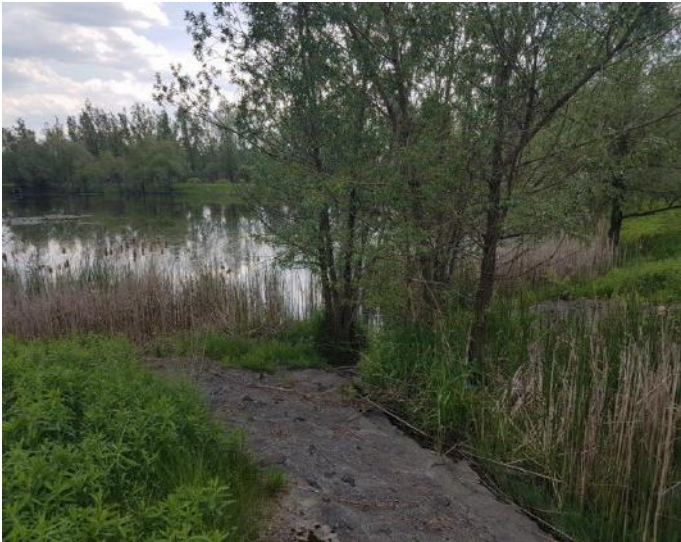
E. Concrete inlet channel looking downstream

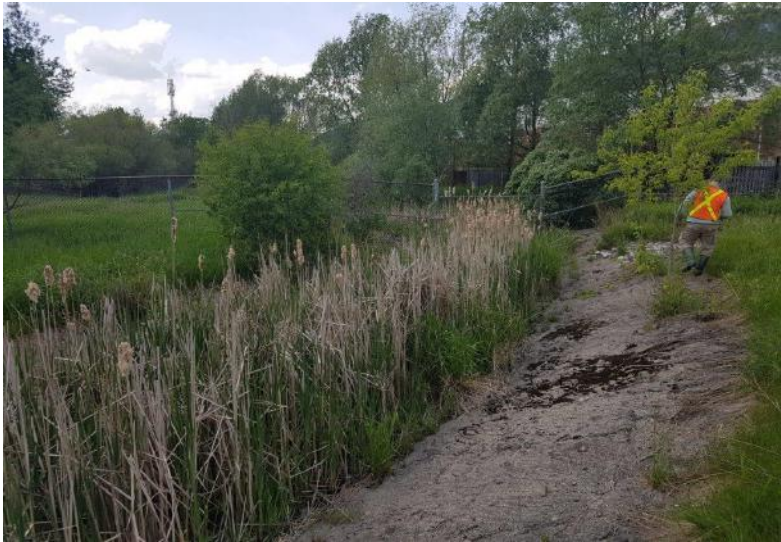
F. Concrete inlet channel looking upstream towards pipe opening

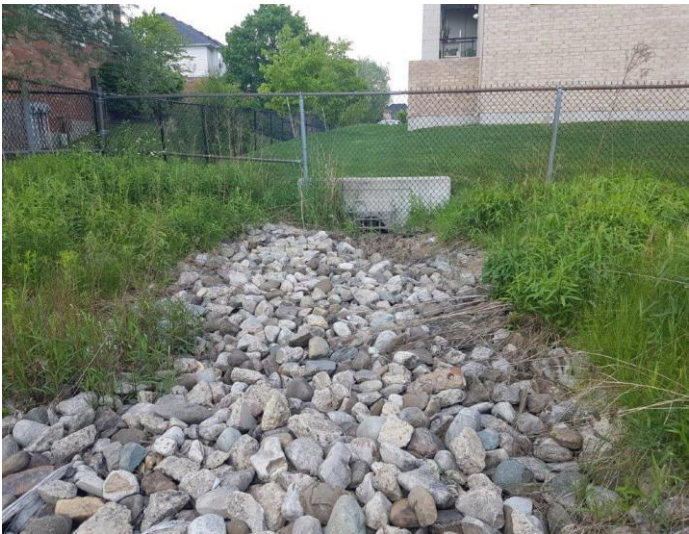
G. Downstream end of second pipe with 15% blockage from riprap

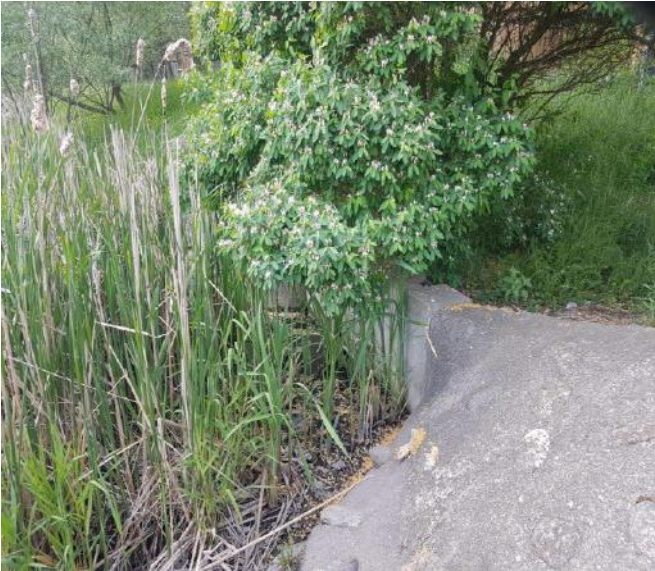
<p>H. Pipe inlet along channel with dense vegetation growth in outfall channel inhibiting flow conveyance</p>

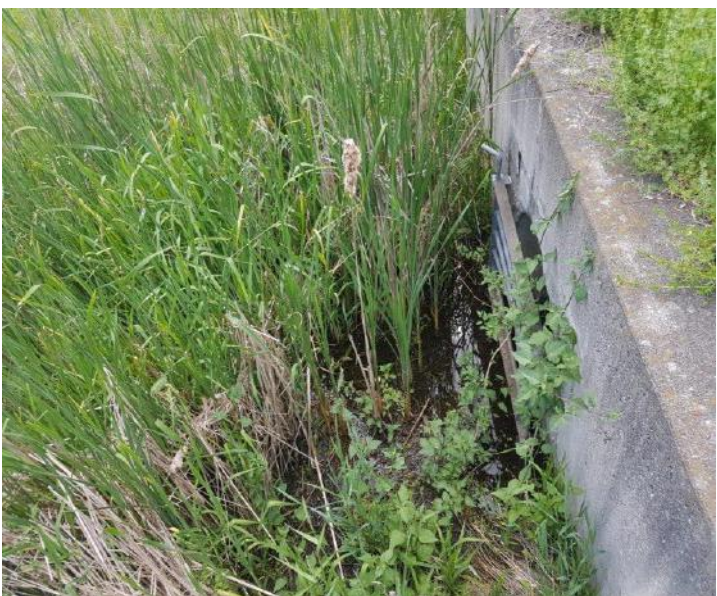
<p>K. Headwall at downstream end of 825mm outlet pipe with dense vegetation immediately downstream</p>

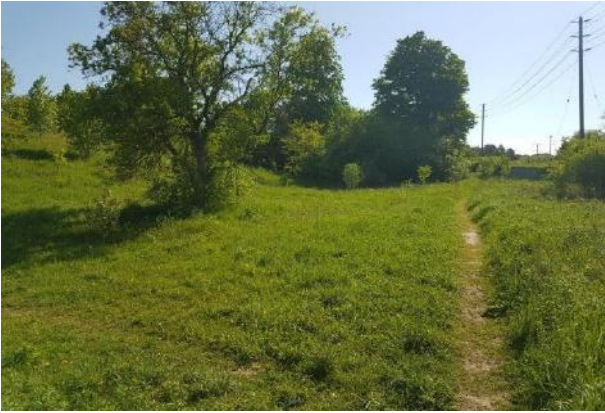
<p>B. Upstream end of dry pond showing access pathway</p>

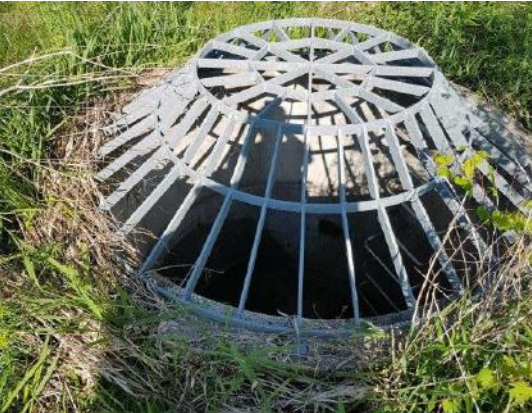
<p>C. 1500mm CBMH with rip-rap in bottom</p>

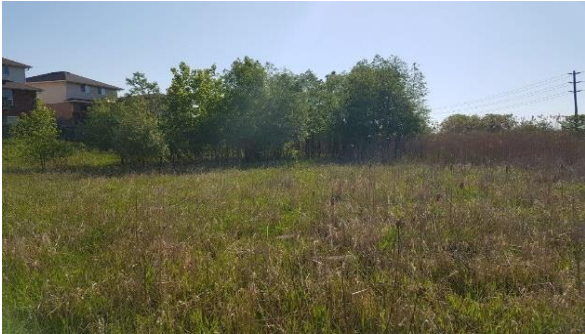
<p>D. Dry pond looking upstream from outlet weir</p>

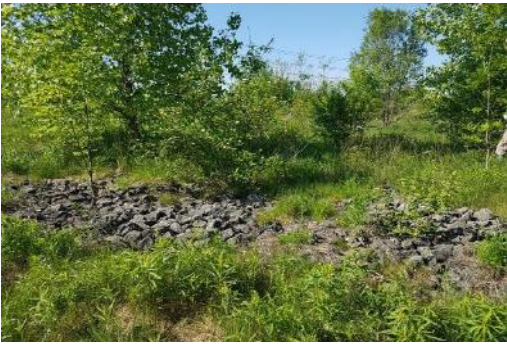
<p>E. Overland weir looking at access path</p>

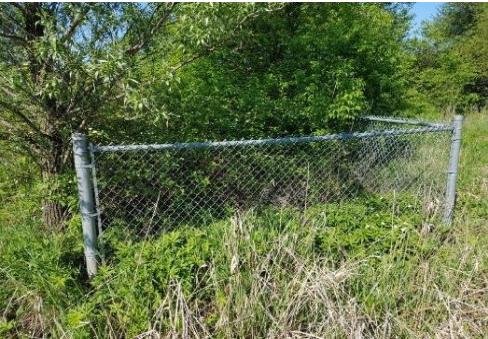
<p>F. Fence around Hickenbottom outlet structure</p>

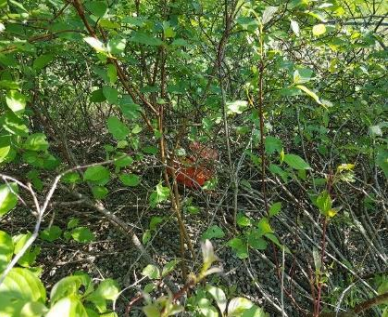
<p>G. Hickenbottom with vegetation overgrowth and sediment accumulation</p>

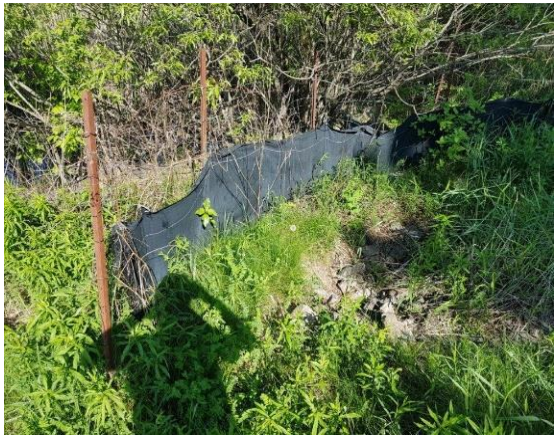
H. Silt fence at outlet channel

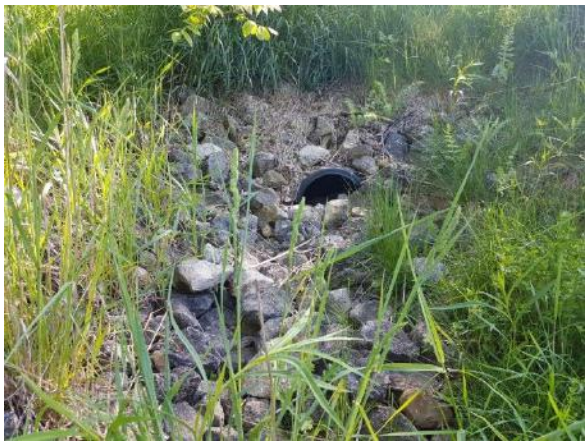
Inspection Summary Table		
Immediate	Moderate	Low
<ul style="list-style-type: none"> <li>300mm outlet pipe (main cell) is 50% clogged by riprap and sediment (Photo I.)</li> <li>Both inlet pipes severely blocked or submerged greatly limiting pond inflow capacity and leads to flooding risk in upstream sewershed (Photo (J, K.))</li> <li>Large amounts of sediment deposition contributing to inlet blockage due to silt fence around inlet pipes (Photo K.)</li> </ul>	<ul style="list-style-type: none"> <li>Outfall channel features nearby tree growth possibly restricting flow, while also having displaced riprap and sediment accumulation</li> <li>Spillway has vegetative overgrowth, displaced riprap, signs of erosion, and is become clogged with debris</li> <li>Hickenbottom has very dense vegetation growth around structure limiting access (Photo G.)</li> <li>1500mm CBMH with beehive grate has riprap in bottom channel of manhole (Photo C.)</li> </ul>	<ul style="list-style-type: none"> <li>Berms showing early signs of erosion, sediment deposition, and displaced riprap</li> <li>No stormwater facility signage present</li> <li>Phragmites and Buckthorn very prevalent (Photo A.)</li> <li>Trash around inlet pipes (Photo K.)</li> </ul>

I. Pond outlet pipe 50% blocked by rip-rap

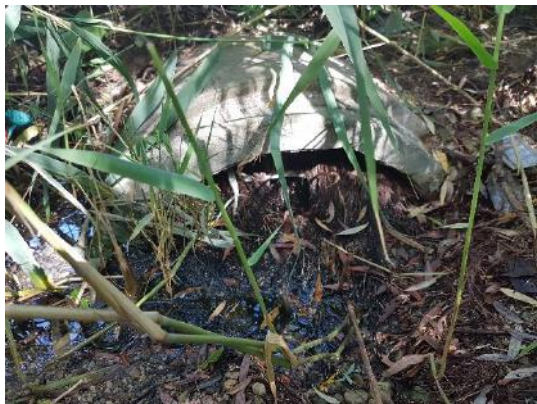
J. 600mm concrete inlet pipe from Valleyhaven Lane 95% blocked with sediment

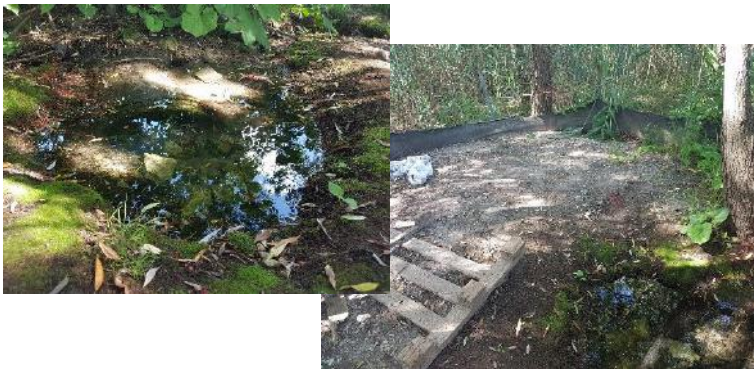
K. 600mm concrete inlet pipe from Henry Court 80% blocked and submerged in small pool. Outfall area filled with sediment and trash present

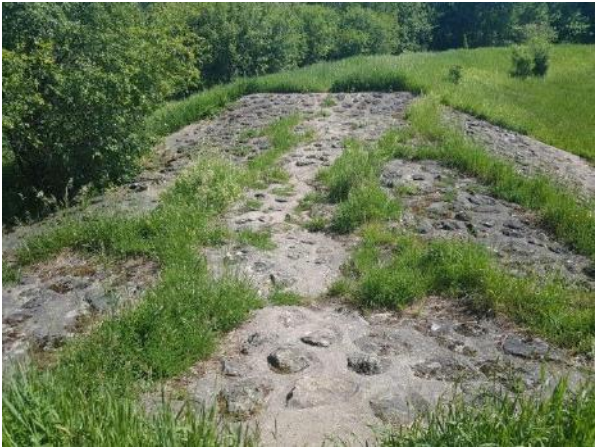
<div data-bbox="1081 727 1662 848">A. Emergency overflow spillway out of infiltration basin showing early grass growth in small cracks</div>

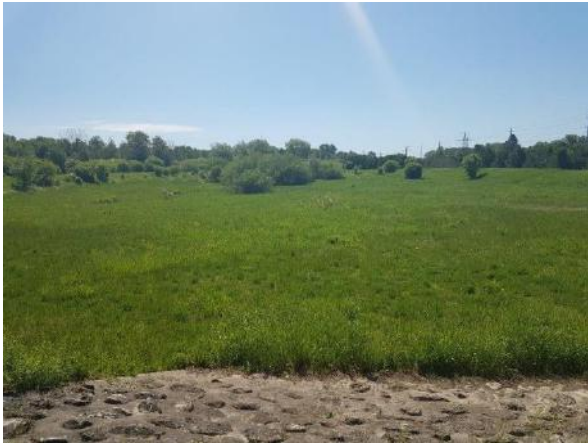
<div data-bbox="1709 727 2290 788">B. Infiltration basin overview</div>

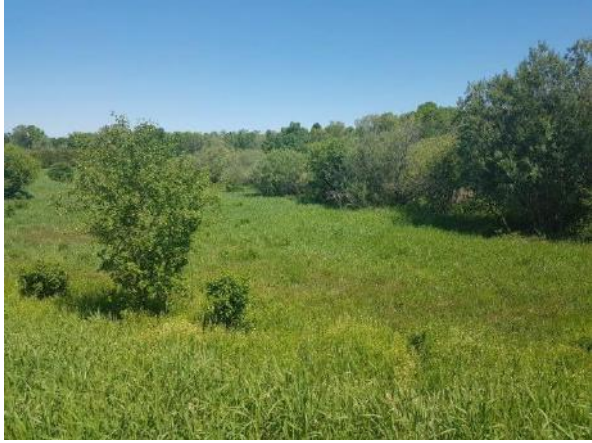
<div data-bbox="2321 727 2902 808">C. Infiltration basin with shrubby tree growth</div>

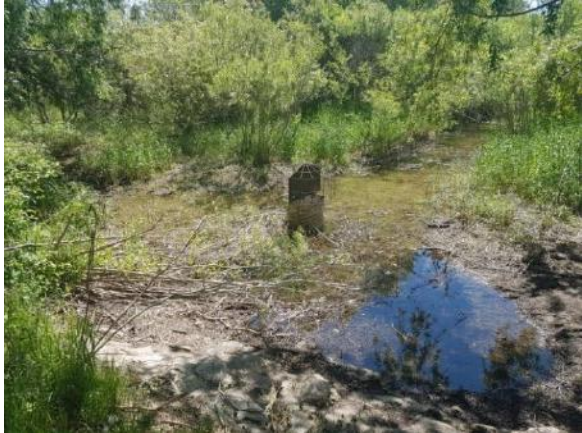
Inspection Summary Table		
Immediate	Moderate	Low
	<ul style="list-style-type: none"> <li>600mm Hickenbottom riser structure showing signs of rust and corrosion degradation, flow restriction from sedimentation, and rip-rap displacement nearby (Photo D.)</li> <li>Sediment accumulating below weir in downstream receiving creek</li> <li>Recharge/dry basin is accumulating sediment and surplus material. Also showing signs of soil erosion (Photo E.)</li> <li>Small trees growing into 450mm CSP inlet pipe in downstream main cell basin. Pipe is damaged from tree growth, and connection to steel headwall is loosened (Photo F.)</li> </ul>	<ul style="list-style-type: none"> <li>Tree and shrub dieback</li> <li>Invasive plants present</li> <li>Poor vehicle access due to limited pathway width and lack of surface treatment</li> <li>No facility signage present and pedestrian paths cross infiltration basin</li> </ul>

<div data-bbox="354 1348 882 1399">D. Damaged riser structure in forebay cell</div>

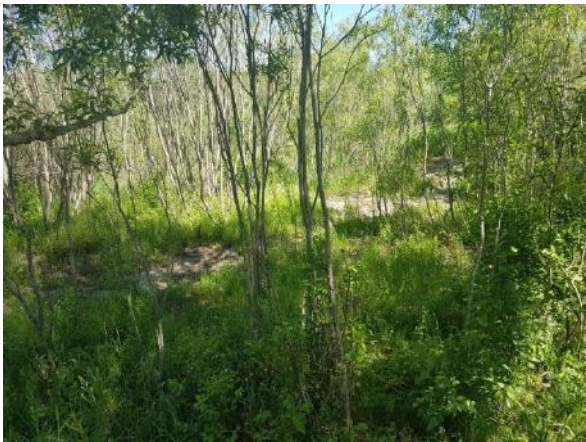
<div data-bbox="1090 1356 1665 1443">E. Dry basin area from forebay outlet showing shrubby tree stand</div>

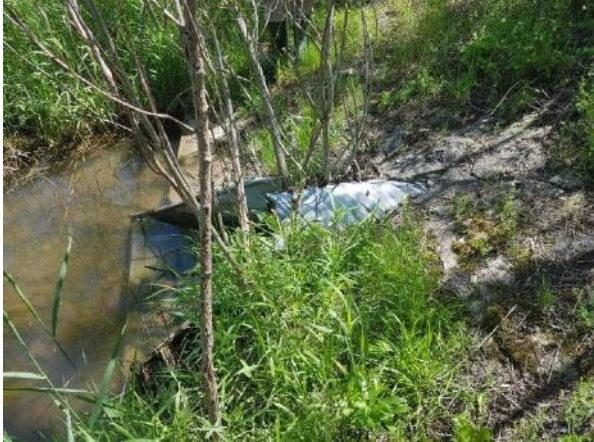
<div data-bbox="1703 1356 2281 1477">F. Pipe outlet to infiltration basin (from outlet structure) showing tree growth in structure</div>

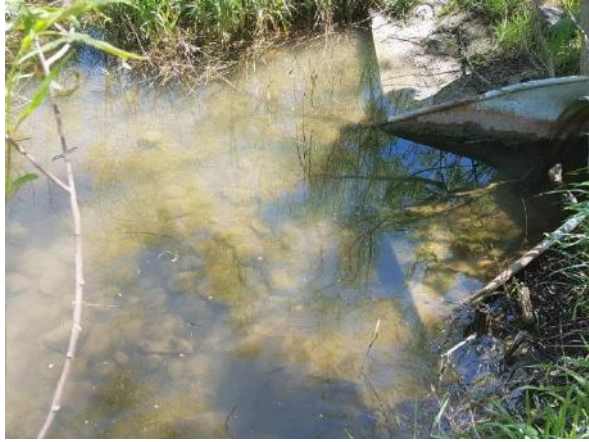
<div data-bbox="2324 1356 2912 1413">G. Settling pool at pipe inlet</div>

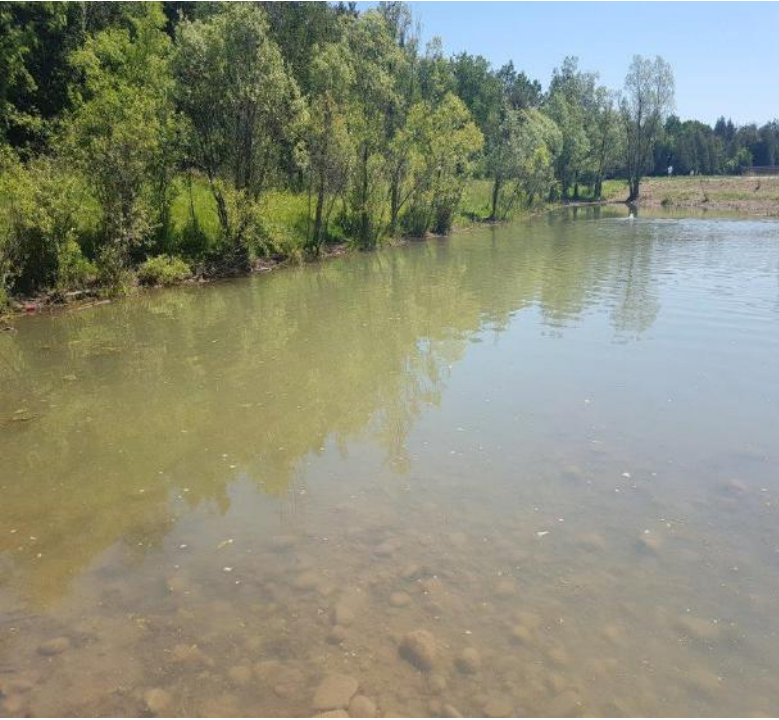
Inspection Summary Table		
Immediate	Moderate	Low
<ul style="list-style-type: none"> <li>Pond has high levels of permanent standing water (Photo A.)</li> <li>Outer embankment/ berm of pond is poorly vegetated and appears heavily eroded (Photo B.)</li> </ul>	<ul style="list-style-type: none"> <li></li> </ul>	<ul style="list-style-type: none"> <li>Small personal garbage (food waste, cups, etc) found on site</li> <li>Tree deadfall in form of limbs and small branches found near inlet of ditch into pond</li> <li>Standing water showing signs turbidity from suspended fine sediments (Photo A.)</li> <li>Drainage channel has 10% sediment accumulation</li> </ul>

<p>A photograph of a pond with still, brownish water reflecting the surrounding trees. The water appears to be permanent standing water.</p> <div data-bbox="870 1018 1535 1080">A. Pond showing permanent standing water</div>

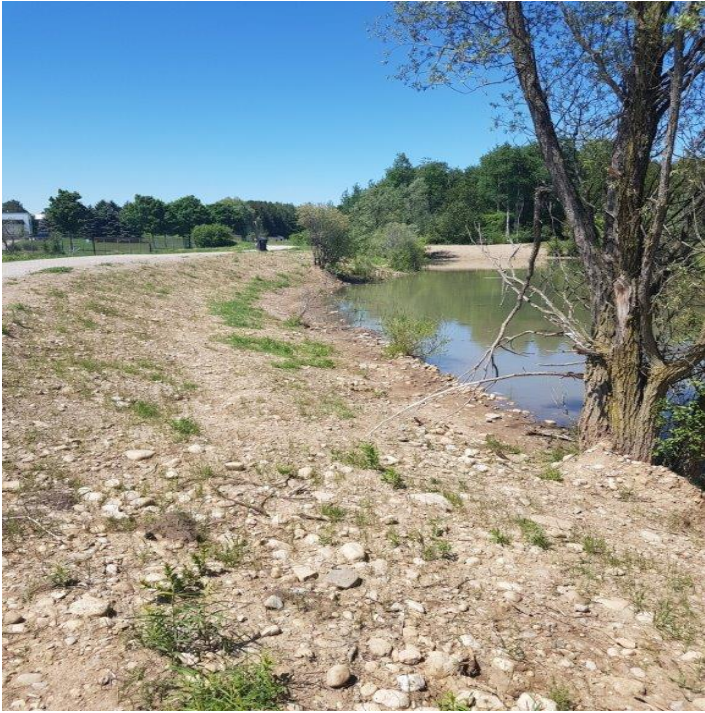
<p>A photograph of a south embankment that is mostly bare, rocky soil with very little vegetation. A large tree stands on the right side of the embankment.</p> <div data-bbox="1628 1018 2296 1074">B. South embankment lacking vegetation</div>

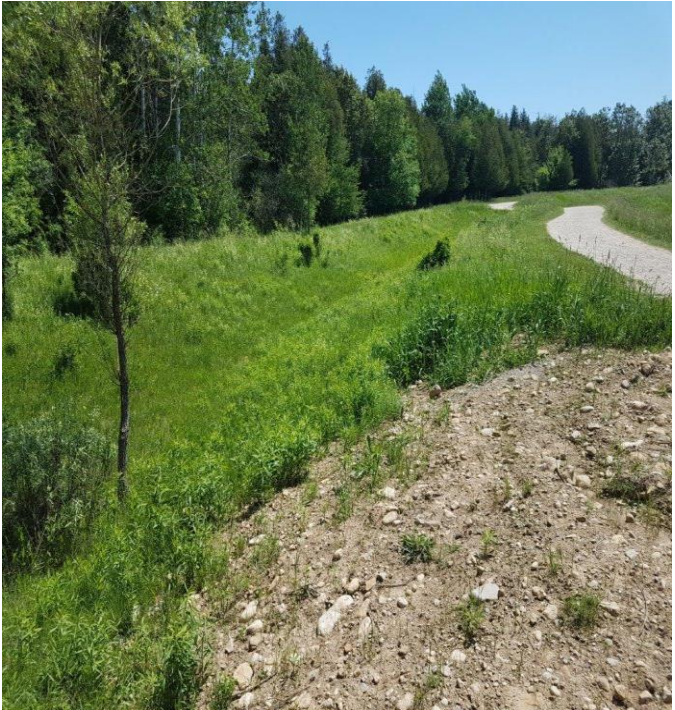
<p>A photograph of a grass swale, which is a shallow, vegetated ditch or channel for water runoff. It is filled with green grass and some small trees.</p> <div data-bbox="2368 1018 3005 1074">C. Upstream grass swale</div>

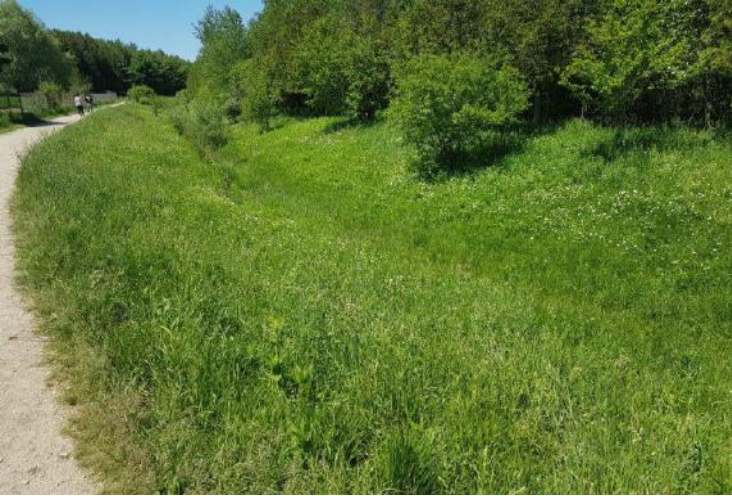
<p>A photograph of a downstream grass swale, showing a wide, shallow channel filled with green grass.</p> <div data-bbox="124 1610 786 1665">D. Downstream grass swale</div>

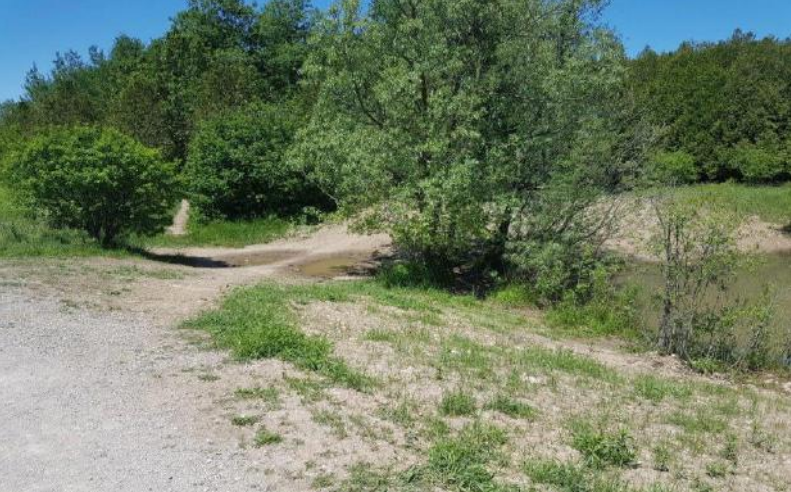
<p>A photograph of an access path and a compacted earth outlet weir. The path is made of gravel and dirt, leading to a small, low weir structure.</p> <div data-bbox="860 1610 1526 1665">E. SE Access Path and compacted earth outlet weir</div>

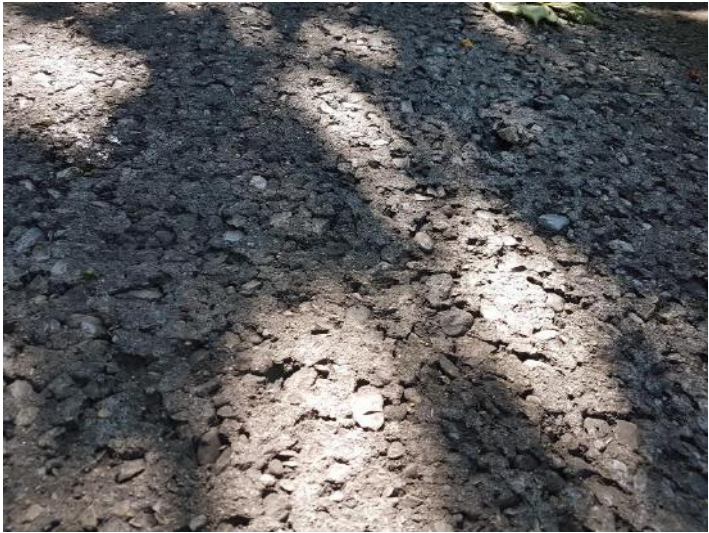
I. South inlet pipe concrete outfall channel showing early signs of erosion.

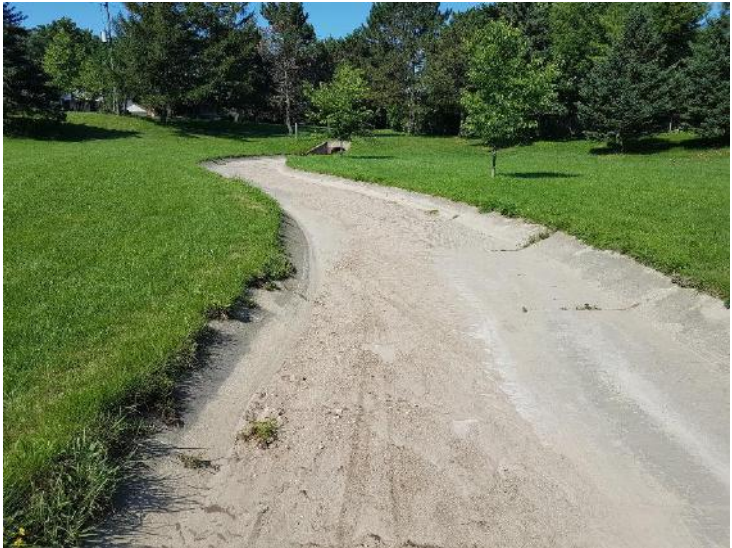
J. Concrete drainage channel going towards outlet structure. Note sediment accumulated at bottom of channel.

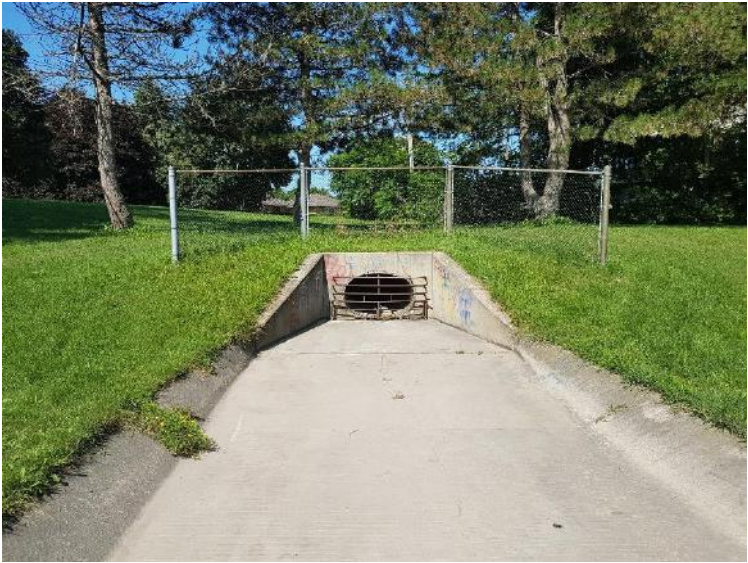
K. Concrete outlet pipe and headwall structure with protective fence. Note graffiti on
