**City of Guelph**

## **Stormwater Management Master Plan**

## Appendix H: Stormwater Management Facility Maintenance Inspection Summary

Prepared by:  
**Aquafor Beech Ltd.**

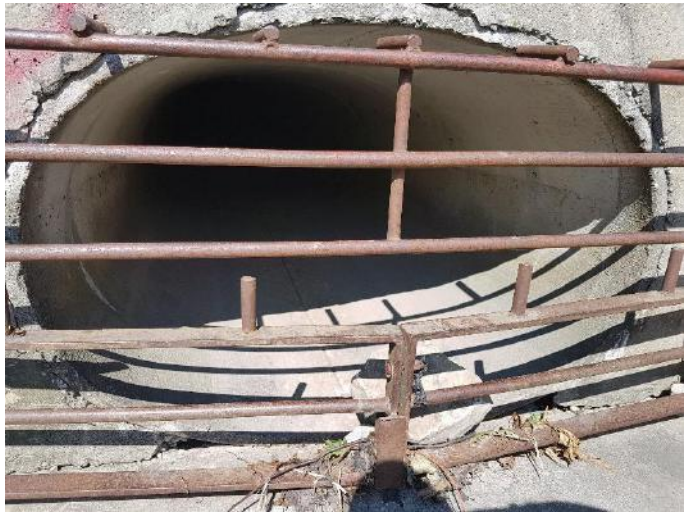
L. Concrete outlet pipe and trash grate.

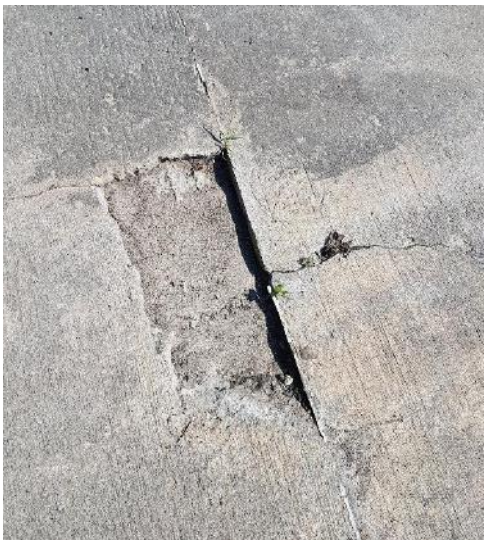
M. Crack in concrete drainage channel near outlet structure. Allows water to infiltrate and may expand with freeze thaw cycles.

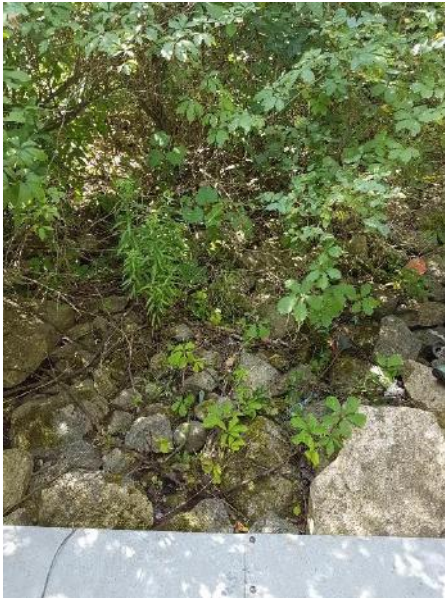
<p>C. North CMP barrel inlet structure from upstream Pond 8.</p>

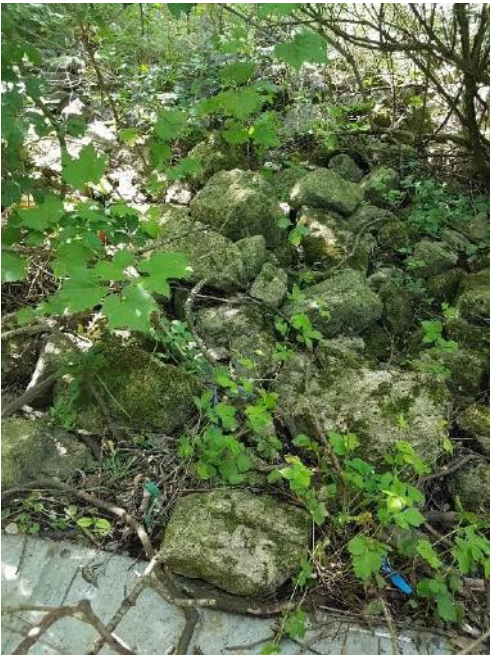
<p>D. Outfall of north CMP inlet showing rip-rap and vegetation growth.</p>

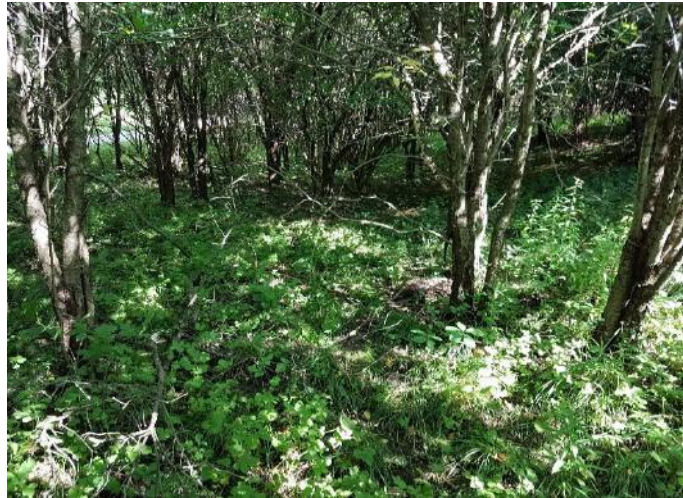
<p>E. Overland flow path from double barrel CMP inlet pipes. Note the prevalent trees and vegetation.</p>

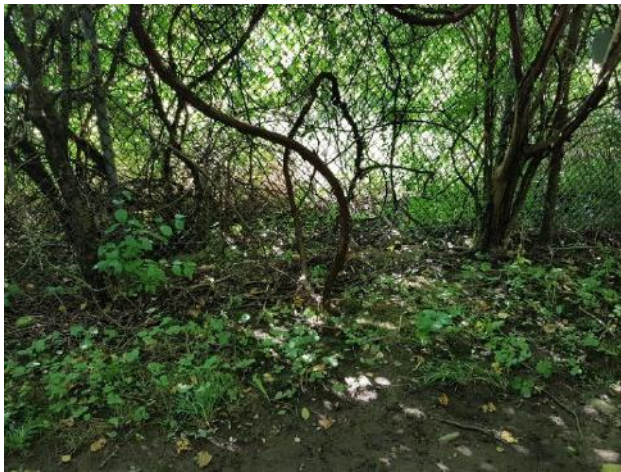
<p>F. Overland flow path from double CMP inlet looking downstream at perimeter fence of Pond 13. Note the accumulation of some plant and woody debris at fence.</p>

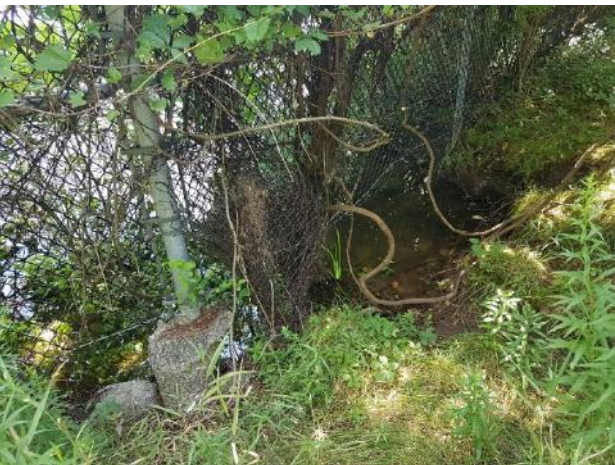
<p>G. Erosion/animal access point into main cell along perimeter fence. Note deteriorating concrete pier.</p>

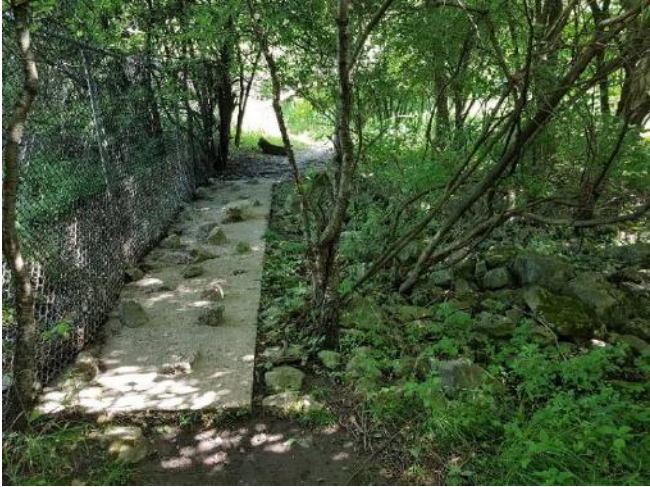
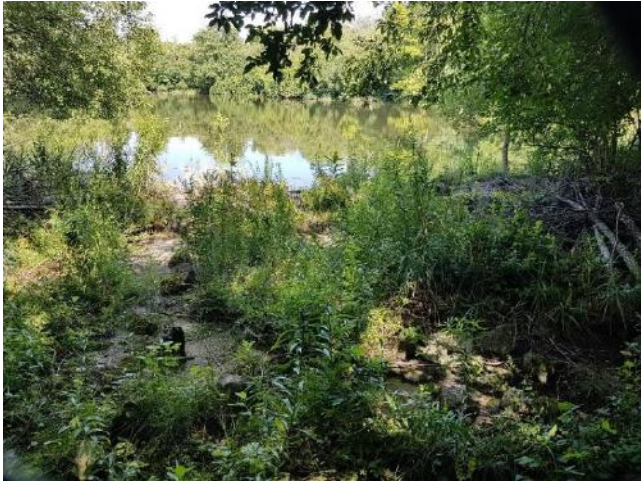
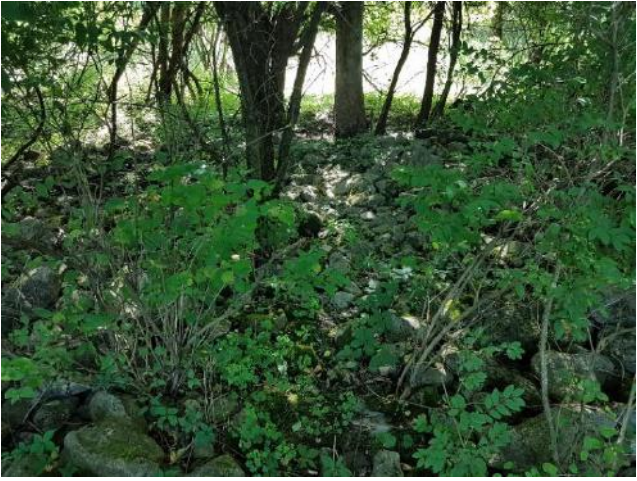
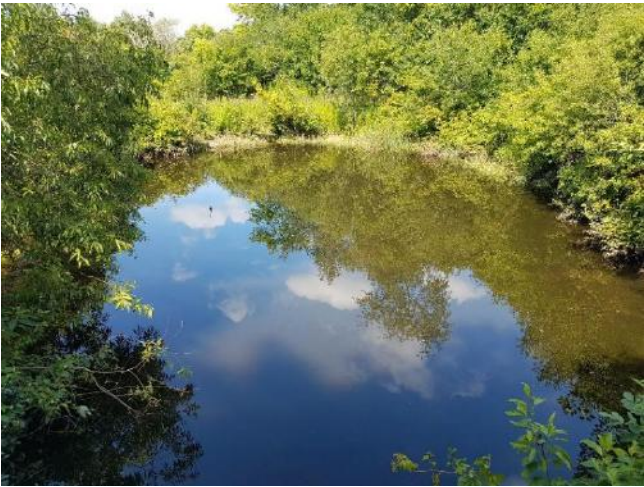
<p>H. Side view of overflow weir from main cell showing the concrete weir end and riprap outflow channel with tree cover.</p>	<p>I. Overflow weir from recharge cell looking towards pond. Note vegetation growth in the concrete weir structure, and permanent pool water levels.</p>	<p>J. Overflow channel downstream of concrete weir edge looking downstream.</p>	<p>K. Pond forebay overview.</p>

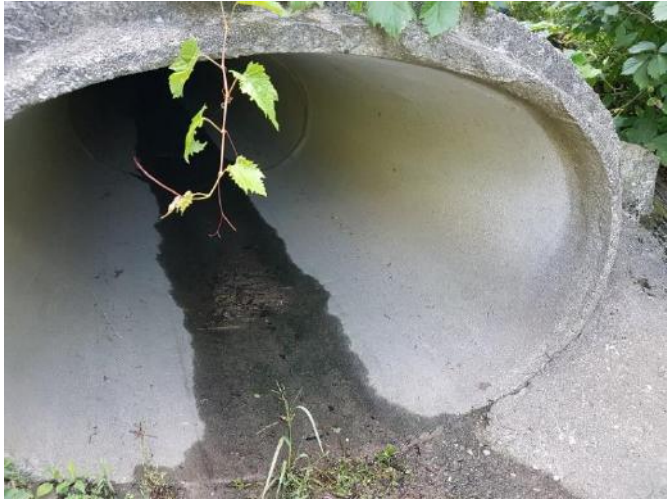
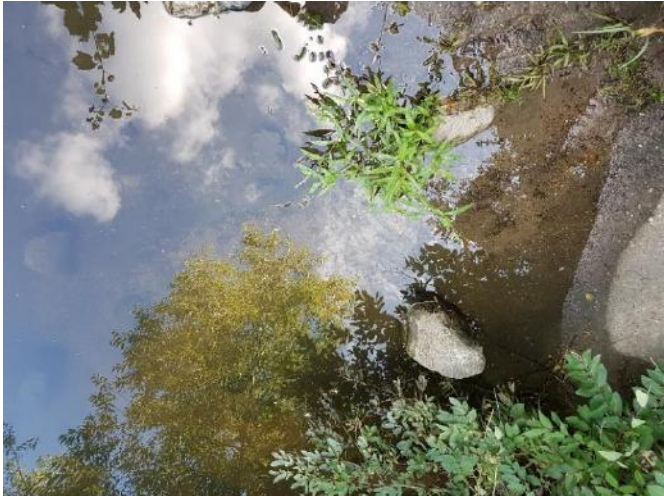
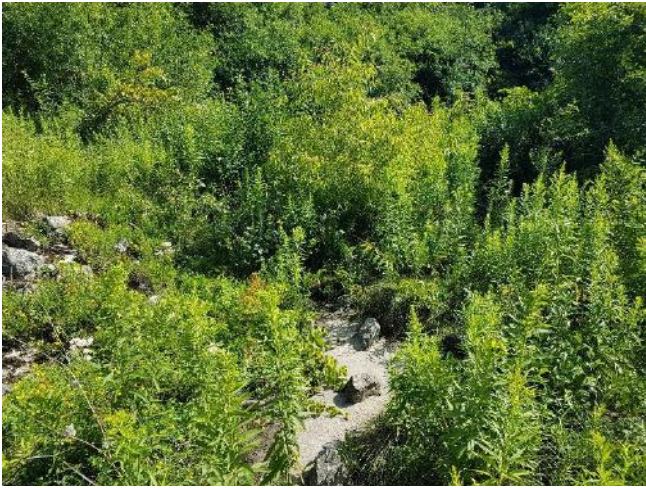
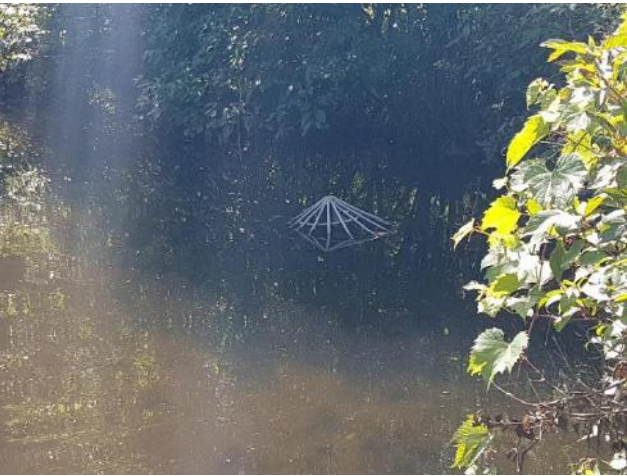
<p>L. Concrete inlet pipe entering forebay.</p>	<p>M. Outfall from forebay inlet pipe showing minor sediment accumulation in the sediment basin.</p>	<p>N. Concrete weir structure for overflow between forebay and main cell with around 50% vegetation growth coverage.</p>	<p>O. Submerged forebay outlet structure consisting of trash grate and anti-vortex plate. Forebay water enters main cell via weir currently.</p>

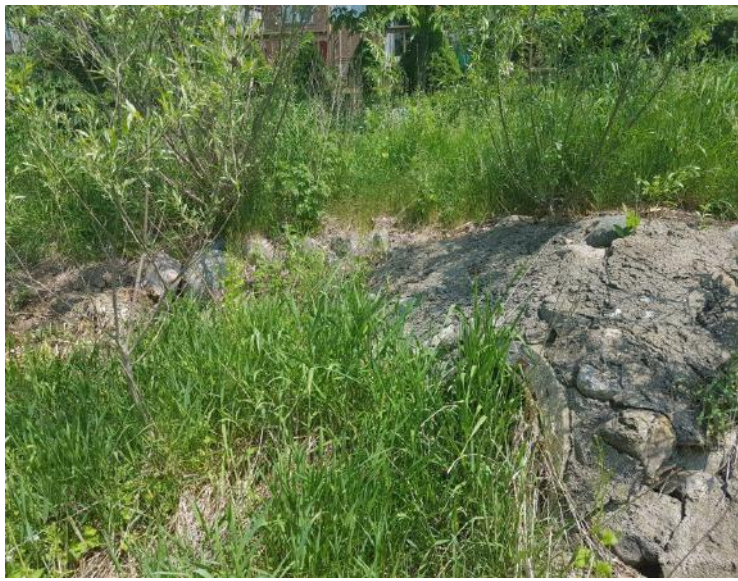
B. Dry pond inlet pipe with vegetation

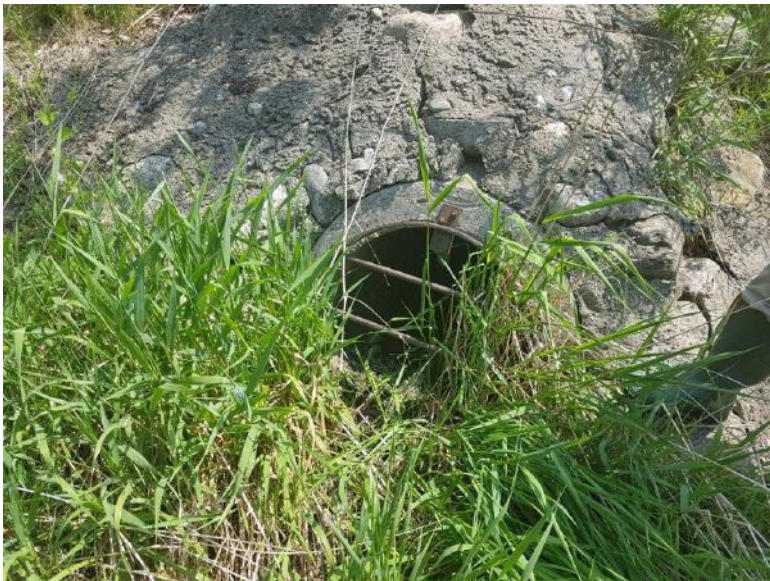
C. Inlet to dry pond 15% blocked by vegetation

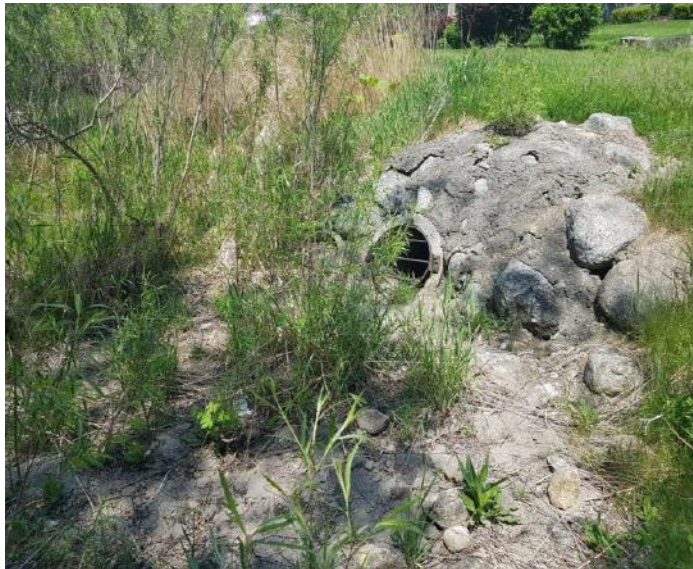
D. Concrete inlet pipe, East Pond

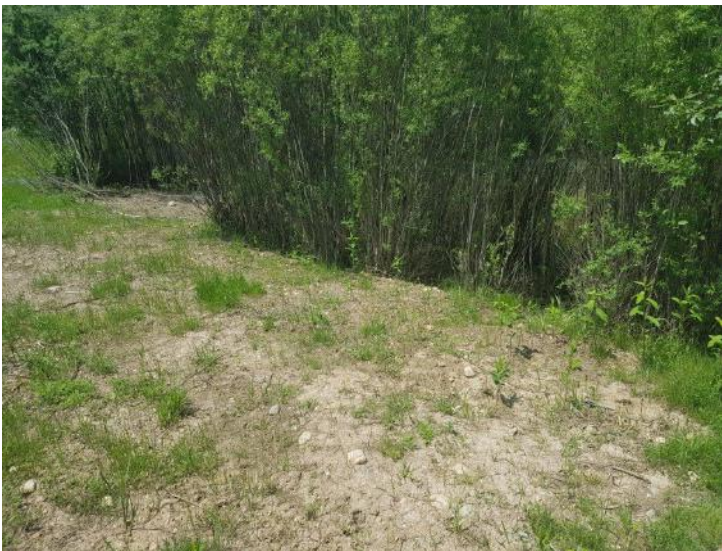
Inspection Summary Table		
Immediate	Moderate	Low
<ul style="list-style-type: none"> <li>Upstream end of outlet pipe is estimated to be 70% buried and filled with sediment (Photo H.)</li> </ul>	<ul style="list-style-type: none"> <li>Algae, sediment, and oily sheen found in inlet and outlet ponds (Photo I, J)</li> <li>Inlet pipe to dry pond is becoming blocked by an estimated 15% from vegetative growth (Photo C.)</li> </ul>	<ul style="list-style-type: none"> <li>Mosquitos prevalent</li> <li>Rip-rap displaced by 825mm inlet pipe outfall, along with berm erosion and sediment deposition (Photo N, O)</li> <li>Garbage found (Photo K.)</li> <li>Lack of stormwater facility signage</li> <li>Inlet headwall 1 m high with no railing</li> <li>Sediment deposition in rip-rap trench</li> <li>Separation berm between East inlet pond and dry pond cell lacks vegetation (Photo A.)</li> <li>Separation berm between dry pond and West outlet lacks vegetation (Photo E.)</li> </ul>

E. Berm from dry pond to west outlet pond with poor vegetation cover

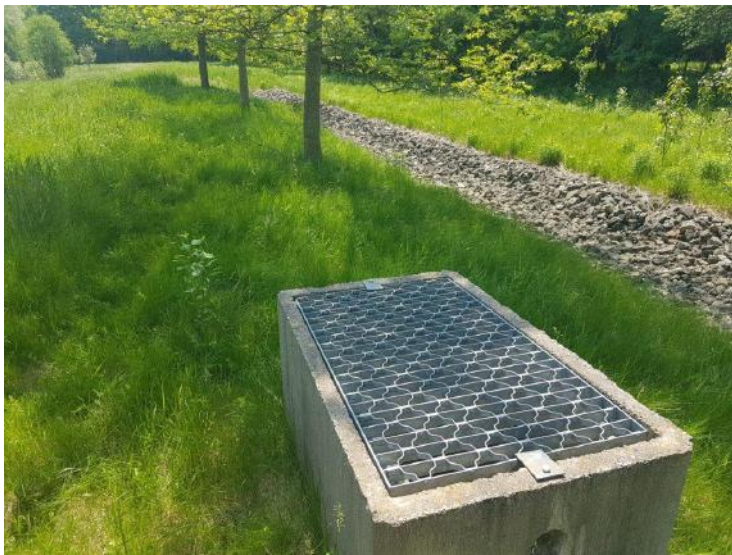
F. Overflow inlet grate structure with rip-rap

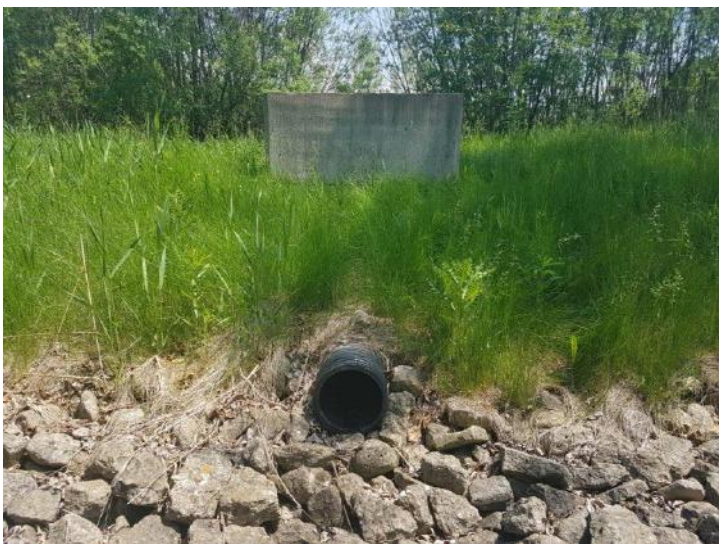
G. Downstream end of pipe with rip-rap (East)

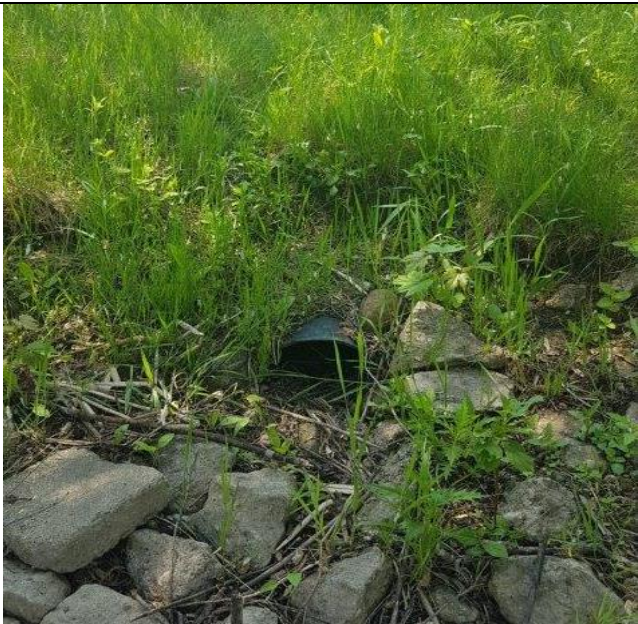
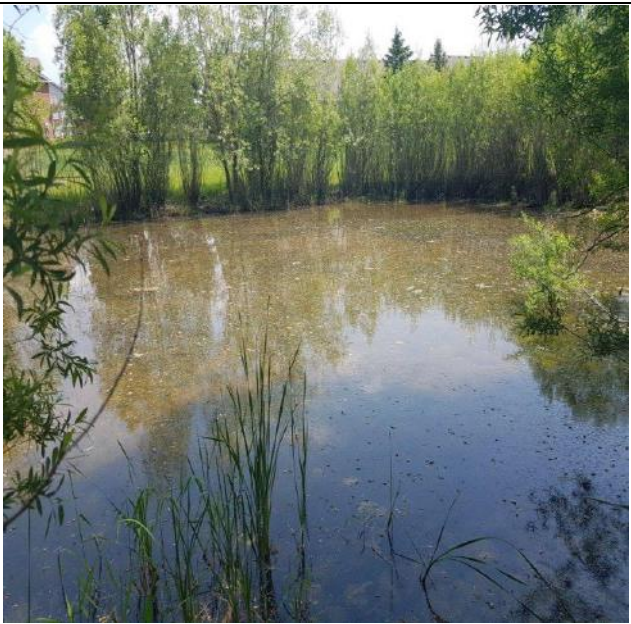
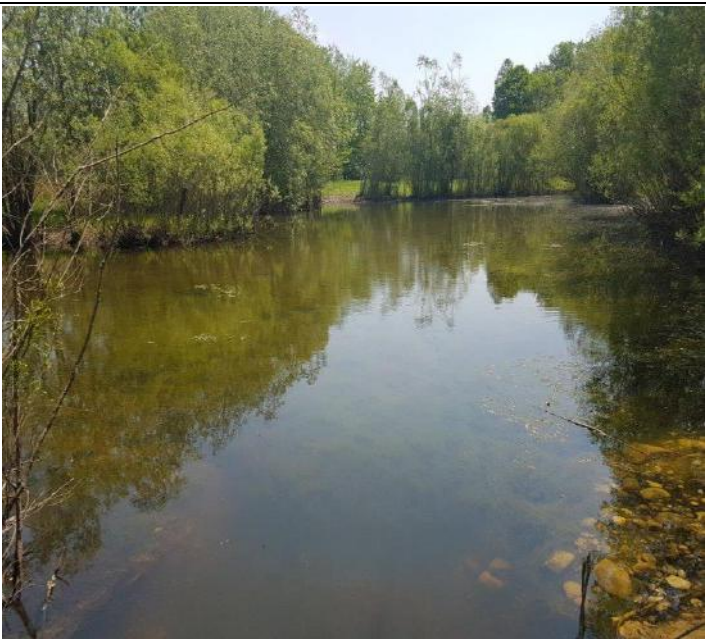
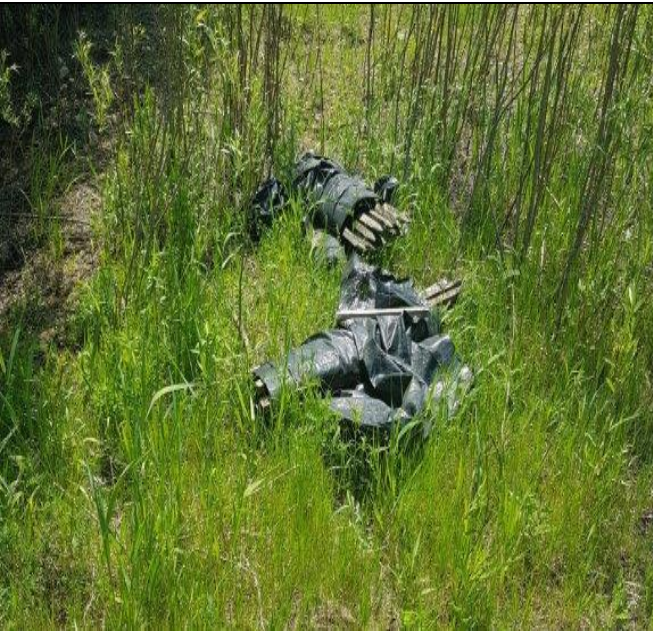
H. Outlet pipe at outlet pool buried up to 70%	I. Outlet pond cell (West) with algae and oily surface sheen	J. Inlet pond cell (East) Overview	K. Construction Debris, East Pond

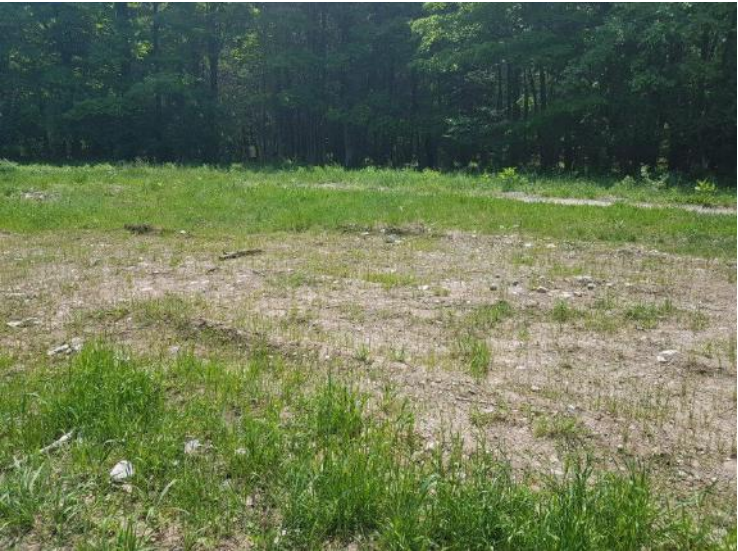
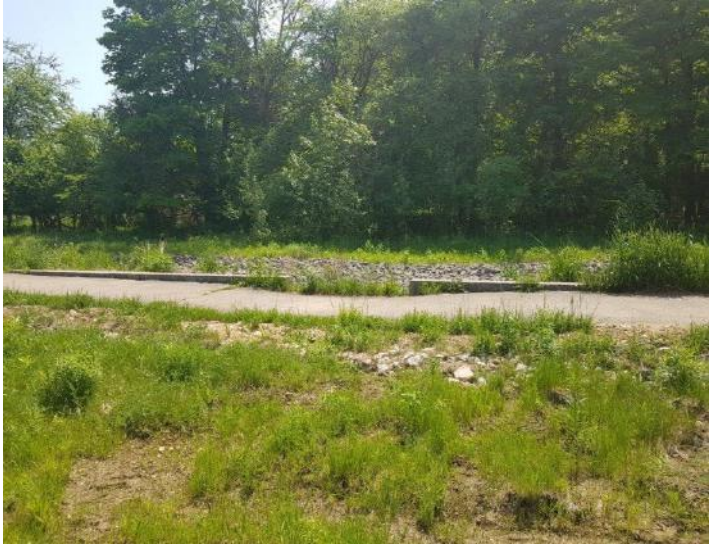
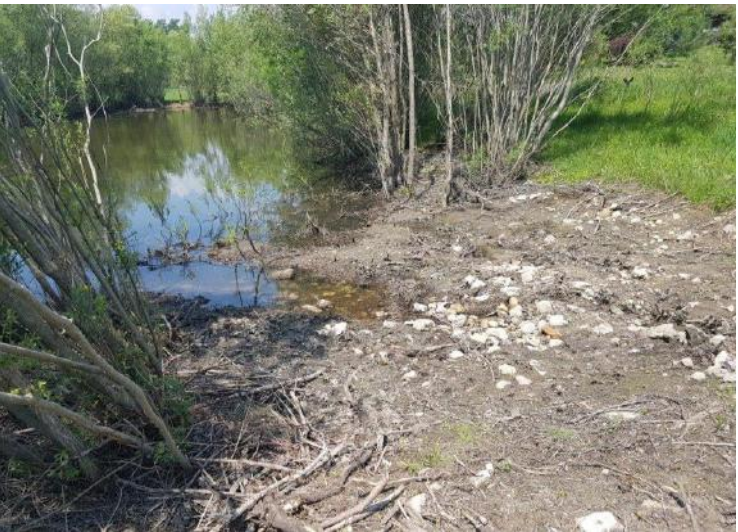
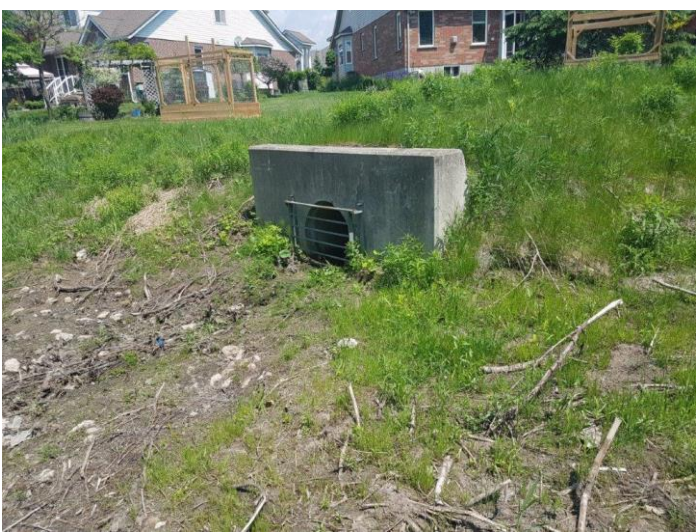
L. Poorly vegetated area	M. Emergency weir and path	N. Sediment and riprap displacement in 825mm inlet outfall	O. 825mm inlet pipe and headwall, East Pond

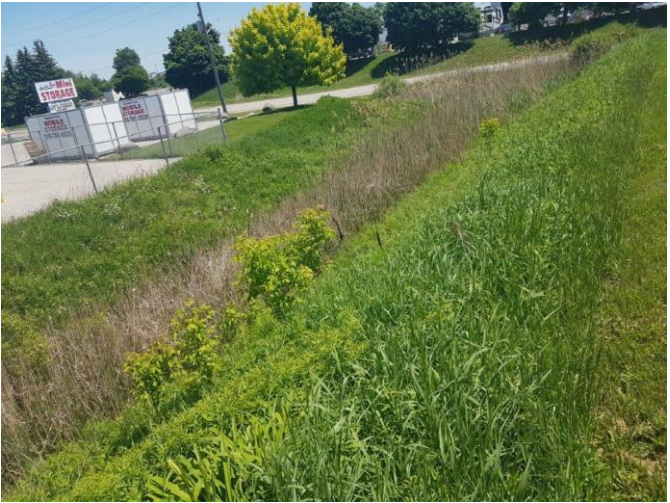
Inspection Summary Table		
Immediate	Moderate	Low
<ul style="list-style-type: none"> <li>300mm CMP inlet pipe in South-East corner of facility is 50% buried restricting design flow (Photo E.)</li> </ul>	<ul style="list-style-type: none"> <li>Riprap channel from PVC inlet pipe accumulating trash and tree deadfall, restricting inlet flow to pond (Photo C.)</li> <li>Standing water showing partial algae growth and sediment accumulation</li> <li>Ditch inlet structure has vegetative overgrowth covering an estimated 20% of grate, in addition to displaced riprap around base of structure (Photo H.)</li> </ul>	<ul style="list-style-type: none"> <li>Trash in upstream swale</li> <li>Dense vegetation in drainage inlet channel that may cause flow restrictions in high flow events (Photo A.)</li> <li>No stormwater facility signage</li> </ul>

A. Channel inlet from Kirkby Court with dense vegetation

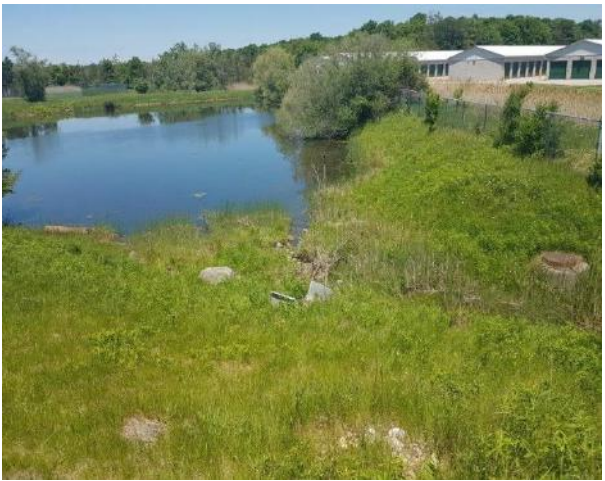
B. Main pond cell

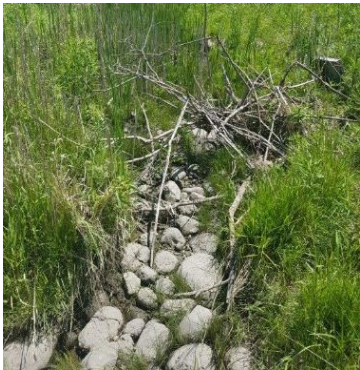
**Description:** Wet pond facility in fair condition. In the Southeast end of the facility is a 200mm inlet pipe that leads to a riprap channel. This channel is becoming blocked by garbage and deadfall which could potentially restrict water flow. The channel directs runoff from the Kirkby Court area into the pond. The pond was also built with an additional 300mm CMP inlet in the South-East corner which is 50% buried in vegetation and sediment. A ditch inlet catchbasin is located in the West end of the pond, functioning as the outlet device. This outlet structure has an estimated 25% coverage from overgrown vegetation.

C. Riprap channel from inlet filled with dead fall and trash debris

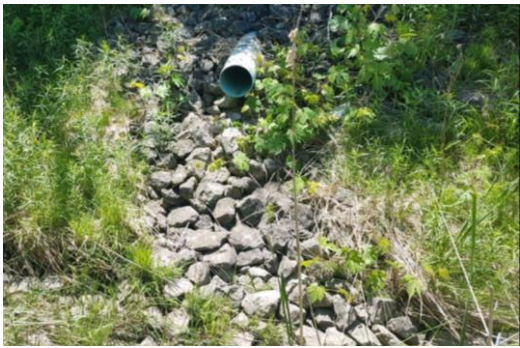
D. 200mm Inlet pipe off channel

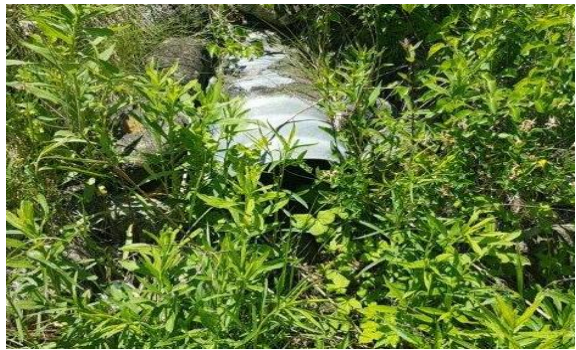
E. CMP 50% buried in vegetation and debris

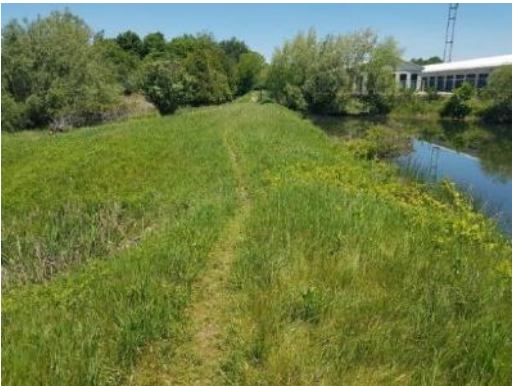
F. Outlet bank/ Overflow weir

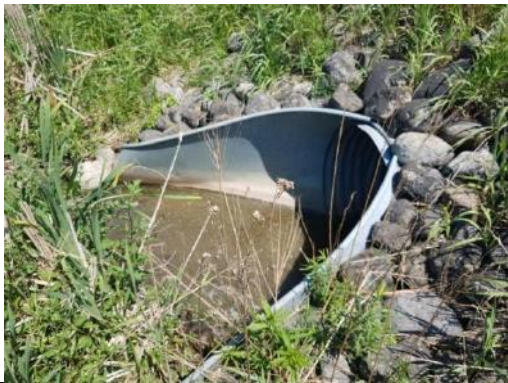
G. Outlet pipe with vegetation immediately downstream

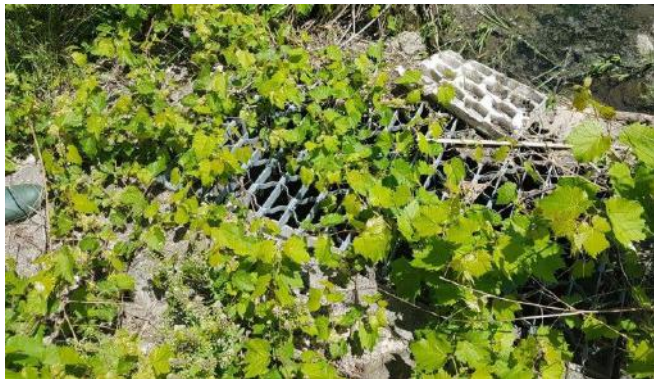
H. Outlet grate structure covered in vegetation

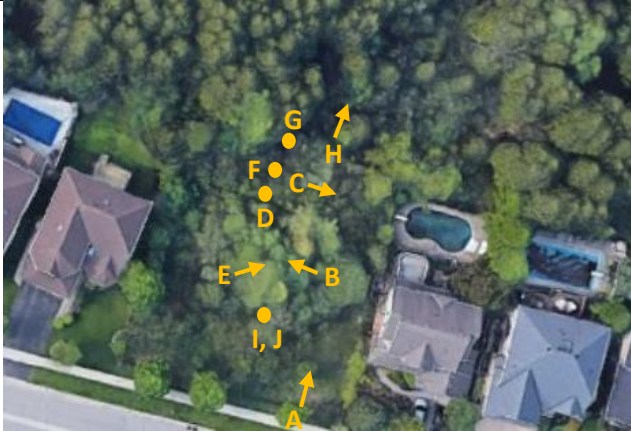
<div>A. Entry Gate with dense vegetation present on inside of opening</div>

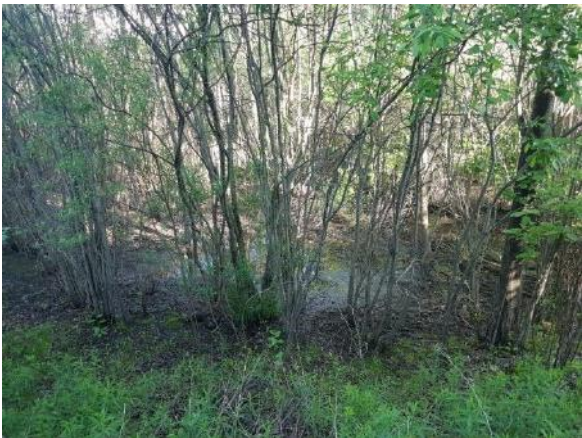
<div>B. Dry pond with dense willow tree stand and ponded water in centre of basin</div>

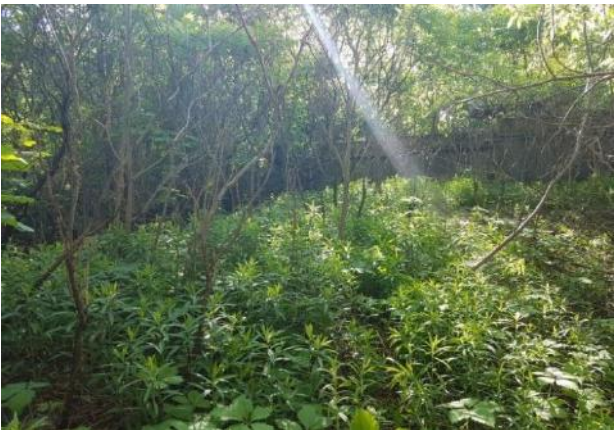
<div>C. Earth Berm that acts as overflow weir on North side of pond</div>

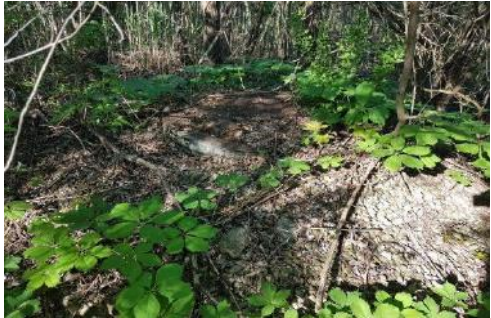
Inspection Summary Table		
Immediate	Moderate	Low
<ul style="list-style-type: none"> <li>Sediment buildup around perforated riser outlet pipe and in basin limiting drainage ability of structure (Photo D.)</li> <li>Sediment approximately 0.5m deep in basin with reference to design drawings</li> </ul>	<ul style="list-style-type: none"> <li>Exposed geo-grid on spillway/rear berm (Photo F.)</li> <li>Ponded water in basin (Photo B, E.)</li> </ul>	<ul style="list-style-type: none"> <li>Fence gate is partially damaged (Photo A.)</li> <li>No stormwater management facility signage (just no trespassing)</li> <li>Dense vegetation in area preventing access (Photo A.)</li> <li>Loose/displaced rip-rap around inlet outfall</li> <li>Minor sediment accumulation in outlet pipe (Photo G.)</li> </ul>

<div>D. Perforated riser outlet structure</div>

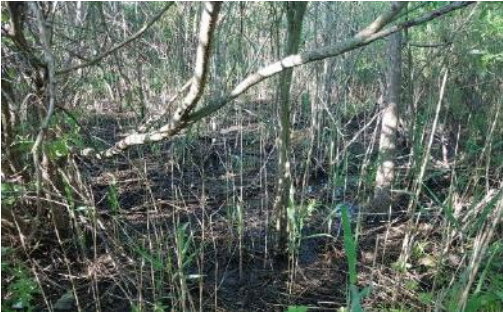
<div>E. Dry Pond basin with dense vegetation growth</div>

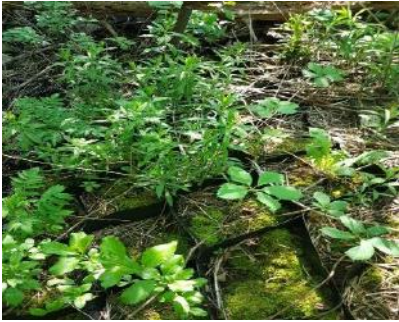
<div>F. Exposed geo-grid on overflow weir</div>

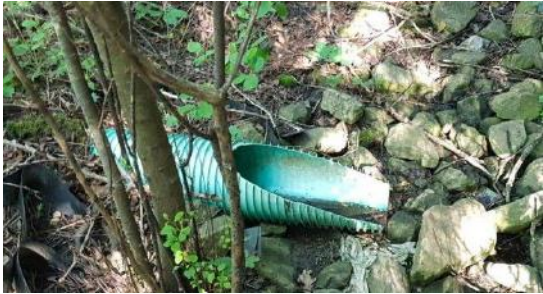
<div>G. Outlet pipe with trace sediment in bottom</div>

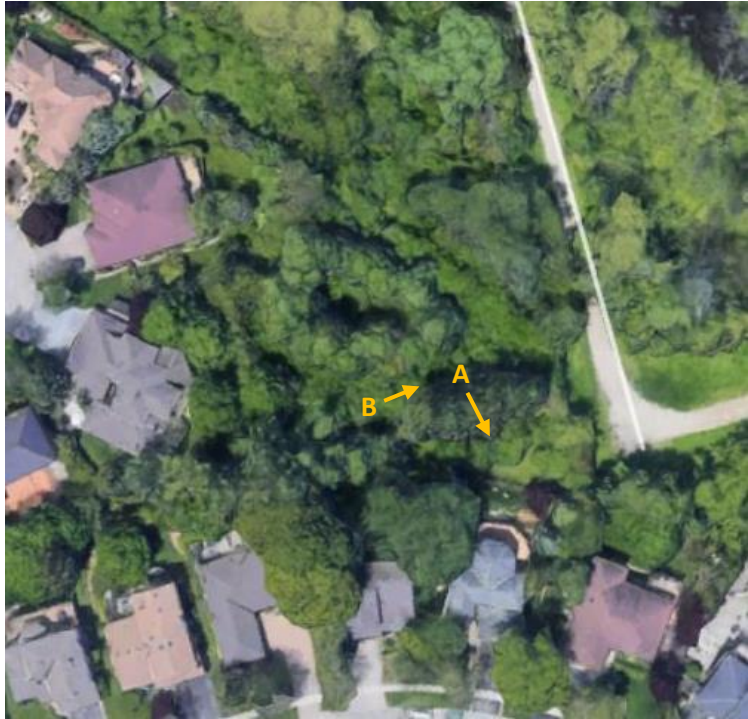
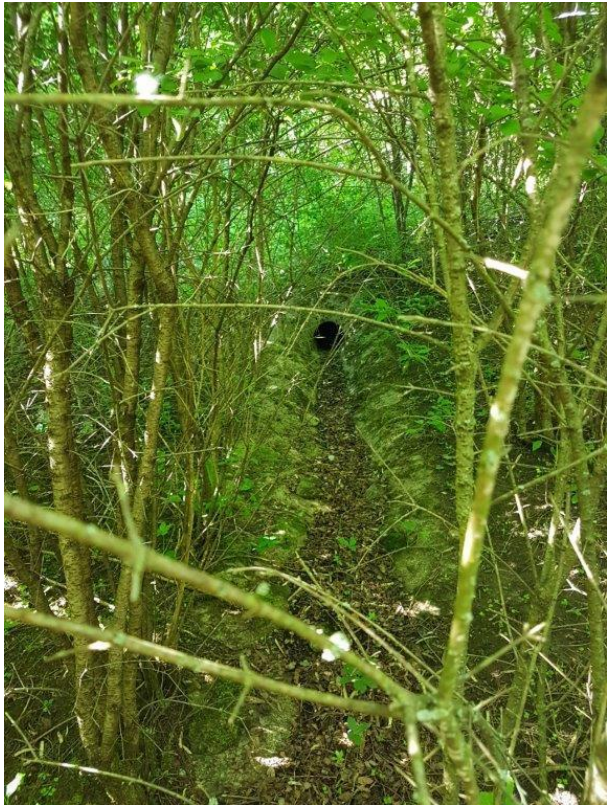
A. Riprap channel and inlet pipe with vegetation and debris in outfall

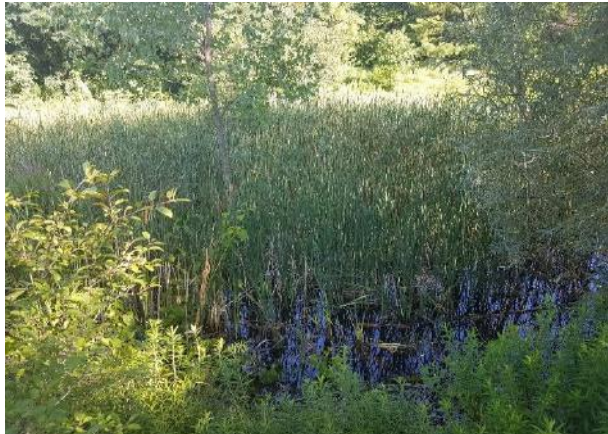
Inspection Summary Table		
Immediate	Moderate	Low
<ul style="list-style-type: none"> <li>150mm-300mm of standing water in pond basin (Photo C.)</li> </ul>	<ul style="list-style-type: none"> <li>Flow restriction in outlet channel caused by vegetation, displaced riprap and debris accumulation (Photo B.)</li> </ul>	<ul style="list-style-type: none"> <li>Rusted gate near pond entrance</li> <li>Mosquitos prevalent</li> <li>Buckthorn present</li> <li>No stormwater facility signage present</li> <li>Inlet pipe has slight cracking along pipe mouth and is showing early signs of erosion (Photo D.)</li> </ul>

<p>C. Pond main cell with standing water and dense cattail cover.</p>

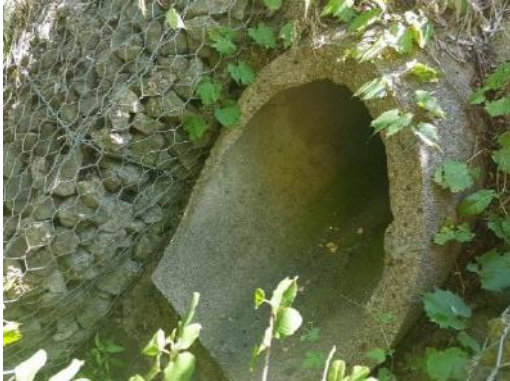
<p>D. Concrete inlet pipe and caged rock wall perimeter.</p>

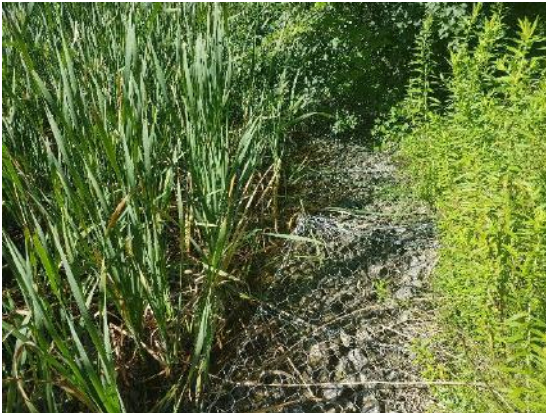
<p>F. Caged rock wall perimeter. Note standing water near top elevation of wall.</p>

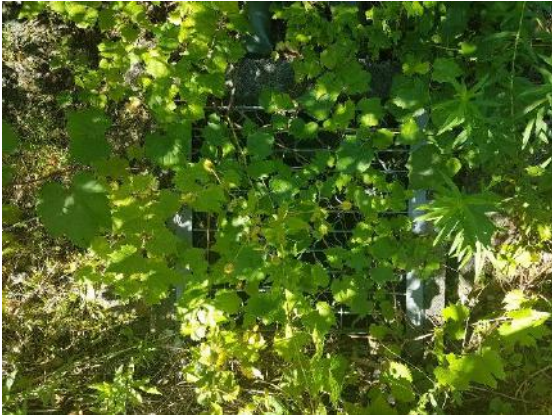
<p>H. Outlet ditch inlet structure with vine growth causing 10% blockage restricting flow.</p>

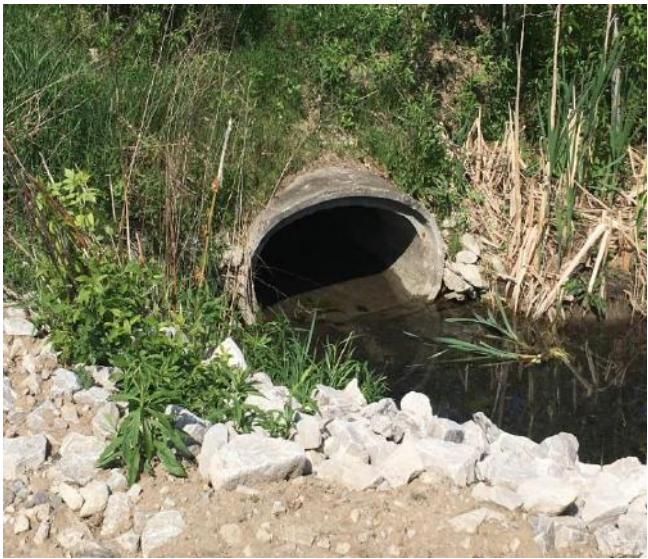
A. Inlet to forebay pond approximately 15% submerged

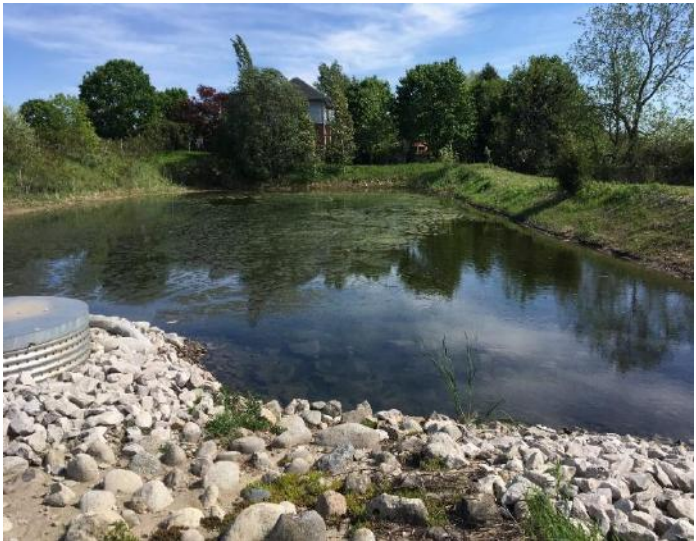
B. Forebay with algae growth and high standing water level

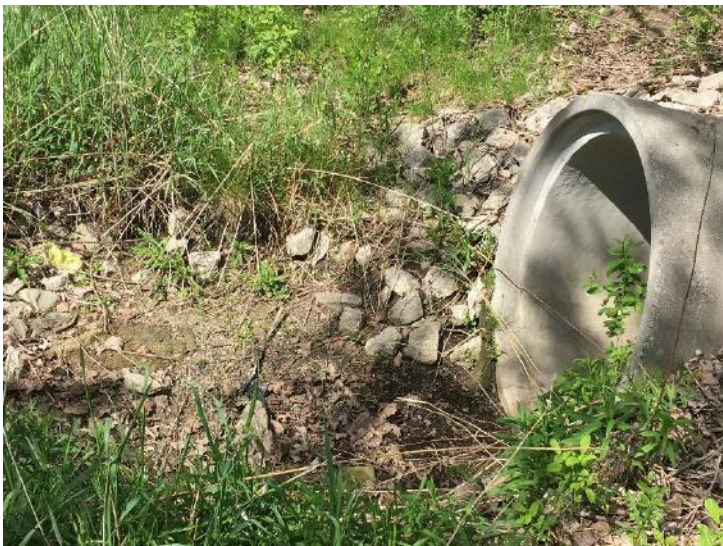
Inspection Summary Table		
Immediate	Moderate	Low
<ul style="list-style-type: none"> <li>675mm dry basin outlet pipe’s downstream end not located (likely buried in rip-rap of weir and restricting flow)</li> </ul>	<ul style="list-style-type: none"> <li>Overflow weir in North West corner of main cell has sediment deposition, and vegetation that is restricting flow (Photo J.)</li> <li>Excess standing water in forebay has algae growth along pond surface (Photo B.)</li> <li>North corner of dry pond basin’s PVC STM inlet pipe is estimated to be 15% blocked (Photo K.)</li> </ul>	<ul style="list-style-type: none"> <li>Perimeter embankment of ponds are eroding, gathering sediment, and steeply sloping requiring aquatic benching at waterline (Photo H.)</li> <li>Phragmites prevalent (Photo L.)</li> <li>Access gate damaged</li> <li>No stormwater facility signage present</li> <li>1050mm concrete inlet pipe to main pond showing early signs of sediment accumulation at pipe mouth in rip-rap (Photo E.)</li> </ul>

E. Early sediment accumulating at mouth of 1050mm pipe inlet

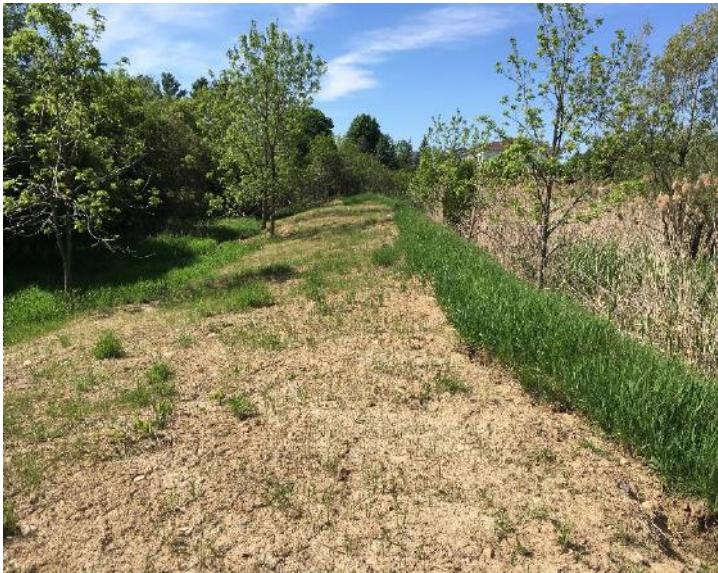
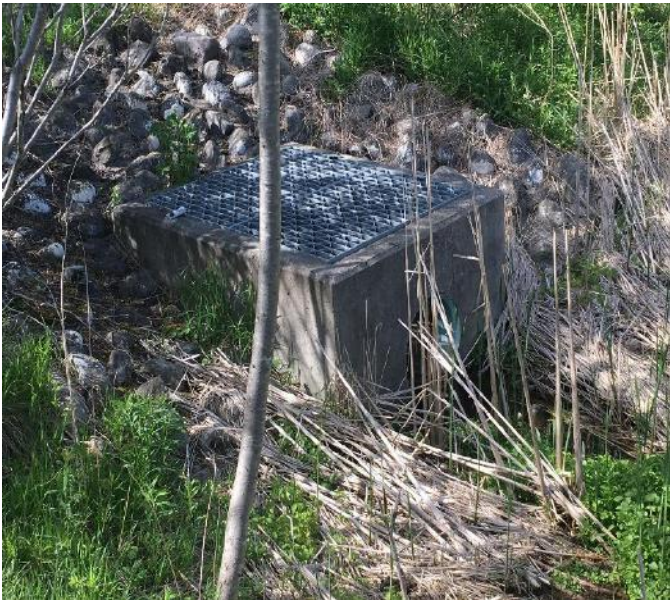
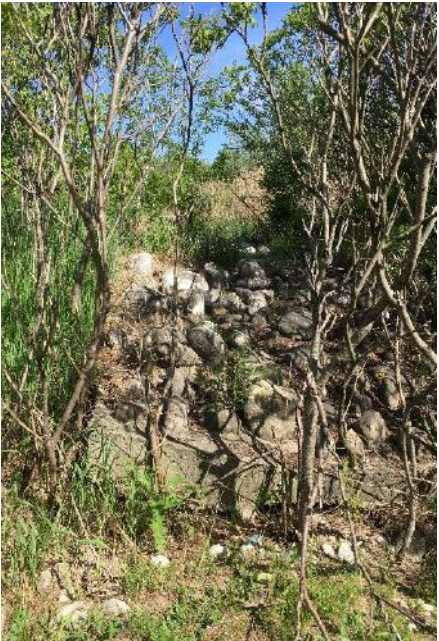
<div>H. Embankment to the West, facing North showing bare spots in vegetation cover</div>	<div>I. Dry pond outlet structure in good condition</div>	<div>J. Dry pond outlet structure and buried 675mm pipe outlet</div>	<div>K.15% buried PVC pipe in North corner</div>

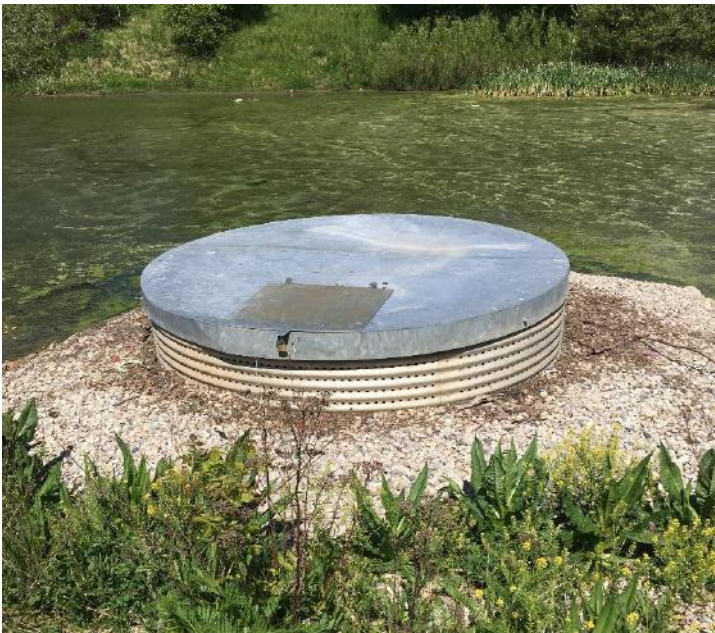
B. Hickenbottom riser with early signs of sediment accumulation

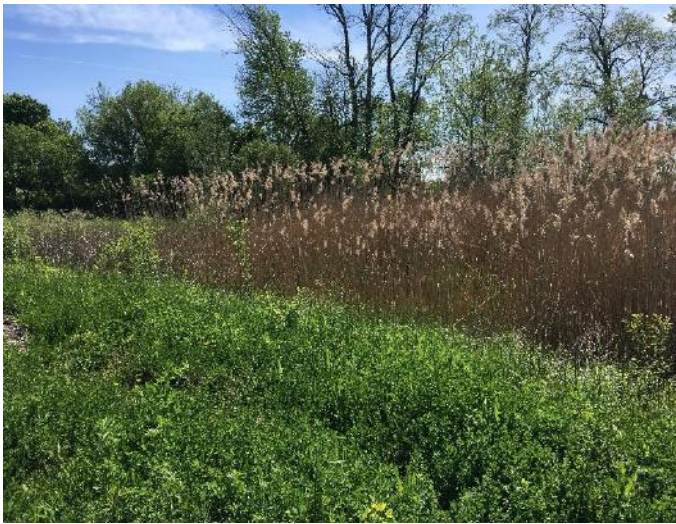
D. Phragmites in dry pond

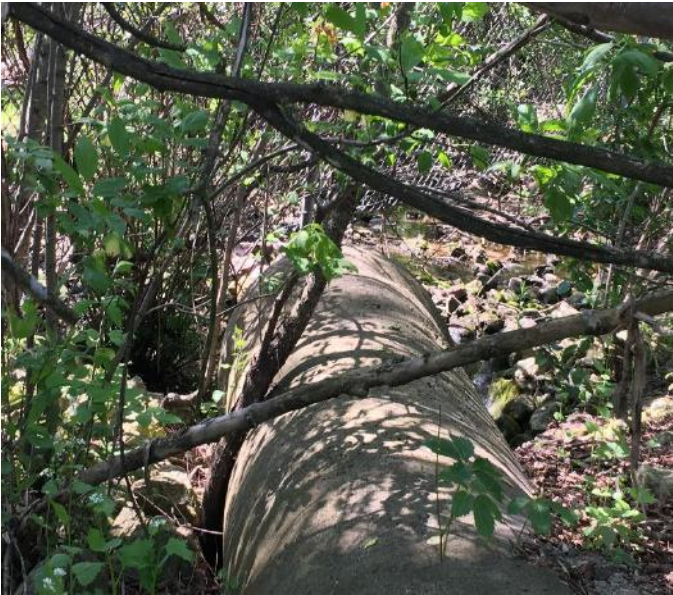
<p>I. Dry pond outlet pipe</p>

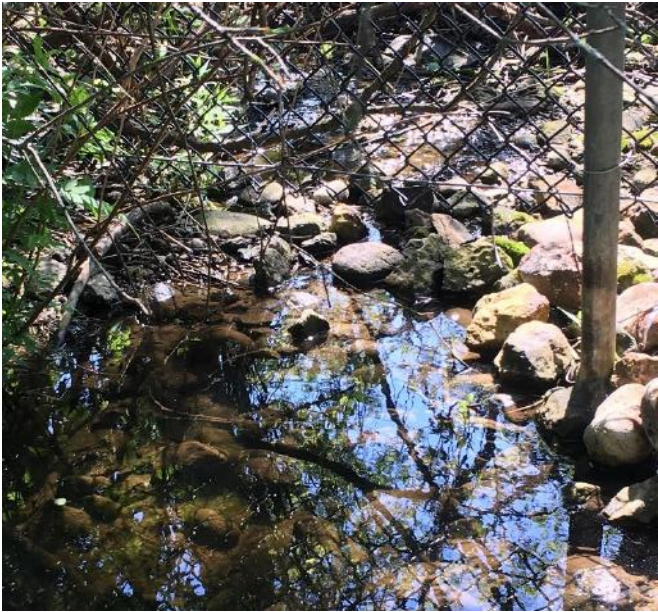
<p>J. Outfall channel from dry pond</p>

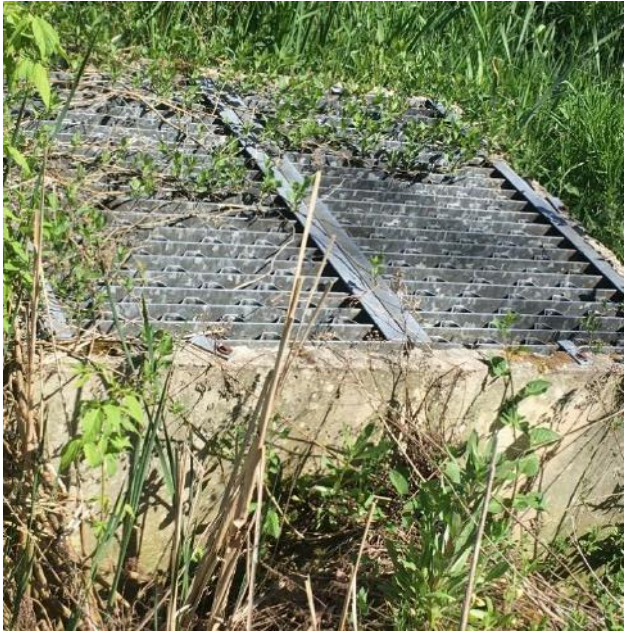
<p>K. Grated outlet structure showing partial clogging</p>

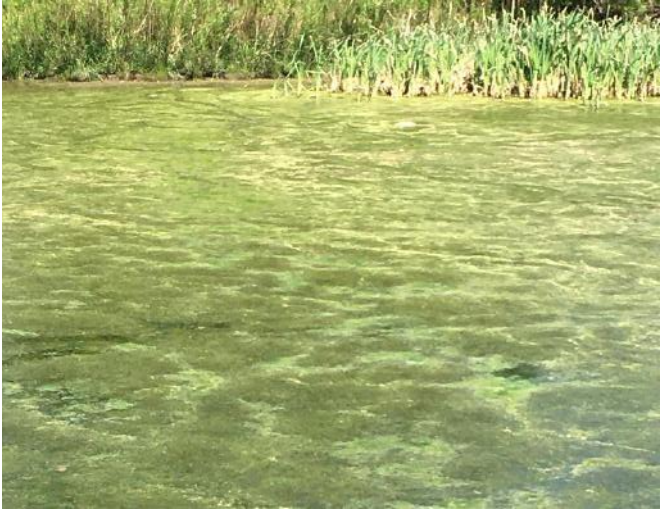
Inspection Summary Table		
Immediate	Moderate	Low
<ul style="list-style-type: none"> <li>Forebay pond with high levels of standing permanent water. Water visibly polluted with thick algae growth on surface, a strong sign of eutrophication (Photo L.)</li> </ul>	<ul style="list-style-type: none"> <li>Grated outlet structure is not easily accessed, has some sediment accumulation, and is partially clogged on its side orifice (est. 15% - Photo K.)</li> <li>Overflow weirs in both forebay and main cell ponds are showing damage including displaced riprap, accumulation of sediments, and partial erosion (Photos G, H)</li> </ul>	<ul style="list-style-type: none"> <li>Phragmites present (Photo D.)</li> <li>Garbage present</li> <li>Poor vegetative growth around forebay</li> <li>Inflow pipes featuring slight sediment deposition</li> </ul>

<p>L. Dense algae and vegetation in forebay cell</p>

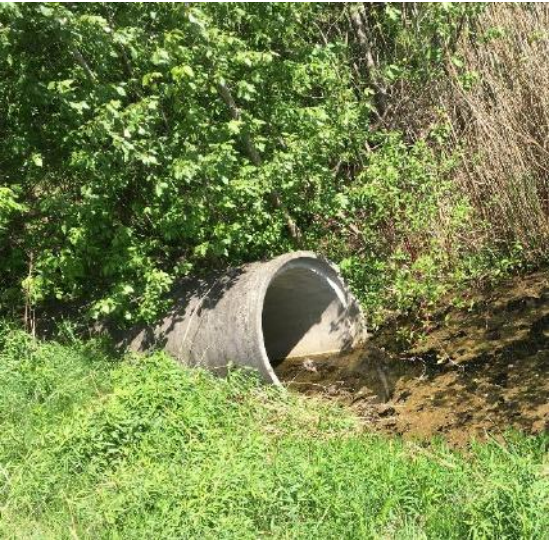
<p>M. Dry pond inlet concrete pipe with small plunge pool</p>
