**City of Guelph**

## **Stormwater Management Master Plan**

## Appendix H: Stormwater Management Facility Maintenance Inspection Summary

Prepared by:  
**Aquafor Beech Ltd.**

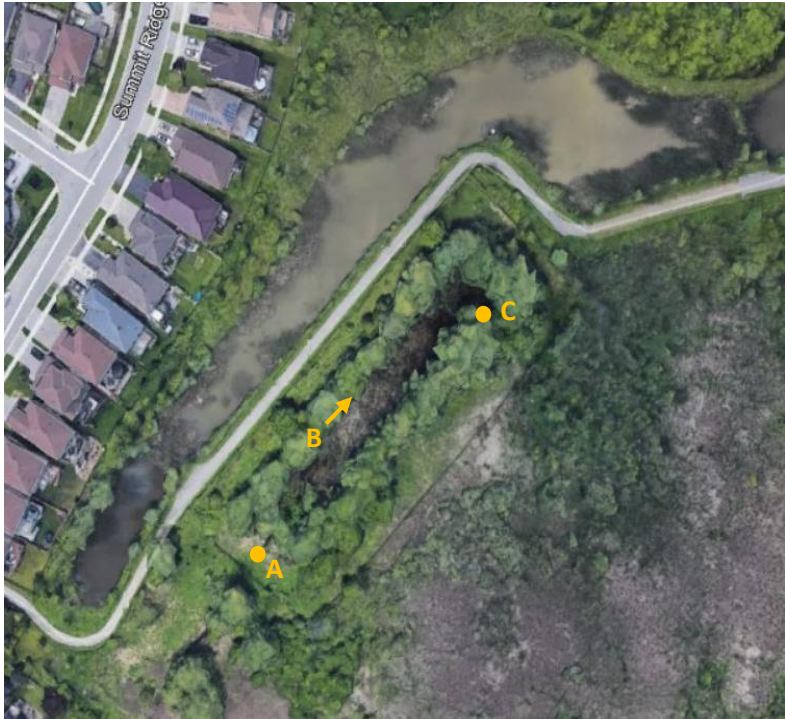
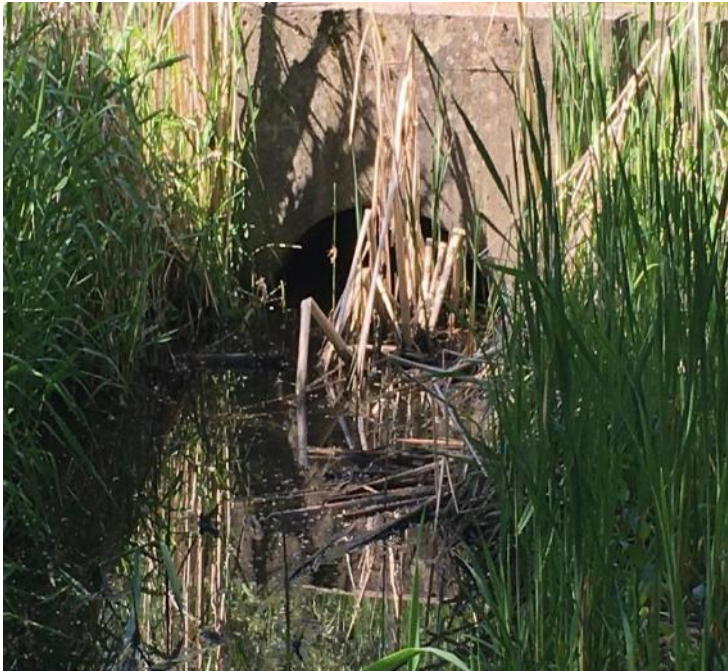
Inspection Summary Table		
Immediate	Moderate	Low
<ul style="list-style-type: none"> <li>Inlet pipe 30% submerged/clogged by sediment and vegetative growth (Photo A.)</li> </ul>	<ul style="list-style-type: none"> <li>vegetative overgrowth causing flow restriction and displaced clear stone around base of structure. (Photo C)</li> <li>Dense vegetation at overflow weir and 200mm outlet pipe discharge point made them inaccessible for assessment, but likely have some degree of flow restriction</li> </ul>	<ul style="list-style-type: none"> <li>No direct access to inlet or outlet</li> <li>Channel partially blocked due to dense vegetative overgrowth in channel</li> <li>No stormwater facility signage present</li> <li>Riser structure is showing signs of rust</li> </ul>

A. Inlet pipe 30% submerged

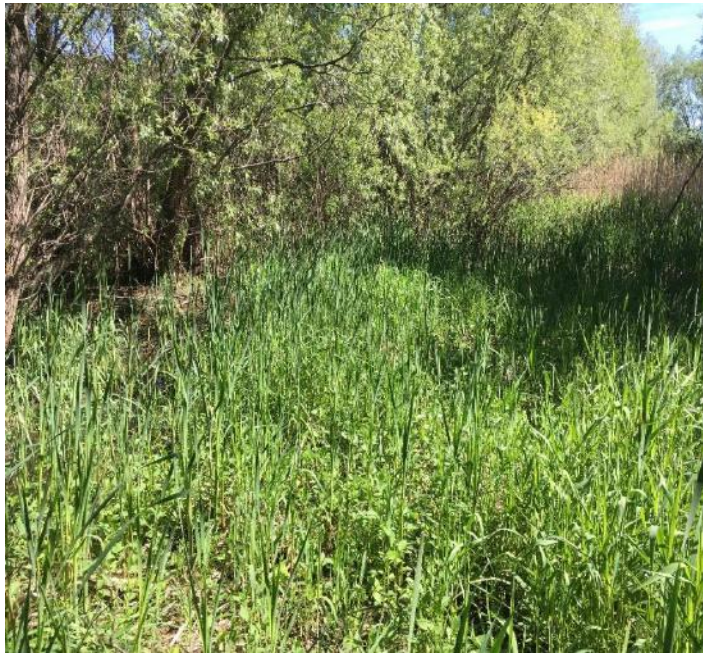
B. Main cell overview showing vegetative growth and willow trees on bank

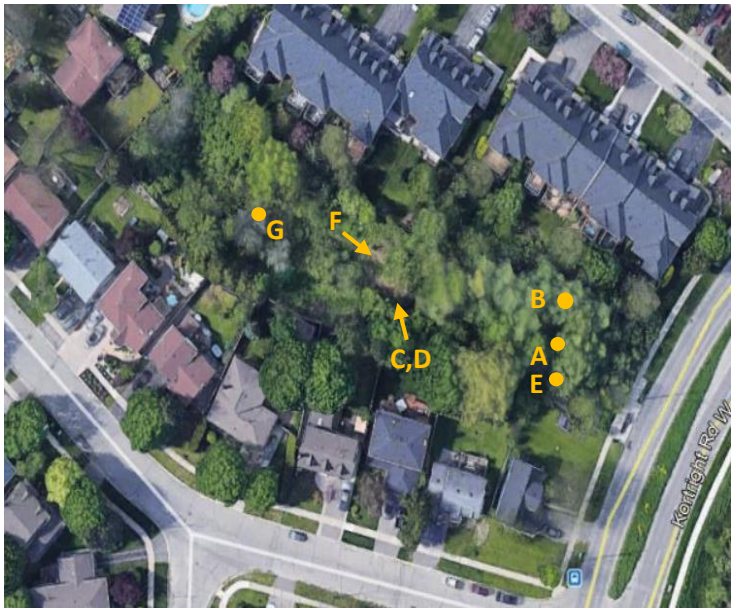
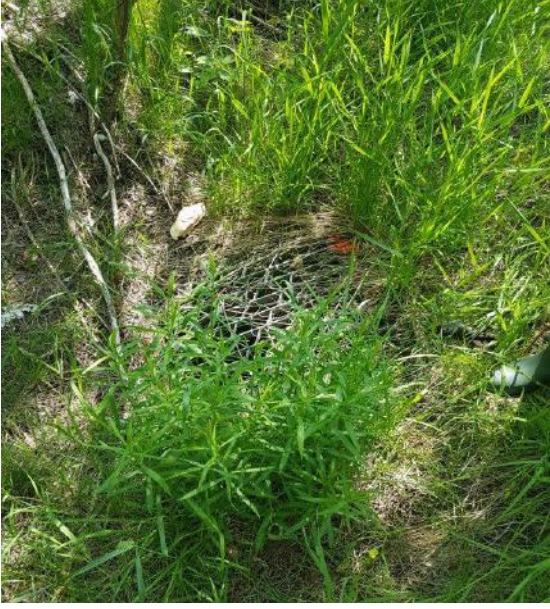
Inspection Summary Table		
Immediate	Moderate	Low
<ul style="list-style-type: none"> <li>Significant sediment accumulation in basin and near perforated riser outlet likely limits outflow capacity of structure (Photo B.)</li> <li>Ditch inlet grate is 30% blocked by vegetation and organic matter (Photo A.)</li> </ul>	<ul style="list-style-type: none"> <li>Separation berm has vegetative overgrowth (Photo G.)</li> <li>Dry basin requires maintenance for sediment, vegetative overgrowth, and standing water (Photo D.)</li> <li>Small garbage upstream in STM sewer and at inlet</li> <li>Dry pond basin has about 300mm of standing water (Photo D.)</li> <li>Inflow pipe filled with an estimated 20% from sediment and organic matter (Photo E.)</li> </ul>	<ul style="list-style-type: none"> <li>Mosquitos prevalent</li> <li>Easy public access from Kortright Rd</li> <li>Dense small trees and shrubs prevalent preventing vehicle access</li> <li>No stormwater facility signage present</li> </ul>

A. Ditch inlet blocked by vegetation and debris

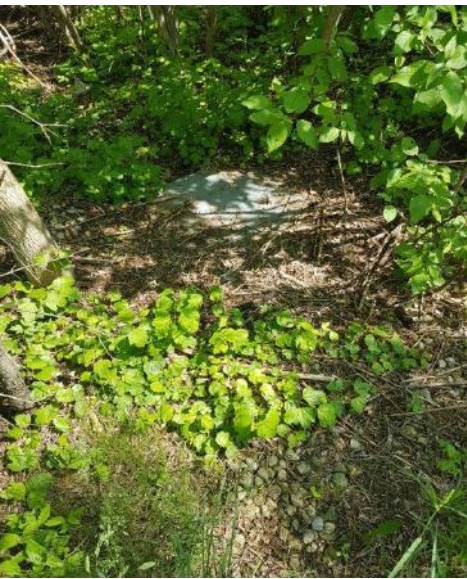
B. Perforated riser outlet with sediment accumulation covering clear stone jacket.

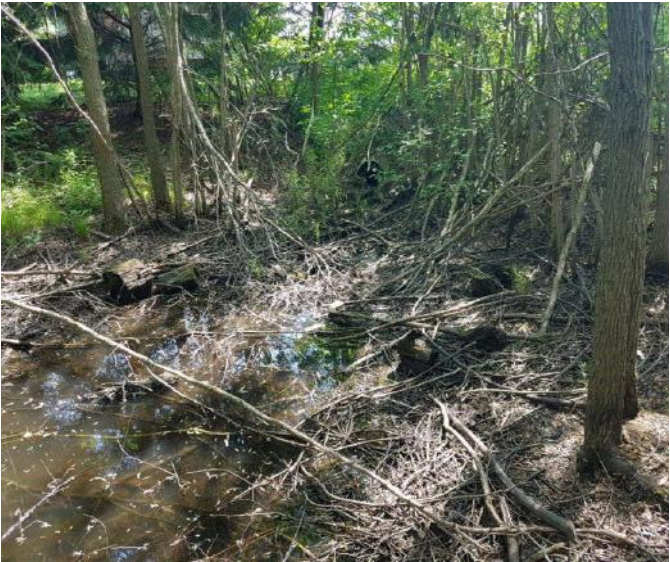
C. Dry Pond basin with standing water

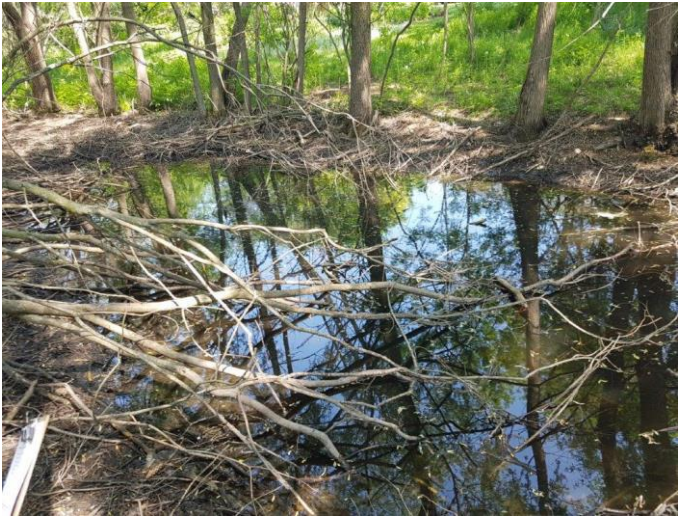
D. Dry pond basin with less than 300mm of standing water and accumulated sediment preventing water from leaving via riser outlet structure

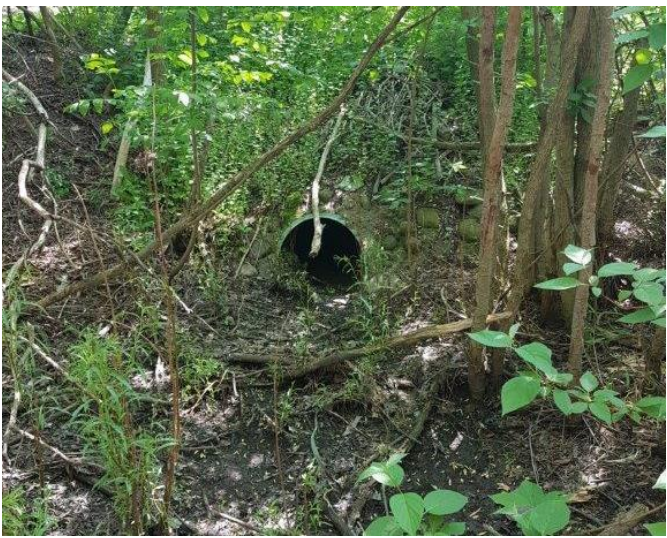
E. Inlet pipe an estimated 15% clogged

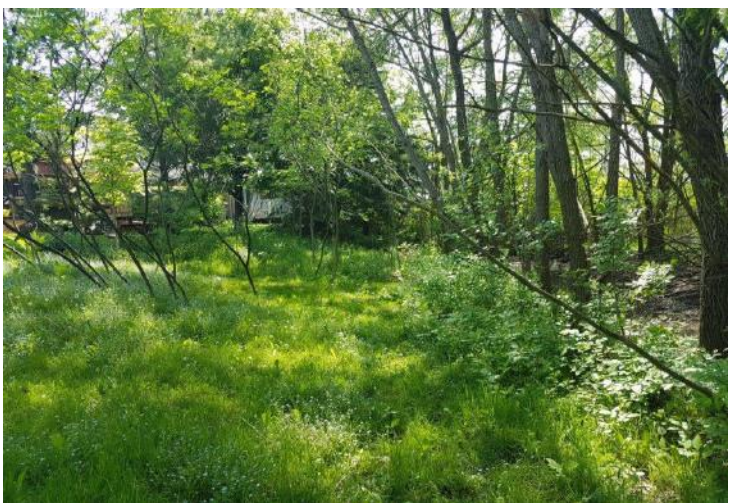
F. Space between facility and homes with no perimeter fence

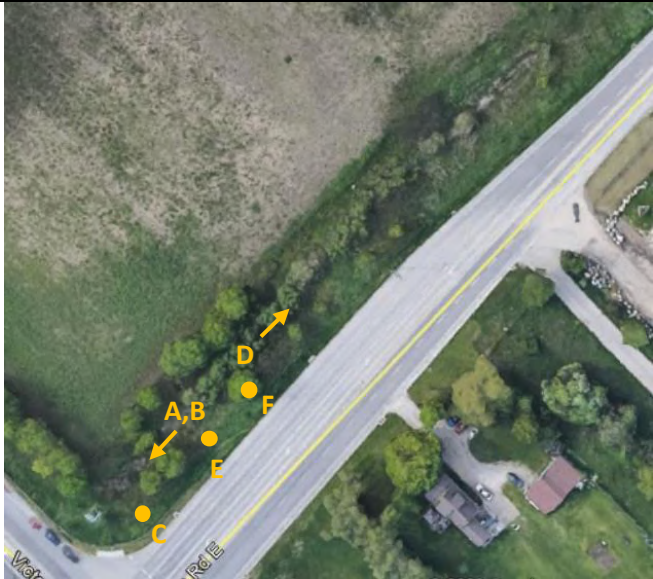
A. Infiltration facility looking towards Victoria Road

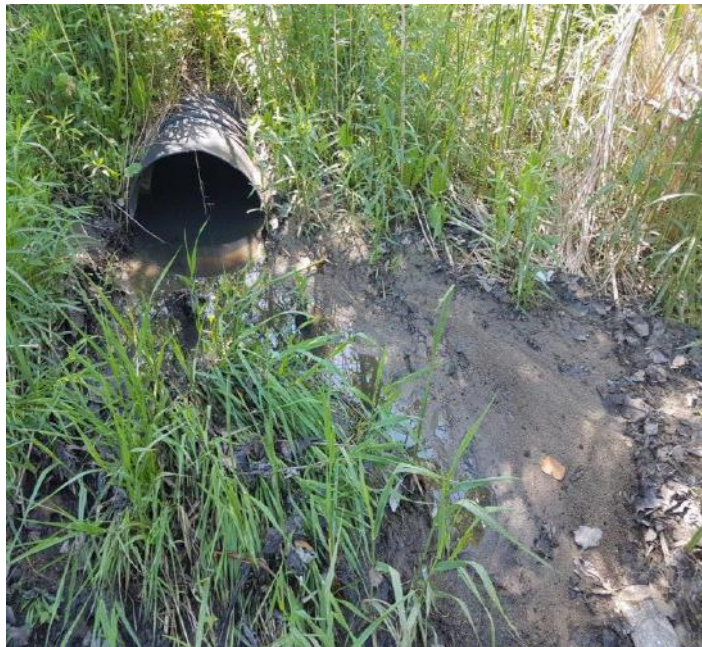
C. 450mm CSP Inlet 20% submerged and sediment deposition near mouth

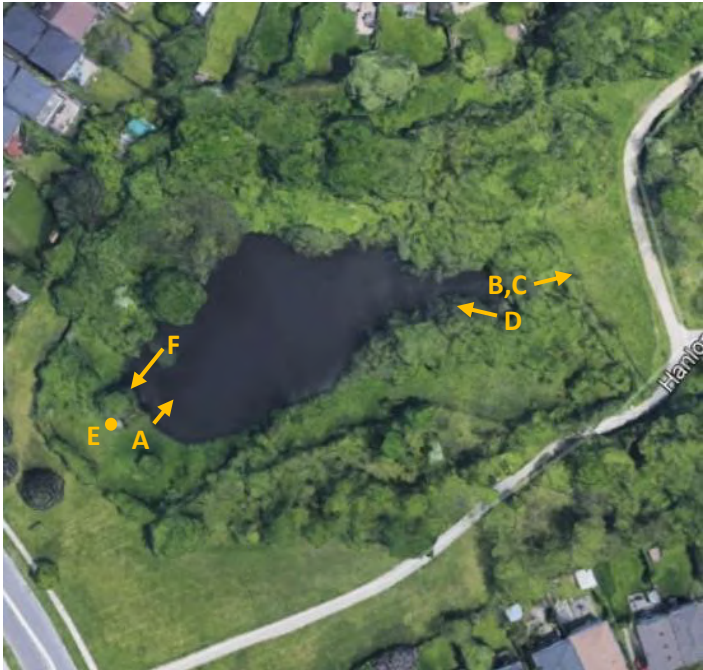
Inspection Summary Table		
Immediate	Moderate	Low
<ul style="list-style-type: none"> <li>•</li> </ul>	<ul style="list-style-type: none"> <li>• Steep embankment at permanent water level and noticeable erosion at points along perimeter (Photos F. and G.)</li> <li>• Trash and deadfall are potential blockage hazards for outlet pipes due to trash grates on downstream ends (Photo B.)</li> </ul>	<ul style="list-style-type: none"> <li>• Steep berm slopes</li> <li>• Catchbasins in upstream neighbourhood are covered with grass</li> <li>• Buckthorn present</li> <li>• Resident ladder access into pond area on east side of facility fence</li> <li>• Sediment peninsula near inlet pipe, potential for limiting flow into main cell (Photo A.)</li> </ul>

A. Main cell with sediment peninsula to the left of photo.

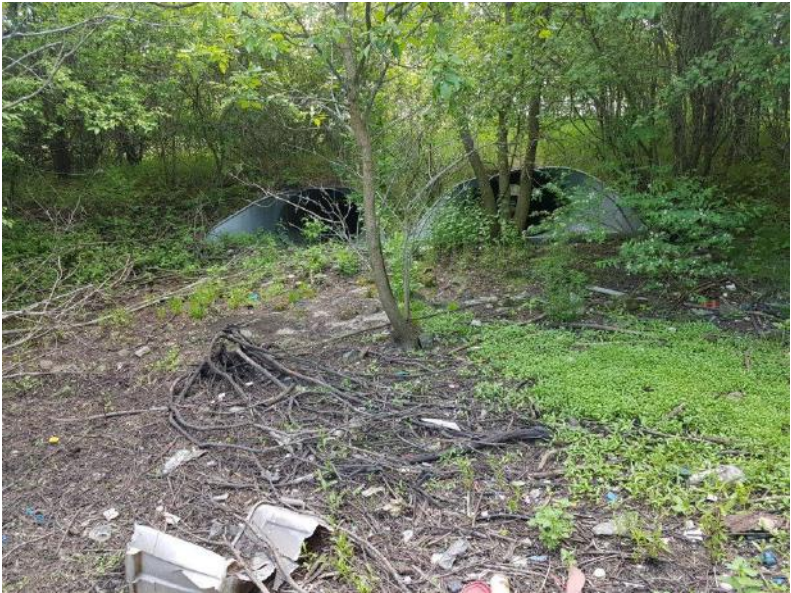
B. Outlet structures with garbage and trees growing in front of pipes

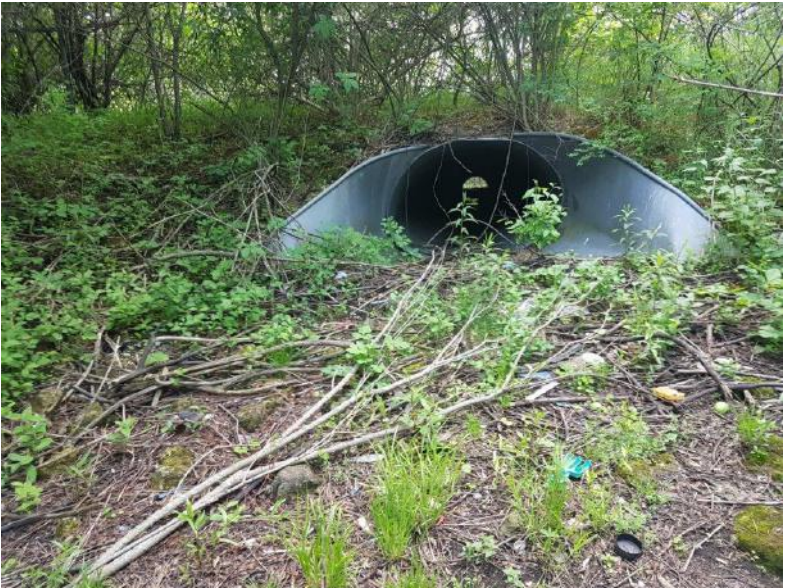
C. Close up of north outlet pipe (no grate on upstream end)

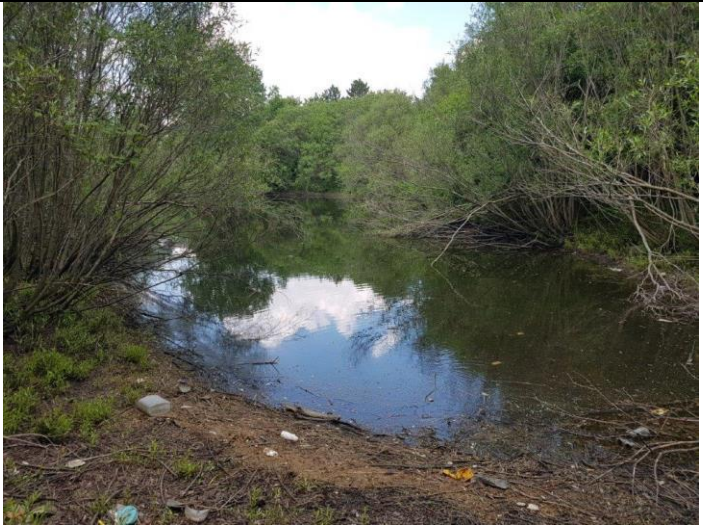
D. Wet pond looking across from outlet end

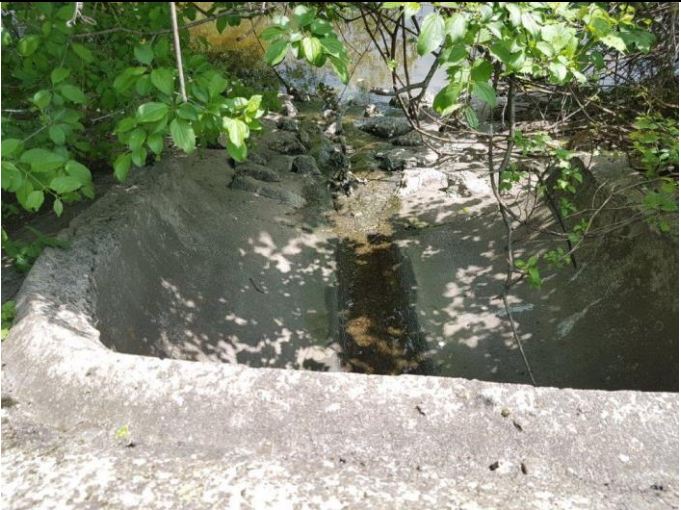
E. Inlet pipe looking at channel into wet pond

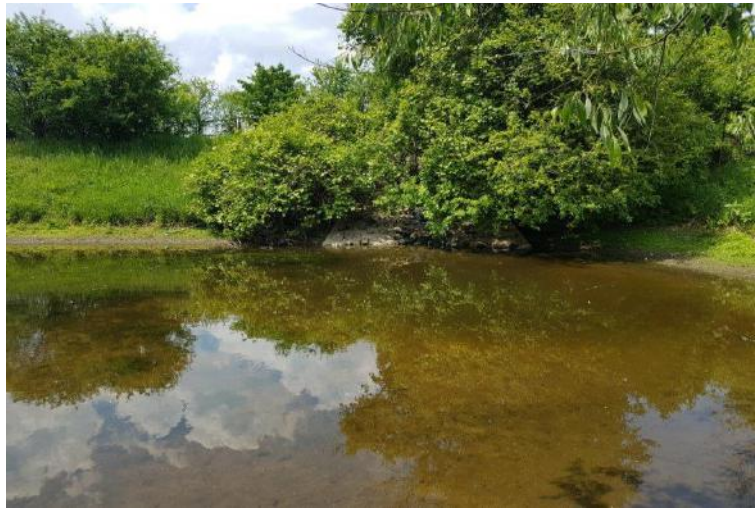
H. Channel from inlet (on peninsula)

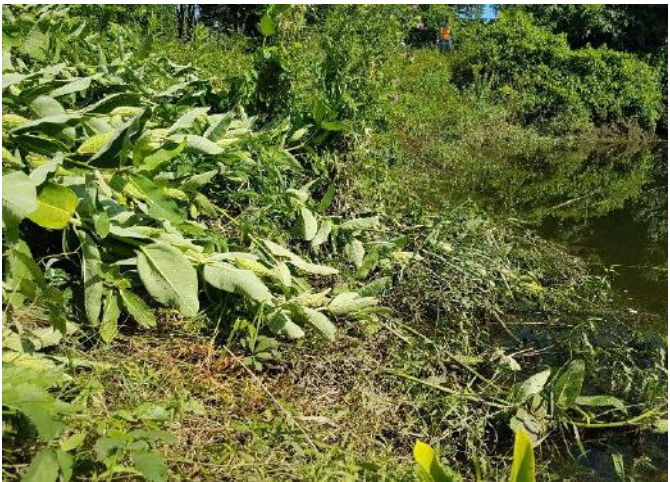
G. Steep pond bank at water line and erosion (hidden by vegetation, see photo F for erosion evidence).

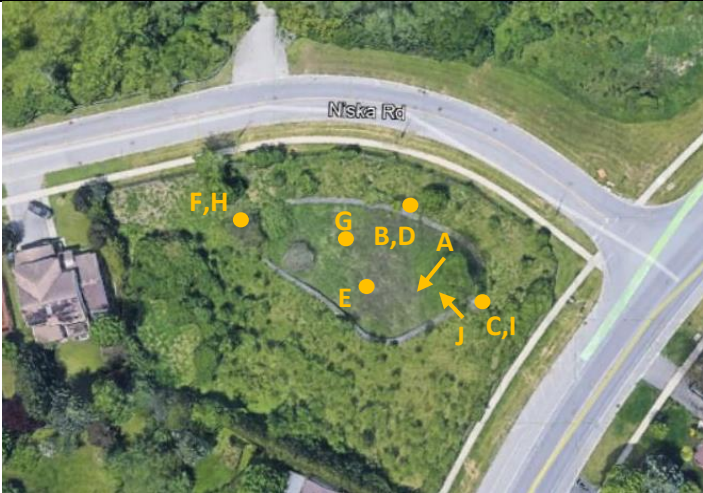
<div>A. Infiltration basin overview</div>

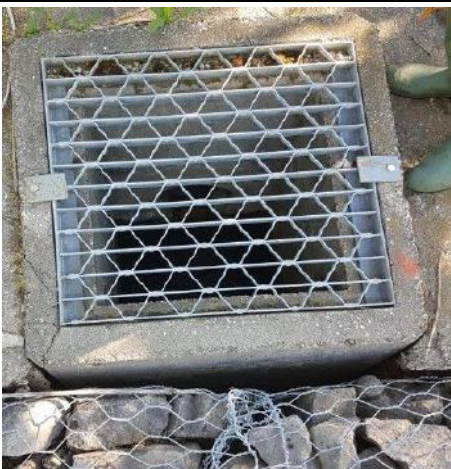
<div>B. outlet grate in good condition</div>

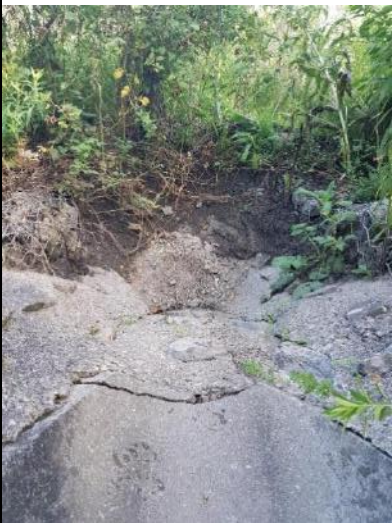
<div>C. East concrete inlet pipe plunge pool with about 10% sediment accumulation.</div>

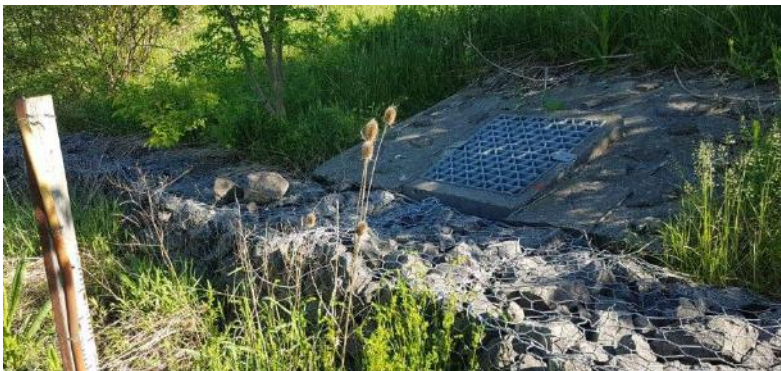
<div>D. Outlet Grate at rock berm wall</div>

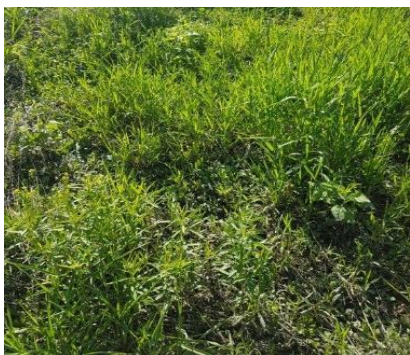
Inspection Summary Table		
Immediate	Moderate	Low
	<ul style="list-style-type: none"> <li>Western 600mm inlet pipe showing partial sediment deposition and reduced access due to vegetative growth (Photos E, F)</li> </ul>	<ul style="list-style-type: none"> <li>East inlet pipe has an estimated 10% clogging due to sediment deposition at pipe outfall (Photo L.)</li> <li>Buckthorn present</li> <li>No signage present besides trespassing sign</li> <li>Dense vegetation around inlet pipes (Photo F.)</li> <li>Under 150mm of standing water in dry basin (after several significant rain events over a three-day period) (Photo I.)</li> </ul>

<div>E. Vegetation in basin</div>

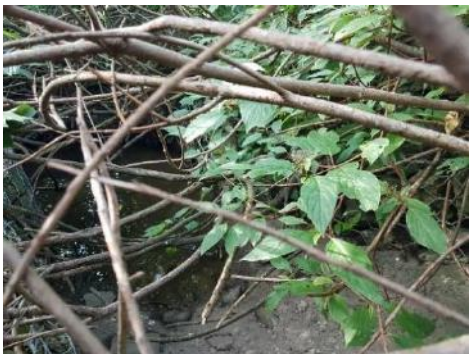
<div>F. West concrete inlet pipe, looking at plunge pool at end of inlet structure.</div>

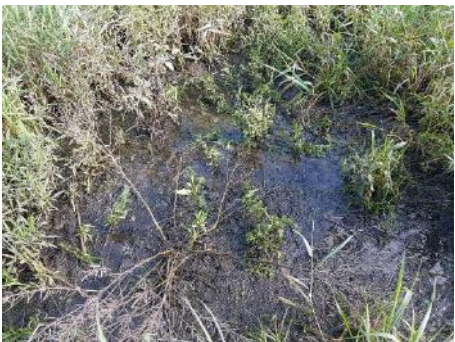
<div>G. Ponded water in the dry pond infiltration basin (photo August 6<sup>th</sup> after two significant rainfall events 3 days prior).</div>

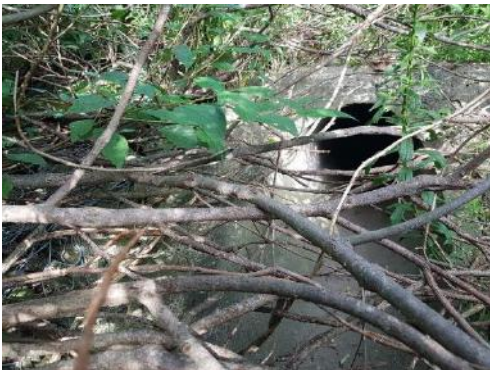
<div>H. West concrete inlet pipe, front view. Note dense brush around pipe and inlet structure limiting access.</div>

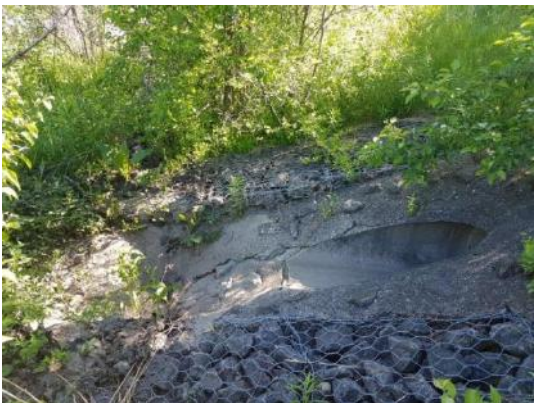
<div>I. East concrete inlet pipe and outfall</div>

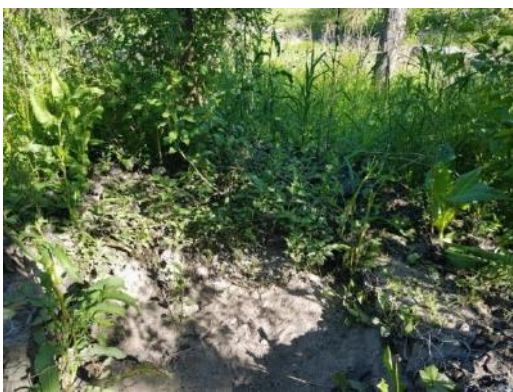
<div>J. Channel from east inlet with sediment</div>

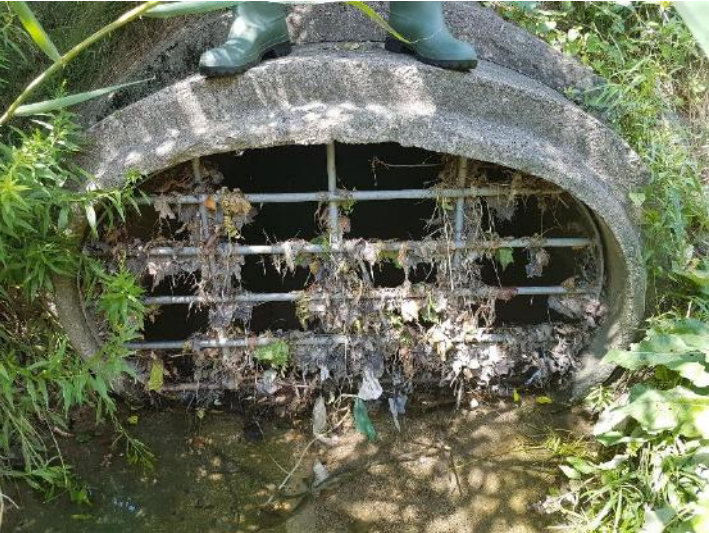
Inspection Summary Table		
Immediate	Moderate	Low
	<ul style="list-style-type: none"> <li>855 x 1345mm Inlet pipe has an estimated 10% blockage from leafy organic matter covering the pipe safety grate (See Photo A.)</li> <li>Numerous soft spots with pooled water indicating facility does not drain or infiltrate water effectively</li> <li>Extremely dense vegetation prevented assessment of outlet pipe and overflow weir (likely some obstruction of these outlet structures due to vegetation presence)</li> </ul>	<ul style="list-style-type: none"> <li>Steep embankment next to Kortright Road along tree line (See Photo E.)</li> <li>Unable to locate/access outlet pipe and outlet channel due to dense vegetation (Photo B.)</li> <li>No stormwater facility signage</li> <li>Phragmites present (Photo B.)</li> </ul>

<p>A close-up photograph of a concrete inlet pipe with a metal trash grate. The grate is partially blocked by debris and vegetation. A person's foot in a green boot is visible at the top of the frame.</p> <p>A. West concrete inlet pipe and trash grate with vegetation and trash litter collected on grate causing a 10% blockage. Note northwest inlet pipe not located in field.</p>

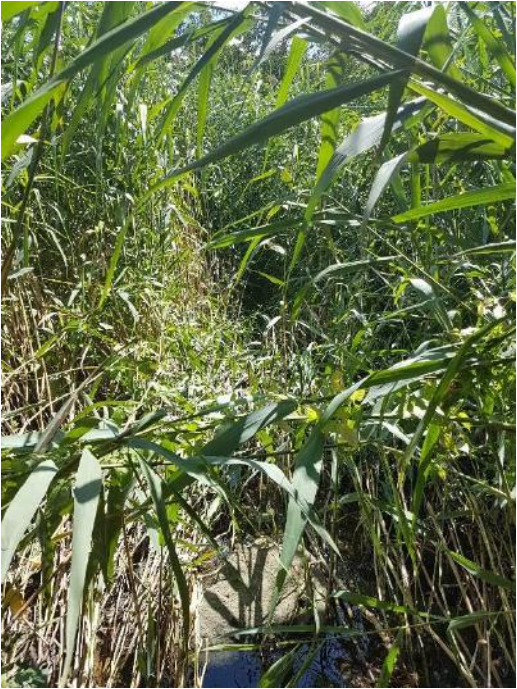
<p>A photograph looking down the inlet outfall channel into the pond's main cell. The channel is filled with dense vegetation, including tall phragmites, which have been pushed over by a recent high flow event.</p> <p>B. Inlet outfall channel looking downstream into the pond's main cell. Note phragmites and dense vegetation pushed over from a recent high flow event.</p>

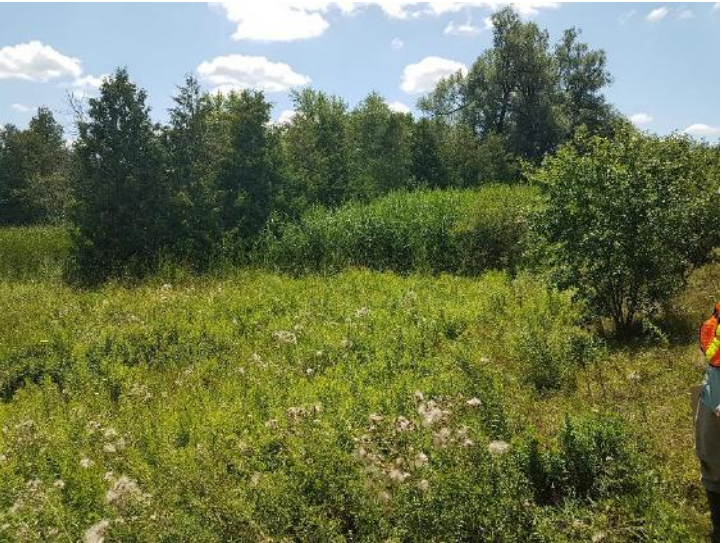
<p>A wide-angle photograph of the pond basin area. It shows a large expanse of dense, green vegetation, including a stand of phragmites, along a low flow channel that runs out of the west inlet pipe.</p> <p>C. Overview of pond basin area, including phragmites stand along low flow channel out of west inlet pipe.</p>

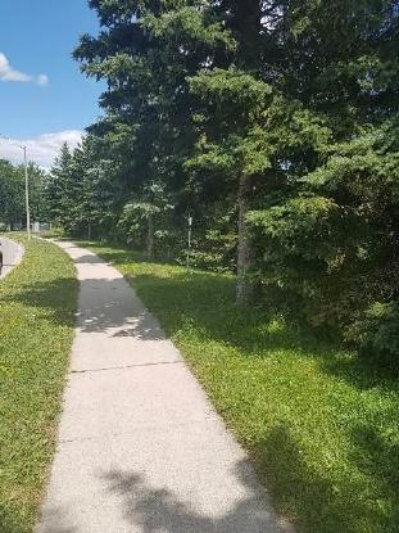
<p>A photograph of Kortright Road and a concrete pedestrian sidewalk. A dense row of trees is on the right side of the road, limiting quick access into the pond facility.</p> <p>D. Kortright Road and pedestrian sidewalk adjacent to Pond 21 with dense tree row limiting quick access into pond facility.</p>

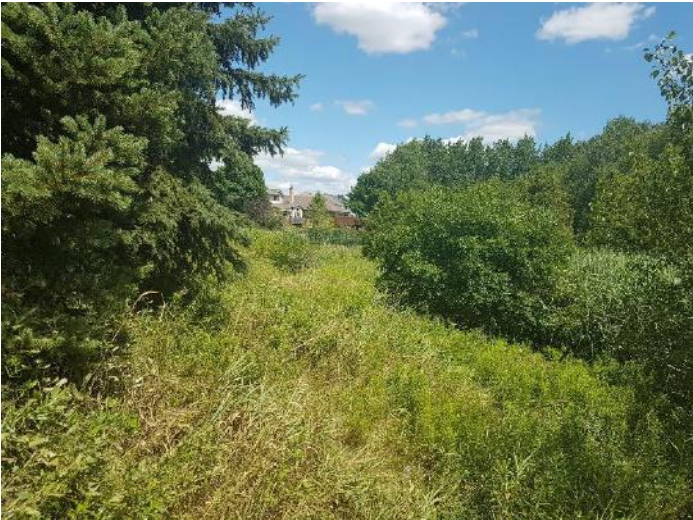
<p>A photograph of the pond embankment along Kortright Road. The embankment is relatively steep and covered with tall grass and shrub growth.</p> <p>E. Pond embankment along Kortright Road with relatively steep bank and shrub growth in basin shown.</p>

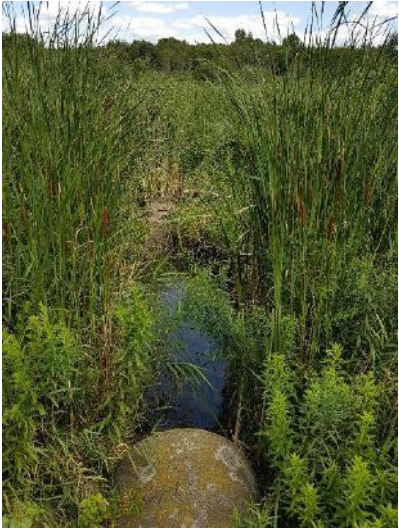
<p>C. Concrete inlet pipe and headwall reinforcement in good condition</p>

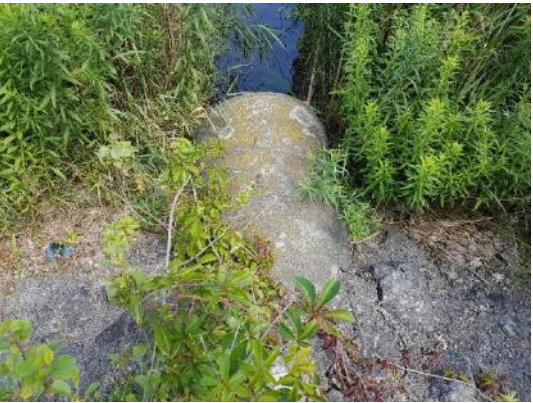
<p>D. Small amount of sediment collected at inlet outfall.</p>

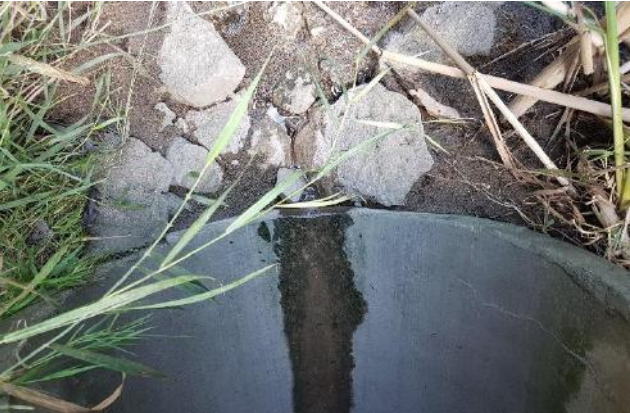
<p>F. North berm of pond basin. Weir on design drawings but little grade change found on berm.</p>

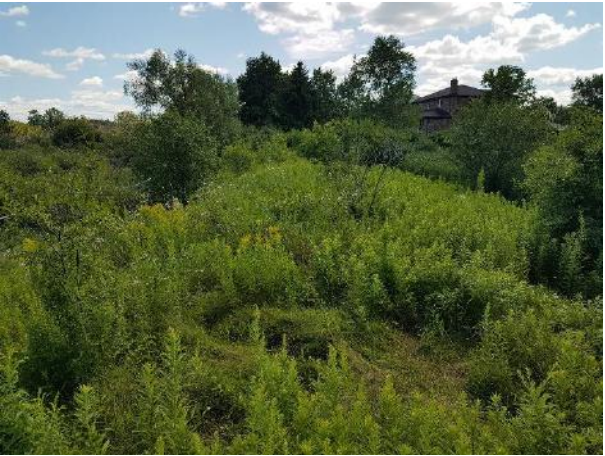
**Description:** Dry pond in fair condition, with notably dense vegetation in main cell. The facility consists of a single dry cell which is designed with a 675mm concrete inlet pipe (South-West side of the pond), and a ditch inlet CB structure that functions as the pond outlet to the North East. The outlet structure is currently 20% blocked by vegetative overgrowth. Fencing along the Northern embankment of the pond is damaged and is sitting at a 45° slant.

<p>G. Perimeter fence on north side of pond shows signs of displacement, toppling.</p>

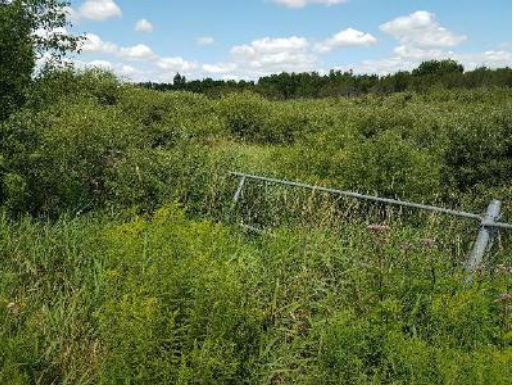
Inspection Summary Table		
Immediate	Moderate	Low
<ul style="list-style-type: none"> <li></li> </ul>	<ul style="list-style-type: none"> <li>Vine overgrowth on outlet grate is blocking inflow to structure by an estimated 20% (Photo H.)</li> <li>Downstream of inlet pipe is showing signs of high inflow with nearby cattails and vegetation pushed over, as well as erosion of pond basin with sediment deposition (Photos B, D)</li> </ul>	<ul style="list-style-type: none"> <li>Dense vegetation in outfall area potentially restricting flow and making difficult to locate/access outlet pipe (Photo J.)</li> <li>Fencing is damaged at several locations of pond, one section found at 45° slant along the Northern pond embankment (Photo G.) and another located next to ditch inlet structure (Photo H.). May be evidence of high outflows or erosion on northern embankment</li> </ul>

<p>H. Ditch inlet structure 20% blocked due to vine growth, and damaged fencing (top right of photo)</p>

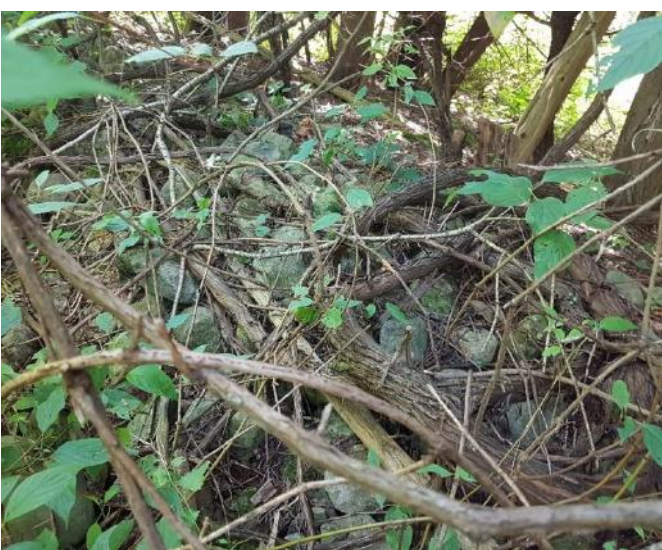
Inspection Summary Table		
Immediate	Moderate	Low
<ul style="list-style-type: none"> <li></li> </ul>	<ul style="list-style-type: none"> <li>375mm PVC inlet is an estimated 30% buried by riprap, sediment and vegetation (Photo F.)</li> <li>Sediment accumulation and dense vegetation growth at perforated riser outlet may limit inflow capacity (Photo A.)</li> <li>300mm outlet pipe blocked 30% at outfall by rip-rap in pipe mouth (Photo G.)</li> </ul>	<ul style="list-style-type: none"> <li>Mosquitoes present</li> <li>No stormwater facility signage present</li> <li>100mm inlet pipe (residential sump drain) blocked 85% by riprap (Photo D.)</li> <li>Rip-rap around inlet pipe displaced</li> </ul>

D. 300mm PVC inlet 85% buried in riprap

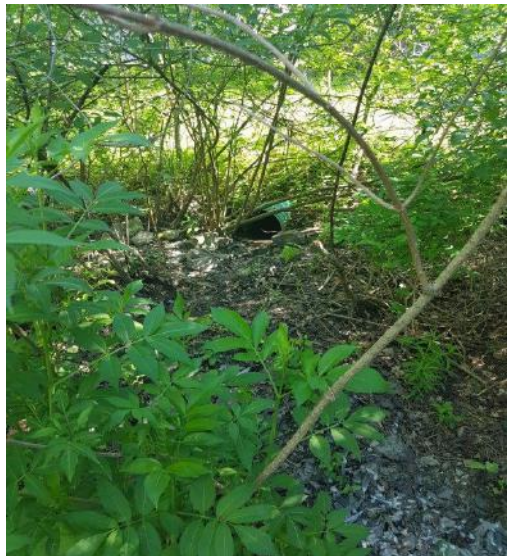
G. 300mm PVC outlet pipe from hickenbottom riser structure with rip-rap around outfall creating a 30% blockage in flow capacity

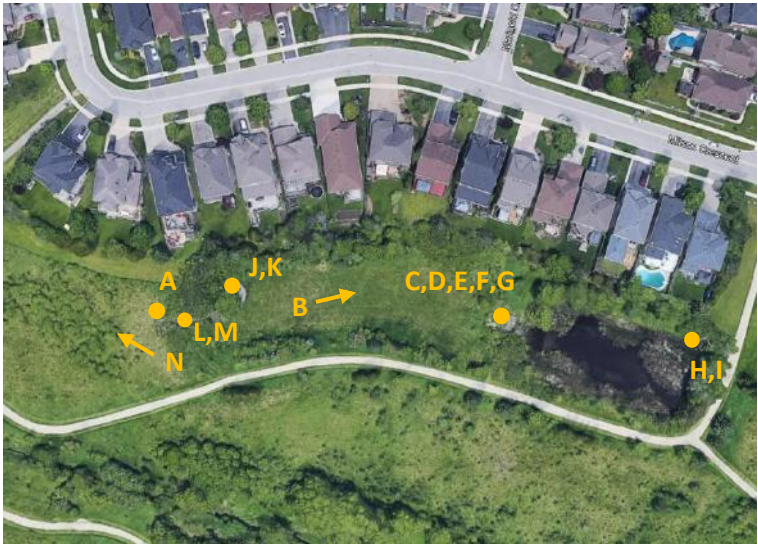
A. Outlet pipe from dry basin perforated riser 30% buried in earth and grass

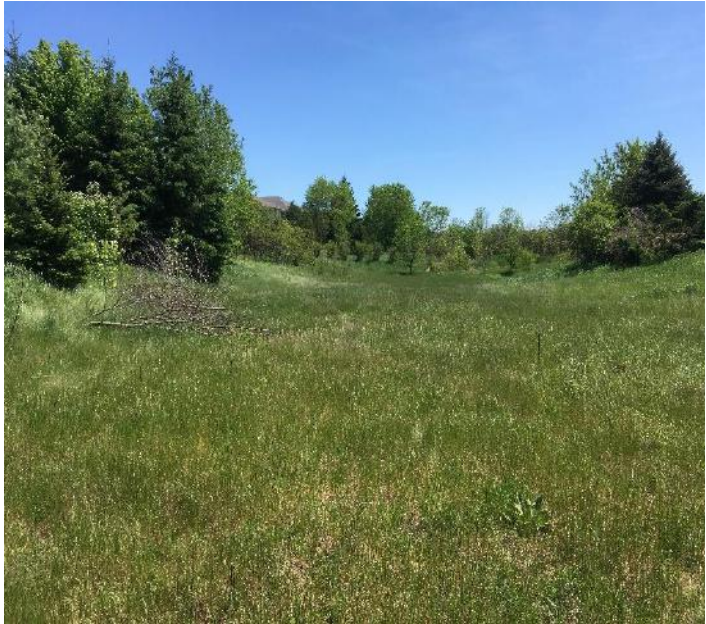
Inspection Summary Table		
Immediate	Moderate	Low
<ul style="list-style-type: none"> <li>Permanent pool water level is approximately 0.2m below the elevation identified in record drawings</li> <li>No permanent pool exists within the main cell portion of the wet pond (Photo B.)</li> </ul>	<ul style="list-style-type: none"> <li>Overflow channel between ponds is becoming cracked, showing signs of weathering, erosion, and sediment deposition (Photo C.)</li> <li>Pipe outlet from dry pond partially buried and surrounded by dense grass (estimated 30%, see Photo A.)</li> </ul>	<ul style="list-style-type: none"> <li>Tree deadfall</li> <li>Dense vegetation in forebay cell and moderate sediment accumulation at outfall from forebay inlet pipe (Photo I)</li> <li>Dense tree growth around dry pond cell perforated riser outlet structure limiting access (Photo J,K.)</li> <li>Heavy vegetation growth on overflow weir from dry pond cell (Photo L.)</li> </ul>

B. Dry pond looking from outlet end

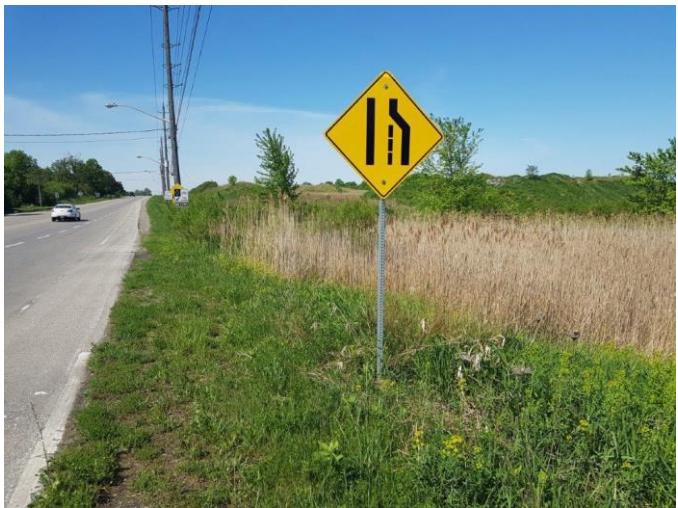
Inspection Summary Table		
Immediate	Moderate	Low
•	•	<ul style="list-style-type: none"> <li>No railings on inlet headwalls (greater than 1m drop) (Photo. H)</li> <li>Heavy Phragmites presence (Photo C.)</li> <li>Upstream of pipe inlets have vegetation growing close to pipe mouth, grass clippings/sediment deposition and loose rock displaced nearby (Photos G, H, L, M, N)</li> <li>Minor sediment accumulation in curb inlets from Stone Road and Watson Parkway (Photo E,F, J.)</li> </ul>

C. Dry Pond with heavy phragmites growth

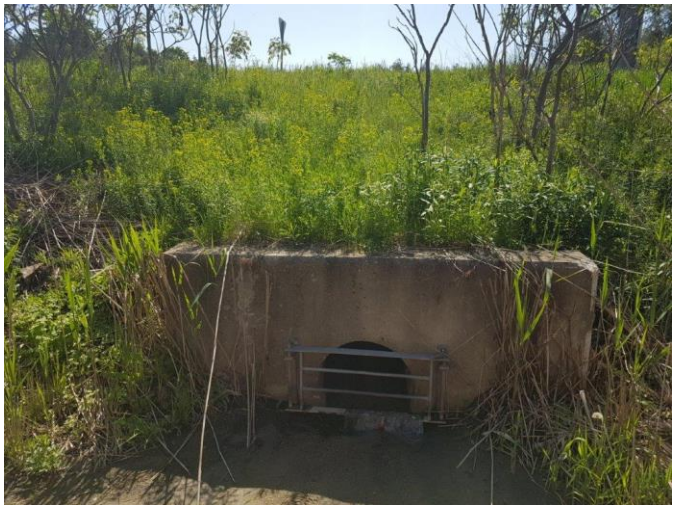
G. Inlet from East 10% filled with sediment
