# Stormwater Management Master Plan

## Appendix M: Erosion Assessment Technical Memorandum – Field Investigations

Prepared by:  
**Aquafor Beech Ltd.**

Reference #: 66636  
August 2021  
Final Report

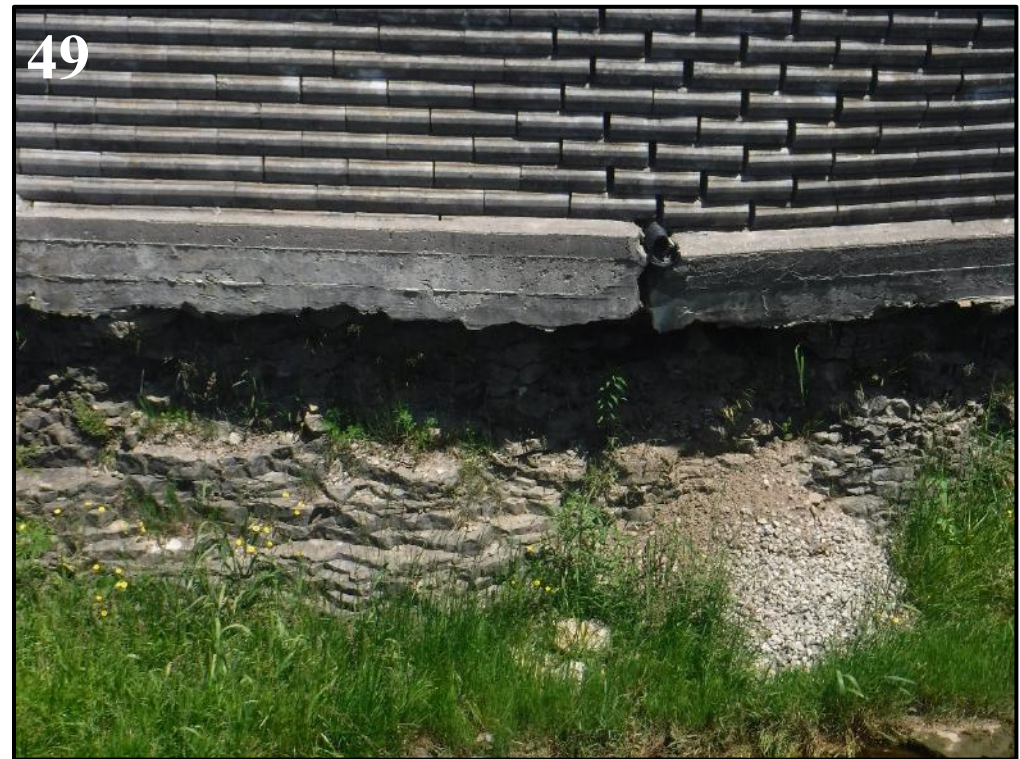
| <b>Erosion Site</b> | 4 | <b>Date:</b> | June 17, 2020 |

| Site Description<br>- Old pedestrian bridge (unsure whether still active), fencing blocking path at top of bridge has been ripped away. Beams under bridge on right bank are broken and cracking, erosion under bridge. | | | |

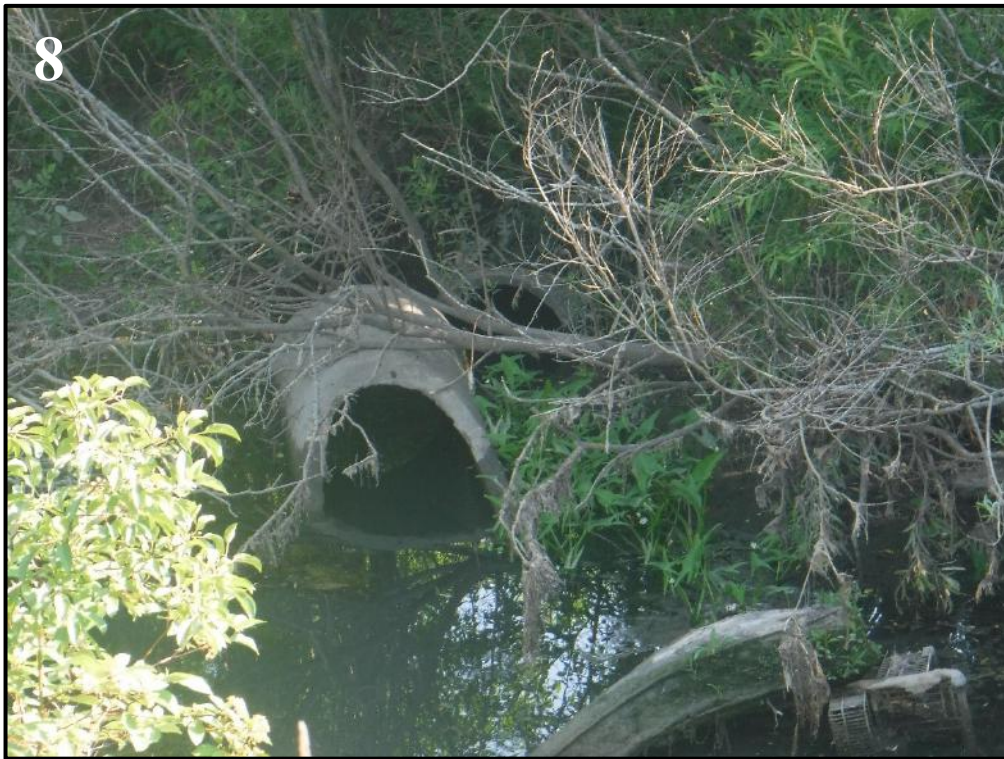
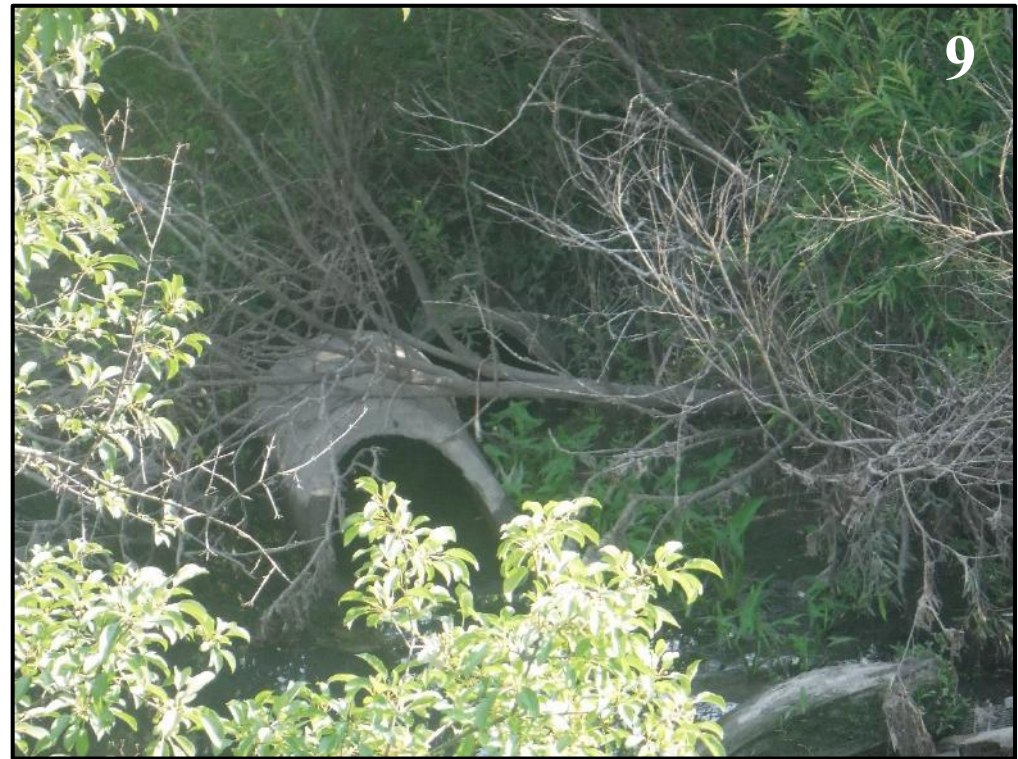
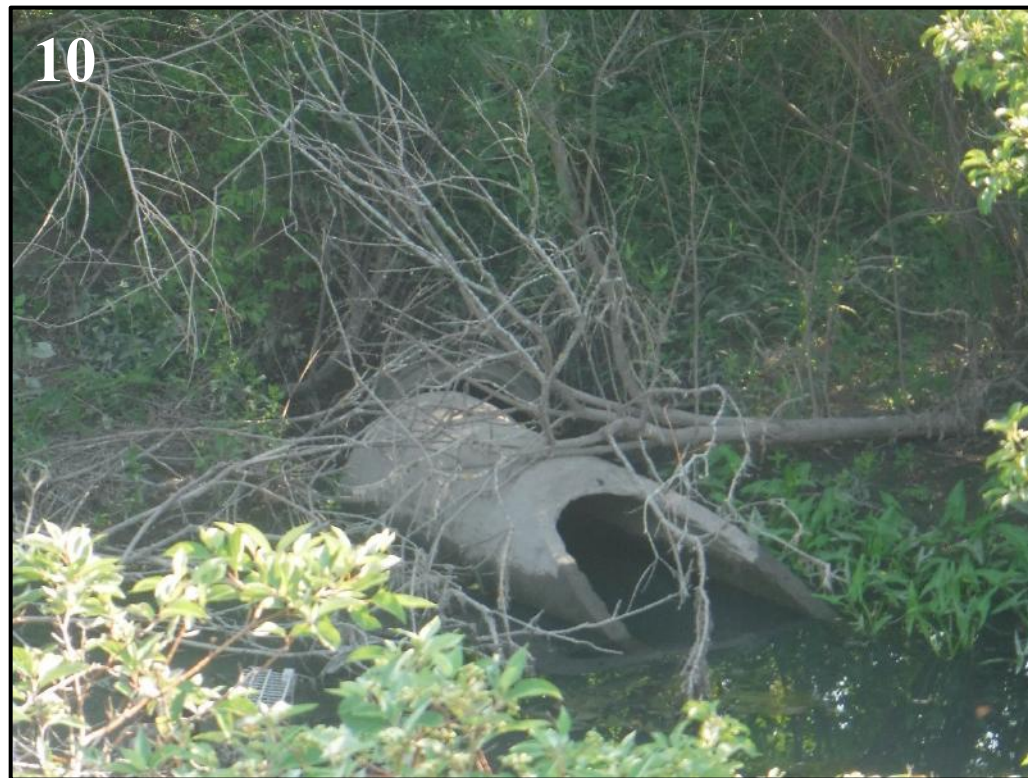
| <b>Erosion Site</b> | 8 | <b>Date:</b> | July 7, 2020 |

| Site Description<br>- Urbanized channel with new path and sediment fencing on left bank, broken concrete pipe outfall on right bank | | | |

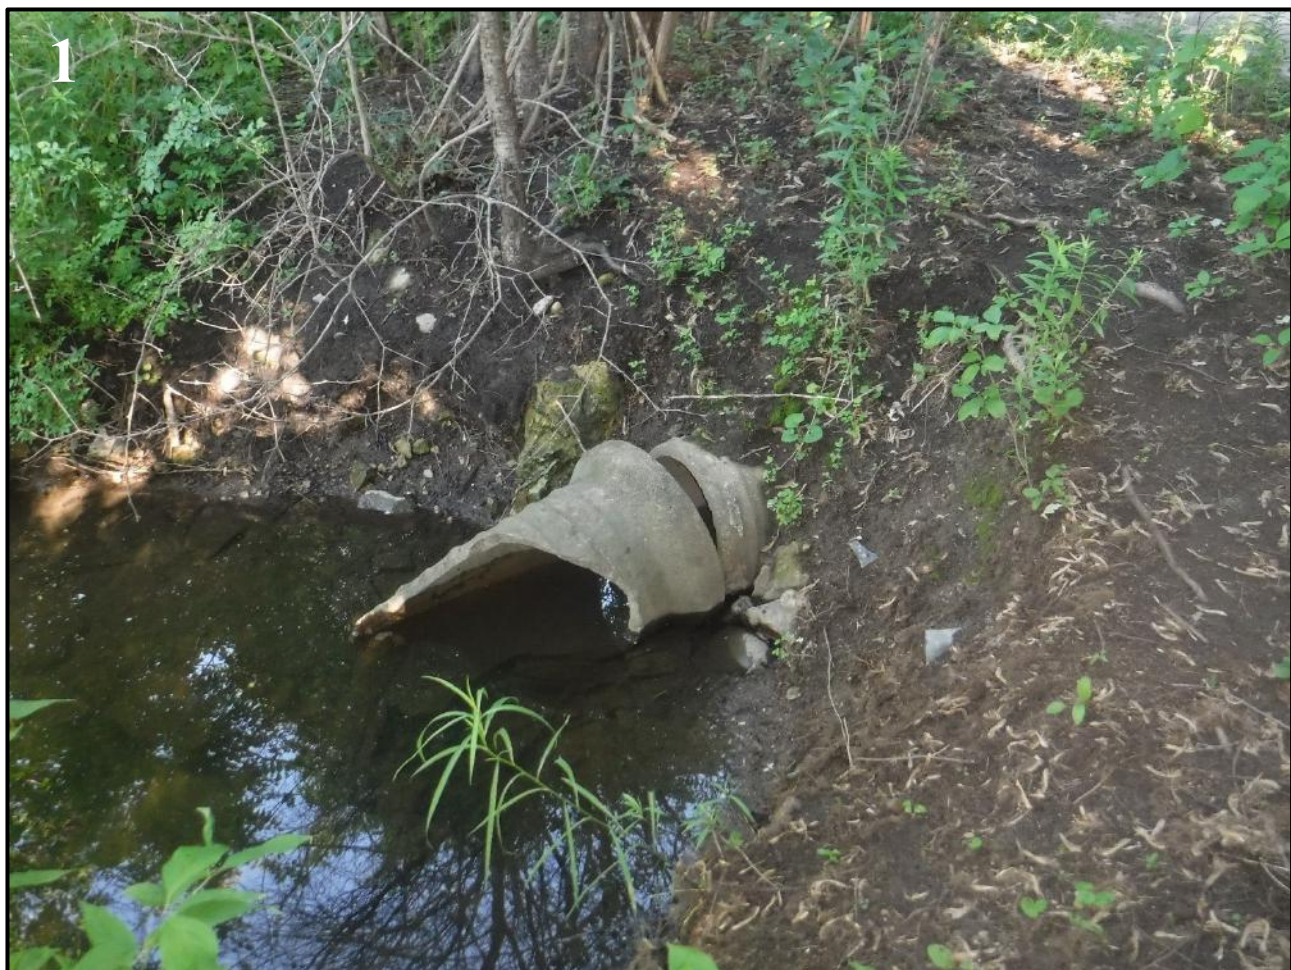
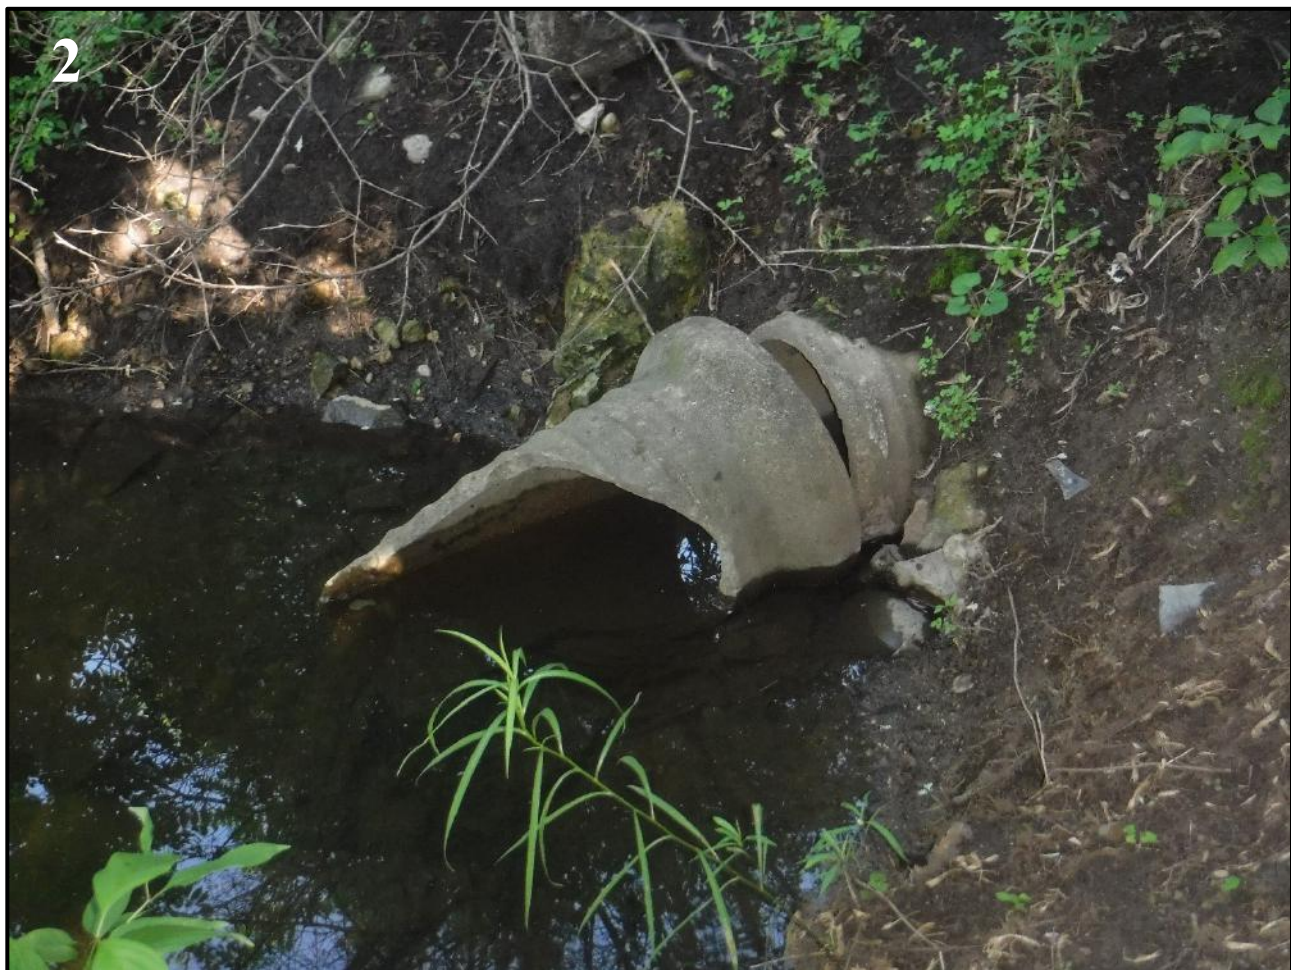
| <b>Erosion Site</b> | 11 | | | <b>Date:</b> | July 14, 2020 |

| Site Description<br>- Area/bank around stormwater outfall eroded, concrete pie cracked and broken, partially obstructed | | | | | |

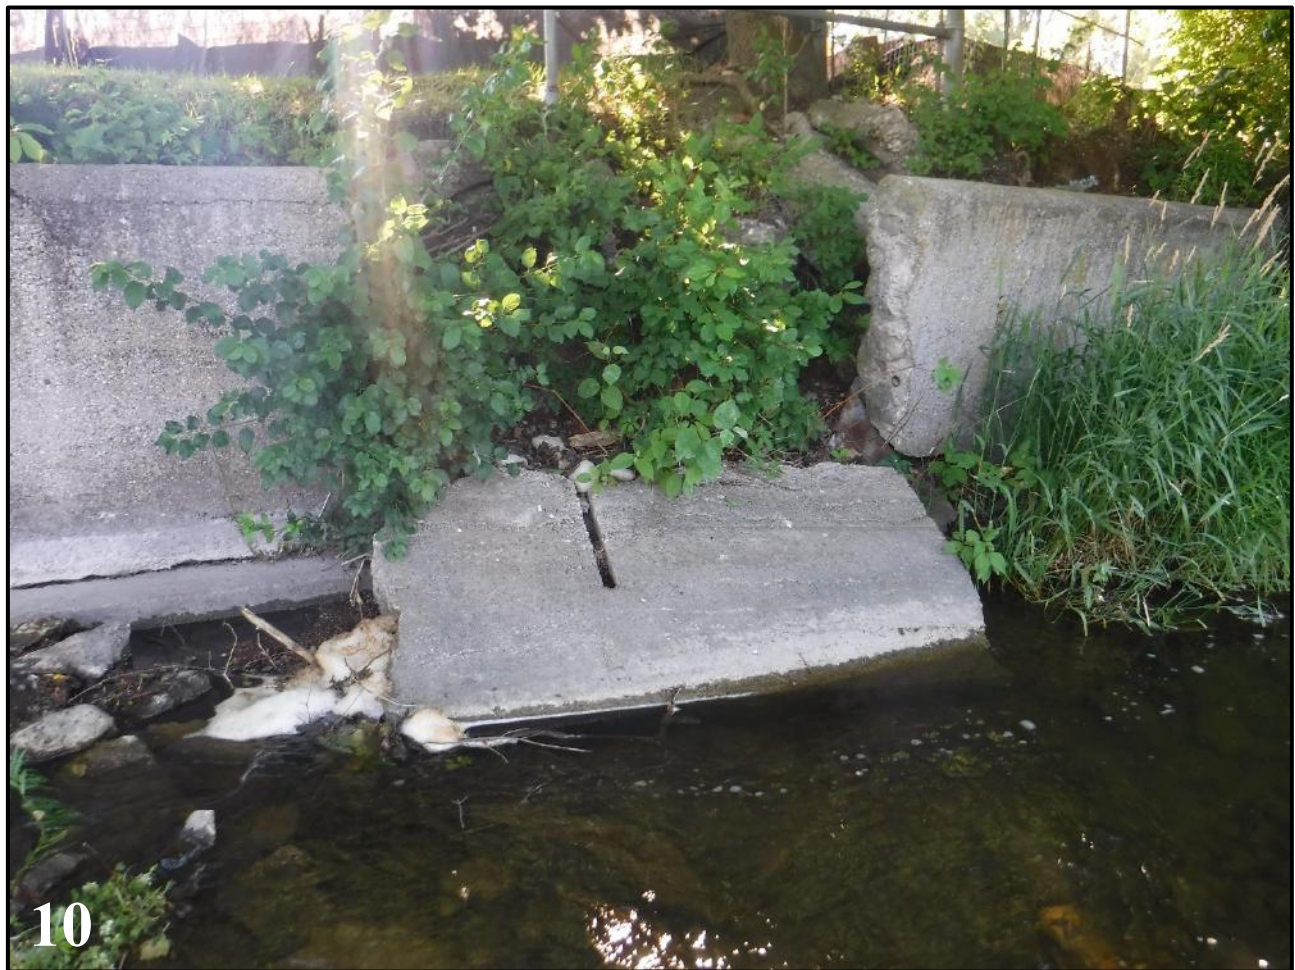
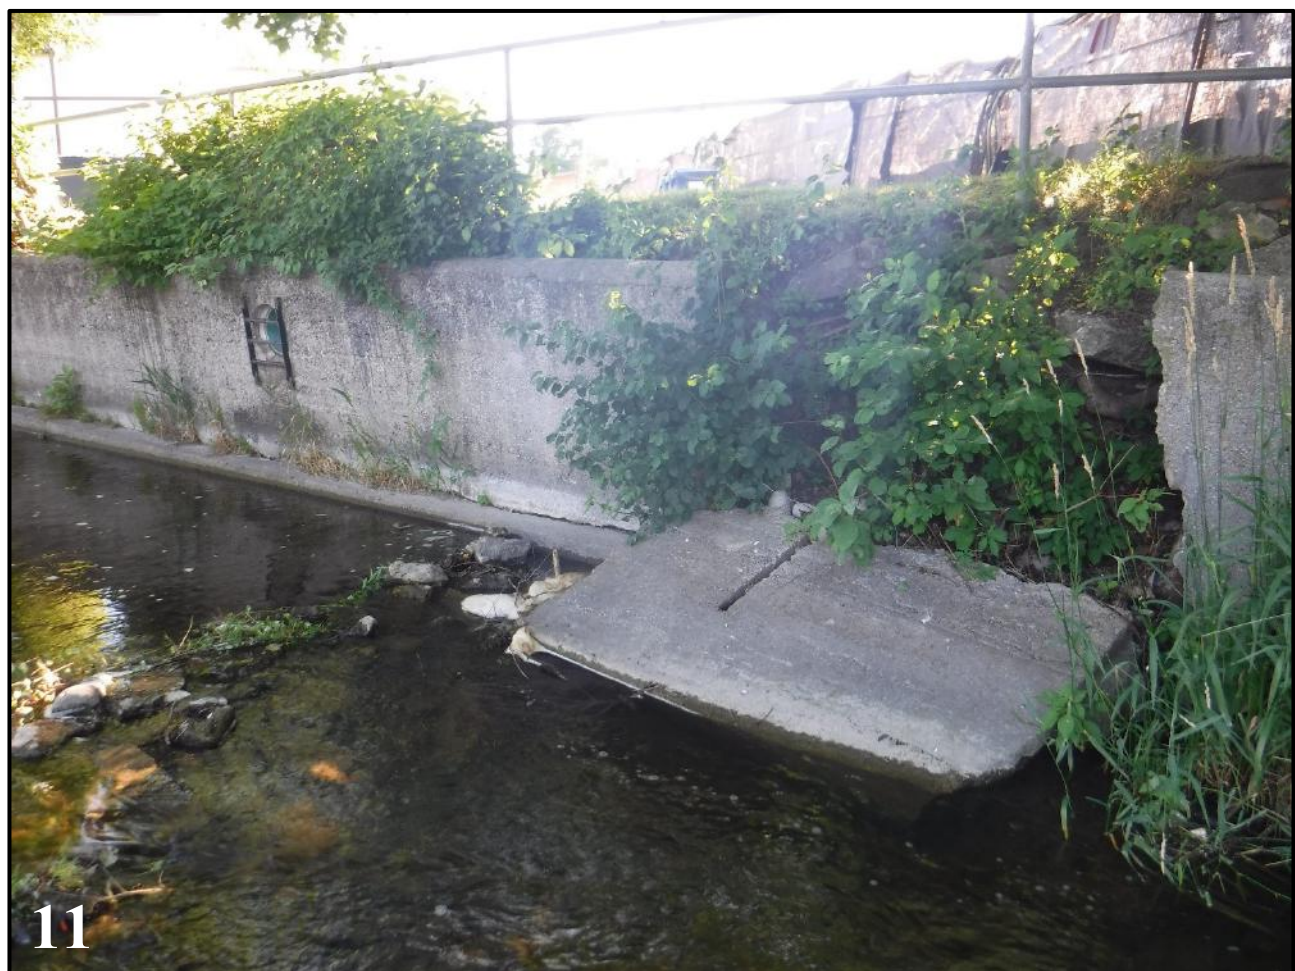
| <b>Erosion Site</b> | 12 | <b>Date:</b> | July 14, 2020 |

| Site Description<br>- Retaining wall approximately 3-4m downstream of outfall is broken and falling into the channel | | | |

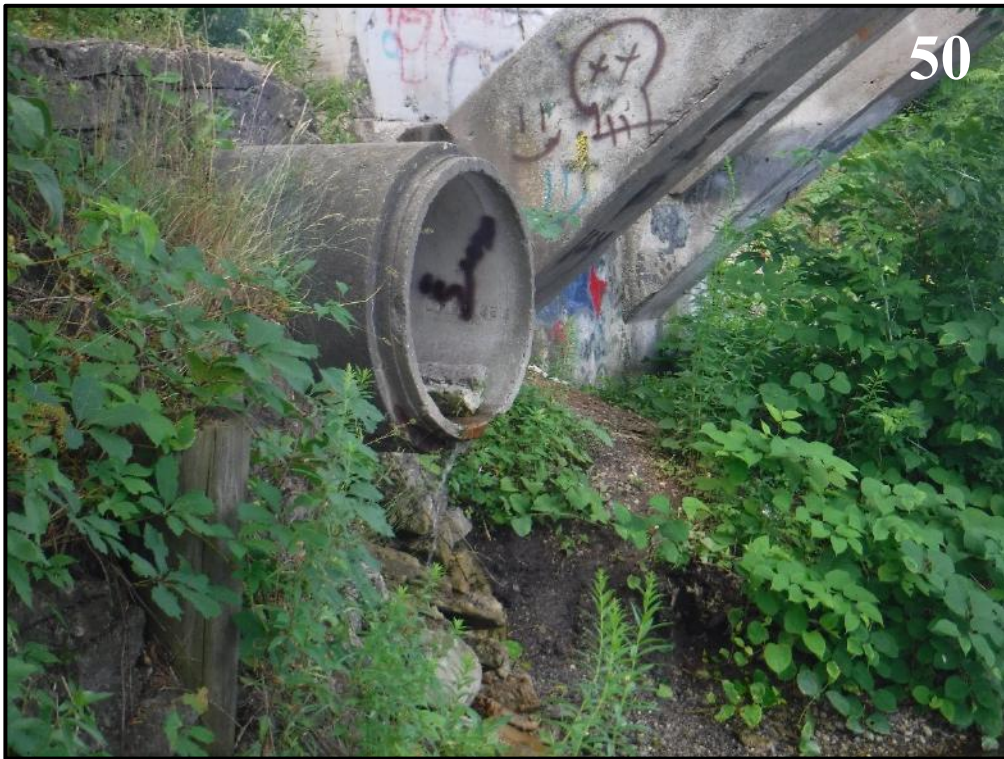
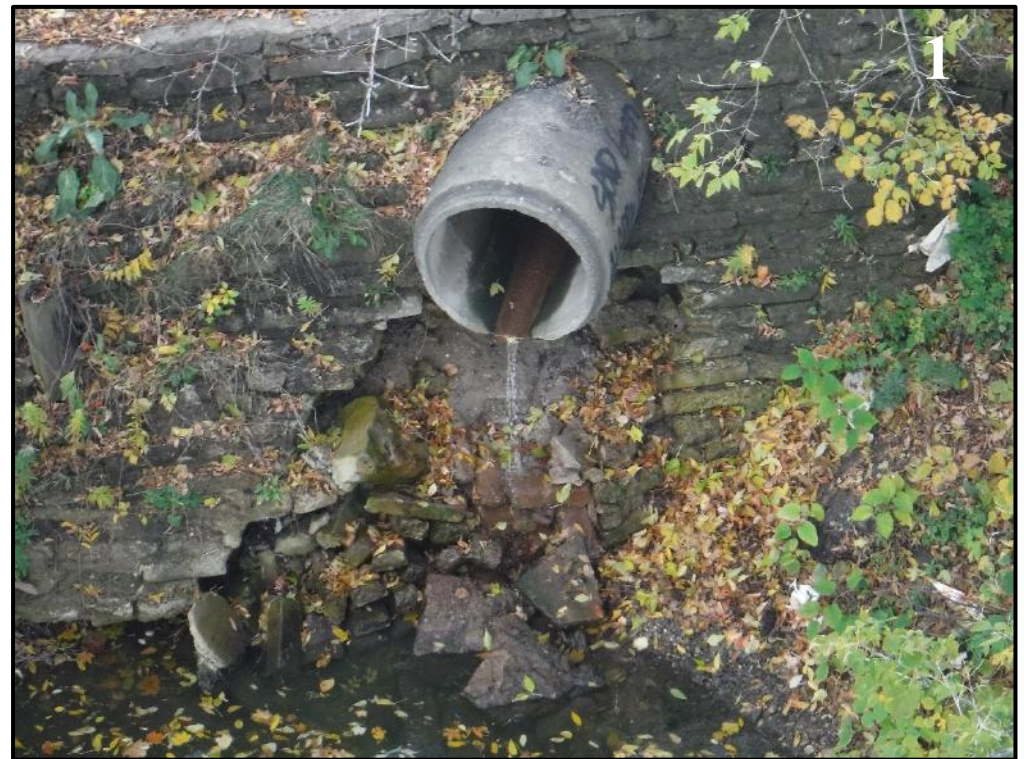
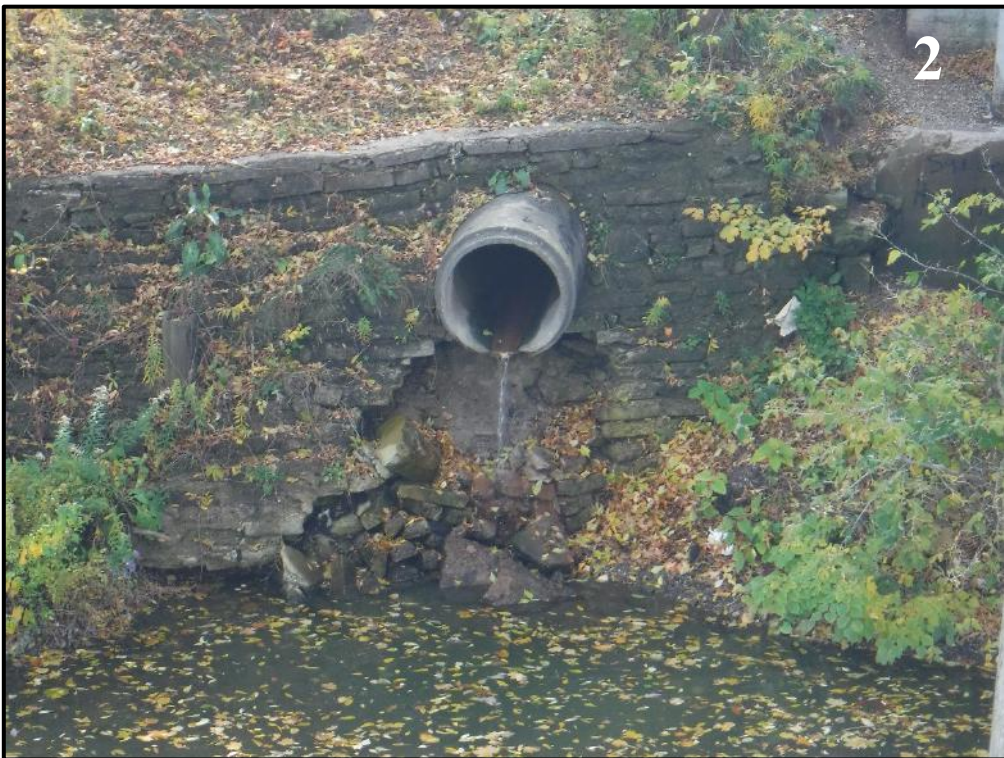
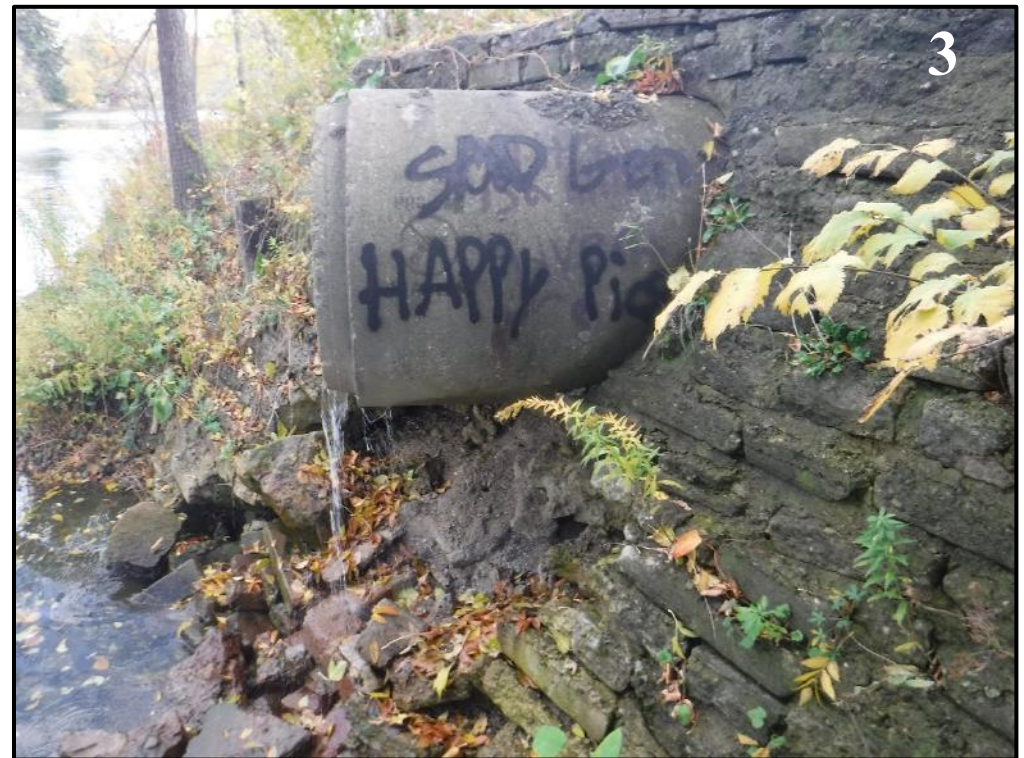
| Erosion Site | 15 | | Date: | July 14, 2020 |

| Site Description<br>-    Stone retaining wall structure below stormsewer outfall is failing, pieces falling into river | | | | |

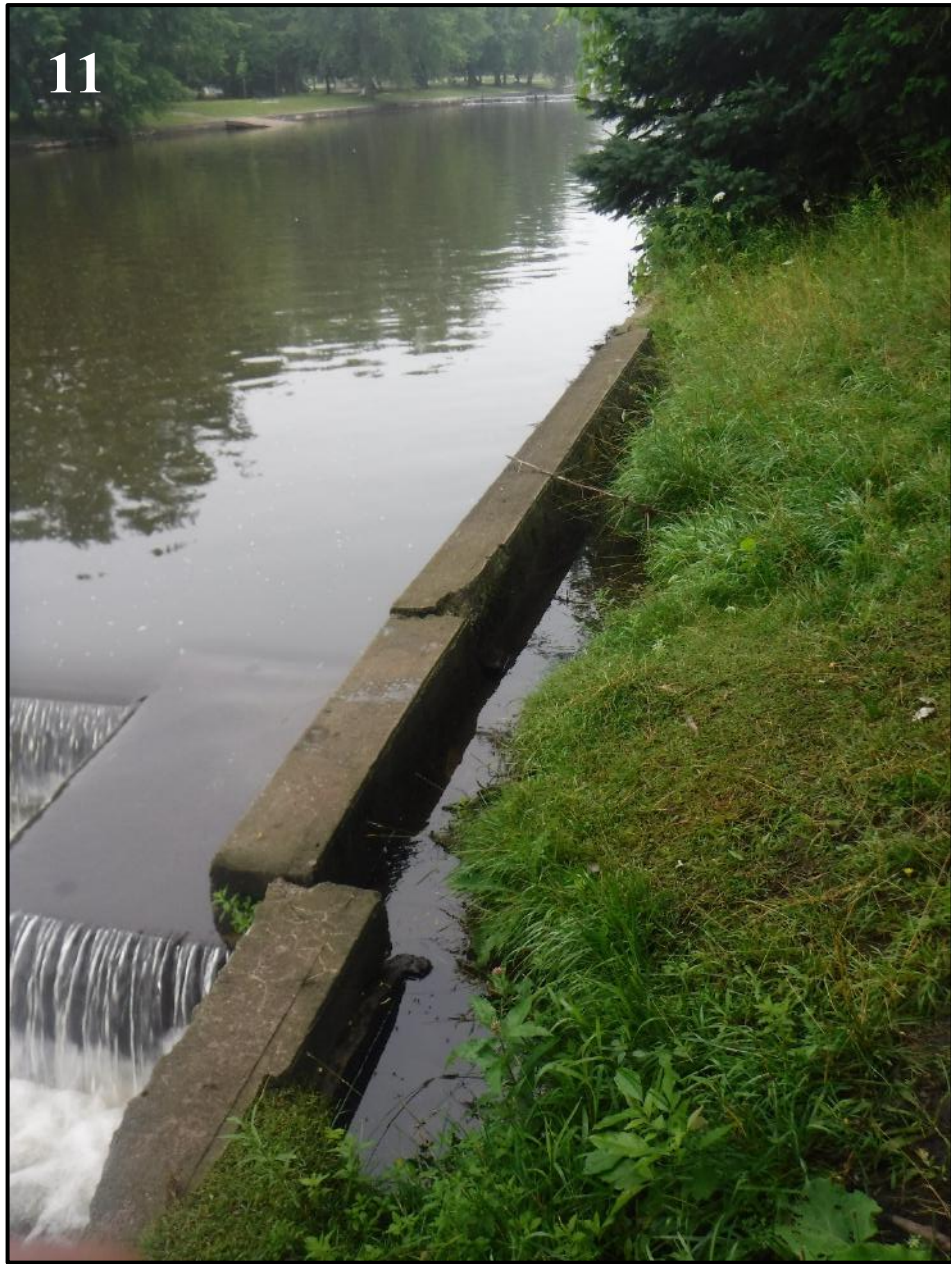
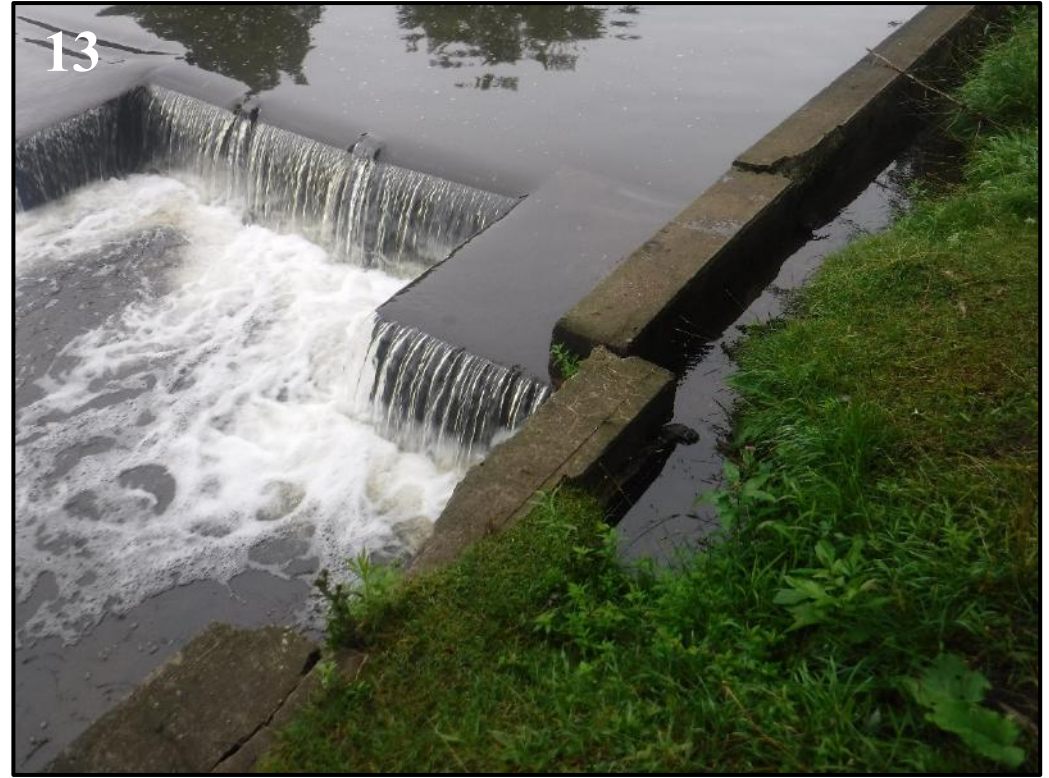
| <b>Erosion Site</b> | 21 | <b>Date:</b> | July 23, 2020 |

| Site Description<br>- concrete retaining wall cracked and in poor condition, has been outflanked | | | |

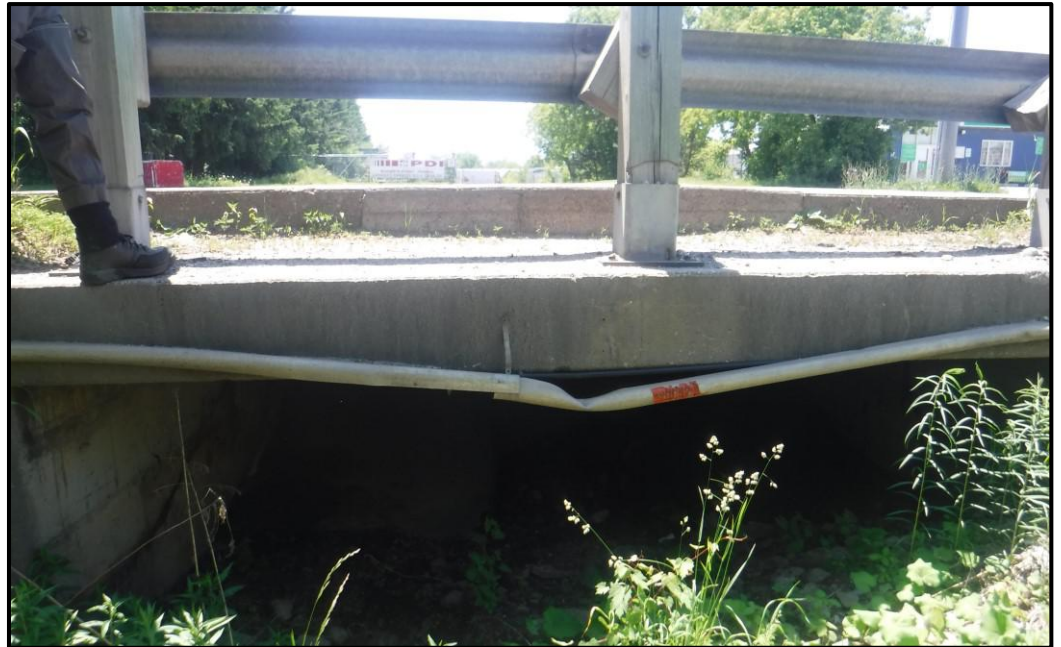
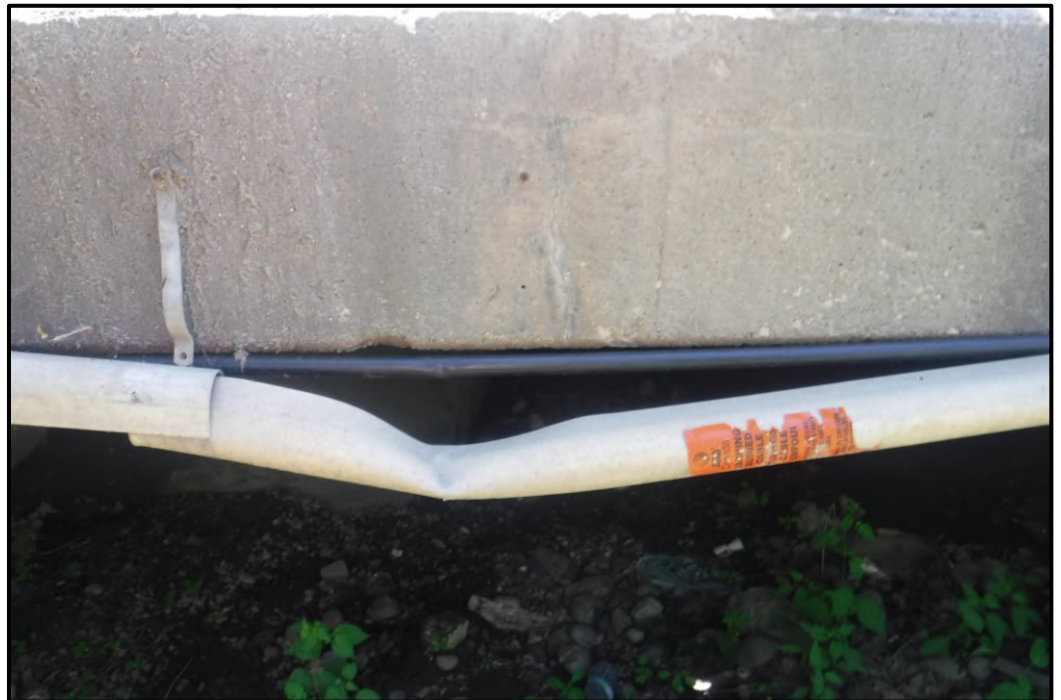
Exposed cable over box  
culvert

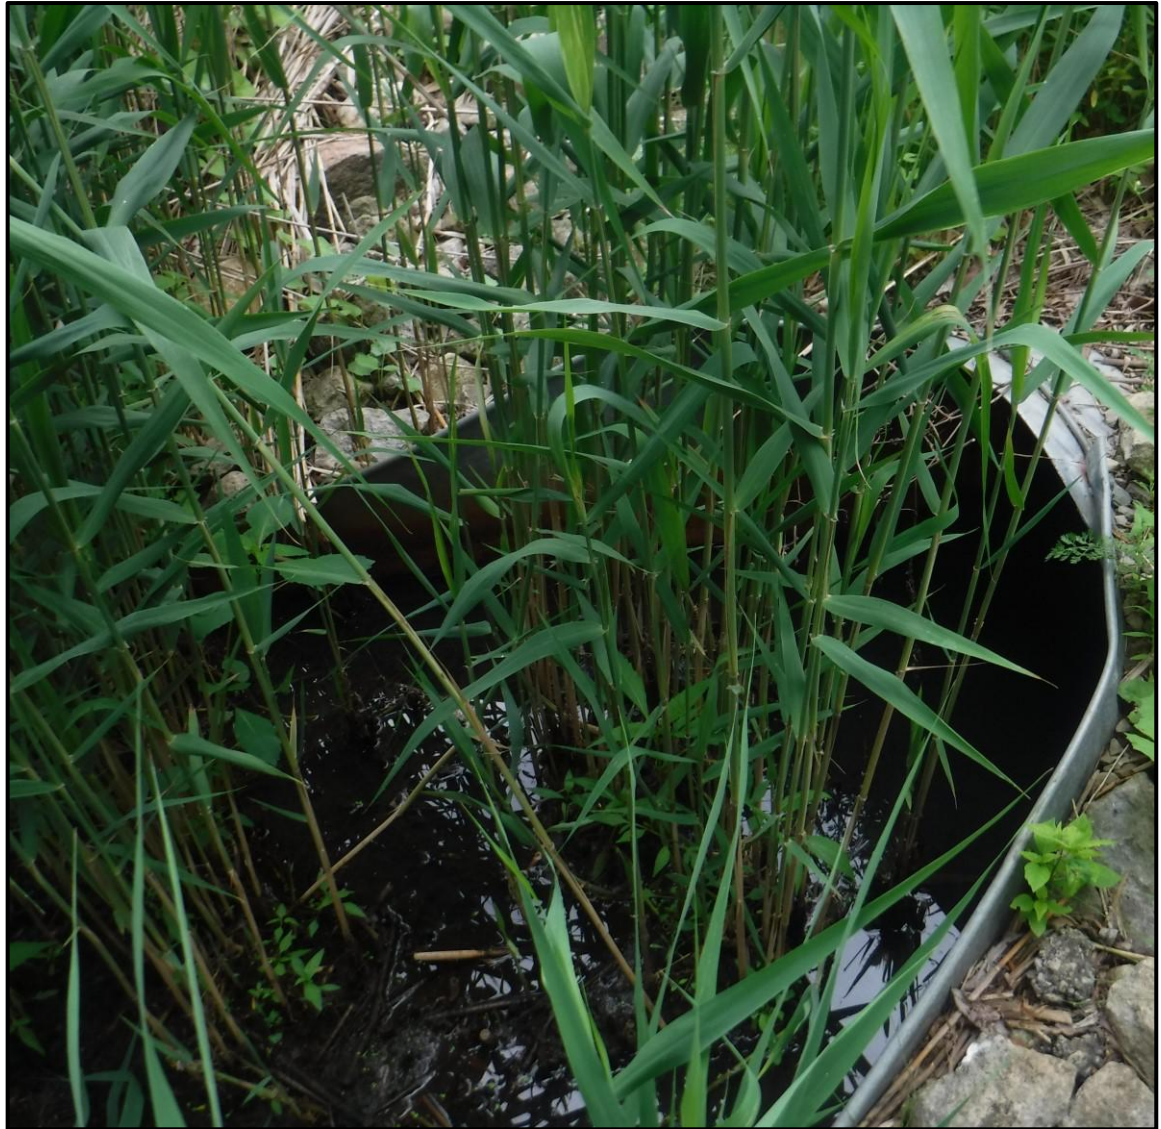
**Site ID: MS#7**

Buildup of sediment and  
vegetation in culvert outlet

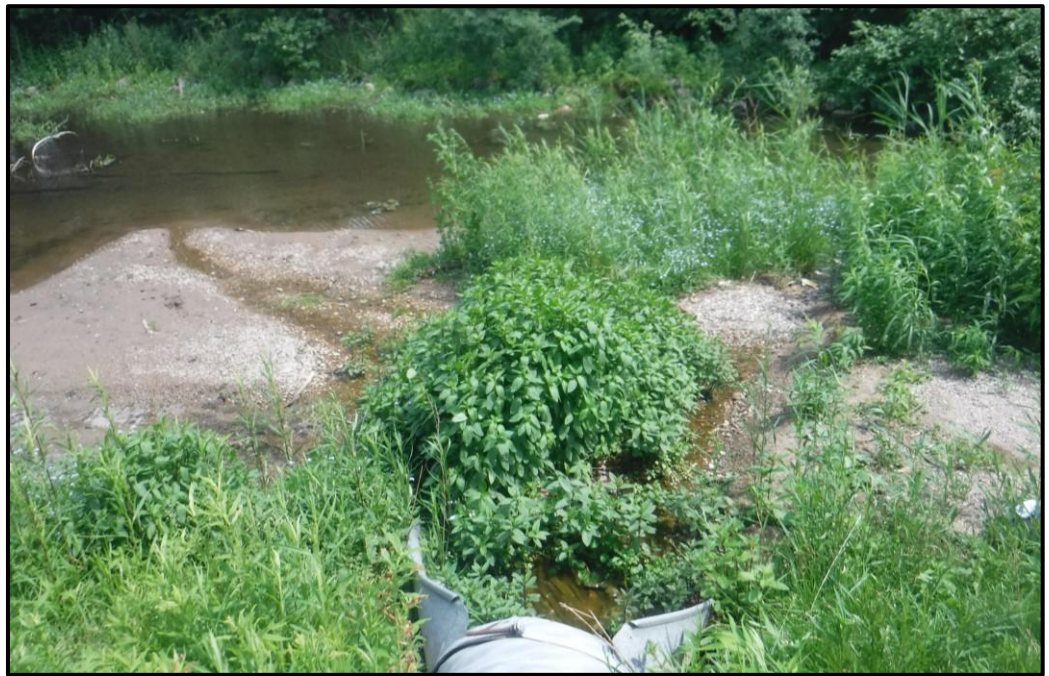
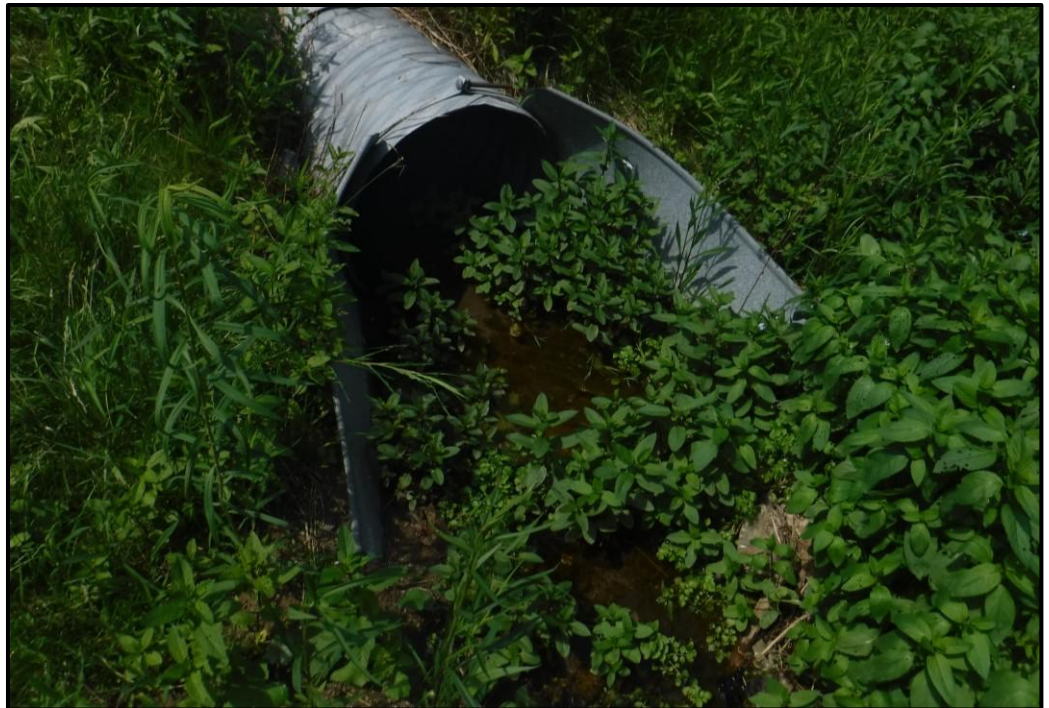
Sediment buildup in and around outlet, vegetation growth in front of outlet

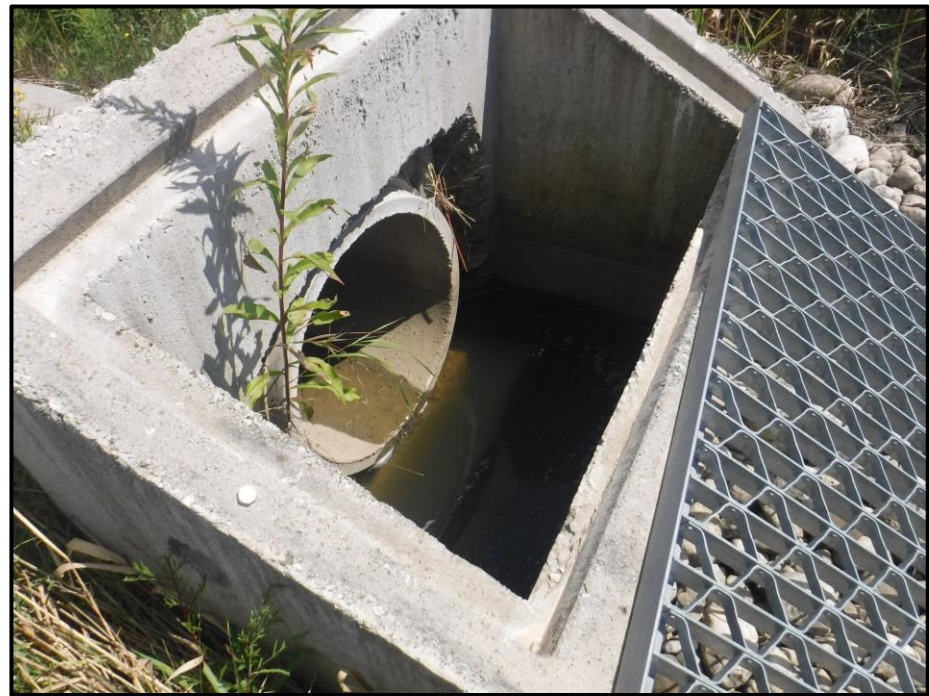
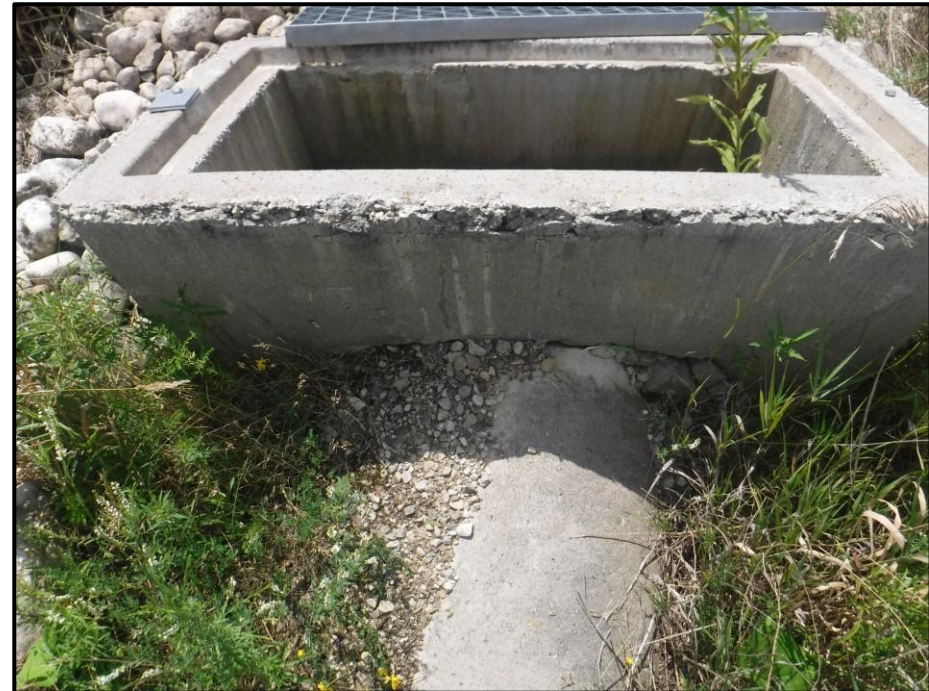
Grate on stormwater outfall is  
dislodged

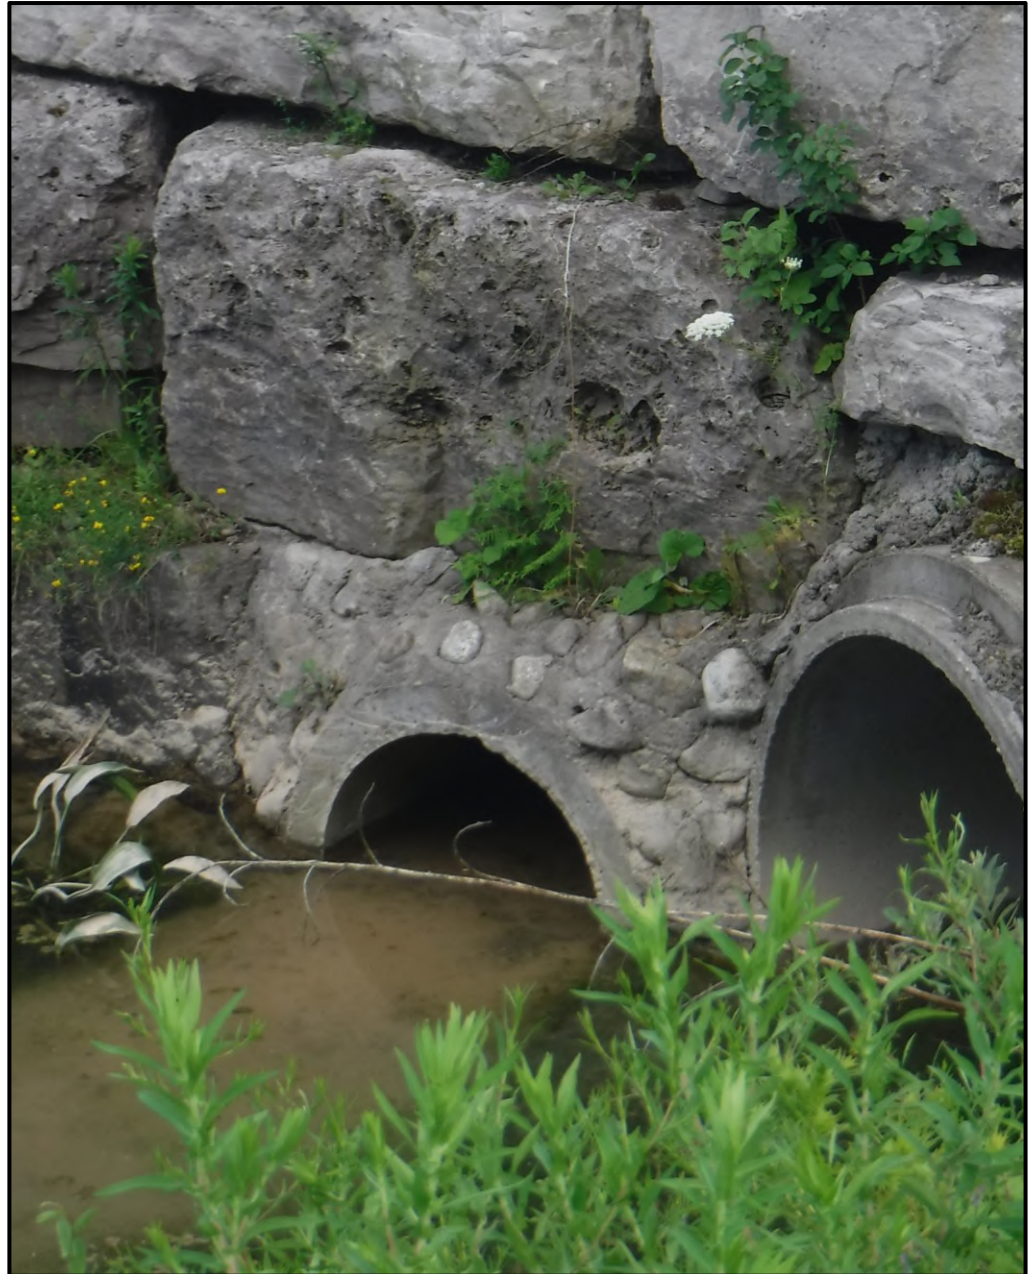
**Site ID: MS#25**

Sediment buildup in stormwater outfall

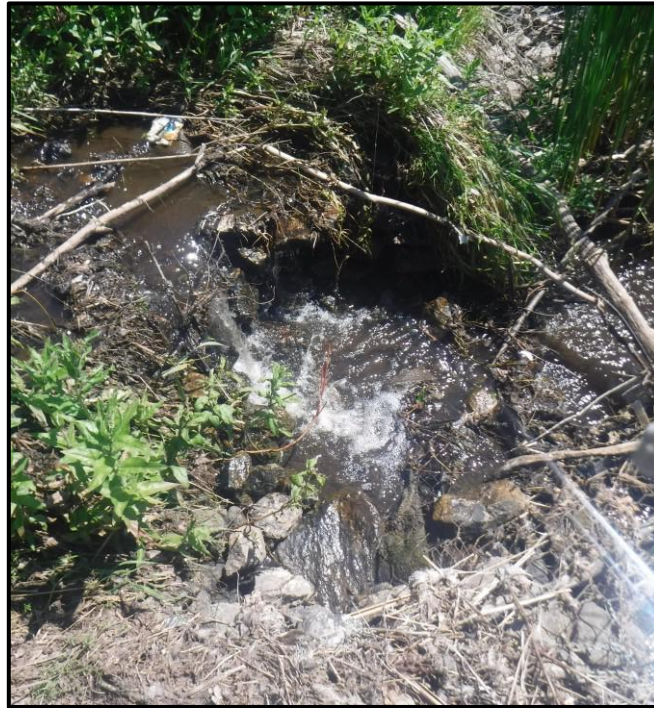
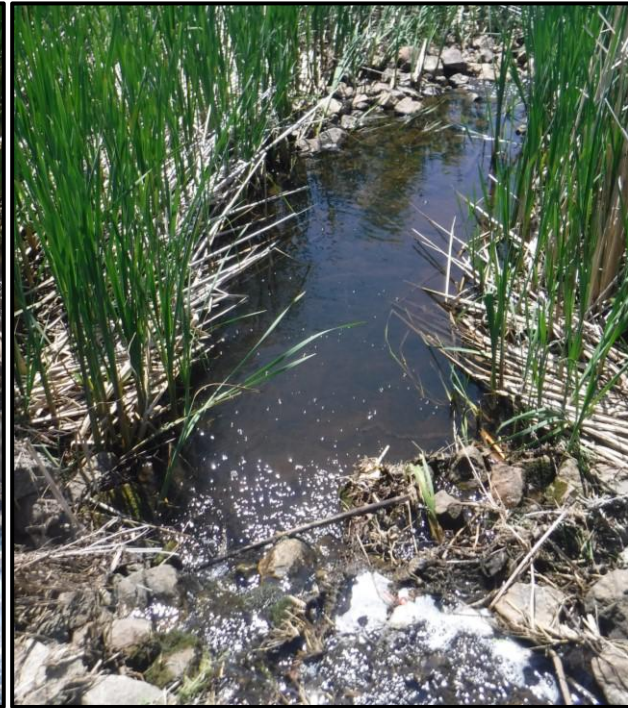
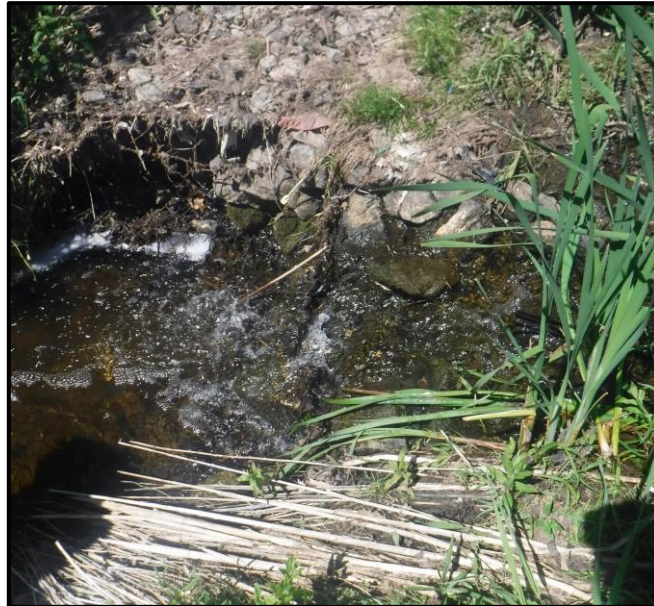
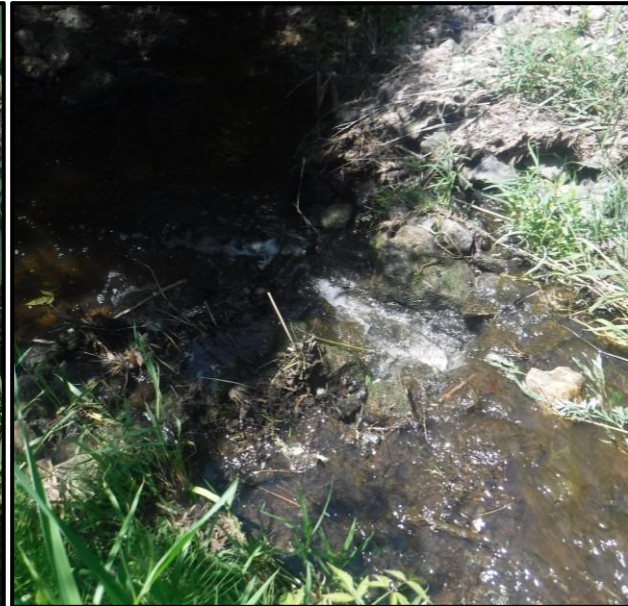
Multiple gabion baskets in channel have burst, some minor fish barriers

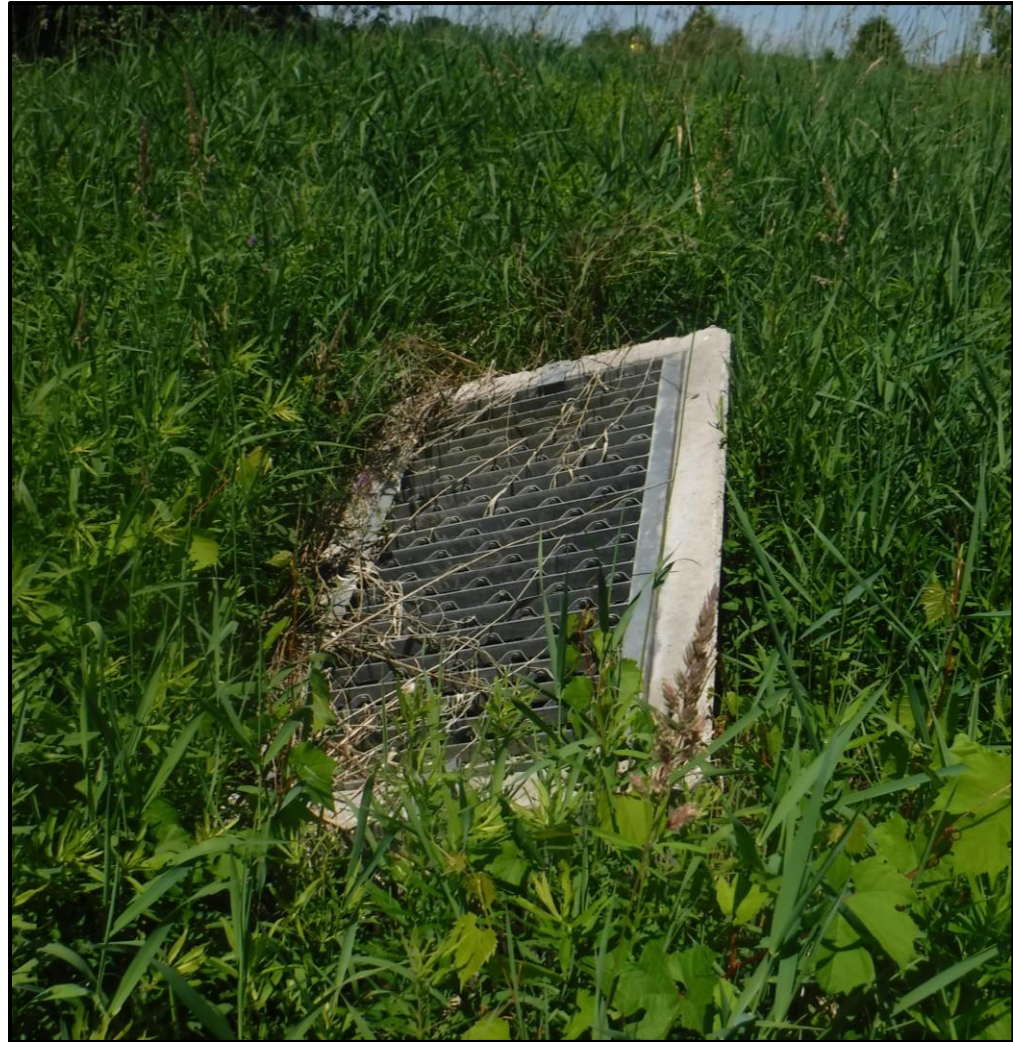
**Site ID: MI#7**

Large catch basin appears to have shifted in ground
