# Stormwater Management Master Plan

## Appendix M: Erosion Assessment Technical Memorandum – Field Investigations

Prepared by:  
**Aquafor Beech Ltd.**

Reference #: 66636  
August 2021  
Final Report

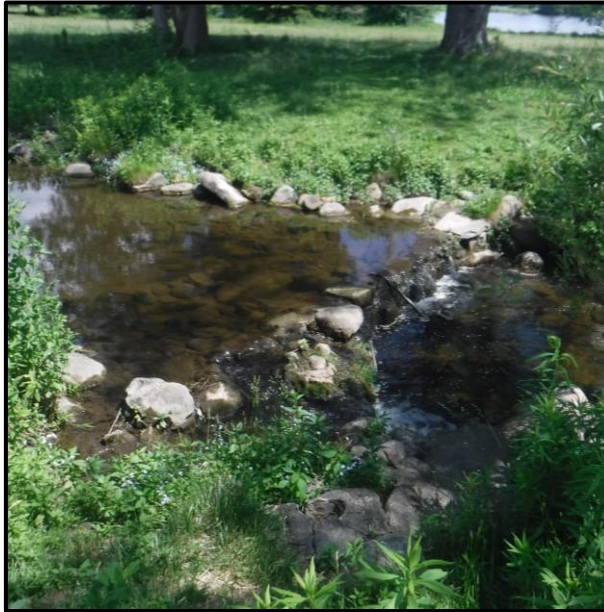
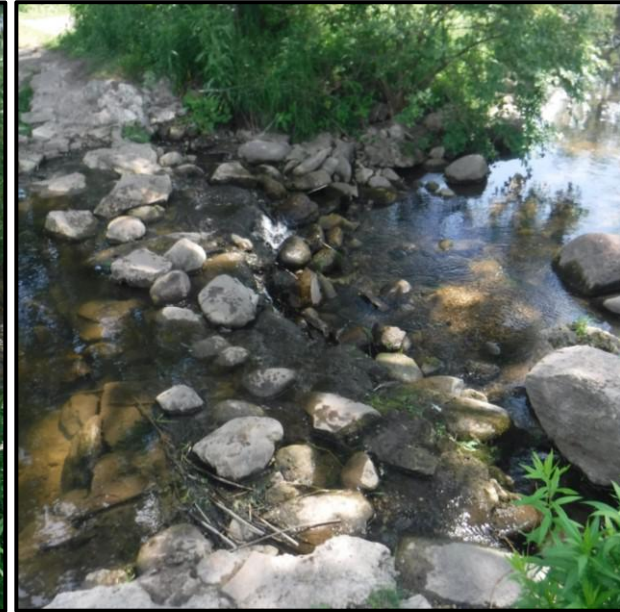
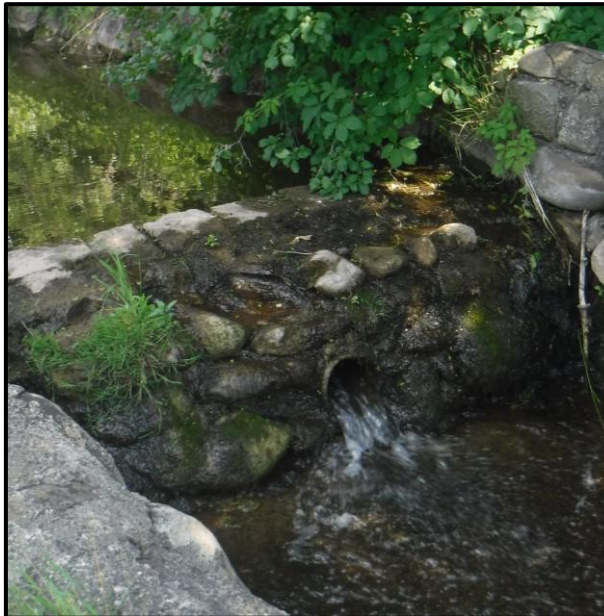
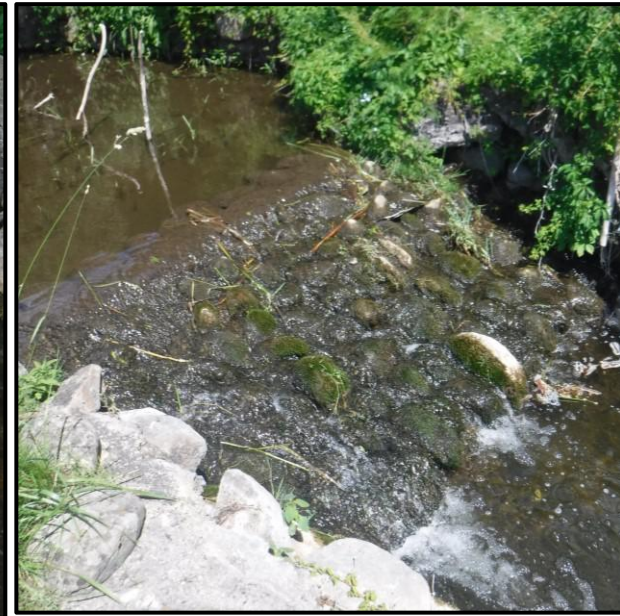
**Issue:**

Multiple fish barriers in  
close proximity in channel

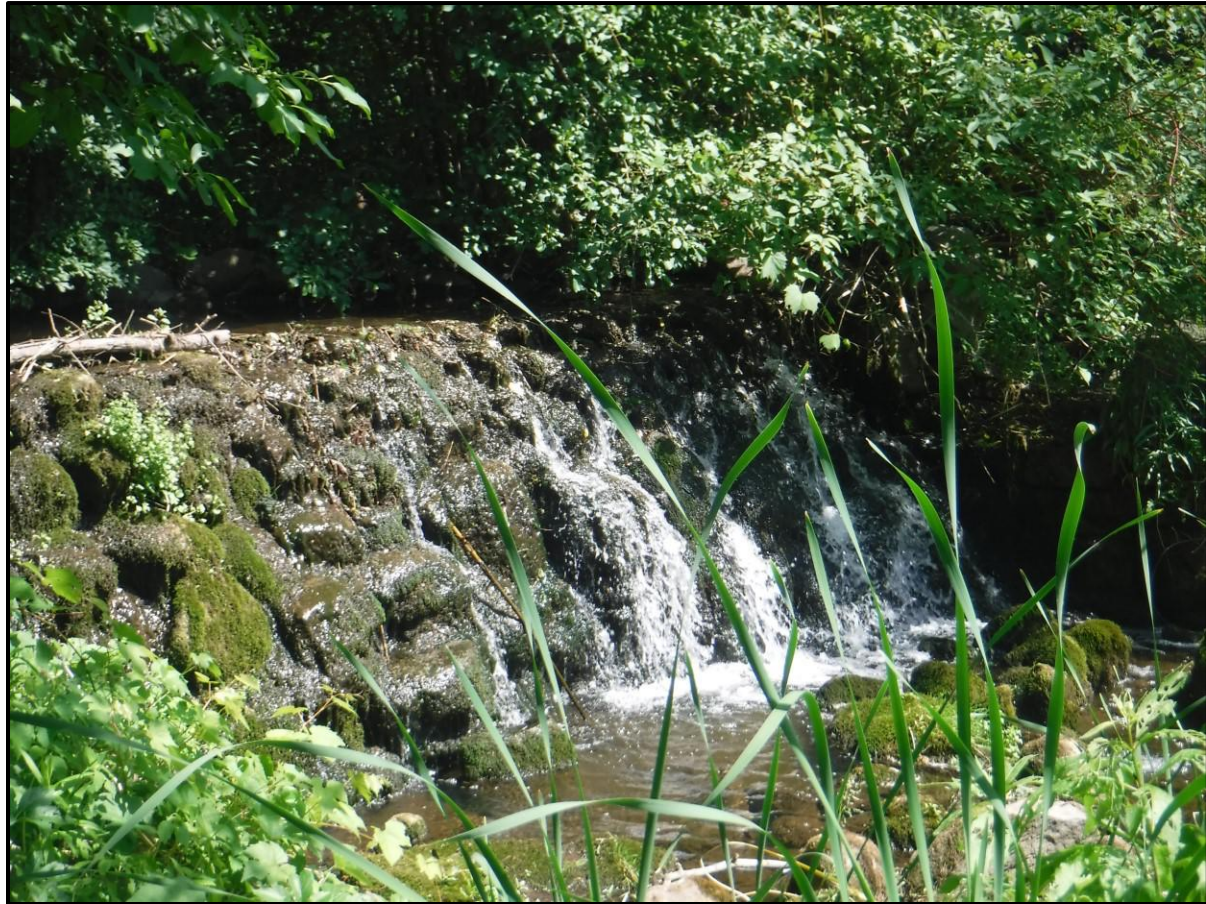
**Site ID: MI#10**

**Issue:**

Fish barrier in channel

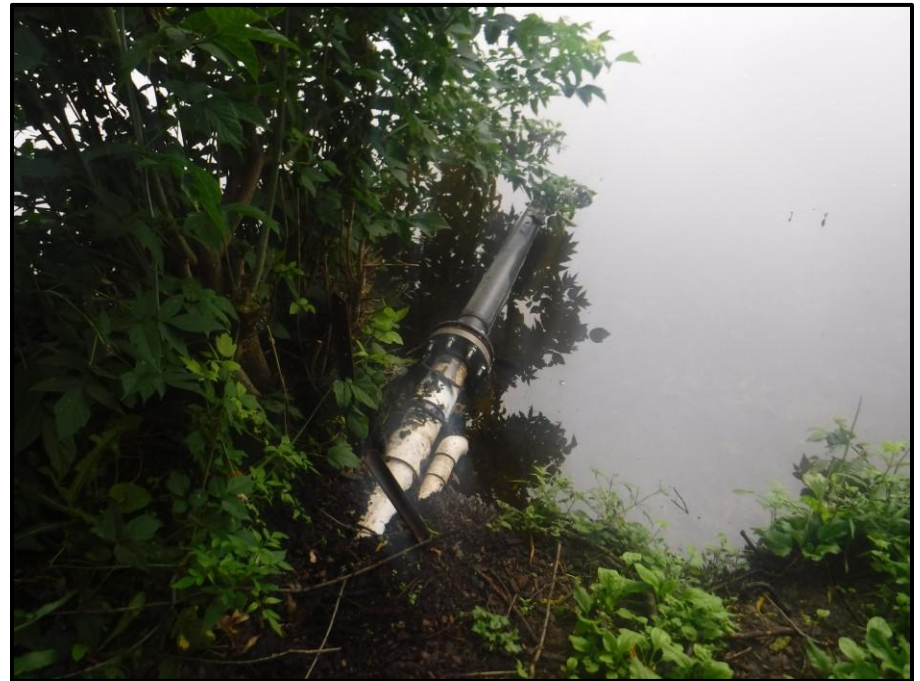
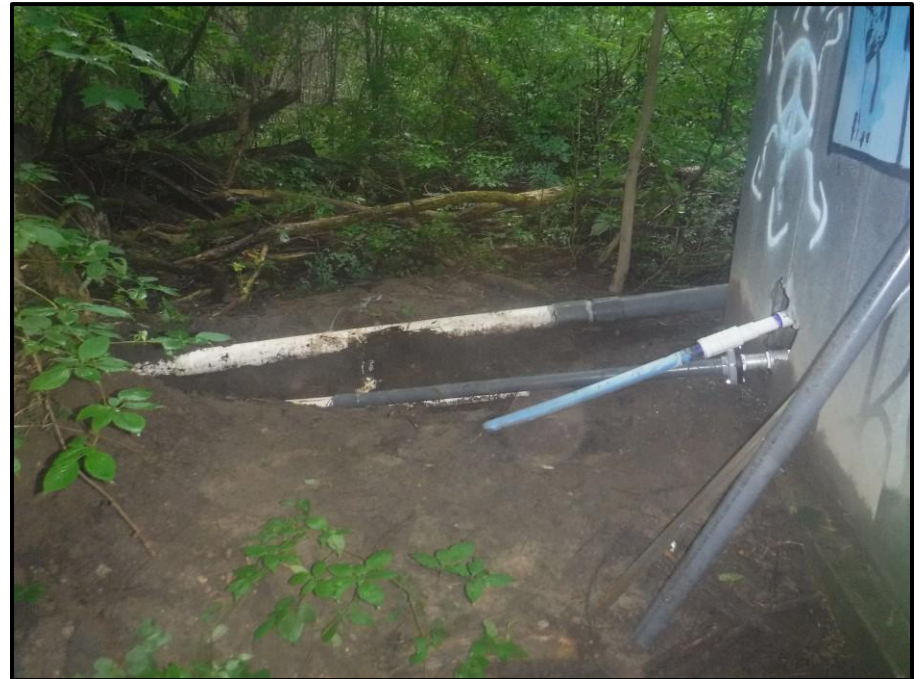
**Issue:**

Exposed pipe in river and just off of foot trail, appears to be from nearby golf course

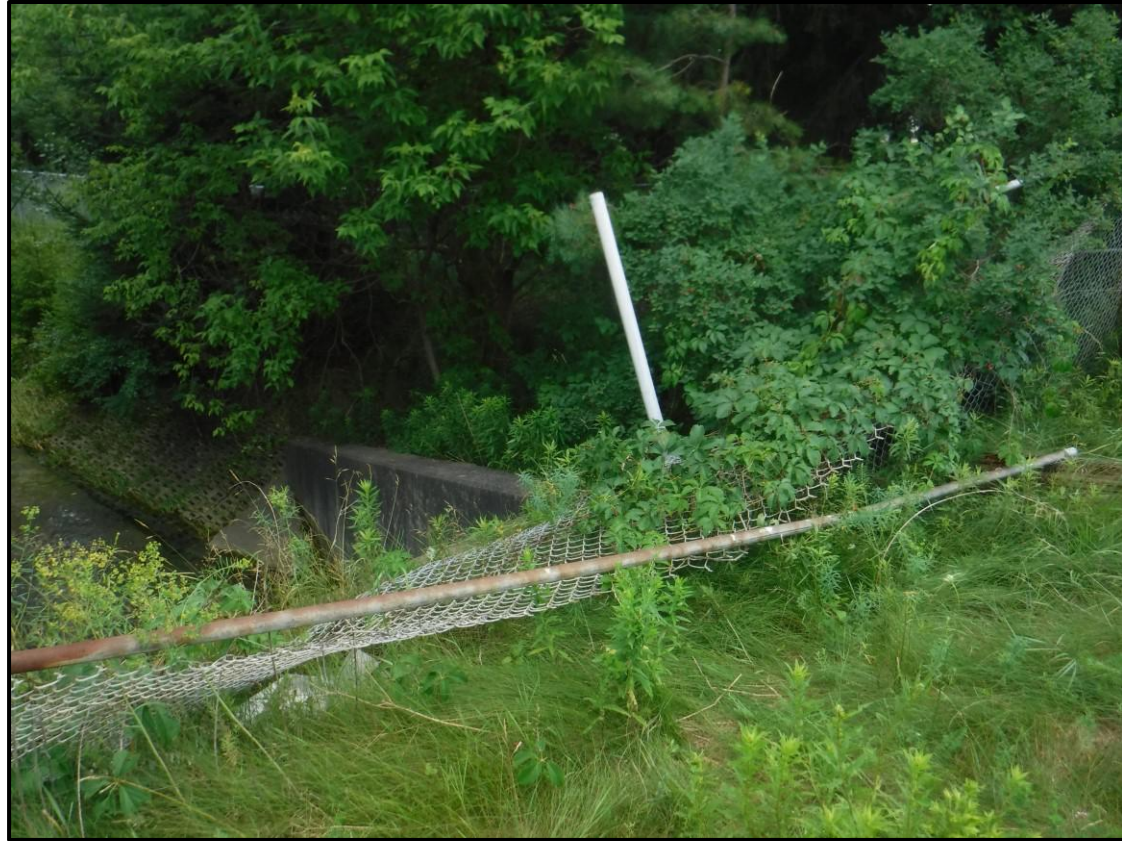
**Site ID: MI#16**

| No. | Watercourse | Reach | Description |
|---|---|---|--|
| MI#16 | Tributary of Speed River | SR-H1 | Fence around channel and outfall have fallen over and in poor condition |

**Issue:**

Fence around channel and  
outfall is not secure, channel  
can be easily accessed
